# Fairchild Pond Management Plan

Village Board Approval – August 18, 2022

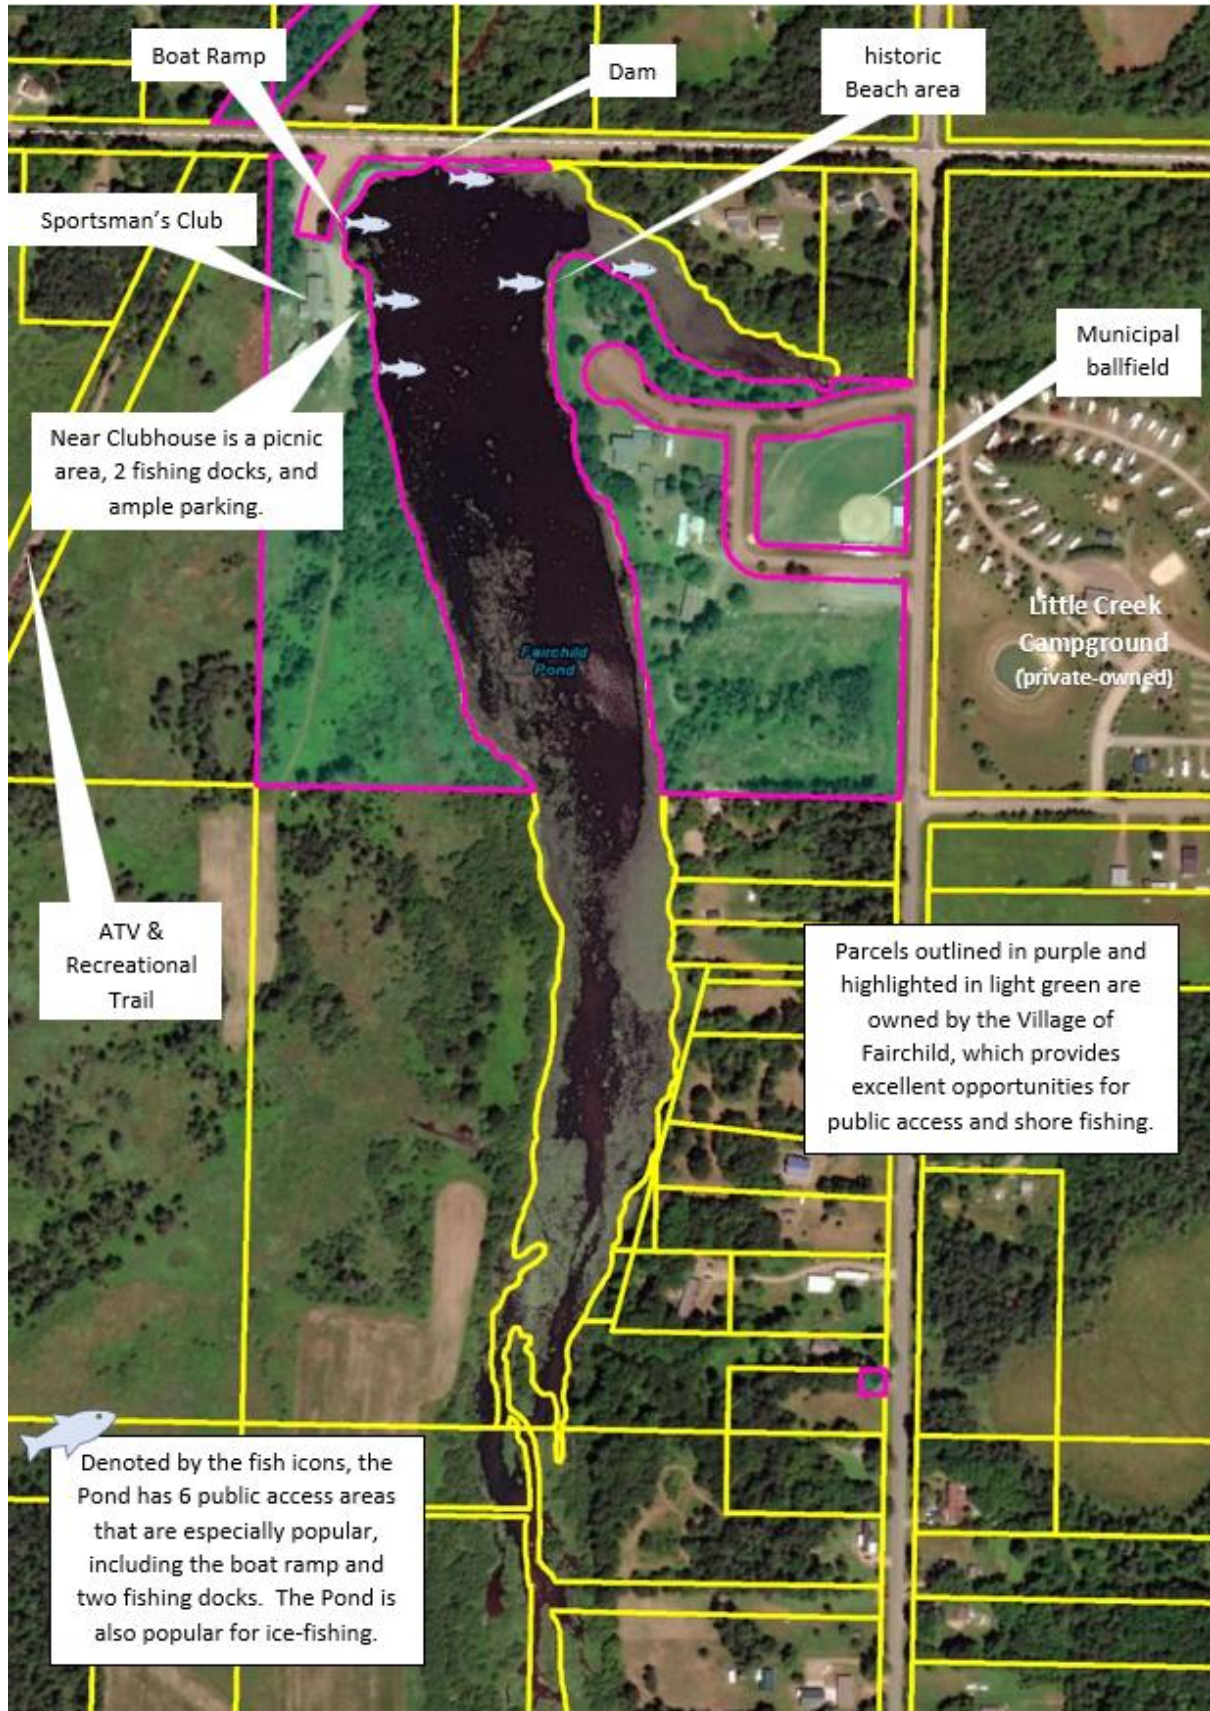
Figure 3. Fairchild Pond Area

The Village's land outlined in purple is tax-exempt and includes:

- The clubhouse of the Sportsmen's Club and related amenities are located on the northwest side of the Pond, including archery range, picnic area, fishing docks, parking area, and a small boat ramp. Amish will typically park their horses and buggies just north of the clubhouse along the tree line where a metal hitching post has been installed. The Club's shooting range is located just across Pond Road to the north.
- The dam is located on Village property on the north side of the Pond. A dry hydrant for fire protection is located just east of the dam.
- There are four private homes on the Village's land on the east side of the Pond.
- The municipal ballfield is also located on the Village property east of the Pond, while the remaining Village property is open space.
- The map shows the location of the former beach area that has silted in and is now used for shore fishing.

Fairchild Pond is an important social and economic asset to the community and larger area and is the community's central gathering place for outdoor recreation. As shown previously in Figure 3, the Pond is easily accessible by the public, with adjacent public roads and Village-owned land surrounding most of the north-half of the Pond.

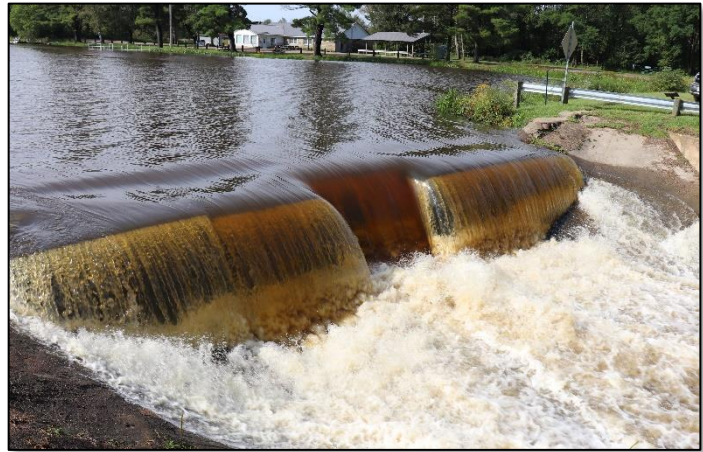
The Pond is brown with suspended sediment the day following heavy rains in August 2021, though floating vegetation is also washed downstream.

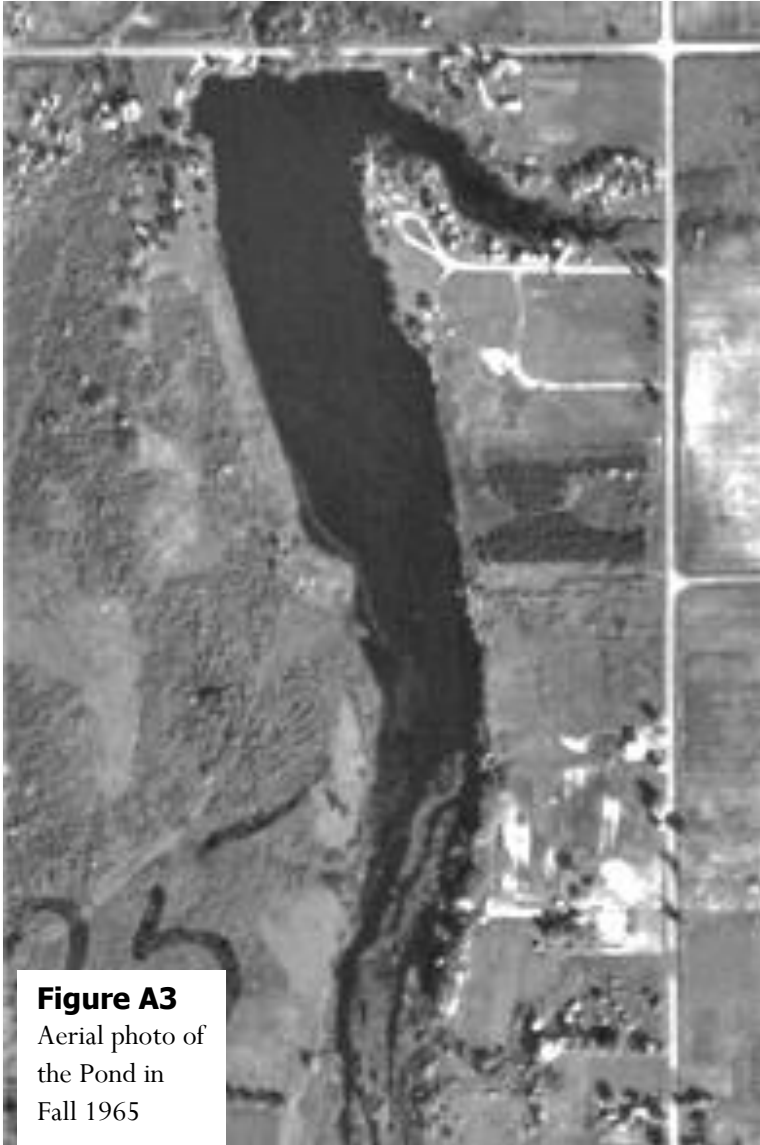
**Figure A3**  
Aerial photo of  
the Pond in  
Fall 1965

A 1951 aerial photo shows only two homes near the Pond, but by 1965, shown in **Figure A3**, a beach with dock would be created along the eastern shoreline, along with a changing house, pavilion, and outhouse; these buildings no longer exist; and sediment and grasses have since reclaimed the beach. In his Fairchild book, Gene Miller reminisces about skating, swimming, fishing, and duck hunting at the Pond; the trees overhanging the bank to the east of the dam were used as diving platforms.

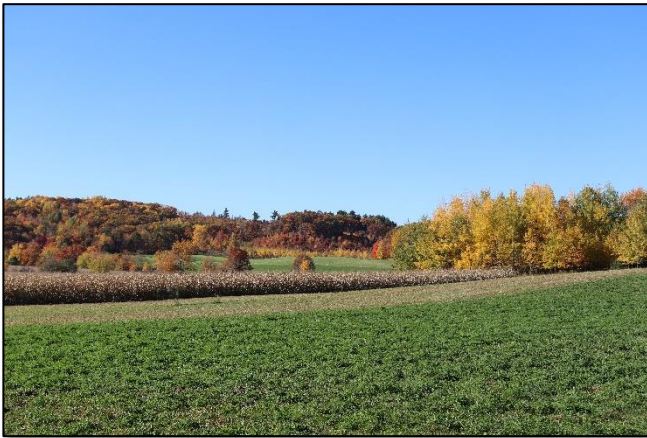
The drainage basin (or sub-watershed) that drains into Fairchild Pond is approximately 7,184 acres or 11.23 square miles. As shown by **Figure B1** on the following page, the majority of the basin lies within the Town of Cleveland in northern Jackson County. Perhaps surprising to some, most of the Village of Fairchild does not naturally drain to Fairchild Pond; instead, much of the Village drains to the northwest to McGaver Creek.

The sub-watershed is in a physical geography and ecologic transition zone. The headwaters of most streams feeding Fairchild Pond to the south and west lie within the hills of the Western Uplands or Driftless Area; this more rugged, hilly region avoided being covered by recent glaciers and extends along much of the western edge of the State. This is why forest dominates much of the southern and southwestern parts of the basin. As one moves northeast across the basin, the Western Uplands slope towards the Central Plains, which is generally flatter with sandier soils and sizable areas of wetlands.

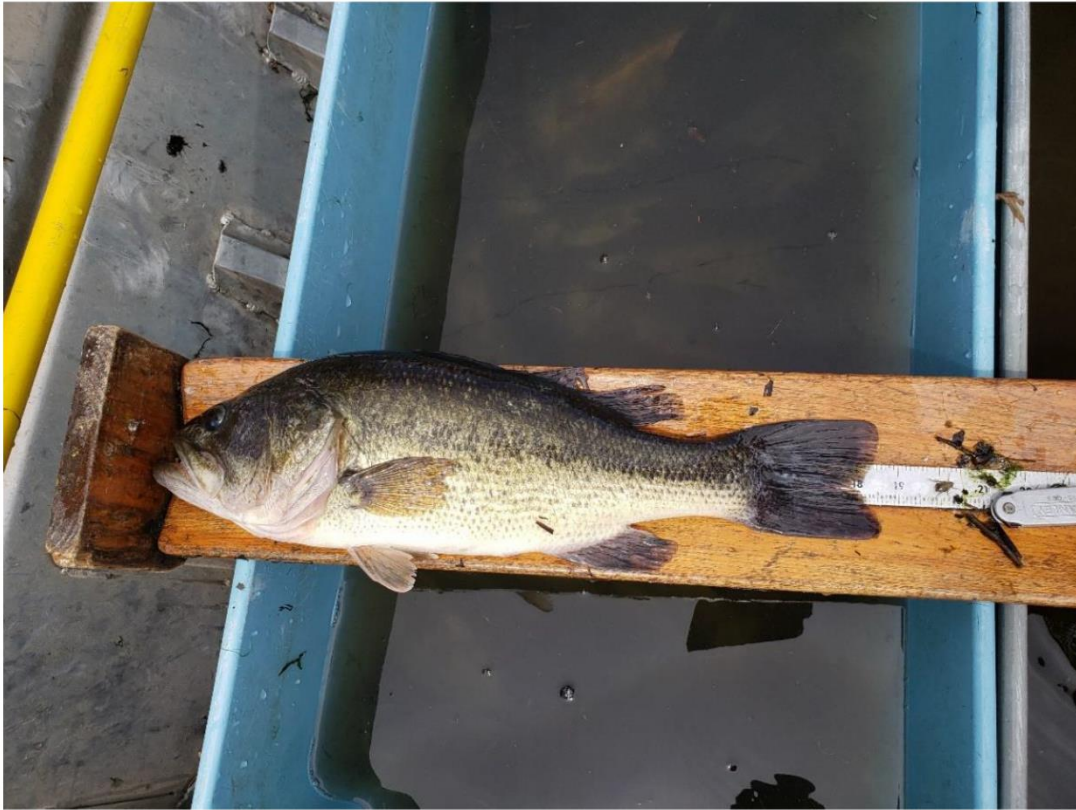
**Largemouth Bass:** 39 largemouth bass were captured. The average size was 11.9 inches (range 3.5"-18.2").

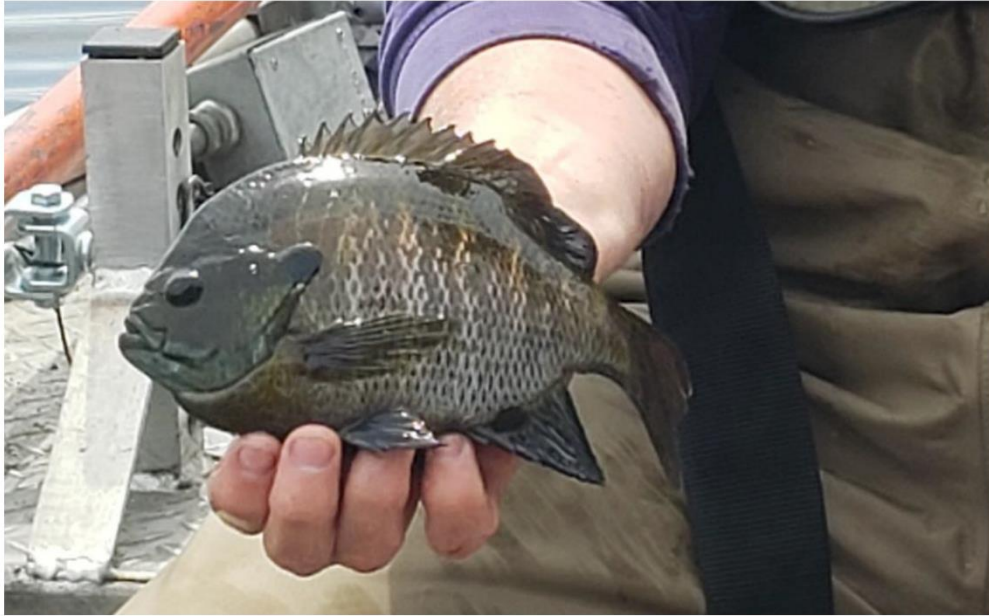
**Bluegill:** 77 bluegill were capture. The average size was 6.2 inches (range: 3"-8.6").

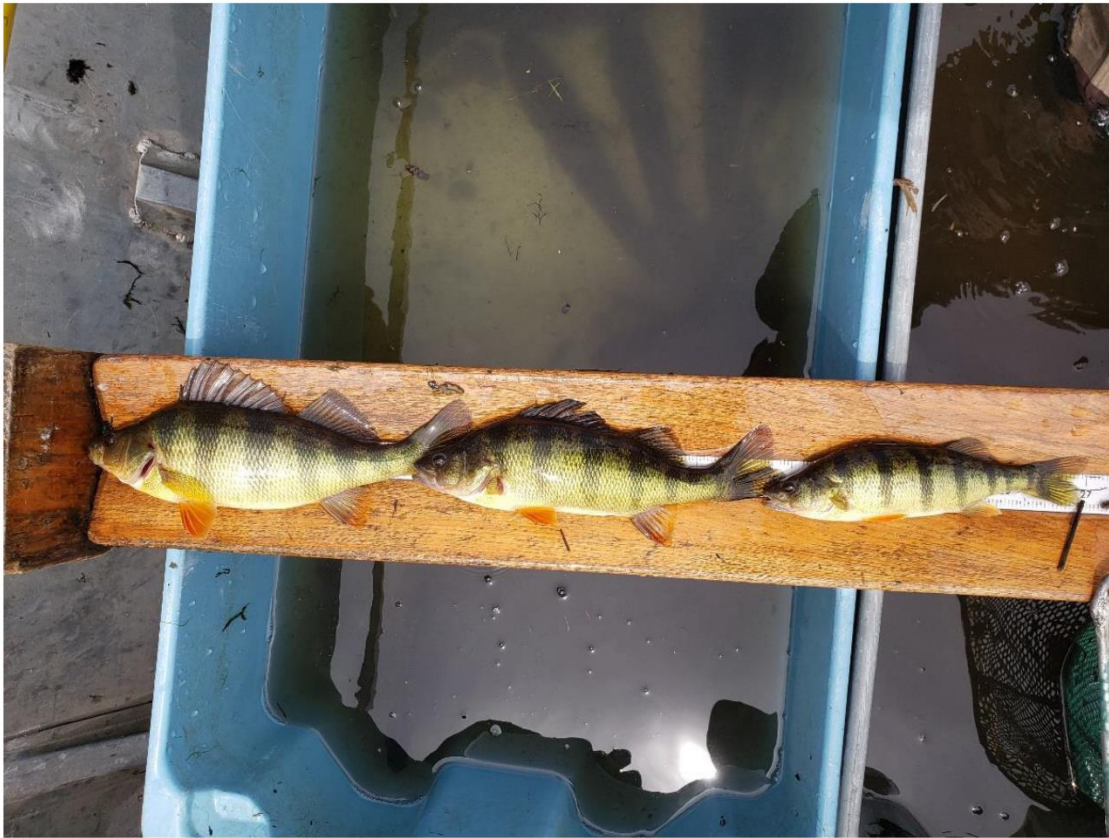
**Yellow Perch:** 10 yellow perch were captured. The average size was 7.6" (range: 4.1"-14.1").
