RICE LAKE BARRON COUNTY

2022 MANAGEMENT SUMMARY REPORT WBIC: 2103900

Prepared by: Dave Blumer, Lake Educator

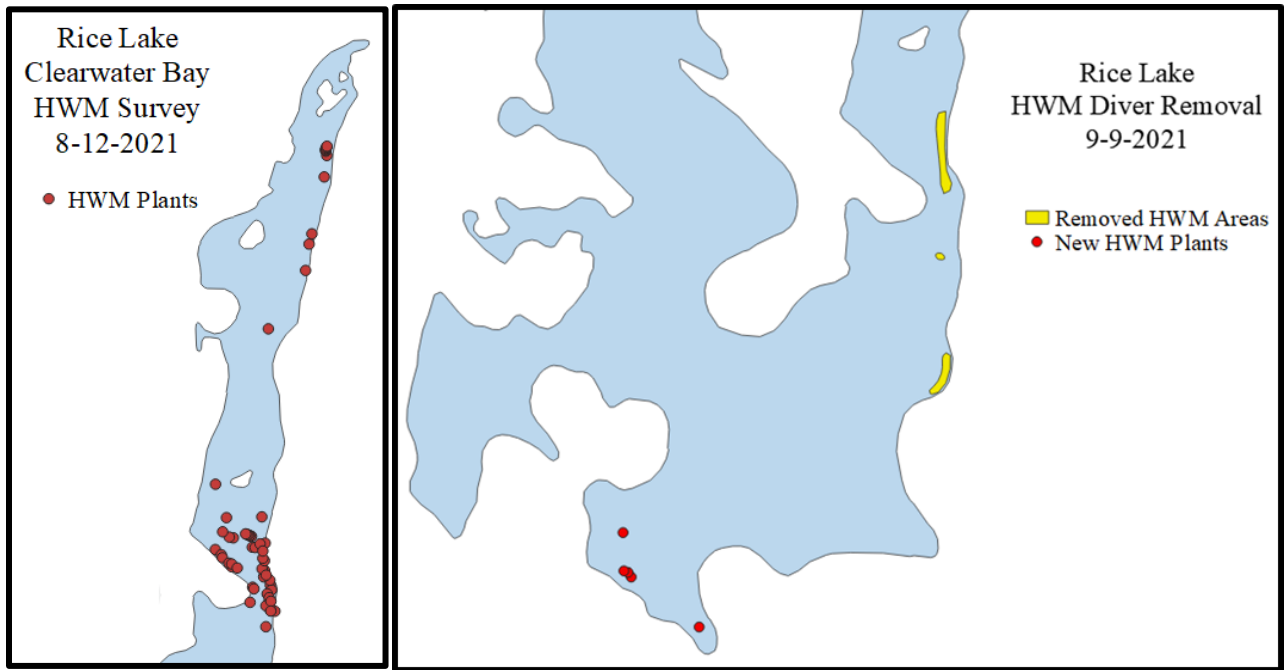
Figure 1: 8-12-2021 LEAPS HWM survey (left), and 9-9-21 Lutra Biological survey (right)

Based on EWM surveys completed by LEAPS and the RLPRD in the late summer and fall of 2021 (Figures 1&2), a chemical treatment plan was put together for 2022. The treatment plan included seven beds of EWM totaling 5.81

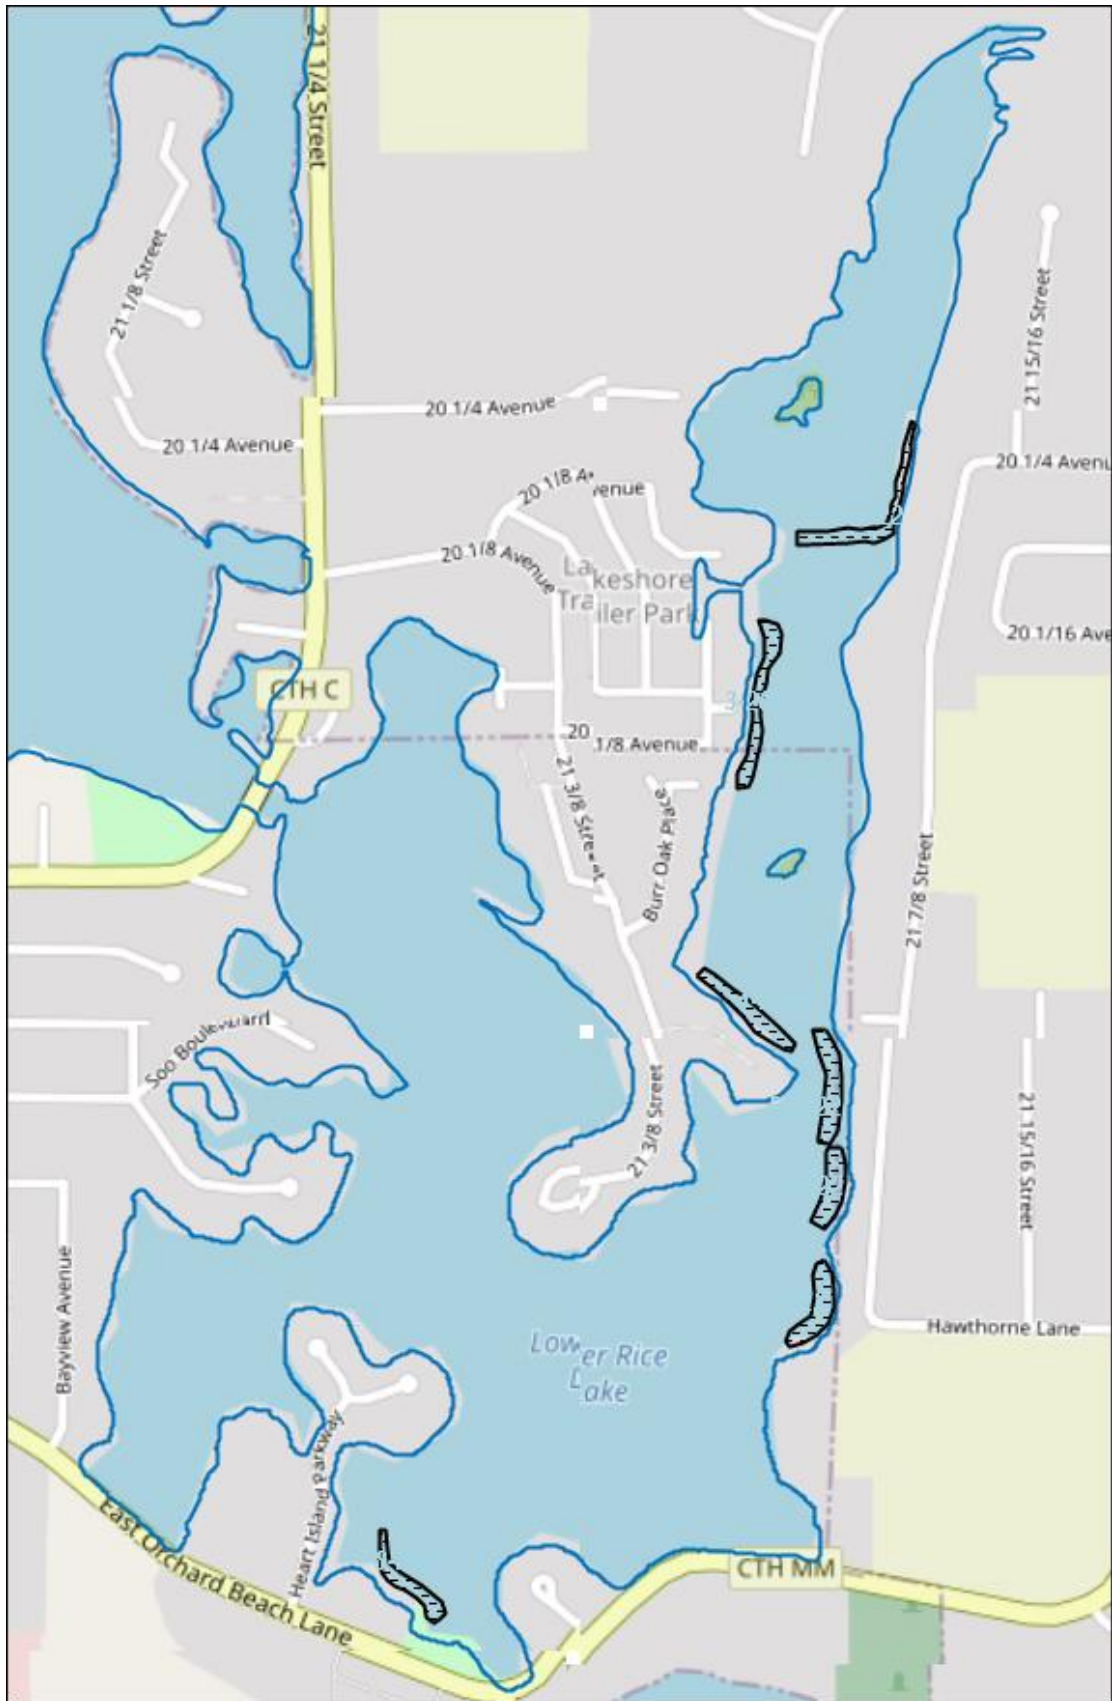
Figure 3: 2022 Preliminary HWM chemical treatment areas (7 beds = 5.81 acres)

acres (Figure 3). A WDNR chemical application permit was applied for on April 14, 2022 for both the HWM treatment and the CLP treatment (see future section). It was approved by the WDNR on May 5, 2022.

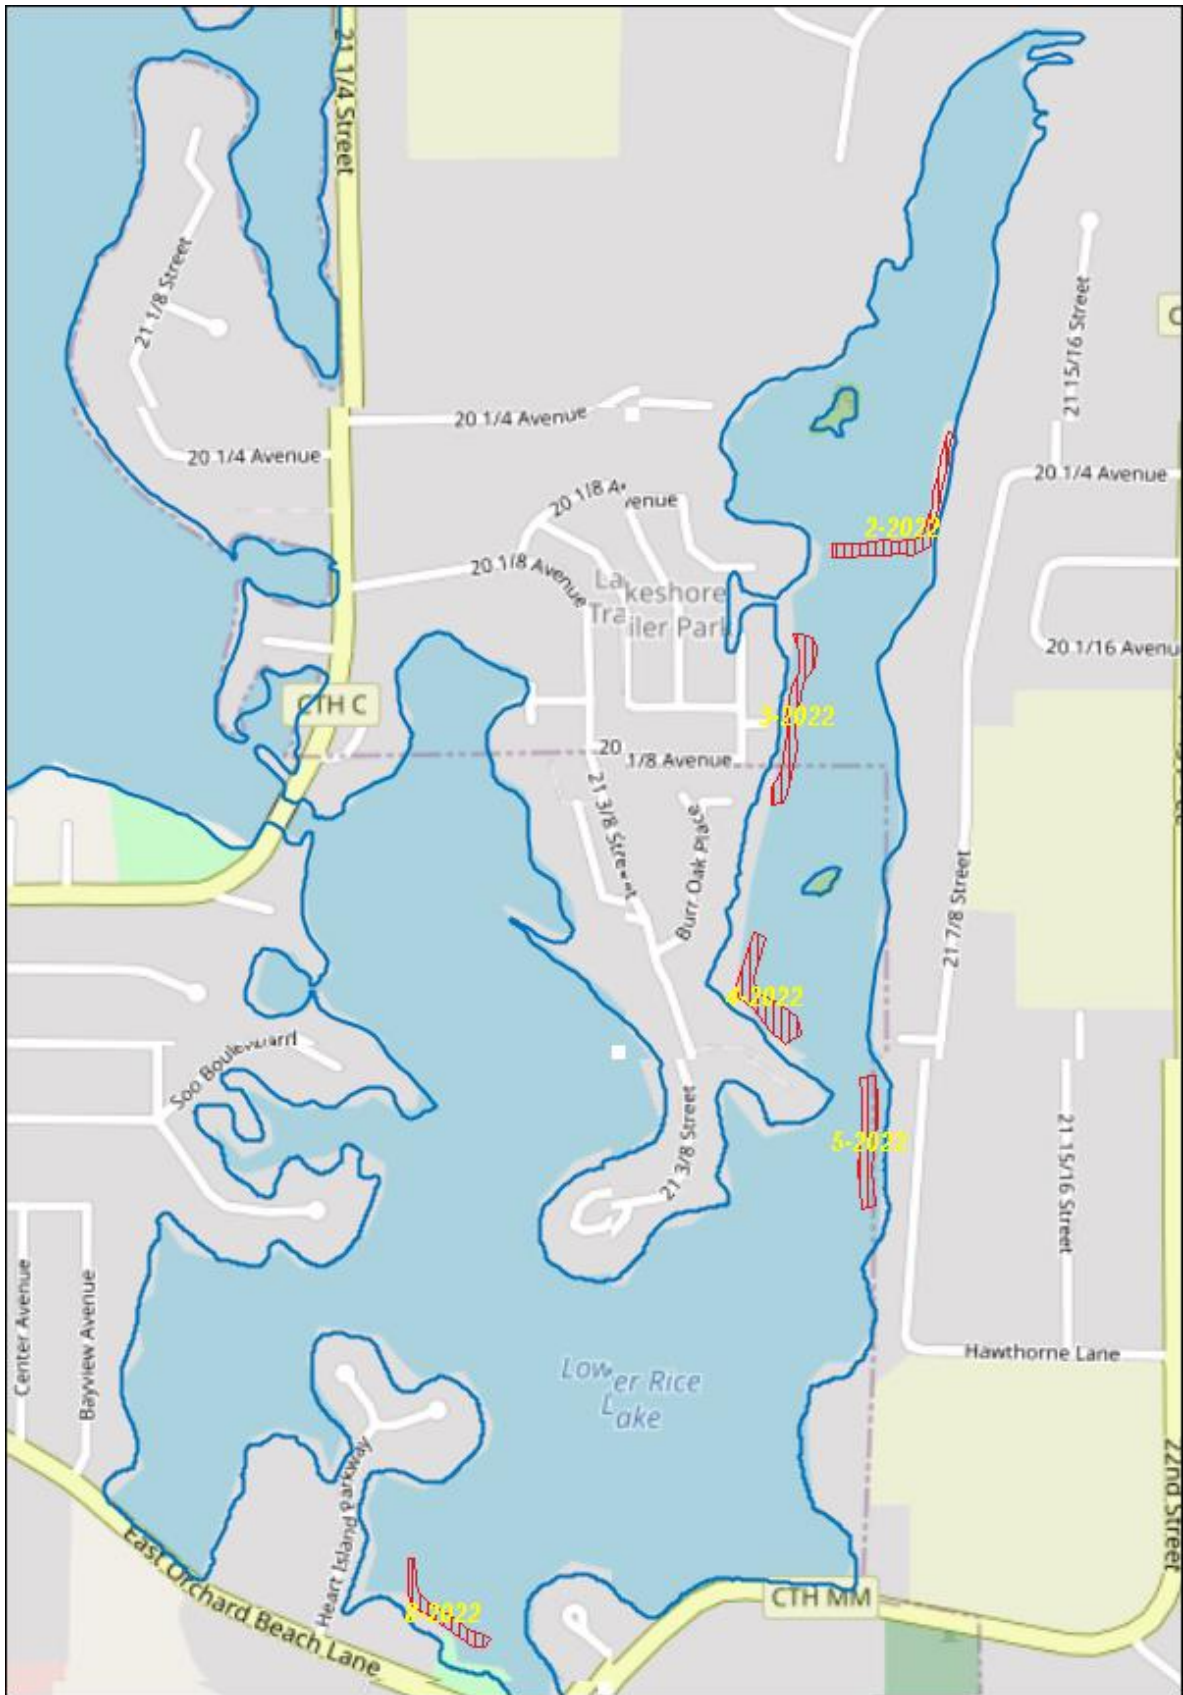
Figure 4: 2022 Final HWM chemical treatment proposal (5 beds = 4.45 acres)

After a pre-treatment readiness and point-intercept survey, the final chemical treatment proposal was reduced to only five beds totaling 4.45 acres (Figure 4). The herbicide to be used was ProcellaCOR at 3 to 4 pdus per acre-foot (Table 1). According to product documentation by SePRO, the company that manufactures and distributes ProcellaCOR, application rates are generally <0.01 part per million (ppm) or milligrams per liter (mg/L) instead of the 1-4ppm required for more commonly used 2,4D-based herbicides. At 4pdus/acre-foot, the expected concentration to be applied to the treated areas is around 0.008 ppm or 7.7 ppb.

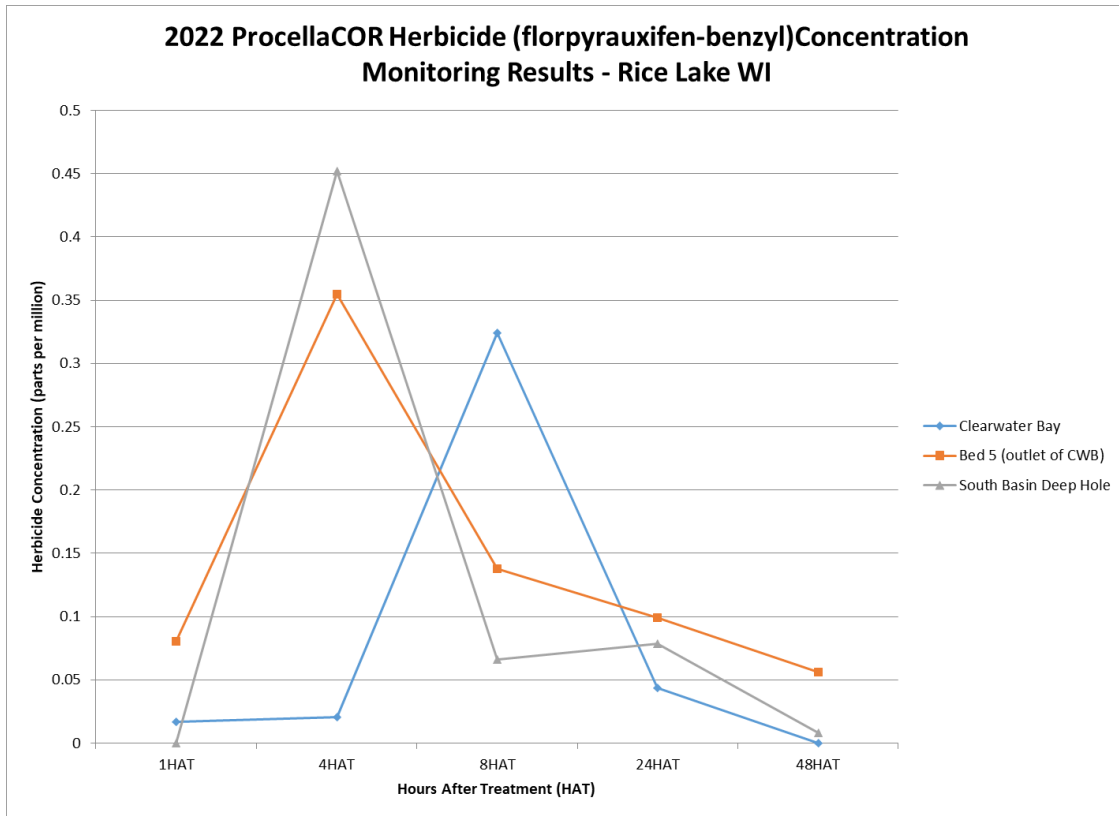
Figure 6: ProcellaCOR herbicide concentration sampling results

Figure 6 reflects what happened with the herbicide once it was applied. The Bed 5 site was the only sampling site directly within a treated area. In Bed 5, at 1 hour after treatment (HAT), the concentration of ProcellaCOR was measured at 0.0806 ppm or 80.6 ppb, far exceeding the applied rate. By 4 HAT, the concentration had increased to 355 ppb. At 8 HAT it was down a third to 138 ppb. At 24 HAT it was at 99.2 ppb, and at 48 HAT 55.8 ppb. The HWM in this bed should have been effectively killed by this treatment.

In Clearwater Bay, the sampling site was not in a directly treated area. Instead it was in the center of the bay. If the entire volume of the area of Clearwater Bay that was adjacent to actual treatment sites had been treated with the amount of ProcellaCOR used, the expected whole bay concentration would have been around 0.02 ppb. However, water samples collected at the Clearwater Bay site indicated ProcellaCOR concentrations from a low of “zero” ppb after 48 hours to as much as 324 ppb at 8 HAT. This level of herbicide should have been enough to kill nearly all of the HWM present in that area of Clearwater Bay at that time.

Even in the South Basin, the concentration of ProcellaCOR was measureable; however, it took until 4 HAT for it to be recorded. At that time, the concentration was measured at 452 ppb which seems very high. At all other measured times; the concentration was well below 100 ppb through the 48 hours that were measured.

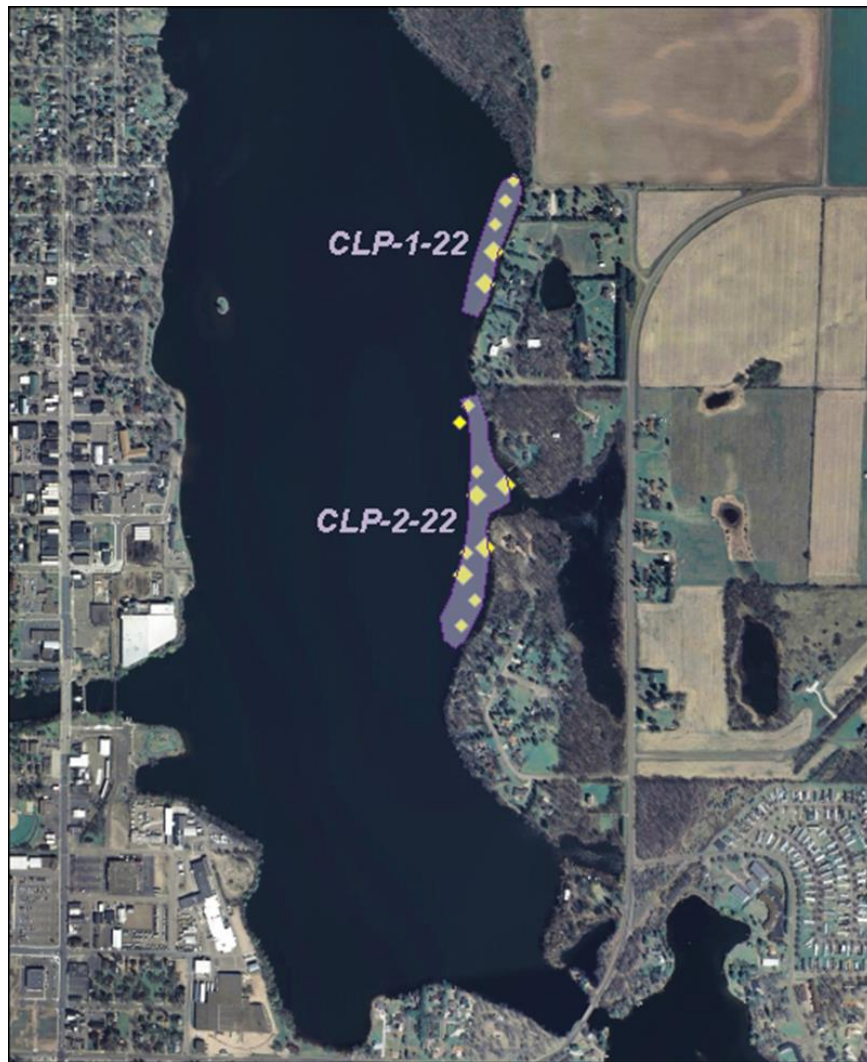
Figure 8: 2022 CLP chemical treatment proposal - map

The RLPRD completed CLP management in 2022. Based on 2021 mapping results and discussion with the operators of the RLPRD aquatic plant harvesters, it was decided to chemically treat an area of the lake along the east shore where dense growth CLP requires a lot of extra harvesting time. A 2022 spring treatment was proposed that covered two areas totaling 9.88 acres were planned (Table 3, Figure 8).

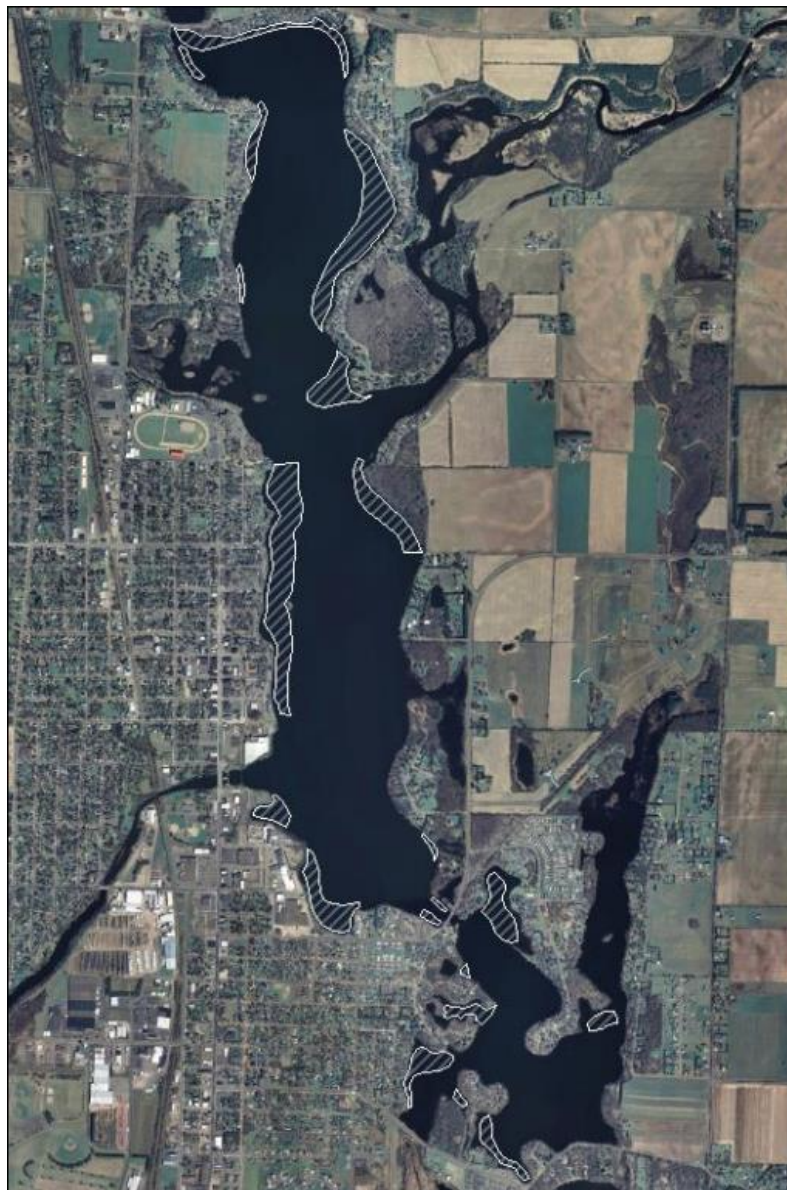
Figure 9: 2022 CLP harvesting map

In addition to the chemical treatment along the east shore of the lake, the RLPRD also completed mechanical harvesting of CLP in other areas of the lake. A mechanical harvesting permit was submitted to the WDNR on April 14, 2022 and was approved by the WDNR on May 6, 2022. Harvesting of CLP is generally done lake-wide wherever abundant CLP is located. The permit however included 20 areas totaling 112 acres (Table 4, Figure 9).

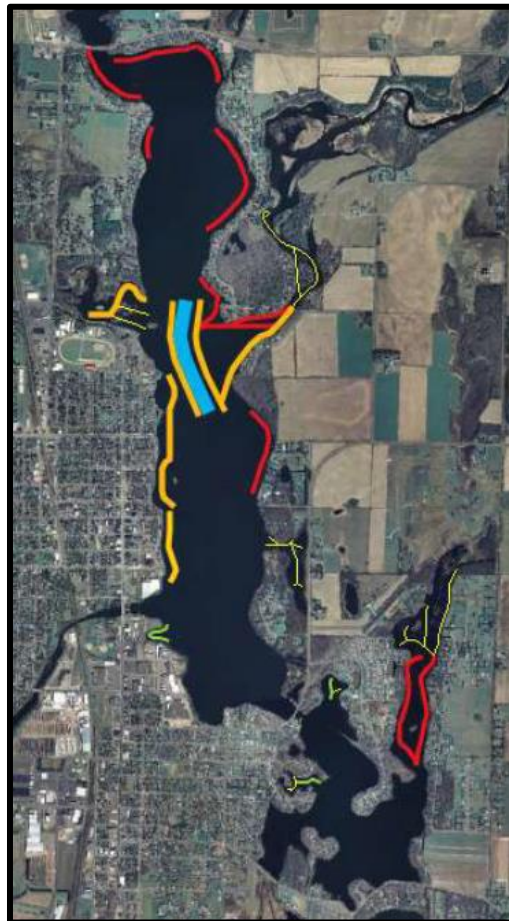
Figure 10: 2022 Rice Lake navigation lanes

In addition to harvesting CLP from the lake, and additional 66 acres of navigation lanes and channels are kept open through harvesting during the summer. The WDNR harvesting permit that was prepared for CLP harvesting also included the navigation lanes in Table 5 and Figure 10.

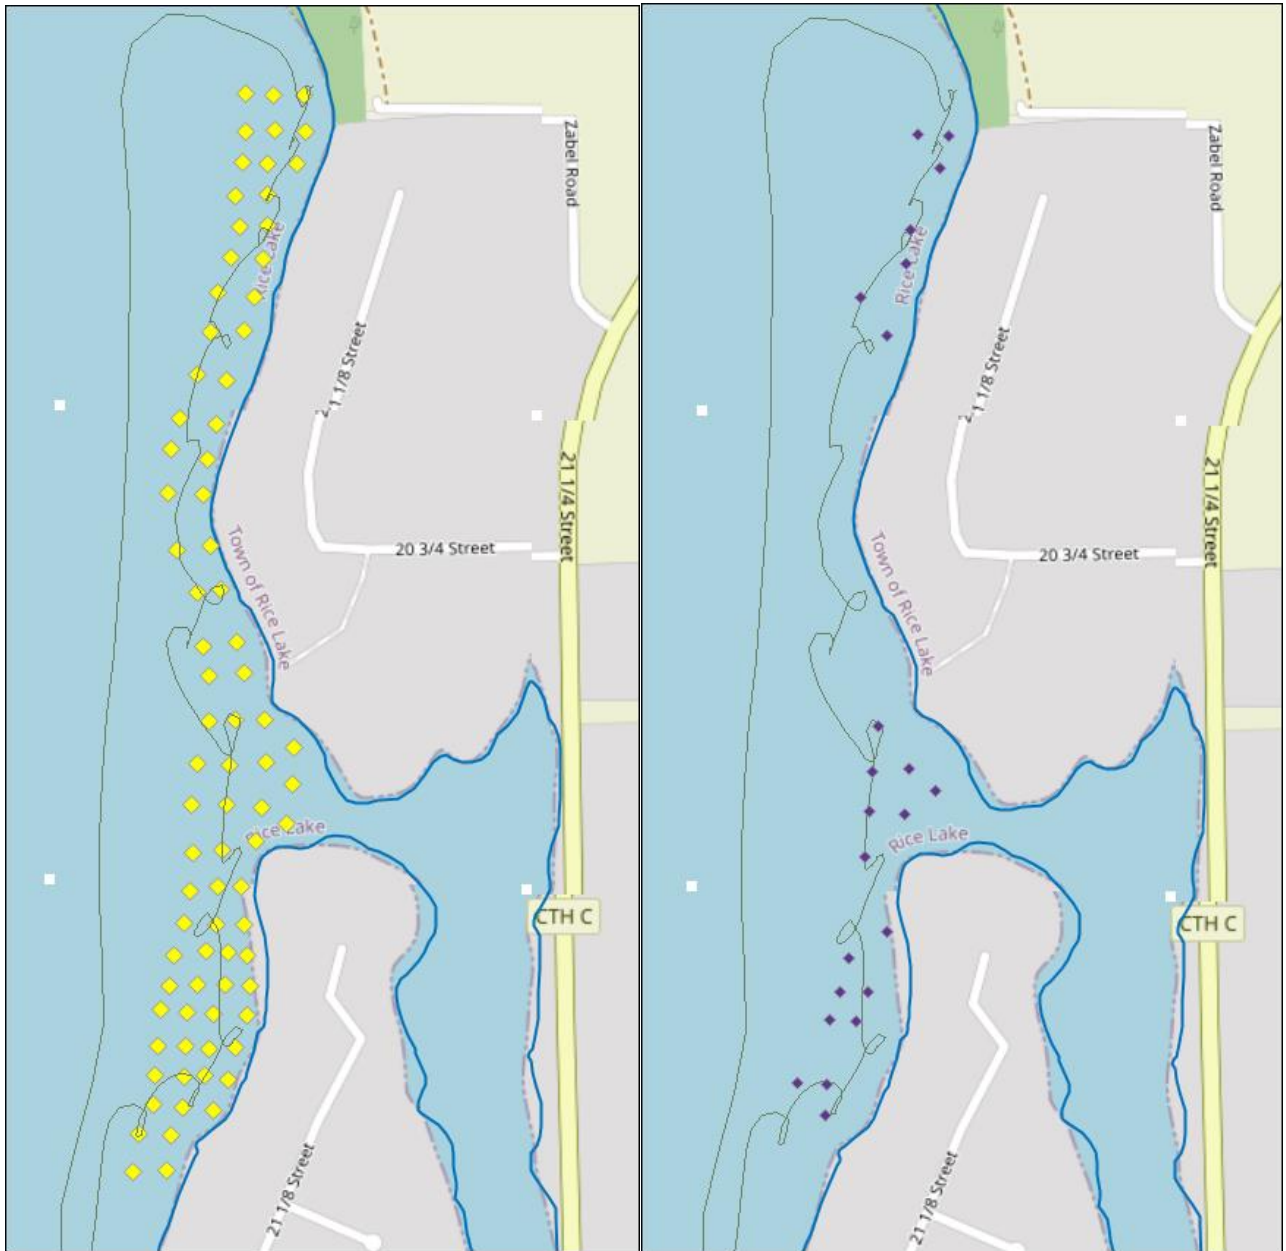
Figure 11: 2022 CLP pre-treatment PI survey points: original 100-pts (left); points with CLP on May 17, 2022 (right)

The first was a CLP treatment readiness survey on May 13, 2022 in support of the proposed chemical treatment of CLP along the east shore of the lake. That survey showed that CLP was detectable, leading to a 100-pt PI survey within the proposed treatment areas completed on May 17, 2022. During the 100-pt PI survey, 23 of the 100 points had CLP on the rake averaging at least a 2 (moderate infestation) for rakehead density (Figure 11). Based on these results, the proposed chemical treatment of CLP on the east shore of the lake was completed.

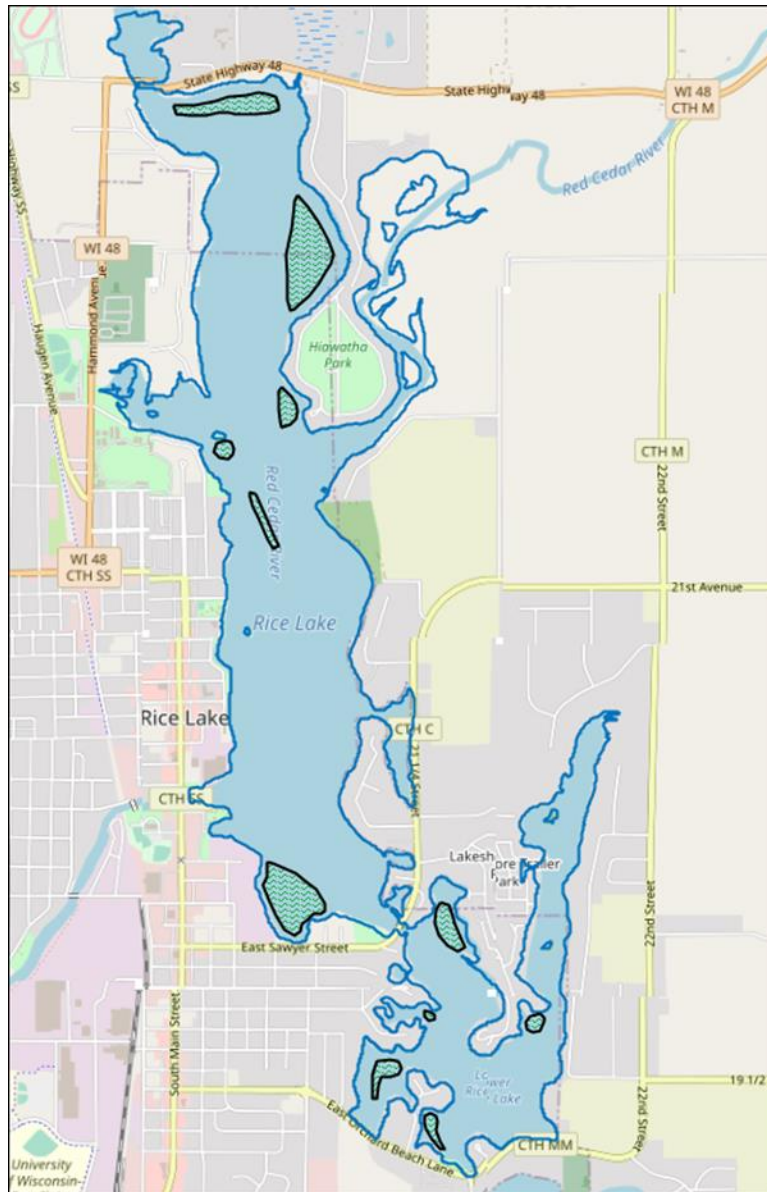
Figure 12: June 2022 CLP bed mapping on Rice Lake

For the first time, CLP bed mapping on Rice Lake was completed by RLPRD volunteers and employees. In mid-June, 2022 CLP was mapped in the entire lake. Surveyors mapped 11 areas totaling 61.6 acres of CLP (Figure 12). The total acreage of CLP in 2022 was <50% of what was mapped in 2021 (134.5 acres) reflective of the changes in growing conditions that can affect the amount of CLP growth in any given year. Interestingly, there is no CLP along Lakeshore Dr. on the west shore, or along the east shore. Both of these areas typically have a lot of CLP. Lakeshore Dr. was chemically treated in 2021. The east shore was chemically treated in 2022. The mapped CLP information will be used to inform CLP management in 2023.

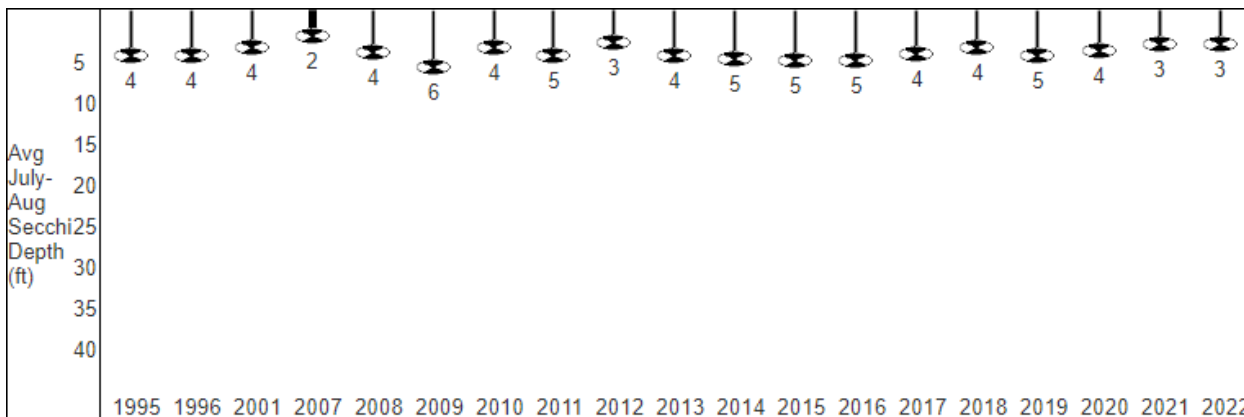
Figure 14: Historic Secchi disk readings of water clarity at the Central Basin in Rice Lake

The average summer (July-Aug) Secchi disk reading for the Central Basin was 3.25 feet. This value is a little lower than historic readings for the Central Basin, but consistent with values from 2021 (Figure 14). Typically the summer water was reported as clear and green. This suggests that the Secchi depth may be mostly impacted by algae. Algal blooms are generally considered to decrease the aesthetic appeal of a lake because people prefer clearer water to swim in and look at. Algae are always present in a balanced lake ecosystem. They are the photosynthetic basis of the food web. Algae are eaten by zooplankton, which are in turn eaten by fish.

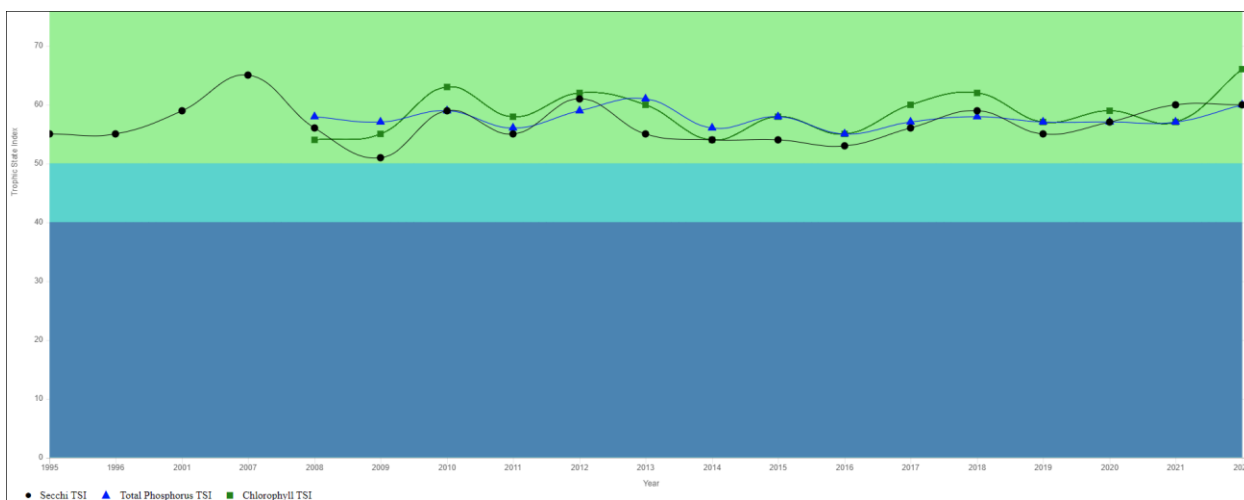
Figure 15: Historical TSI values for water clarity, total phosphorus, and chlorophyll-a at the Central Basin in Rice Lake

The overall Trophic State Index (based on chlorophyll) for Rice Lake at the Central Basin was 66 (Figure . This TSI suggests that water quality in the Central Basin was eutrophic, or nutrient rich. This TSI usually suggests blue-green algae become dominant and algal scums are possible, extensive plant overgrowth problems possible. These conditions accurately describe the Central Basin of Rice Lake in 2022.

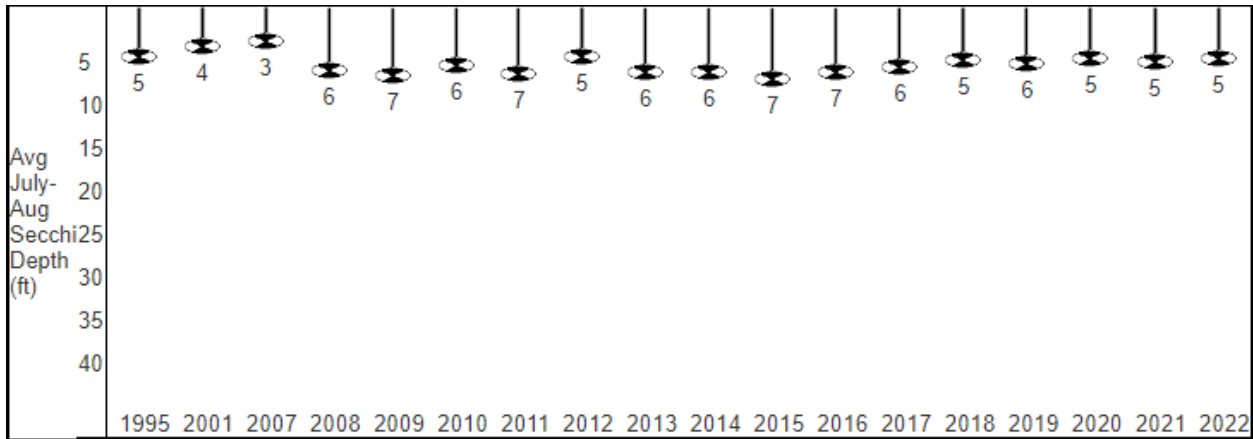
Figure 16: Historic Secchi disk readings of water clarity at the South Basin in Rice Lake

The average summer (July-Aug) Secchi disk reading for the South Basin was 5.06 feet. This is consistent with historic water clarity in the South Basin of Rice Lake (Figure 16). Typically the summer water was reported as clear and green.

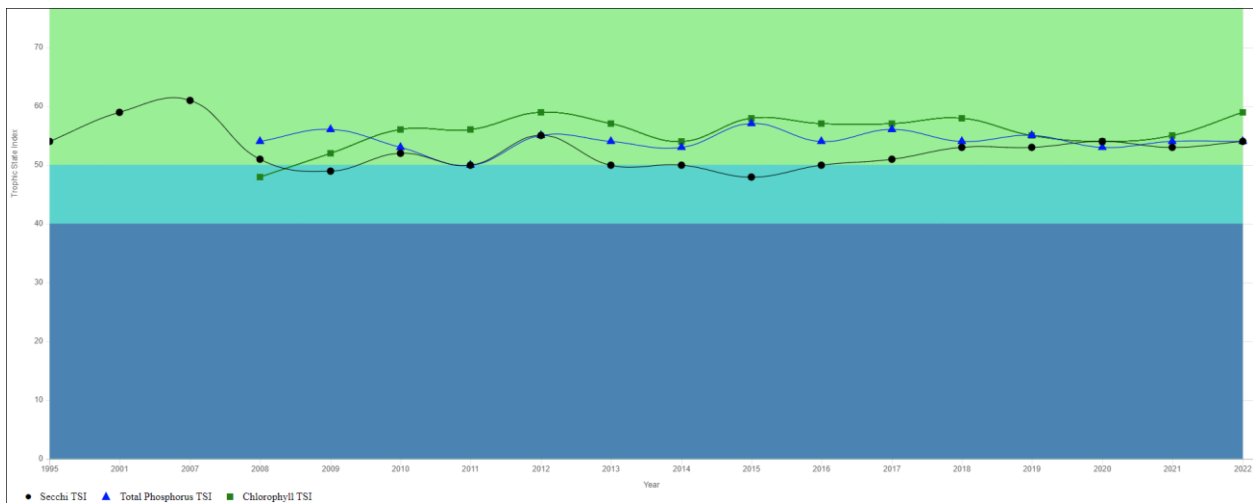
Figure 17: Historical TSI values for water clarity, total phosphorus, and chlorophyll-a at the South Basin in Rice Lake

The overall Trophic State Index (based on chlorophyll) for the South Basin was 59 (Figure 17). Like the TSI for the Central Basin, this value was higher than it was in 2021. The TSI suggests that the South Basin of Rice Lake was eutrophic. This TSI usually suggests decreased clarity, fewer algal species, oxygen-depleted bottom waters during the summer, plant overgrowth evident, warm-water fisheries (pike, perch, bass, etc.) only.

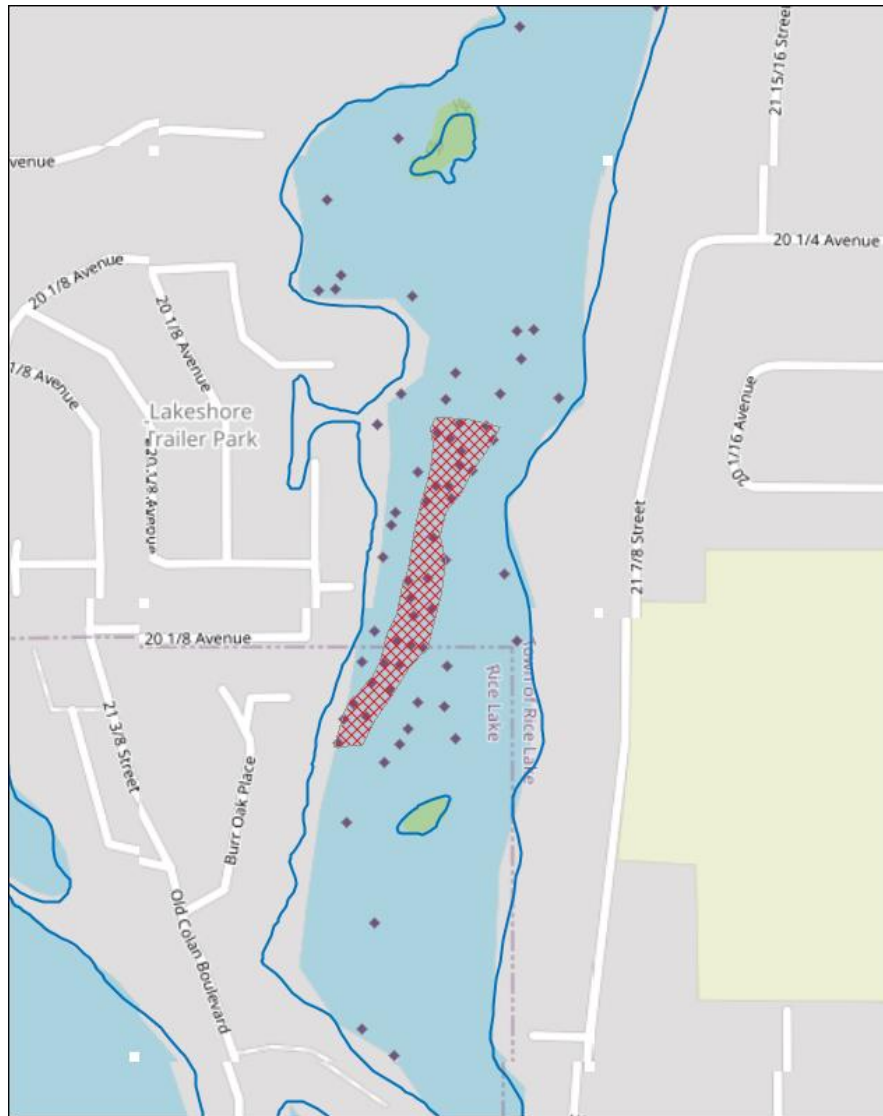
Figure 19: 2023 potential HWM chemical treatment area in Clearwater Bay

Preliminary HWM management planning for 2023 includes more physical and diver removal of individual plants in both Clearwater Bay and the South Basin. A small chemical treatment of one area of Clearwater Bay totaling 2.8 acres has been proposed (Figure 19). If the treatment is permitted, ProcellaCOR at a little higher application rate will be the recommended herbicide. An alternative treatment would include a larger area and use a liquid 2,4D-based herbicide.
