RICE LAKE BARRON COUNTY

2023 MANAGEMENT SUMMARY REPORT WBIC: 2103900

Prepared by: Dave Blumer, Lake Educator

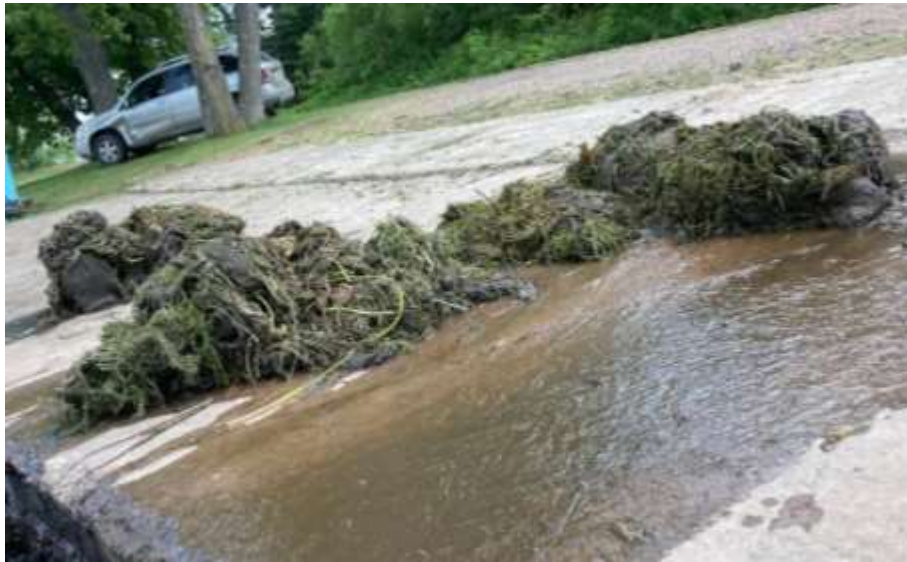
Figure 2: HWM removed on May 31 by free diving. Removed HWM was dumped at the aquatic plant harvesting dump site off Lakeshore Dr.

HWM was physically removed from the South Basin on three different dates in 2023 – May 31, June 8, and June 20. Between the three dates, 16.5 hours of removal time was logged and at least sixteen 18-gallon totes of HWM were removed (Figures 2&3). After the third free diving event, the dive team reported that any more removal was likely pointless because there was too much!

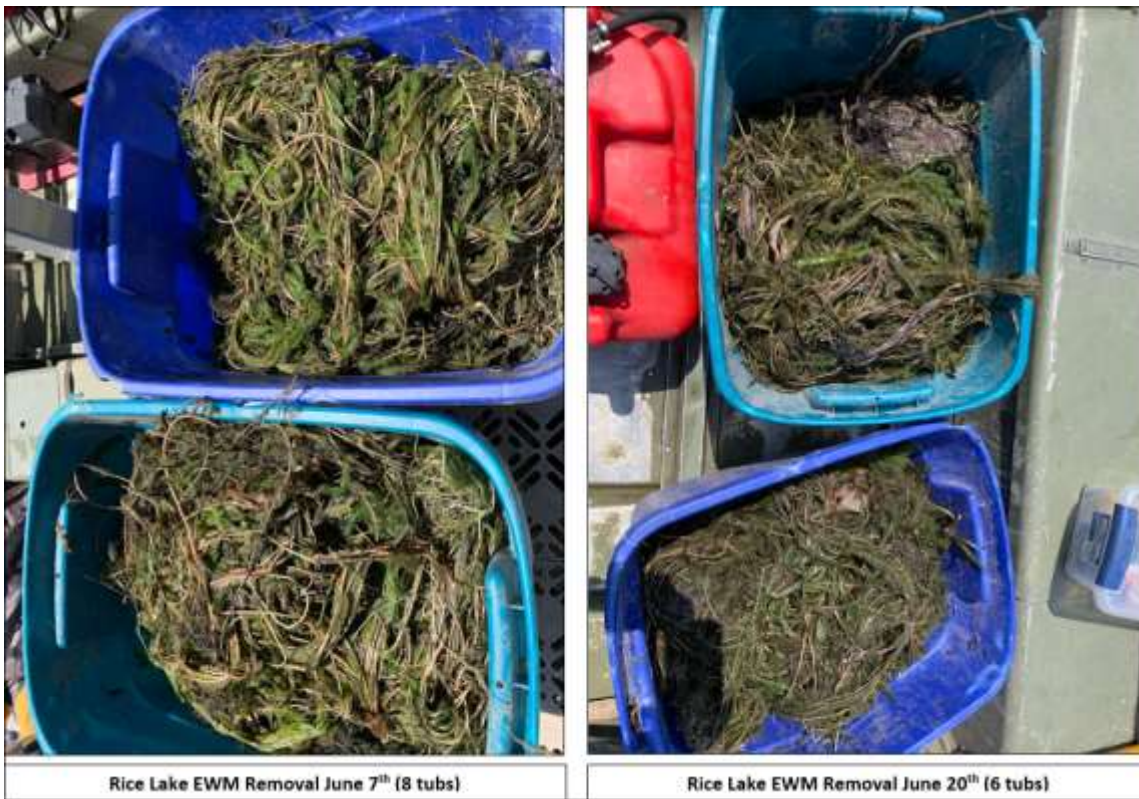
Rice Lake EWM Removal June 7th (8 tubs)

Rice Lake EWM Removal June 20th (6 tubs)

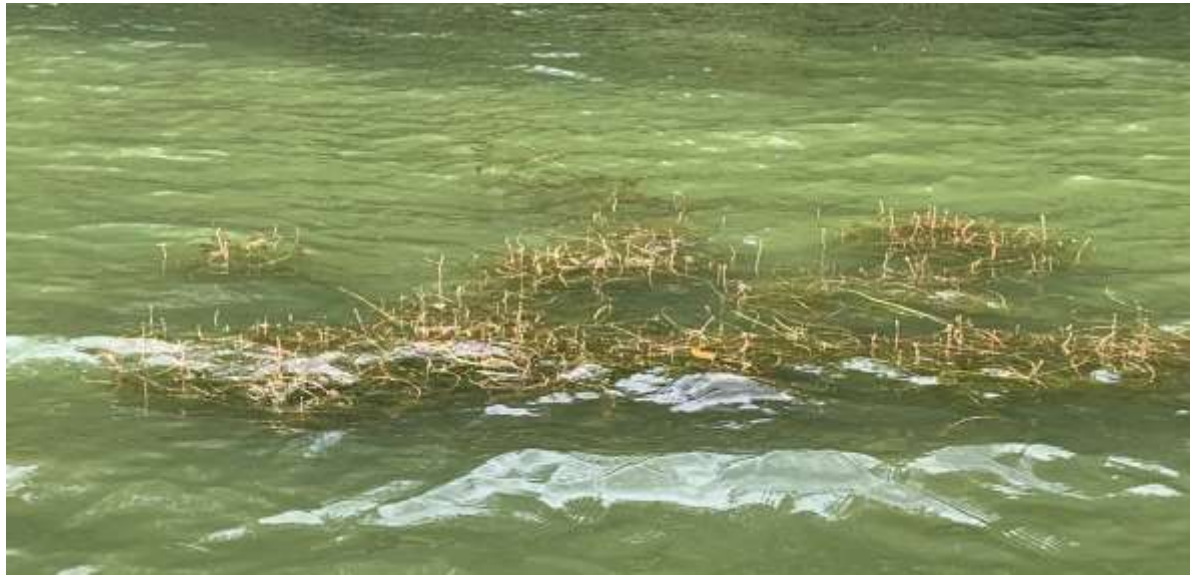
Figure 4: Hybrid watermilfoil bed with flowers in the South Basin on Sept. 10, 2023

A fall HWM survey completed on September 10, 2023, was timed perfectly for identifying HWM. It is usually very difficult to accurately document the location of HWM during the fall survey due to large amounts of native, Northern watermilfoil (NWM) that is present at the same time. However, during the Sept 10 survey, HWM was in its flowering stage with flower heads sticking out of the water several inches wherever HWM were found (Figure 4). Every HWM bed located had flowers, regardless of size. NWM does not produce flower heads, so it was clear that the beds were HWM.

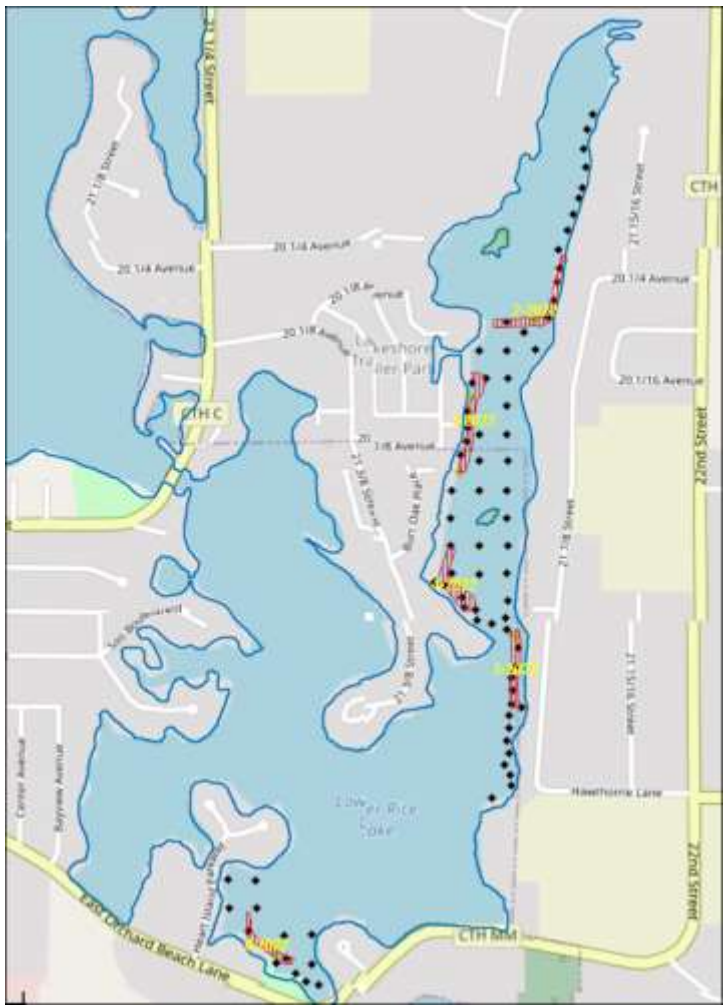
Figure 6: 2022 pre- and post-chemical treatment PI aquatic plant survey points (100 total)

In support of the chemical treatment of HWM in Clearwater Bay and the South Basin using ProcellaCOR, a pre- and post-treatment point-intercept survey grid was established. The grid included 100 points within proposed treatment areas and throughout Clearwater Bay and parts of the South Basin (Figure 6). On May 15, 2022, LEAPS completed a pre-treatment survey of these points. During that survey, 53 of the 100 points surveyed had aquatic vegetation present (Table 1). The average depth of aquatic plants was 5-ft with plants documented in as much as 9.5-ft of water. During the pre-treatment survey 12 species of aquatic plants were identified including HWM and CLP.

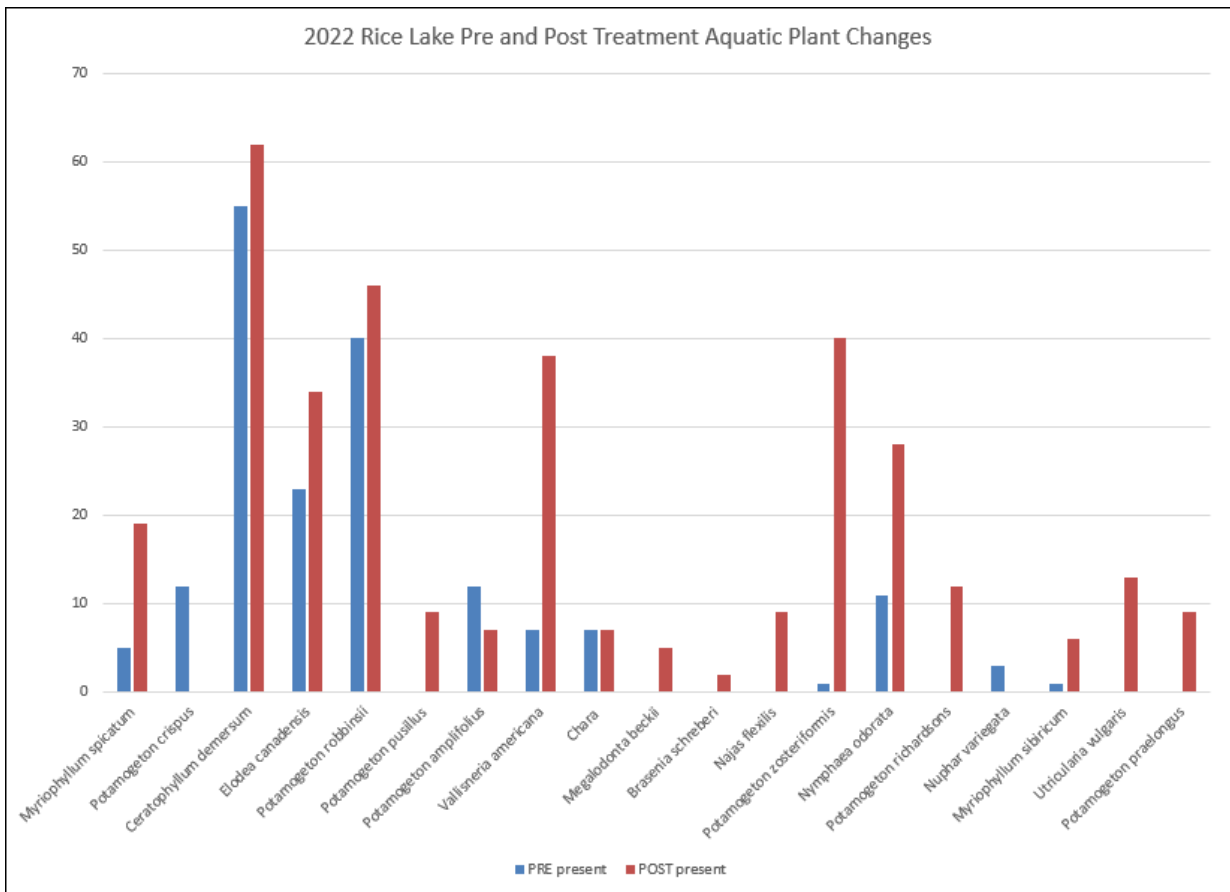
Figure 7: 2022 Pre- and post-treatment aquatic plant changes in Rice Lake, Barron County

The 100 points were again surveyed in early September 2022 by LEAPS. During the post-treatment survey, 17 different aquatic plant species including HWM but not CLP were found. Unfortunately, the amount of HWM increased significantly between the pre- and post-treatment survey. Fall 2022 HWM bed mapping suggested that the amount of HWM was down in the 2022 areas treated with ProcellaCOR, but up substantially in areas that were not chemically treated. Table 1 compares the statistics from the pre and post survey. Figure 7 shows the changes in aquatic plants between the two surveys. All the data from the post-treatment survey is higher than that from the pre-treatment survey, suggesting the treatment had little impact on either HWM or native aquatic plants. CLP is down between the two surveys, but this is likely due to it being too late in the season to find CLP.

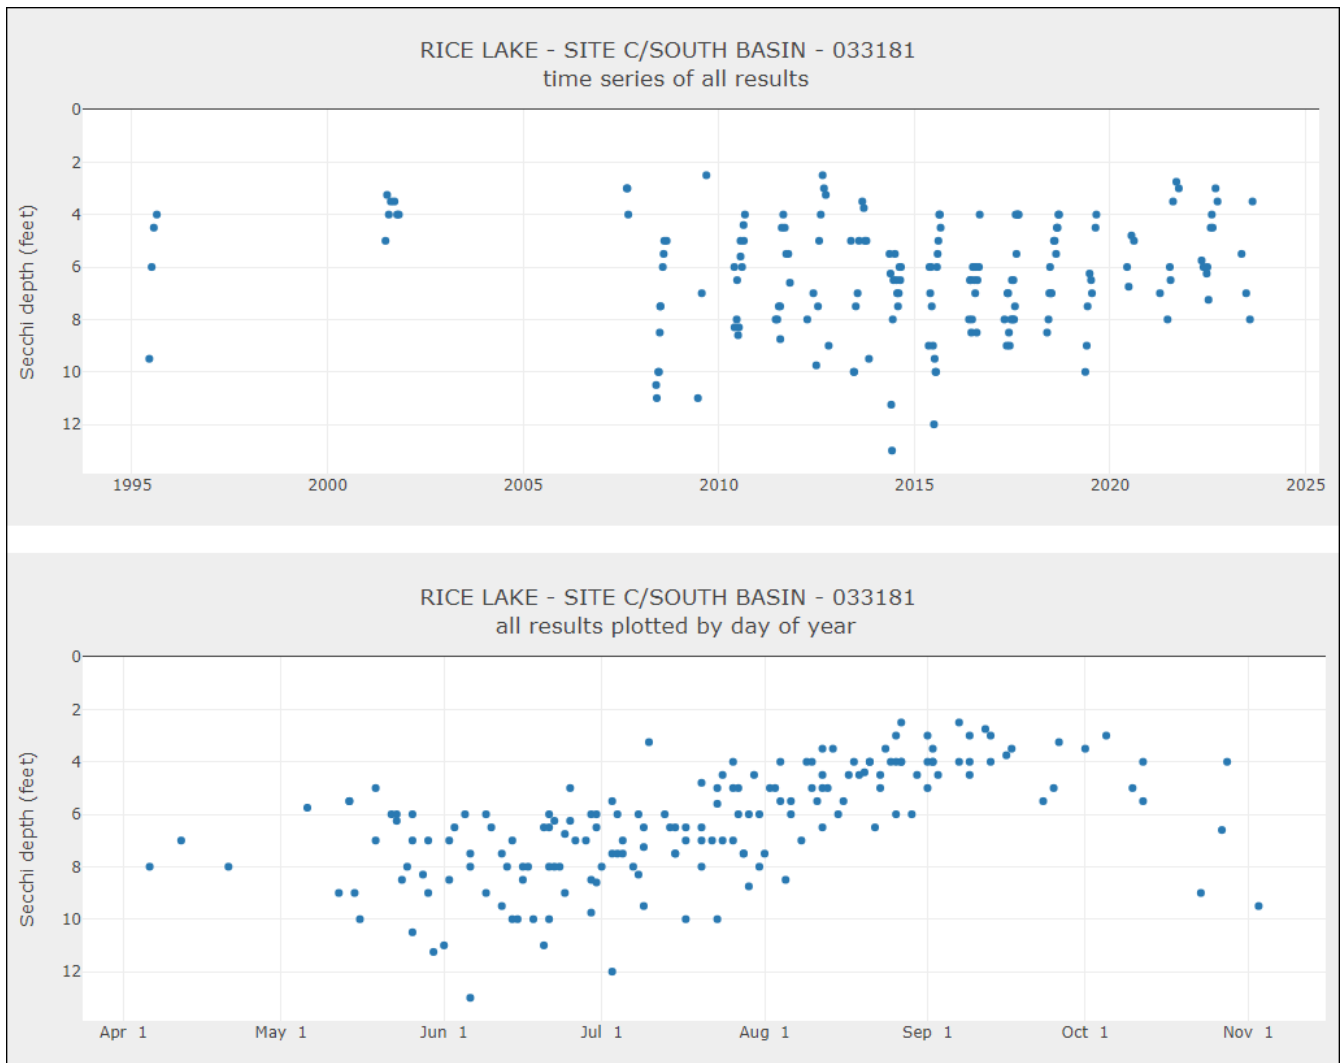
Figure 13: All Secchi disk readings of water clarity taken from the South Basin in Rice Lake (top); all Secchi disk readings through the open water season (bottom) (WEx, 2024).

Figure 13 reflects all the Secchi disk readings taken in the South Basin since readings began. Readings start out in the 6-10ft range through early summer, and then drop to 3-5ft in August and September. When looking at all the data, the only significant trend is that Secchi disk readings in the early summer spring (May - July) are trending to worse readings.

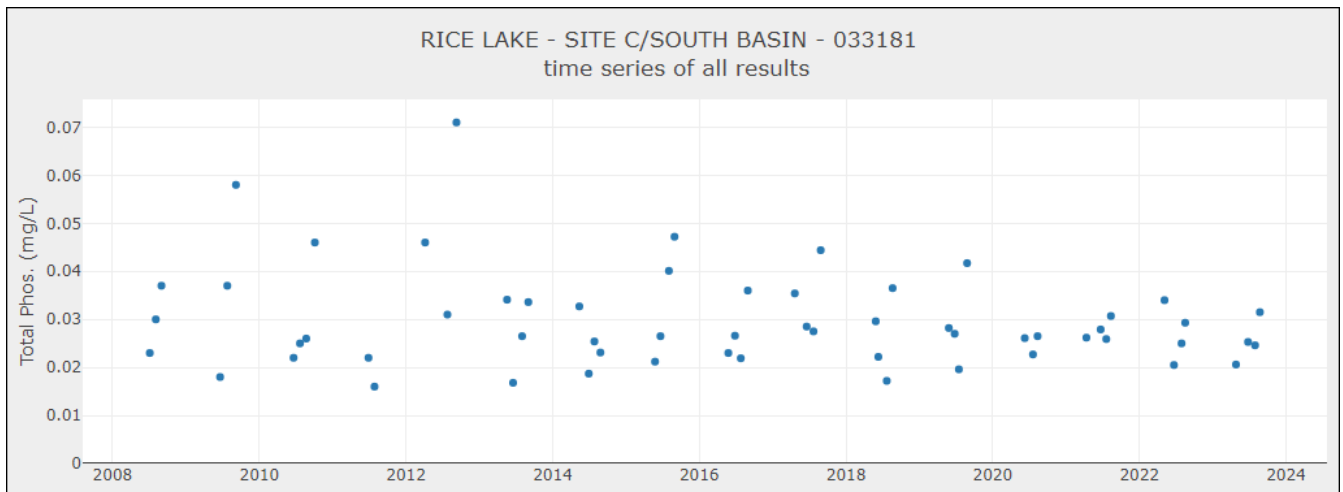
Figure 15: All TP data collected from the South Basin of Rice Lake (WEx, 2024)

Figure 15 shows all TP data collected from the South Basin since about 2008. Like with Secchi disk readings of water clarity, the only significant trend in TP is that the early summer concentrations are increasing (Figure 16). Increasing phosphorus is not ideal and can lead to worsening water quality.

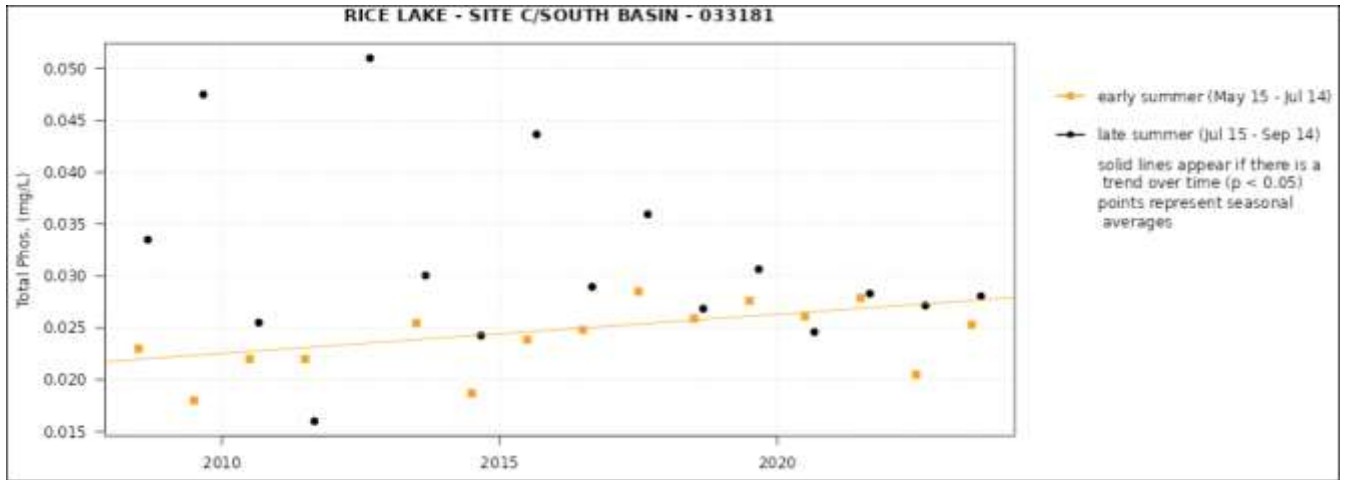
Figure 16: Significant trends in TP concentrations in the South Basin of Rice Lake (WEx, 2024)

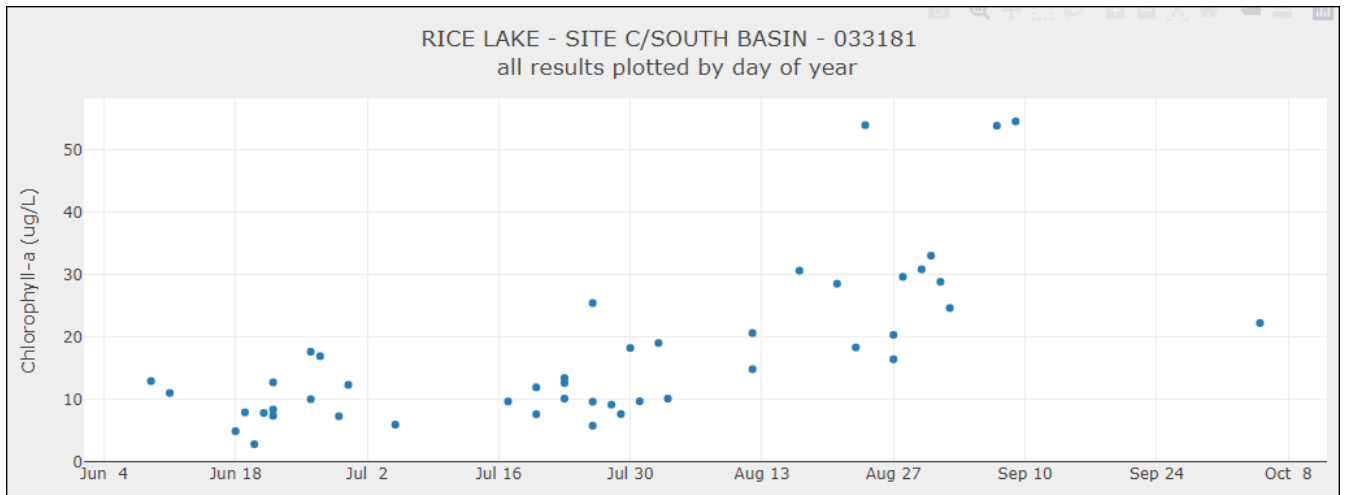
Figure 17: Seasonal Chla concentrations in the South Basin of Rice Lake (WEx, 2024)

Chla concentrations in the South Basin increase rapidly in late July (Figure 17), again primarily due to nutrient release from the bottom sediments of the lake. And like Secchi disk readings of water clarity and TP, the only significant trend is an increasing one in the early summer (Figure 18). Increasing levels of Chla indicate more algae in the lake to turn the water green.

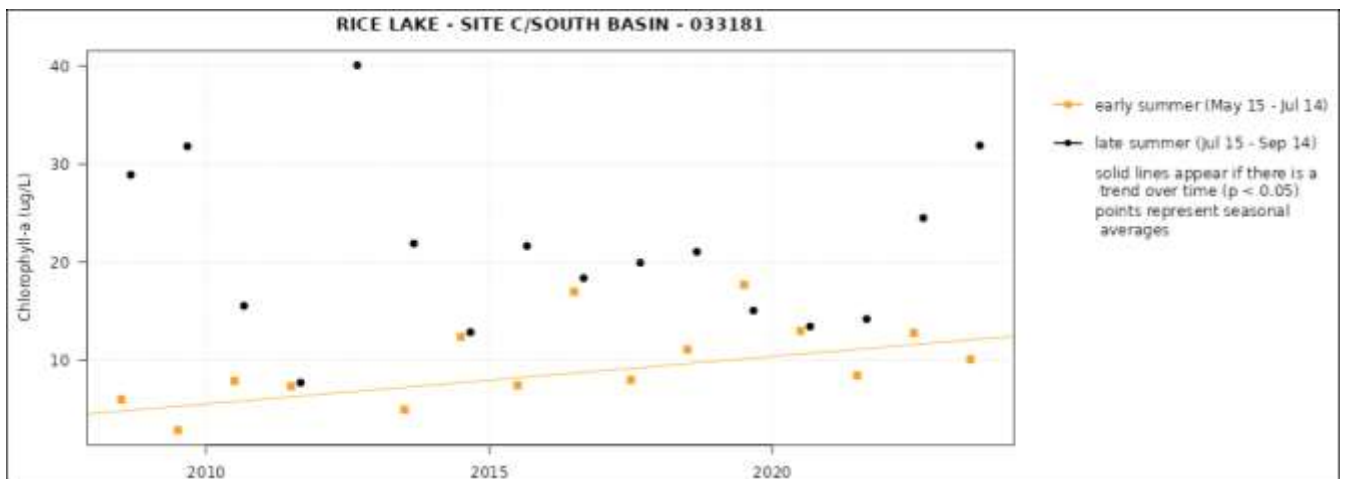
Figure 18: Significant trends in Chla from the South Basin of Rice Lake (WEx, 2024)

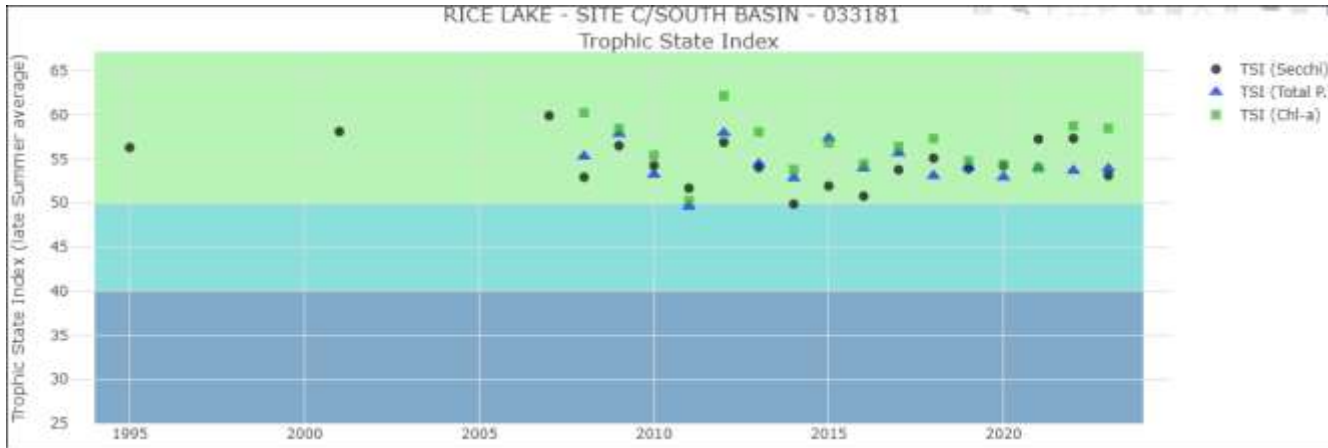
Figure 19: Historical TSI values for water clarity, total phosphorus, and chlorophyll-a at the South Basin in Rice Lake (WEx, 2024)

All three parameters – Secchi disk readings of water clarity, TP, and Chla can be combined in one formula and put in a Trophic State Index (TSI) scale from 0-100. The TSI equations use late summer (July 15 - September 15) averages of Secchi depth, total phosphorus, and chlorophyll- α . Values greater than 50 are considered Eutrophic and may lead to excess nutrients, lower water clarity, and greater risk of harmful algal blooms and hypoxia (low oxygen). Values between 40 and 50 are considered Mesotrophic with moderate levels of nutrients and moderate water clarity. Values less than 40 are considered Oligotrophic with low levels of nutrients, high water clarity, and lower risk of hypoxia. Figure 19 represents all TSI data for the South Basin in Rice Lake. Nearly all the data collected puts the South Basin of Rice Lake in the eutrophic category for lakes.

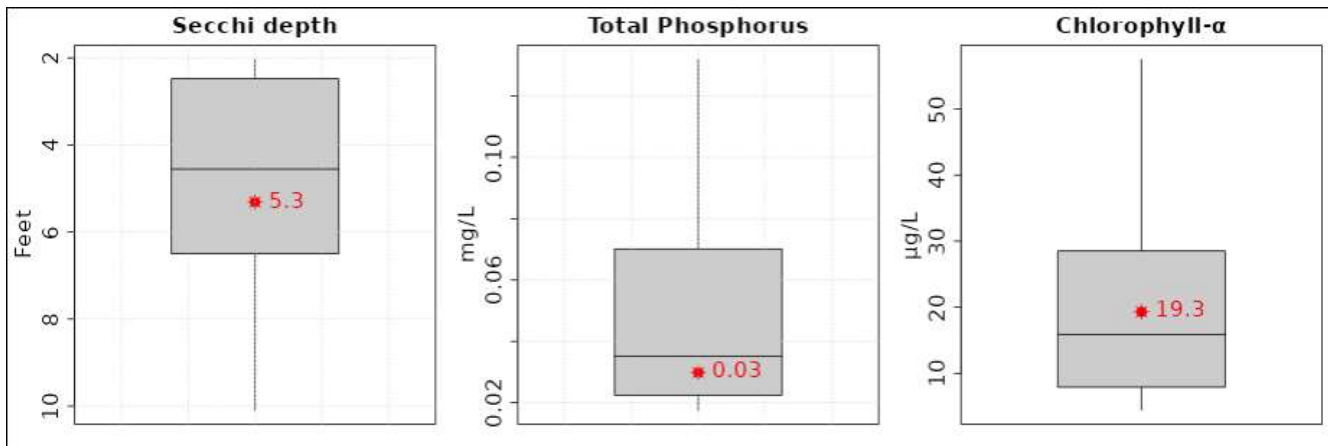
Figure 20: Water quality parameters from the South Basin of Rice Lake compared to other similar lakes (WEx, 2024)

When late summer trophic indicator averages (red) from the South Basin from the last 10 years are compared to other reservoir lakes like Rice Lake (Figure 20), we see that Rice Lake is better than average for Secchi and TP, and worse than average for Chla.

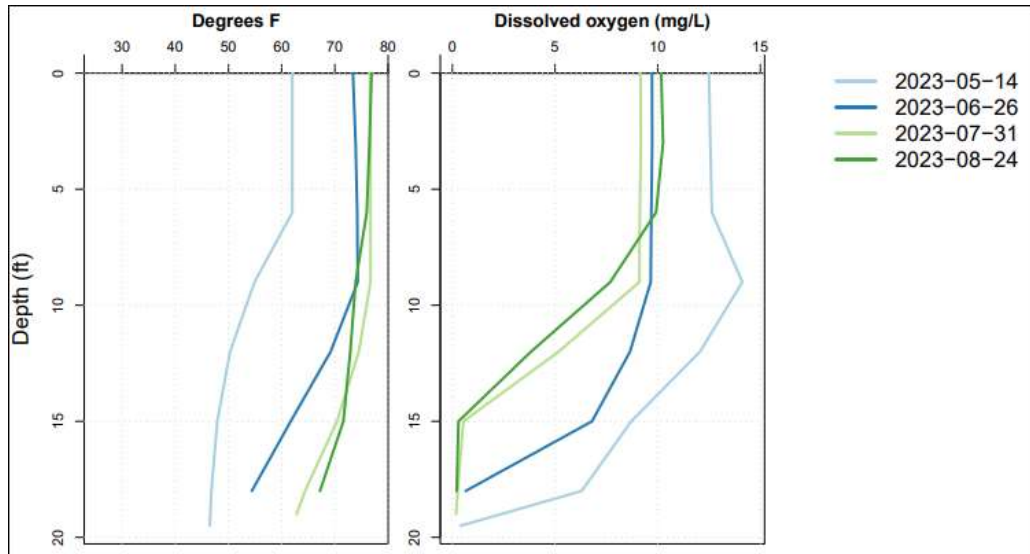
Figure 21: Temperature and DO profiles from the South Basin of Rice Lake (WEx, 2024)

As mentioned, temp and DO profiles were collected from the South Basin in 2023. Because of its depth and relatively small size, the South Basin stratifies in the mid to late summer. Stratification means the lake water splits into several different areas. Warm, nutrient and oxygen rich water rises to the surface (epilimnion). Colder, water with much less or no oxygen drops to the bottom (hypolimnion). Both happen due to density differences in cold and warm water. The two layers are separated by a third layer called the thermocline. When diving into the water, the thermocline is where the water starts to feel colder. According to the profiles taken, the thermocline establishes

somewhere in the 10-15ft depth beginning in late July (Figure 21) and lasts through late September and early October before the layers break down and mix again.

With little or no DO in the bottom waters of the South Basin, a chemical reaction occurs between iron and phosphorus that allows phosphorus formally trapped in the bottom sediments to be released back into the water column. This is what generally leads to the algae blooms and very green water in Rice Lake in the summer.

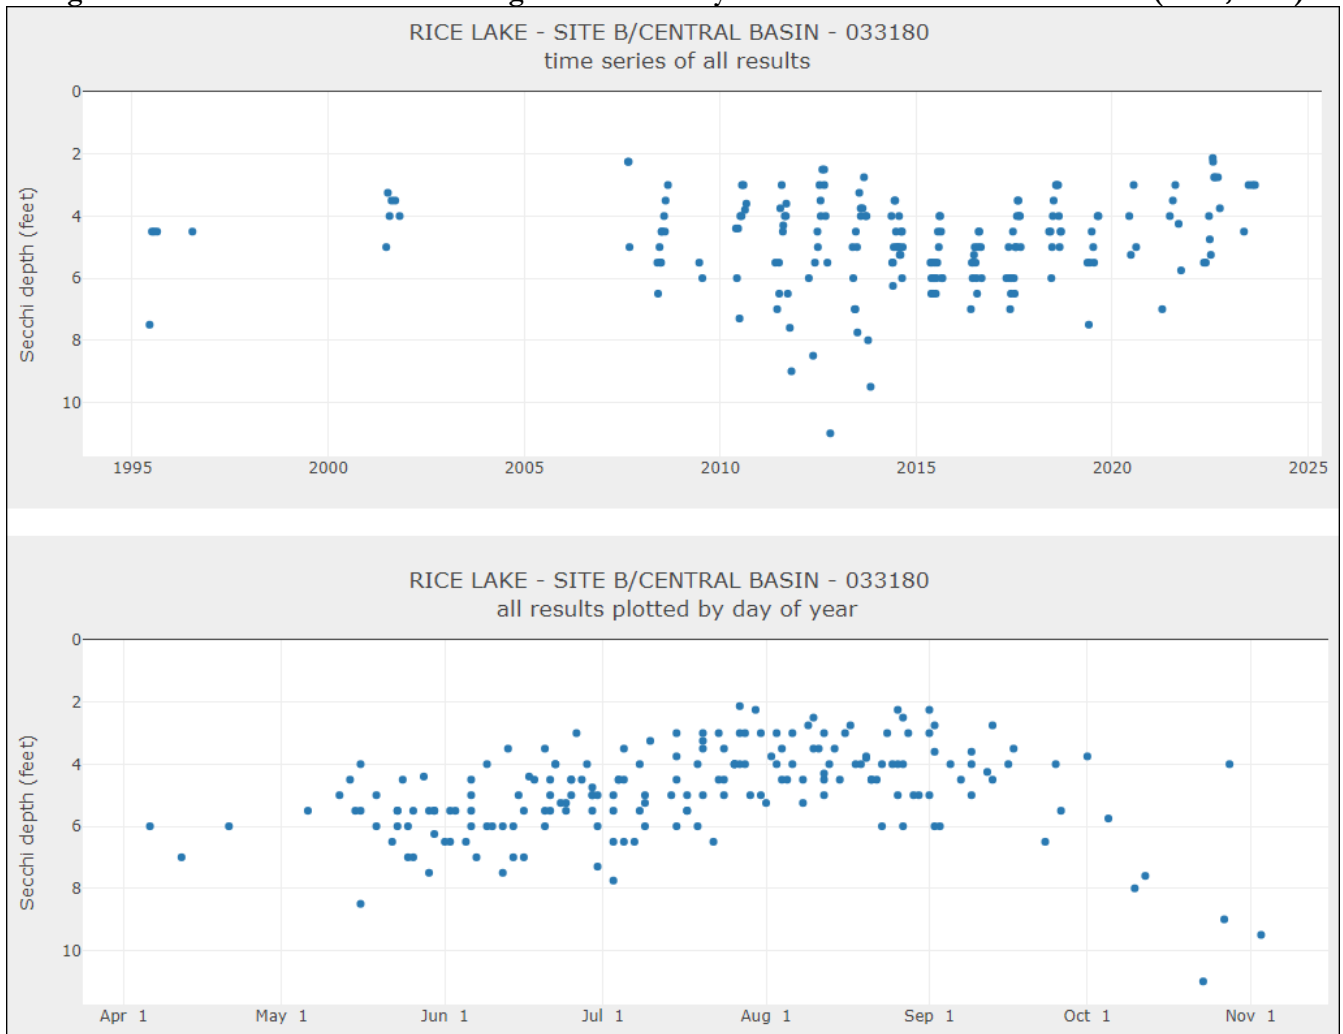
Figure 23: All Secchi disk readings of water clarity taken from the Central Basin in Rice Lake (top); all Secchi disk readings through the open water season (bottom) (WEx, 2024).

Figure 23 reflects all the Secchi disk readings taken in the Central Basin since readings began. Readings start out in the 4-7ft range through early summer, and then drop to 3-5ft in August and September. When looking at all the data, there are no significant trends showing water clarity is getting better or getting worse.

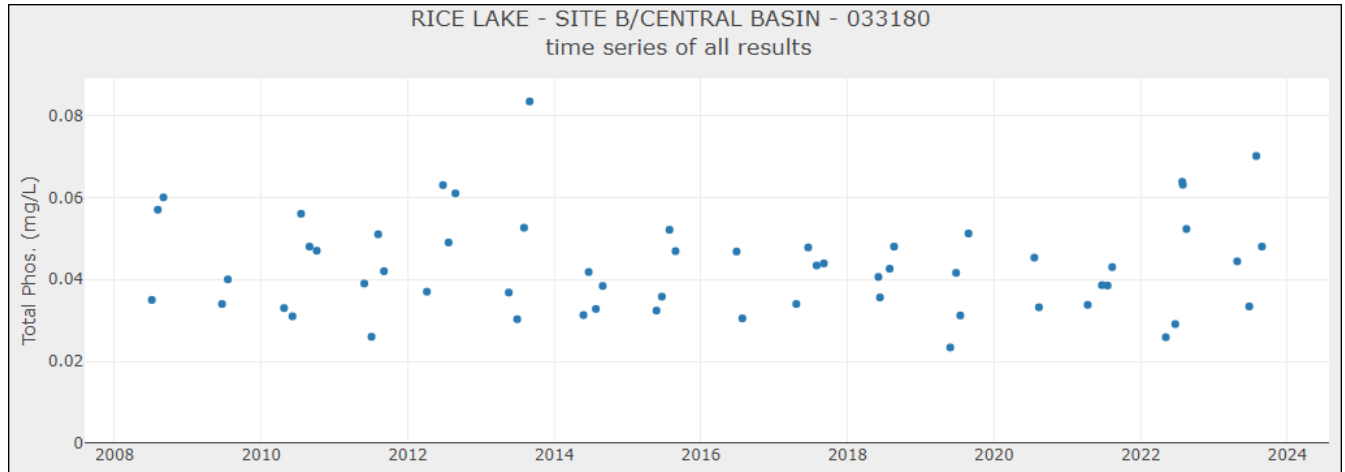
Figure 24: All TP data collected from the Central Basin of Rice Lake (WEx, 2024)

Figure 24 shows all TP data collected from the Central Basin since about 2008. Like with Secchi disk readings of water clarity, there are no significant trends showing TP getting better or worse in the Central Basin.

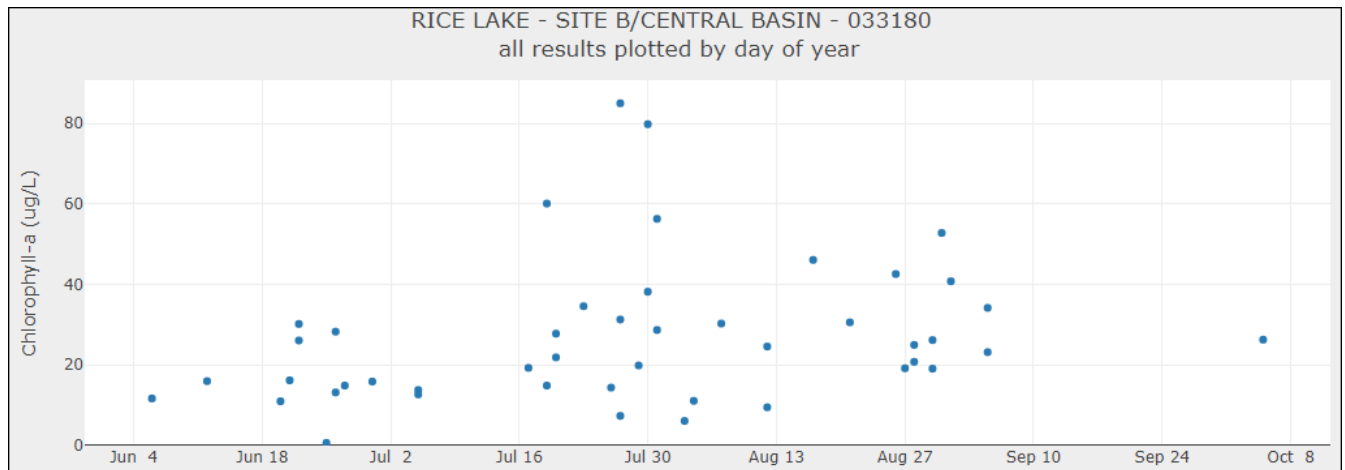
Figure 25: Seasonal Chla concentrations in the Central Basin of Rice Lake (WEx, 2024)

Chla concentrations in the Central Basin remain consistent throughout most of the summer season (Figure 25). This is due in part to the continuous flow of water through the Central Basin flushing out the algae over the dam into the Red Cedar River downstream. Early summer Chla is the only parameter that shows any significant trend to report. Unfortunately, like in the South Basin, Chla in the Central Basin shows a significant trend toward higher or worsening concentrations in the early summer (Figure 26).

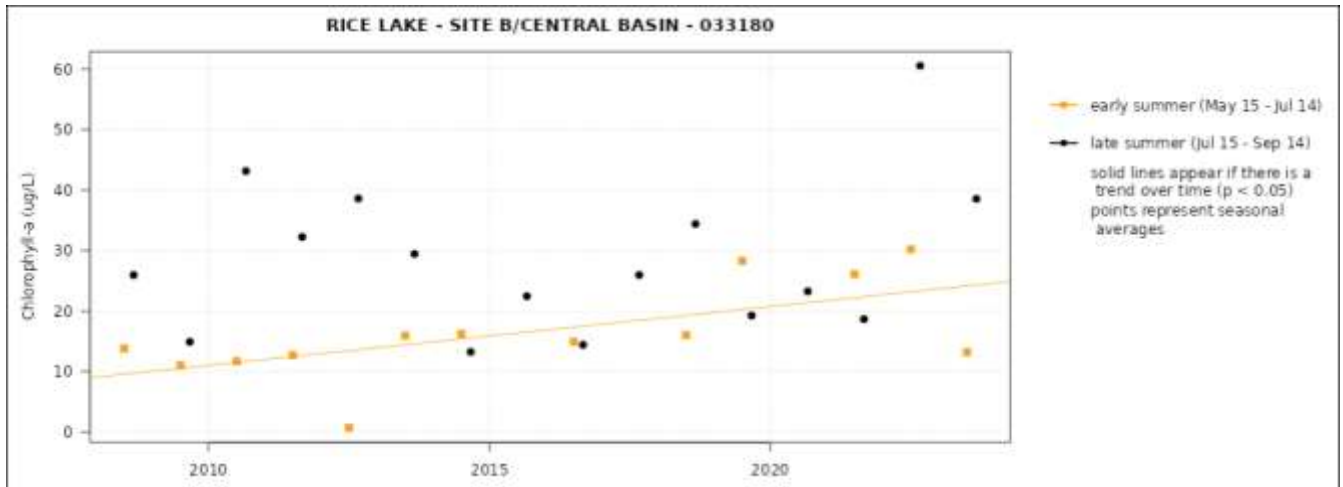
Figure 26: Significant trends in Chla from the Central Basin of Rice Lake (WEx, 2024)

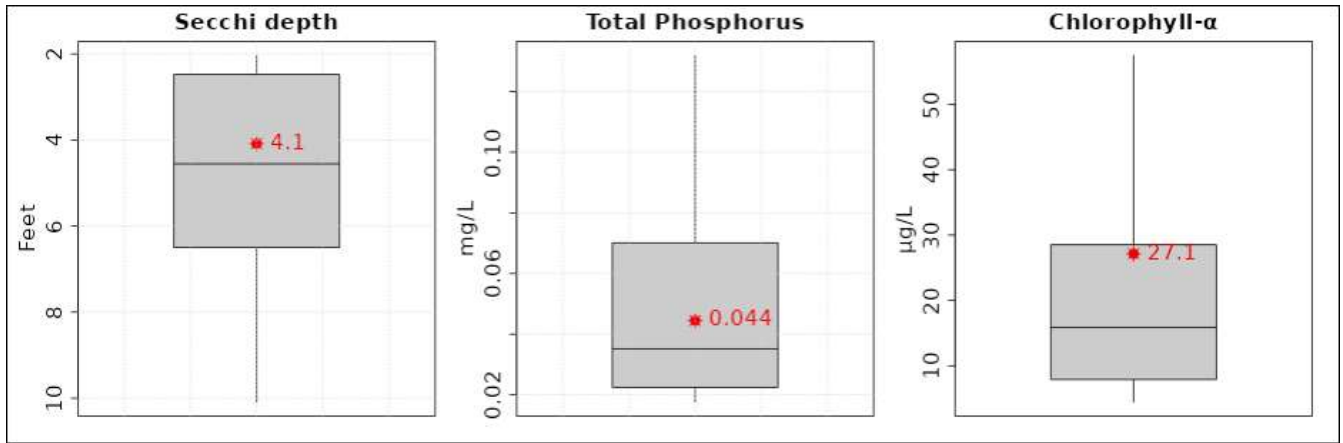
Figure 28: Water quality parameters from the Central Basin of Rice Lake compared to other similar lakes (WEx, 2024)

When late summer trophic indicator averages (red) from the Central Basin from the last 10 years are compared to other reservoir lakes like Rice Lake (Figure 28), we see that water quality in the Central Basin of Rice Lake is worse than average for Secchi, TP, and Chla.

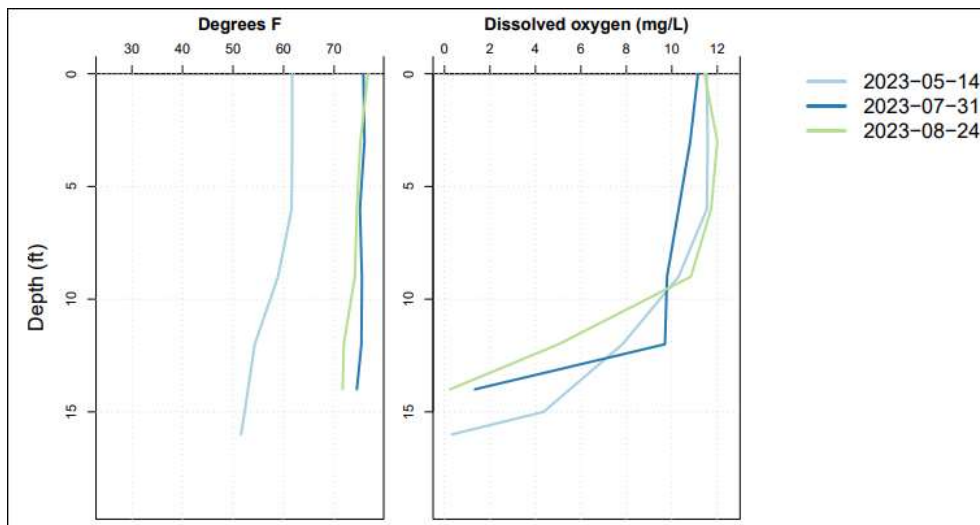
Figure 29: Temperature and DO profiles from the Central Basin of Rice Lake (WEx, 2024)

As mentioned, temp and DO profiles were collected from the Central Basin in 2023. Because of its depth and the fact that the river runs through it, the Central Basin does not stratify (Figure 29). DO levels do decrease starting at about 10ft.

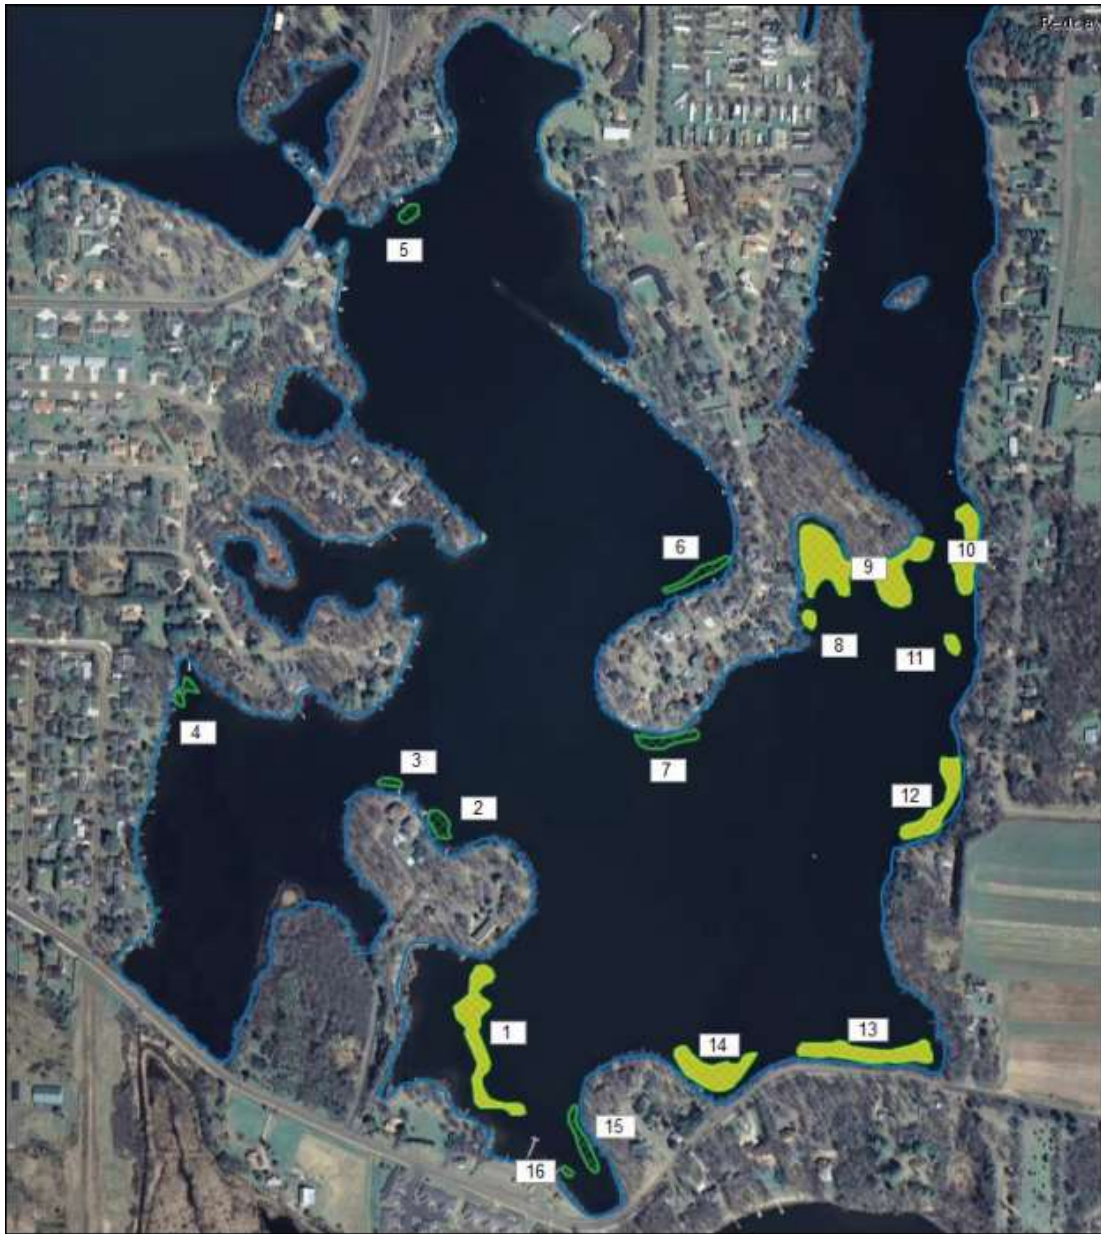
Figure 30: 2024 preliminary HWM herbicide application proposal

The current proposal for the South Basin includes four areas encompassing eight of the sixteen HWM beds identified in the Fall 2023 survey (Figure 30, Table 4). The other beds from that survey were managed with scuba diver removal in late September 2023. Follow-up monitoring will be done in those areas. Herbicide concentration testing is planned for after the 2024 ProcellaCOR application.
