**Horseshoe Lake Property Association, Inc.  
Horseshoe Lake  
Washburn County**

**2023 Horseshoe Lake, Washburn County EWM Diver Removal/DASH Project**

**Grant# ACEI31623**

**Interim Progress Report**

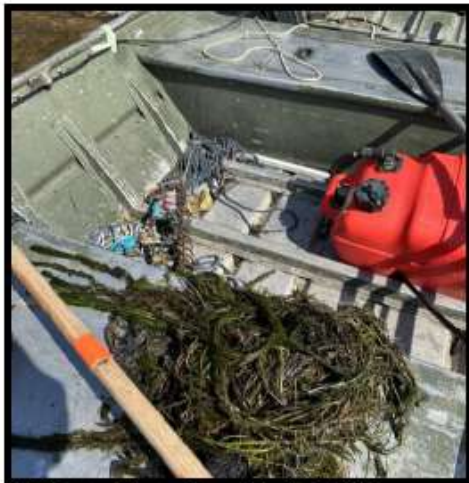
EWM plants raked out on the north shoreline 7/26/23

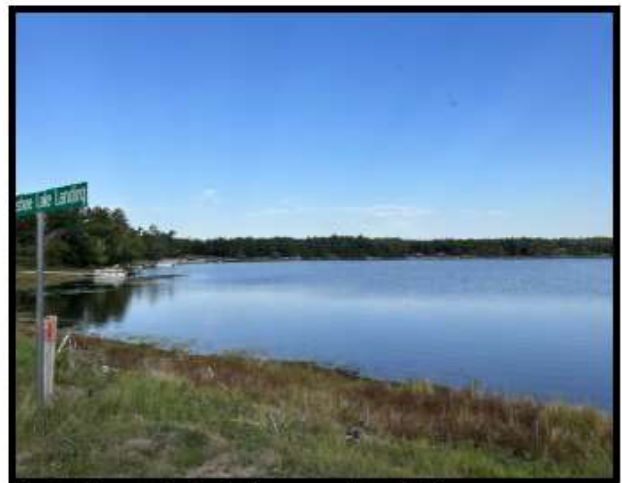
Continued low water levels and calm survey conditions 9/4/23

On September 4<sup>th</sup>, we returned to the lake to again look for surviving Eurasian water-milfoil. We noted a further drop in water levels, and, because of low winds and continued good clarity, we found we could see down approximately 7-8ft. In total our search transects covered 19.0km (11.8 miles) (Figure 6).

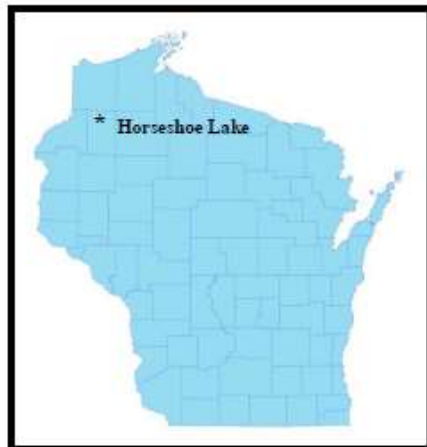
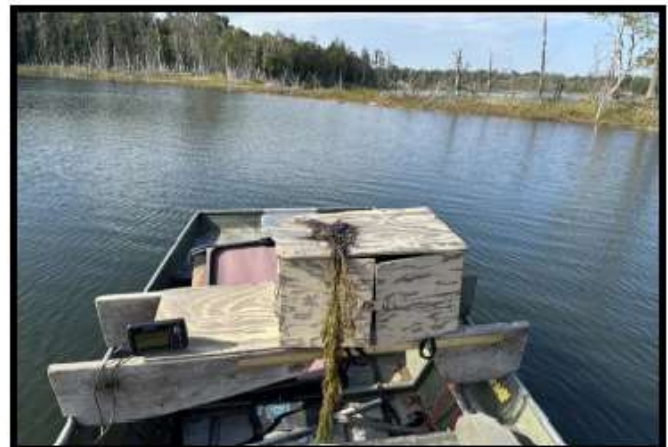
EWM raked out near the channel 9/4/23
