**Curly-leaf pondweed (*Potamogeton crispus*)
Point-intercept and Bed Mapping Surveys, and
Warm-water Point-intercept Macrophyte Survey
Upper Eau Claire Lake – WBIC: 2742700
Bayfield County, Wisconsin**

The Town of Barnes – Aquatic Invasive Species Committee and the
Wisconsin Department of Natural Resources (Grant ACEI24521)

Endangered Resource Services, LLC
Matthew S. Berg, Research Biologist
St. Croix Falls, Wisconsin
June 20-21 and July 27-28, 2021

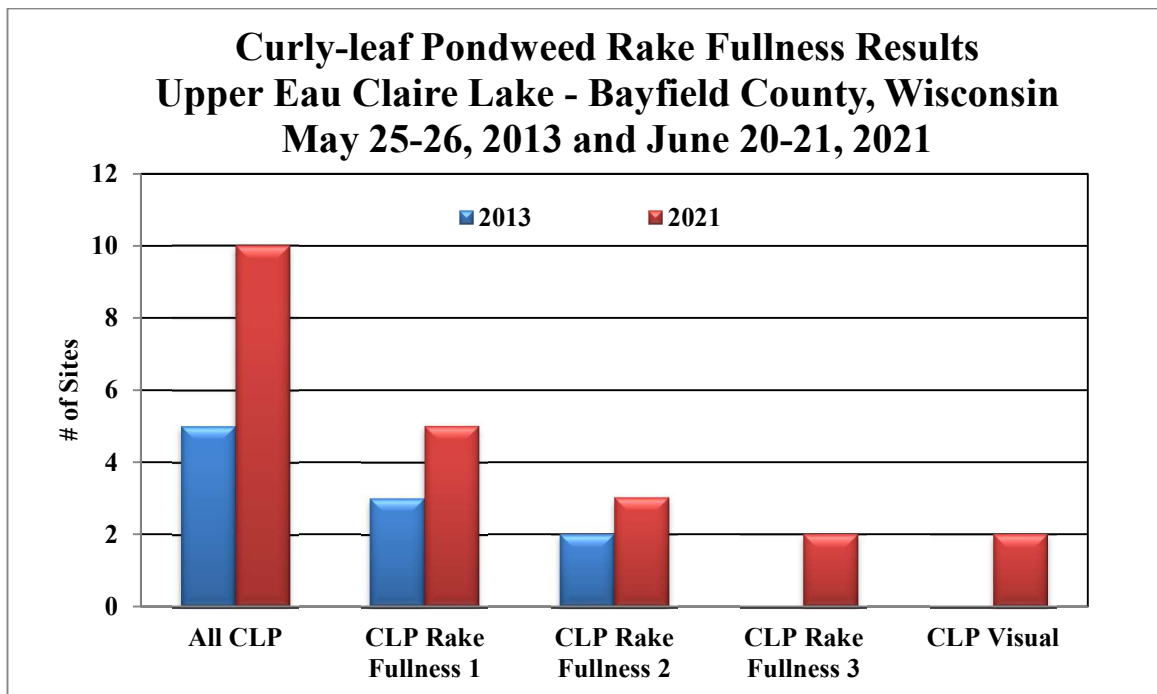
Figure 4: 2013 and 2021 Changes in Early-season CLP Rake Fullness

Comparing the 2013 and 2021 early-season surveys found increases in all categories of Curly-leaf pondweed growth (Figure 4); however, none of these changes were significant. This may mean the non-significant increase ($p=0.16$) in coverage and the non-significant increase in density ($p=0.21$) were simply due to the later date of the 2021 survey, changes in season growing conditions, or a combination of the two. It could also mean that CLP is expanding on the lake, but that the suction harvesting program is slowing this expansion.

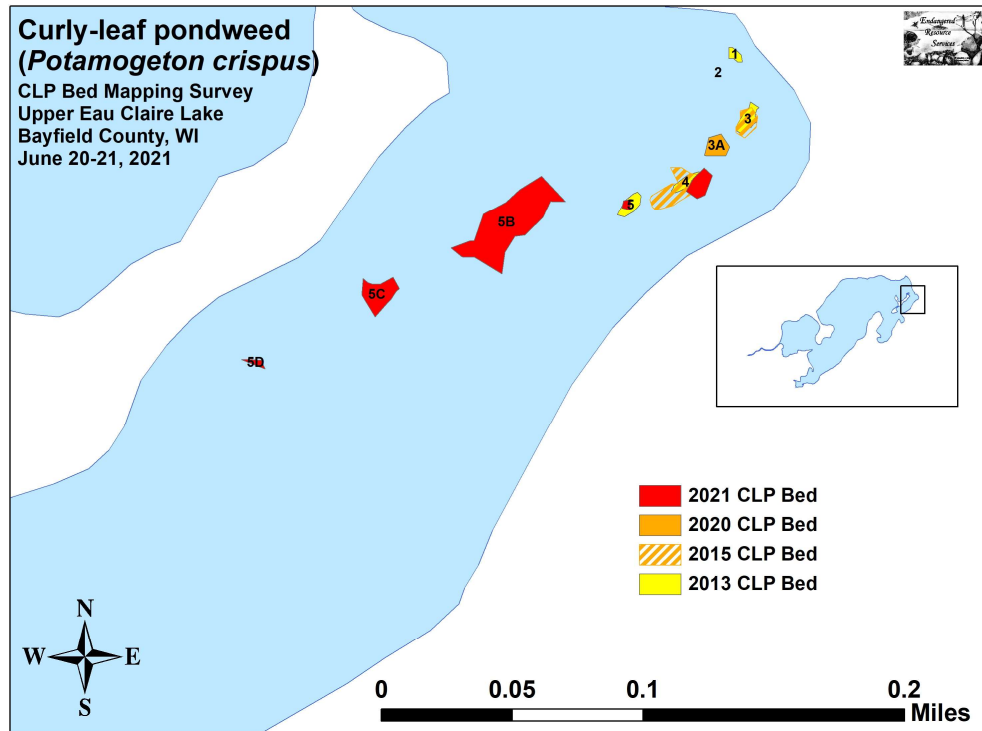
**Figure 5: Curly-leaf Pondweed Beds –
East of Three-in-One Island – 2013, 2015, 2020, and 2021**

The 2015 survey found four beds that totaled 0.17 acre with the biggest (Bed 4) covering 0.11 acre and the smallest (7B) encompassing <0.01 acre (Table 1). Collectively, this was an increase of 0.06 acre from the 2013 survey; however, this amount was within the error range of the GPS. Each of these beds was canopied, had a low mean rake fullness of 1, and a rake range that varied from 1-2 (low to moderate). Although canopied, because these beds were so small, they were easily avoided, and it seemed unlikely that they would cause even minor navigation impairment.

East of Three-in-One Island, we noted that three of the beds we mapped in 2013 (Beds 1, 2, and 5) had completely disappeared after volunteers pulled plants in these areas during the 2014 growing season. We also saw no evidence of CLP in the deep-water areas bordering Pease Bay where we mapped Beds 6 and 8 in 2013. At these locations, it may be that CLP, which was never dense, just didn't canopy or even get close enough to the surface that we could see it. It may also be that localized conditions prevented turions from germinating in 2015.

Our 2020 survey found two "beds" totaling 0.04 acre – a 0.13-acre decline (-76.5%) from 2015 (Table 1). Bed 3A east of Three-in-One Island consisted of about 30 total plants most of which we were able to rake remove. Bed 5A also contained only about 20-30 plants, but they were in a tight cluster and covered a much smaller area. We were also able to rake remove most of them although some turions broke off as the plants were beginning to senesce. Other than a few floating plants that had broken free from the bottom, we saw no evidence of CLP anywhere else in the lake. Following the survey, we were informed that the BAISS boat had already been on the lake, and that may explain the sharp decline relative to the 2015 survey.

In 2021, we mapped seven areas totaling 0.69 acre. This was a 0.65-acre increase (+1,605%) compared to 2020, but still represented only 0.07% of the lake's total surface area (Table 1). The biggest was 0.37 acre (Bed 5B) while the smallest (Beds 5 and 5D) covered <0.01 acre. All three beds occurred in a nearly continuous low to moderate density line running down the channel east of Three-in-One Island in water from 5-13ft deep (Figure 5). In Pease Bay, the only CLP seen was a new bed (5AA) in the northeast side bay (Figure 6). Unfortunately, for the first time ever, we also found a small but very dense deepwater bed (Bed 9) in the lake's far southwest bay (Figure 7). Even with the 2021 increase in acreage, none of the lake's CLP beds were likely to cause more than moderate impairment, and even that was questionable as most beds were easily avoided.

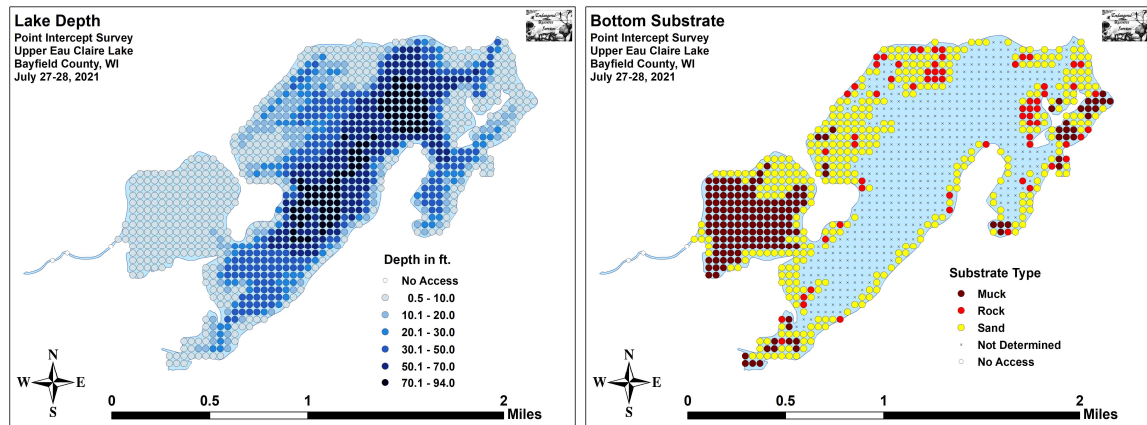
Figure 8: Lake Depth and Bottom Substrate

Of the 620 survey points where we could determine the substrate, 27.3% were muck and sandy muck (169 points), 62.3% were pure sand (386 points), and 10.5% were rock (65 points). Sand and rock dominate the majority of the nearshore lake bottom as well as around Three-in-One Island, the flats and bars in the northwest bay, and the northeast end of the outlet bay. In the lake's bays and the channel east of Three-in-One Island, these sandy areas quickly transition to a nutrient-poor sandy muck at most depths over 7ft. In the outlet bay, this muck was a thick marl, while in the bog bay near the channel to Devil's Lake, it was a more nutrient-rich organic muck (Figure 8) (Appendix IV).

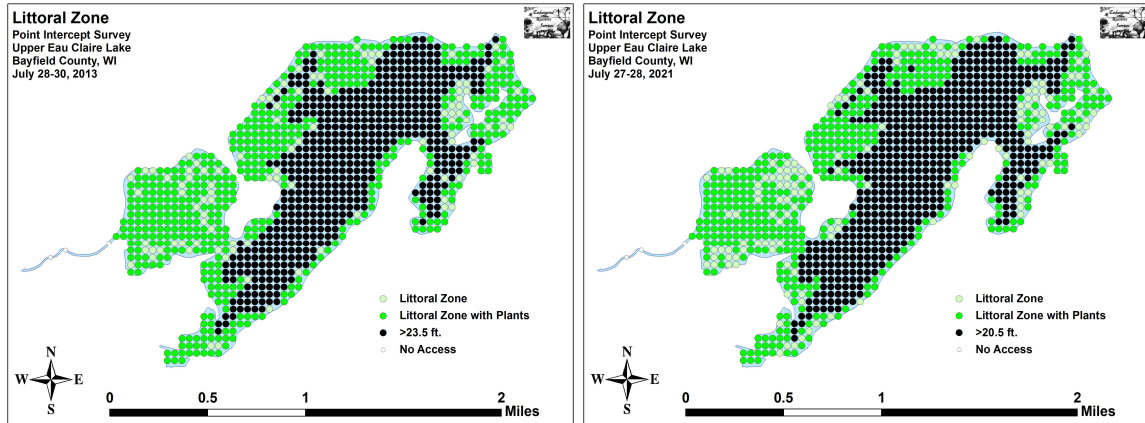
Figure 9: 2013 and 2021 Littoral Zone

During the July 2021 survey, we found macrophytes at 437 sites (38.3% of the bottom and 76.1% of the 20.5ft littoral zone) (Figure 9). This was a non-significant decline ($p=0.18$) from 2013 when plants were present at 506 sites (44.4% of the entire lake bottom and in 83.5% of the then 23.5ft littoral zone). Plants were consistently found to 17ft, but they became much patchier beyond this depth (Figure 10).

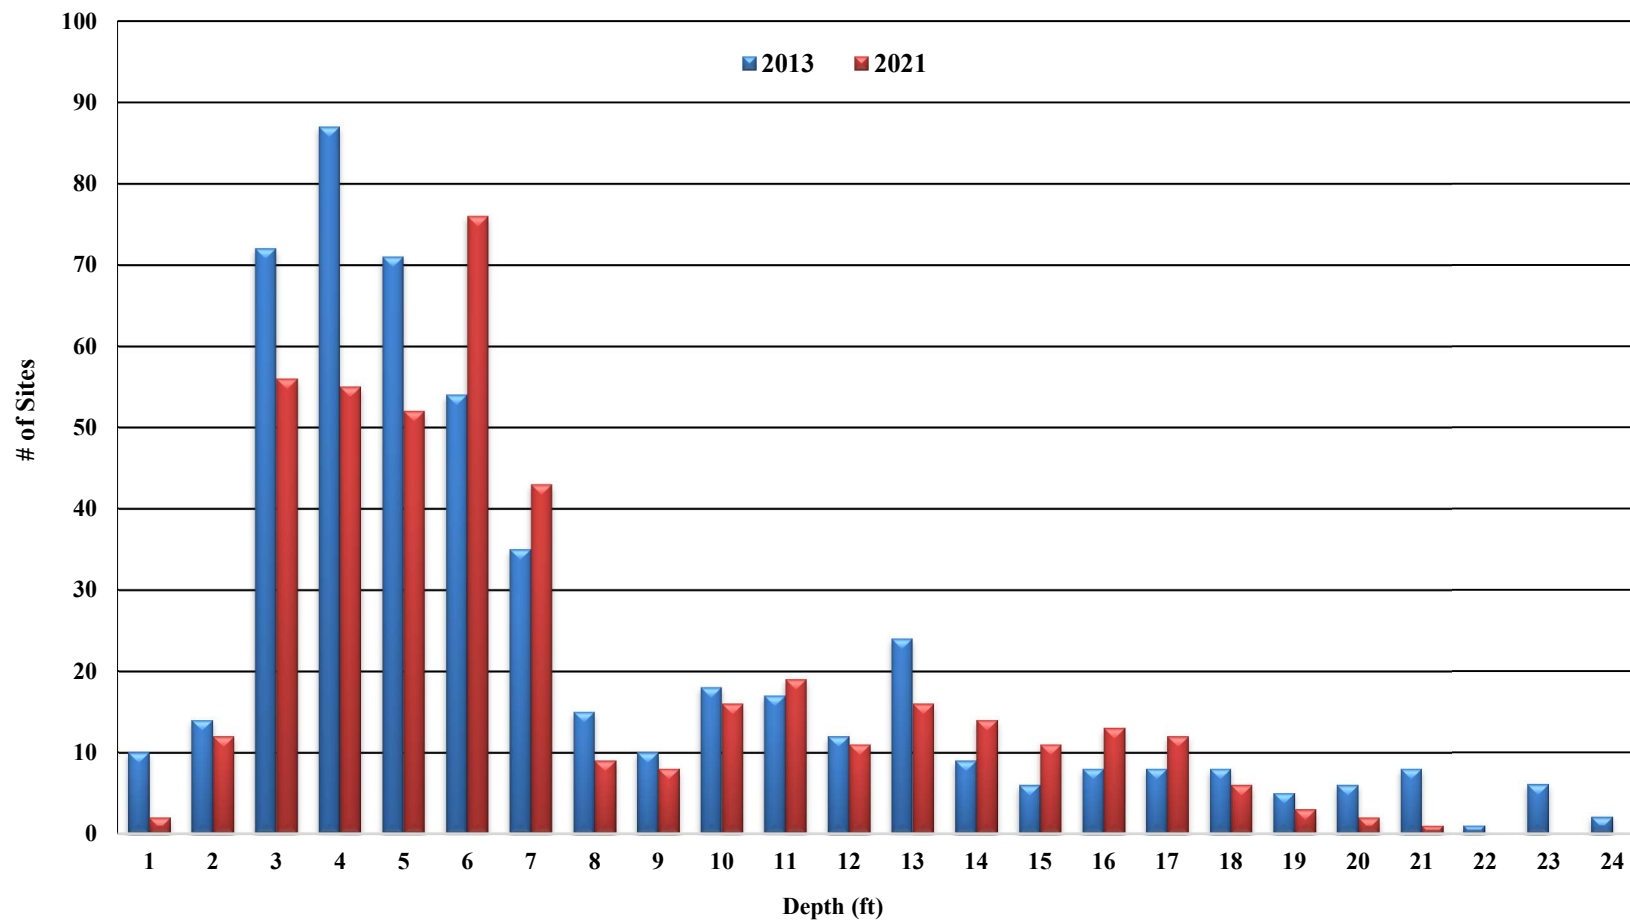
Figure 10: 2013 and 2021 Plant Colonization Depth Chart

Plant growth in 2021 was strongly skewed to deep water as the mean depth of 7.3ft was much greater than the median depth of 6.0ft (Table 2). This mean was identical to 2013, but the median was up sharply from 5.0ft during our original survey (Appendix V).

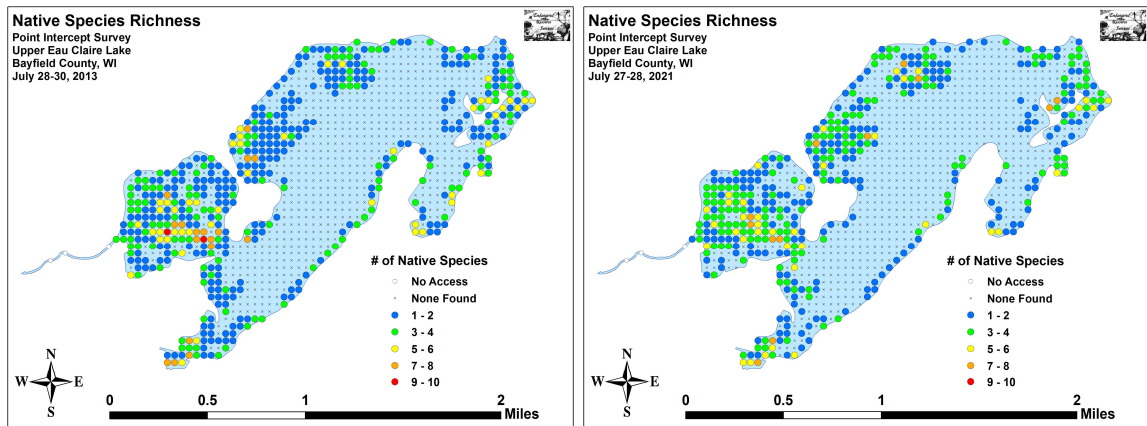
Figure 11: 2013 and 2021 Native Species Richness

From 2013 to 2021, mean native species richness at sites with native vegetation saw a non-significant increase ($p=0.11$) from 2.56 species/site in 2013 to 2.69 species/site in 2021. Visual analysis of the map showed few changes in localized richness (Figure 11) (Appendix V).

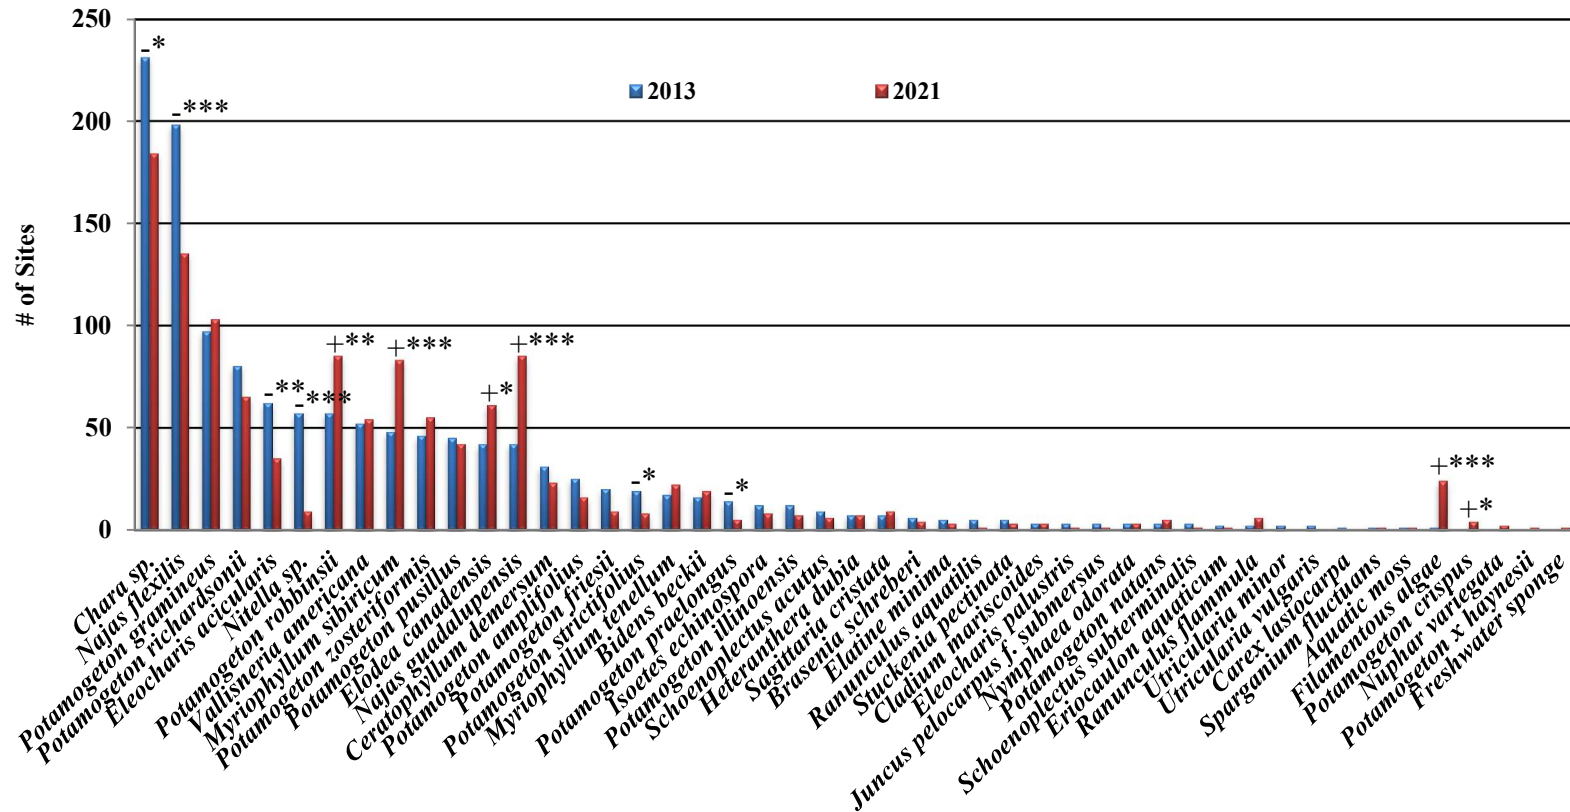
Figure 13: 2013-2021 Macrophyte Differences for All Species

Our 2013 survey identified Muskgrass, Slender naiad, Variable pondweed, and Claspingleaf pondweed as the most common species (Table 3). They were found at 45.65%, 39.13%, 19.17%, and 15.81% of sites with vegetation and encompassed 46.80% of the total relative frequency. Needle spikerush (4.79%), Nitella (4.40%), Fern pondweed (4.40%), and Wild celery (4.02%) were the only other species with relative frequencies over 4.00% (Species accounts and maps for all plants found in July 2013 can be found in the project folder).

The 2021 survey documented Muskgrass (42.11% of points with vegetation), Slender naiad (30.89%), Variable pondweed (23.57%), and Southern naiad (19.45%) as the most common species with a combined relative frequency of 43.15% (Table 4). Fern pondweed (7.23%), Northern water-milfoil (7.06%), Claspingleaf pondweed (5.53%), Common waterweed (5.19), Flat-stem pondweed (4.68), and Wild celery (4.60%) also had relative frequencies over 4.00% (Density and distribution maps for all native plant species found in 2021 are located in Appendix VI).

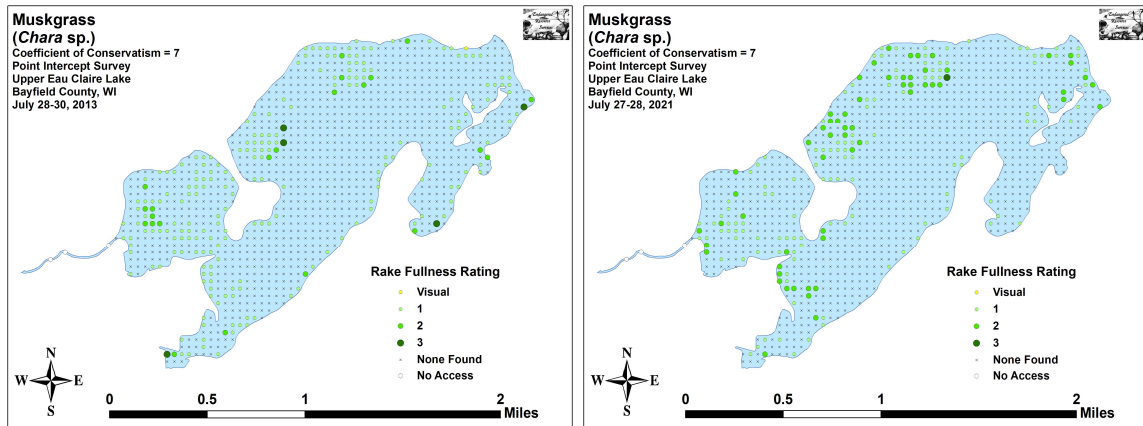
Figure 14: 2013 and 2021 Muskgrass Density and Distribution

Muskgrass, the most common species during each of the surveys, was found throughout the lake (Figure 14). In 2013, it was present at 231 sites with a mean rake fullness of 1.14. The 2021 survey documented a significant decrease ($p=0.03$) in distribution (184 sites), but a highly significant increase ($p<0.001$) in mean density (mean rake fullness of 1.33).

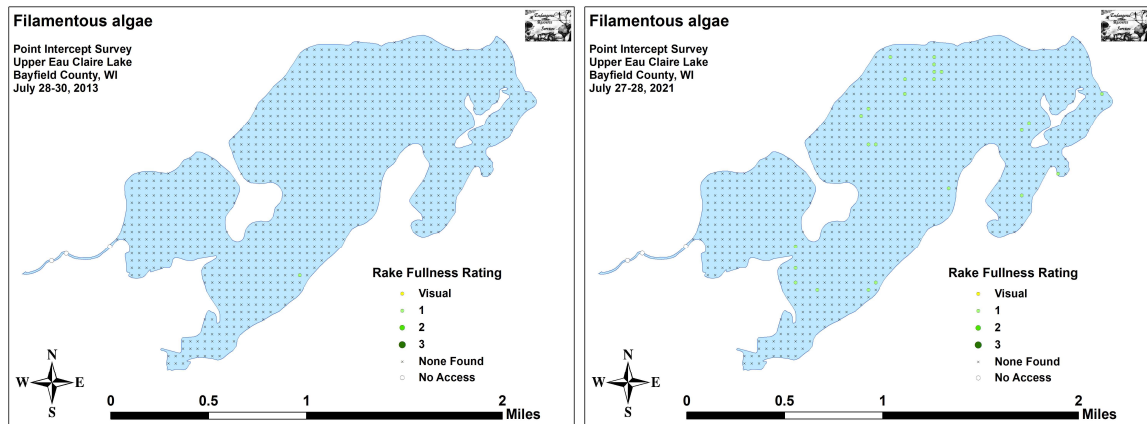
Figure 24: 2013 and 2021 Filamentous Algae Density and Distribution

Filamentous algae are normally associated with excessive nutrients in the water column from such things as runoff, internal nutrient recycling, and failed septic systems. In 2013, these algae were located at a single point with a rake fullness of 1 (Figure 24). The 2021 survey documented a highly significant increase ($p<0.001$) in distribution, but all 24 points again had a rake fullness of 1. These points were scattered throughout the entire lake suggesting the nutrients feeding this growth are not from a single source.

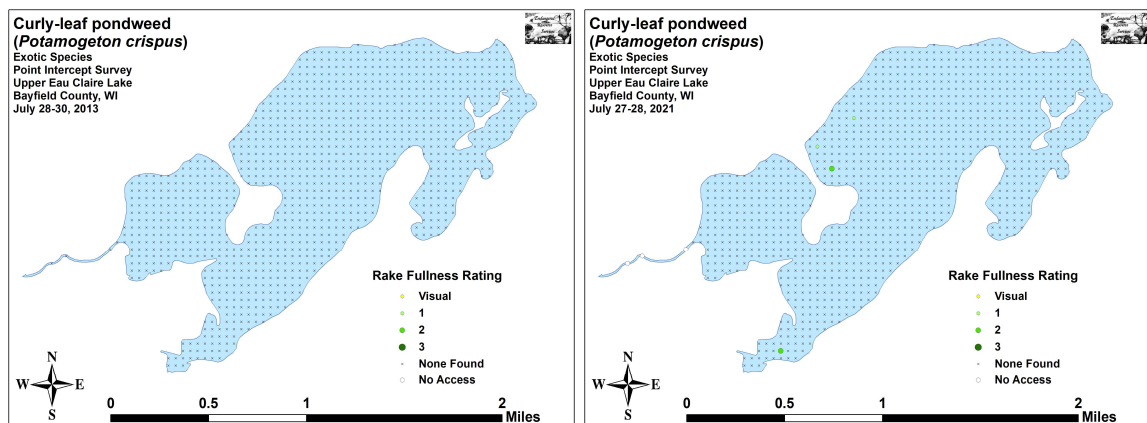
Figure 25: 2013 and 2021 Late Summer CLP Density and Distribution

Curly-leaf pondweed normally completes its annual life cycle by late June, and most plants have set turions and senesced by early July. During our July 2013 survey, we saw no evidence of CLP anywhere in the lake. In July 2021, CLP was still present in the rake at four points with a mean rake fullness of 1.50 – this included several areas in the northwest bay where we hadn't found it previously (Figure 25) (Appendix VII). Compared to 2021, this was a significant increase ($p=0.04$) in distribution.
