**Curly-leaf pondweed (*Potamogeton crispus*)
Bed Mapping Survey
Lower Eau Claire Lake – WBIC: 2741600
Douglas and Bayfield Counties, Wisconsin**

Survey Conducted by and Report Prepared by:

Endangered Resource Services, LLC
Matthew S. Berg, Research Biologist
St. Croix Falls, Wisconsin
June 21, 2023

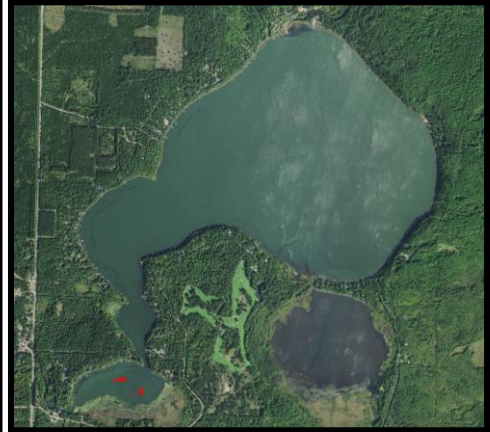
Lower Eau Claire Lake aerial photo with 2023 CLP beds.

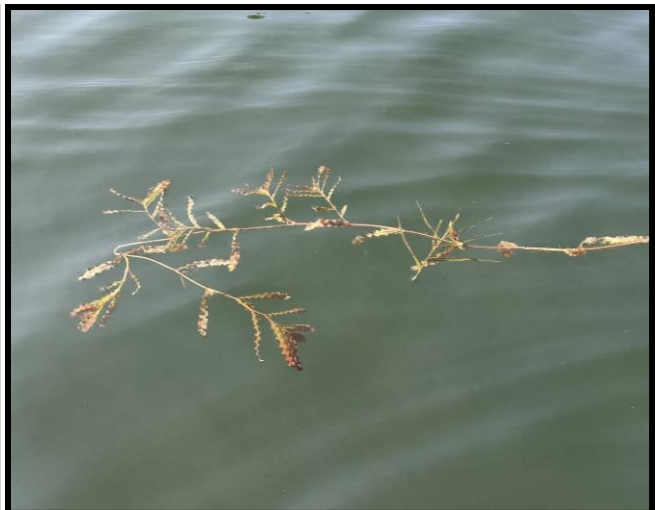
Curly-leaf pondweed in the outlet bay showing "lasagna noodle" margins – 6/21/23
