**Eurasian water-milfoil (*Myriophyllum spicatum*)  
Late Summer Bed Mapping Survey  
Red Lake (WBIC: 2492100)  
Douglas County, Wisconsin**

**Project Initiated by:**

The Red Lake Association, Lake Education and Planning Services, LLC and the Wisconsin Department of Natural Resources (Grant # ACEI32023)

Endangered Resource Services, LLC  
Matthew S. Berg, Research Biologist  
St. Croix Falls, Wisconsin  
September 7, 2024

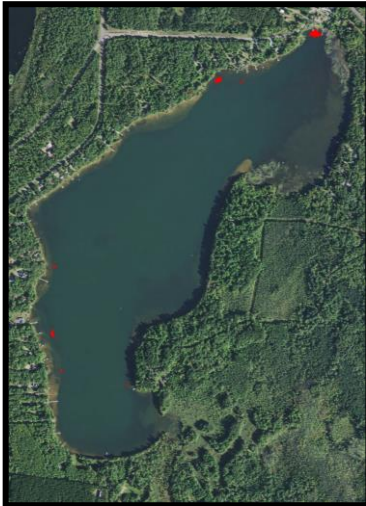
Red Lake EWM Beds (in red) – 9/4/23

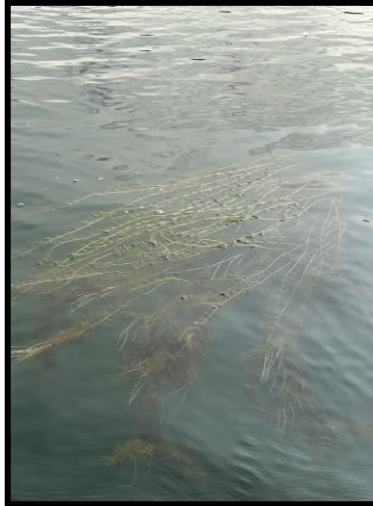
Giant Floating EWM plant – 9/7/24

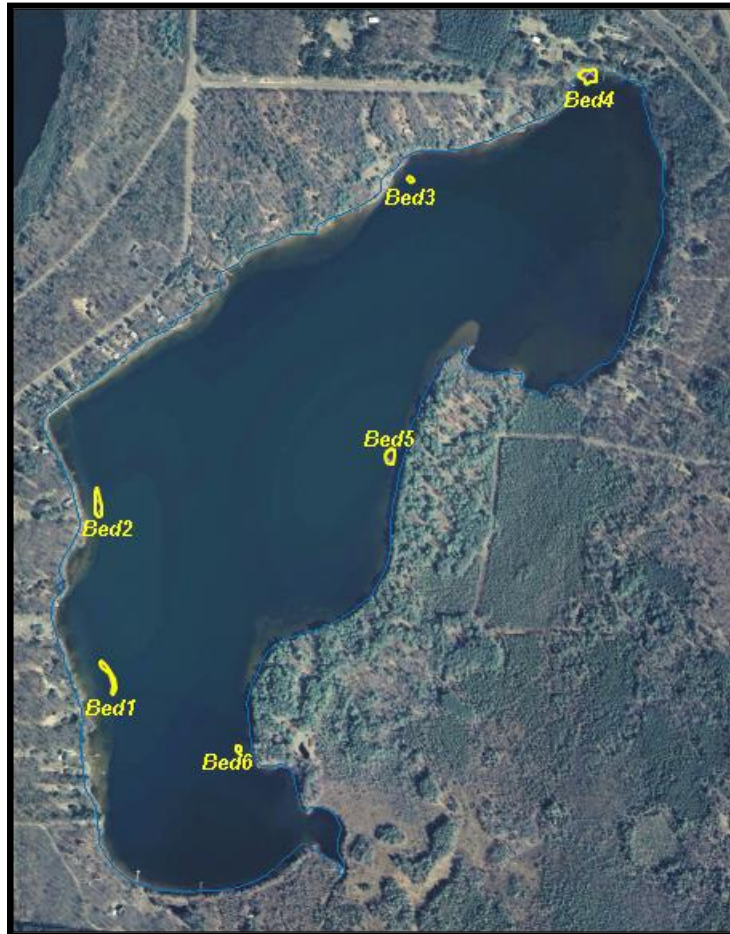
**Figure 3: 2024 Eurasian Water-milfoil Manual Removal Areas**

On June 30<sup>th</sup>, Lake Education and Planning Services, LLC (LEAPS – Dave and Lana Blumer) snorkel removed Eurasian water-milfoil from Areas 3, 4, and 5. This was followed by DASH removal (Aquatic Plant Management, LLC) of EWM from Areas 1 and 6 on August 29<sup>th</sup> (Figure 3) (Appendix I).

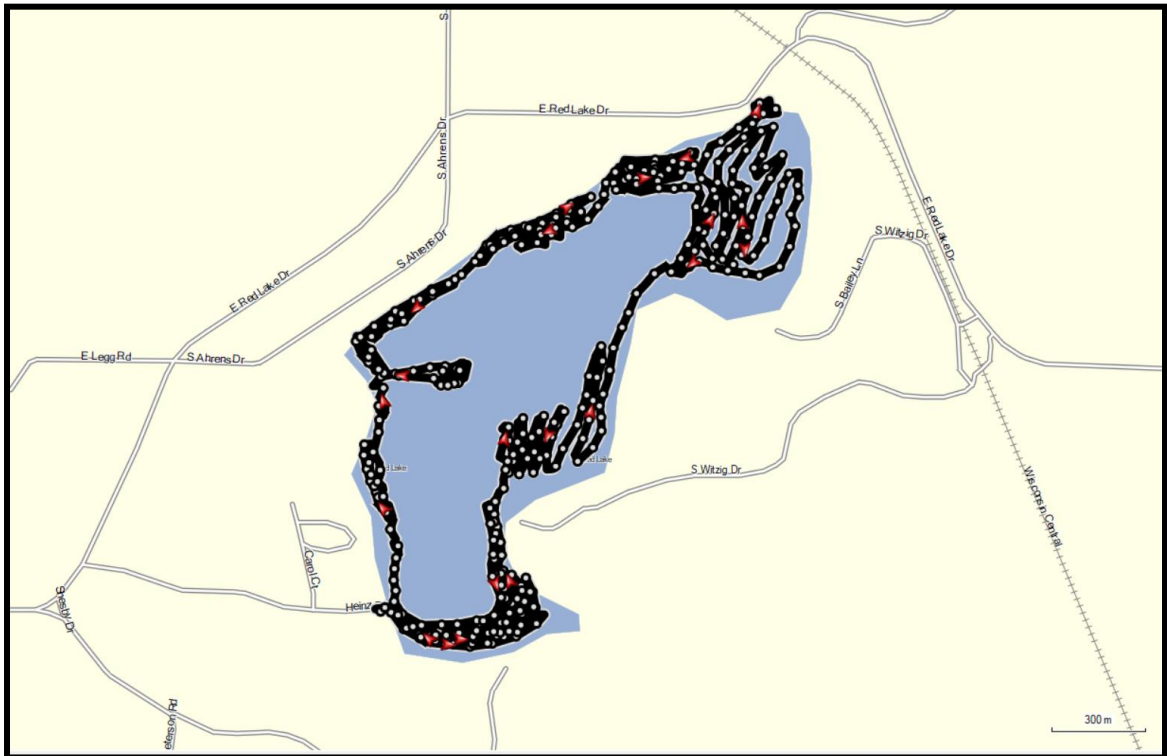
**Figure 4: September 7, 2024 Littoral Zone EWM Survey Transects**

On September 7<sup>th</sup>, we surveyed transects covering 20.0km (12.4 miles) spending extra time in the 2024 manual removal areas, the 2021, 2022, and 2023 treatment areas, looking at all areas that previously supported Eurasian water-milfoil beds, and searching in the northeast bay where fragments from elsewhere would likely be blown by the prevailing winds (Figure 4). We had mostly sunny skies and calm winds which allowed us to see down 7-8ft into the water column – slightly better than normal due to the exceptionally good conditions. We were pleased to again find no sign of EWM in the 2023 treatment area (Beds 6 and 6A). Unfortunately, other than Area 5, all areas that had snorkel or DASH removal conducted in 2024 continued to have EWM present (Figure 5) (Appendix II). Collectively, we mapped 11 microbeds and high-density areas that totaled 0.54 acre (0.21% of the lake’s surface area). The largest true bed was Bed 11 which covered 0.12 acre, was canopied, and seemed likely to cause at least minor navigation impairment. Conversely, “Beds” 2A, 13, and 16 had regular but only scattered EWM, and were likely better described as “high density areas”. Outside of these areas, we found and rake removed five isolated individual plants (Table 1).

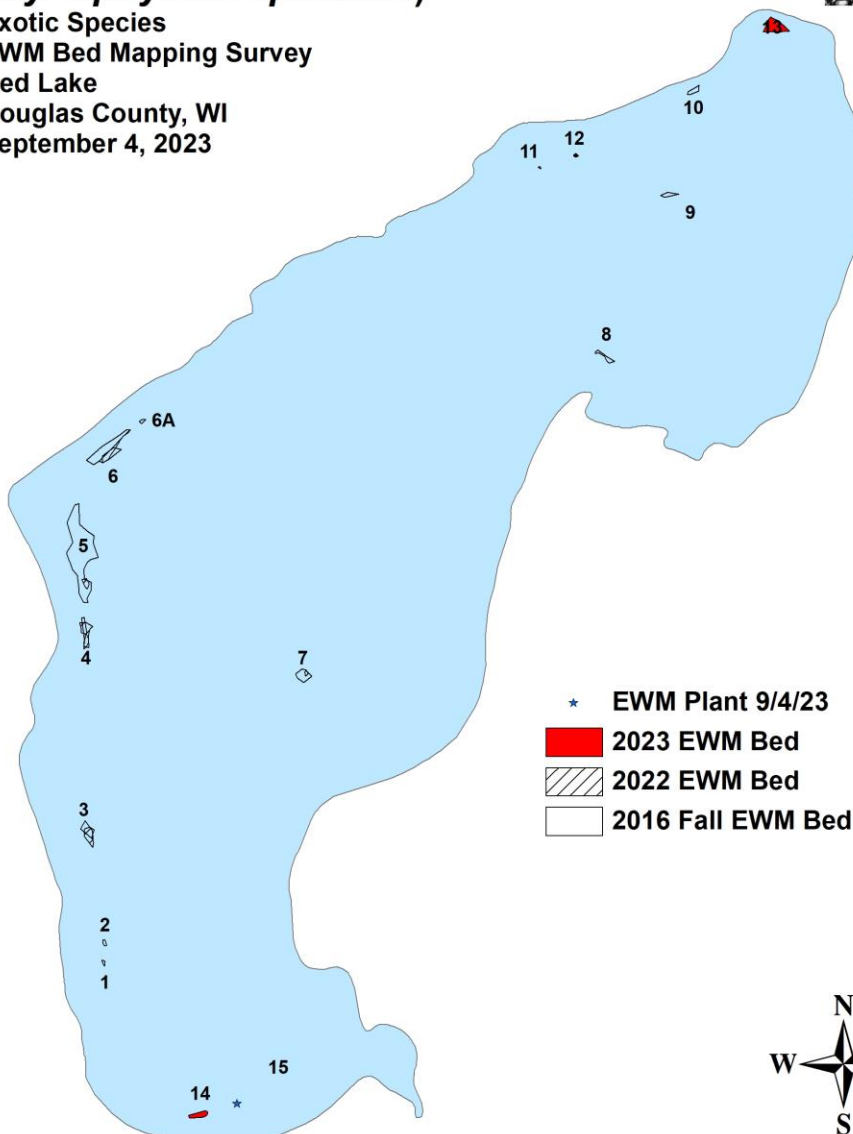
Exotic Species  
EWM Bed Mapping Survey  
Red Lake  
Douglas County, WI  
September 4, 2023

- \* EWM Plant 9/4/23
- 2023 EWM Bed
- ▨ 2022 EWM Bed
- 2016 Fall EWM Bed

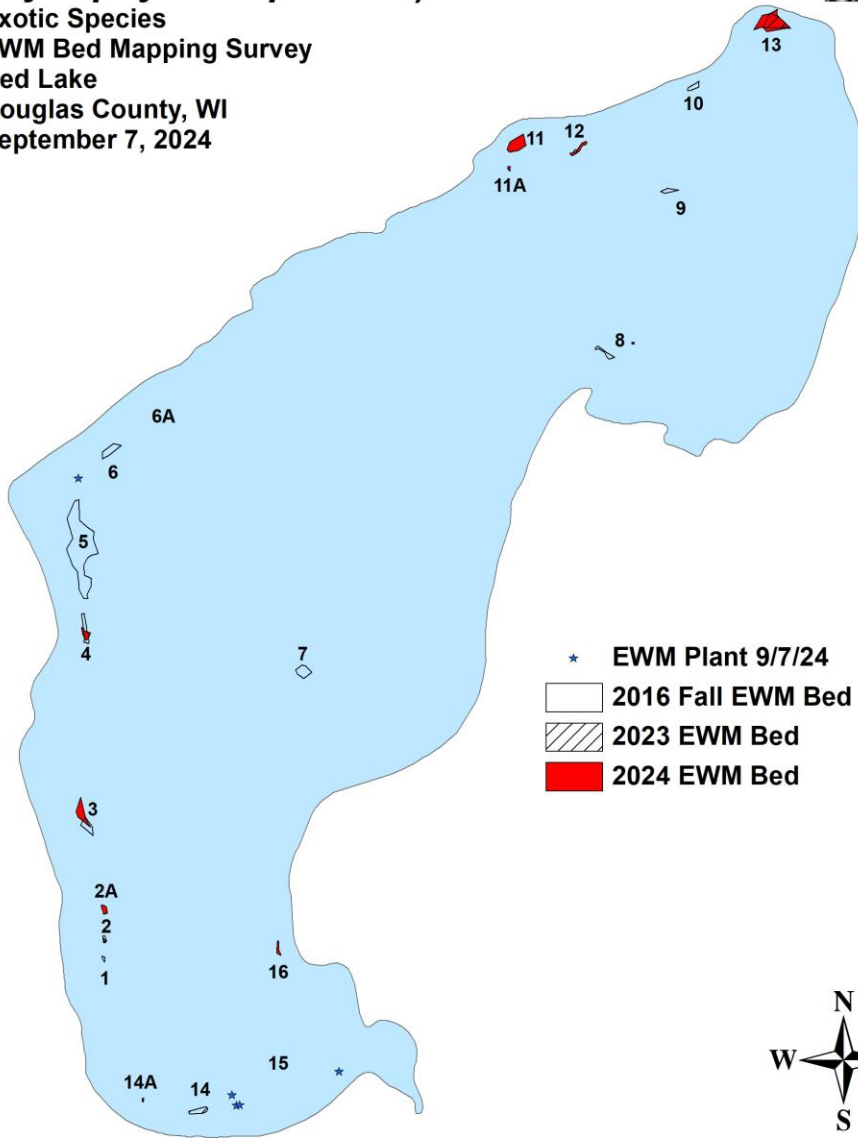
Exotic Species  
EWM Bed Mapping Survey  
Red Lake  
Douglas County, WI  
September 7, 2024

- \* EWM Plant 9/7/24
- 2016 Fall EWM Bed
- ▨ 2023 EWM Bed
- 2024 EWM Bed
