LAKE REDSTONE

2022-32 9-KEY ELEMENT WATERSHED AND LAKE MANAGEMENT PLAN

January 27, 2022

Developed by: Dave Blumer, Megan Mader, and Heather Wood
Lake Education and Planning Services, LLC
Cameron, WI 54822

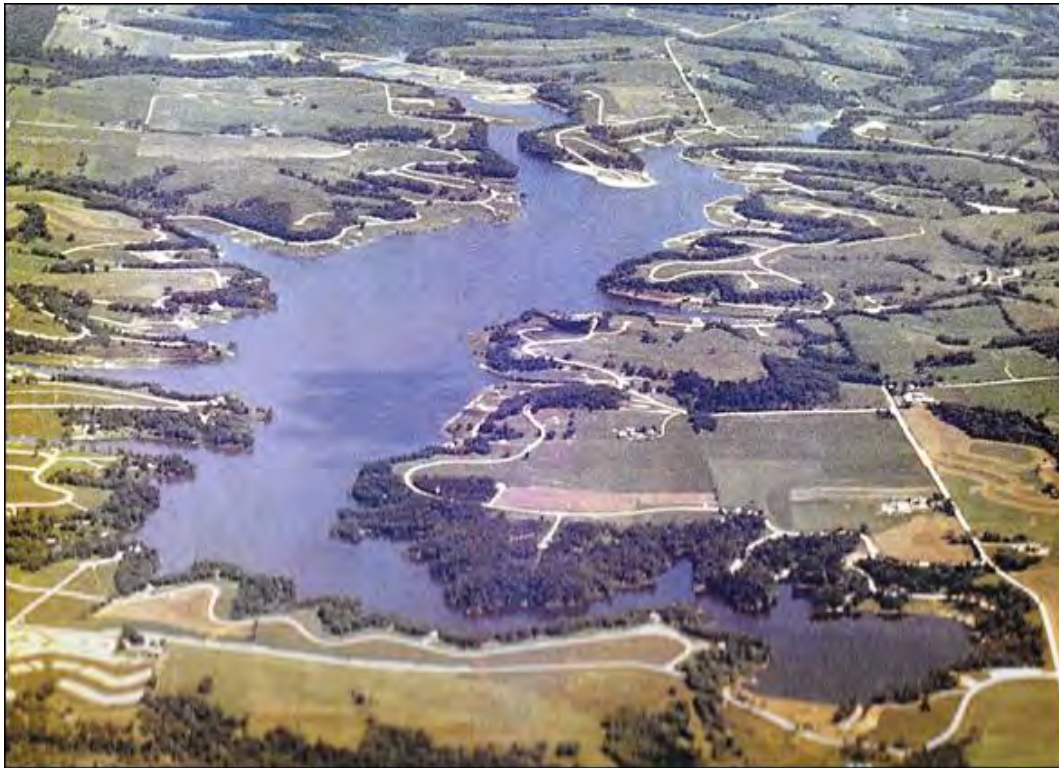
Figure 1: Lake Redstone shortly after filling. The two branches of Big Creek that flow into the lake are at the top of the picture. The dam is located at the lower right of the picture.

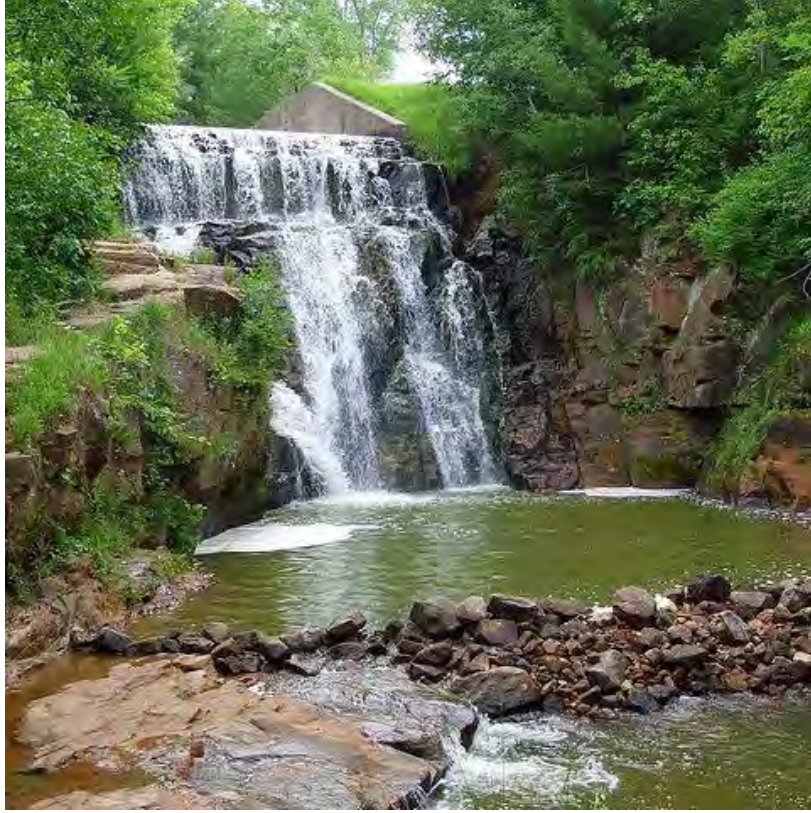
Figure 2: Cascading waterfall from the top draw spillway at the outlet of Lake Redstone (LRPD Facebook Page)

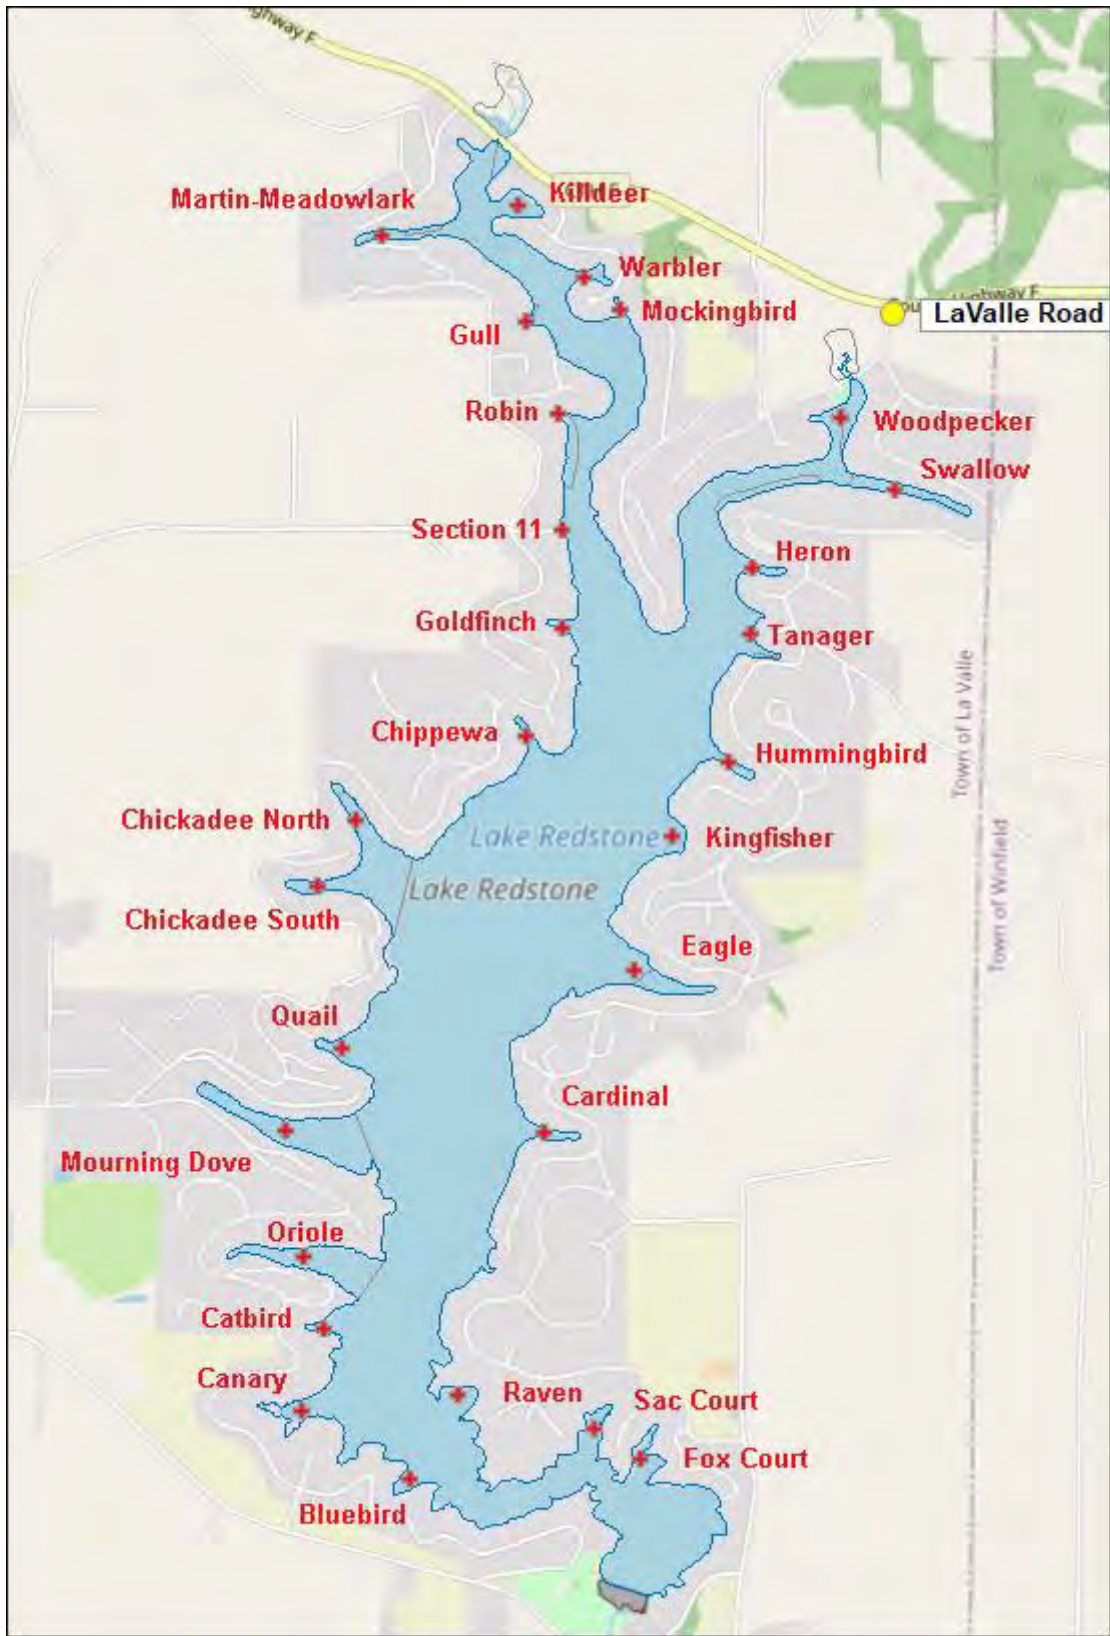
Figure 3: Individual bay names on Lake Redstone

The topography of Lake Redstone includes many fjord-type bays around the lake. Each of these bays drains some portion of the watershed or riparian area of the lake. When discussing the lake and management actions, individual bays are often referred to by name. These names are generally determined by the road that travels around the bay or the name of the sub-division associated with it (Figure 3).

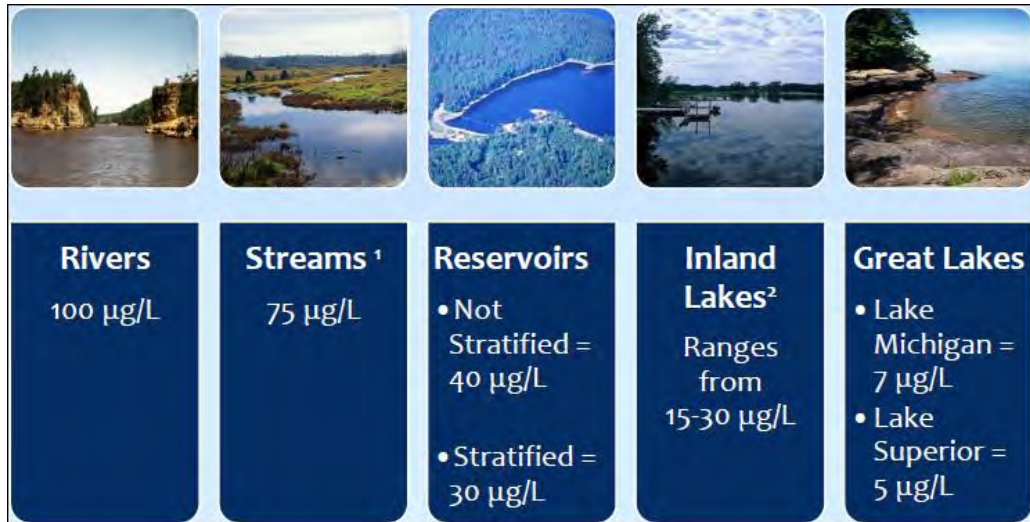
The Wisconsin acceptable standard for summer TP in the REC category for stratified reservoirs like Lake Redstone is a geometric mean concentration $\leq 30\text{-}\mu\text{g/L}$ (Figure 4). If the summer mean concentration of TP exceeds this level, the water is considered impaired. The Wisconsin assessment protocol for Chl-*a* is based on the number of days in a sampling season (July 15-September 15) that have moderate algal levels based on Chl-*a* concentrations that exceeds $20\text{-}\mu\text{g/L}$. Once that level has been exceeded, the amount of algae in the surface water it represents discourages people from swimming (Figure 5). If the concentration of Chl-*a* exceeds $20\text{-}\mu\text{g/L}$ on more than 5% of the expected lake use days, then the water is considered impaired.

Figure 4: Wisconsin numeric water quality standards for phosphorus (WI-DNR, 2019)

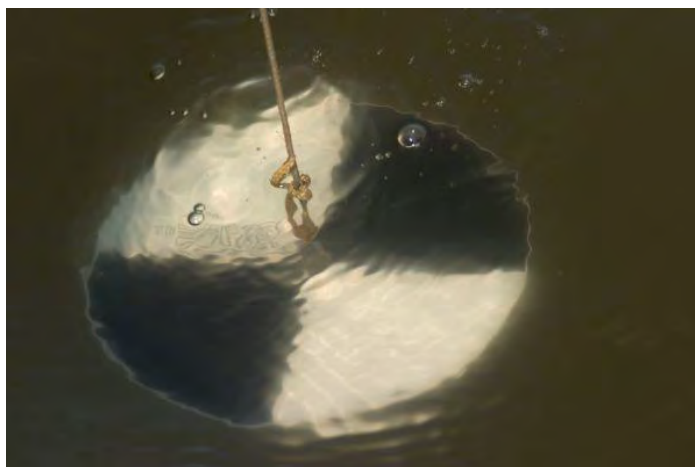
Water clarity is a measurement of how deep sunlight can penetrate into the waters of a lake. It can be measured in a number of ways, the most common being an 8” disk divided into four sections, two black and two white, lowered into the lake water from the surface by a rope marked in measurable increments (Figure 8). The water clarity reading is the point at which the “Secchi” disk when lowered into the water can no longer be seen from the surface of the lake. Water color (like dark water stained by tannins from nearby bogs and wetlands), particles suspended in the water column (like sediment or algae), and weather conditions (clouds, wind, or sunlight) can impact how far a Secchi disk can be seen down in the water. Some lakes have Secchi disk readings of water clarity of just a few inches, while other lakes have conditions that allow the Secchi disk to be seen for dozens of feet before it disappears from view.

Figure 8: Secchi disk

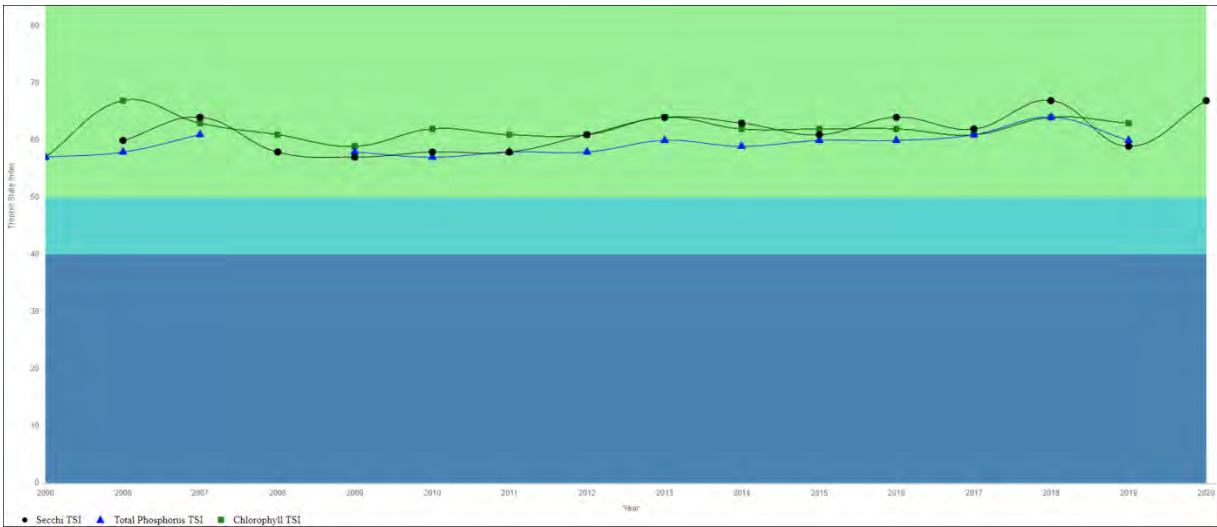
Figure 10: Lower Site (SWIMS ID 573129) – Navajo Court

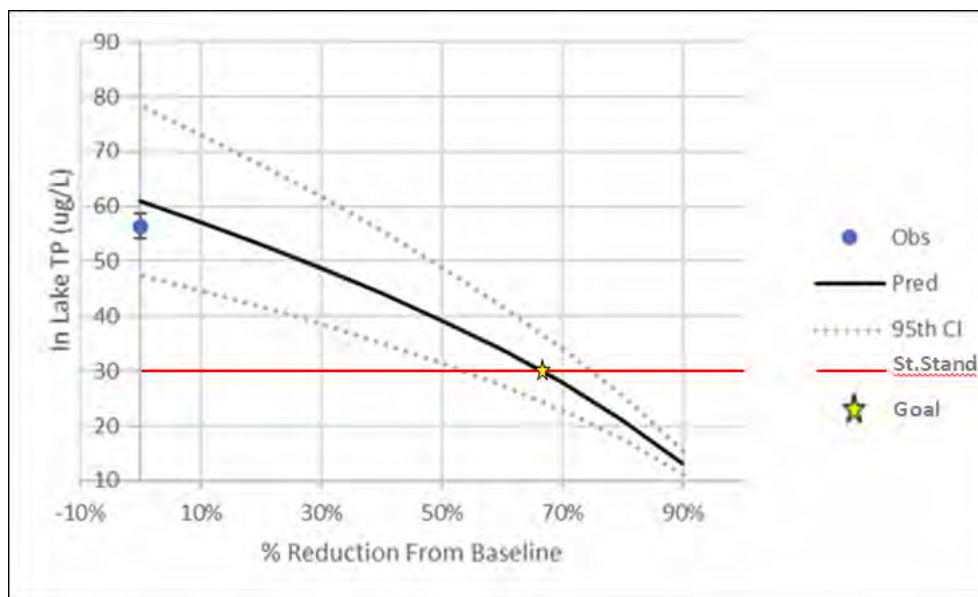
Figure 13: Bathtub predicted in-lake TP response to external TP load reductions. Error bars represent the 90th percentile confidence interval of observed values. The Star represents the goal for deep reservoirs like Lake Redstone set by the State of Wisconsin.

To provide some insight of potential lake response to reduced loadings, baseline TP loadings were reduced incrementally to evaluate resultant changes in in-lake TP concentrations (Figure 13). It is from this representation of the data that it is predicted that a 67% reduction in TP loading is necessary for the lake to meet state water quality standards. Note that these model outputs assume that the lake is in equilibrium with respect to any internal recycling (i.e. steady state condition). As watershed loads are reduced, there may be a lag in lake TP response as the system is adjusting to its new equilibrium. The length of this lag period is highly dependent on lake hydrology, morphometry, and sediment chemical characteristics. If substantial reduction in watershed loading is achieved and doesn't correspond to improvements in water quality; and if further investigation into the impact of and mechanisms controlling internal phosphorus recycling support them, then it may be appropriate at that time to implement practices like application of alum designed to control or minimize internal loading.

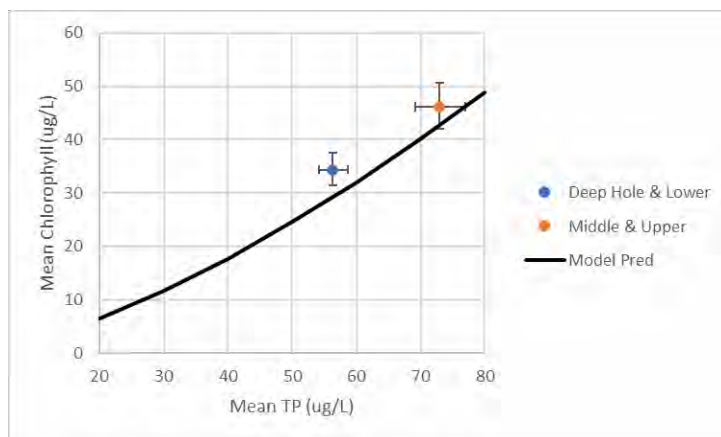
Figure 14: Jones & Bachman (1976) predicted mean Chl-*a* concentration. Error bars represent the 90th percentile confidence interval of observed values (Oldenburg, 2021).

best model fit. While the Jones & Bachman model was the best fit, based on measured Chl-*a* concentrations in the lake, it underestimates values. To account for this, and to provide a conservative estimate of the chlorophyll response, predictions from the model were adjusted upwards by 11%. Figure 14 reflects the expected change in Chl-*a* concentration with changes in TP concentration.

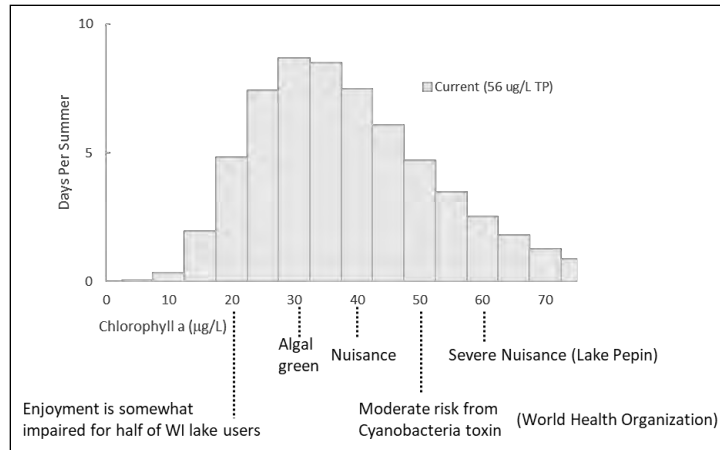
Figure 15: Estimated current distribution of chlorophyll bloom frequency for Lake Redstone in relation to user perception metrics (Oldenburg, 2021).

Figure 15 estimates the frequency and intensity of algae blooms in Lake Redstone based on current summer conditions under all three of these metrics.

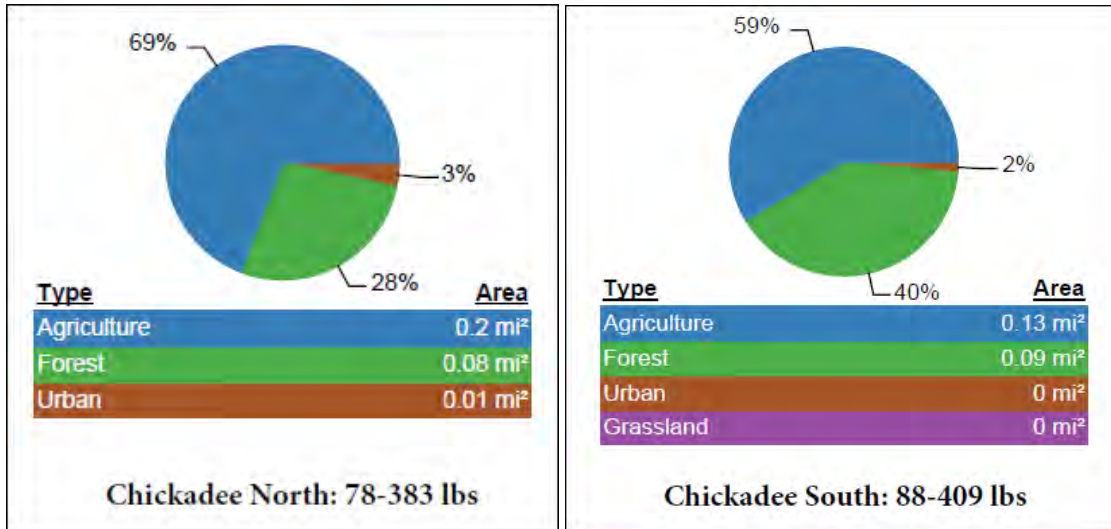
Figure 22: PRESTO outputs for land use and estimated annual phosphorus loading from Chickadee North and Chickadee South

For each area delineated, a PRESTO report was generated to better define the contributing area to each bay (Figures 22-24). If the mean annual loading of phosphorus from each of these reaches is used and compared to the STEPL estimate of phosphorus loading from the entire Lower Lake Redstone sub-basin, they account for 26.8% of what is potentially entering Lake Redstone from this sub-basin.

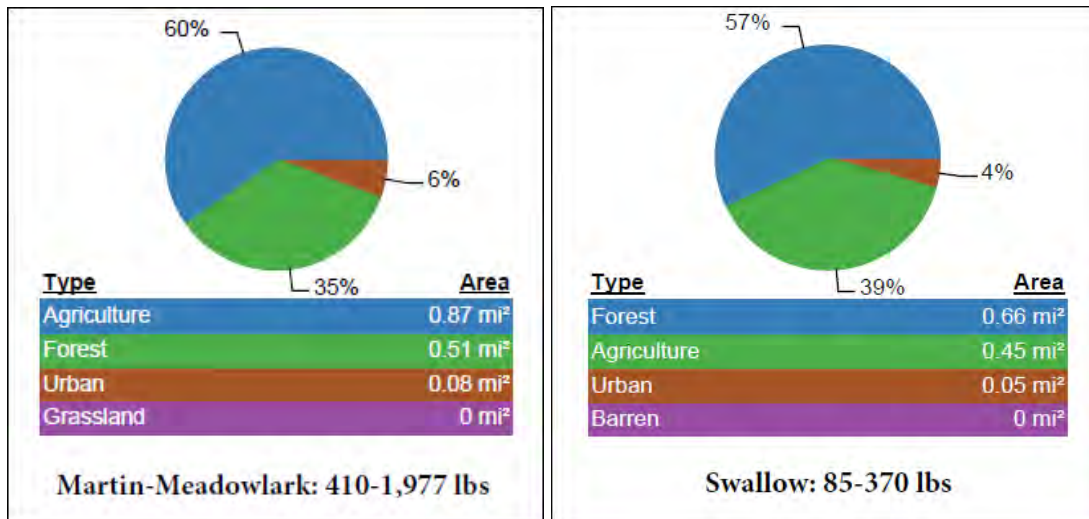
Figure 23: PRESTO outputs for land use and estimated annual phosphorus loading from Martin-Meadowlark and Swallow

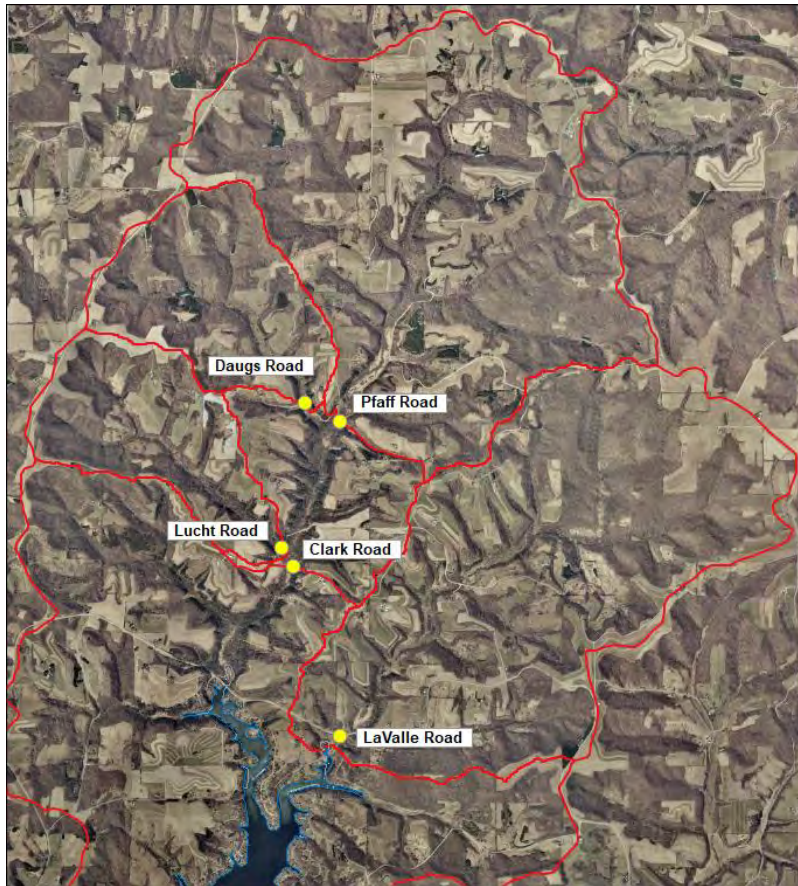
Figure 32: 2018-2020 Tributary Sampling Sites

Starting in 2018, Juneau and Sauk Counties partnered with the LRPD and their consultant to try and determine nutrient and sediment loading from the two major tributaries (east and west branches of Big Creek) flowing directly into the lake, and three tributaries flowing out of the Daug's, Lucht, and Pfaff sub-basins into the west branch of Big Creek (Figure 32). Basic stream flow and volume determination using pressure transducers, stream gauges, and volunteer data collection following guidelines in the Water Action Volunteer Stream Monitoring Program⁴ along with collection of water samples to test for an array of water quality parameters (Table 14) were to be conducted manually by LRPD volunteers. Loading calculations were to be completed by Juneau and Sauk County personnel.

With the installation of the automated sampling equipment, sampling of the smaller streams coming from the Daug, Lucht, and Pfaff sub-basins was suspended in 2020. However, two other sites were added where perennial streams enter Martin-Meadowlark and Swallow Bays. Monitoring of these two sites was added to begin to try and determine nutrient and sediment loading from smaller stream reaches within the watershed that form gullies that drain directly into Lake Redstone in the Lower Redstone sub-basin.

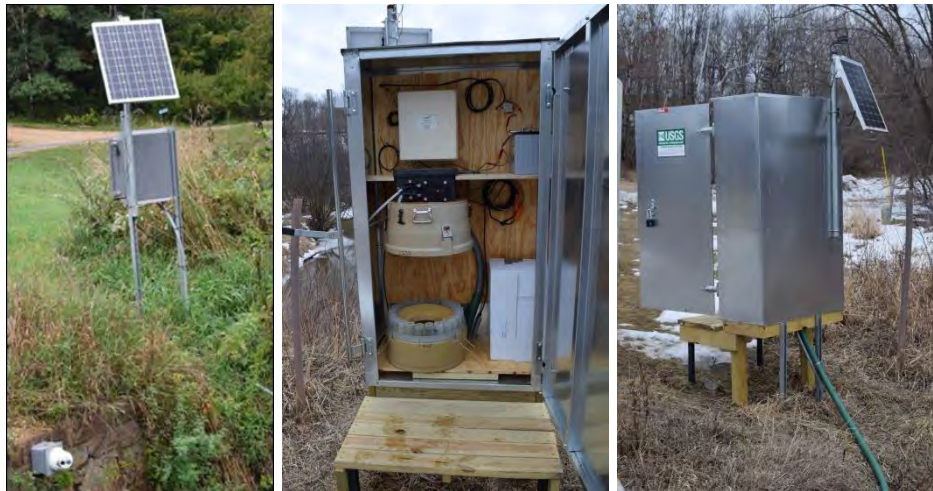
In 2019, the LRPD, their consultant, and the counties partnered with the USGS to explore a different method of collecting site discharge data – camera image stage-interpretation. This technology involved the installation of cameras to provide continuous monitoring of stream stage, while volunteers continued to collect monthly baseline water samples (Figure 33).

In 2020, in cooperation with the USGS automated sampling equipment was installed at the monitoring stations on the east branch (LaValle Road) and west branch (Clark Road) of Big Creek (Figure 33). The automated sampling equipment mechanically collects 6-8 water samples during a given storm event. Following the storm, LRPD volunteers collect the water samples from the sampling stations and ship them to USGS labs for analysis of TP and TSS. Based on the data provided by this analysis along with stream flow provided by the monitoring equipment, the total load of phosphorus and suspended solids entering the lake can be more accurately calculated by USGS staff. The automated sampling stations will remain in place as long as there is funding to support it.

Figure 33: Camera installation for “camera image stage-interpretation” (left) (K. Keegstra, 2019); Typical USGS recording streamflow-gaging station with automatic water sampler for load determinations (middle & right) (K. Keegstra, 2021)

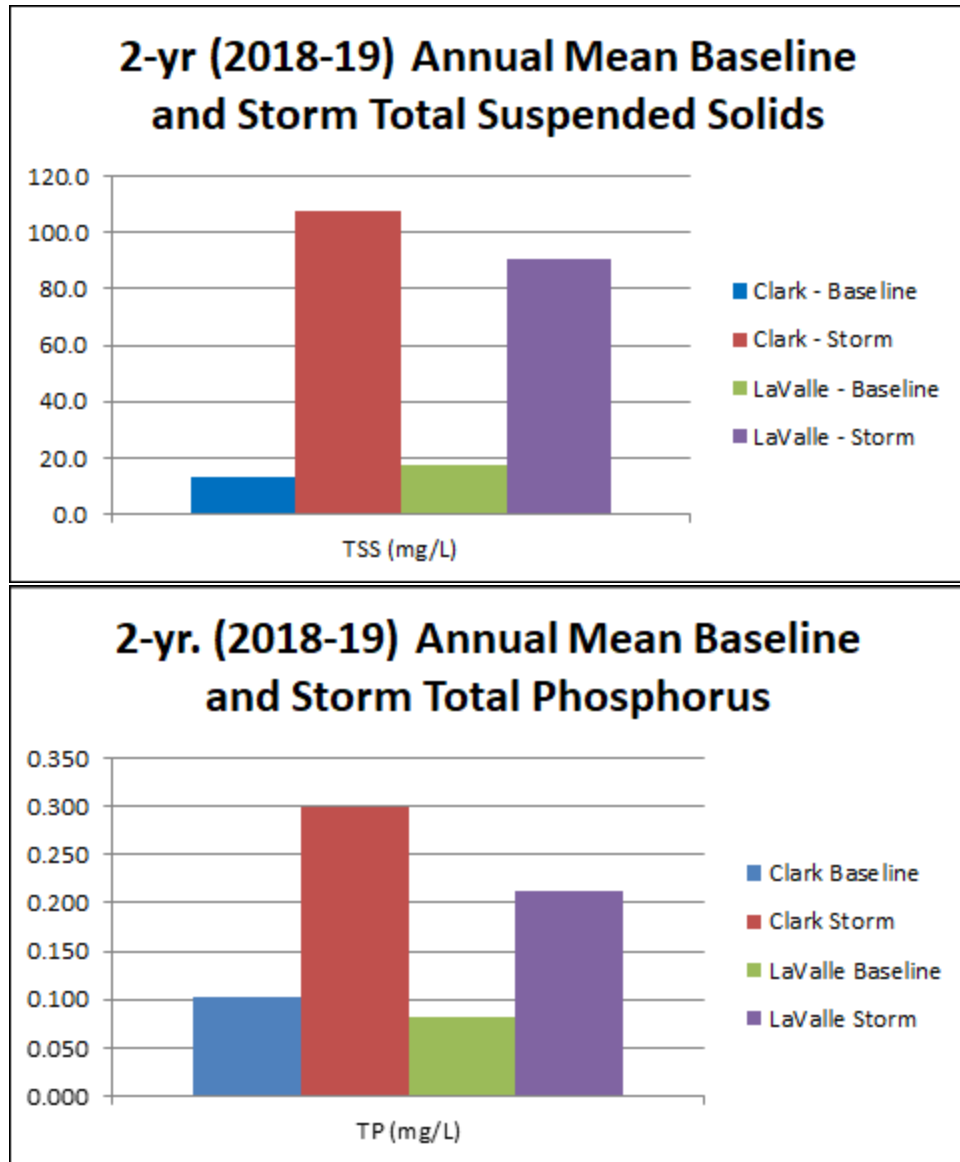
Figure 34: Comparisons of TSS (top) and TP (bottom) concentrations in water samples collected from Clark Road (west branch of Big Creek) and LaValle Road (east branch of Big Creek)

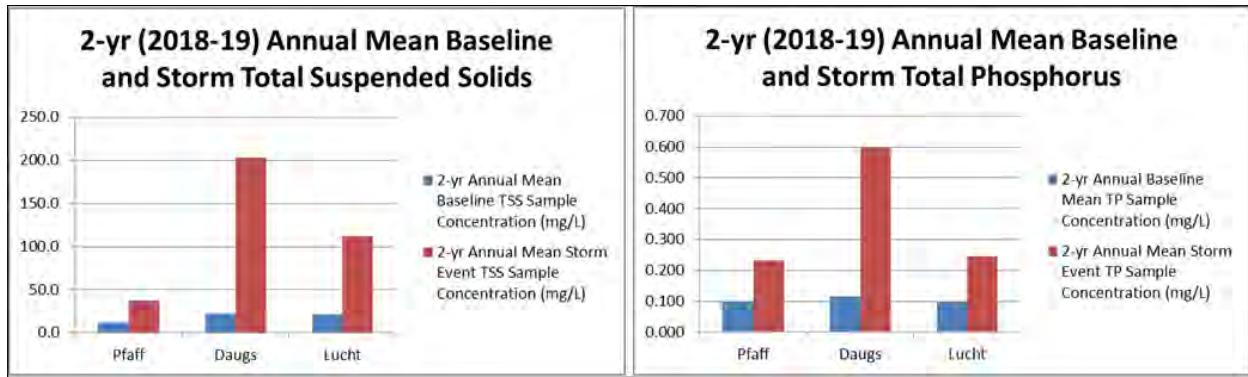
Figure 35: Comparisons of TSS and TP concentrations in water samples collected from Pfaff, Daug's, and Lucht sub-basins

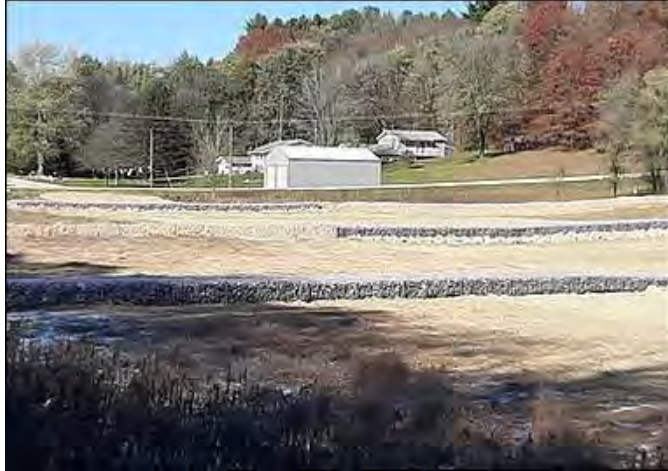
Many of the bays around the lake have had runoff-reducing BMPs installed on them in the past including rock chutes, energy stilling basins, and retention basins (Figure 37). One example is a single dirt berm at the head of Mourning Dove Bay that was replaced in 2020 with three rows of gabion baskets filled with rock after having been washed out and repaired after flooding in 2008, and again in 2018 (Figure 38). Currently, the LRPD is seeking bids for another repair project at the head of Swallow Bay where a spillway was damaged during the 2018 flooding.

Figure 38: Stone-filled gabion baskets placed at the head of Mourning Dove Bay (LRPD Website)

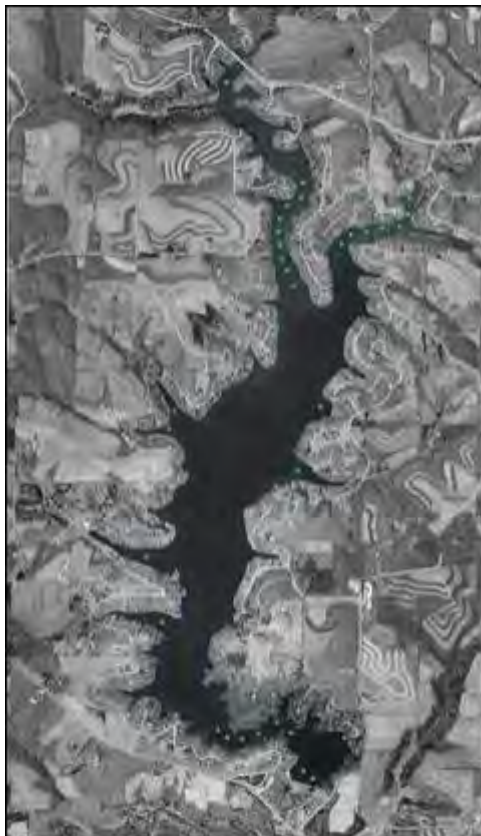
buoys essentially wherever the distance from shore to shore is 400-ft or less (Figure 39). In addition, the Town of LaValle has an ordinance (Section 11.01.05 Controlled Areas), that establishes an Emergency Slow No-Wake designation for all of Lake Redstone during high water conditions. Aquatic invasive species education, planning, and prevention activities/BMPs including Clean Boats, Clean Waters and AIS monitoring are implemented on a regular basis by the LRPD and supported by the Town of LaValle and LRPOA.

Figure 39: Approximate location of buoys designating “no-wake” areas on Lake Redstone (Town of LaValle)

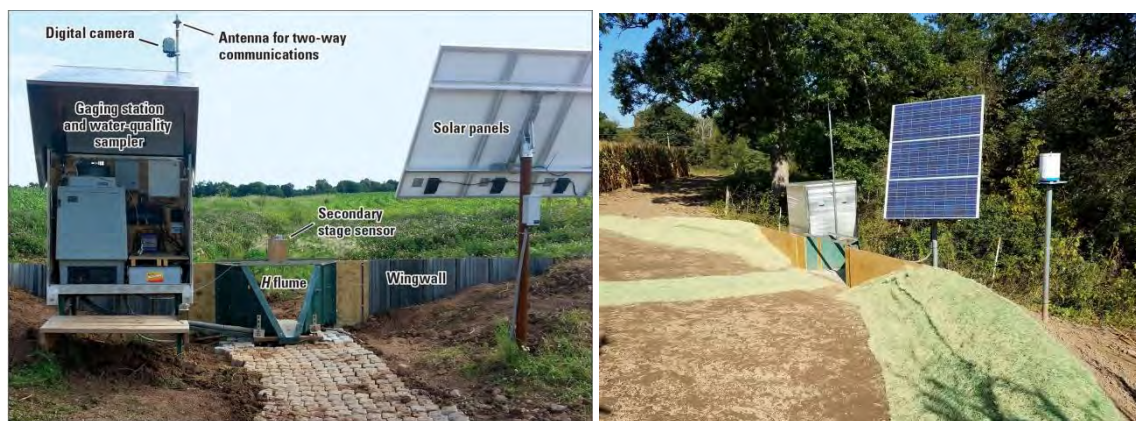
Two edge-of-field monitoring stations were installed in the watershed to measure and collect runoff from monitoring basins (Figure 40). Located in the Driftless area of the state, this region is geologically unique with land areas that were by-passed by the glaciers leaving steep terrain susceptible to flash runoff events and erosion that can increase the amount of sediment and nutrients lost from agricultural land and carried into streams, rivers, and lakes. Samples are collected with remote technical assistance from the USGS, and are analyzed for nitrogen, phosphorus and sediment. The Juneau County LWR Department performs sample collection and site maintenance at edge-of-field monitoring stations.

Figure 40: Example edge-of-field surface water monitoring station/system (left); actual Lake Redstone watershed edge-of-field monitoring station

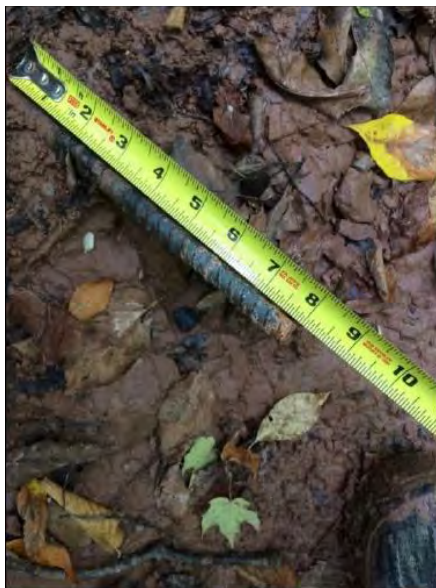
Figure 43: Erosion pin inserted into a streambank showing 8” of soil eroded after inspection in Kankapot Creek, Calumet County, Wisconsin.

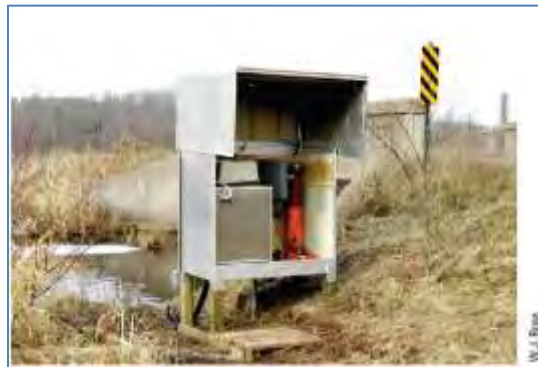
Figure 10 – Typical U.S. Geological Survey recording streamflow-gaging station with automatic water sampler for load determinations (Garn, Elder, & Robertson, 2003).

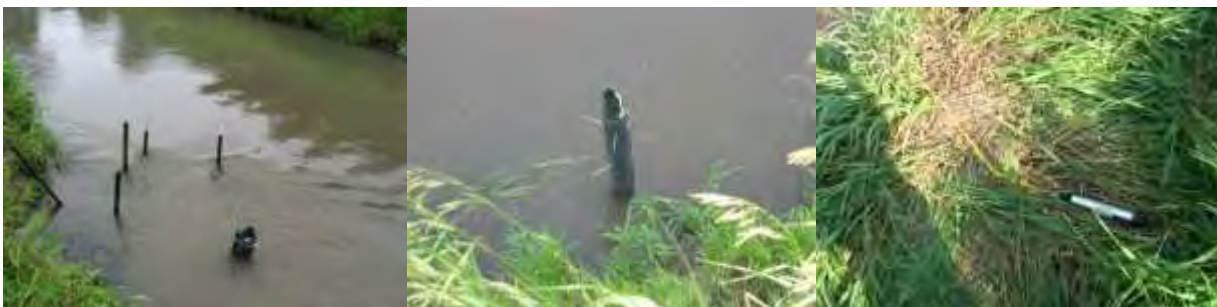
Figure 11 – Installation of pressure transducers (data logger) to measure depth of water (Papanicolaou, 2017)

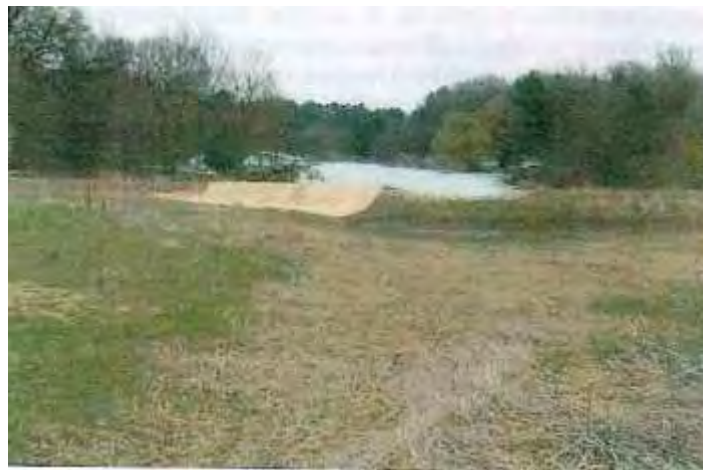
Figure 16- Sediment Trap at Mourning Dove Bay (Montgomery Associates Resource Solutions, LLC, 2011)

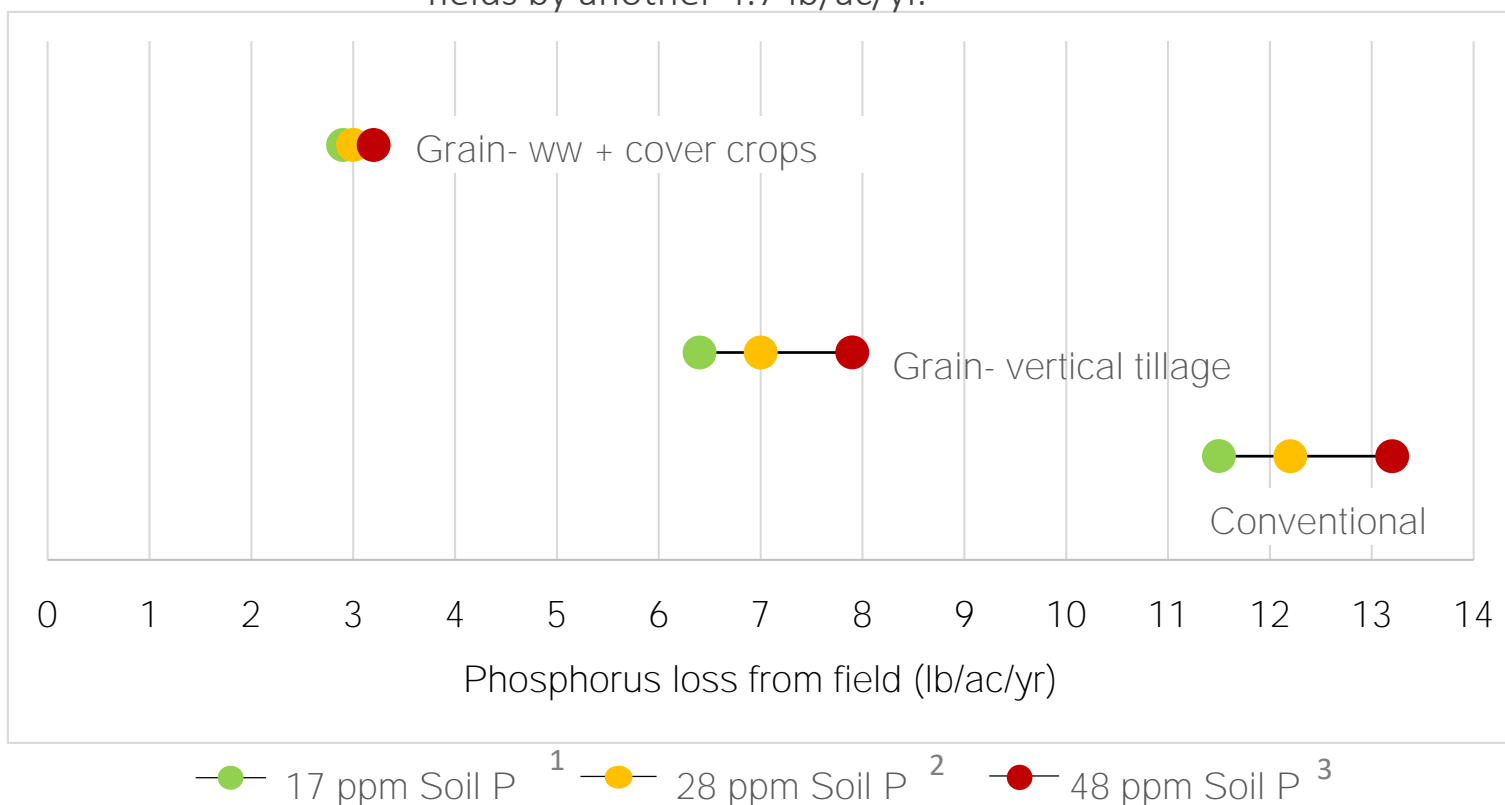
The Wisconsin Phosphorus Index (PI) estimates the average annual runoff P from a farm field based on: manure application rate and timing, P fertilizer additions, soil test P, crop rotation and field operations.
