**Cold-water Aquatic Invasive Species Shoreline Survey
and Warm-water Point-intercept Macrophyte Survey
Murphy Flowage - WBIC: 2110900
Rusk County, Wisconsin**

Endangered Resource Services, LLC
Matthew S. Berg, Research Biologist
St. Croix Falls, Wisconsin
June 5 and July 31, 2023

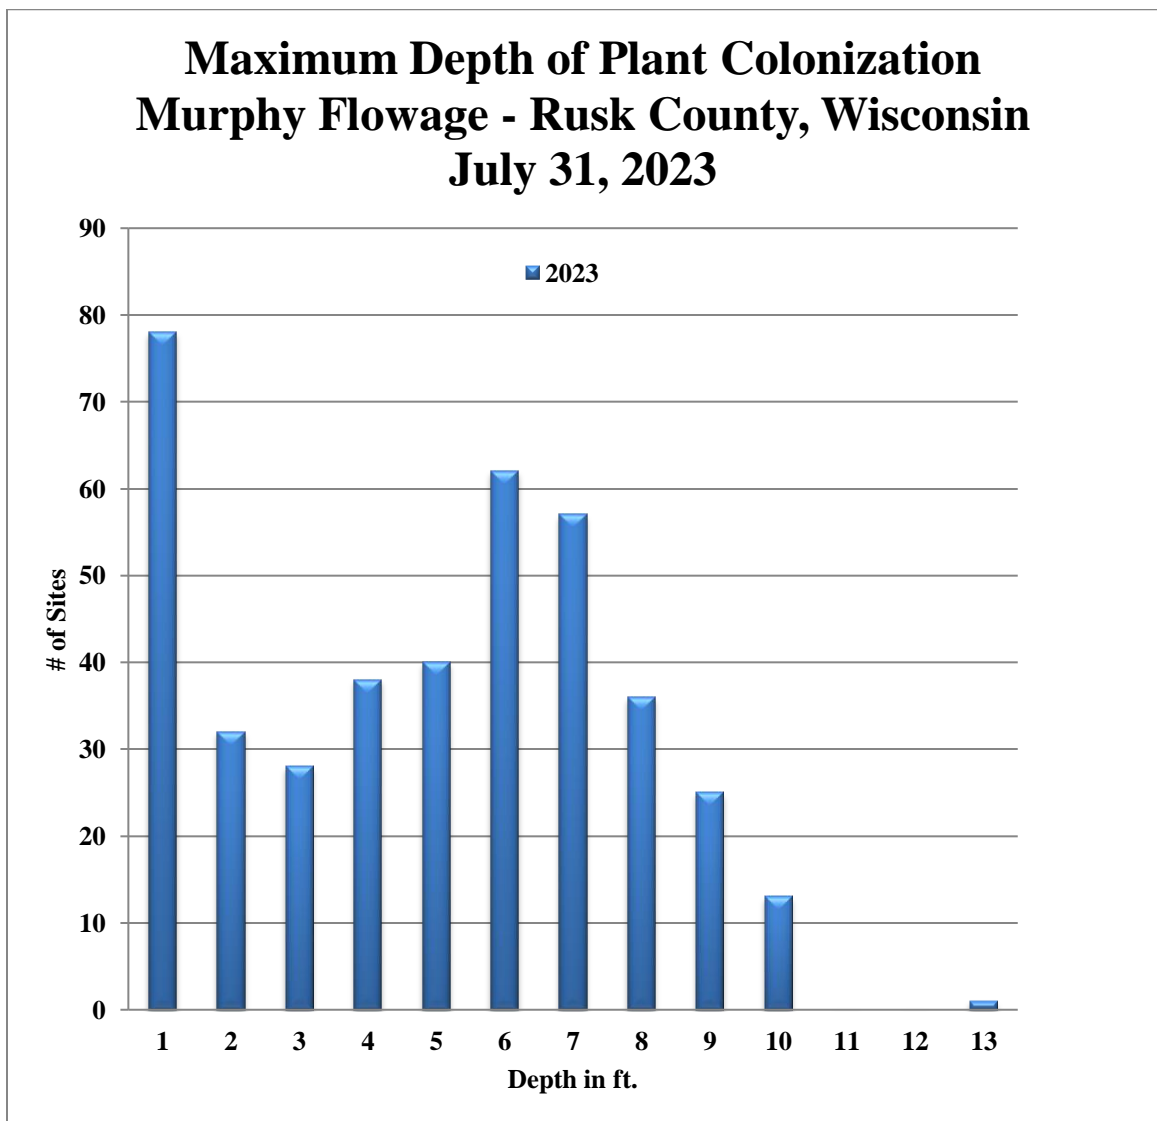
Figure 6: Plant Colonization Depth Chart

We found plants growing at 410 points (Table 1). As the entire flowage fell into the 13.0ft littoral zone, this extrapolated to 93.6% of the total lake bottom having plants present (Figure 5) (Appendix IV). Overall plant colonization was slightly skewed to shallow water as the mean depth of 4.6ft was less than the median depth of 5.0ft (Figure 6).

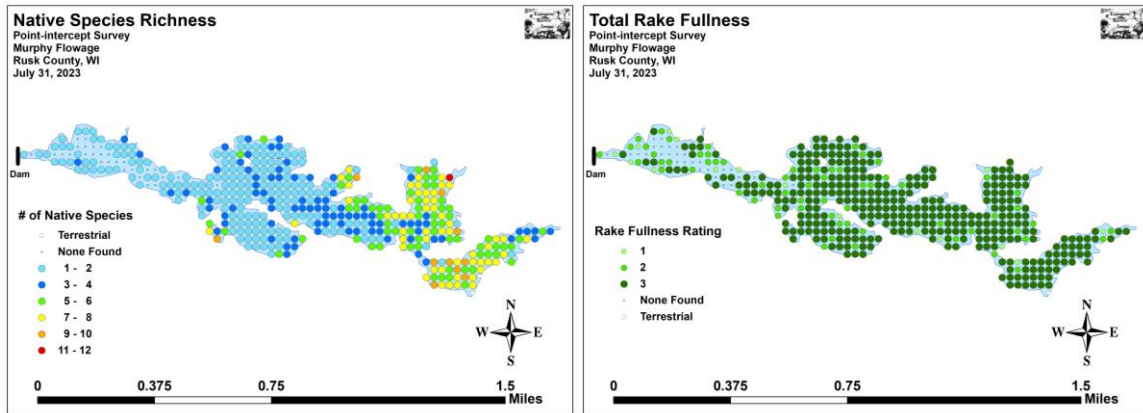
Figure 7: Native Species Richness and Total Rake Fullness

Localized richness was moderately high as we calculated a mean native species at sites with native vegetation of 3.50 species/site. We noted that almost all points in the shallow muck flats in the Lawler and Hemlock Creek Inlet bays, as well as the boggy areas at the far ends of the south-central bay, had at least five species present in the rake. Conversely, we found that few samples taken in over 6ft had more than two species in the rake (Figure 7) (Appendix IV).

We determined the biomass at sites with vegetation was an exceptionally high mean total rake fullness of 2.77. Visual analysis of the map showed that almost all areas shallower than 9ft were dominated by dense vegetation, and plant beds were canopied in most areas that were shallower than 6ft (Figure 7) (Appendix IV).

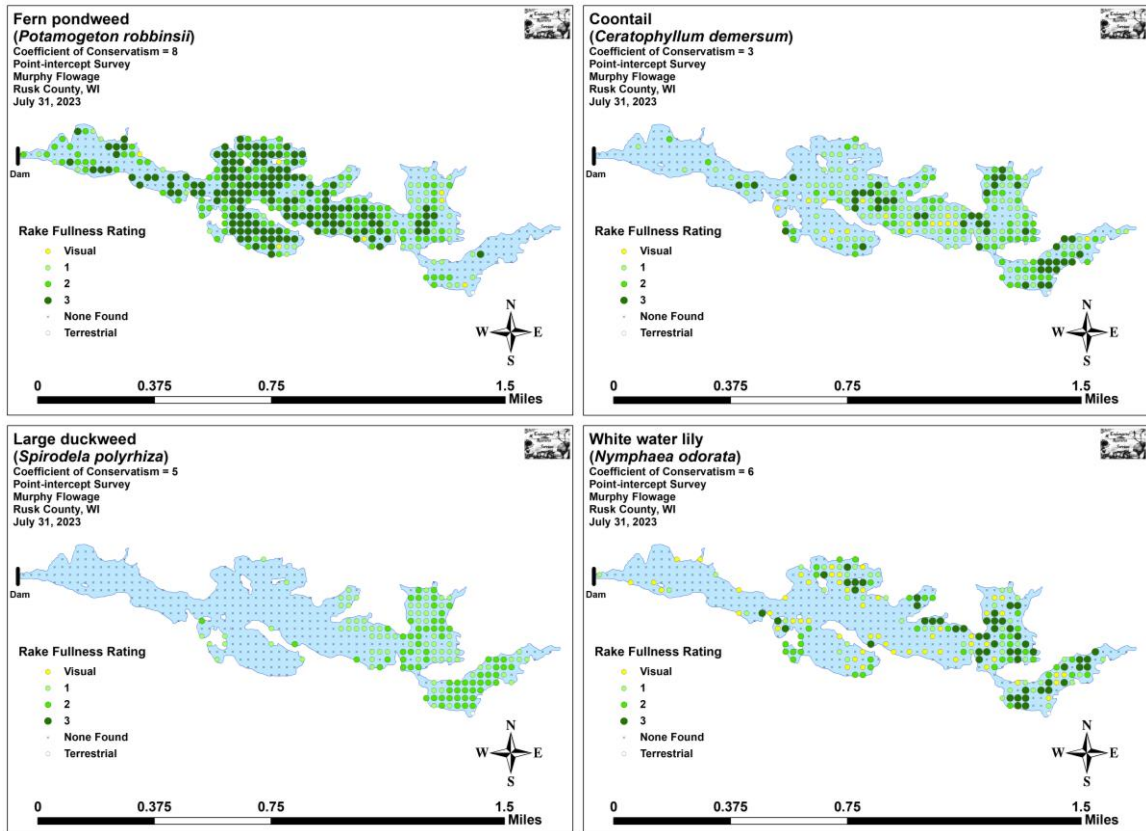
Figure 8: Murphy Flowage's Most Common Species

When considering the flowage as a whole, Fern pondweed, Coontail, Large duckweed, and White water lily were the most widely-distributed macrophyte species (Figure 8). They were present at 77.80%, 56.34%, 35.37%, and 33.17% of survey points with vegetation respectively; and, collectively, they accounted for 57.75% of the total relative frequency (Table 2). Small duckweed (8.41%), Common watermeal (7.85%), and Common waterweed (4.49%) were the only other species with relative frequencies over 4.00% (Native species maps and species accounts for all plants are located in Appendixes V and VI).

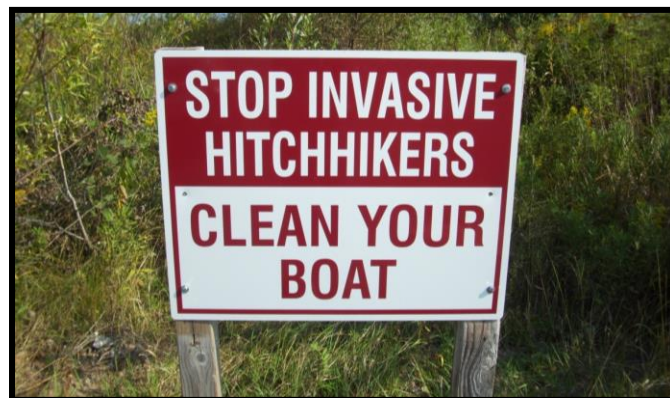
Figure 14: Potential Secondary Sign to be Placed Near the Water's Edge

With no landing monitoring program in place, a small standard WDNR AIS sign is currently serving as the "guardian of the lake". Adding a secondary sign that is located at the waterline is another potential actionable item for the RCLA to consider. Hopefully, a simple bright sign will increase the chances that visitors will remember to check their boat carefully before launching (Figure 14).
