# **Aquatic Invasive Species Meandering Visible Littoral Zone Survey Long Lake (WBIC: 2478200) Polk County, Wisconsin**

Long Lake Protection and Rehabilitation District, Harmony Environmental,  
and the Wisconsin Department of Natural Resources – (Grant ACEI20218)

Endangered Resource Services, LLC  
Matthew S. Berg, Research Biologist  
St. Croix Falls, Wisconsin  
August 19, 2023

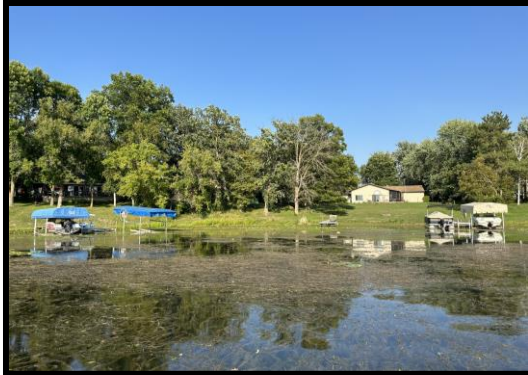
Dense mat of canopied NWM in Long Lake's southeast bay (8/19/23)

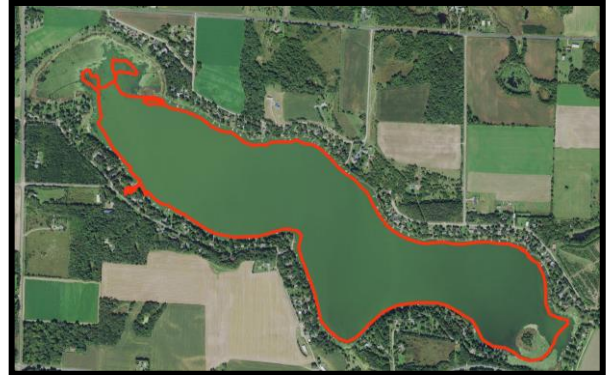
Aerial photo with survey tracks (8/19/23)

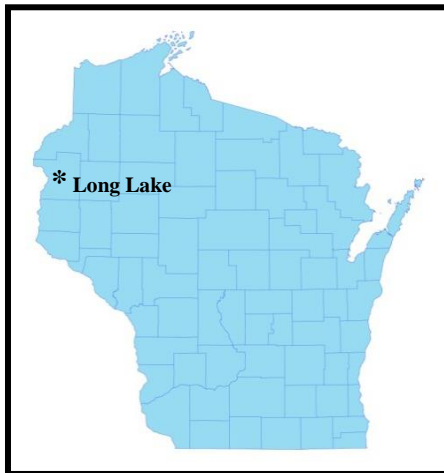
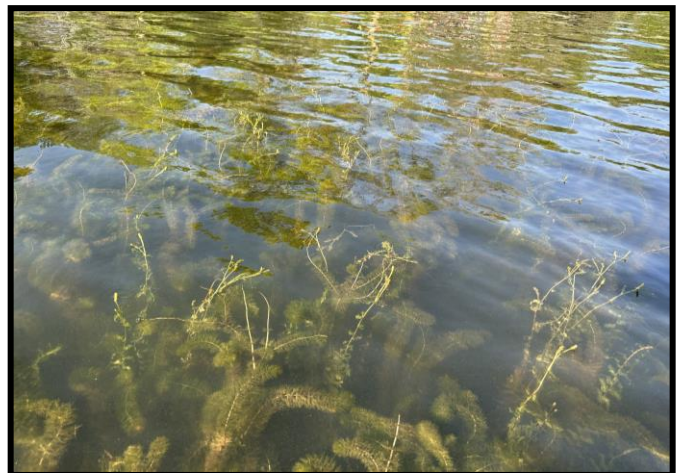
Close-up photo of a dense Northern water-milfoil bed (8/19/23)

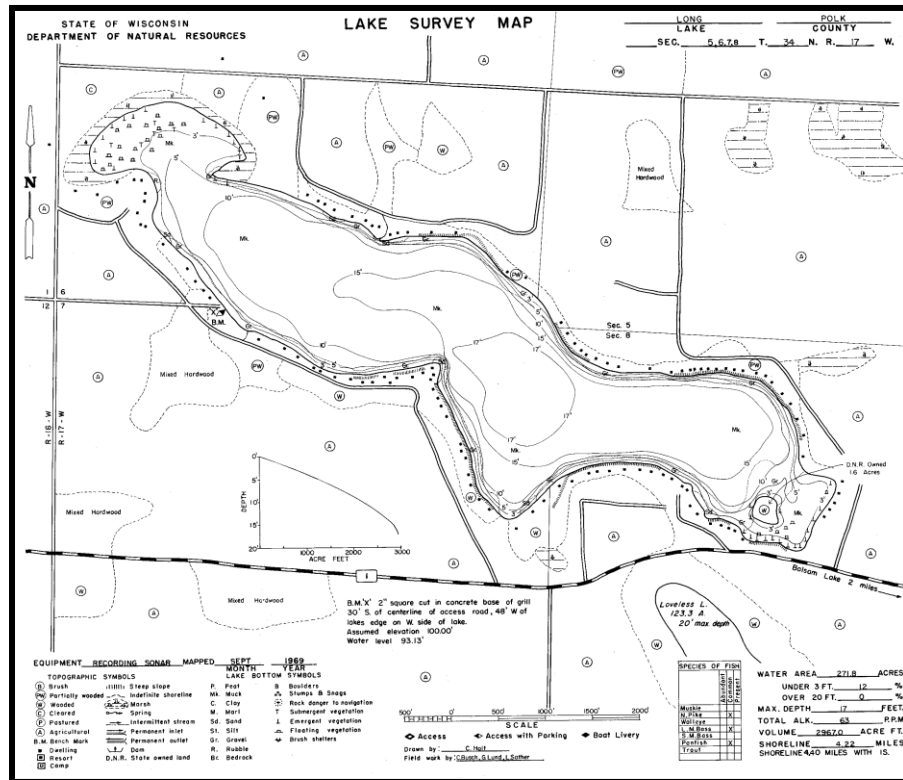
**Figure 1: Long Lake Bathymetric Map**

Long Lake (WBIC 2478200) is a 272-acre seepage lake in central Polk County, Wisconsin in the Town of Balsam Lake (T34N R17W S5-8). It reaches a maximum depth of just over 17ft in the central basin and has an average depth of approximately 11ft (Busch et al. 1969) (Figure 1). The lake is eutrophic and visibility is generally poor with summer Secchi readings averaging 5.1ft since 1992; however, **the 2021 mean reading of 12.0ft (the most recent year available) was the highest since records began** (WDNR 2023). The bottom substrate in the lake's bays and central basin is predominately thick organic muck, while exposed points and most north/south shorelines are dominated by gravel and sand.

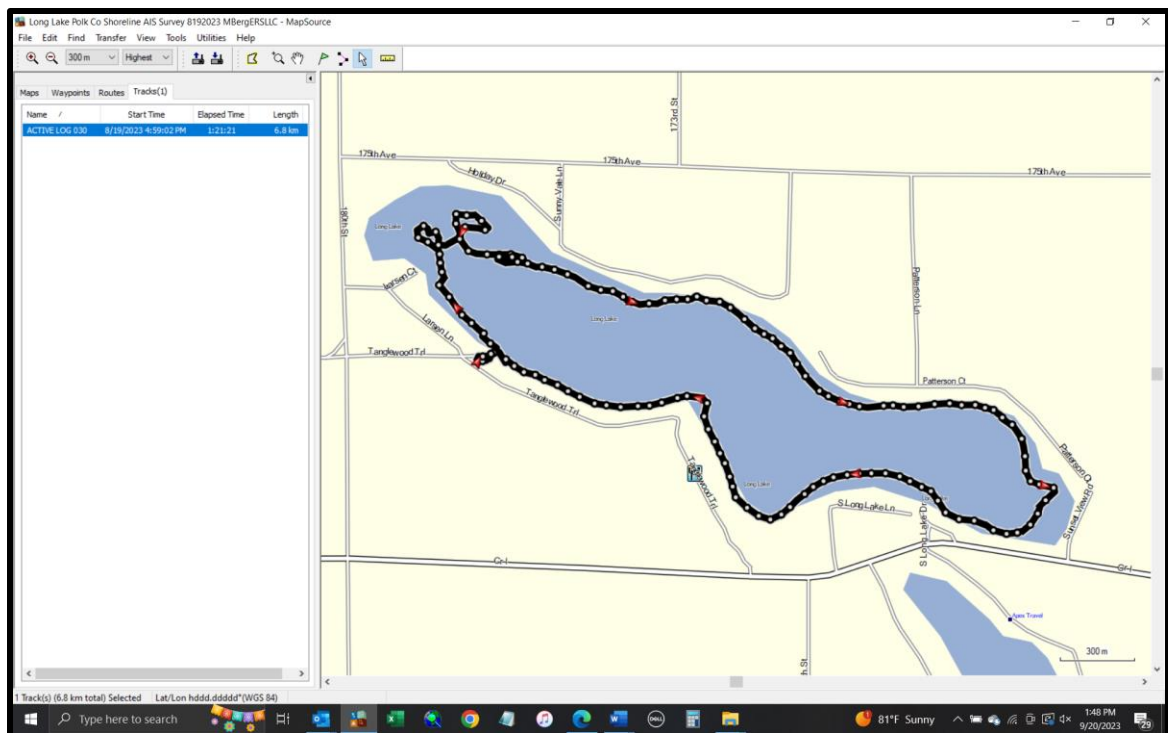
Figure 2: 2023 Shoreline Survey Tracks

We surveyed transects totaling 6.8km (4.2 miles) throughout the lake's visible littoral zone (Figure 2), but we **did NOT find any evidence of Purple loosestrife or Eurasian water-milfoil anywhere around or in Long Lake**. However, we again noted that the lake has large amounts of Northern water-milfoil (NWM) (*Myriophyllum sibiricum*) – a native species that is closely related to EWM and abundant in <3m of water; especially in the southeast bay (see the cover page of this report). Despite their superficial resemblance, EWM and NWM can be told apart by their number of leaflets – NWM has <24 whereas EWM normally has >26 (Figure 3). EWM also tends to have a bright red growth tip on the top of the plant whereas NWM has a bright lime green growth tip. In the fall, NWM forms winter buds on the tips of shoots whereas EWM has none.

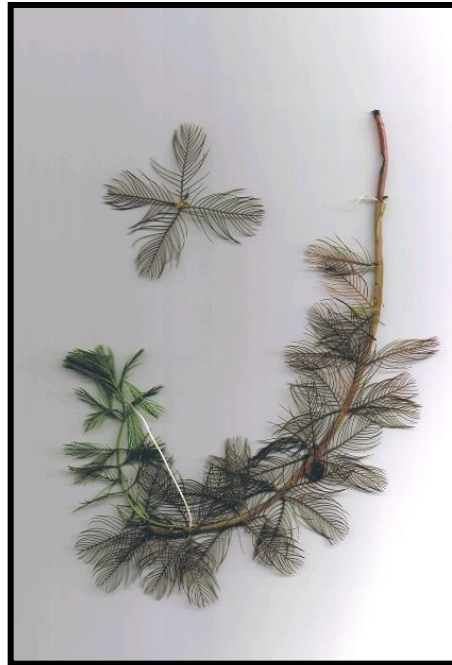
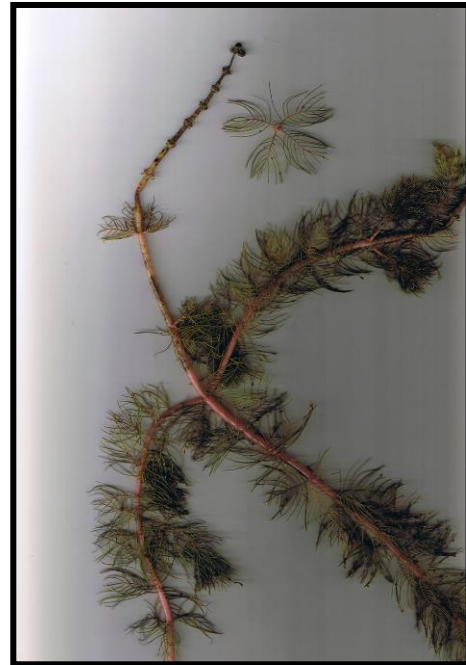
**Figure 3: Eurasian and Northern Water-milfoil Identification (Berg 2007)**

Eurasian water- milfoil

Northern water-milfoil

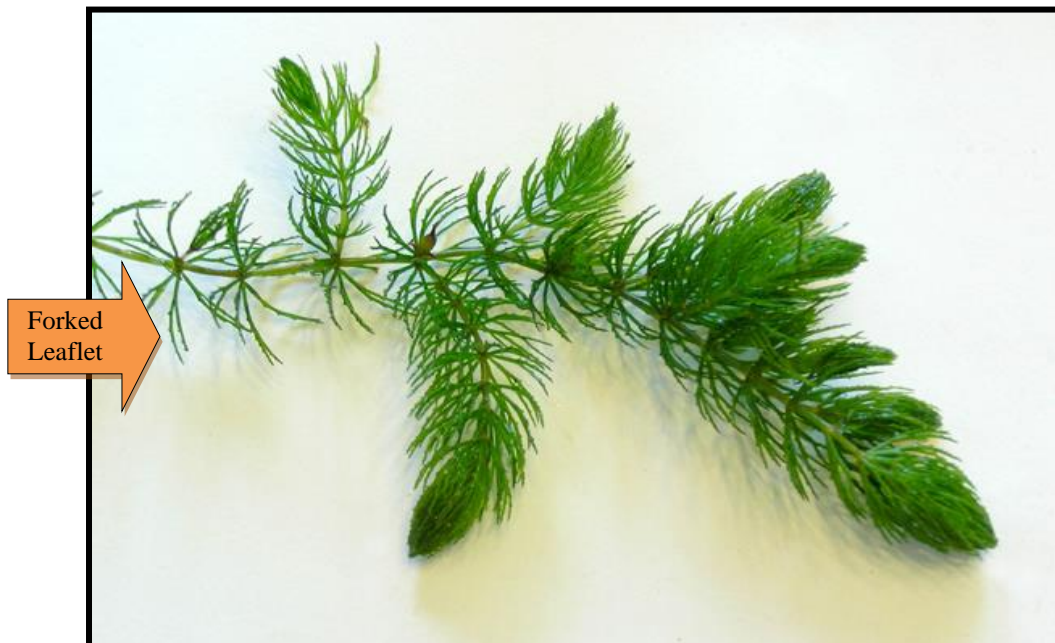
**Figure 4: Coontail Identification (Hassler 2011)**

Coontail (*Ceratophyllum demersum*), another somewhat similar looking beneficial native species, was also present in large numbers. It was especially common in the northwest bay and on the outer edge of the littoral zone in 3-4m of water over sandy and organic muck substrates. Unlike the milfoils, Coontail's leaflets fork and have tiny spines (Figure 4).
