# Curly-leaf pondweed (*Potamogeton crispus*)

## Pretreatment and Follow-up Surveys

### Long Lake - WBIC: 2478200

### Polk County, Wisconsin

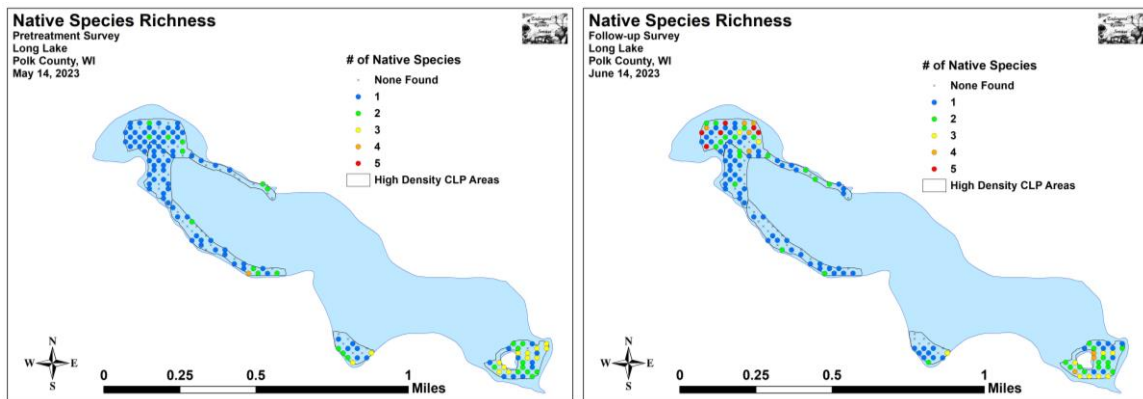
**Figure 6: Pretreatment/Follow-up Native Species Richness**

We found localized native species richness to be quite low throughout the lake. Mean richness at points with native plants climbed from 1.42 species/site in May to 1.87 species/site in June – a moderately significant increase ( $p=0.002$ ). Analysis of the maps showed most of these increases occurred in the northwest and southeast bays (Figures 6) (Appendix IV).

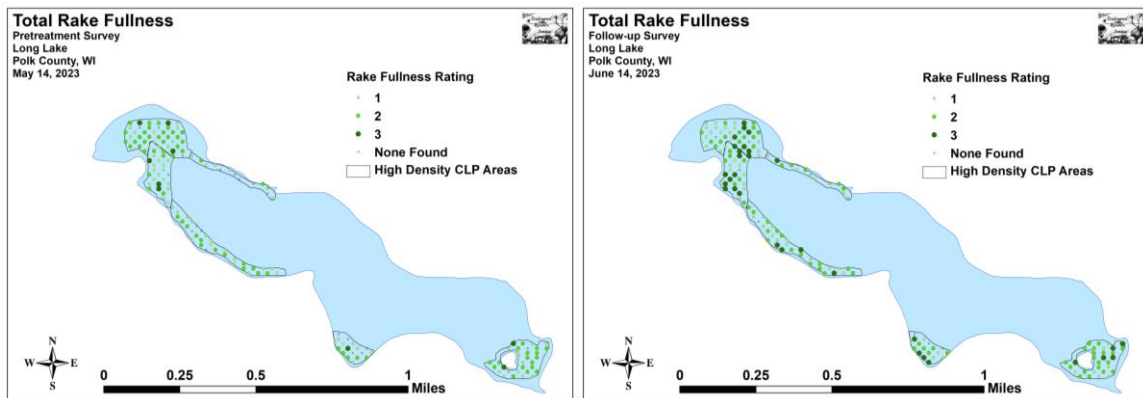
**Figure 7: Pretreatment/Follow-up Total Rake Fullness**

Total mean rake fullness was a low/moderate 1.61 in May before undergoing a moderately significant increase ( $p=0.002$ ) to a mean of 1.73 in June (Figures 7) (Appendix IV).
