1.0 INTRODUCTION

Found Lake is a 336-acre drainage lake in Vilas County that has a maximum depth of 21 feet (Photo 1.0-1). Found Lake is located within the St. Germain River Watershed. The Found Lake Property Owners Association (FLPOA) contracted Onterra to conduct an AIS monitoring survey during 2018 as outlined within their lake management plan (*Town of Saint Germain Lake Management Plan* - April 2013).

Map 1
Found Lake
 Vilas County, Wisconsin
June 2021
EWM Survey Results

Map 3
Found Lake
Vilas County, Wisconsin
June 2022
EWM Survey Results

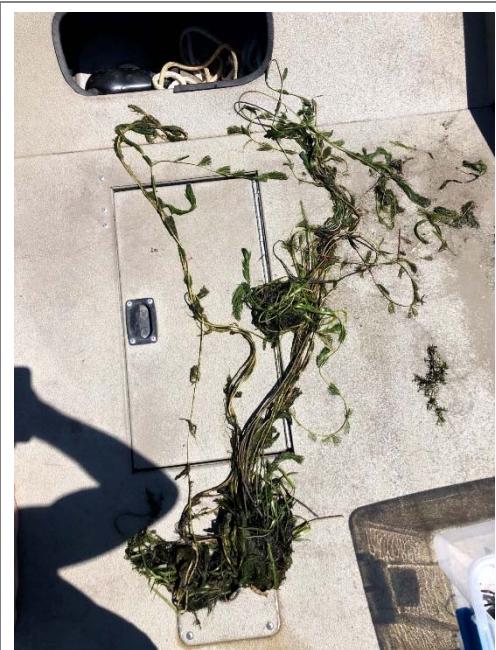
Photograph 3.1-1. EWM harvested from Found Lake during Onterra's June 23, 2021 Survey. Photo credit Onterra.

During the survey, crews located three EWM plants just north of island in about 6 feet of water (Map 1). The plants were growing up to the surface and slightly canopying. One of Onterra's ecologists got in the water, followed the plants down, and removed them by the roots. All three plants were removed with a high confidence level of removing the entire root crown. The other crew member on the boat kept a look out for fragments during the process. The extracted plants are shown in Photo 3.1-1. Following the removal efforts, the crew continued to scour the area both from the surface and with the submersible camera, not locating any additional EWM. The crew also searched the original area located in June 2018 from the surface and with the underwater camera, not detecting any EWM.

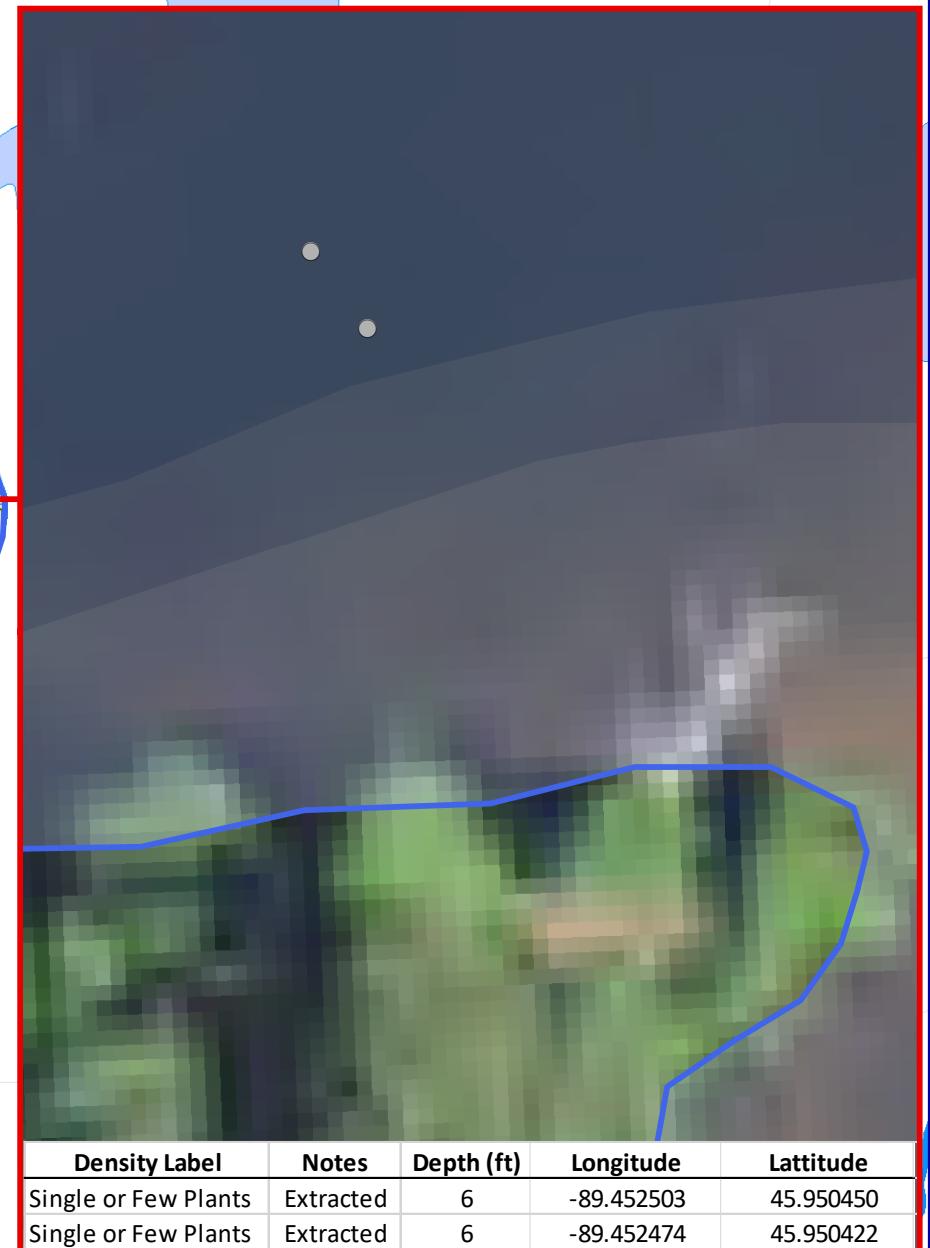
EWM Single or Few Plants
 (6/23/2021)

Historic EWM Occurrence
 (6/21/2018)

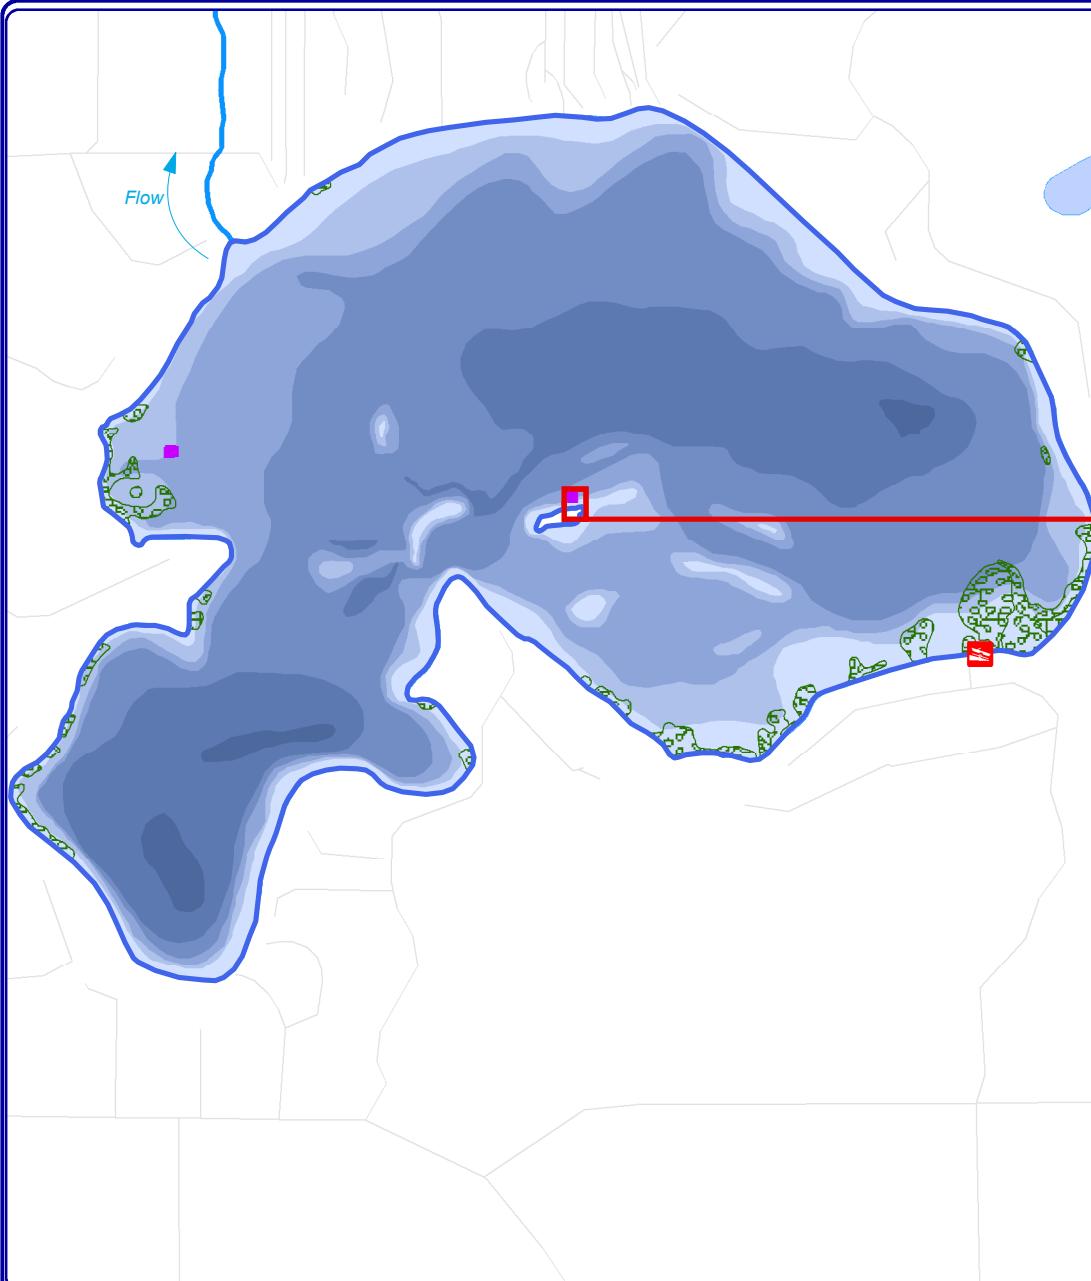
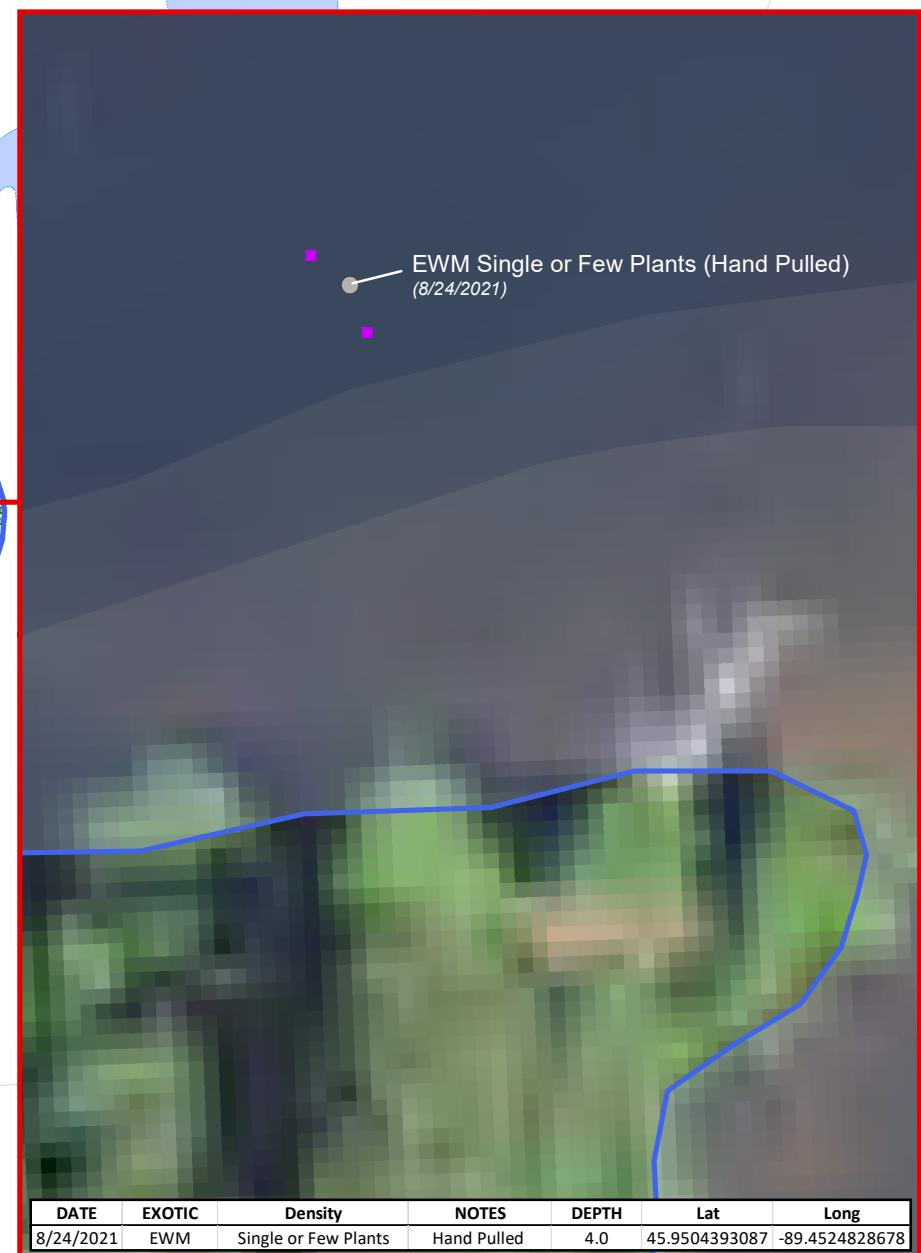
Onterra conducted a late-summer EWM Mapping Survey on Found Lake on August 24, 2021. Weather conditions were favorable with partly sunny conditions and low winds. During the course of the day, the crews searched the entire littoral area of the lake and gave an extra level of focus in all sites where EWM had been located in the past. One EWM plant was located in the vicinity of the island where harvesting efforts took place earlier in the year. The plant was growing up to near the water's surface in approximately four feet of water as displayed on the Map 2. The crew successfully extracted this plant by the roots. A submersible camera was deployed in this area as well and numerous transects through the site yielded no additional EWM occurrences. The crew did not observe any northern watermilfoil in the site while it was present elsewhere around the lake. Crews did not find any other EWM occurrences in the lake including the former 2018 location.

EWM Single or Few Plants
(8/24/2021)
 Historic EWM Occurrences
(2018 and June 2021)

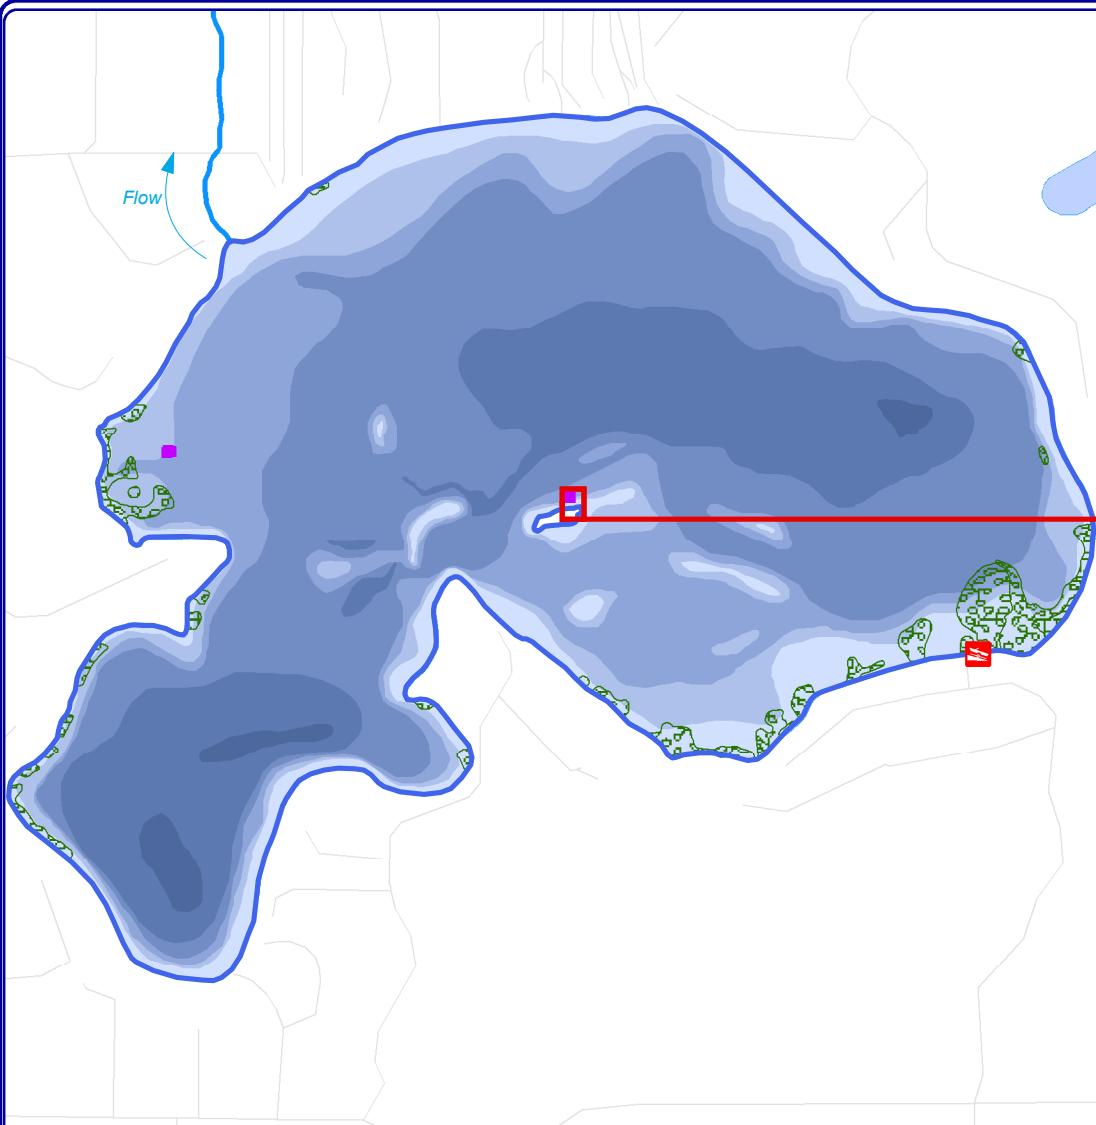
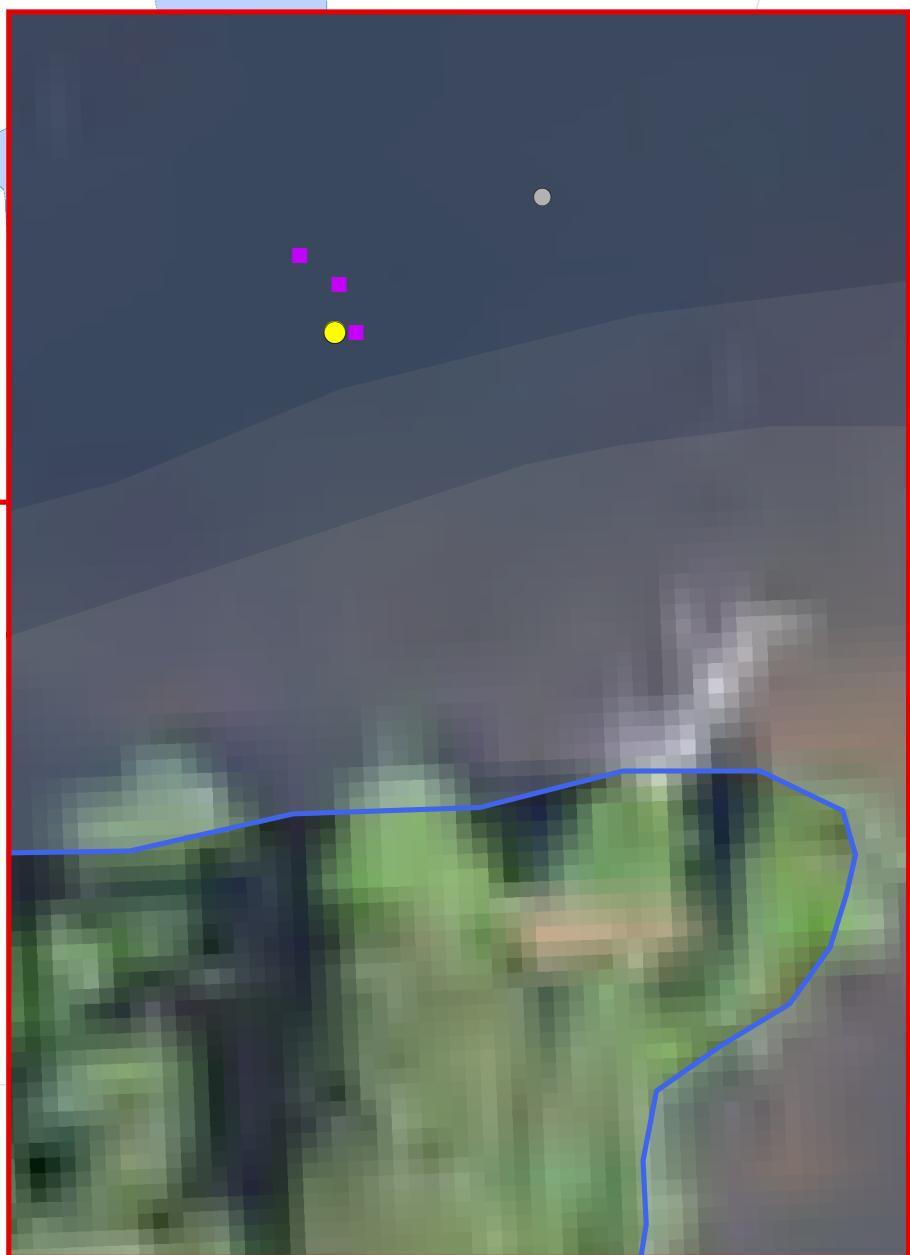
Onterra completed an ESAIS survey on Found Lake on June 27, 2022. The survey crew meandered the entire littoral zone with good conditions, as skies were sunny and the wind decreased throughout the day. The survey crew encountered a clump of EWM plants (5-6 individual plants in close proximity) and an additional single plant on the north side of the island (Map 3). This was the same location of the EWM that was mapped during the 2021 surveys. These plants were reaching the waters' surface and easily spotted. The crew conducted several transects with a submersible camera around this area but could not locate any additional EWM plants. A submersible camera was also used on the 2018 EWM location in the west end of the lake but no EWM was found in this area.

Exotic	Density	Depth (ft)	Latitude	Longitude
EWM	Single or Few Plants	5	45.95047	-89.452378
EWM	Clump of Plants	6	45.950422	-89.452485

Survey Date: June 27, 2022

The FLPOA contracted with APM, LLC again in 2022 to harvest the EWM plants that were located during Onterra's June 2022 survey. A dive team from APM, LLC visited Found Lake on July 25, 2022. The dive crew harvested approximately one cubic foot of EWM from the site north of the island. Dive notes indicated highly scattered EWM plants in the site. A dive search was also completed in the west bay in the vicinity where EWM was originally found within the lake, and no EWM was observed in that location. Additional details of the professional harvesting efforts are included within the EWM Removal Summary report authored by APM, LLC and included in Appendix A.

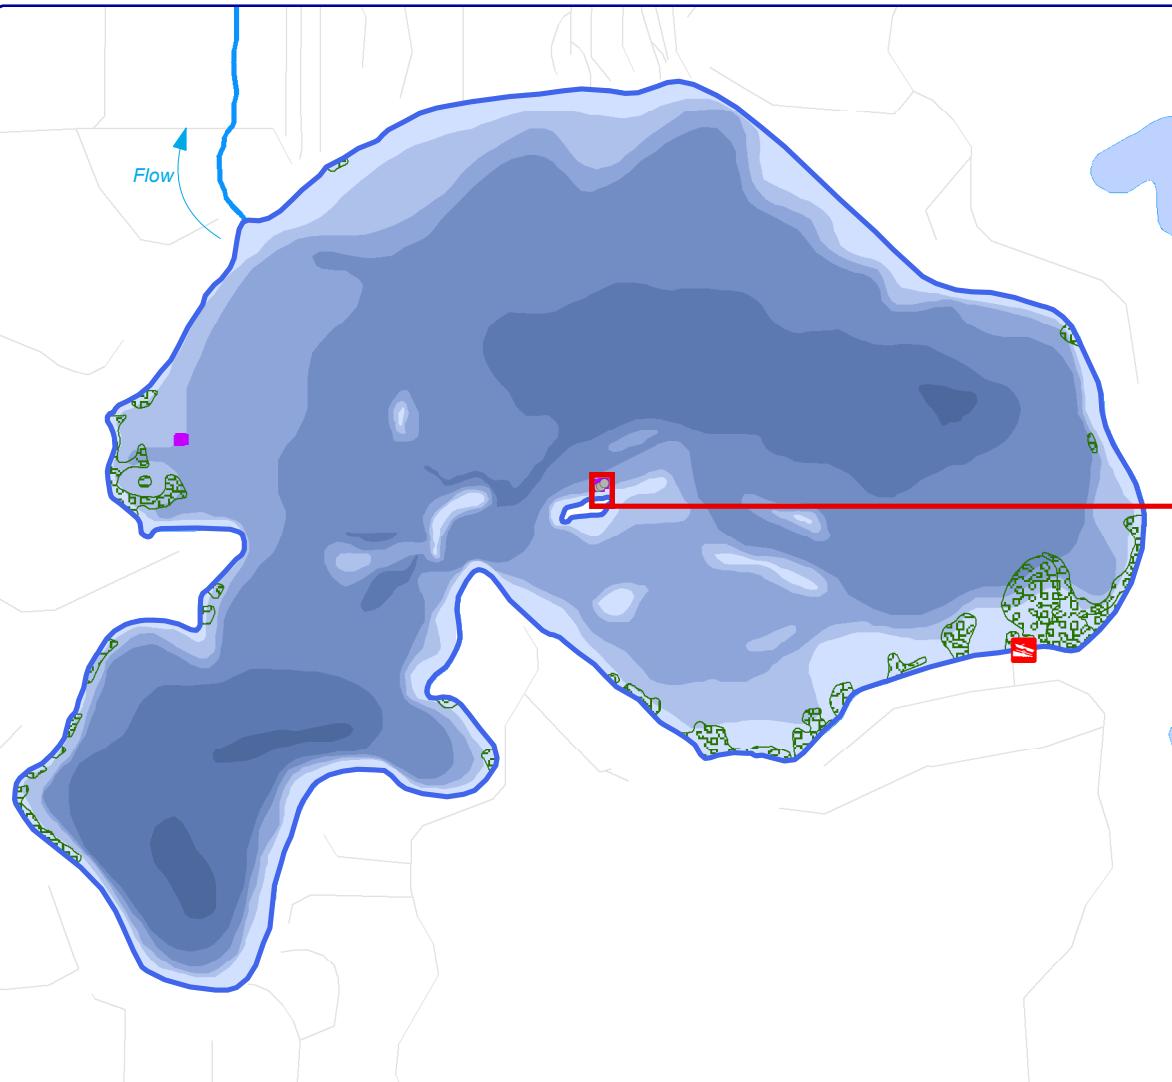
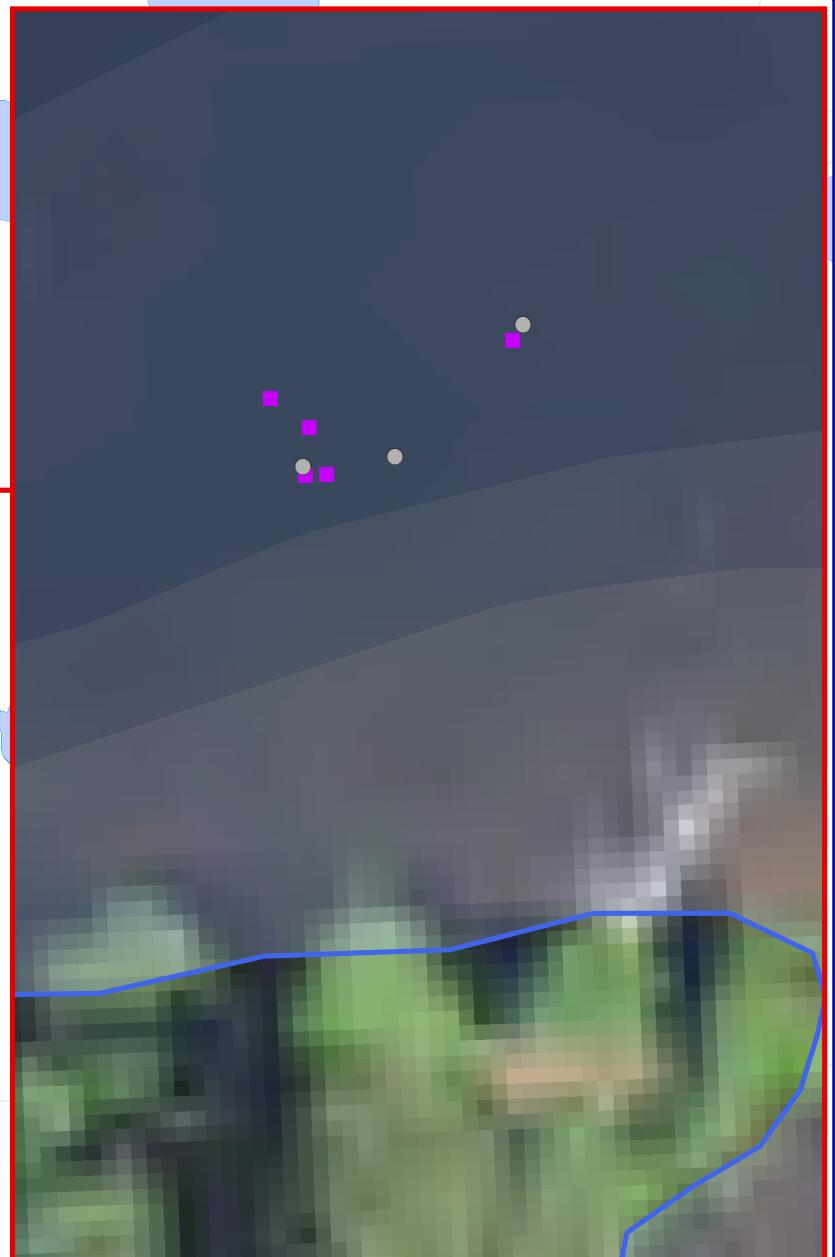
Map 4
Found Lake
Vilas County, Wisconsin
September 2022
EWM Survey Results

Two of Onterra's field survey crews completed a late-season EWM mapping survey on Found Lake on September 21, 2022. The purpose of the survey was to search for and map all occurrences of EWM in the lake. The crew conducted a visual meander survey through all littoral areas of the lake. All previously documented EWM locations were loaded onto the on-board GIS software, and these sites were given added focus including the deployment of a submersible camera. The results of the survey are displayed on Map 4. In total, the crews marked three *single or few plants* occurrences in the same general area of the lake as most past findings, just north of the island. These plants were not visible from the surface and were spotted on the submersible camera. The crew noted the plants were a couple feet tall.

Exotic	Density	Depth (ft)	Latitude	Longitude
EWM	Single or Few Plants	5	45.9504251920	-89.4524864345
EWM	Single or Few Plants	5	45.9504283420	-89.4524391178
EWM	Single or Few Plants	5	45.9504752253	-89.4523730178

- Single or Few Plants
- Floating-Leaf and/or Emergent Plant Community (Mapped August 2019)
- Historic EWM Occurrences (2018, 2021, and June 2022)

The FLPOA plans to move forward with an EWM harvesting effort in 2023 by a local volunteer diver. The EWM plants located in the last mapping survey will be searched for and harvested by the diver. A late-summer professional EWM mapping survey is planned to occur in 2023 which the FLPOA would pay for without the aid of state grant funds. Considerations will be made to schedule the late-summer mapping survey on the earlier side of the seasonal spectrum (ie. early/mid-August) such that in the event EWM is located, the FLPOA could mobilize another harvesting effort following the survey. Once again, the FLPOA is encouraged to conduct volunteer EWM surveillance efforts in 2023 to supplement the professional monitoring efforts. Volunteer monitoring should prioritize search efforts in areas where EWM has been located in the past.

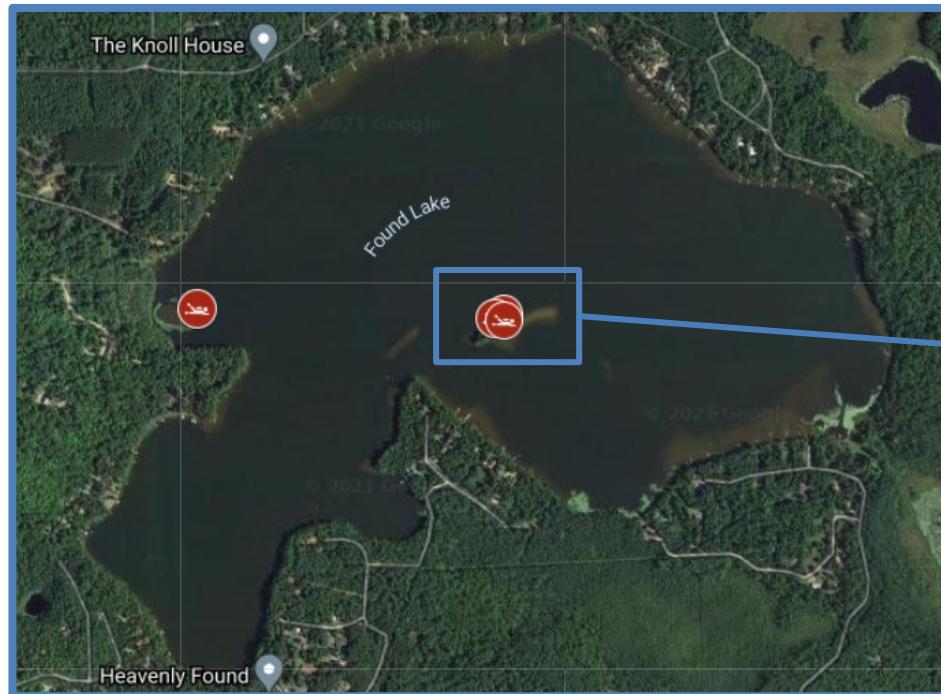
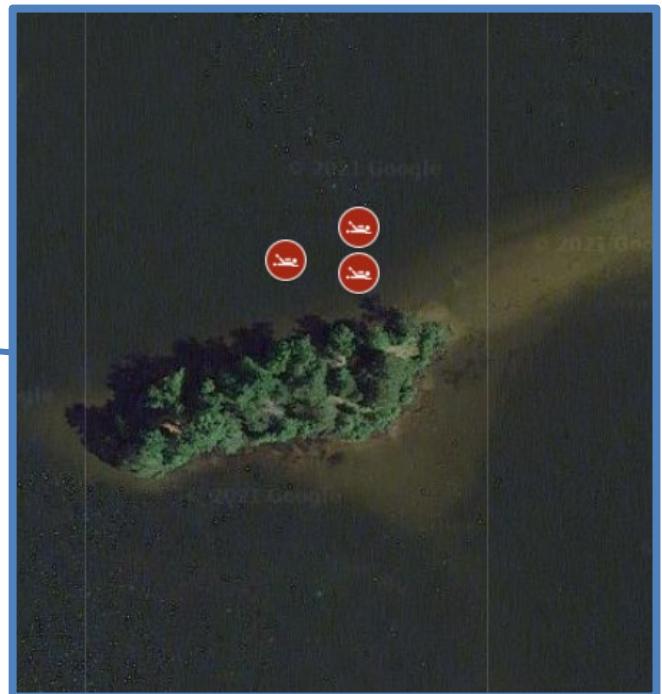
Map of Found Lake Dive Sites

Dive Highlights and Recommendations: The dive team spent the majority of their time on the north end of the island in the center of Found Lake. On the first dive near the island the team found 14 EWM plants. As the team moved east, they covered a larger surface area, but only located 2 plants. The team shifted efforts to the eastern bay where EWM had historically been found. After locating no plants during their third dive, the team shifted back near the island where they located 2 more plants. Continued monitoring and management efforts are important to prevent the spread of EWM throughout Found Lake.

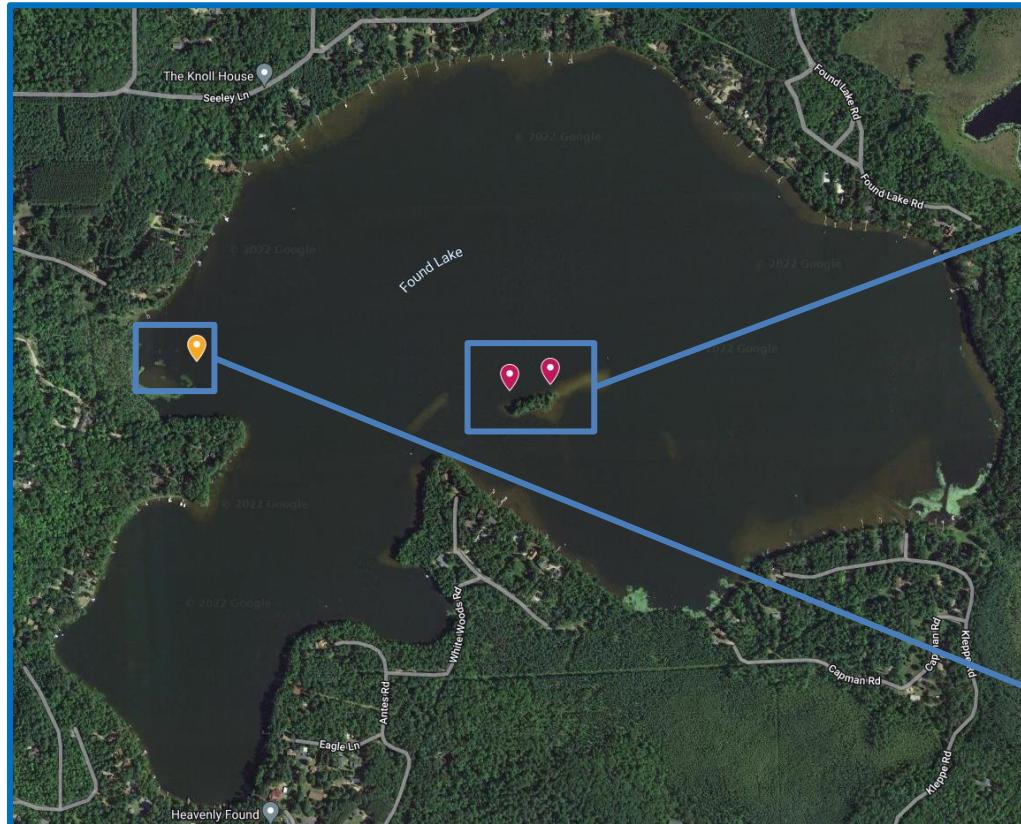
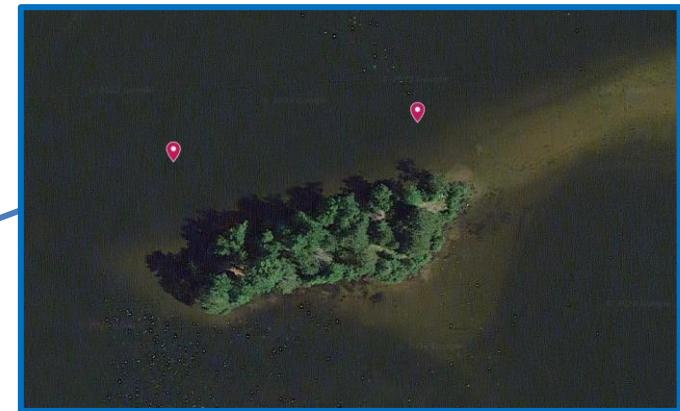
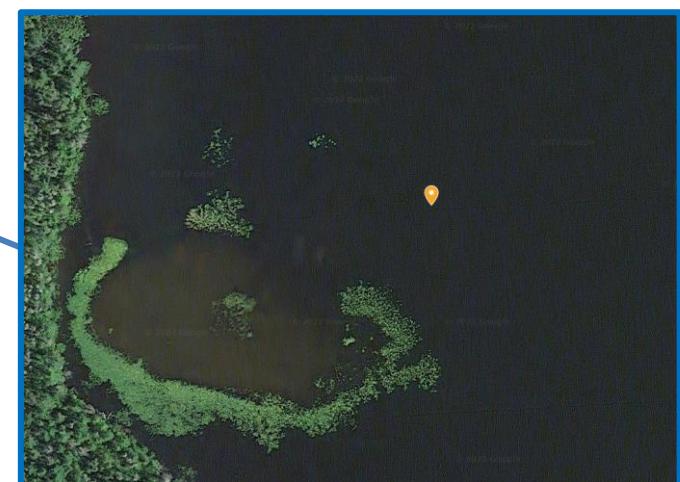
Map of Found Lake Dive Sites

Dive Highlights and Recommendations: The dive team spent the bulk of their time at the island, where they removed 1 cubic feet of EWM. Overall, Found Lake should continue to take an Integrated Pest Management (IPM) approach and evaluate different strategies to manage the EWM population on the lake. Continued monitoring and management efforts are important to prevent the spread of EWM throughout Found Lake.

- 📍 Island (2)
- 📍 W Bay (1)
