Wisconsin Department of Natural Resources
Surface Water Grants Program
Aquatic Invasive Species
Grant # ACEI25721

Buckatabon Lakes Eurasian Watermilfoil Management Project

Upper and Lower Buckatabon Lakes - Vilas County, WI

2021 Annual Reporting

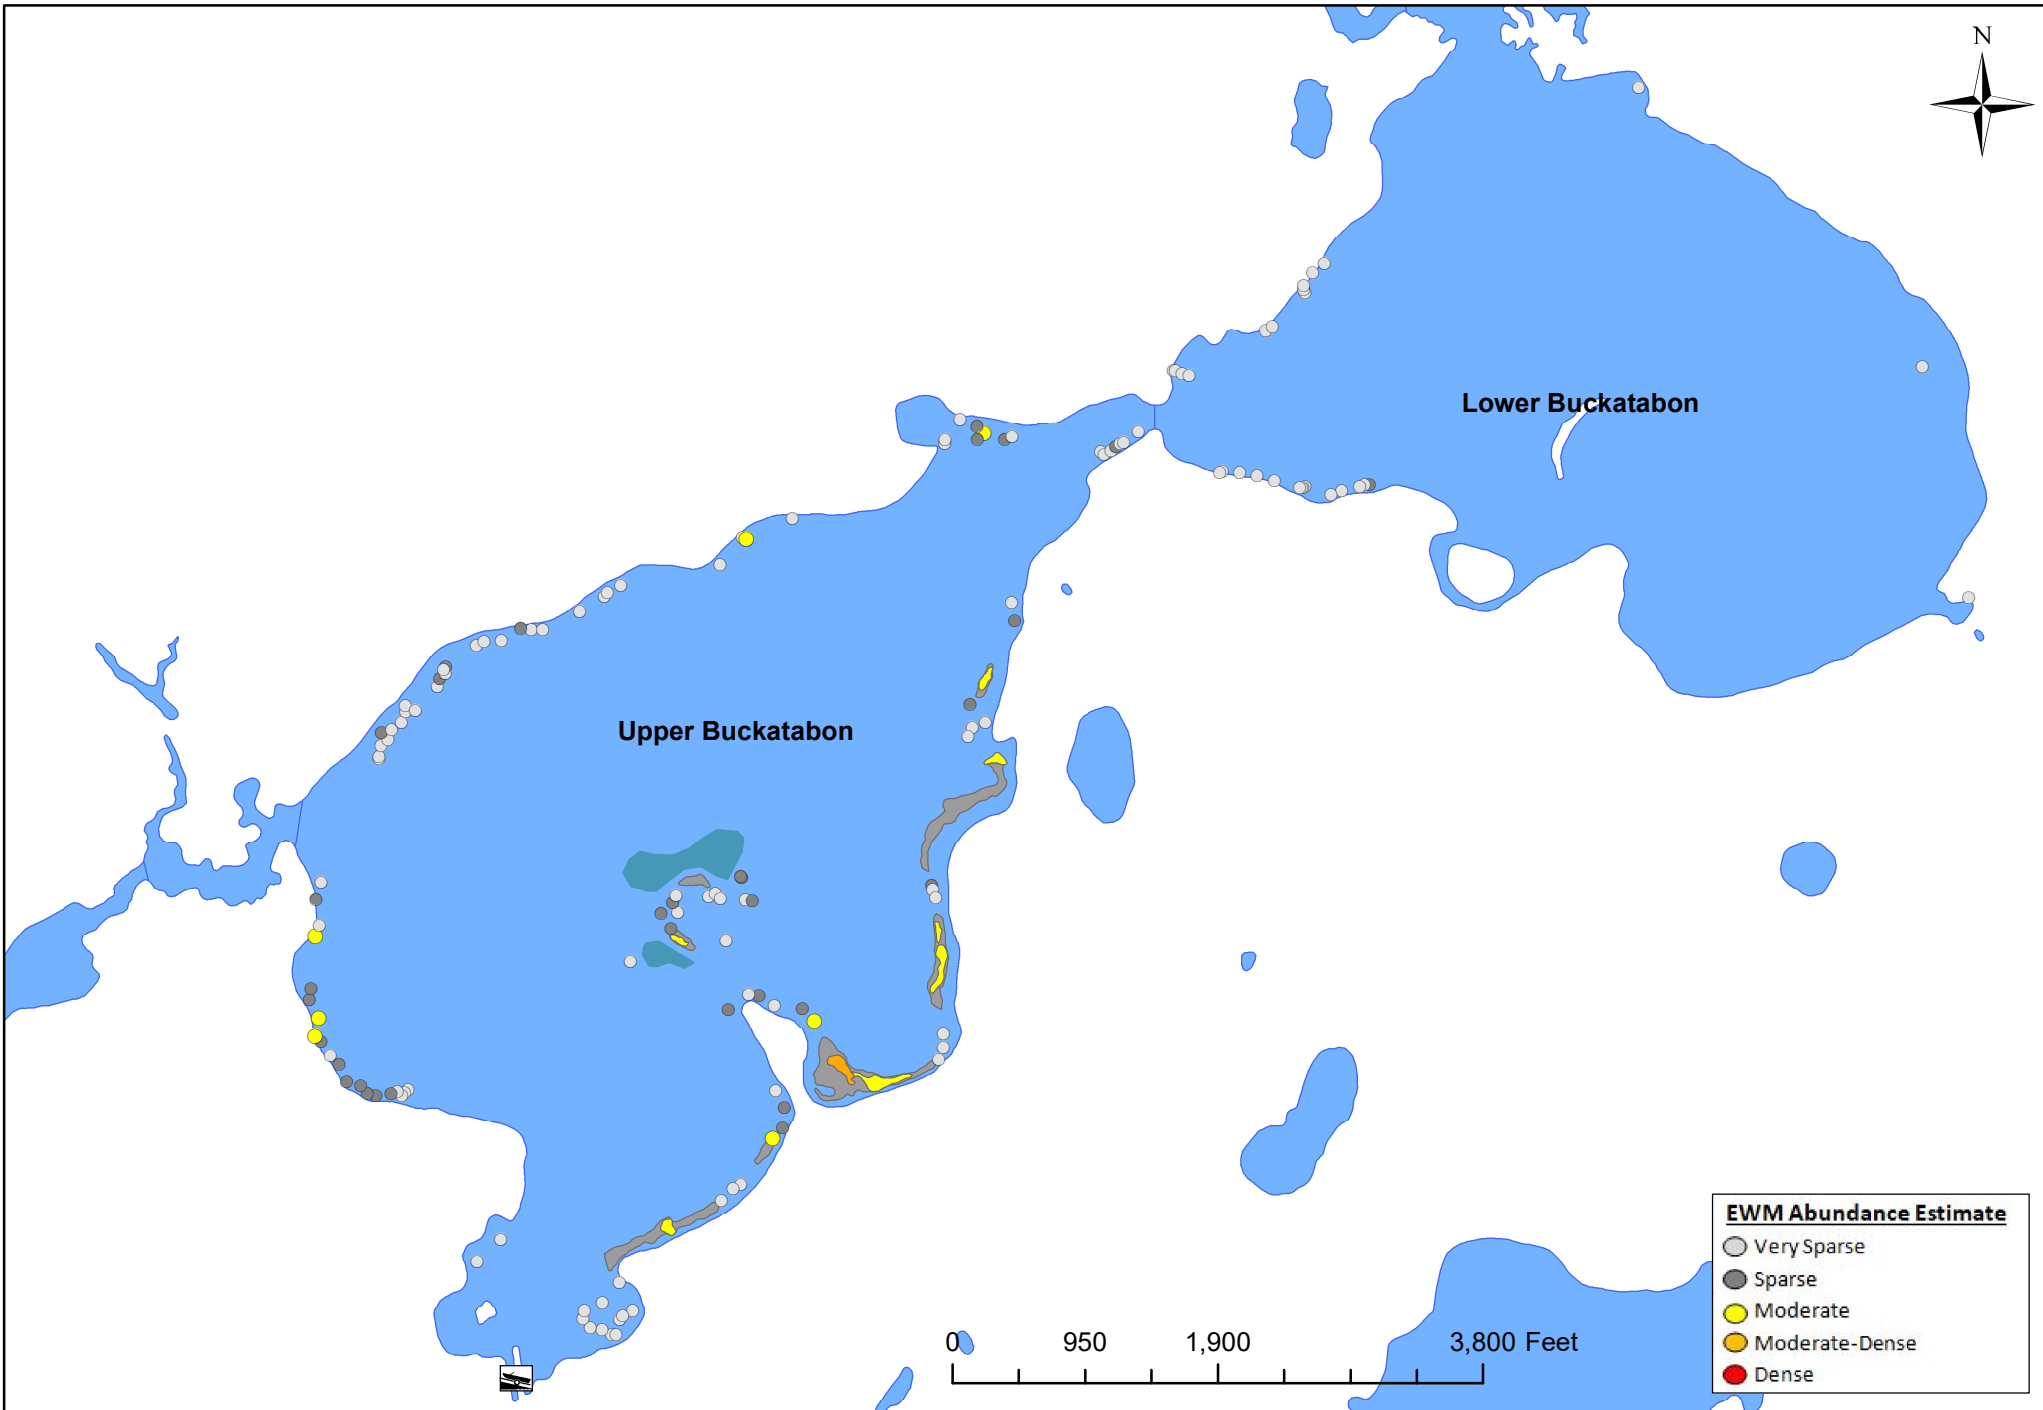
Buckatabon Lakes
Early Season - EWM Relocation Survey
2021

Lake: Buckatabon Lakes, Vilas County, WI
 Map Date & Creator: 06.17.2021, Many Waters, LLC
 Survey Date: 6.8.21 & 6.9.21
 Source: WDNR hydro, EWM-Many Waters
 File: Buckatabon_ES_2021

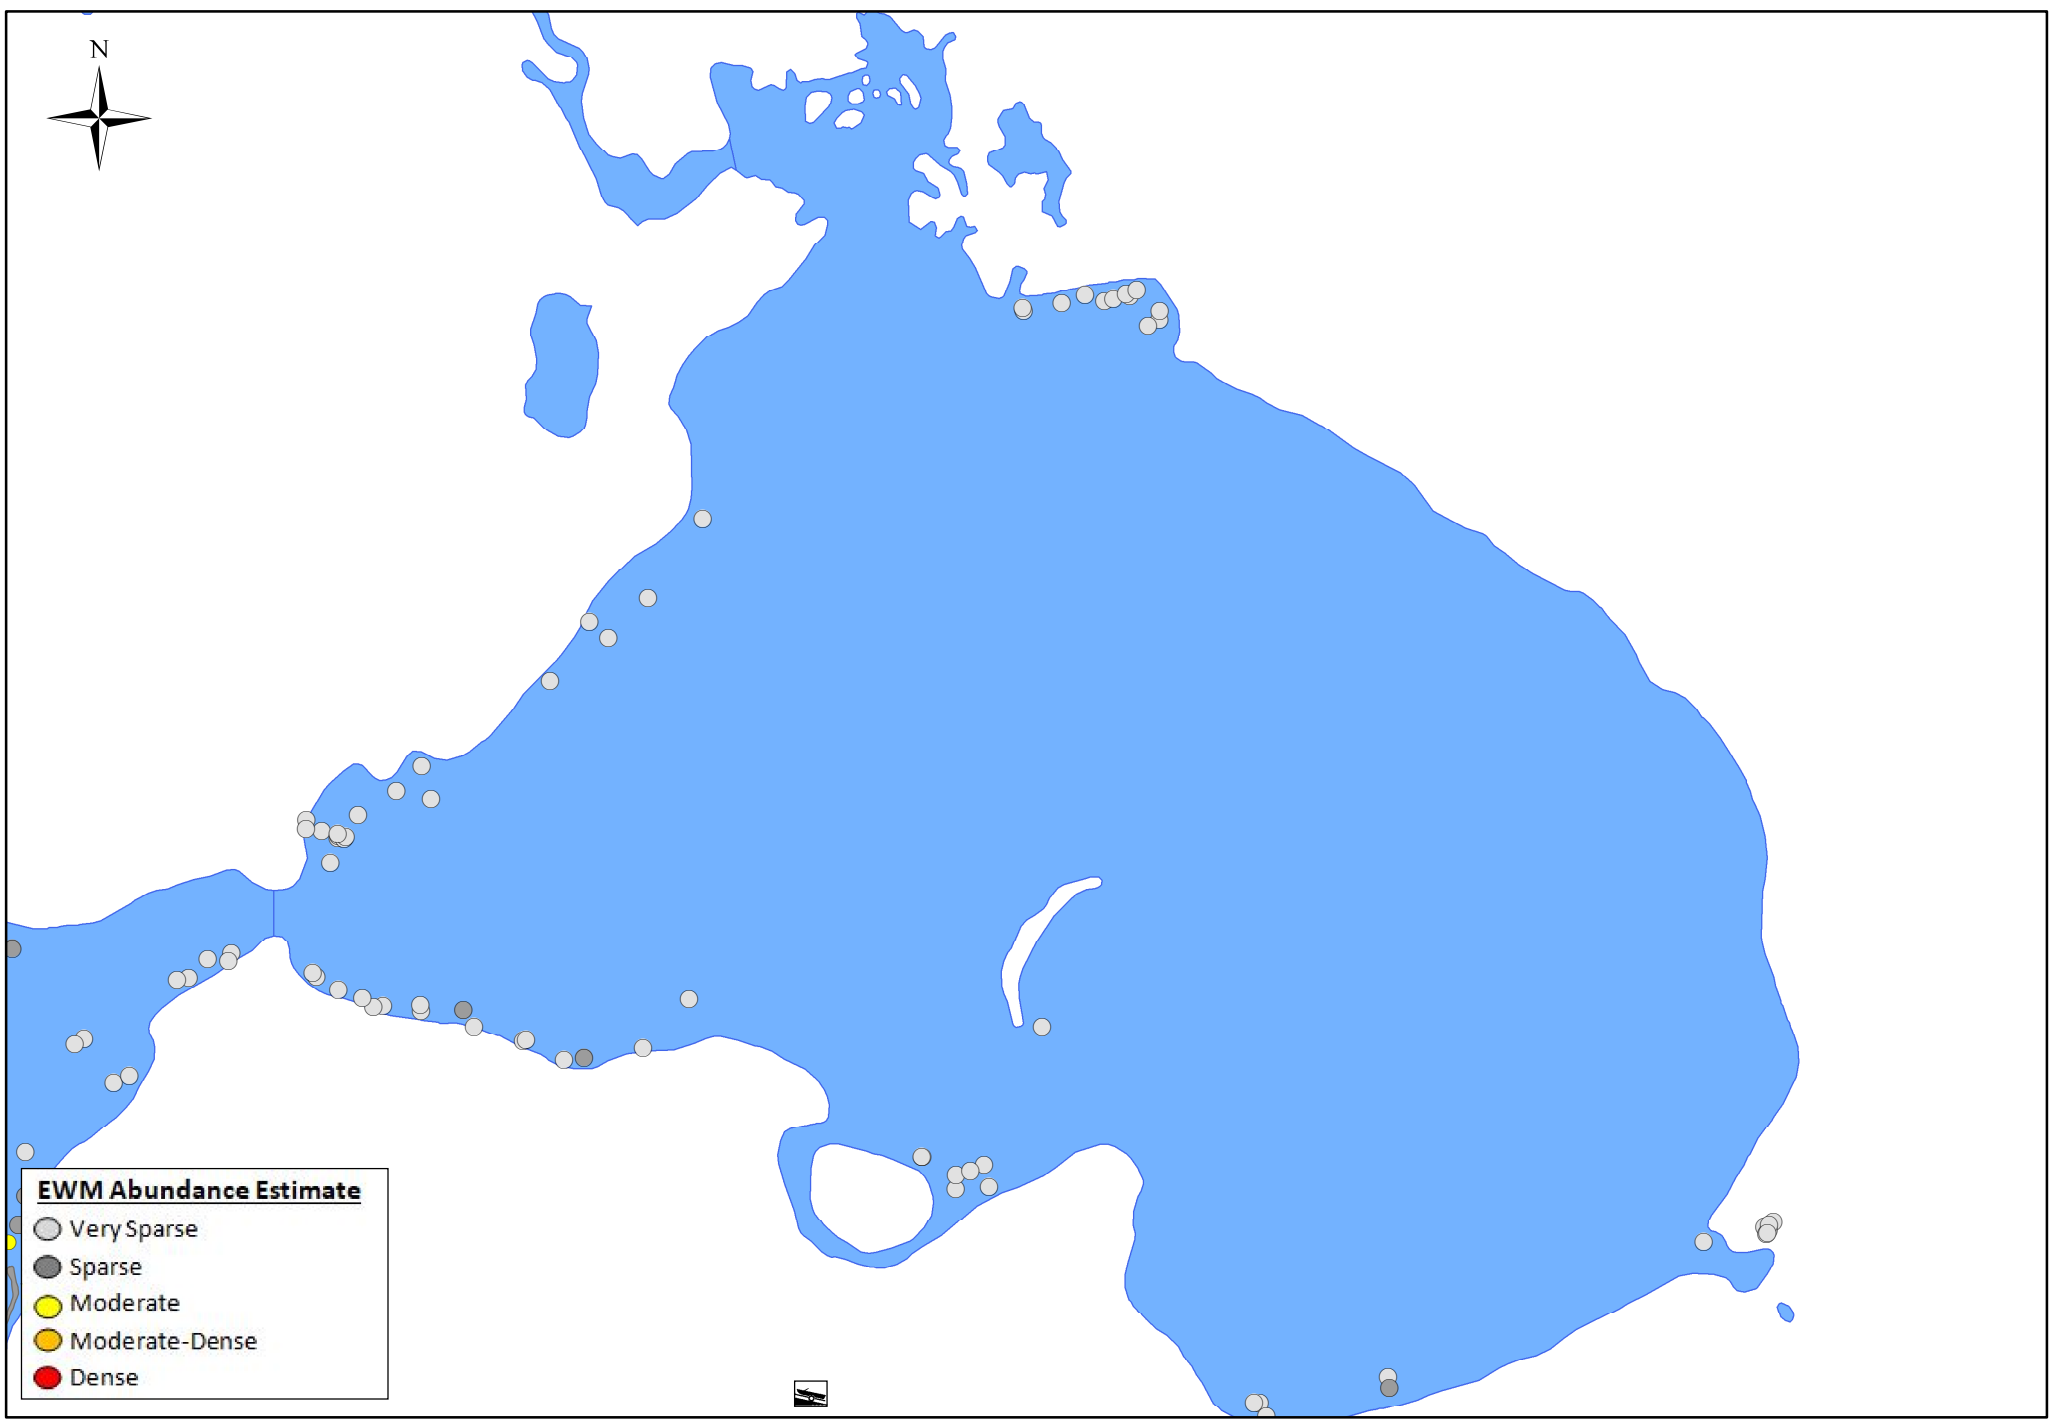
**Lower Buckatabon Lake - Vilas County, WI
Mid/Late Season EWM Survey
2021**

Lake: Lower Buckatabon Lake, Vilas County, WI
Map Date & Creator: 12/30/21, Many Waters, LLC
Survey Date: 8/19/21 & 9/13/21
Source: WDNR hydro, EWM-Many Waters
File: Buckatabon_MLSS_2021

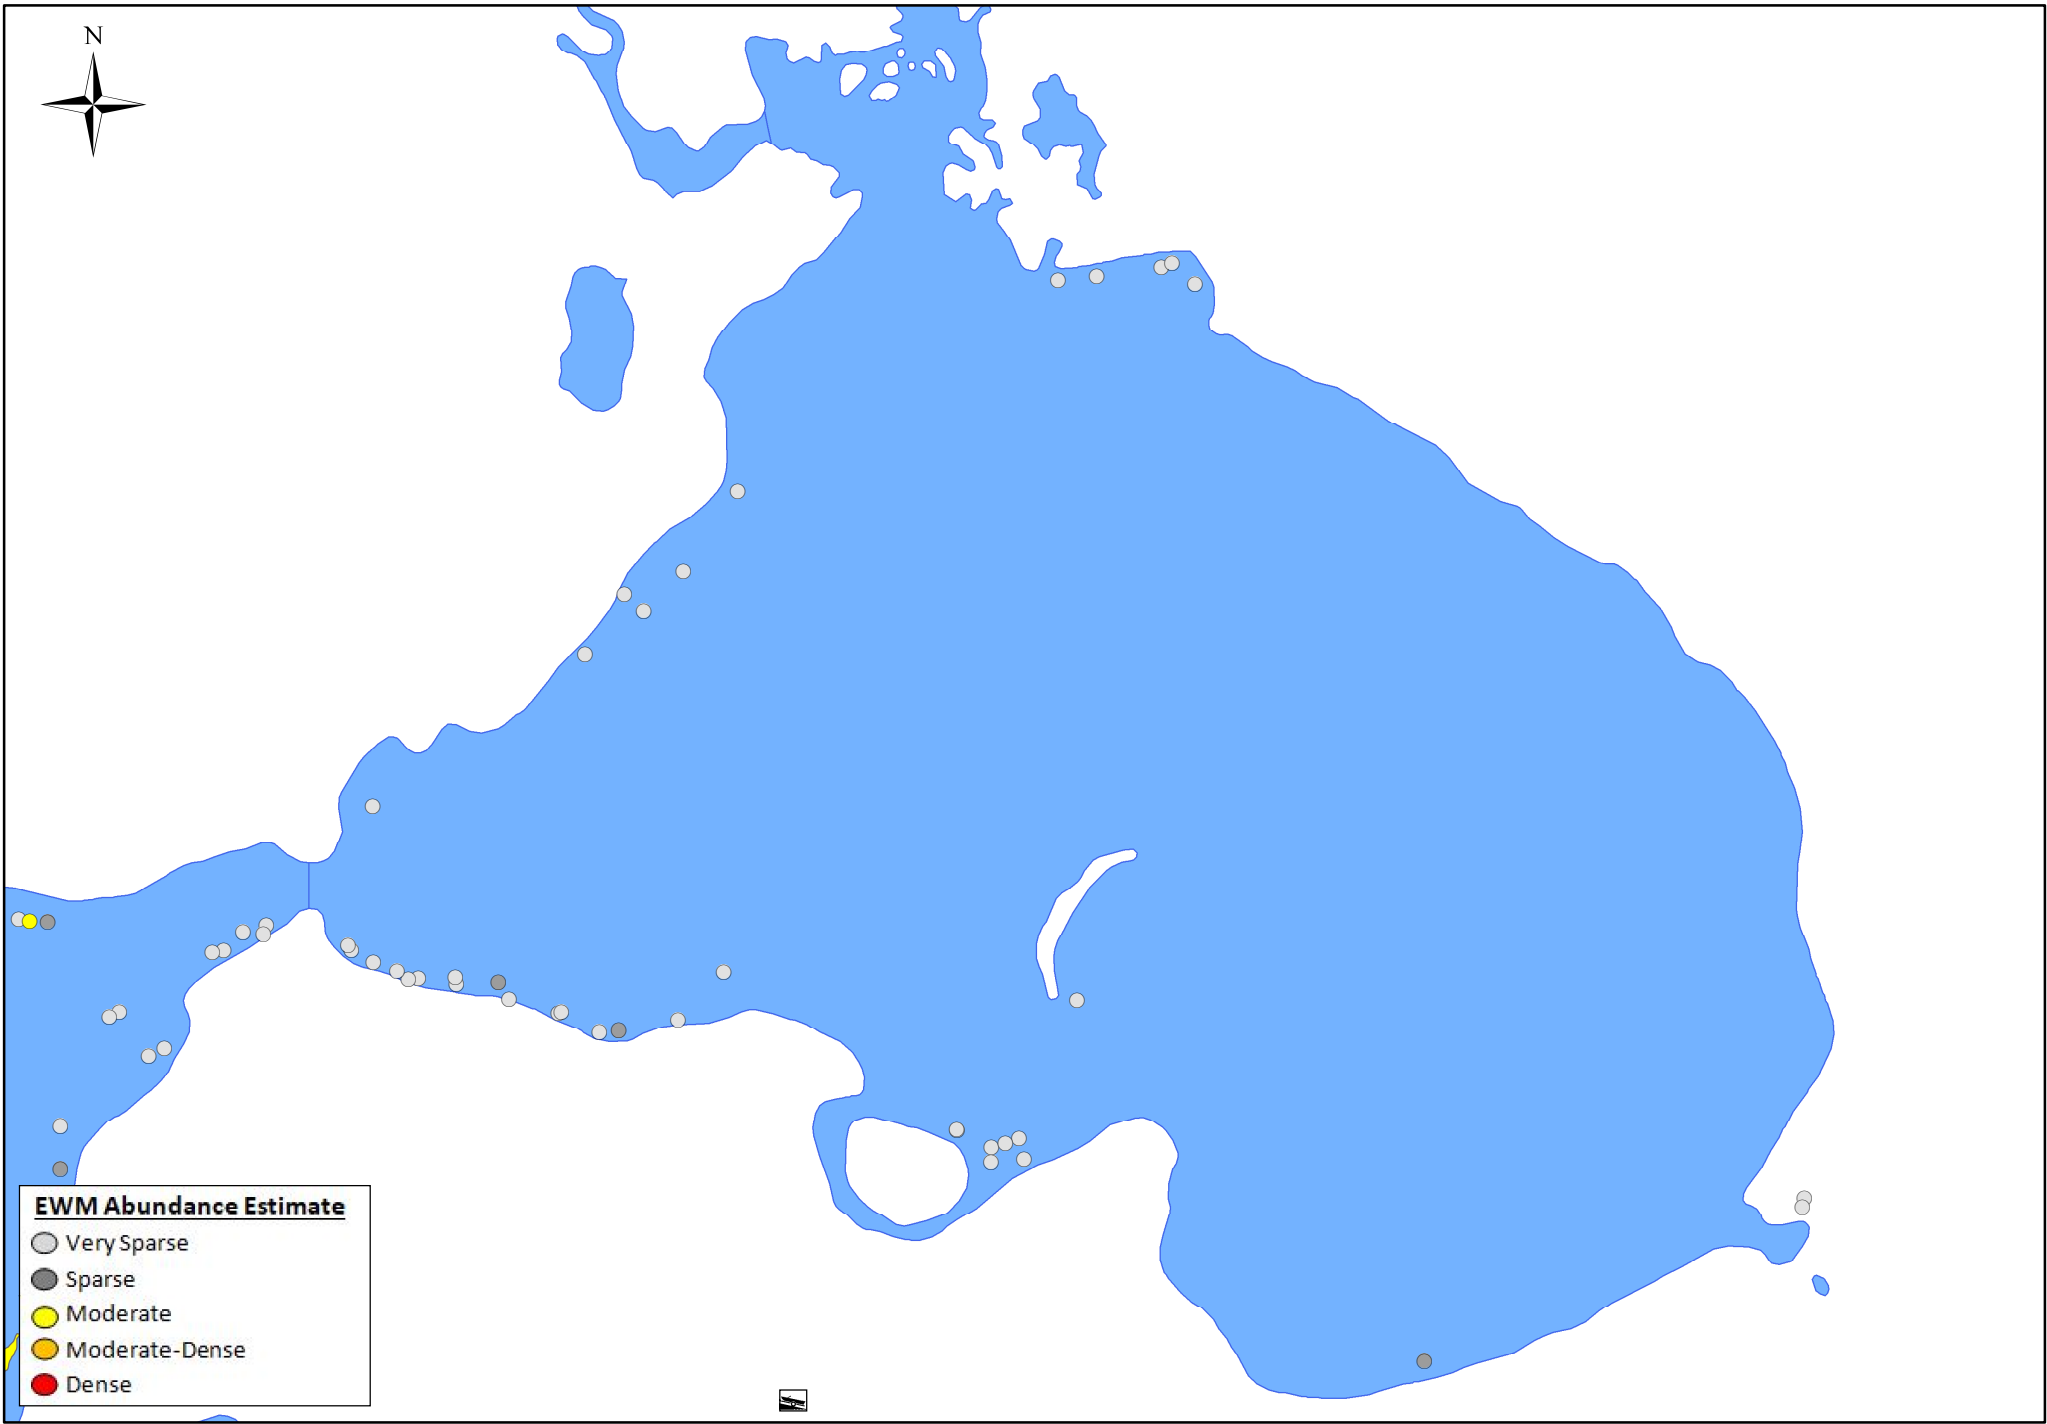
Lower Buckatabon Lake - Vilas County, WI
End of the Year - EWM Locations
2021

Lake: Lower Buckatabon Lake, Vilas County, WI
Map Date & Creator: 12/30/21, Many Waters, LLC
Survey Date: 10/5/21
Source: WDNR hydro, EWM-Many Waters
File: Buckatabon_EOY_2021

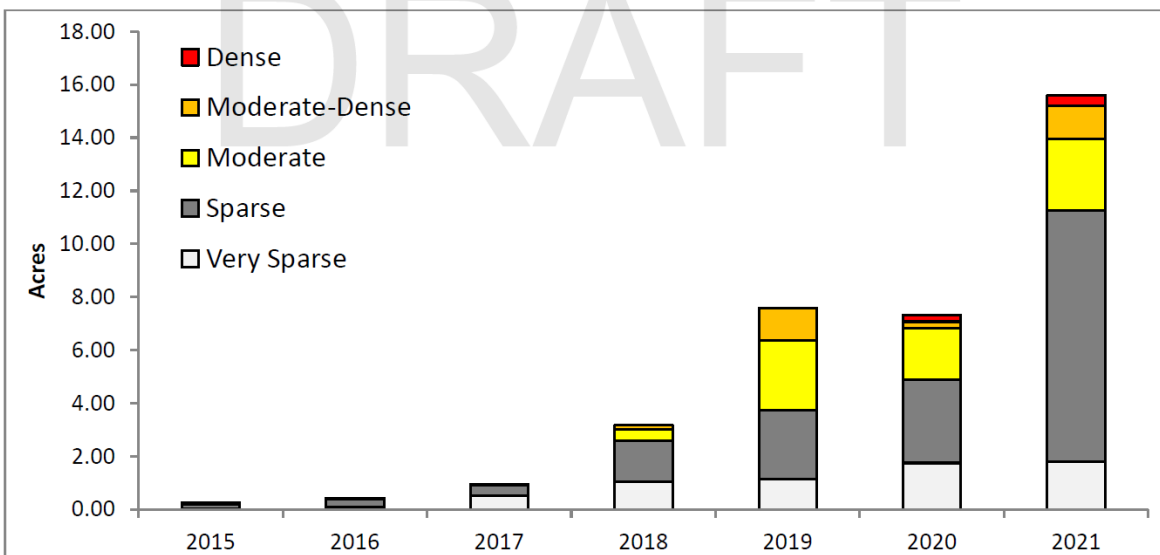
Figure 4. Change in EWM abundance from 2015-2021 on Upper Buckatabon and Lower Buckatabon Lakes. Courtesy of Many Waters, LLC.

It can be helpful to see how density and acreage changes from year to year by the following chart provided by Many Waters, LLC. Note that this chart includes data from Lower Buckatabon Lake, however the majority of EWM is found on Upper Buckatabon. In 2020 there were 0.26 acres, and in 2021 there were 0.37 acres of EWM were considered “dense” on both Upper and Lower Buckatabon.

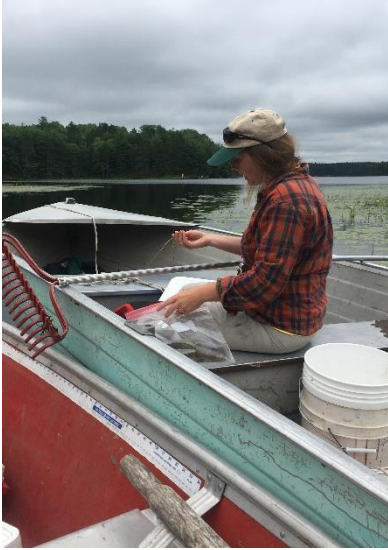
Fullness Rating	Coverage	Description
1

Only few plants. There are not enough plants to entirely cover the length of the rake head in a single layer.
2

There are enough plants to cover the length of the rake head in a single layer, but not enough to fully cover the tines.
3

The rake is completely covered and tines are not visible.

Figure 6. Cathy Higley processing plant samples from the Aquatic Plant Point Intercept survey; rake fullness rating descriptions. Photo courtesy of Emily Heald. Diagram courtesy of WI DNR.

Total rake fullness for each site as well as individual species found was recorded as 1, 2, or 3 as described in Figure 6.

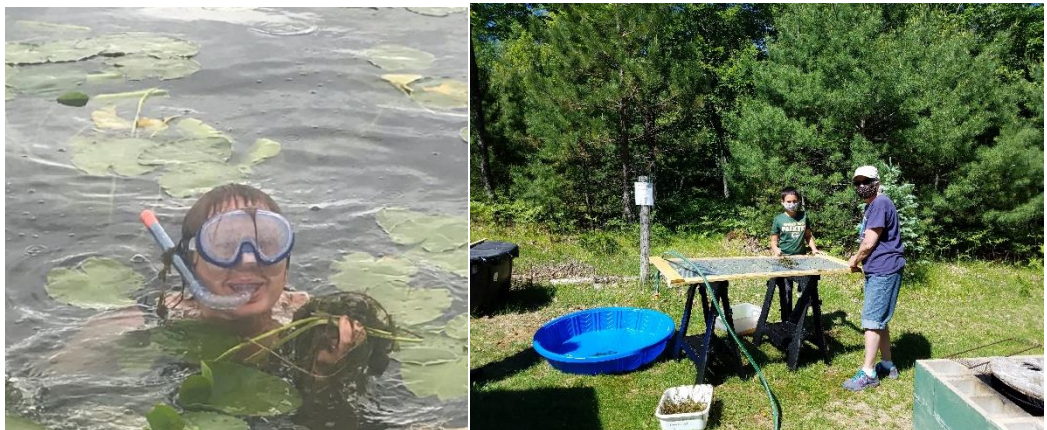
Figure 8. Land & Water Staff snorkeling to collect EWM; BLA member Carolyn Barthel and her grandson cleaning and bundling EWM stems.

Water Staff snorkeled to collect and then process stems of EWM from Upper Buckatabon Lake. After collection, stems were then washed, trimmed, bundled, and weighted with a rock before being placed in troughs.

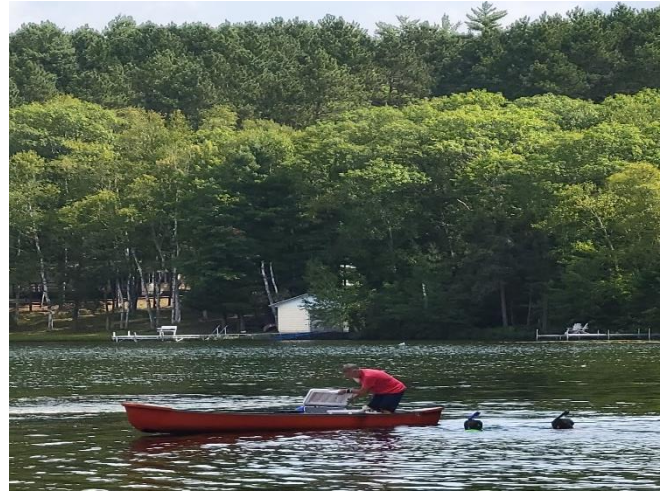
Figure 9. BLA volunteer Tom Christensen canoes weevil filled EWM bundles out to Vilas County Land & Water Staff snorkelers who attach them to existing EWM on the lake in Benson’s Bay.

Using the average rate of return on weevil rearing in “Biological Control of Eurasian Watermilfoil” it is estimated that 3,151 weevils were released into Benson’s Bay on August 19, 2021. EWM bundles containing weevils in all life stages were loaded into a canoe and snorkelers tied the bundles to existing EWM plants in Benson’s Bay with jute twine. This method of

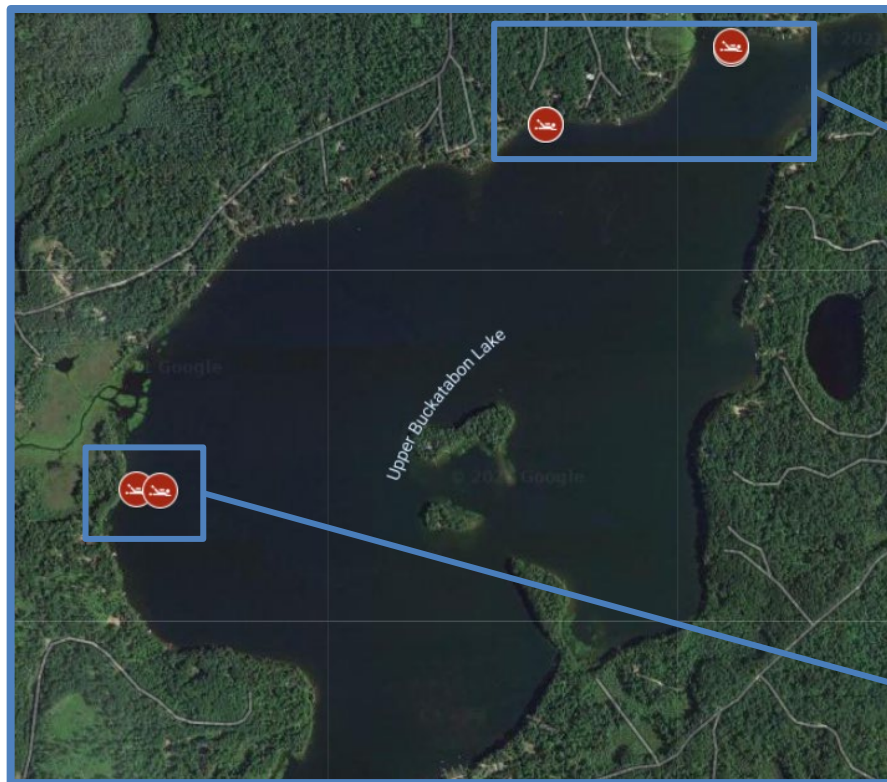
Map of Upper Buckatabon Lake Dive Sites

Dive Highlights and Recommendations: The dive team spent the bulk of their time at sites B-21 and D-21, where they removed 166 cubic feet of EWM. Overall, Upper Buckatabon Lake should take an Integrated Pest Management (IPM) approach and evaluate different strategies to manage the EWM population on the lake. Continued monitoring and management efforts are important to prevent the spread of EWM throughout Upper Buckatabon Lake.
