Wisconsin Department of Natural Resources
Surface Water Grants Program
Aquatic Invasive Species
Grant # ACEI25721

Buckatabon Lakes Eurasian Watermilfoil Management Project

Upper and Lower Buckatabon Lakes - Vilas County, WI

2022 Final Reporting

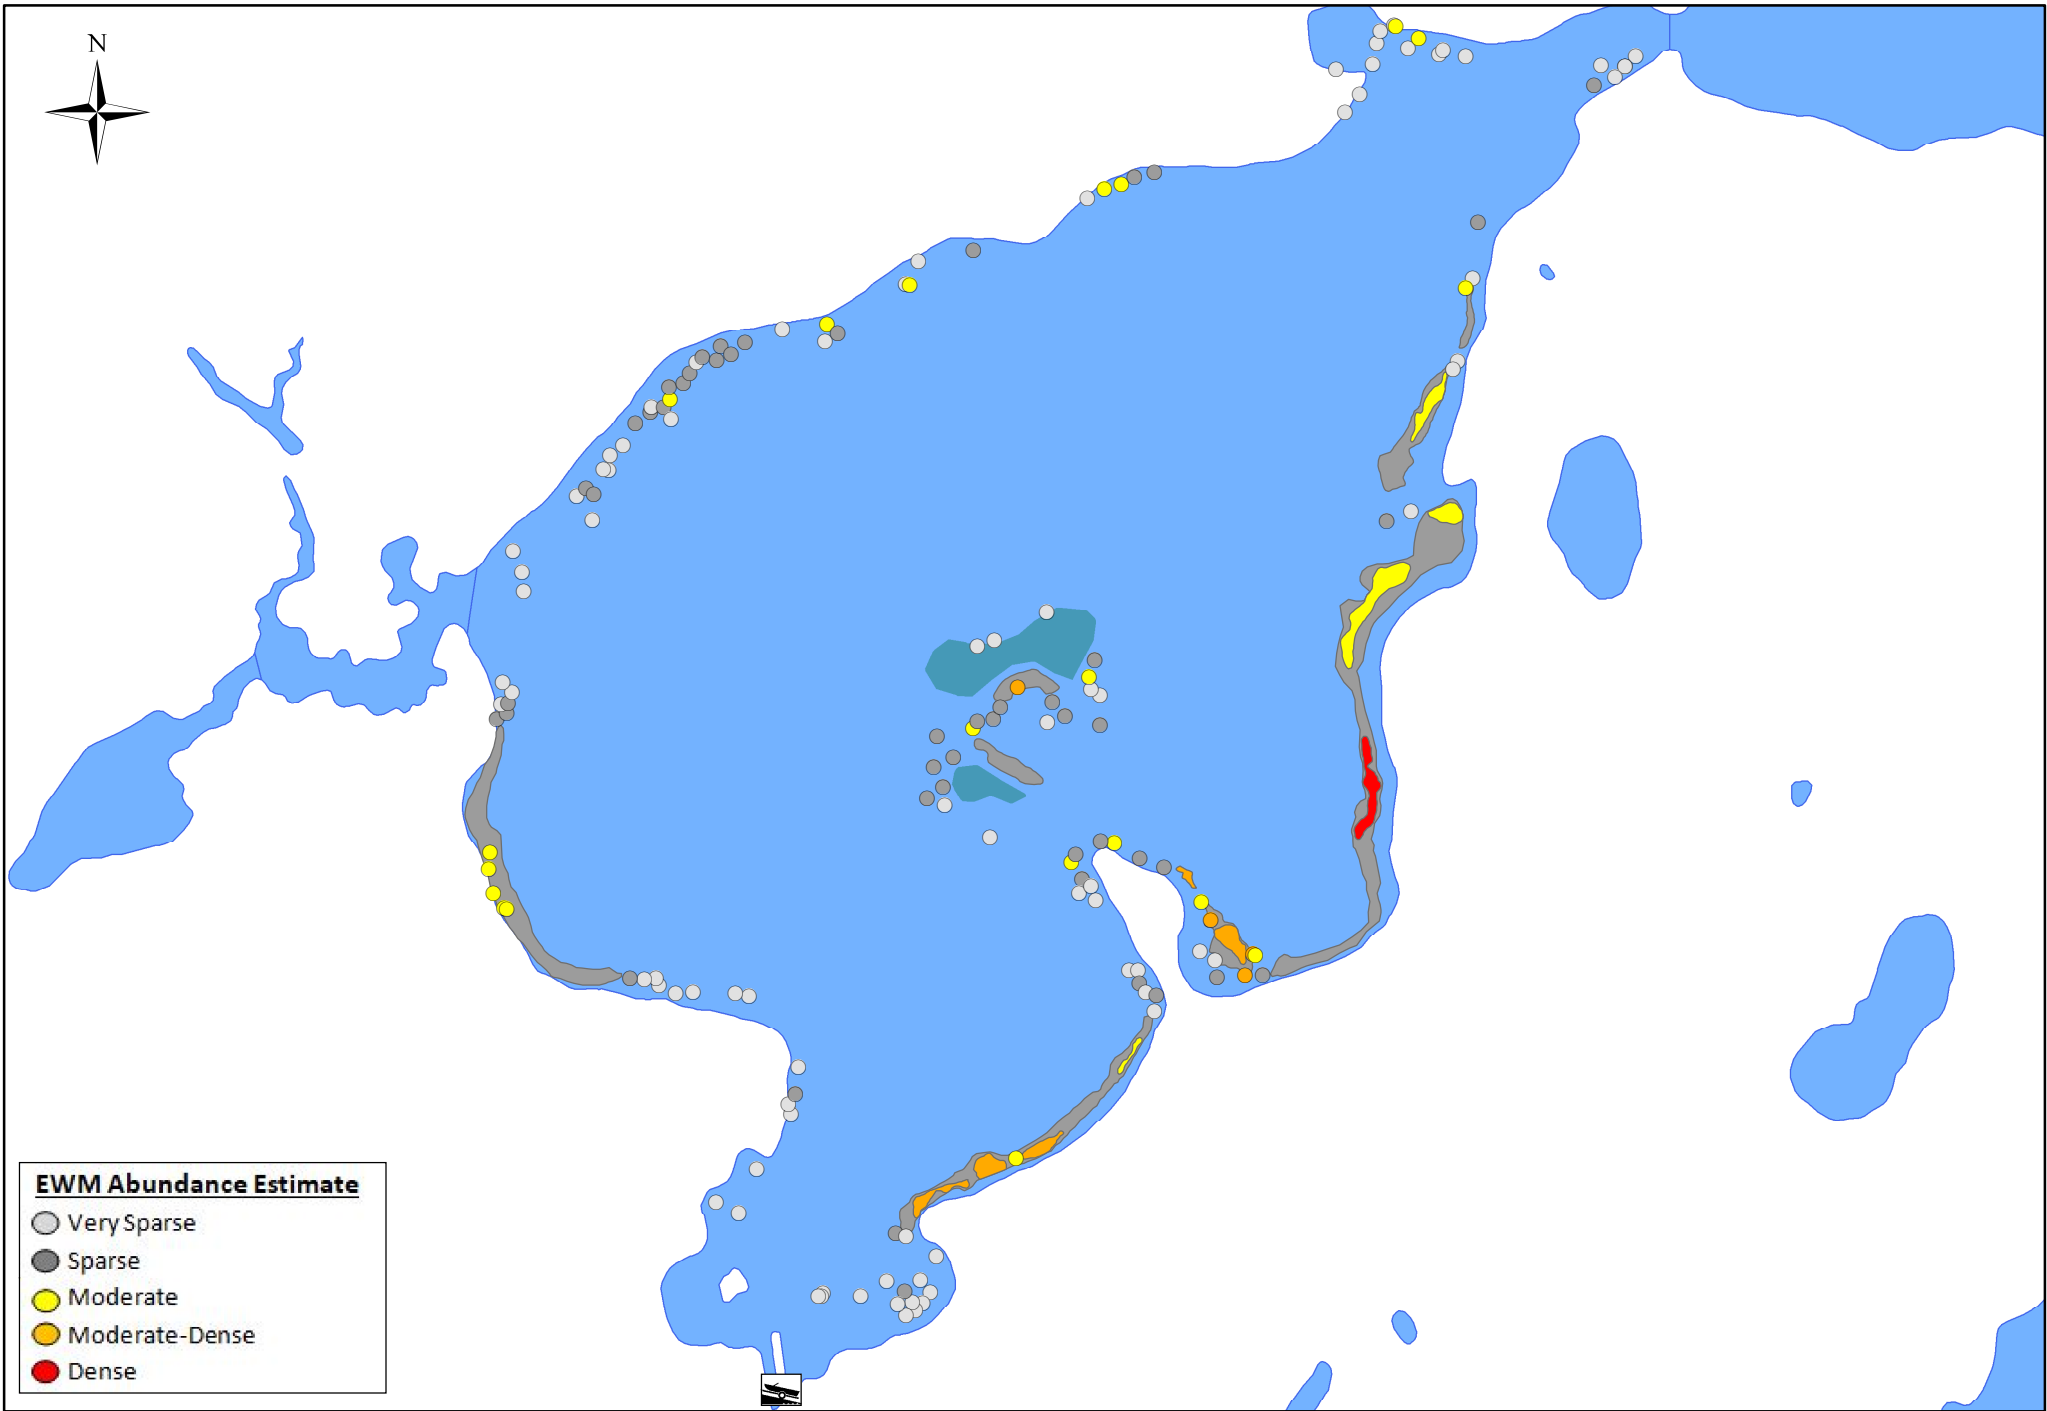
**Upper Buckatabon Lake - Vilas County, WI
Mid/Late Season EWM Survey
2022**

Lake: Upper Buckatabon Lake, Vilas County, WI
Map Date & Creator: 11/6/2022, Many Waters, LLC
Survey Date: 8/26/22 & 10/1/2022
Source: WDNR hydro, EWM-Many Waters
File: Buckatabon_MLSS_2022

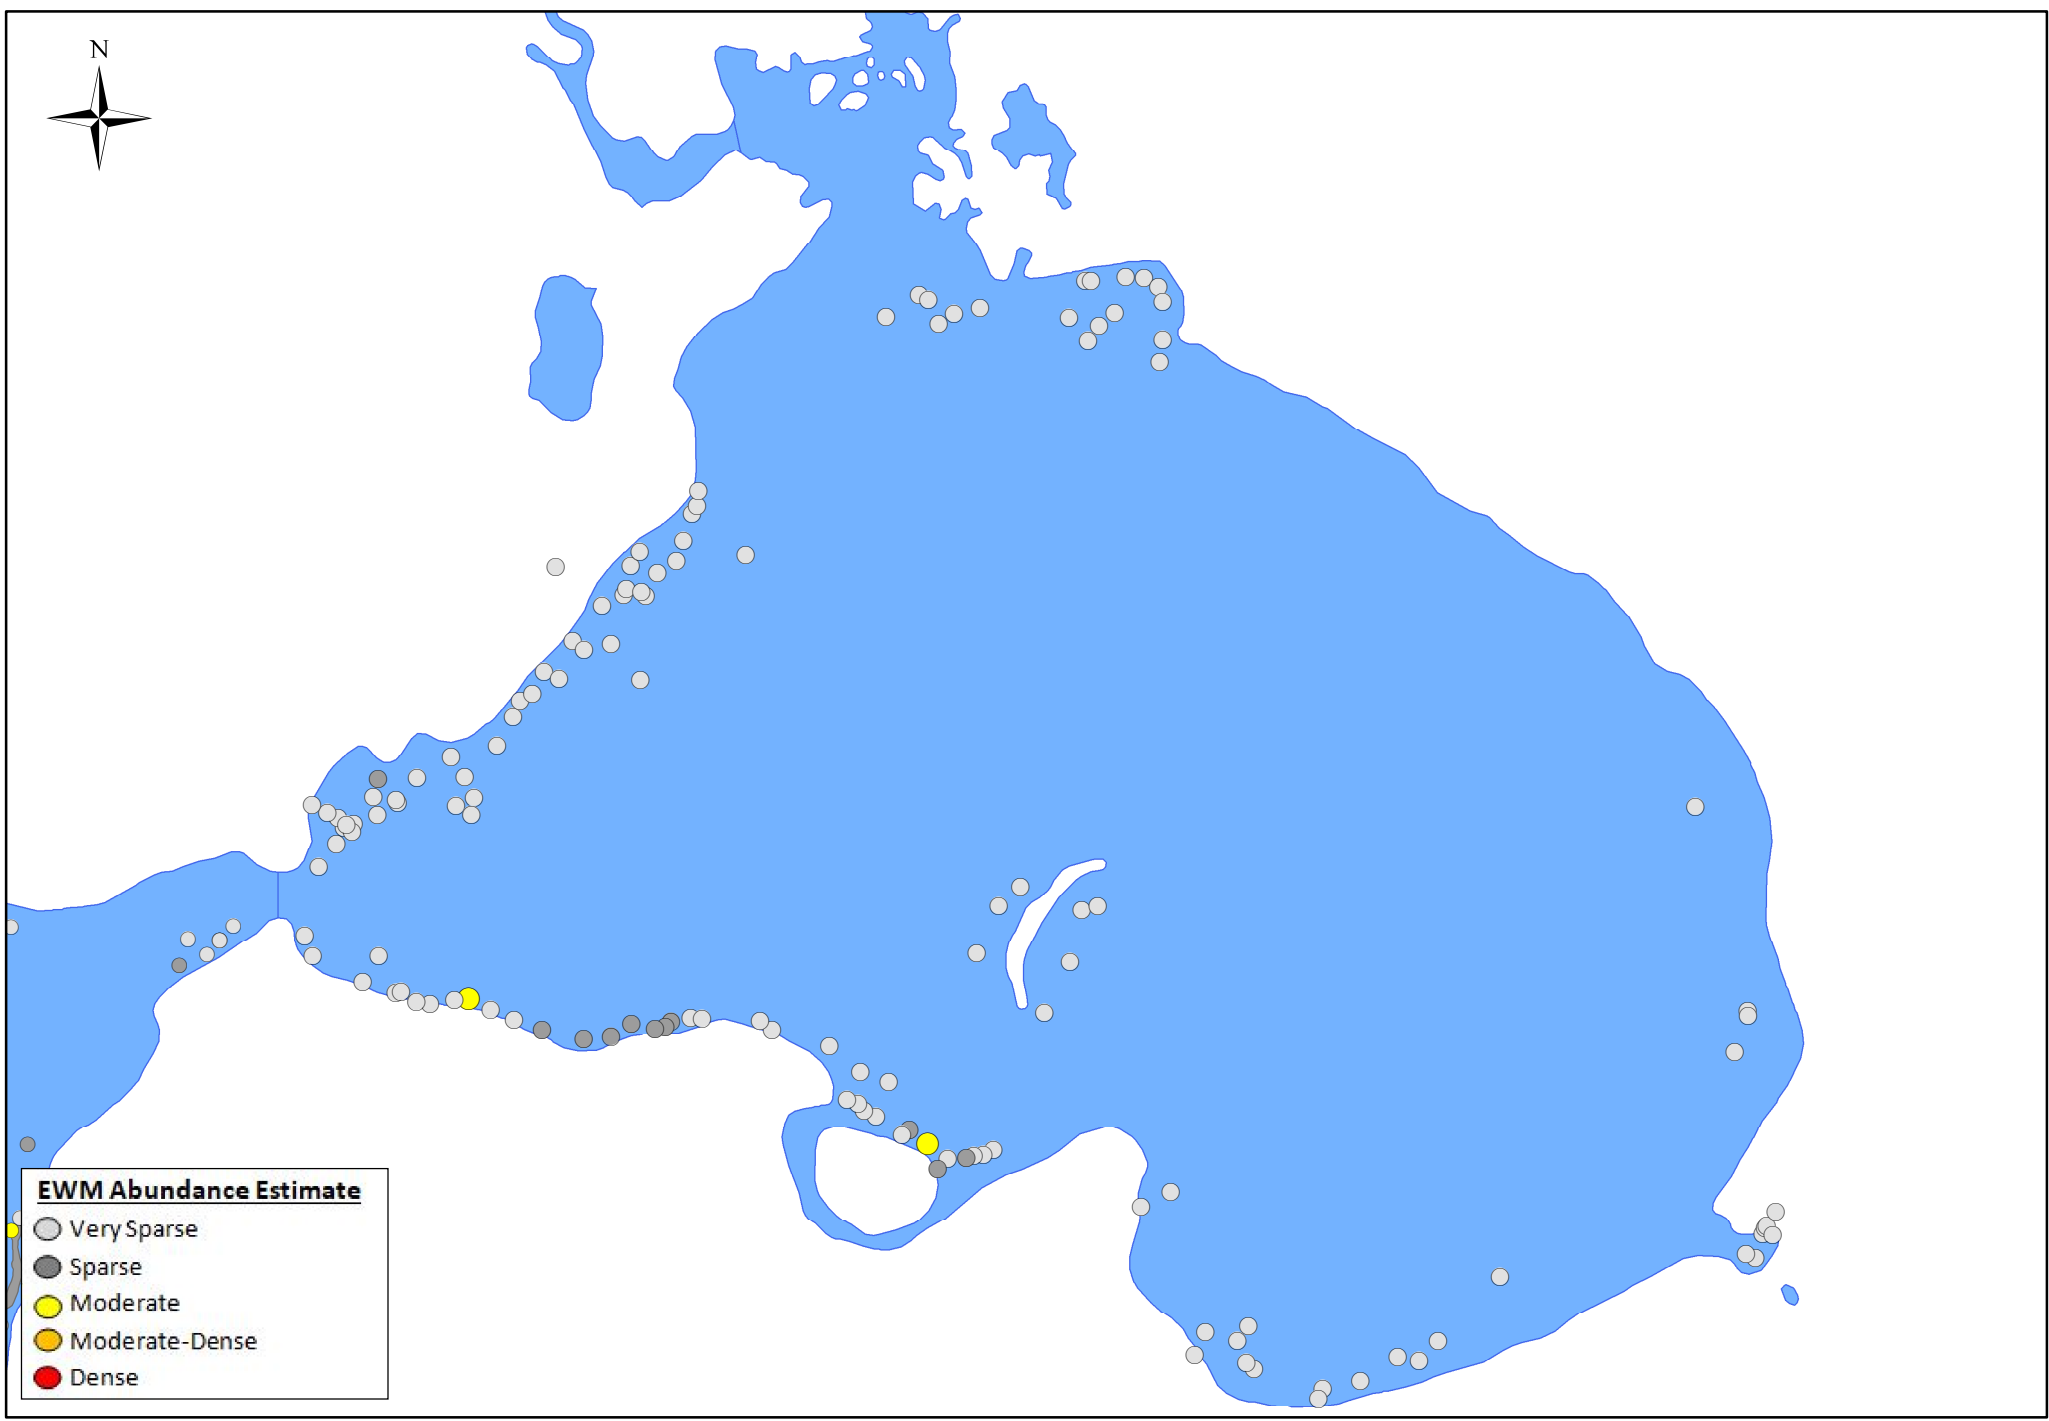
Lower Buckatabon Lake - Vilas County, WI
Mid/Late Season EWM Survey
2022

Lake: Lower Buckatabon Lake, Vilas County, WI
Map Date & Creator: 11/6/2022, Many Waters, LLC
Survey Date: 8/16/2022
Source: WDNR hydro, EWM-Many Waters
File: Buckatabon_MLSS_2022

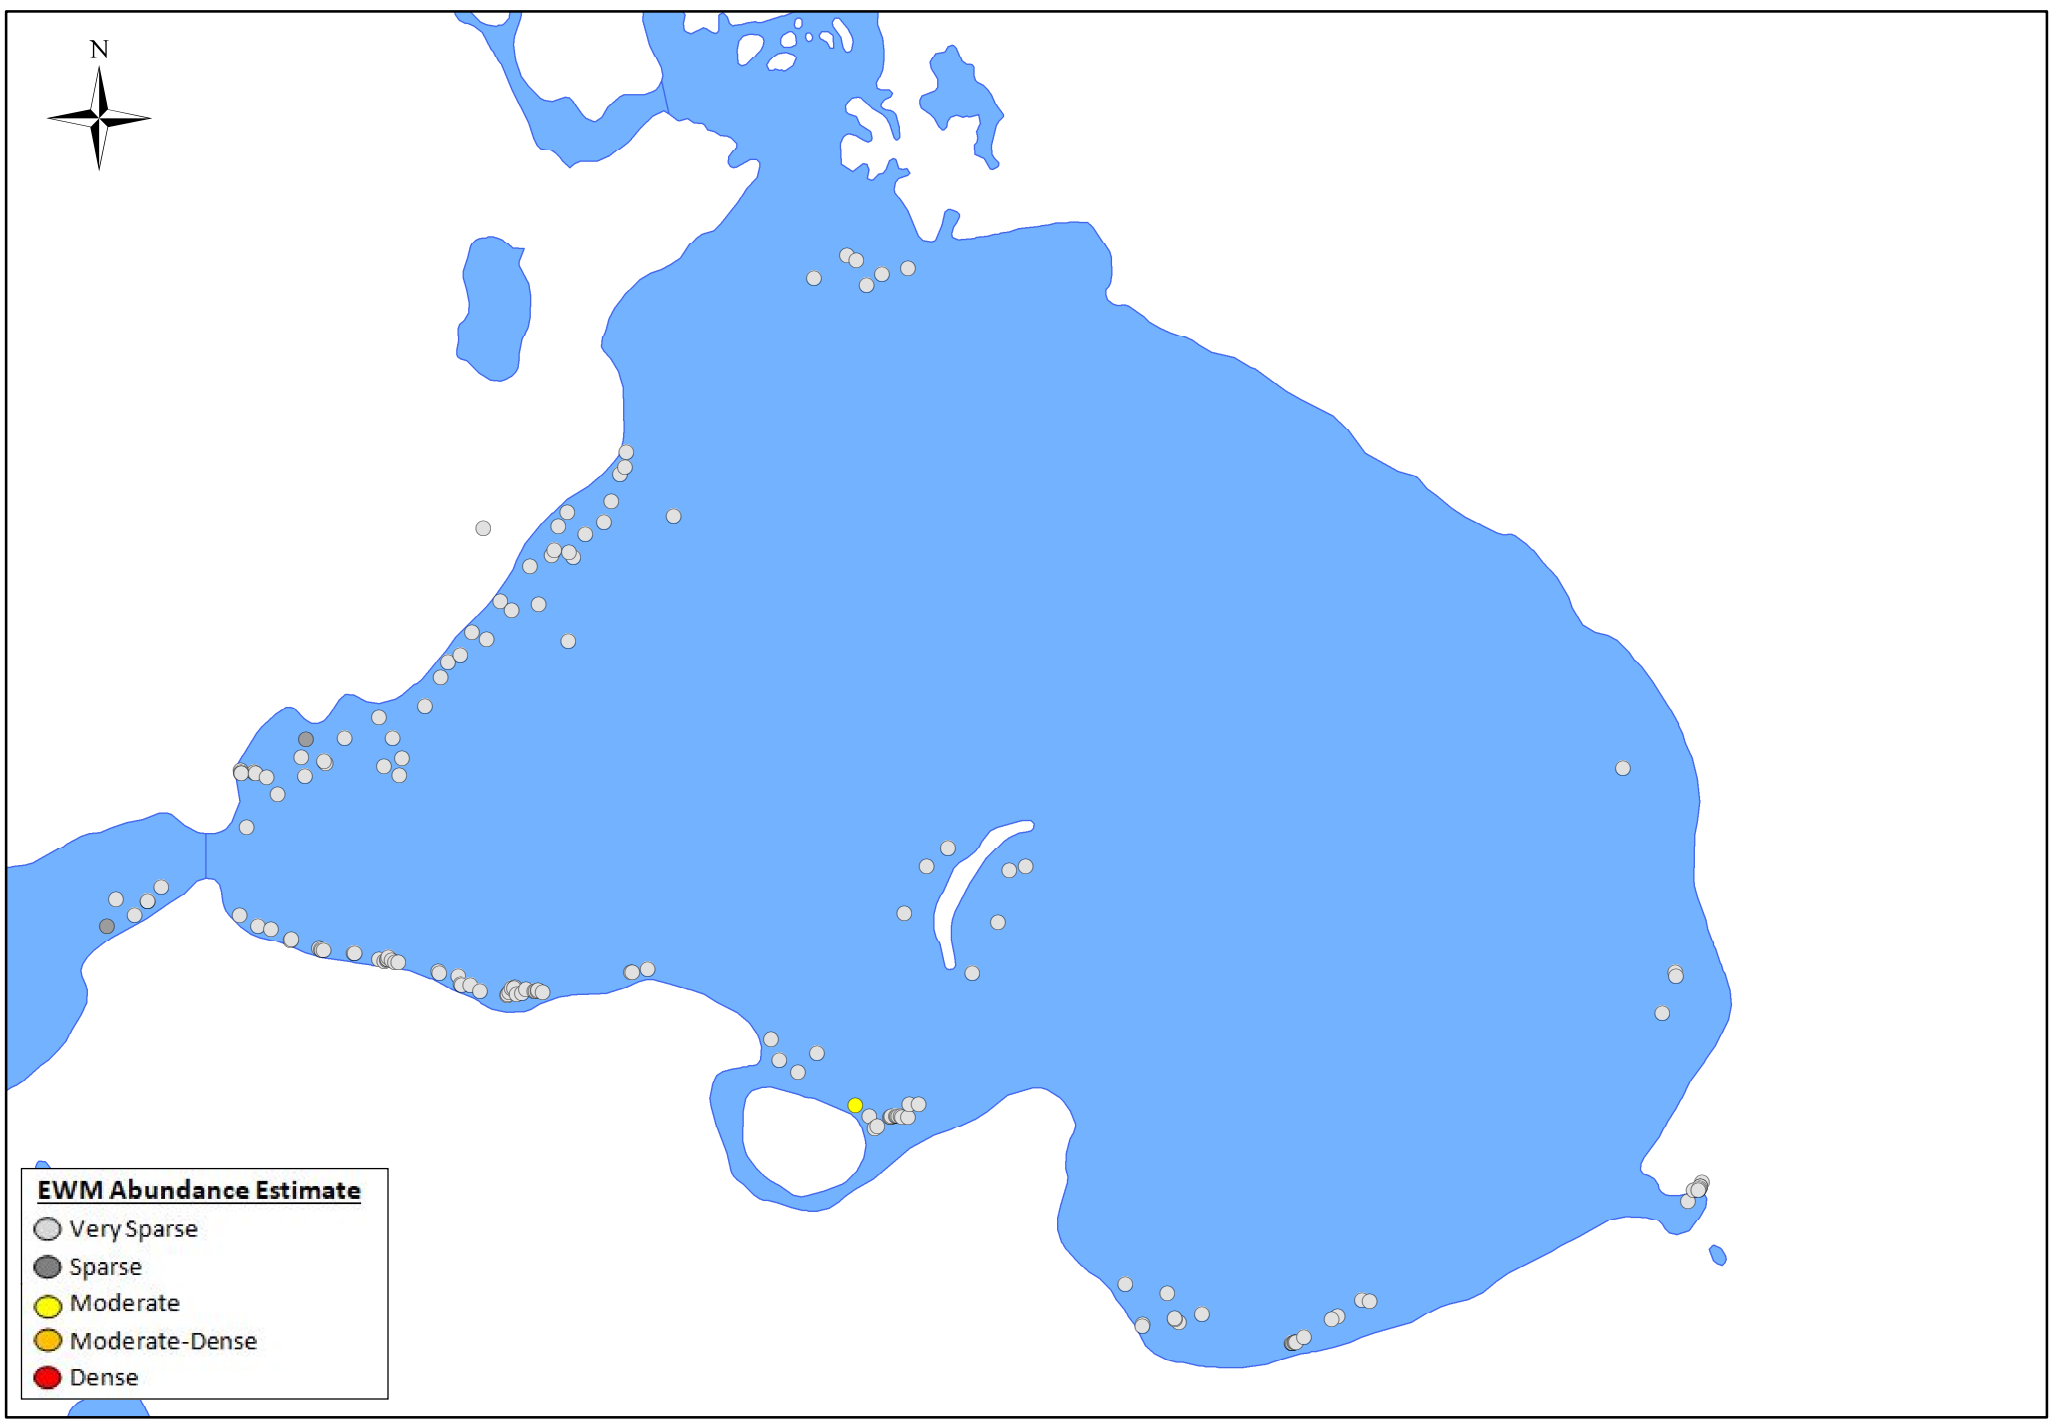
Lower Buckatabon Lake - Vilas County, WI
End of the Year EWM Locations
2022

Lake: Lower Buckatabon, Vilas County, WI
Map Date & Creator: 1/17/23, Many Waters, LLC
Survey Dates: 8/26/2022, 10/1/2022 & 10/14/22
Source: WDNR hydro, EWM-Many Waters
File: Buckatabon_EOY_2022

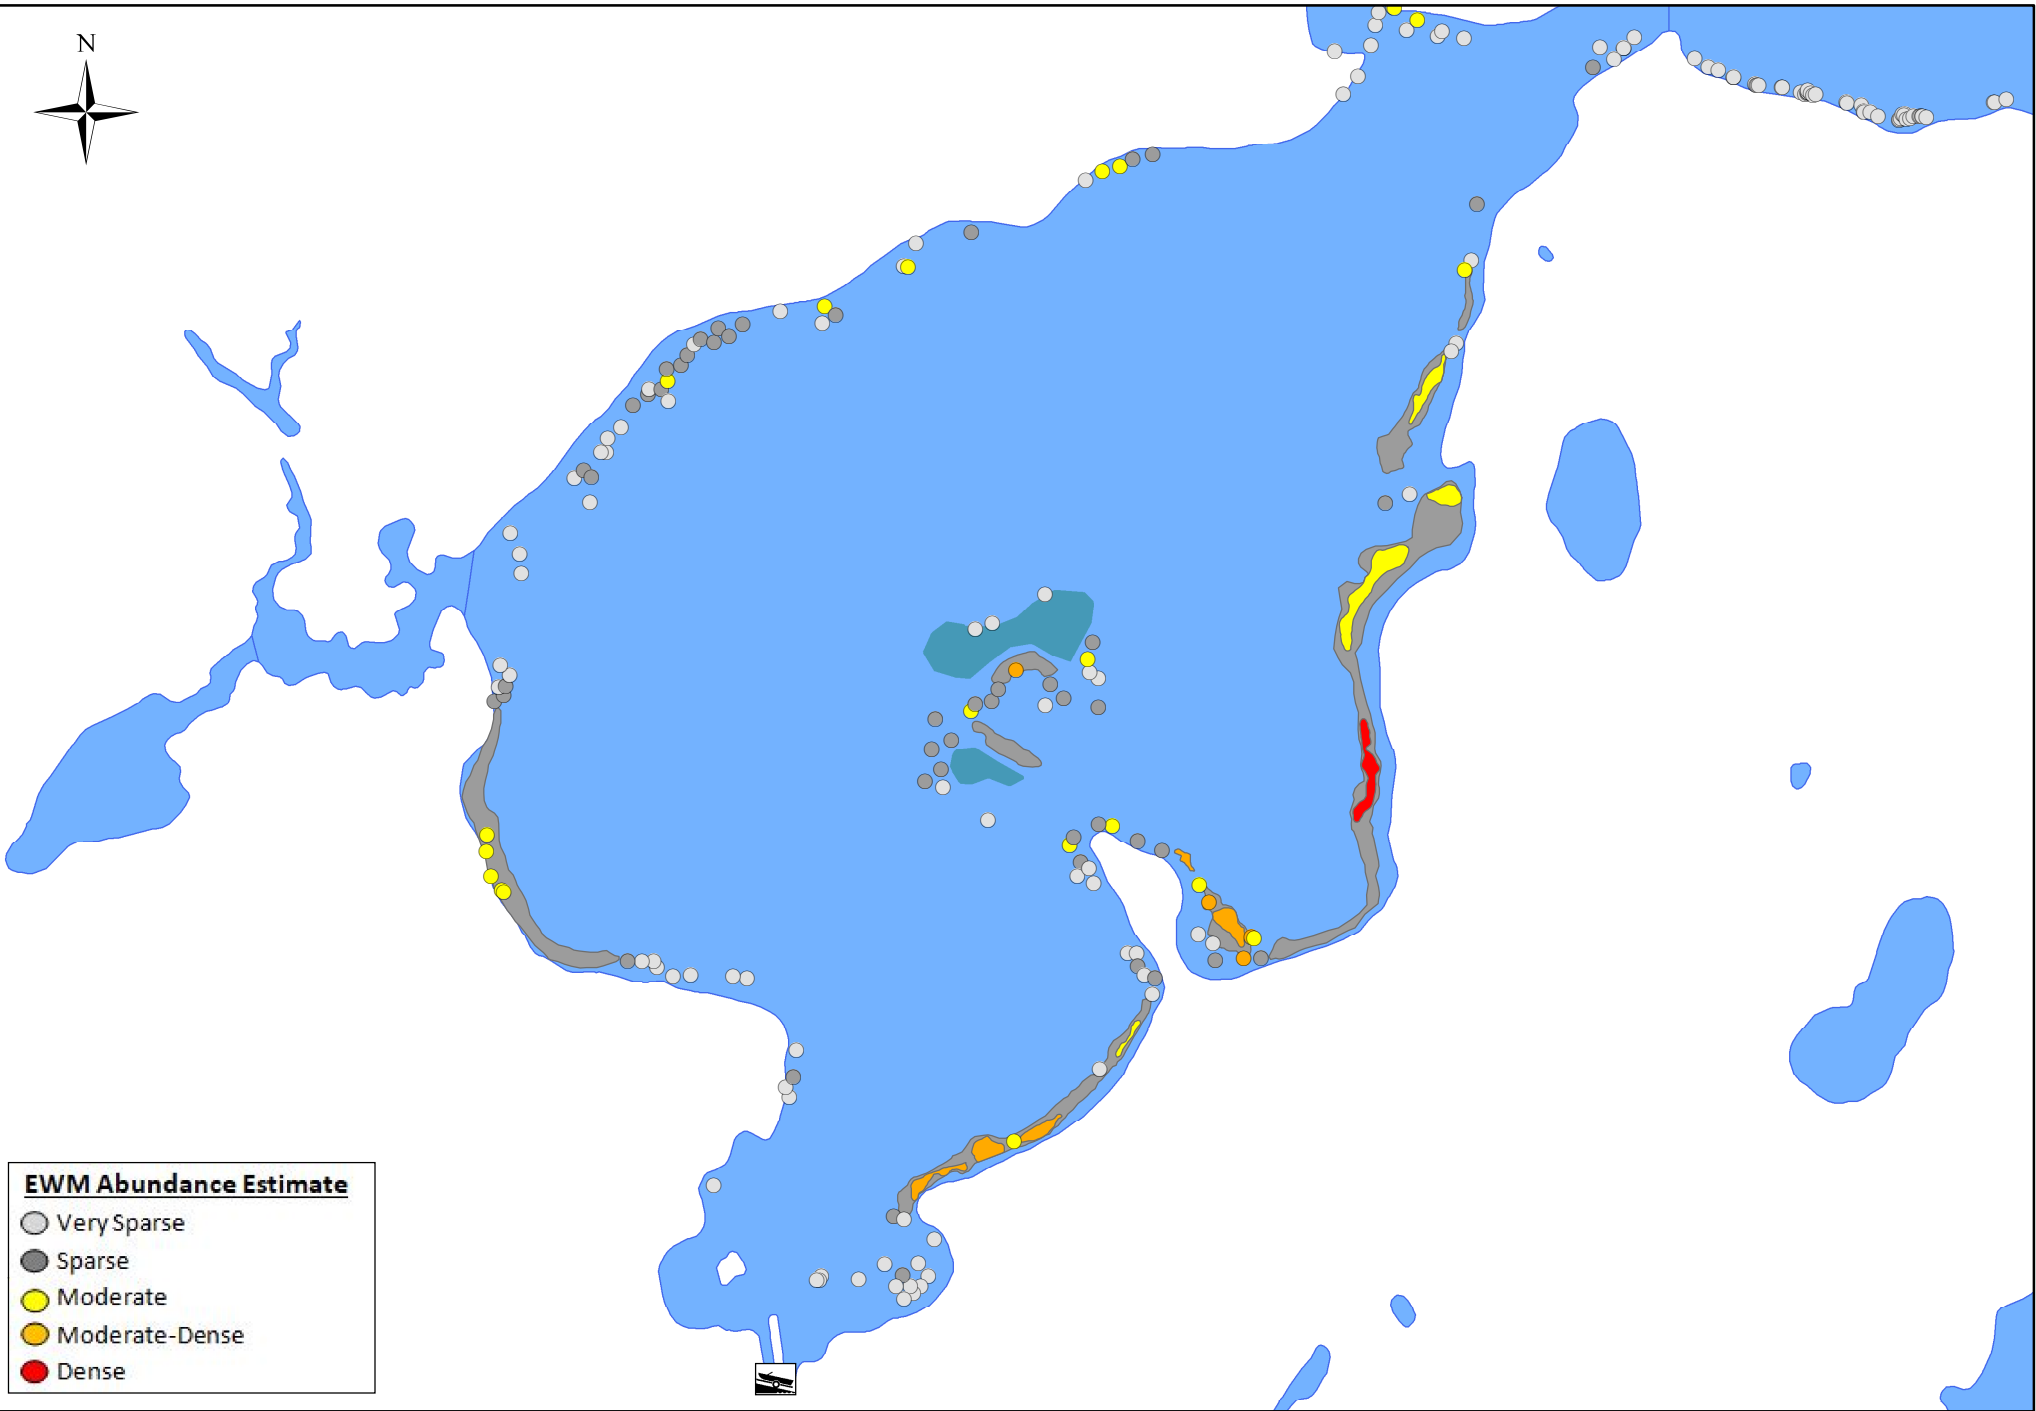
Upper Buckatabon Lake - Vilas County, WI
End of the Year EWM Locations
2022

Lake: Upper Buckatabon, Vilas County, WI
Map Date & Creator: 1/17/23, Many Waters, LLC
Survey Dates: 8/16/22, 8/26/2022 & 10/1/2022
Source: WDNR hydro, EWM-Many Waters
File: Buckatabon_EOY_2022

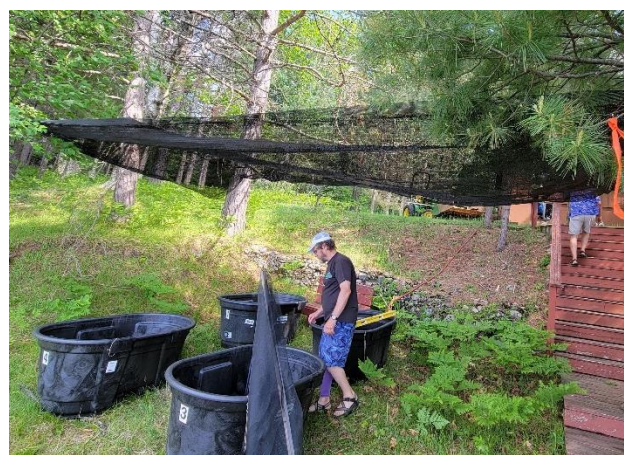
Figure 7. BLA volunteer Dan Benson helping to set up the 2021 weevil rearing site on Upper Buckatabon. These cattle troughs held the harvested EWM for rearing the weevils. This was discontinued in 2022 due to increased weevil density in food collection sites.

The process of rearing weevils necessitates that EWM stems be taken out of the target lake (in this case Upper Buckatabon Lake) as food and placed in the cattle troughs for rearing. This will avoid introducing EWM genetic strains or EWM hybrids from other

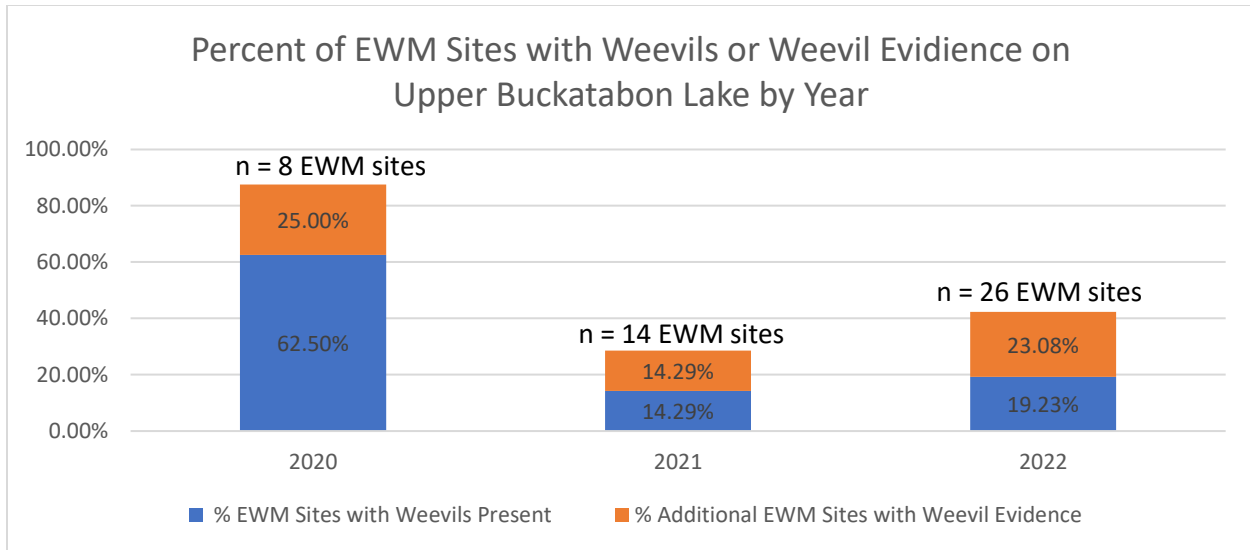
Figure 14. Percentage of EWM sites that had weevils or showed weevil evidence from 2020-2022.

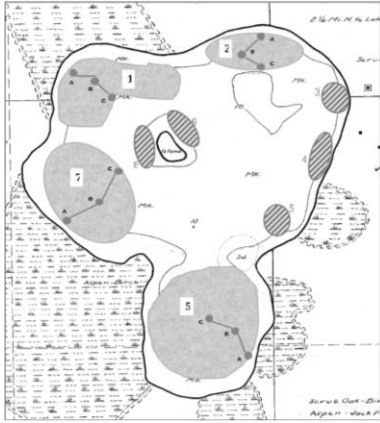
Figure 15. Citizen Lake Monitoring Native Water-Milfoil Weevil example transect map.

Following the protocols, 10 24-inch-long stems were collected at random at each transect point, 5 from either side of the boat. These stems were preserved in ethanol and assessed for all life stages of weevils. Each EWM bed had a total of 30 stems collected and was used to find an average number of weevils/stem in each EWM bed. See protocol example map below:

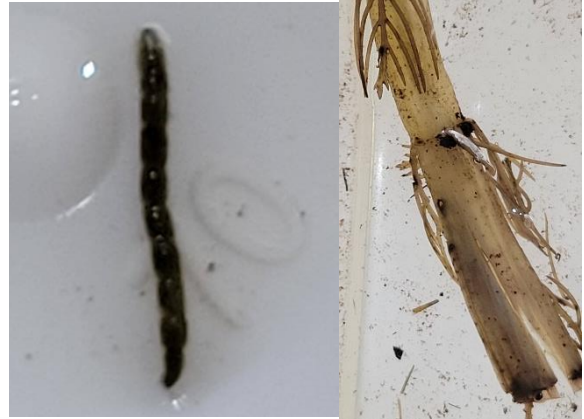
Figure 17. Midge larvae found inside a northern watermilfoil stem on Upper Buckatabon, and the dissected stem where it was found. Notice the pinholes on the left side of the stem.

A stem burrowing insect that was not a weevil larva was found in a stem of northern watermilfoil from the samples collected on Upper Buckatabon. PJ Liesch, the Extension Entomologist from the Insect Diagnostics Lab was able to say the insect is a type of midge larvae, however, he could not confirm genus or species (Liesch 2023). Some midges are stem miners. Most often these midge stem miners build tubes in plant tissue to draw water and ingest diatoms, but others feed directly on leaves or other plant tissue (Balciunas 1982). It is unclear if the midge was consuming the stem tissue or simply using it as habitat. The exact location of this midge larvae was not recorded.

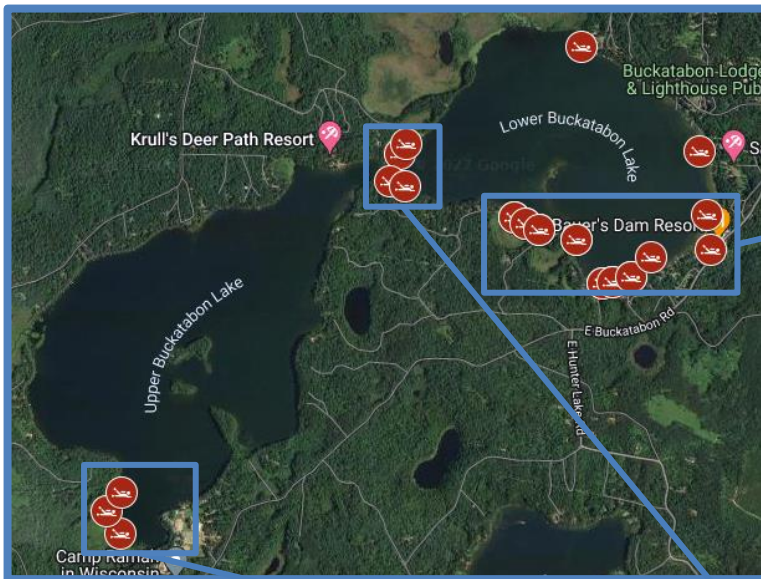
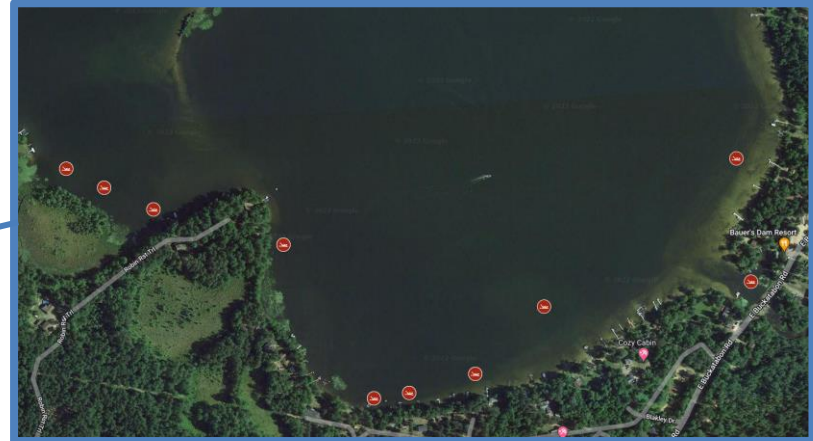
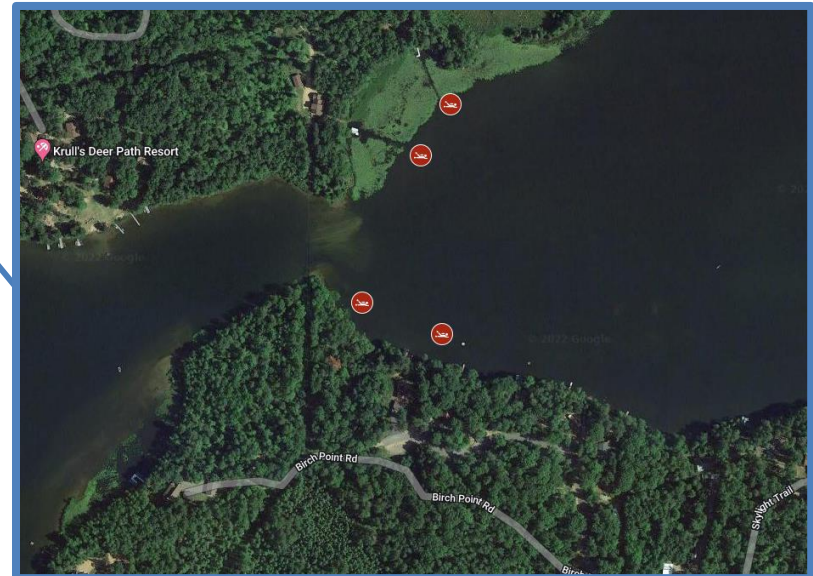
Map of Buckatabon Dive Sites

Dive Highlights and Recommendations: The hand harvesting team made their way clockwise around Lower Buckatabon, diving at prioritized locations along certain sections of shoreline. Overall, Buckatabon Lakes should continue to take an Integrated Pest Management (IPM) approach and evaluate different strategies to manage the EWM population on the lake. Continued monitoring and management efforts are important to prevent the spread of EWM throughout Upper and Lower Buckatabon Lake.
