## 1.0 INTRODUCTION

Anvil Lake, Vilas County, is an approximate 392-acre mesotrophic seepage lake with a maximum depth of 35 feet estimated during 2020 (Map 1 and Photograph 1.0-1). The lake harbors a high-quality native aquatic plant community with 37 native species, 22 of which have a coefficient of conservatism of 7 or higher. Anvil lake also contains a population of Vasey's pondweed (*Potamogeton vaseyi*), a native aquatic plant listed as special concern in Wisconsin due to its relative rarity. The lake maintains high water clarity, with an average summer Secchi disk depth of 12 feet.

# 2022 Eurasian Watermilfoil Harvest Report

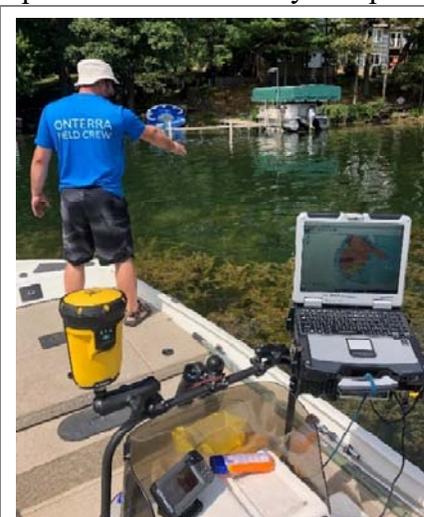
**Photograph 2.0-1. EWM mapping survey on a Wisconsin lake.**  
Photo credit Onterra.

While the point-intercept survey is a valuable tool to understand the overall plant population of a lake, it does not offer a full account (census) of where a particular species exists in the lake. During an AIS Mapping Survey, the entire littoral area of the lake is surveyed through visual observations from the boat (Photograph 2.0-1). Field crews supplemented the visual survey by deploying a submersible camera along with periodically doing rake tows. The AIS population is mapped using sub-meter GPS technology by using either 1) point-based or 2) area-based methodologies. Large colonies >40 feet in diameter are mapped using polygons (areas) and are qualitatively attributed a density rating based upon a five-tiered scale from *highly scattered* to *surface matting*. Point-based techniques were applied to AIS locations that were considered as *small plant colonies* (<40 feet in diameter), *clumps of plants*, or

*single or few plants*. Overall, each survey has its strengths and weaknesses, which is why both are utilized in different ways as part of this project.

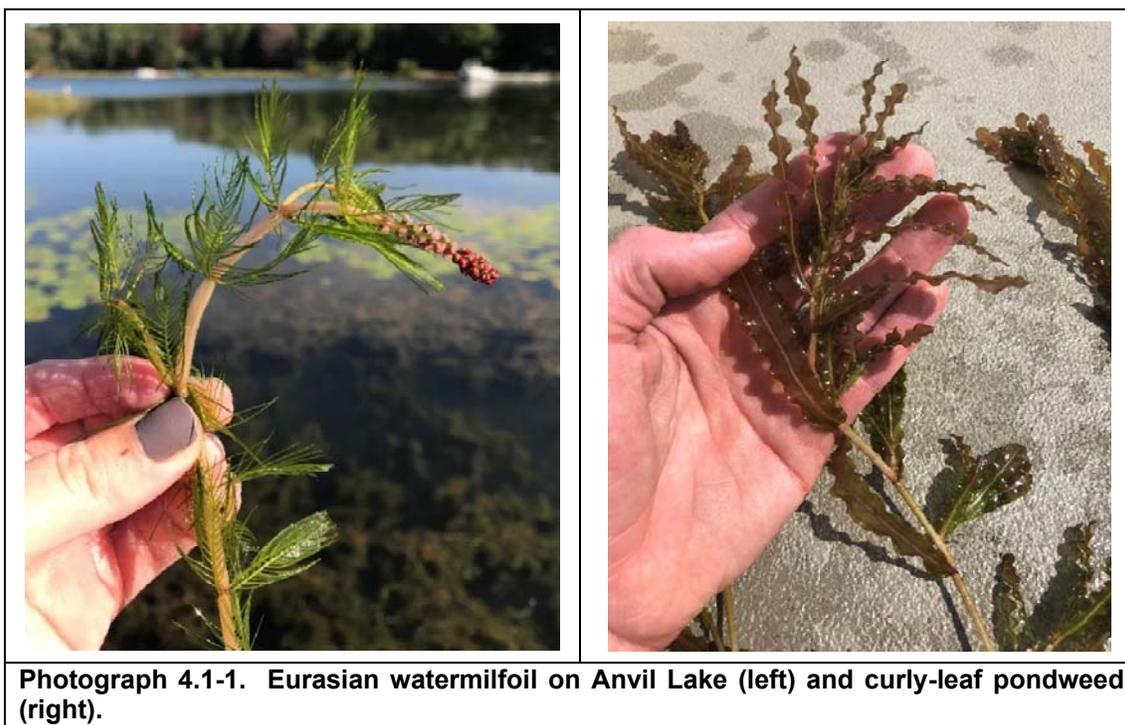
Curly-leaf pondweed (Photograph 4.1-1) was discovered in Anvil Lake in 2013, and its population has since remained modest. An Early Season AIS Survey is planned to occur in approximately late-June 2023 to assess the CLP population and subsequently provide an update to the population. Continued monitoring of the CLP population will yield information on its dynamics in Anvil Lake. This invasive species can cause great ecological and recreational impacts on some lakes, but in other lakes including many in northern Wisconsin, the CLP population remains low and does not cause these impacts. At these low levels, there are likely no observable ecological impacts to the lake and are no reductions in ecosystem services to lake users.
