RED CEDAR LAKES

2023 MANAGEMENT SUMMARY REPORT

Prepared by: Dave Blumer, Lake Educator

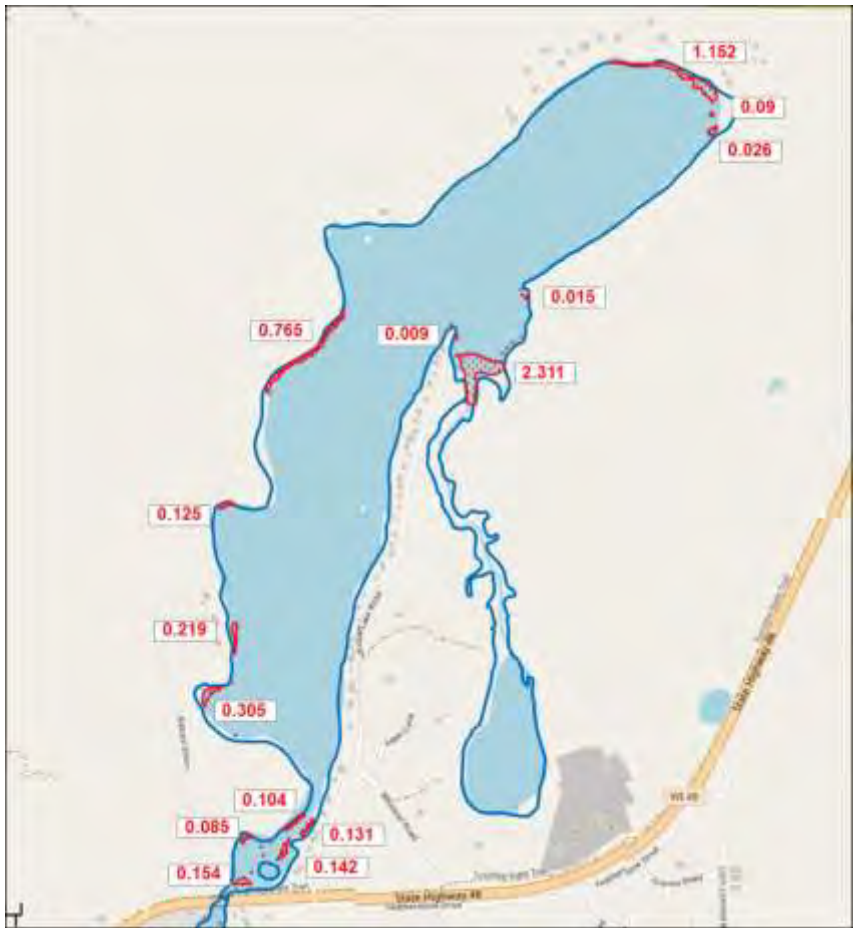
Figure 1: June 2022 Bed Mapping Results – 15 beds of CLP with a mean of 0.38 acres = 5.7 acres

In all, APM was able to remove 77.0 cubic feet of CLP from Balsam Lake. Only two of the 15 beds were included in their removal project, at best perhaps up to an acre of CLP (Figure 2). To complete what little CLP removal they did, the total cost was \$4,202.38. That much money could have been used to manage between 5 and 6 acres of CLP with the endothall-based aquatic herbicide Aquathol K.

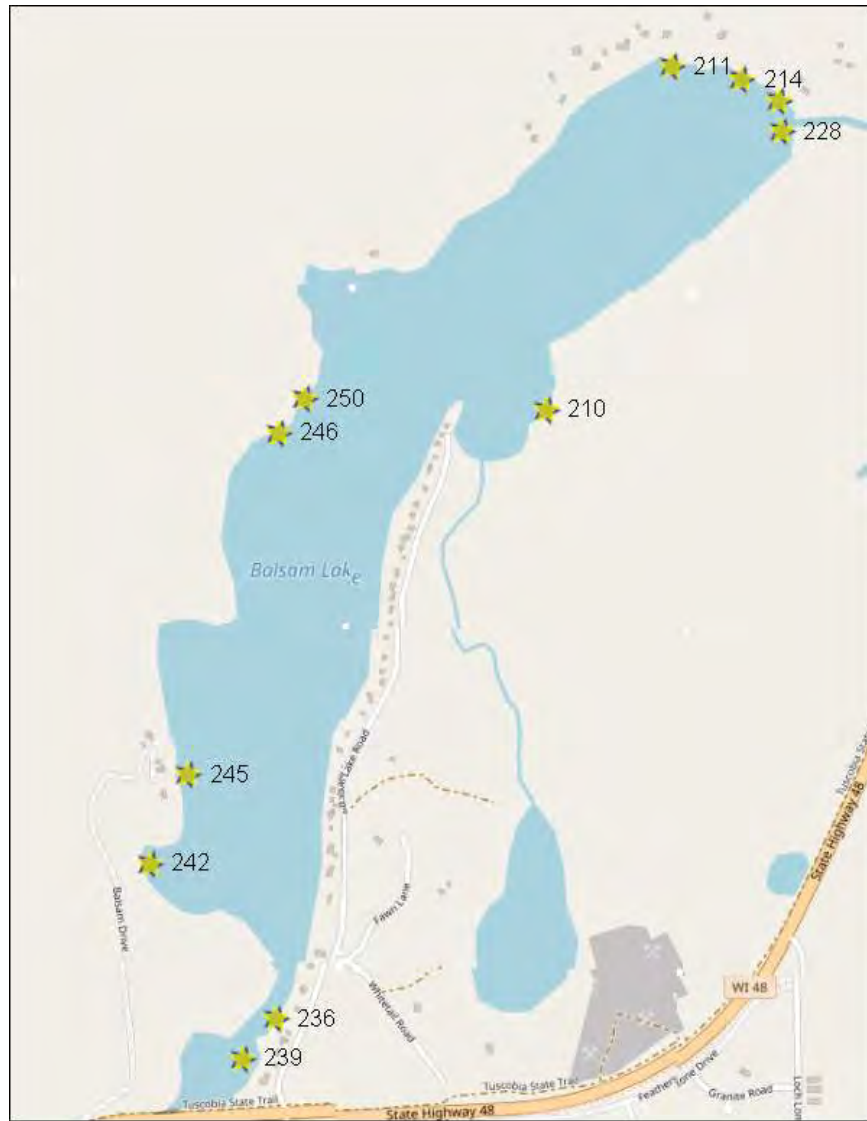
Figure 3: May 27, 2023 Balsam Lake CLP points – LEAPS

CLP bed mapping in Balsam Lake, completed on two different dates in 2023. The first survey on May 27 documented 42 points with CLP. A repeat survey was completed on June 22. In that survey an additional 20 points was added and one bed of CLP totaling 0.31 acres was mapped on the north end of the lake (Figure 4). All other CLP was mostly scattered plants or small clumps (Figure 3). As previously mentioned, DASH was used to remove CLP from two areas of the lake – the north end and near the boat landing. Despite the removal of 77cuft of CLP from these two areas in early June, it was difficult to tell any difference in abundance or density.

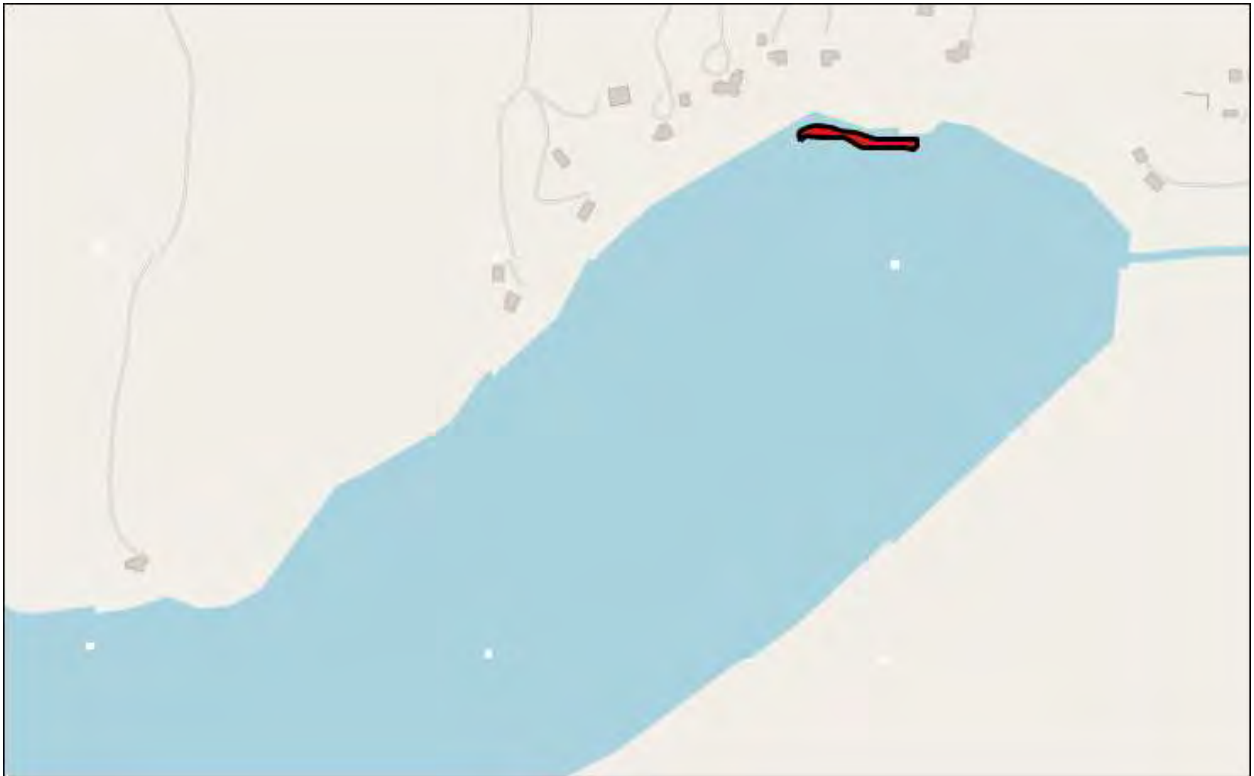
Figure 4: Balsam Lake CLP bed (0.31 acres) mapped on June 22, 2023 (LEAPS)

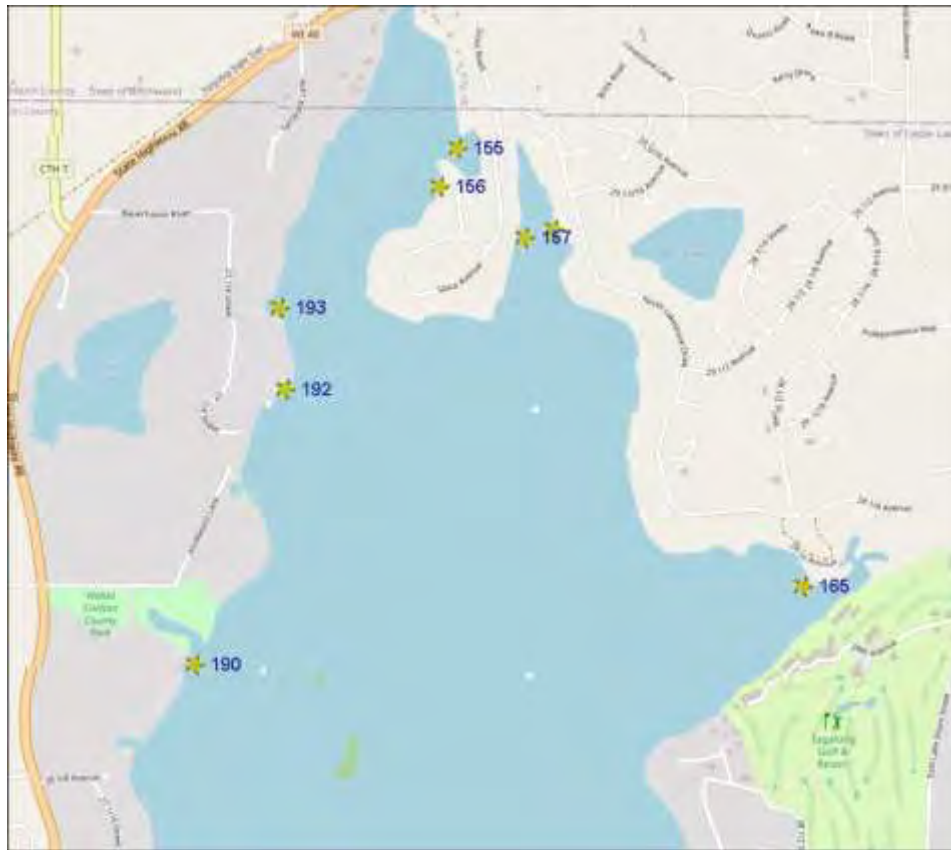
Figure 5: 2023 CLP mapping results from the North, Middle, and Lower Basins of Red Cedar Lake - LEAPS

A CLP bed mapping survey on Red Cedar Lake on June 22 & 24 documented 118 points with CLP (Figure 5). A majority of these points were individual plants or small clumps, not dense enough or large enough to be considered a bed. Only two areas had what was considered a bed of CLP. The two areas totaled 0.5 acres (Figure 6). After the survey it was determined that at least in 2023, DASH could have removed nearly all of the CLP that was found. However, it would likely take several days to make it around the lake removing all the CLP.

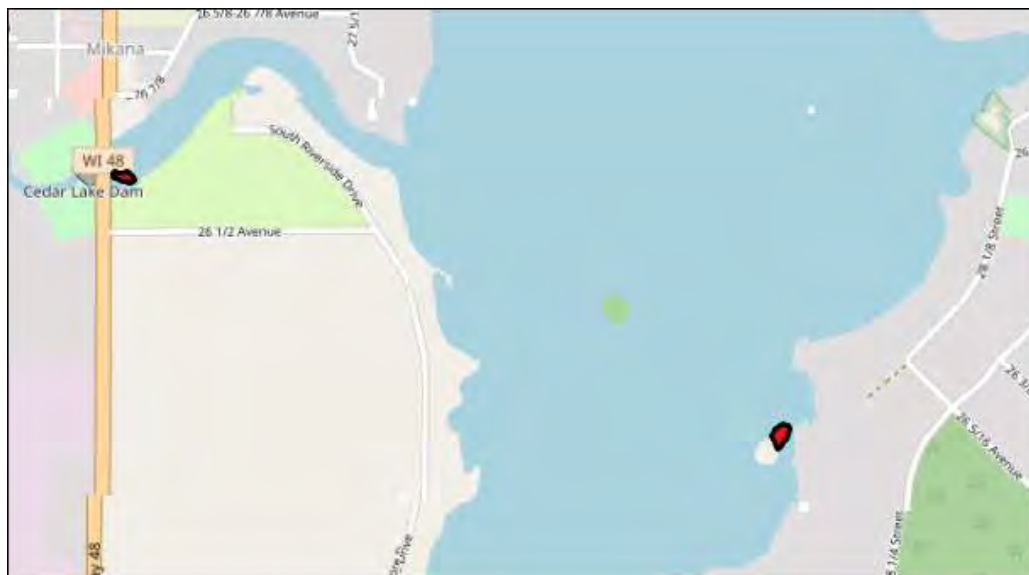
Figure 6: 2023 Red Cedar Lake CLP beds (0.5 acres) – LEAPS

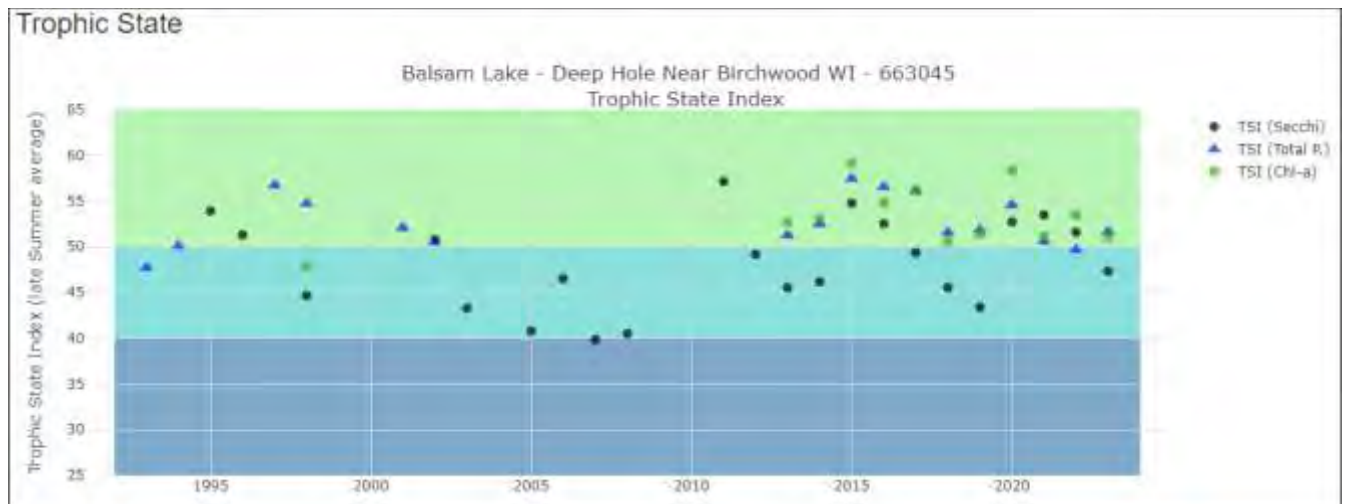
Figure 9: Historic TSI values for Secchi, total phosphorus, and chlorophyll-a in Balsam Lake, Washburn County at the Deep Hole Near Birchwood (WEx, 2024)

Balsam Lake - Deep Hole Near Birchwood WI in Washburn County was sampled on 11 different days during the 2023 season. Parameters sampled included: water clarity (Secchi disk), temperature, dissolved oxygen, total phosphorus, chlorophyll-a. The Trophic State Index values for the three parameters – Secchi disk readings of water clarity, total phosphorus, and chlorophyll-a places Balsam Lake mostly in the eutrophic, or nutrient-rich category for lakes (Figure 9). Balsam Lake is considered a deep, two-story fishery lake, although it does not currently support a cold-water fishery. When compared to other two-story fishery lakes, these values identify Balsam Lakes as way worse than average for all parameters (Figure 10). There are no significant trends, good or bad, for any of the three main parameters.

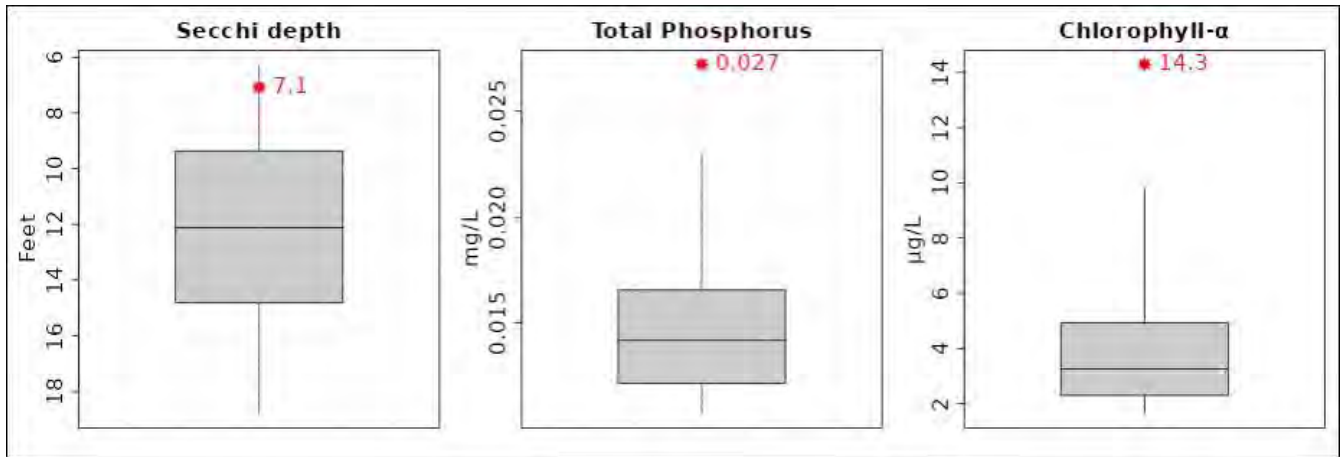
Figure 10: Trophic status compared to similar lakes using data from the last 10 years (WEx, 2024)

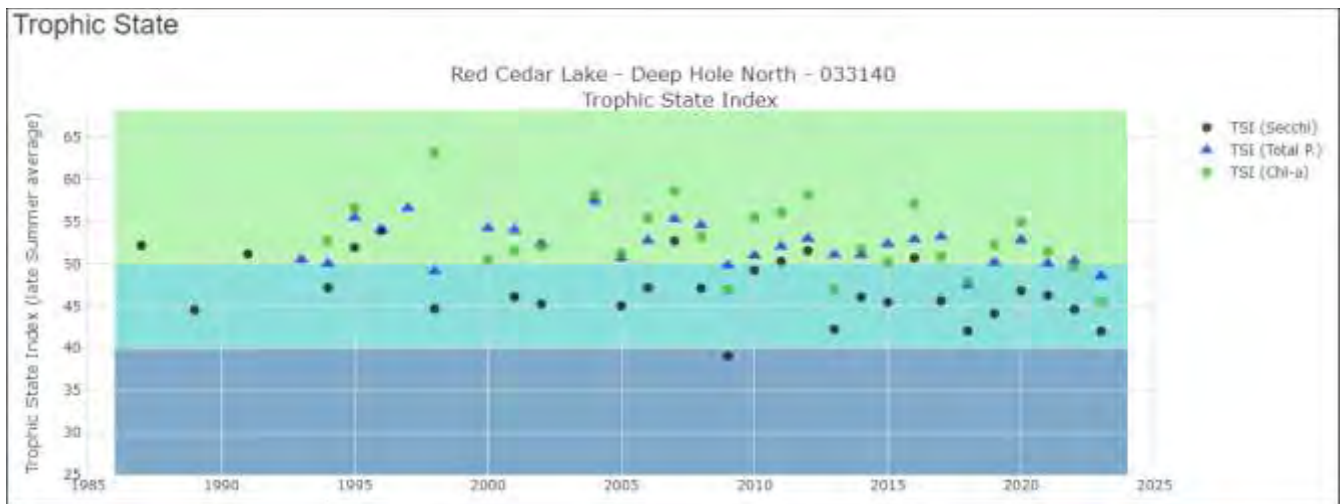
Figure 11: Historic TSI values for Secchi, total phosphorus, and chlorophyll-a in Red Cedar Lake, Barron County at the Deep Hole North (WEx, 2024)

Red Cedar Lake - Deep Hole North was sampled on 10 different days during the 2023 season. Parameters sampled included: water clarity (Secchi disk), temperature, dissolved oxygen, total phosphorus, chlorophyll. The Trophic State Index values for the three parameters – Secchi disk readings of water clarity, total phosphorus, and chlorophyll-a places Red Cedar Lake split between the mesotrophic and eutrophic categories (Figure 11). Eutrophic lakes are nutrient-rich, with either a lot of aquatic plants or a lot of algae. Mesotrophic lakes are less nutrient rich but may still have a lot of vegetation. Red Cedar Lake is considered a deep, two-story fishery lake, although its ability to support a cold-water fishery is marginal at best. When compared to other two-story fishery lakes, these values identify Red Cedar Lake as way worse than average for all parameters (Figure 12). In the late summer, there are significant trends toward improving water clarity and quality in Secchi disk readings, total phosphorus, and chlorophyll.

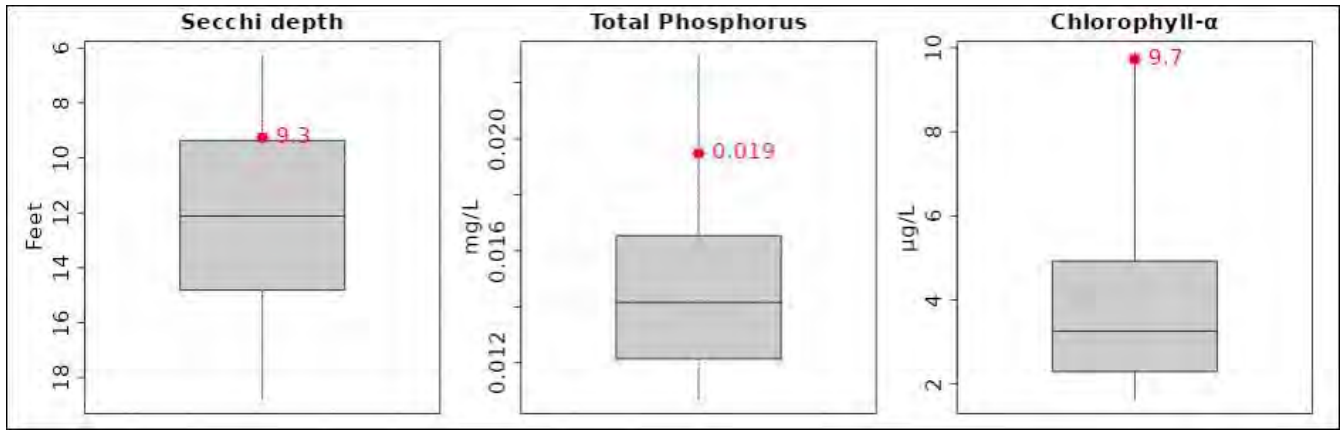
Figure 12: Trophic status compared to similar lakes using data from the last 10 years (WEx, 2024)

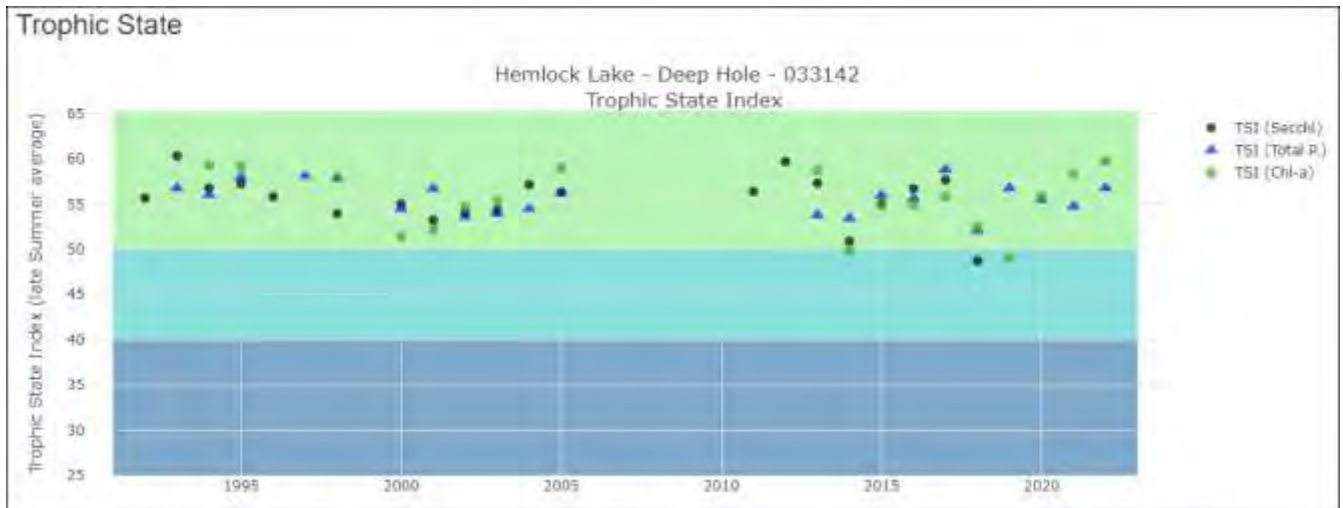
Figure 13: Historic TSI values for Secchi, total phosphorus, and chlorophyll-a in Hemlock Lake, Barron County (WEx, 2024)

The Trophic State Index values for three parameters – Secchi disk readings of water clarity, total phosphorus, and chlorophyll-a places Hemlock Lake in the eutrophic, or nutrient-rich category for lakes (Figure 13). When compared to similar lakes, these values identify Hemlock Lakes as better than average in all three categories (Figure 14). There are no significant trends, good or bad, for any of the three main parameters.

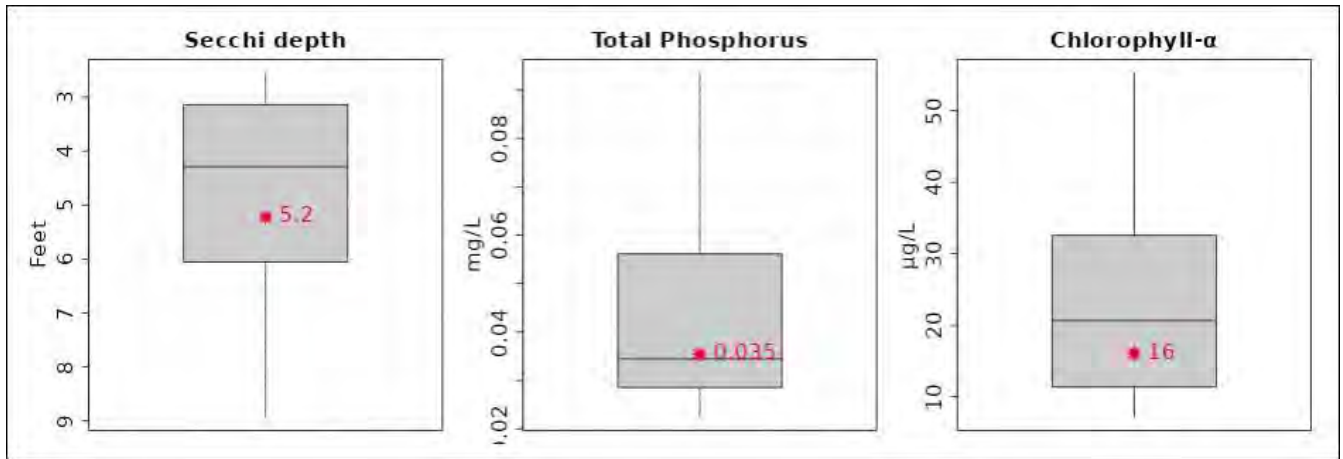
Figure 14: Trophic status compared to similar lakes using data from the last 10 years (WEx, 2024)

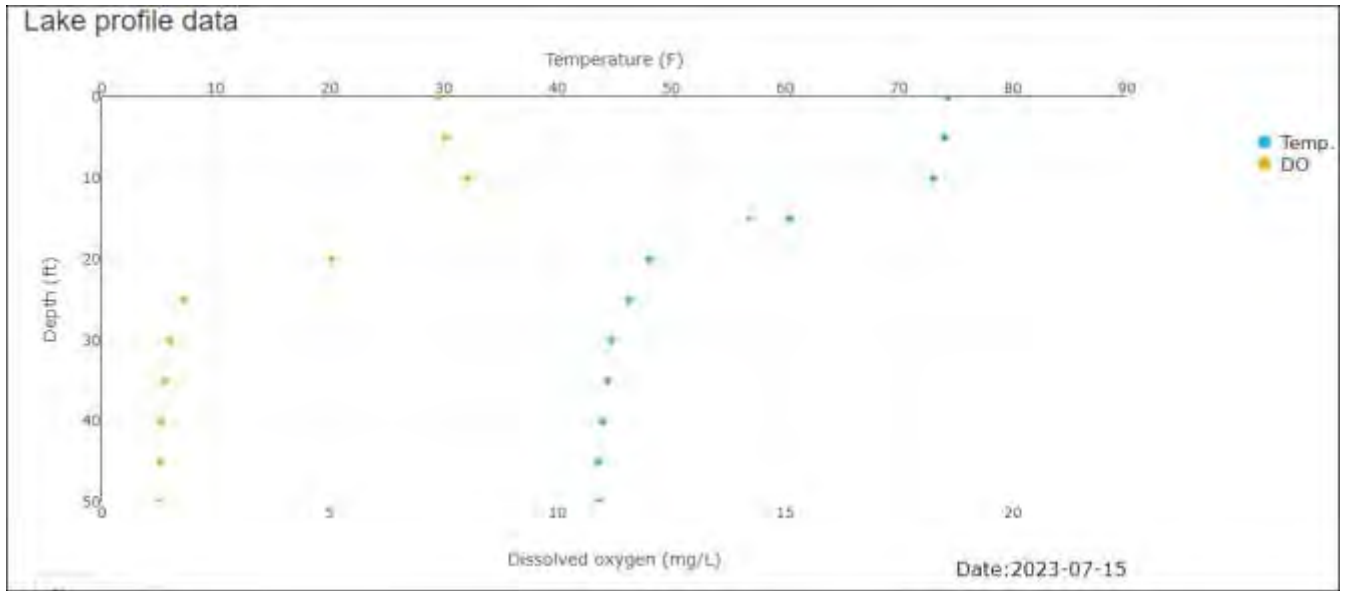
Figure 15 shows a typical mid-summer (July) profile for Balsam Lake. The thermocline gets established at about 20-ft. DO concentration plummets after 20-ft. Water temperature drops substantially as well. Of note is that there seems to be a band of oxygen producing algae that hovers right near the thermocline as indicated by the DO concentration at about 18-ft being so high compared to the rest. This is likely not an anomaly as it happens quite frequently in Balsam Lake.

Figure 15: Temperature and DO profile from July 2023 – Balsam Lake (WEx, 2024)

Temperature and dissolved oxygen (DO) profiles were collected from both Balsam and Red Cedar Lakes in 2023. The last time temperature and DO were collected from Hemlock Lake was in 2020. Balsam and Red Cedar are considered deep water, stratified lakes. When a lake stratifies, it means that in the summer, the water column separates in to three distinct layers, the epilimnion (warm surface water), the hypolimnion (colder bottom water), and the thermocline (a transition zone between the surface and bottom waters). Water at the surface of the lake is warmer and oxygen rich. Water at the bottom of the lake is colder and generally loses oxygen through the early part of the season until there is no oxygen left in the bottom waters. When there is no oxygen, it means there can be no fish and it means that additional nutrients may be dumped back into the water column when previously bound phosphorus breaks away from the iron in the sediment.

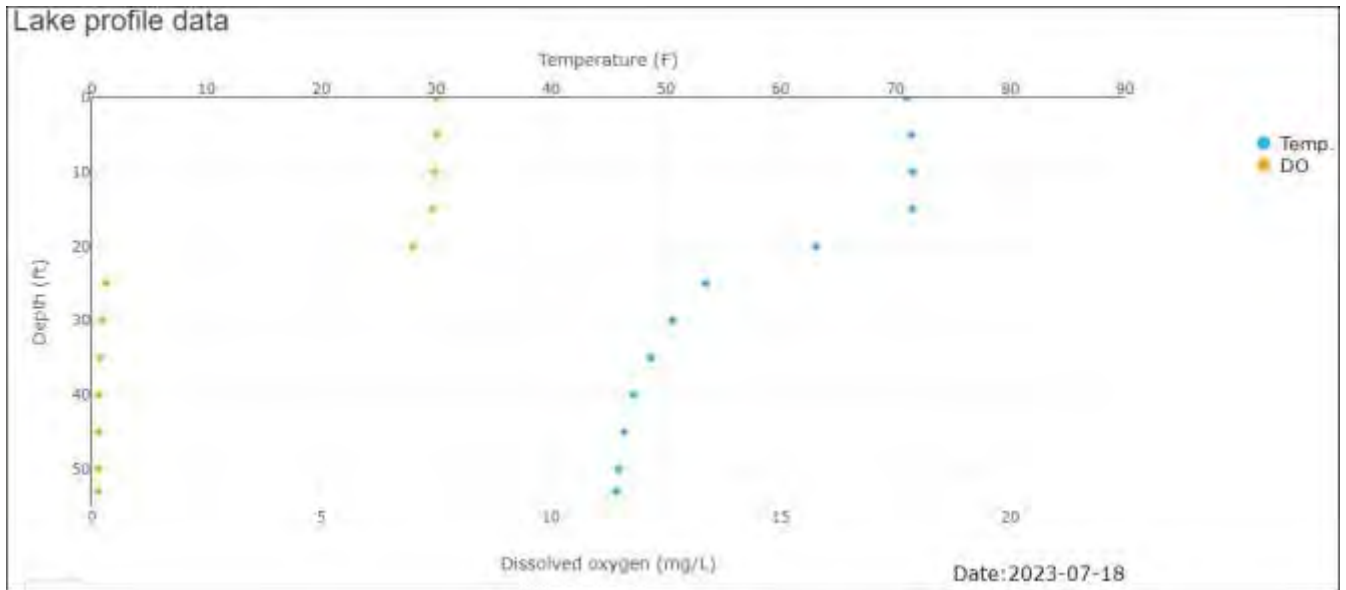
Figure 16 shows a typical mid-summer (July) profile in Red Cedar Lake. Like Balsam, a thermocline gets established around 20-ft. DO concentration plummets after 20-ft. Water temperature drops substantially as well. Red Cedar Lake does not show the band of algae near the thermocline like Balsam Lake does.

Figure 16: Temperature and DO profile from July 2023 – Red Cedar Lake (WEx, 2024)

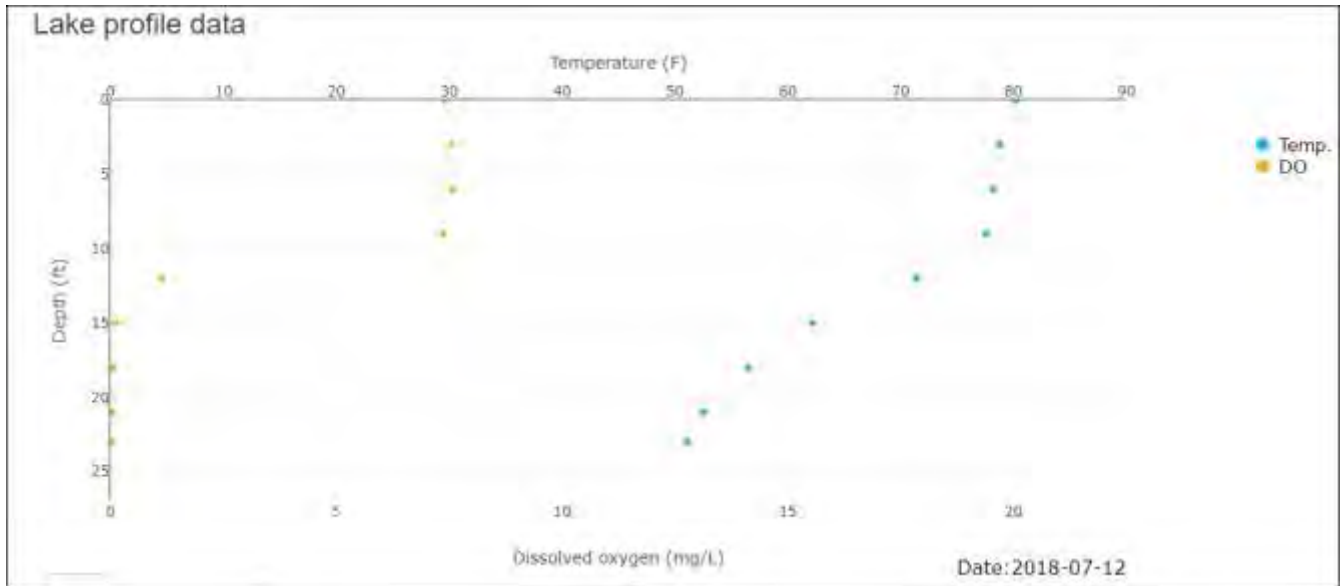
Hemlock Lake is considered a shallow drainage lake. The last profile data was collected in 2020. But in the late 20-teens Hemlock Lake also appeared to stratify in the summer with a thermocline established at about 12-15 feet (Figure 17). Below that, DO plummets and water temperature drops. In many previous years, Hemlock Lake remains mostly mixed and does not form a hard and fast thermocline. Until new data is collected, however, Hemlock Lake is considered a stratified lake.

Figure 17: Temperature and DO profile from July 2018 – Hemlock Lake (WEx, 2024)

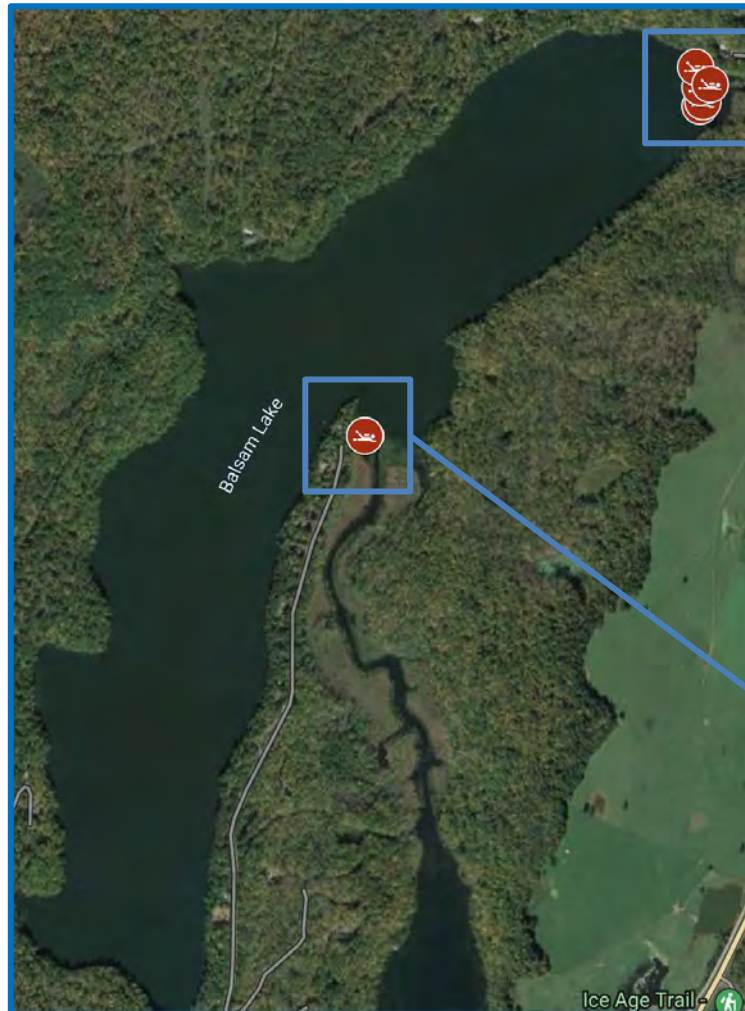
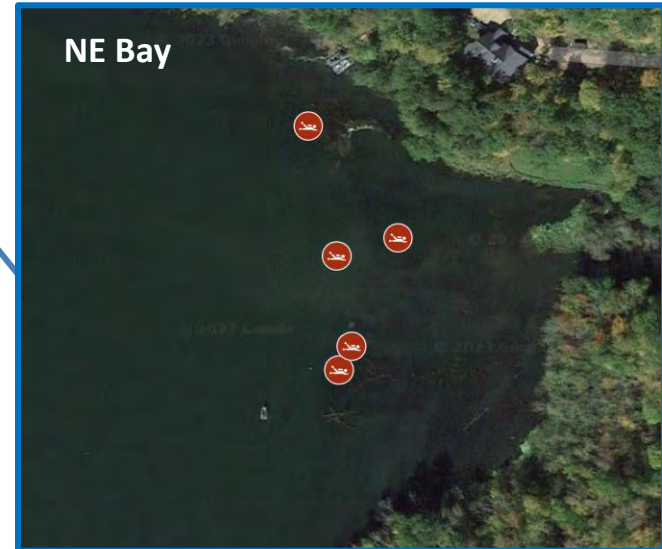
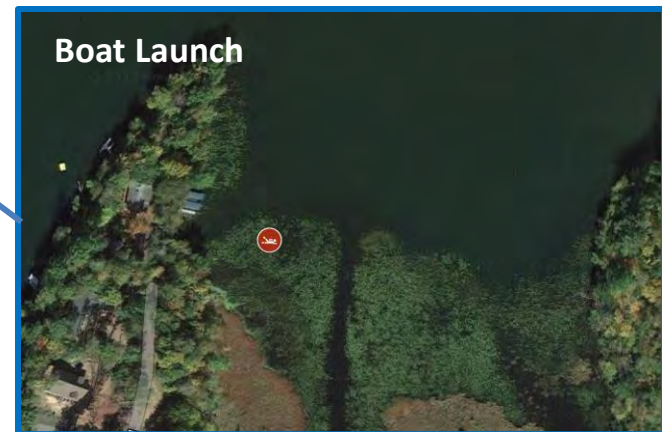
Map of Balsam Lake Dive Sites

Dive Highlights and Recommendations: The dive team spent two days at Balsam Lake, however storms forced the second day to end earlier than planned. The team spent the bulk of their time focusing on CLP in the northeast section of the lake. Overall, Balsam Lake should continue to take an Integrated Pest Management (IPM) approach and evaluate different strategies to manage the CLP population on the lake. Continued monitoring and management efforts are important to prevent the spread of CLP throughout Balsam Lake.

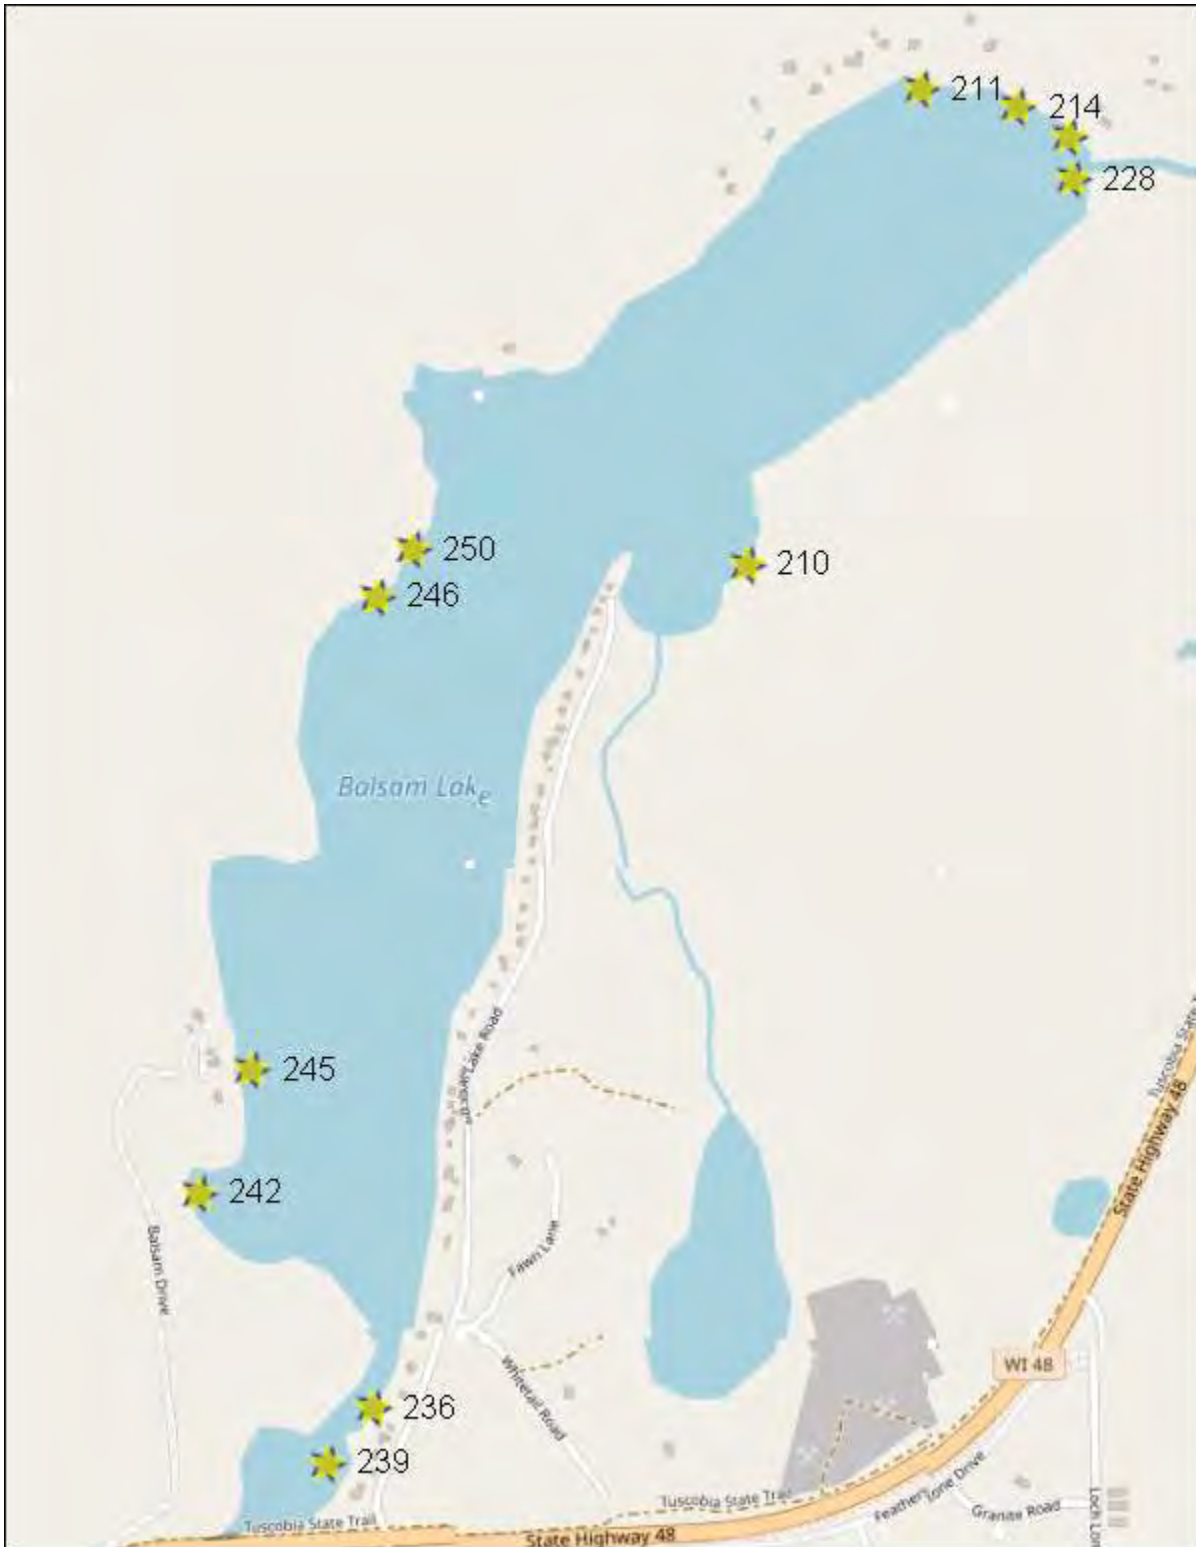
2023 Balsam Lake CLP Meandering Survey 5/27 and 6/22/2023 (LEAPS)

The first 2023 CLP survey of Balsam Lake was completed on May 27. During that survey, 42 points with CLP were mapped.

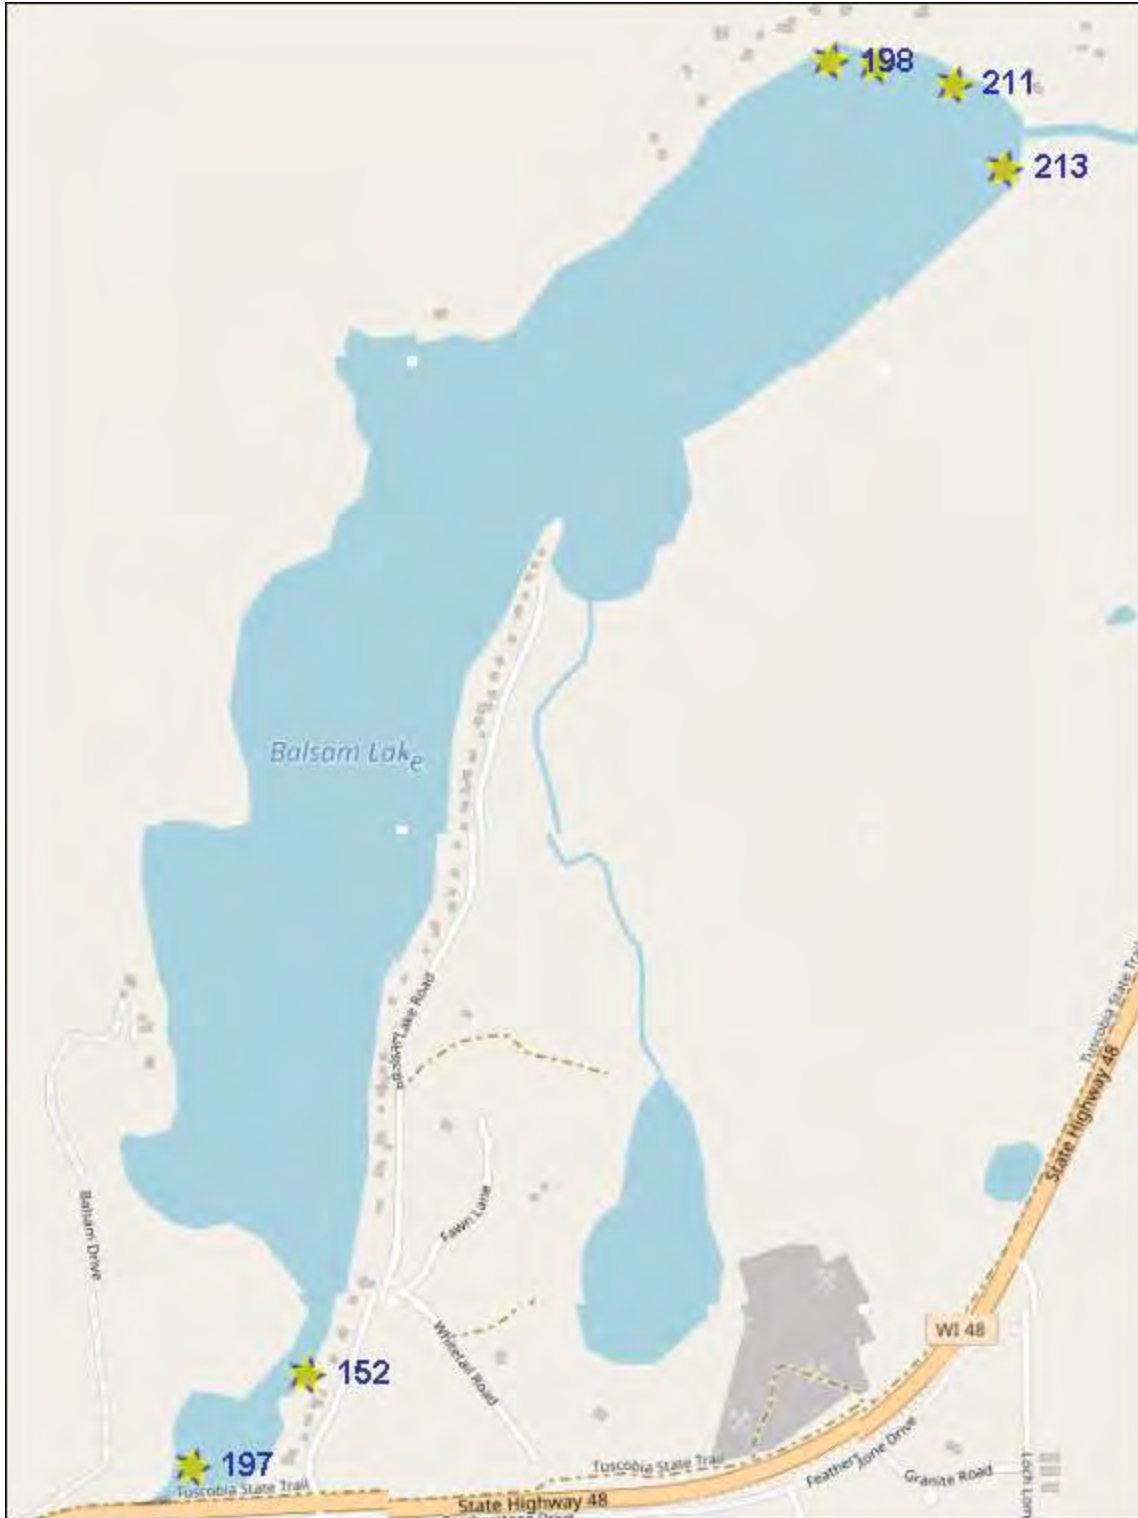
2023 Re-survey of Balsam Lake completed on June 24, after DASH removal. CLP was still prevalent in both the north end and the south end channel leading to Red Cedar Lake. These areas were considered high density areas, with the north end CLP bed covering an estimated 0.31 acres. A CLP bed is defined as an area where greater than 50% of the plants are CLP and there is a definable edge.

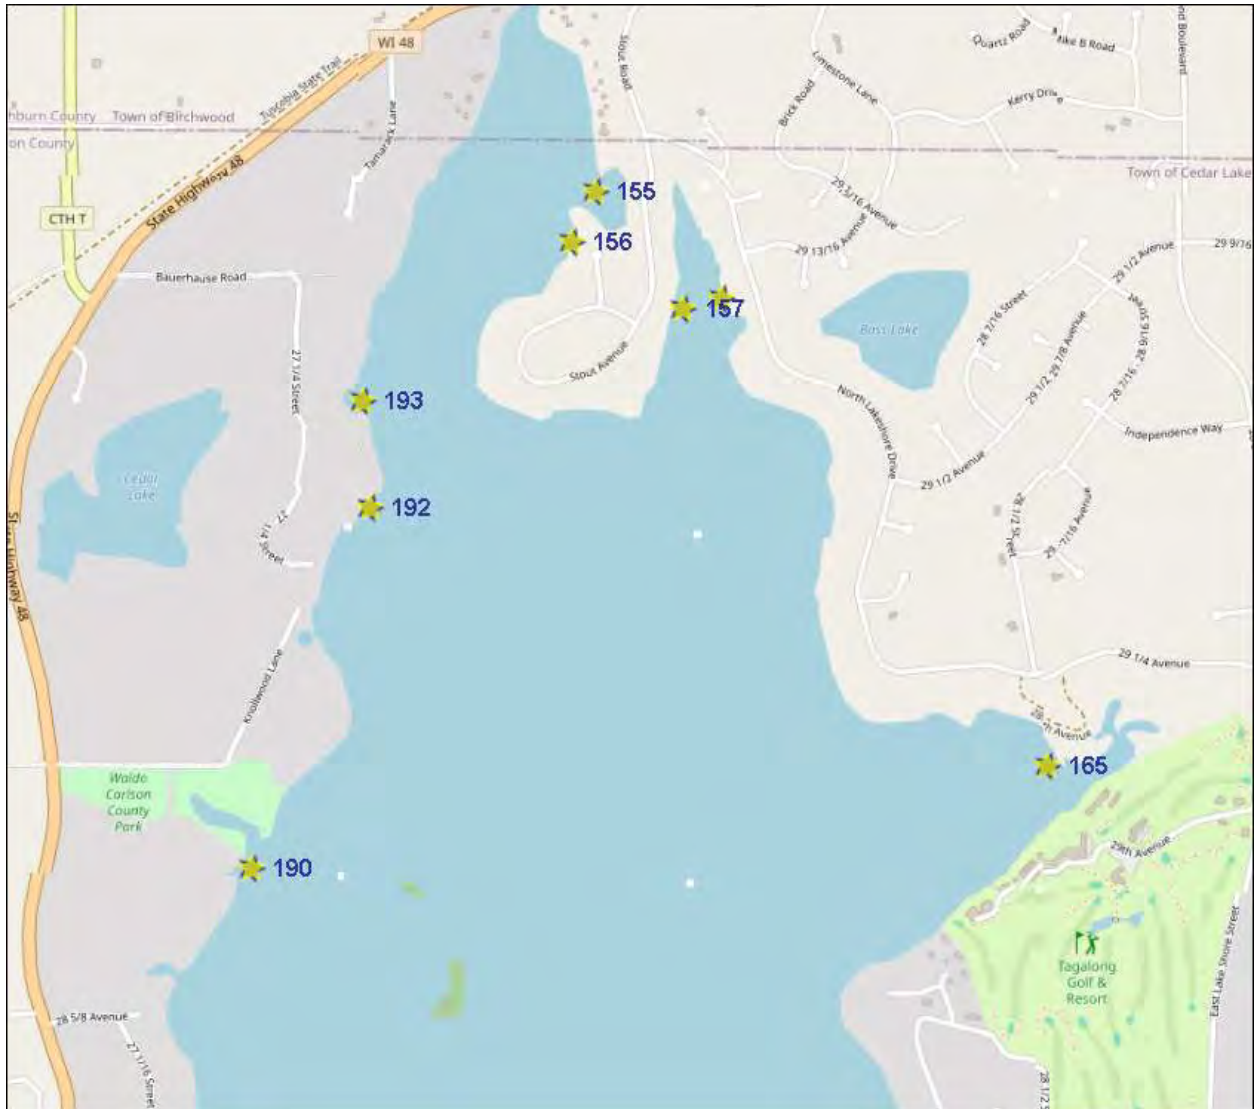
2023 Red Cedar Lake CLP Meandering Survey Points June 22 & 24, 2023 (LEAPS)

A total of 118 points with CLP were taken during the June survey. Nearly all these points were individual plants or small clumps. Only two areas were determined to be bed-forming (greater than 50% of the plants present are CLP and the area has a definable edge). They totaled 0.5 acres (see next figure). The survey determined that CLP was widespread, but only a couple of areas were dense enough to cause any navigation impact. Mostly the CLP plants were just providing some early season fish habitat.

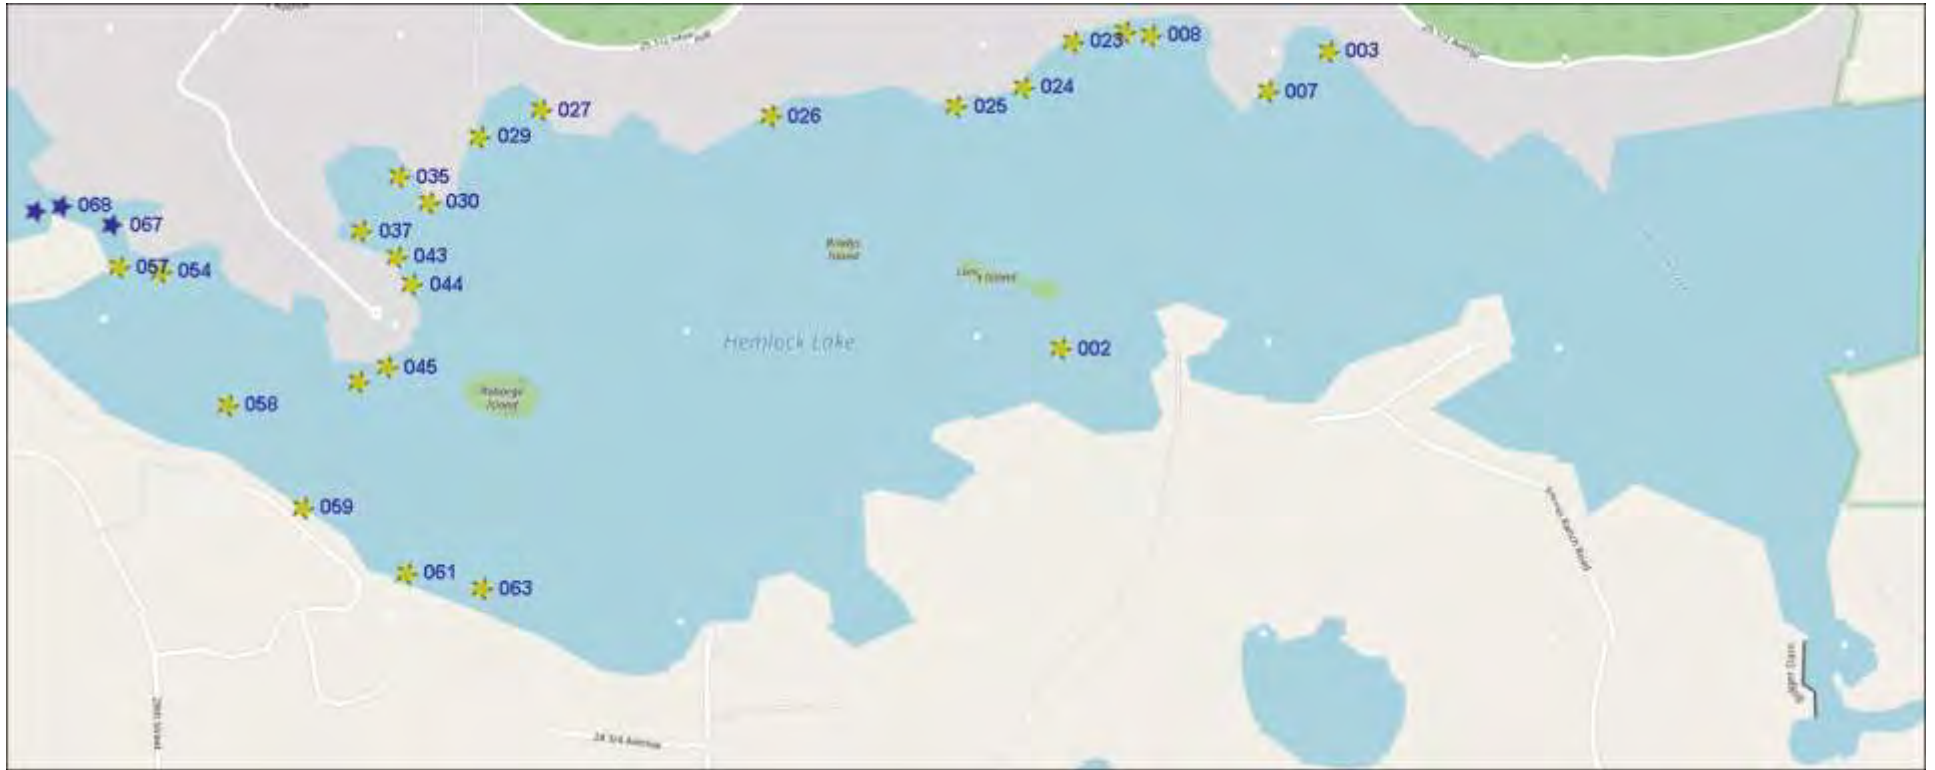
65 points where CLP was identified, however only 0.11 acres of CLP was considered “bed-forming”, meaning at least 50% of the plants present are CLP and the area has a definable edge.

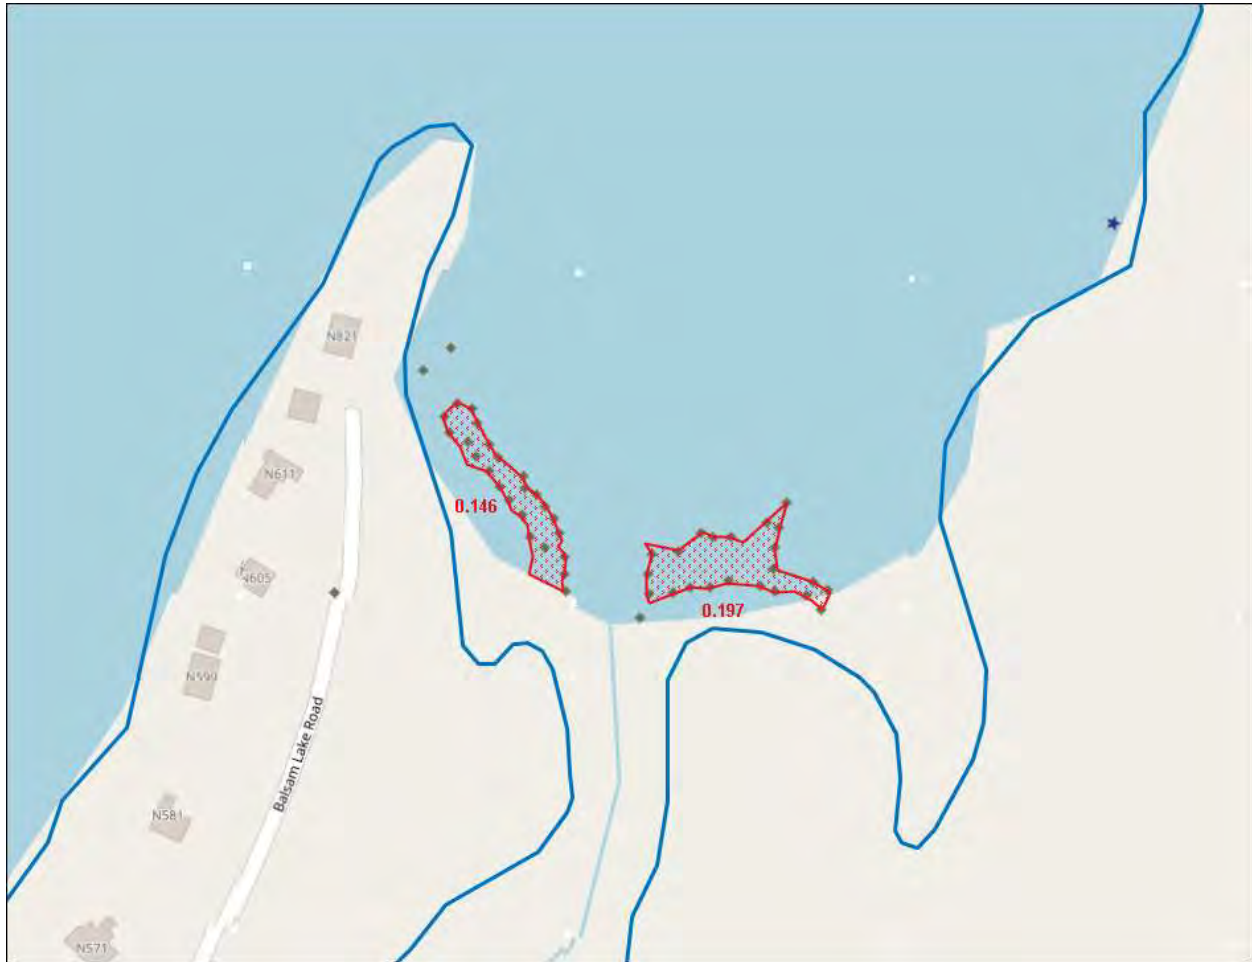
2023 Wild Rice Mapping – Balsam Lake, Washburn County (part of the Red Cedar Lakes)

West side of Mud Lake Channel = 0.15 acres

East side of Mud Lake Channel = 0.20 acres
