RED CEDAR LAKES

2023 MANAGEMENT SUMMARY REPORT

Prepared by: Dave Blumer, Lake Educator

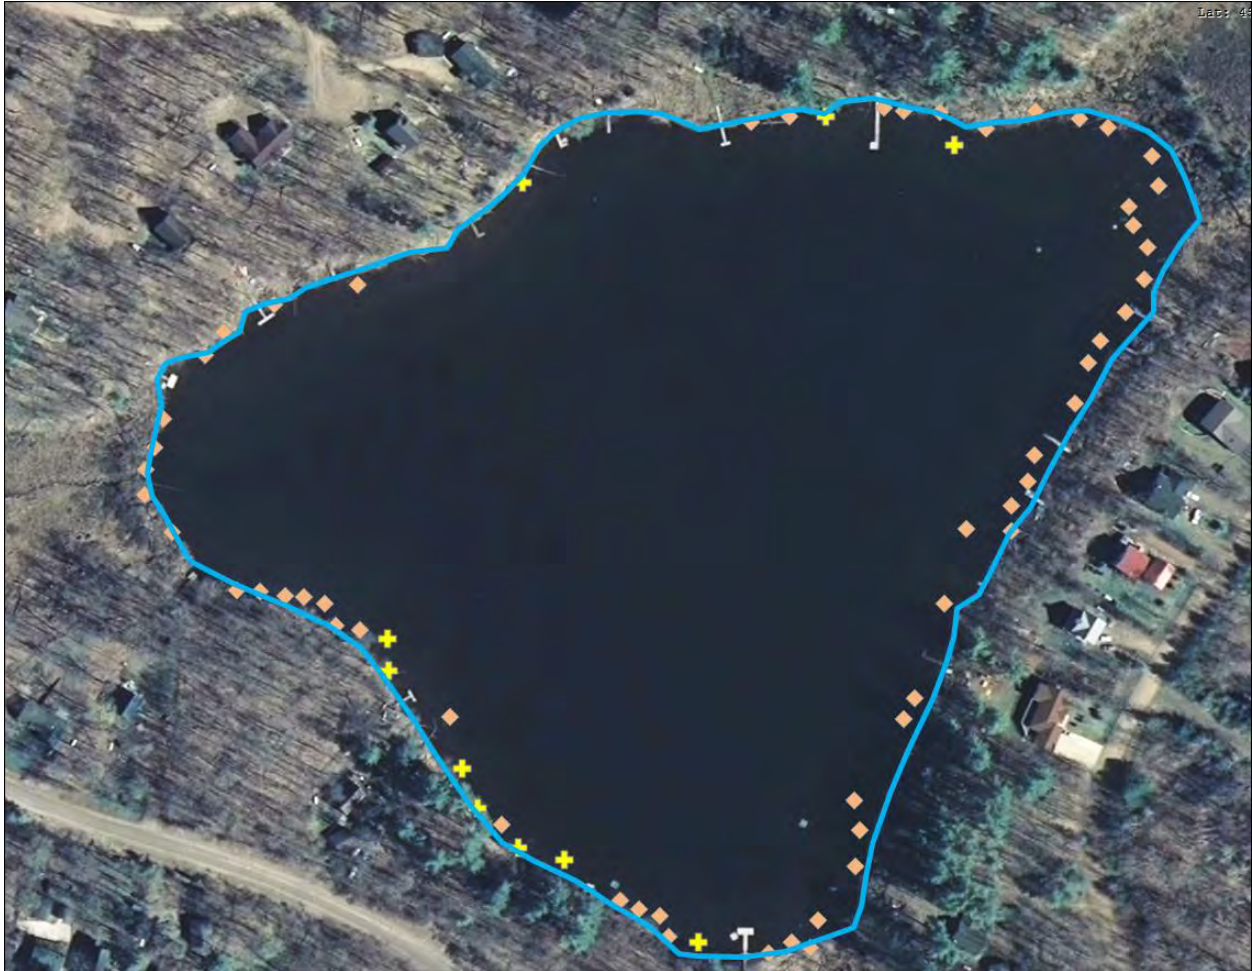
Coarse Woody Habitat (CWH) in Bass Lake, Barron County (near Red Cedar Lake)

Survey Details: 0.73 miles of shoreline, 20.4 acres of open water.

83 points with CWH (114 points/mile)

50 points connected to shore

33 points not connected to shore

12 points with a branchiness rating of "2" (yellow crosses)

22 points with a branchiness rating of "1"

Bass Lake is in pretty good condition in reference to CWH.

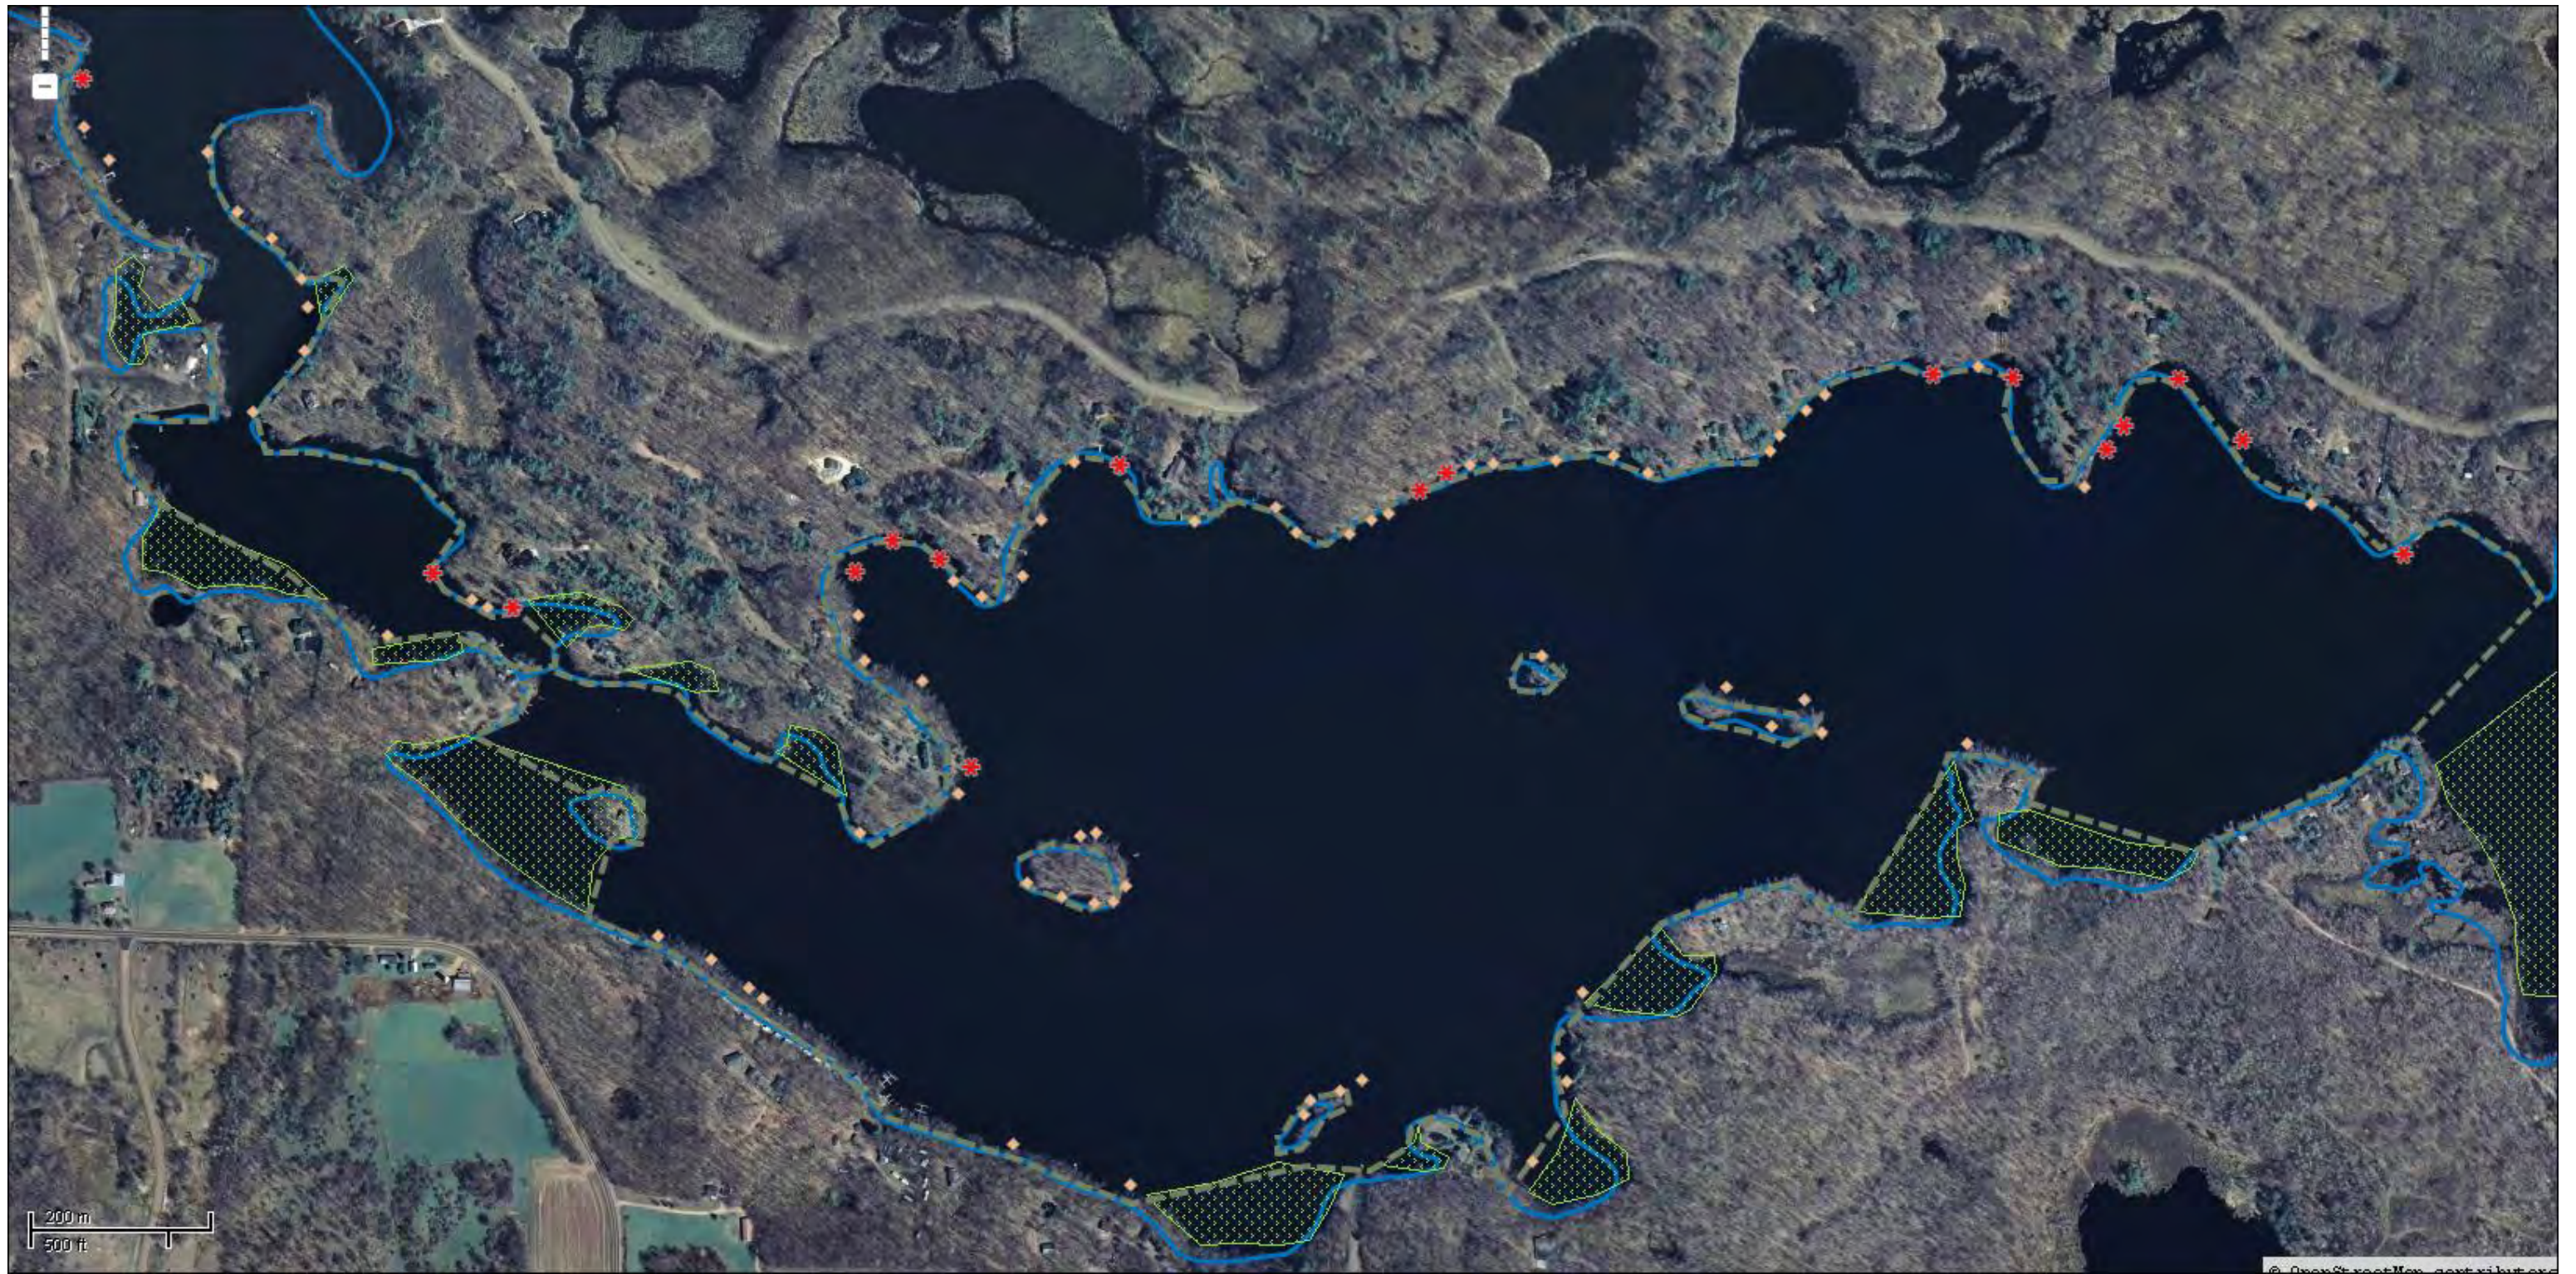
2023 Hemlock Lake, Barron County Coarse Woody Habitat Survey

94 points, 73 connected to shore, 21 not connected to shore: 38 w/no branches, 38 with few branches, and 18 full crowns

Green Hash Areas: ≤ 2 ft in undeveloped areas of the lake, these were not surveyed.

5.92 miles of shoreline were surveyed giving 16 points/mile of shoreline.

The survey that was completed covered approximately 5.92 acres of shoreline of the lake. During the survey, 94 points with CWH were located. To be included in the survey, the CWH had to be at least 5ft long and at least 4in in diameter somewhere along the length. At each point that is documented, the type of CWH is assessed. Type includes trees and logs down in the water but attached to or lying on shore as well; trees, logs and stumps in the water but not attached to the shore; and the level of branchiness the CWH has. Branchiness is based on no branches, a few branches or broken stumps protruding from the main log, and lots of branching like what would be seen if an entire tree crown had fallen in the water.

Of the 94 points documented, 73 were connected to shore and 21 were not connected to shore. There were 18 points with abundant branchiness, 38 with few branches, and 38 w/no branches at all.

The number of locations with CWH (94) on Hemlock Lake represented a dispersion of 16 points or examples of CWH for each mile of shoreline assessed. A similar survey completed on Bass Lake found CWH at 114 points per mile. On Balsam Lake, a survey indicated 37 points per mile.
