# Upper St. Croix Lake Critical Habitat Designation Report

*Douglas County, WI*

Prepared by Alex Smith,  
Northern Region Critical Habitat Coordinator

April 2013

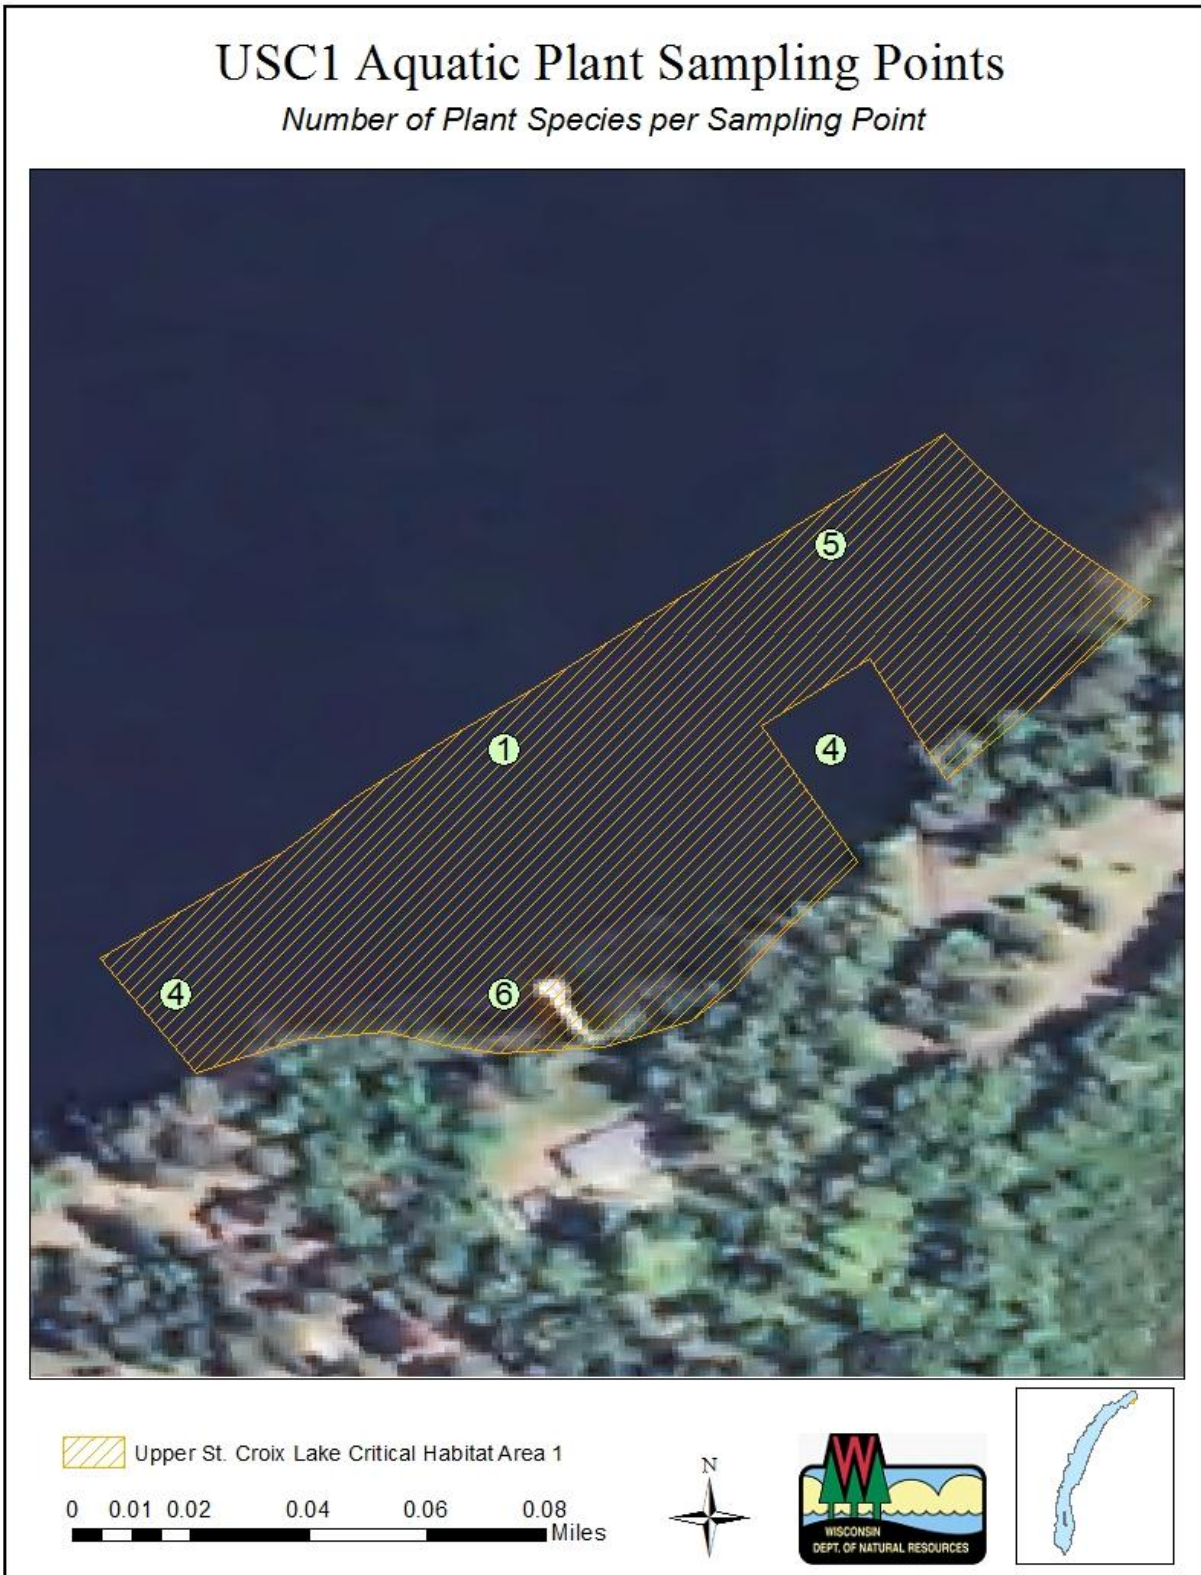
Figure 3. USC1 Critical Habitat Area Map

Critical habitat site USC1 is a Sensitive Area that was designated because of its Emergent and Floating Leaf Vegetation, and Submerged Aquatic Vegetation Important to Fish and Wildlife Habitat. USC1 is 2.8 acres in size and located on the Northeastern shore (Figure 3).

According to the shoreline inventory, there is some riprap in USC 1. The wave energy is moderate. Riprap should not be permitted, and alternative bank stabilization methods should be used instead if evidence of erosion develops.

Established lawn within 35 feet of the water's edge should be replanted with native vegetation to comply with Douglas County shoreland zoning ordinance, minimize erosion and pollution, and improve fish and wildlife habitat.

Buffers and overhanging vegetation, bog fringe and floating, emergent and submersed aquatic plants should be left alone.

Do not actively manage aquatic plants unless an aquatic invasive species should establish.

Implement Fish Sticks project. Contact local DNR Fisheries Biologist to investigate funding and technical assistance opportunities.

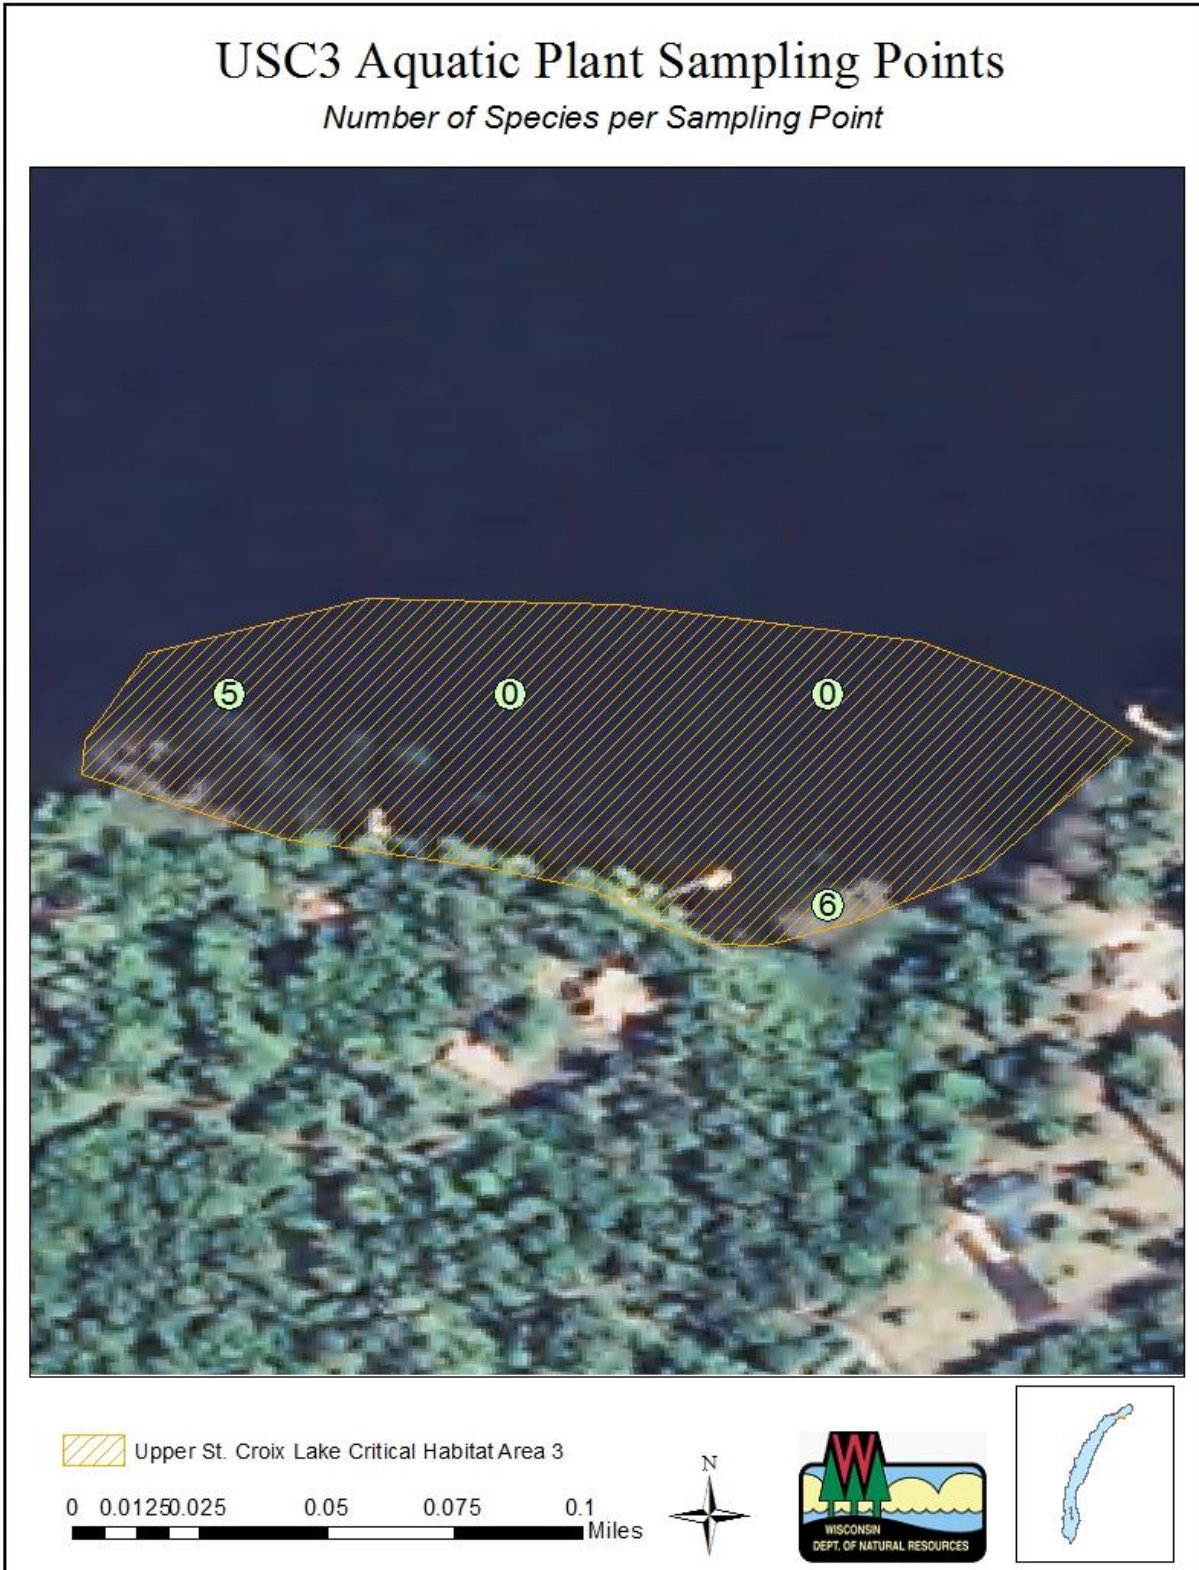
Figure 5. USC3 Critical Habitat Area Map

Critical habitat site USC3 is a Sensitive Area that was designated because of its Emergent and Floating Leaf Vegetation, Submerged Aquatic Vegetation Important to Fish and Wildlife Habitat, and Extensive Riparian Wetland. USC3 is 4.0 acres in size and is located on the Northeastern shore (Figure 5).

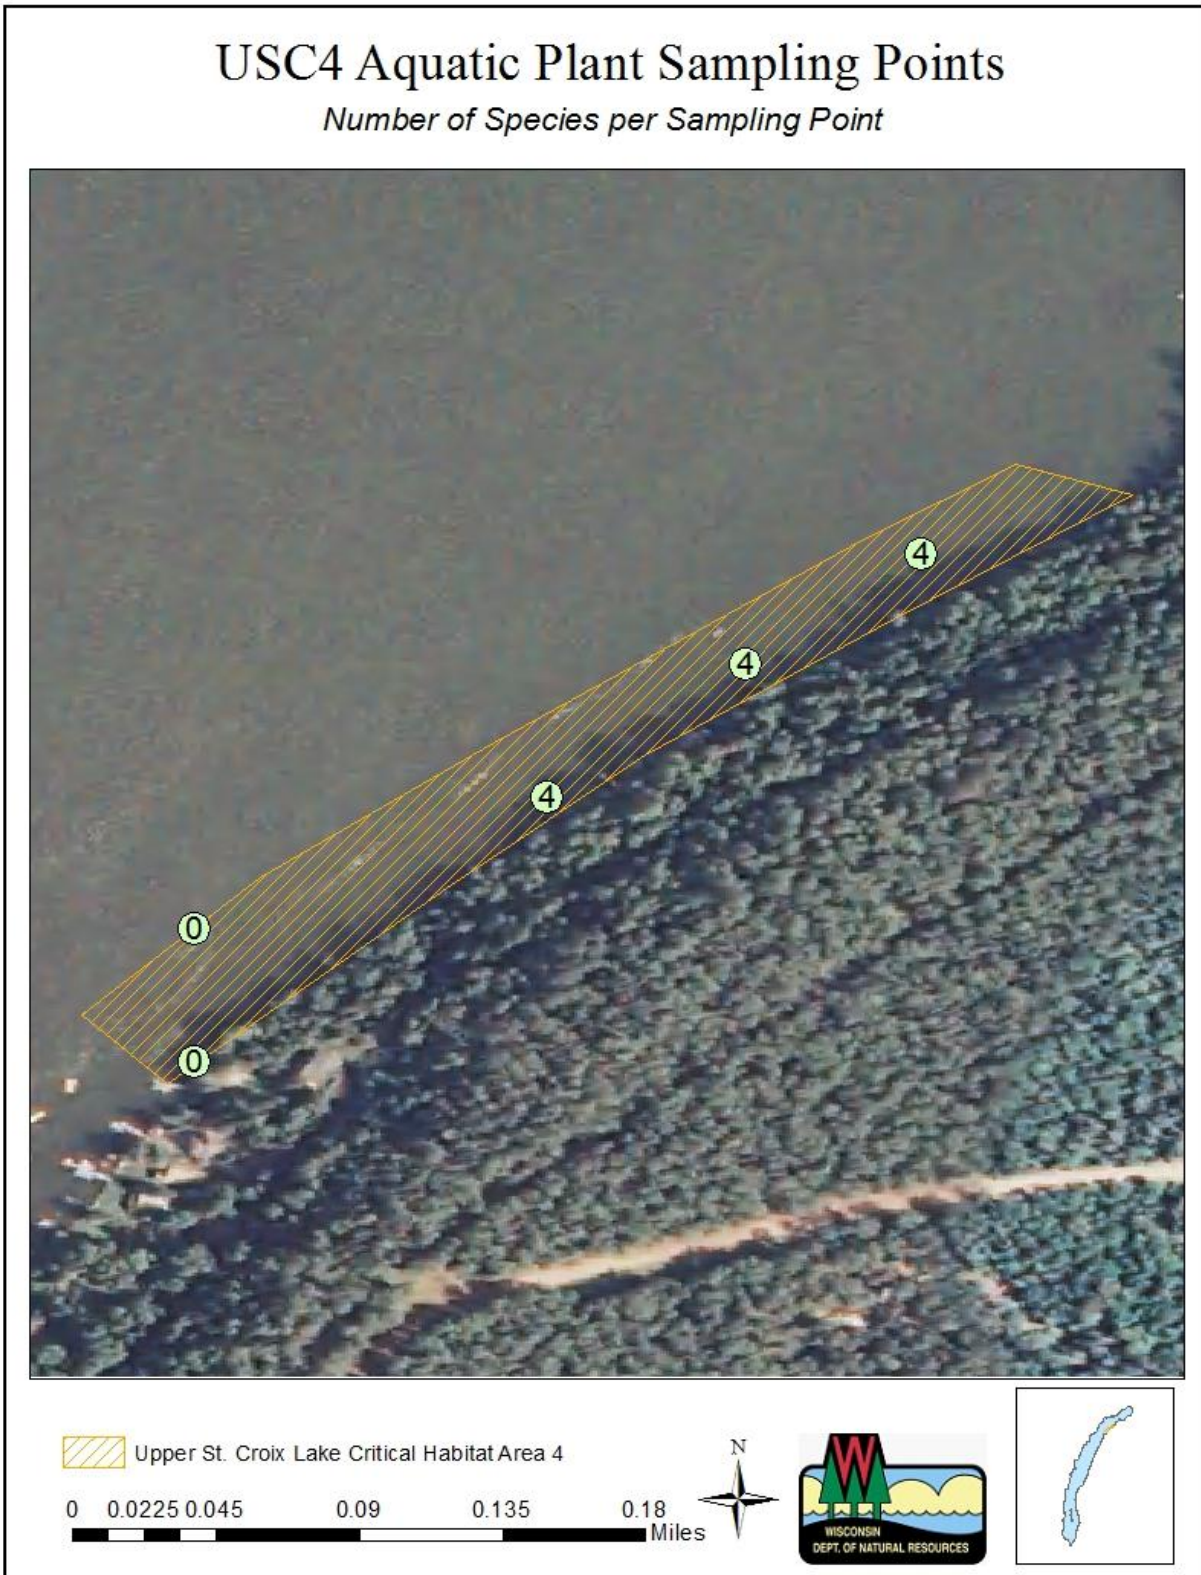
Figure 6. USC4 Critical Habitat Area Map

Critical habitat site USC4 is a Sensitive Area that was designated because of its Woody Habitat and Submerged Aquatic Vegetation Important to Fish and Wildlife Habitat. USC4 is 4.5 acres in size and is located on the Northeastern shoreline of the lake (Figure 6).

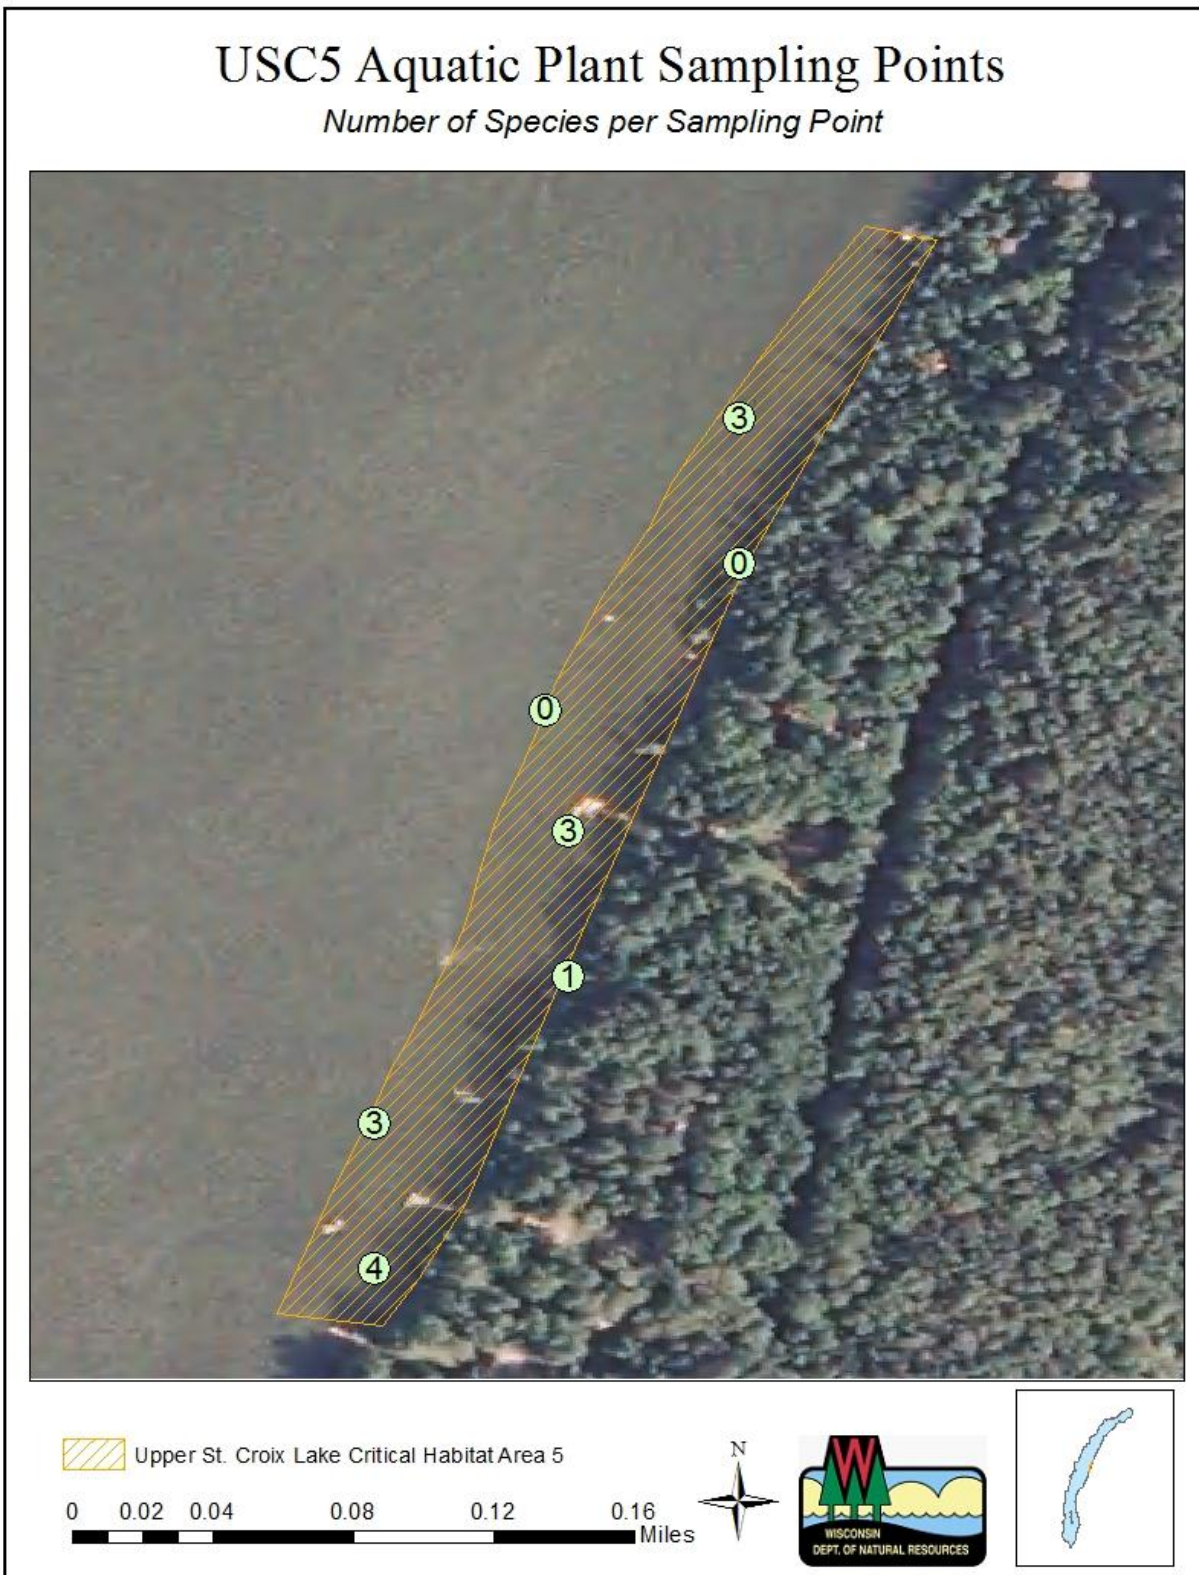
Figure 7. USC5 Critical Habitat Area Map

Critical habitat site USC5 is a Sensitive Area that was designated because of its Woody Habitat and Submerged Aquatic Vegetation Important to Fish and Wildlife Habitat. USC5 is 4.6 acres in size and is located on the Eastern shoreline (Figure 7).

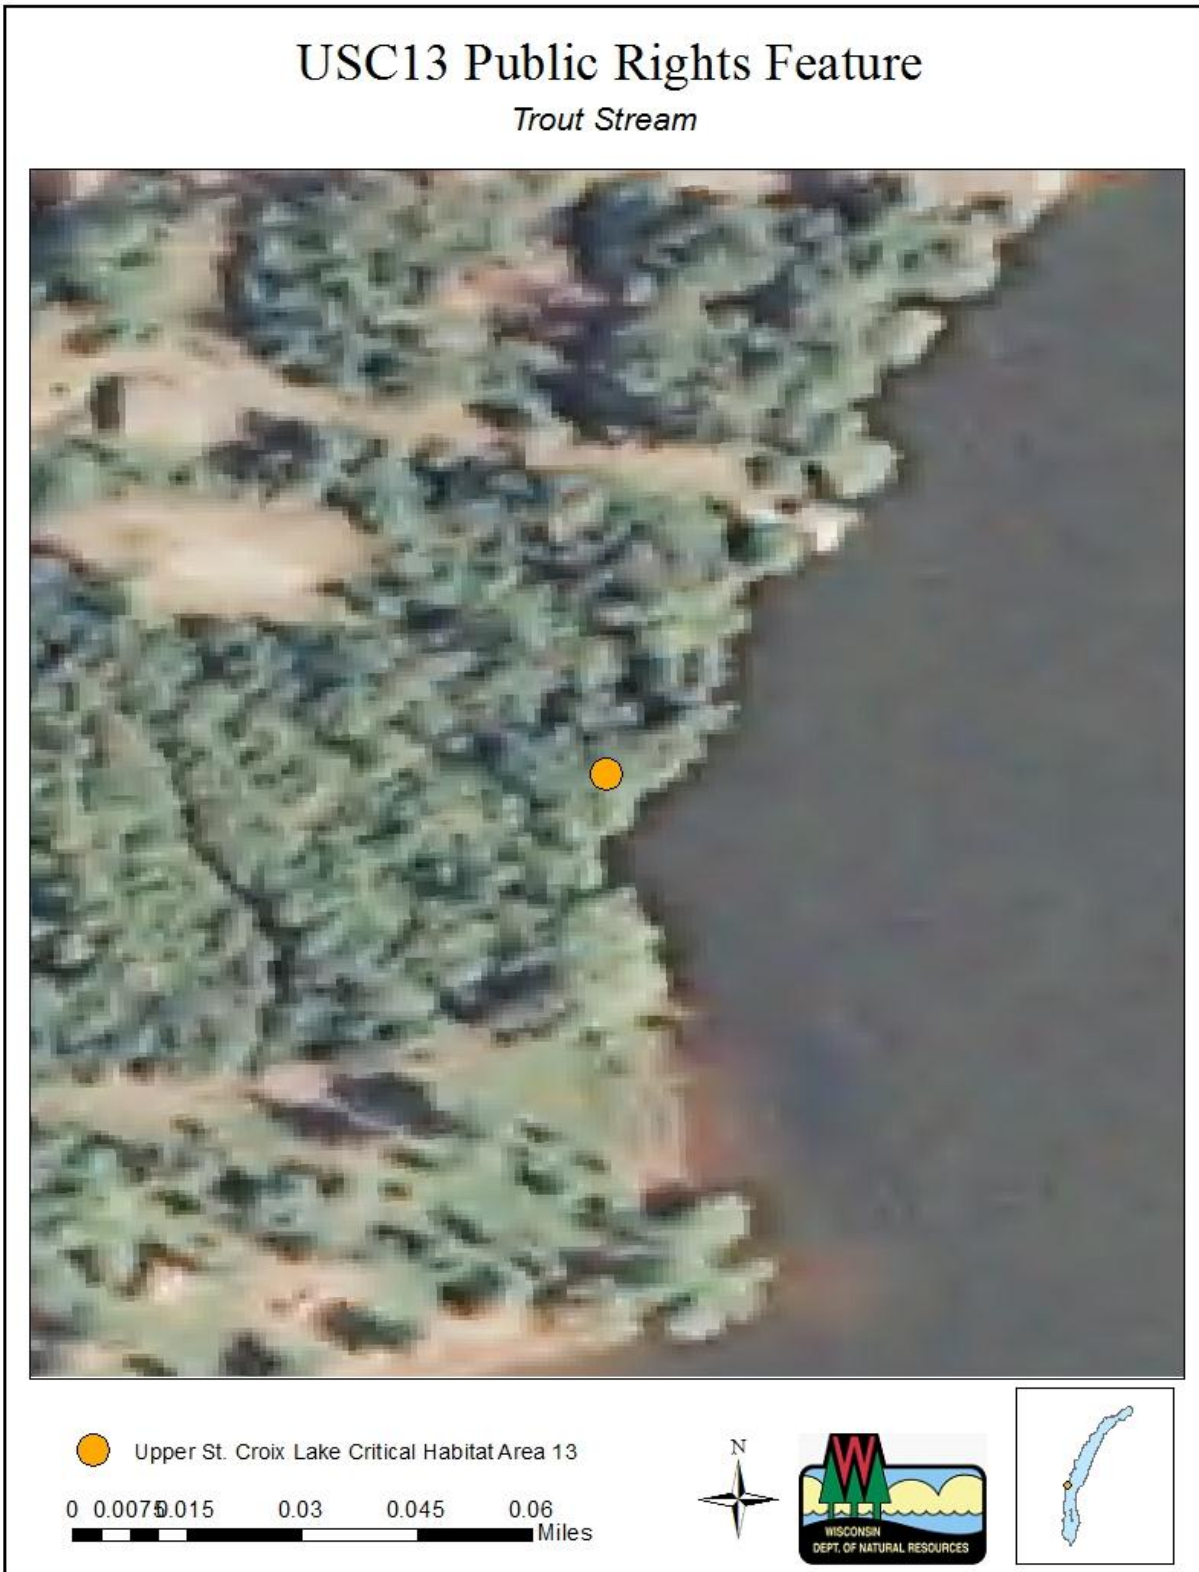
Figure 14. USC13 Critical Habitat Area Map

Critical habitat site USC13 is a Public Rights Feature that was designated because of its Water Quality Features (Trout Stream). USC13 is where Park Creek enters Upper St. Croix Lake. Park Creek is a Class 3 Trout Stream (Figure 15).

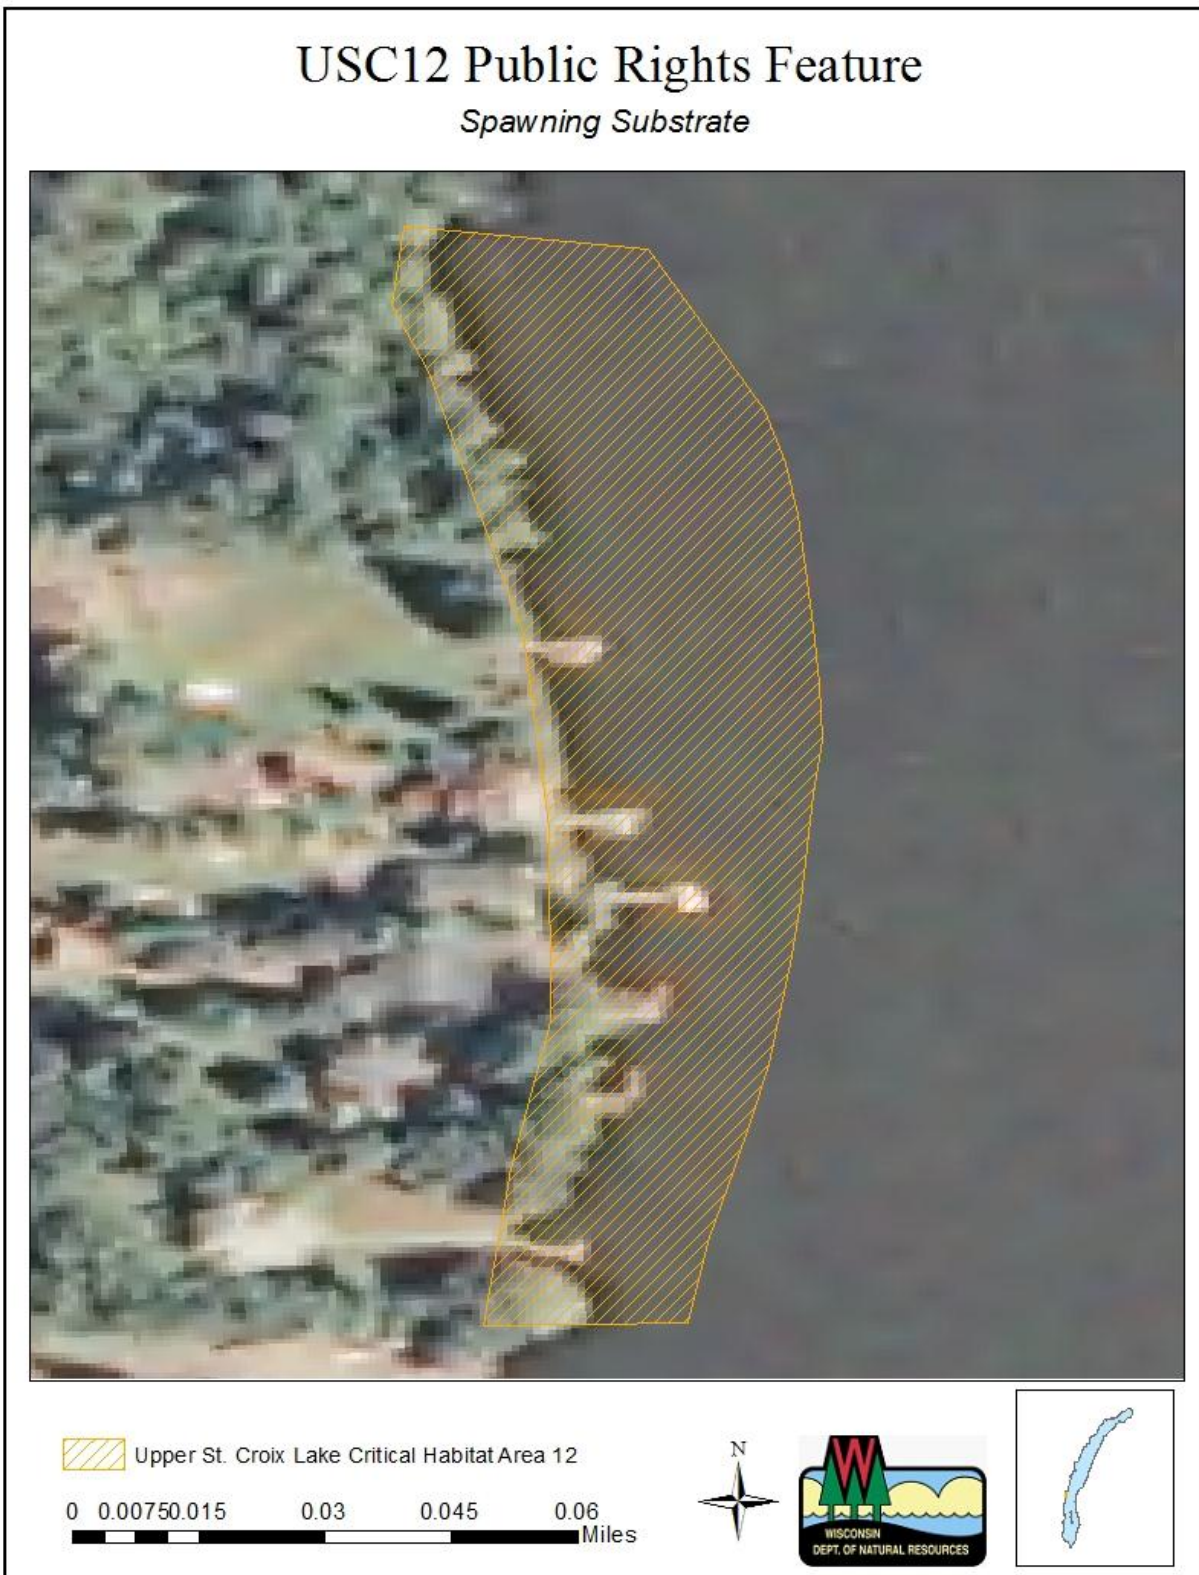
Figure 14. USC12 Critical Habitat Area Map

Critical habitat site USC12 is a Public Rights Feature that was designated because of its Spawning Substrate. USC12 is 1.7 acres in size and is located on the Southwestern shoreline (Figure 14).

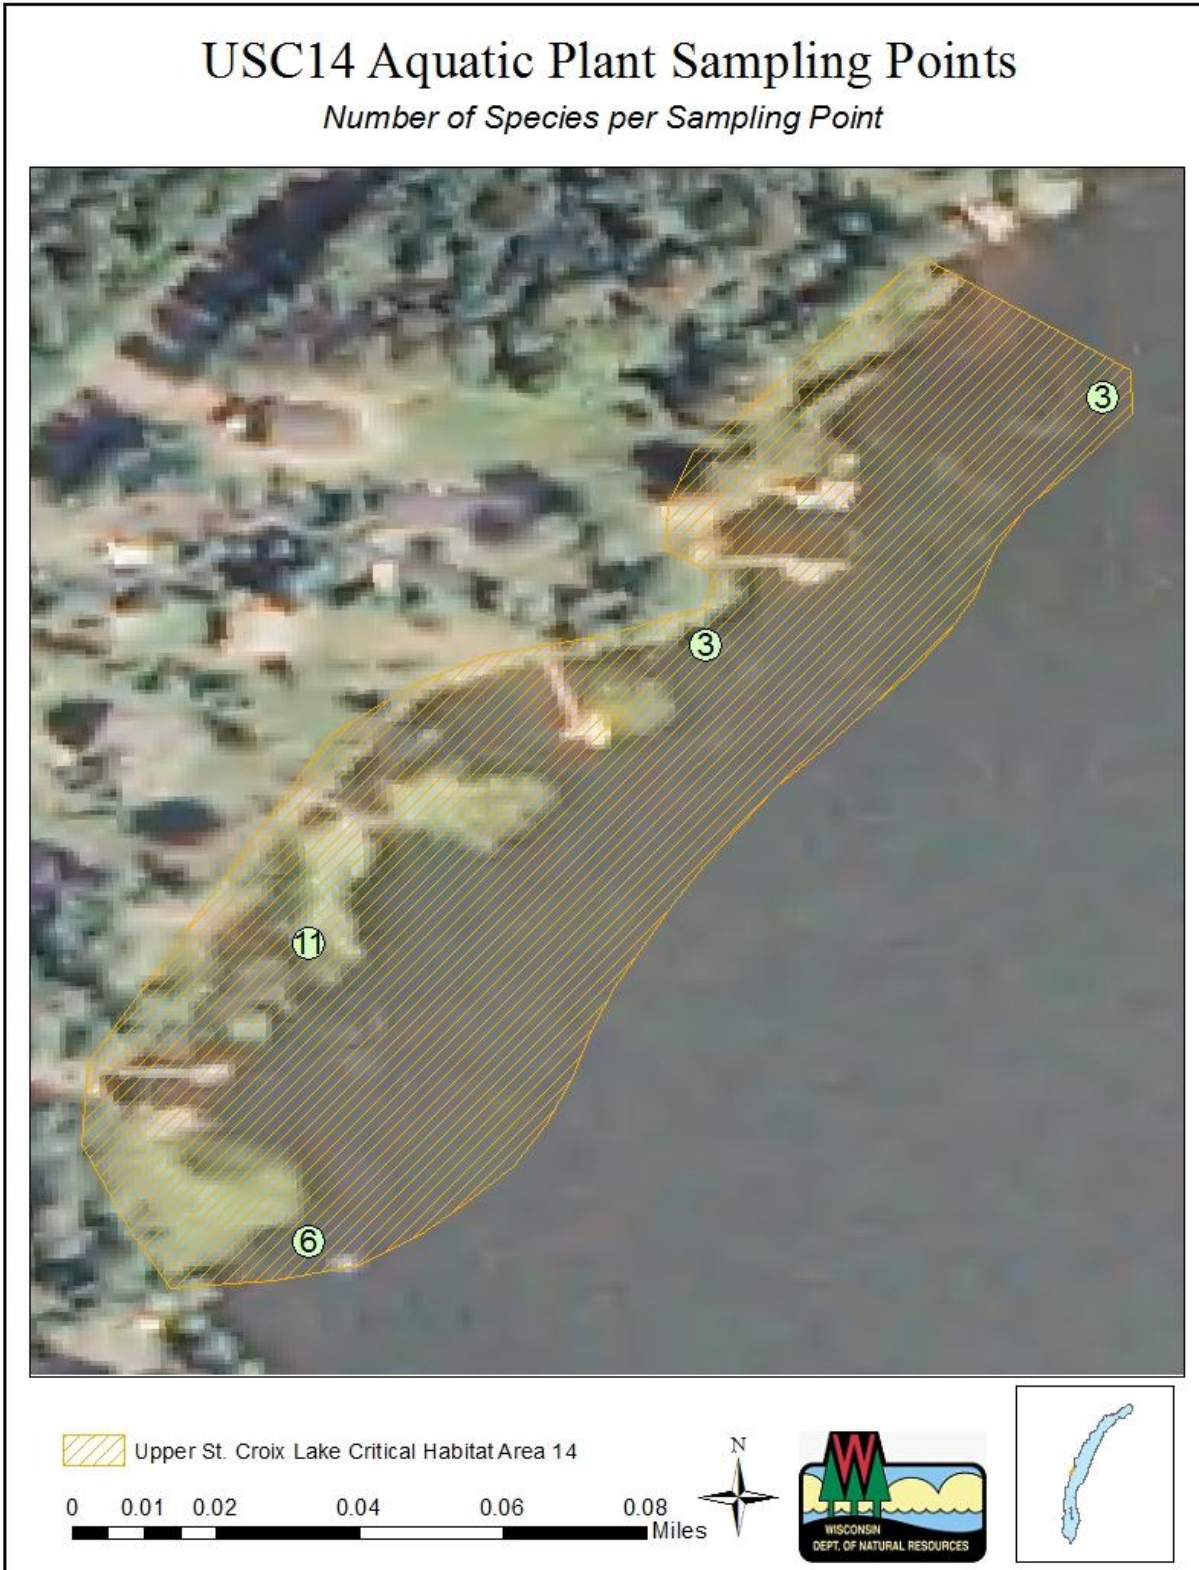
Figure 16. USC14 Critical Habitat Area Map

Critical habitat site USC14 is a Sensitive Area that was designated because of its Emergent and Floating Leaf Vegetation and Water Quality Features. USC14 is 3.3 acres in size and is located at the mouth of Spring Creek which is a Class 2 trout stream (Figure 16).

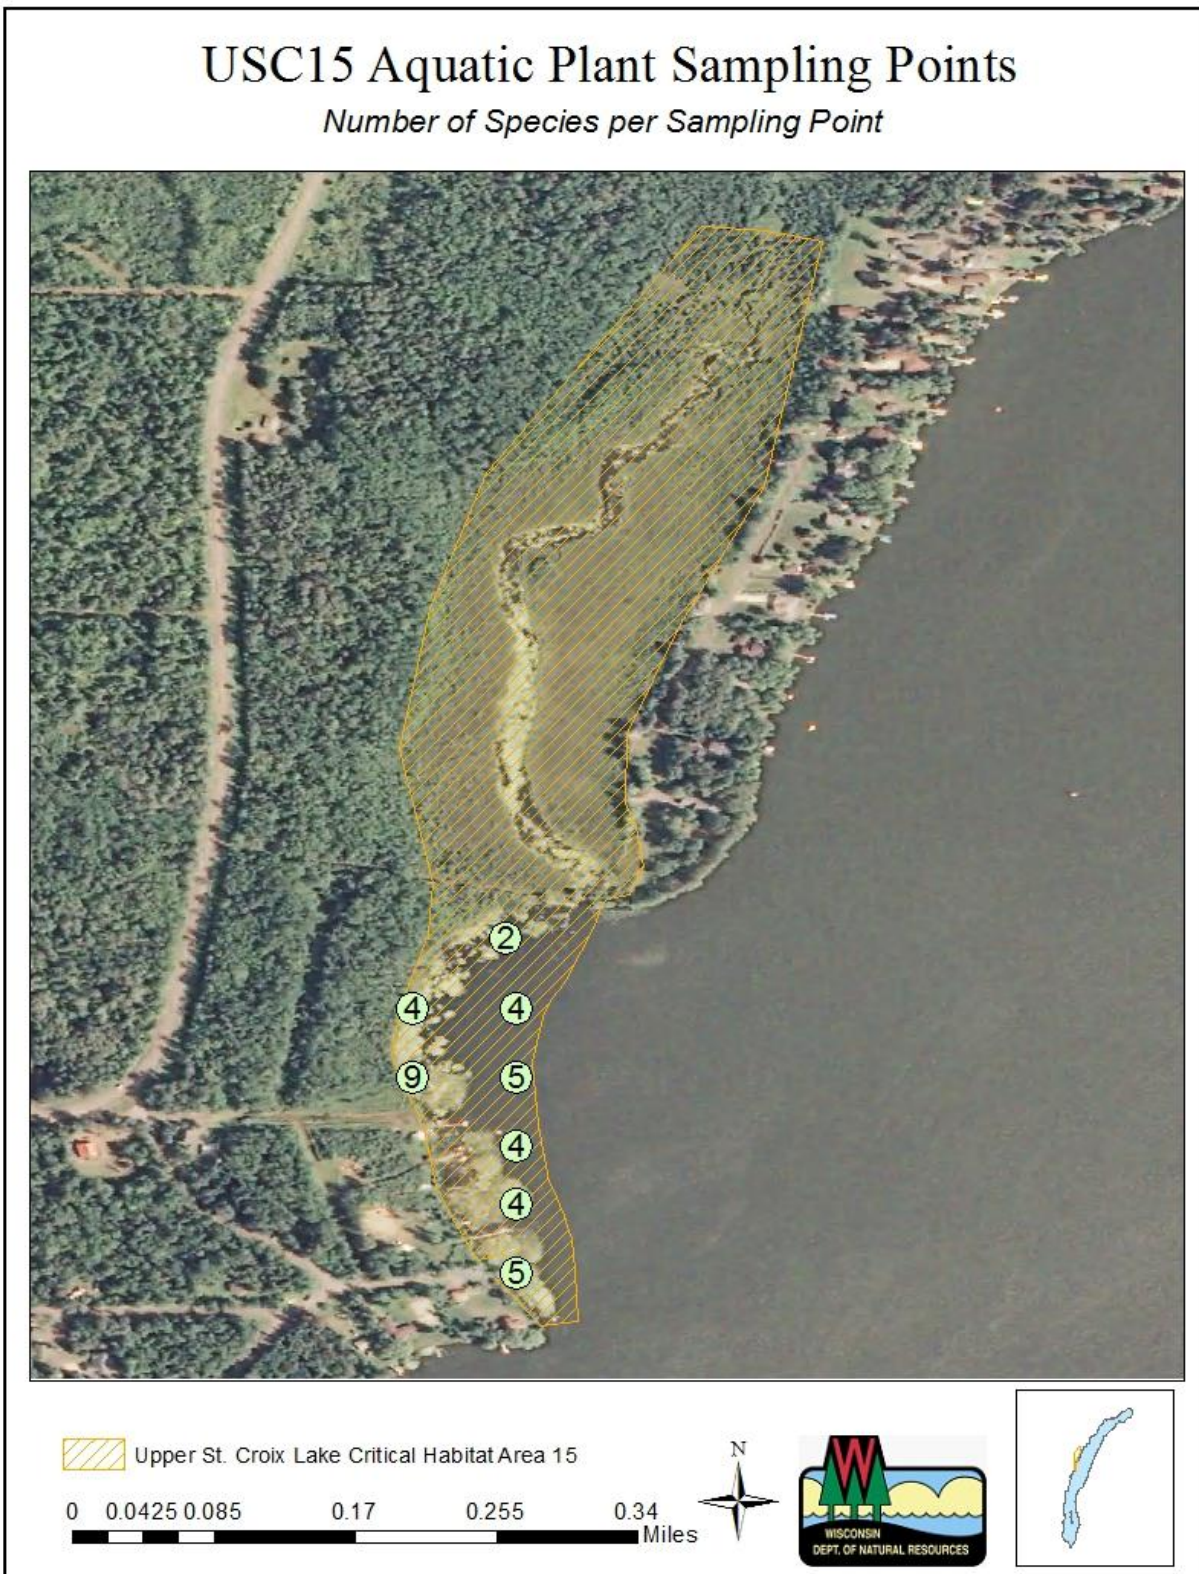
Figure 17. USC15 Critical Habitat Area Map

Critical habitat site USC15 is a Sensitive Area that was designated because of its Emergent and Floating Leaf Vegetation, Extensive Riparian Wetland, and Submerged Aquatic Vegetation Important to Fish and Wildlife Habitat. USC15 is 32.2 acres in size and is located on the Western shoreline. An unnamed stream enters the lake within this sensitive area (Figure 17).

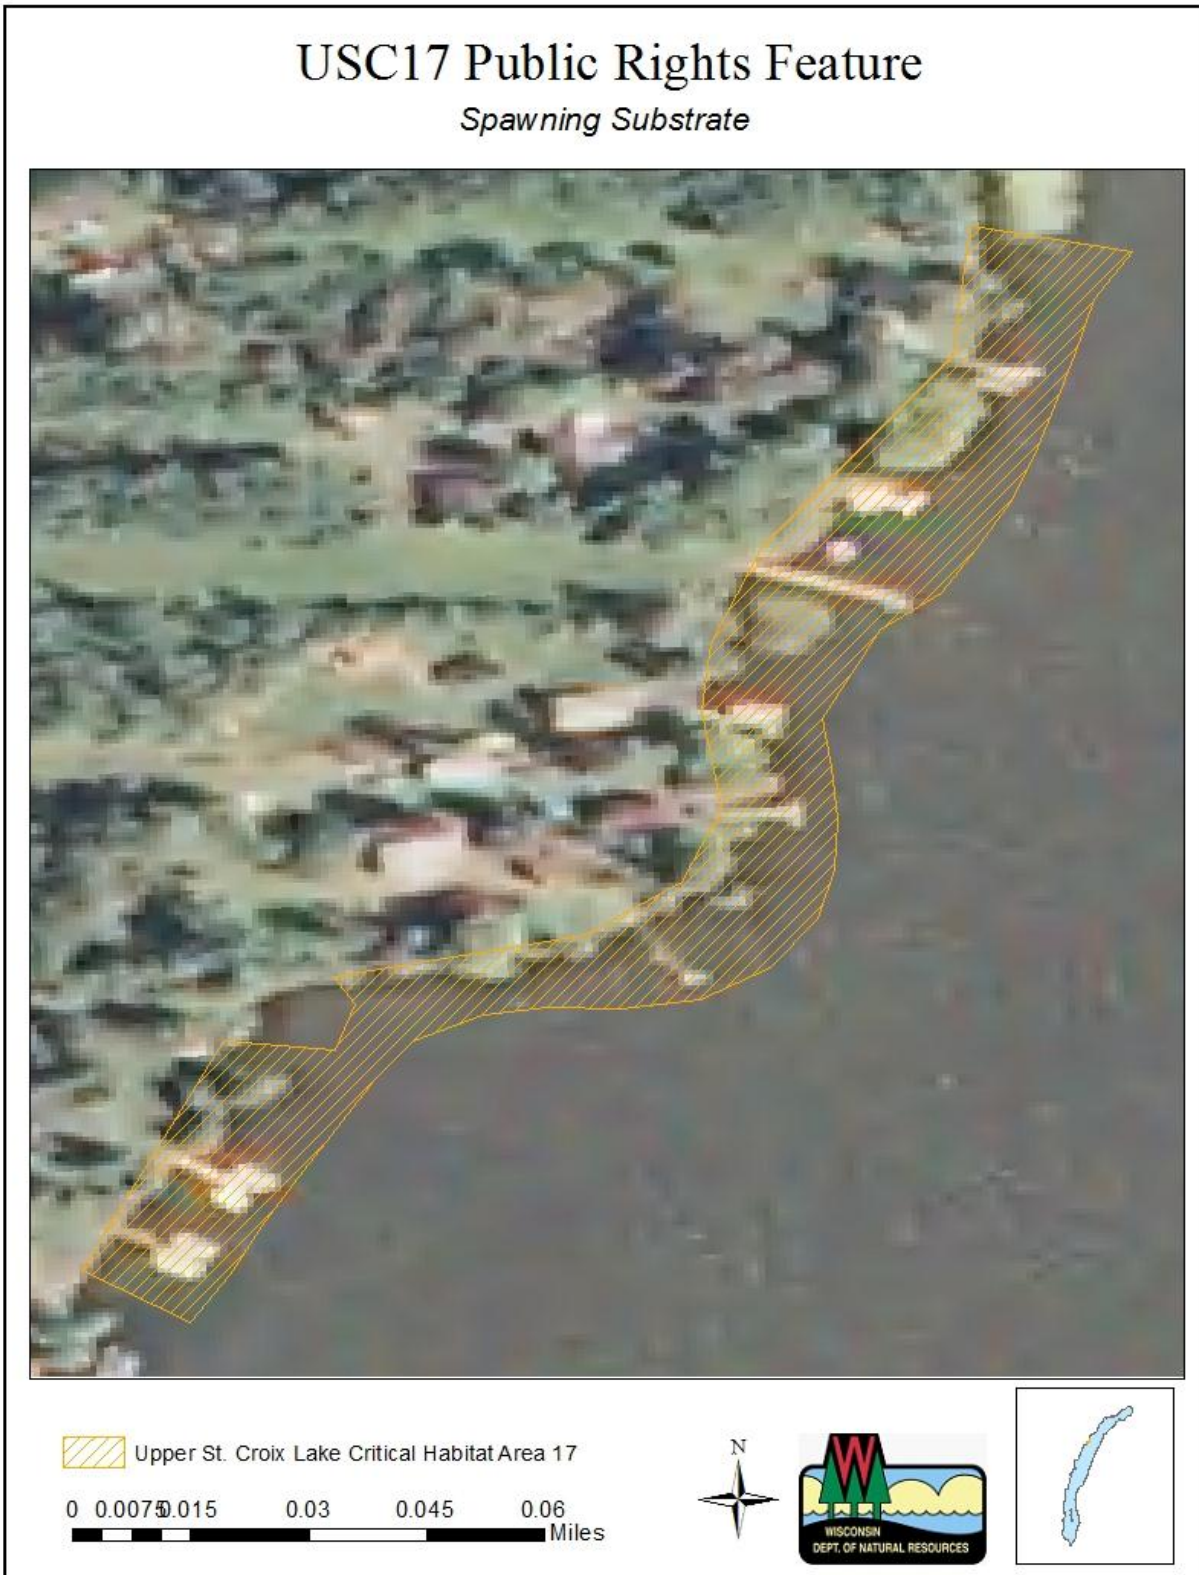
Figure 30. USC17 Critical Habitat Area Map

Critical habitat site USC17 is a Public Rights Feature that was designated because of its Spawning Substrate. USC17 is 1.3 acres in size and is located on the Western Shore (Figure 30).

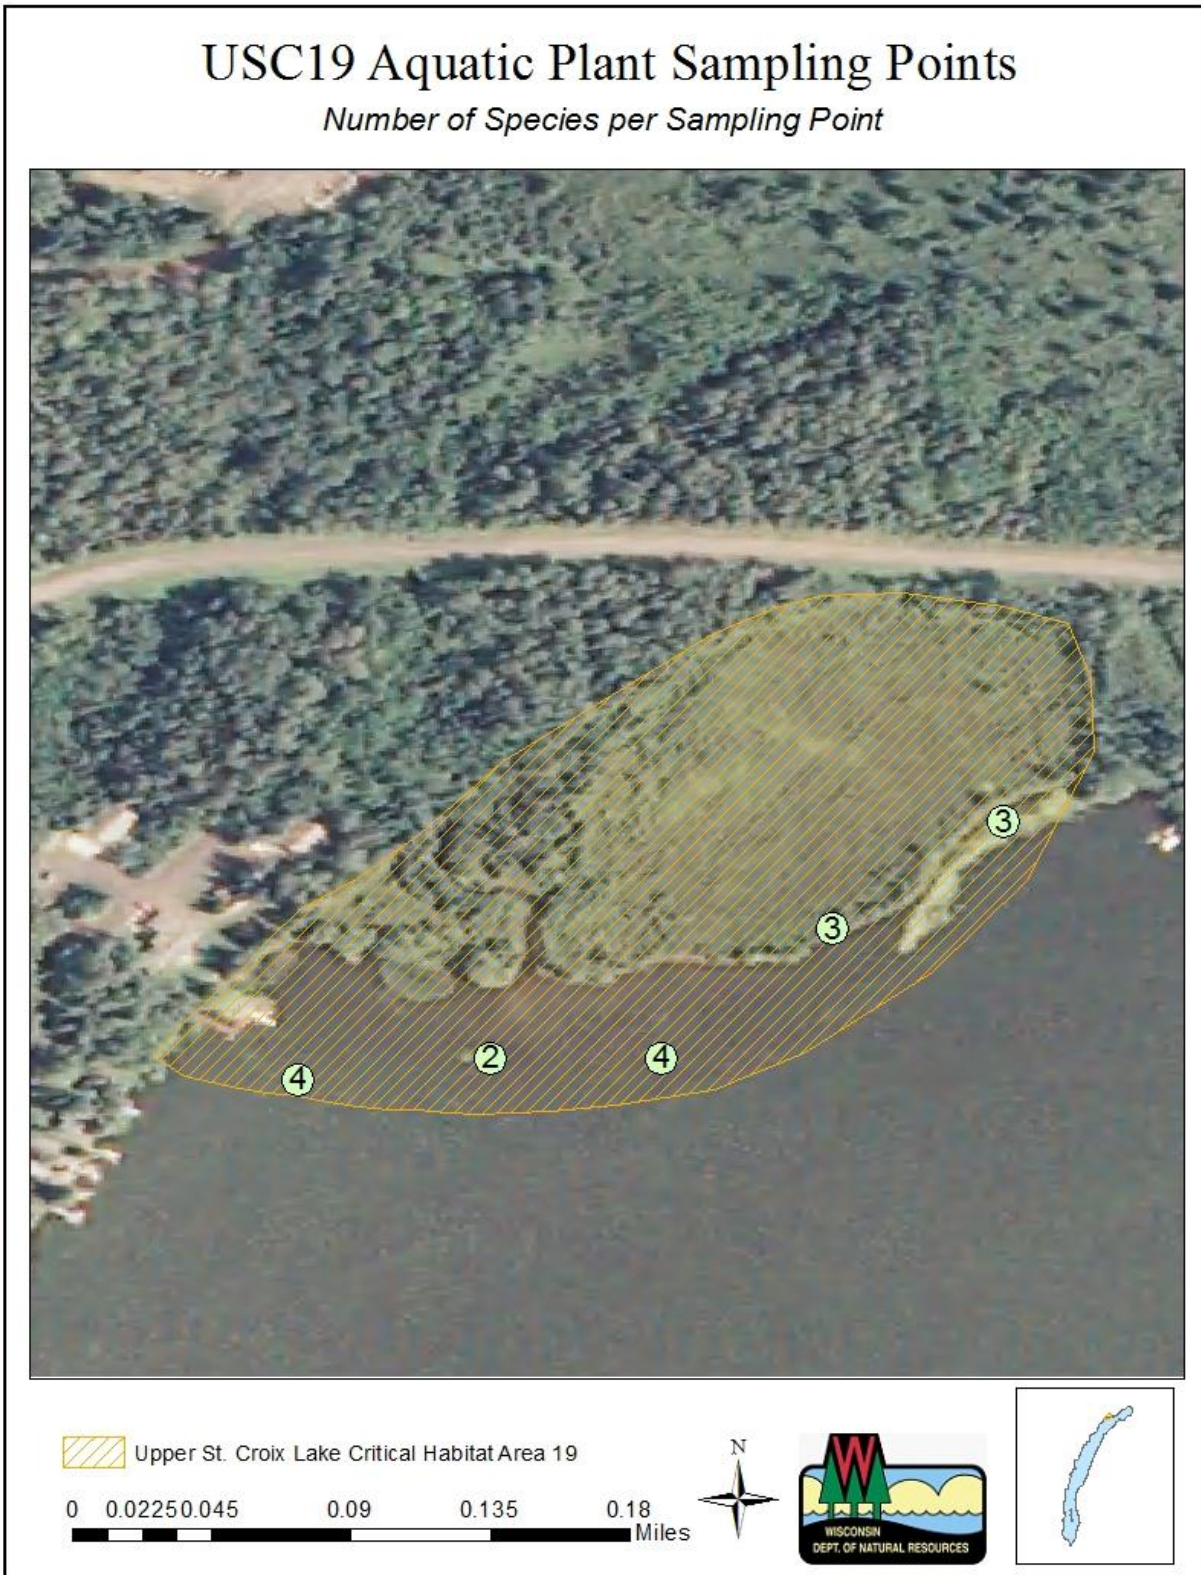
Figure 33. USC19 Critical Habitat Area Map

Critical habitat site USC19 is a Sensitive Area that was designated because of its Extensive Riparian Wetland, Emergent and Floating Leaf Vegetation, Submerged Aquatic Vegetation Important to Fish and Wildlife Habitat, and Water Quality Features. USC19 is 14.3 acres in size and located at the mouth of Beebe Creek which is a Class 1 trout stream (Figure 33).

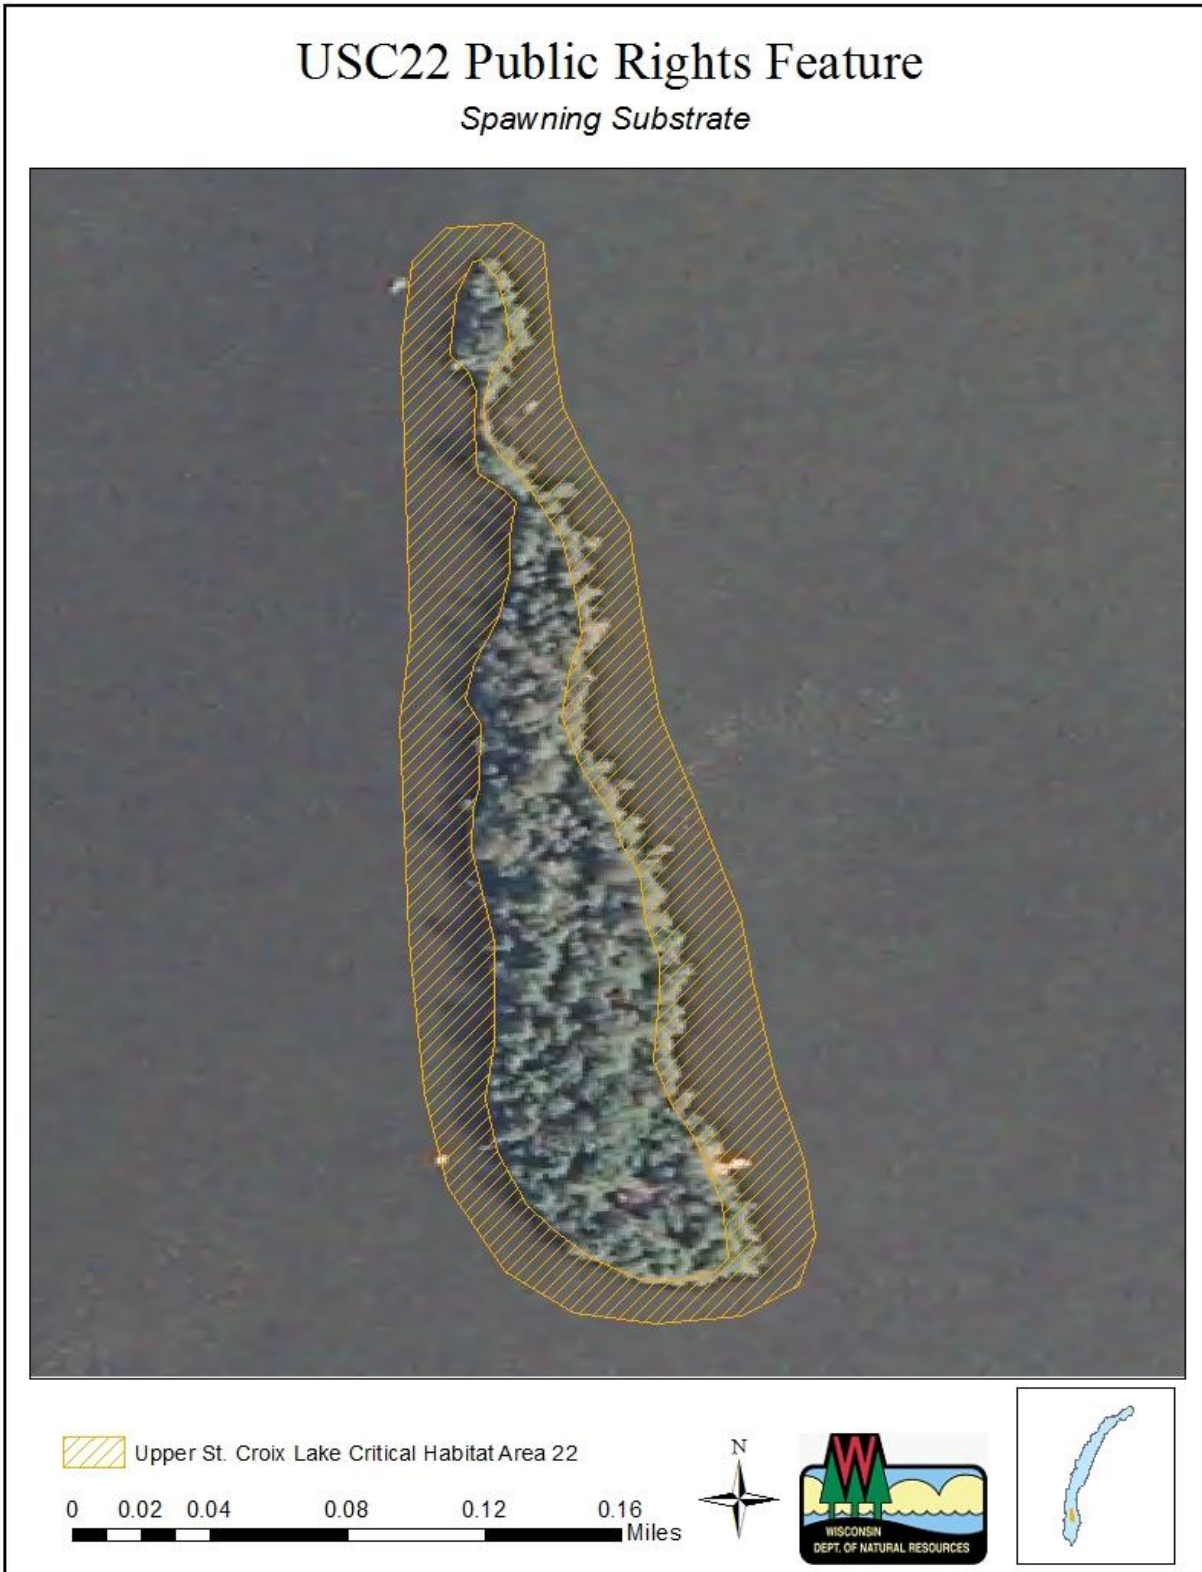
Figure 36. USC22 Critical Habitat Area Map

Critical habitat site USC22 is a Public Rights Feature that was designated because of its Spawning Substrate. USC22 is 5.2 acres in size and encompasses the entire center island (Figure 36).
