An Aquatic Vegetation Survey of Carstens Lake

Manitowoc County, Wisconsin
December 2010

Created by: Brenton Butterfield, Tim Hoyman, & Eddie Heath
Onterra, LLC
De Pere, WI

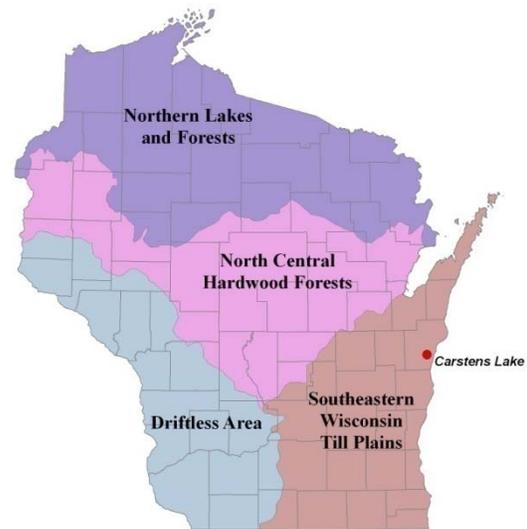
Figure 1. Location of Carstens Lake within the ecoregions of Wisconsin. After Nichols 1999.

Ecoregions are areas related by similar climate, physiography, hydrology, vegetation and wildlife potential. Comparing ecosystems in the same ecoregion is sounder than comparing systems within manmade boundaries such as counties, towns, or states.

Floristic Quality Assessment (FQA) is used to evaluate the closeness of a lake's aquatic plant community to that of an undisturbed or pristine system. The higher the floristic quality, the closer the lake is to an undisturbed system. FQA is an excellent tool for comparing individual waterbodies and the same waterbody over time. In this section, the floristic quality of Carstens Lake will be compared to similar waterbodies within the same Wisconsin ecoregion and the entire state of Wisconsin (Figure 1).

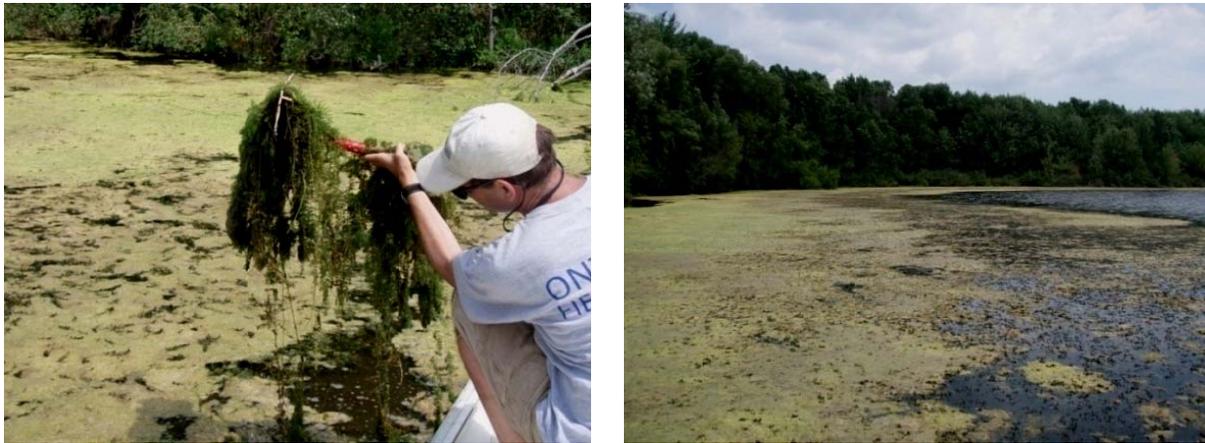
Photo 2. Excessive coontail growth on Carstens Lake. Left: Onterra ecologist with a rake-full of coontail. Right: Surface matting coontail covered in algae within the littoral zone of Carstens Lake. Photographs from 2010 survey.

During the 2010 survey, coontail was observed matting on the surface throughout the entire littoral area of the lake (Photo 2). It is unrealistic to quantitatively define the term “nuisance,” as this designation is subjective by nature. However, the WDNR Science Services researchers indicate that nuisance levels of a given aquatic plant species likely occur when the littoral frequency of occurrence exceeds 35% (Alison Mikulyuk, personal comm.). In 2010, coontail within Carstens Lake had a littoral frequency of approximately 90%; well above this somewhat arbitrary nuisance level benchmark (Figure 4). The over abundance of coontail within Carstens Lake is not unexpected given the environmental state of the lake (high nutrient concentrations and low water clarity), and likely gives coontail a competitive advantage over other aquatic plant species that are not as tolerable of eutrophic conditions.

The commonly non-rooted coontail forms dense canopies in most areas of the lake and causes the nuisance conditions observed. The matted surface is a perfect area for filamentous algae to thrive as well as free-floating plant species such as duckweeds. All of this adds up to a great amount of water surface area that is non-navigable and likely alters the underlying water's dissolved oxygen levels and pH.

At this time, targeting Eurasian water milfoil will not alleviate the concerns brought forth by Carstens Lake stakeholders and therefore is not justified. If the goal of the Carstens Lake stakeholders is to facilitate access to open water areas of the lake, three possibilities exist: 1) manually remove the plants, 2) contract to have the plants cut and removed through mechanical harvesting, and 3) apply herbicides to kill the plants.

If manual removal techniques are able to alleviate the nuisance conditions, they should be utilized first and foremost. However, if this method proves incapable of reducing the nuisance conditions on the lake, a defined plan of management would need to be developed that outlines the goals and locations that mechanical harvesting or herbicide application methods are implemented. This plan would require approval of the WDNR.

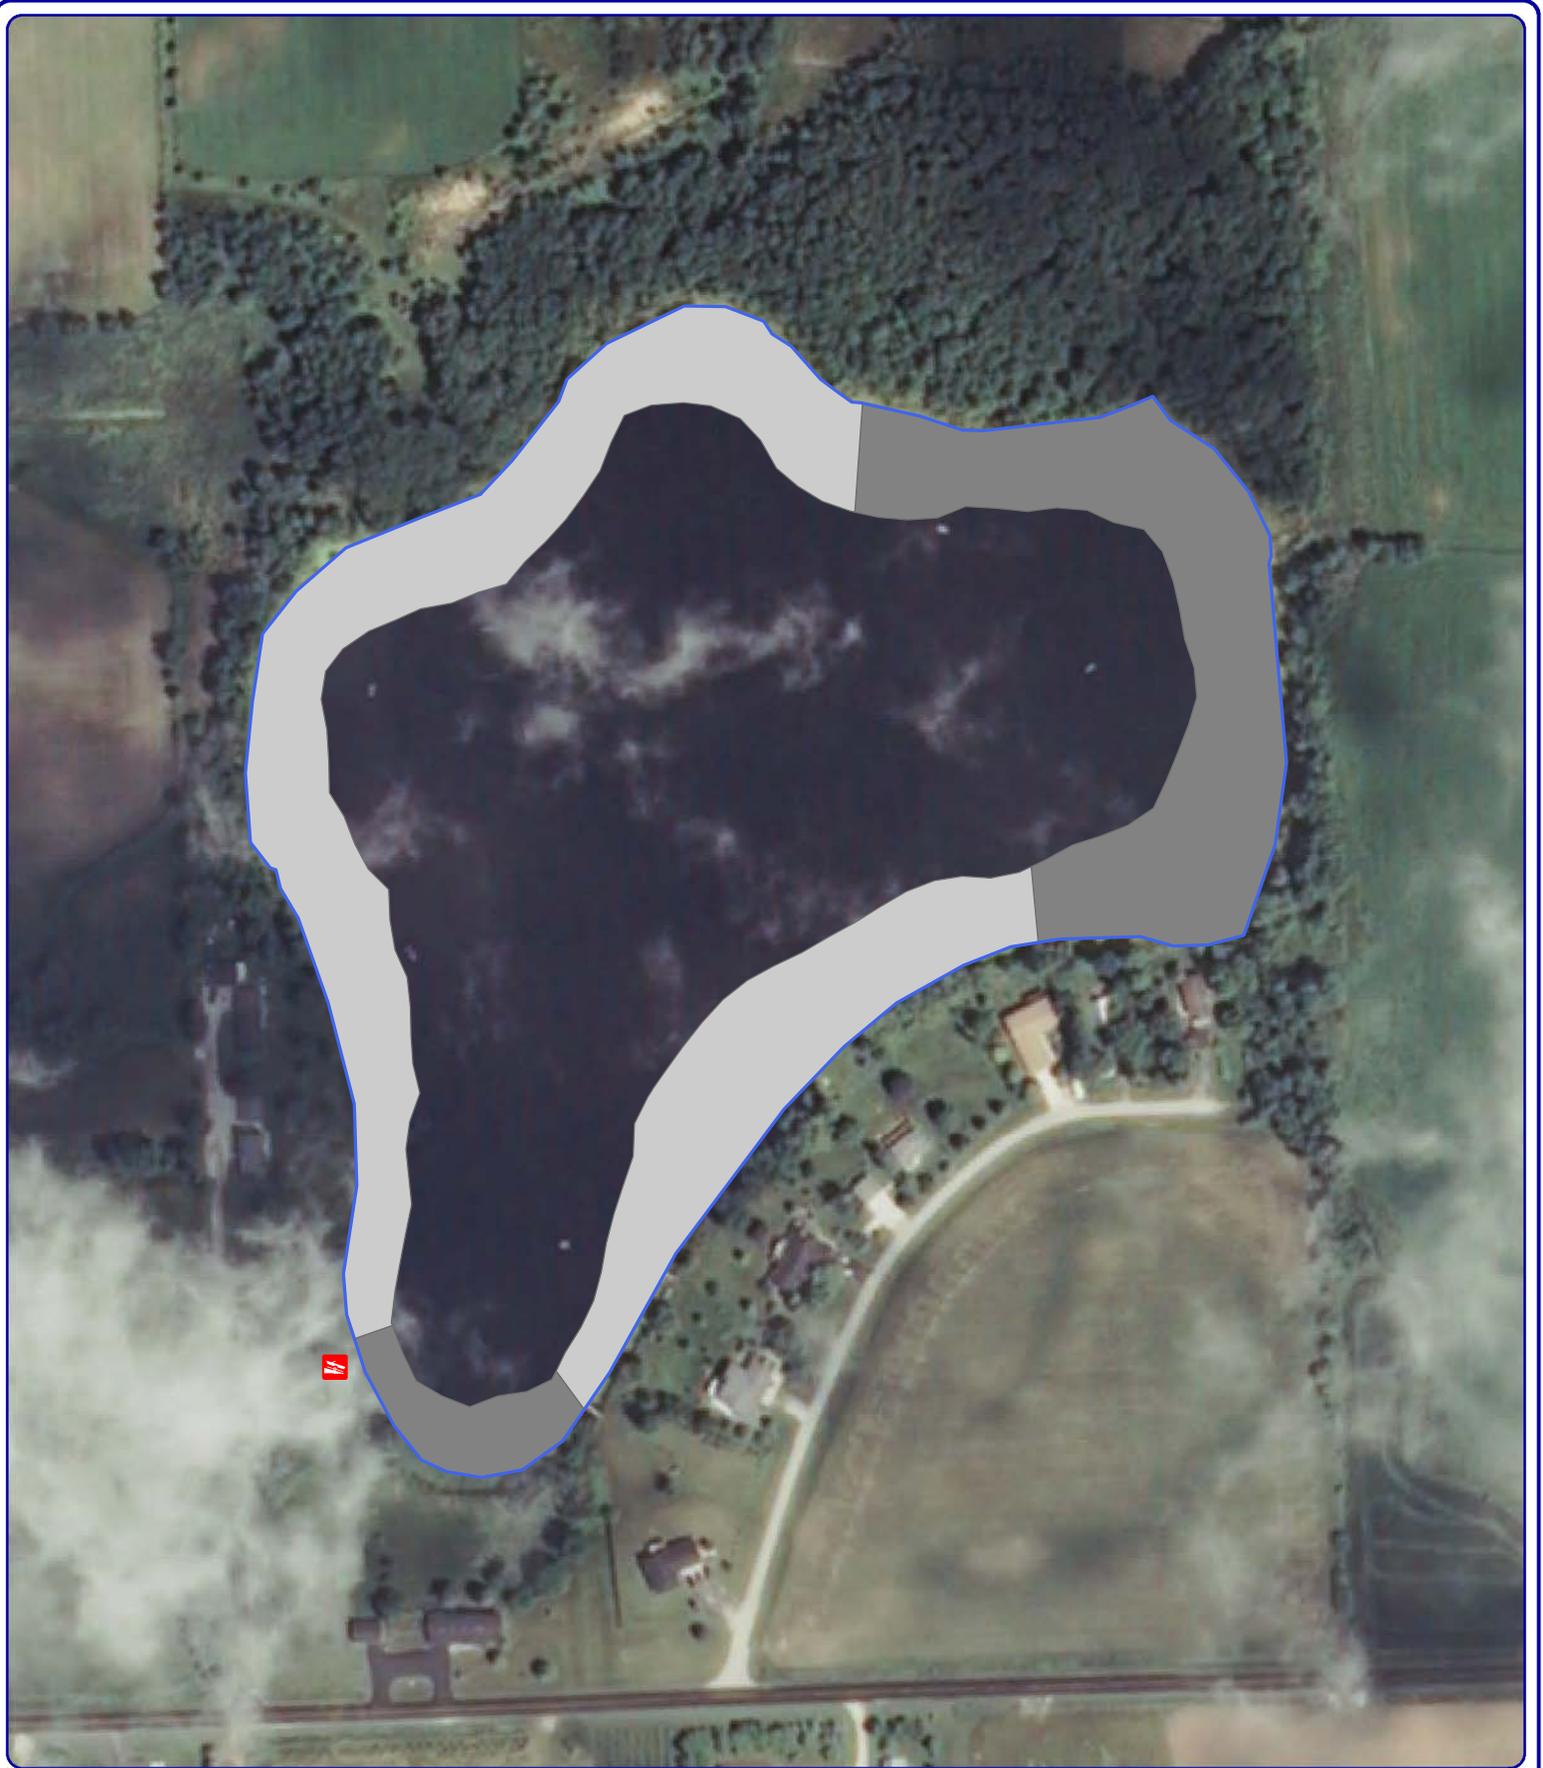
Map 3
 Carstens Lake
 Manitowoc County, Wisconsin
**2010 EWM
 Survey Results**

Eurasian water milfoil, first documented in Carstens Lake in 1993, was the second-most frequently encountered species during the 2010 survey, and was found scattered throughout the entire littoral area (Map #). Despite concerns by the Manitowoc County Lakes Association that Eurasian water milfoil had increased in Carstens Lake, the Chi-square analysis revealed that there is no statistical difference in Eurasian water milfoil occurrence from 2005 and 2010 (Table 2). Though there is a fair amount of Eurasian water milfoil in Carstens Lake, the excessive plant

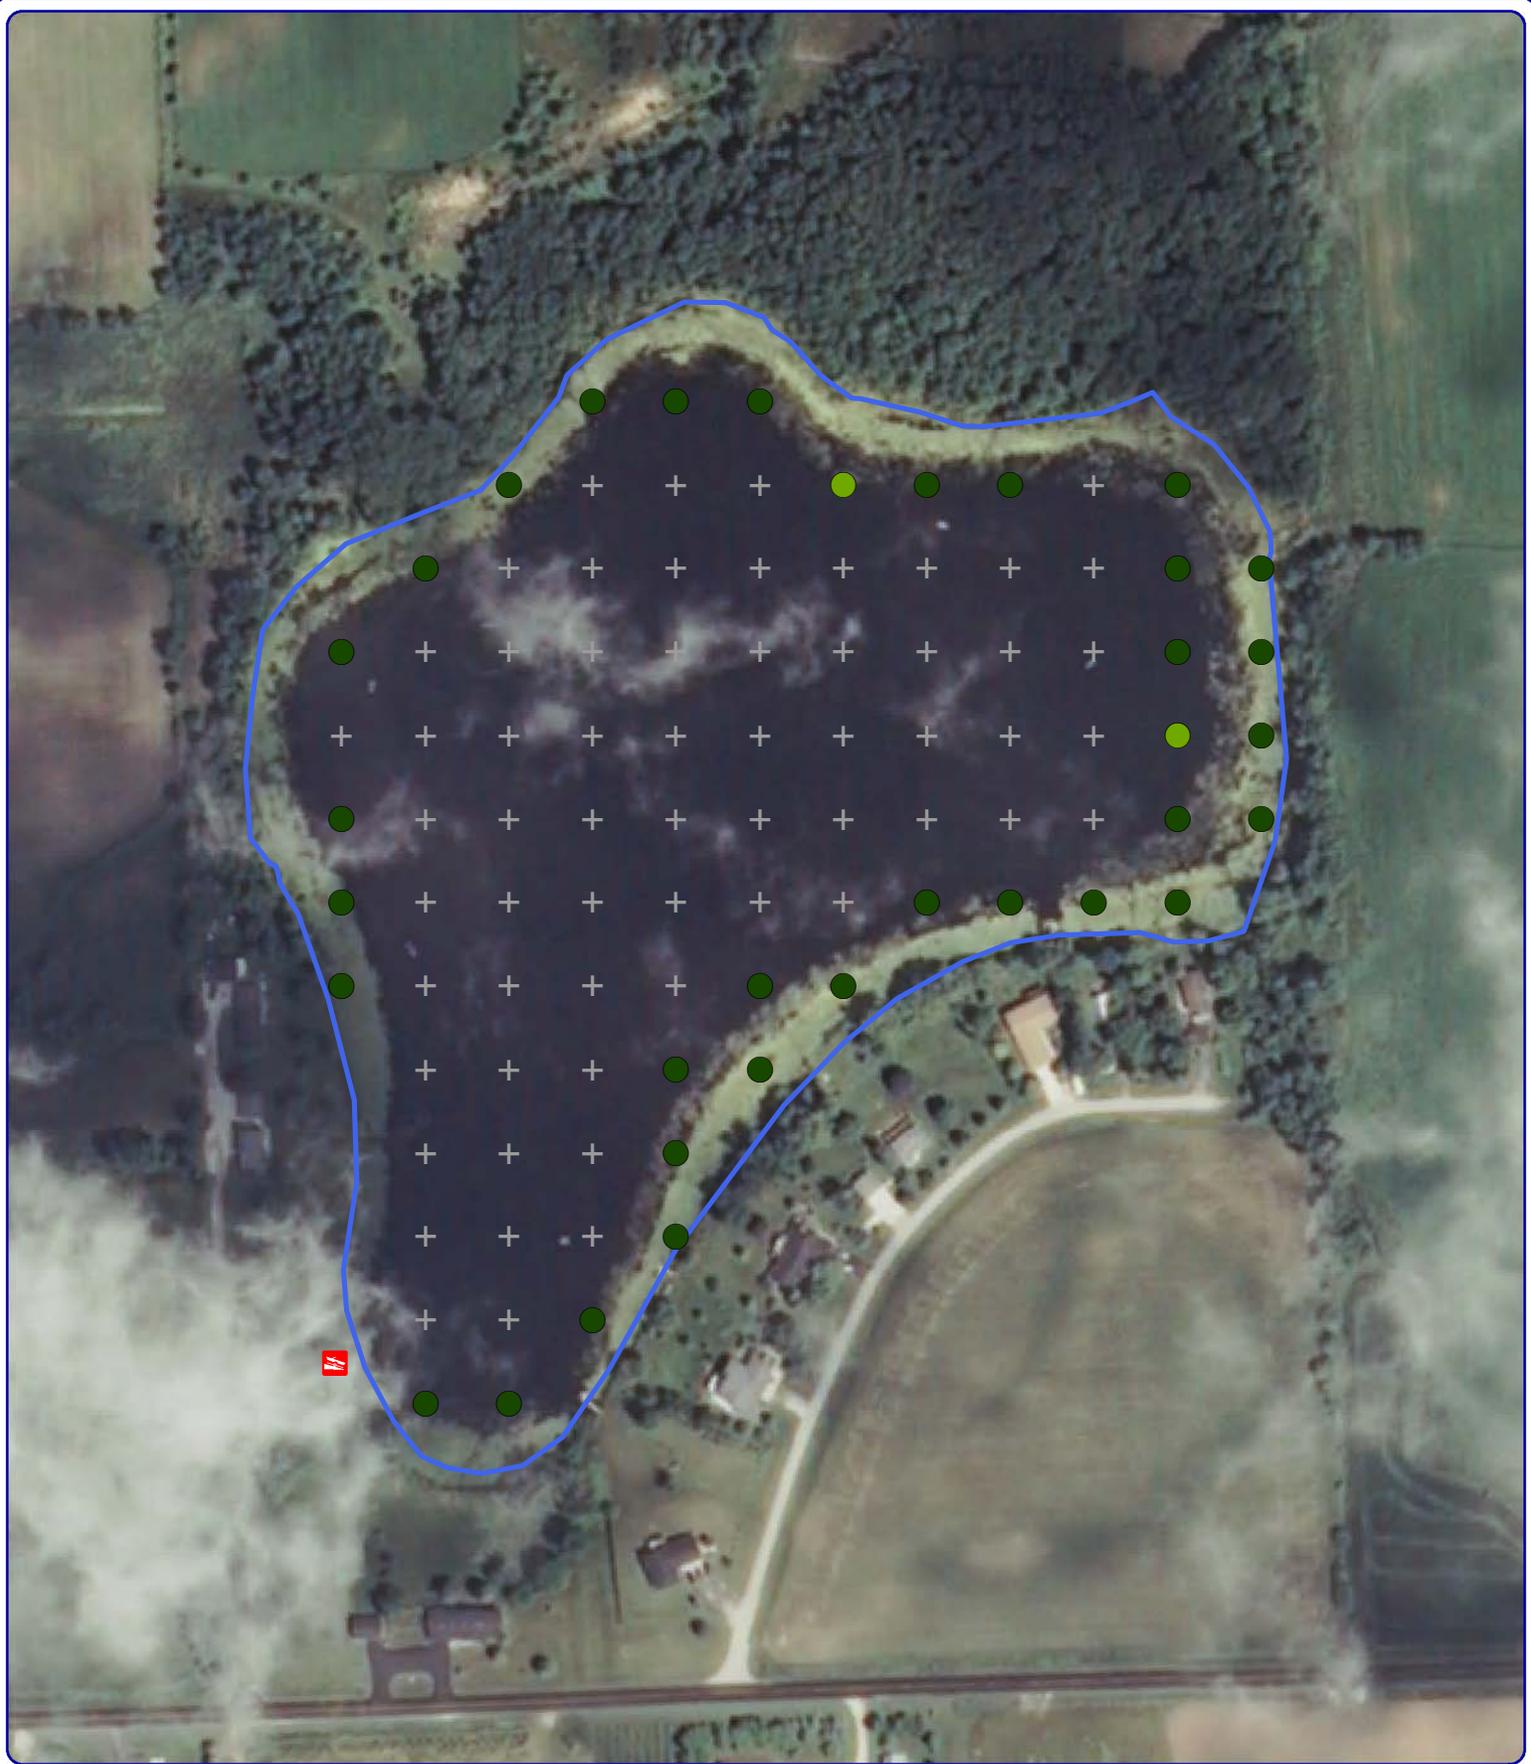
Map 3
Carstens Lake
 Manitowoc County, Wisconsin
2010 P-I Survey
Total Rake-Fullness

rake fullness ratings from the 2010 point-intercept survey. Not surprisingly, 94% of the point-intercept sampling locations that contained aquatic vegetation had the highest rake-fullness rating of 3.

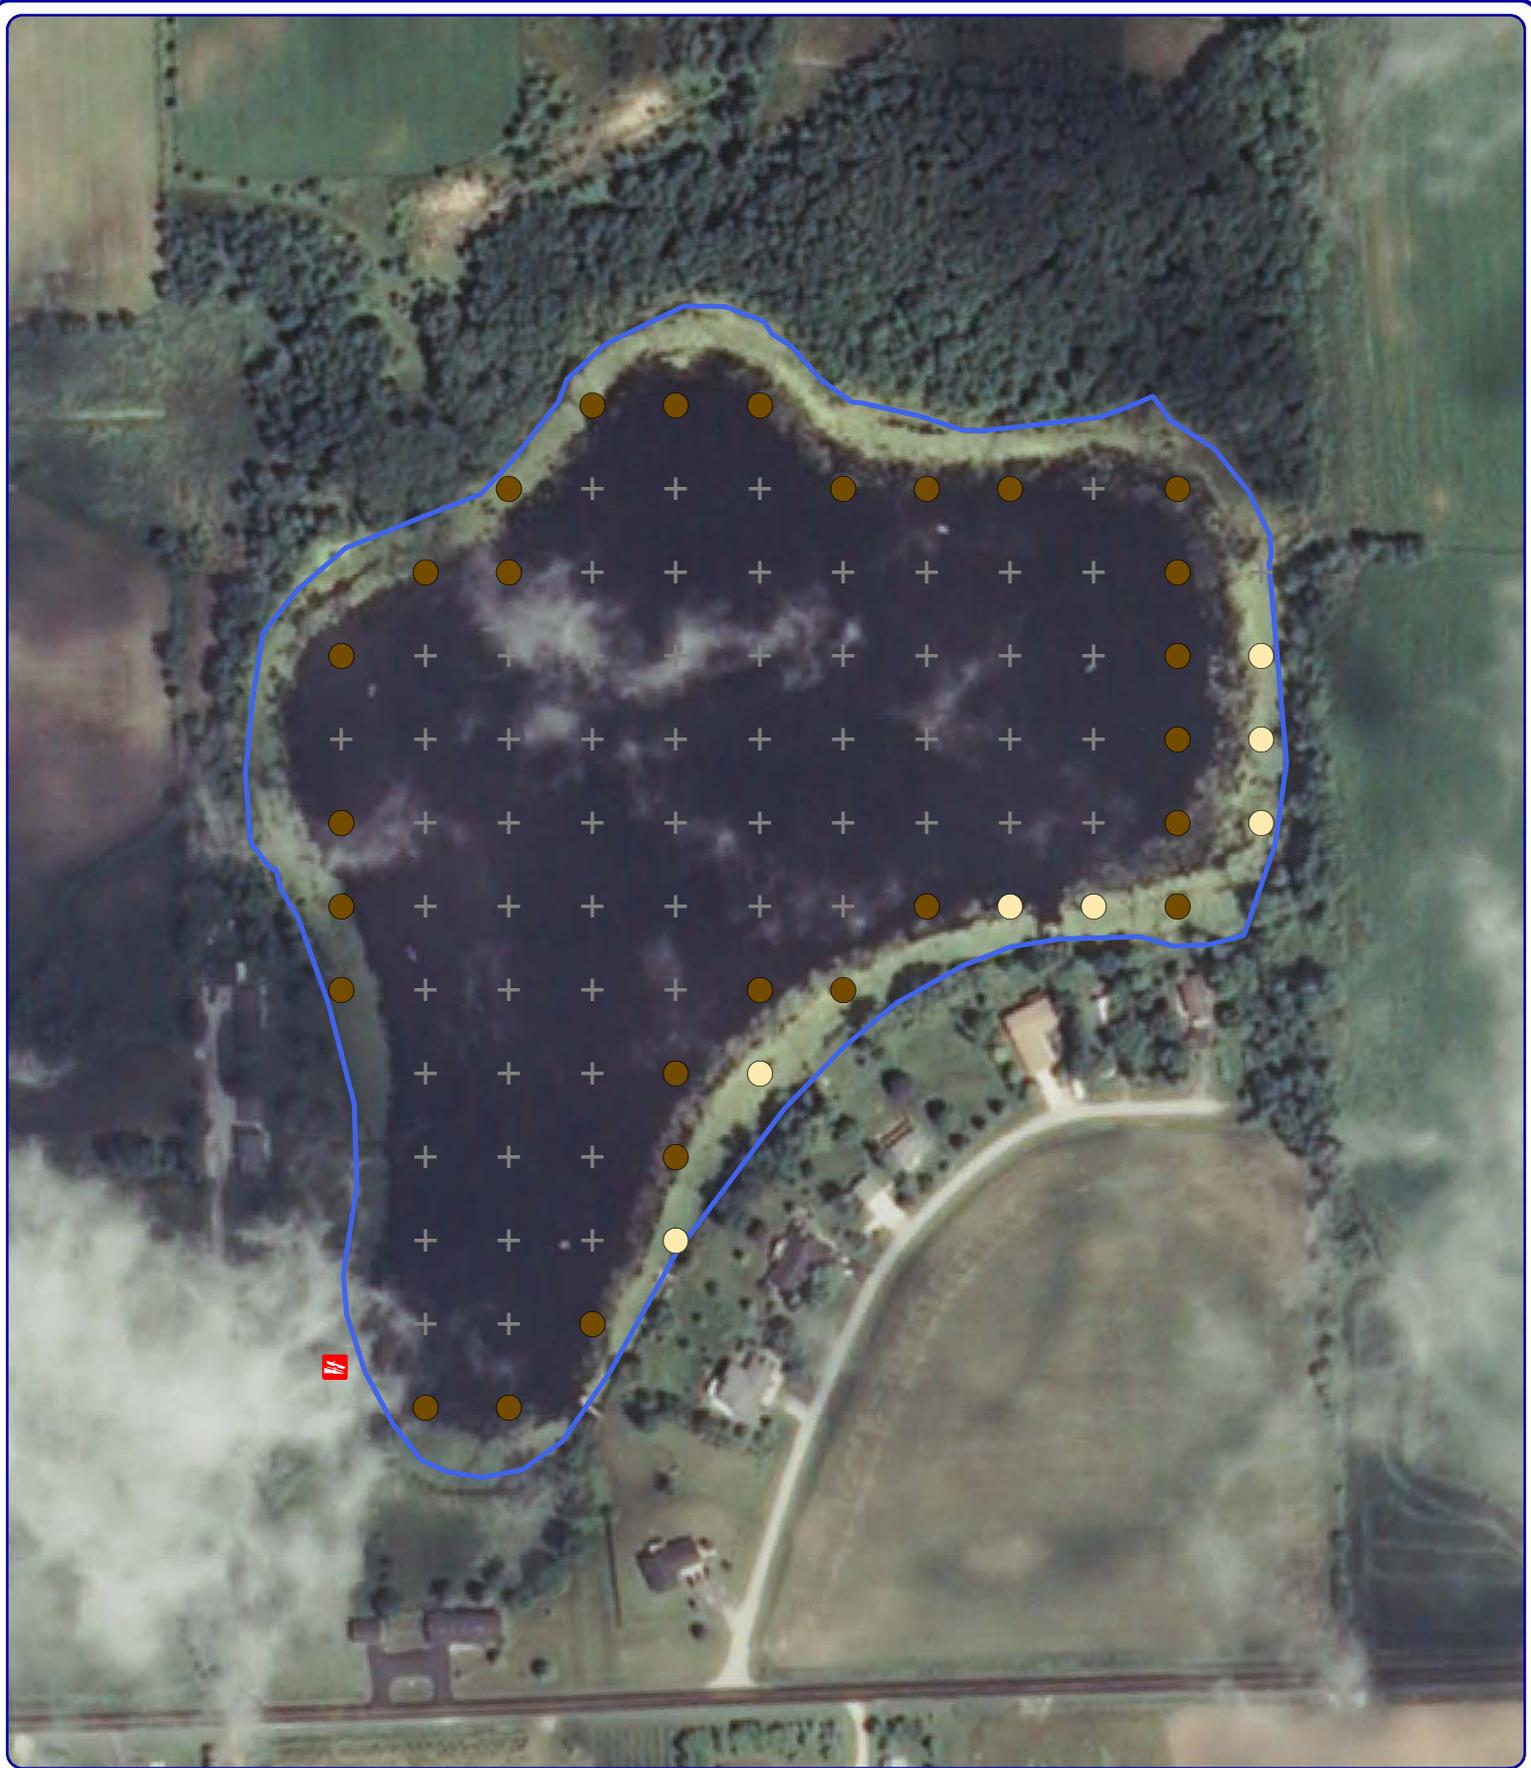
Map 2
Carstens Lake
 Manitowoc County, Wisconsin
Point-intercept Survey
Sediment Types

Eighty percent of the point-intercept locations contained mucky substrate while 20% contained sand (Map 2). Similar to terrestrial plants, most aquatic plant species favor this soft, nutrient-rich sediment. The combination of this substrate and high nutrient concentrations within the water column of Carstens Lake fuels vigorous aquatic plant growth. Map 3 displays the total-
