## FINAL REPORT-2010

*Nymphoides peltata* Eradication from The University of Wisconsin – Madison's Botanical Garden Pond

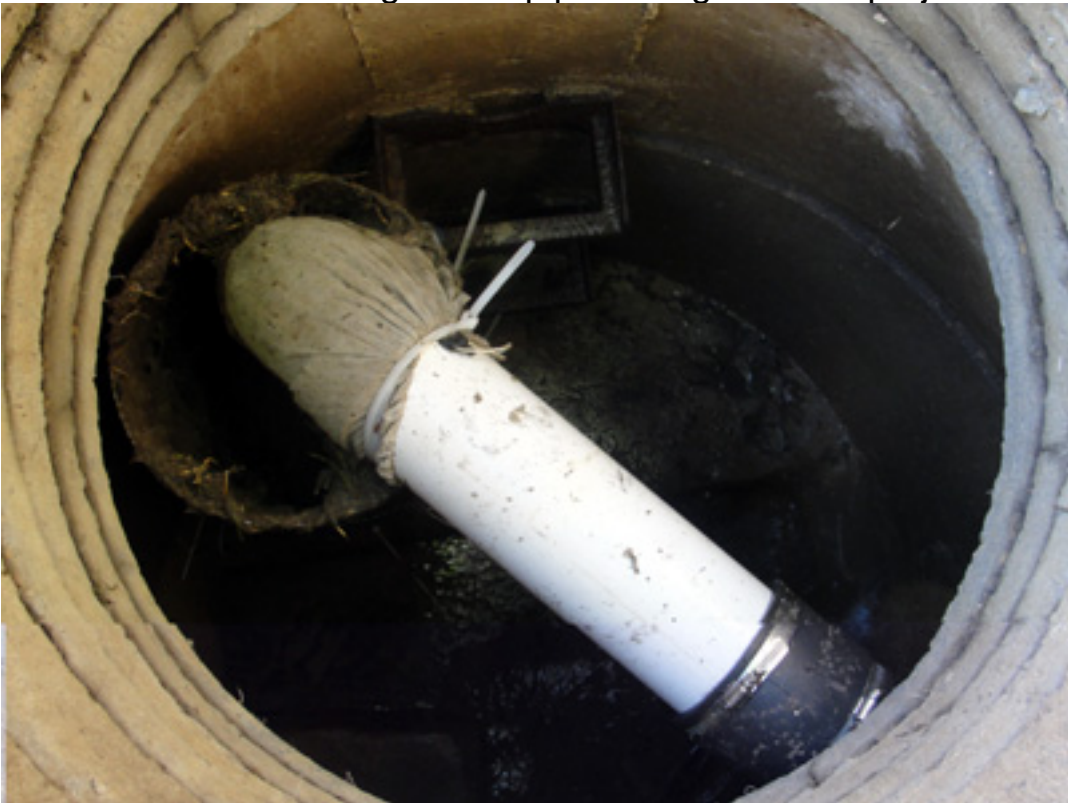
2.UW Physical Plant staff installed and ensured that the pond outlet has the secure filter bag on the pipe through out the project.

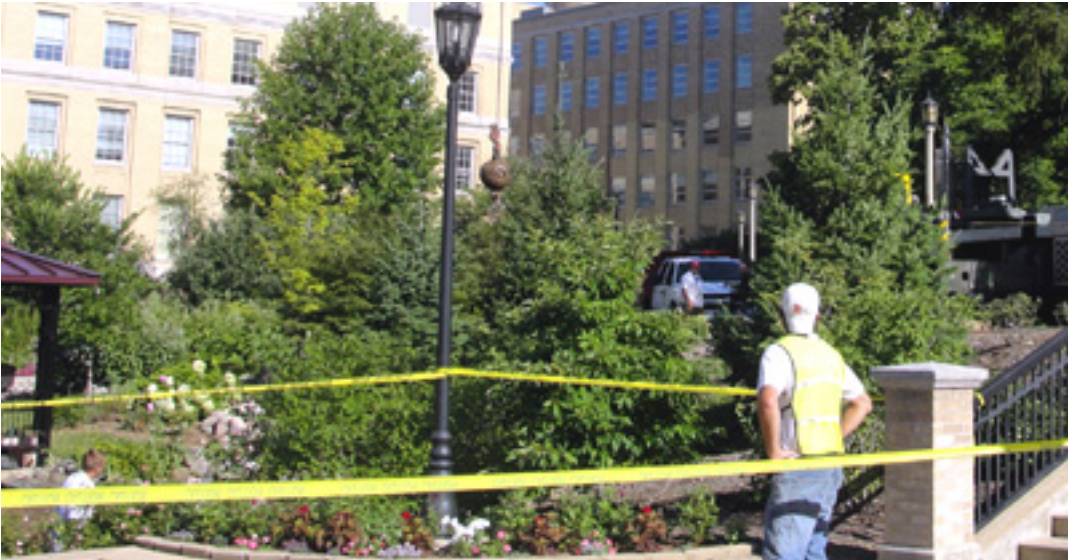
3. Contractor installed lath and yellow tape around work site to discourage public from entering the area.

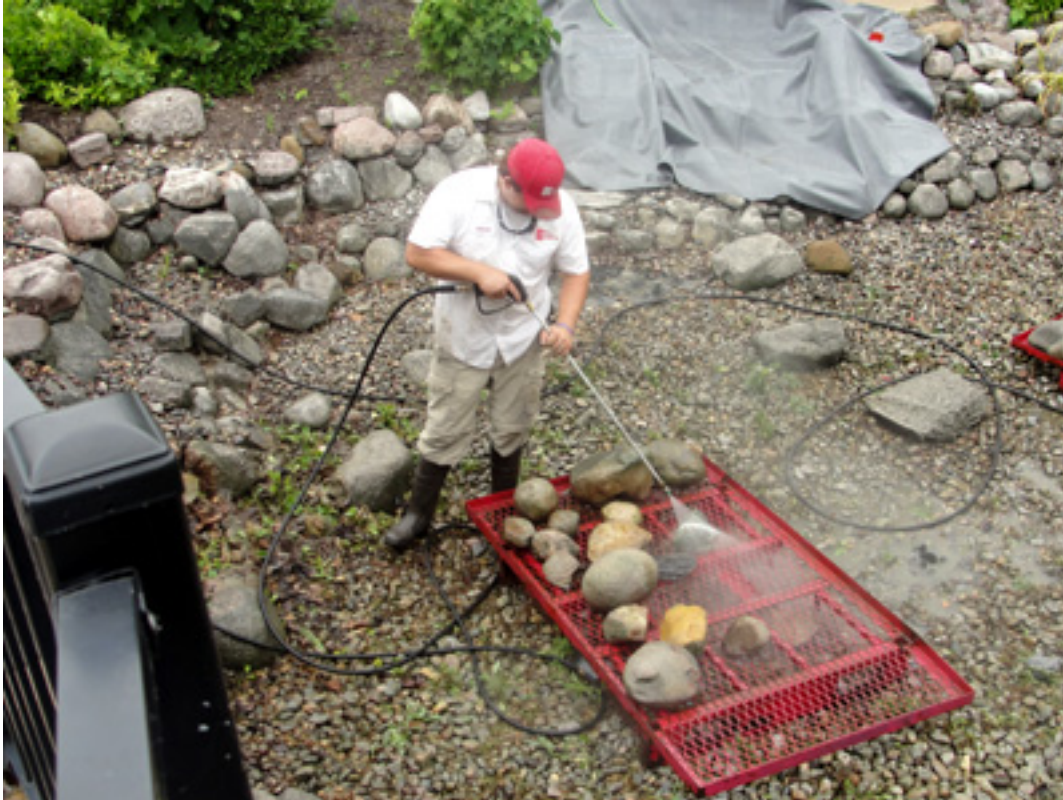
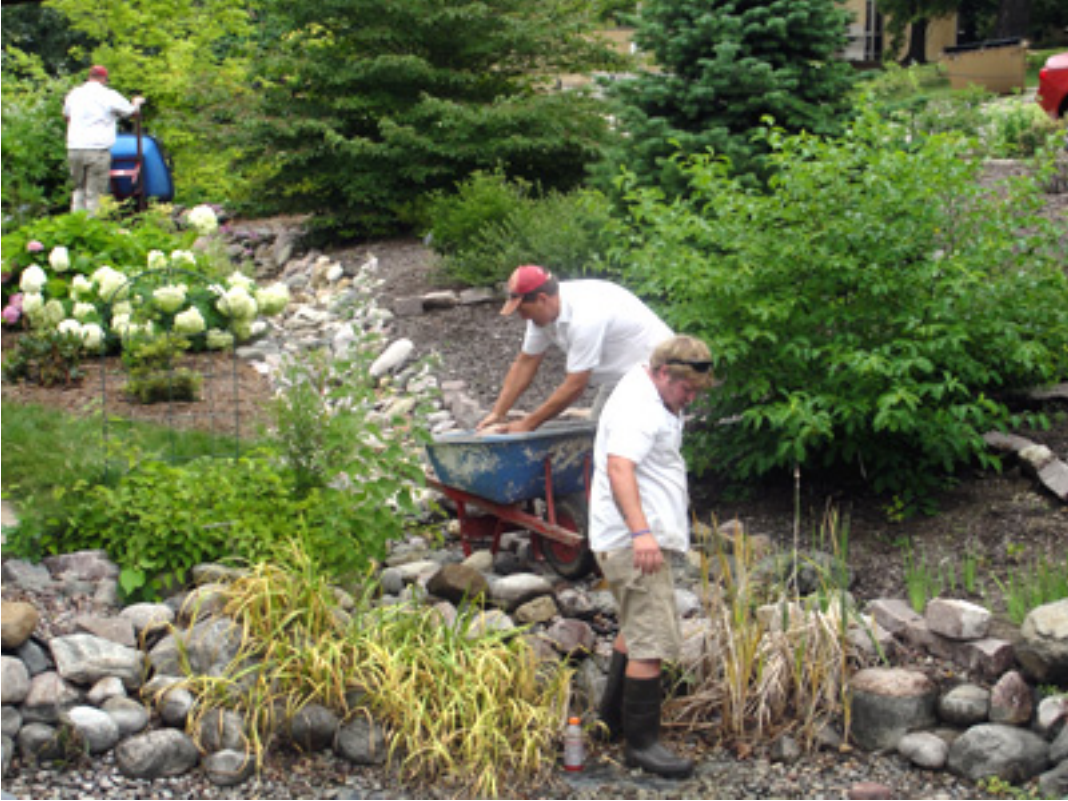
5. In the pond, power-washed large rocks surrounding pond border, manually were removed from the pond. They stacked up elsewhere in the garden. These rocks were reused in the new pond. We agreed that power-washing these large rocks would be effective at ensuring no seeds would remain on their surfaces, so these rocks do not need to be disposed of.

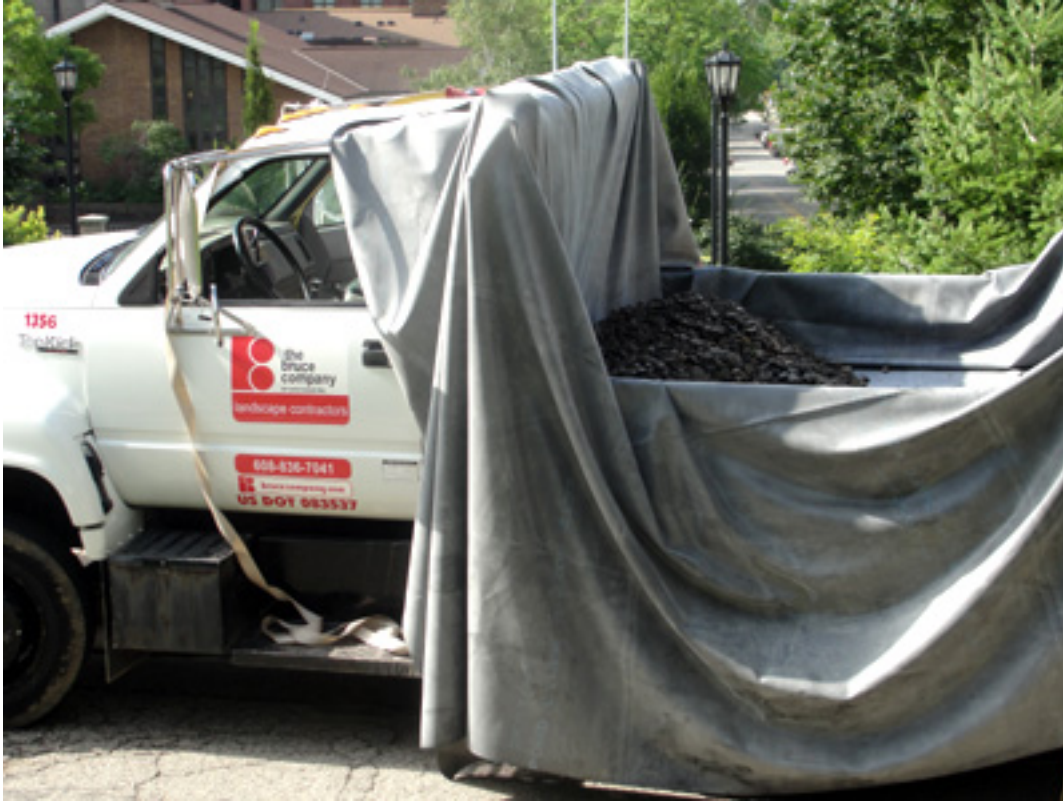
7. They lined the bed of a disposal truck with a generous sized, double layer of Visqueen plastic sheeting to Prevent contamination of the truck liner for transfer of pond materials to landfill, where all deliveries were tarped.

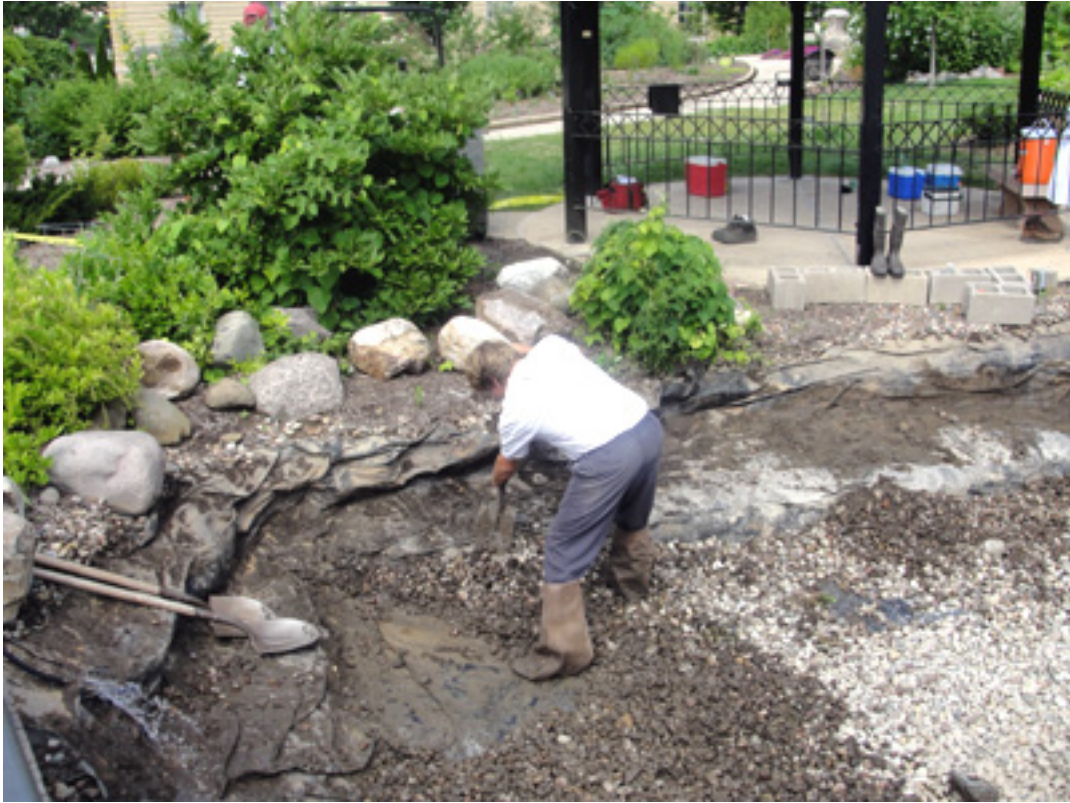
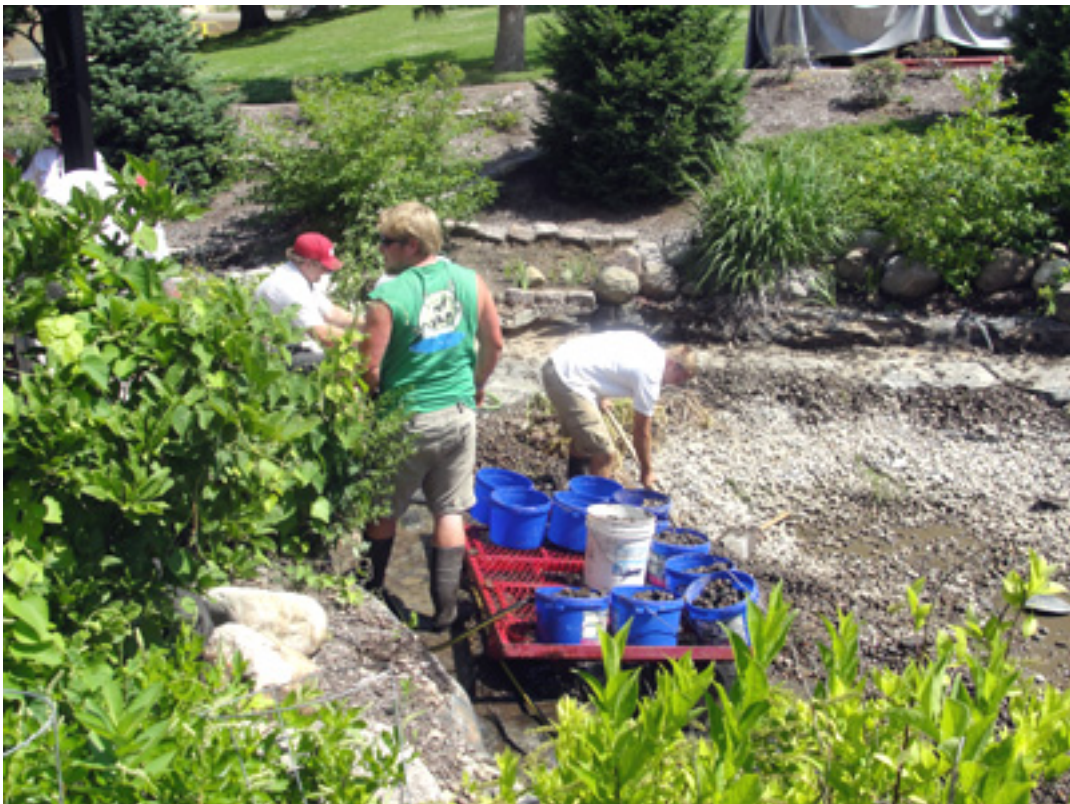
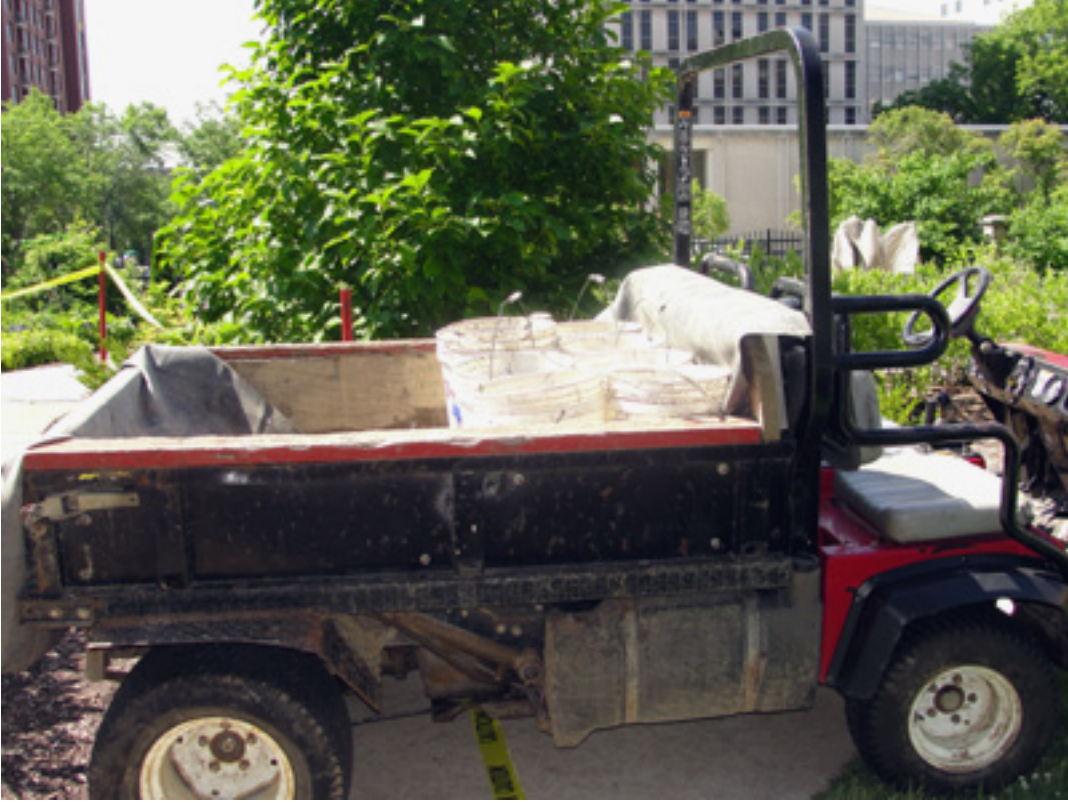
8. Using flat-tipped shovels, workers scooped up all gravel, place them in buckets, handed buckets up to load on a golf cart, which was driven on paths to a removal truck. Bucket exteriors kept free of mud OR hosed off if they got muddy before taking them out of pond basin to avoid moving mud to the golf cart. At the truck, buckets were dumped into the lined bed of the truck.

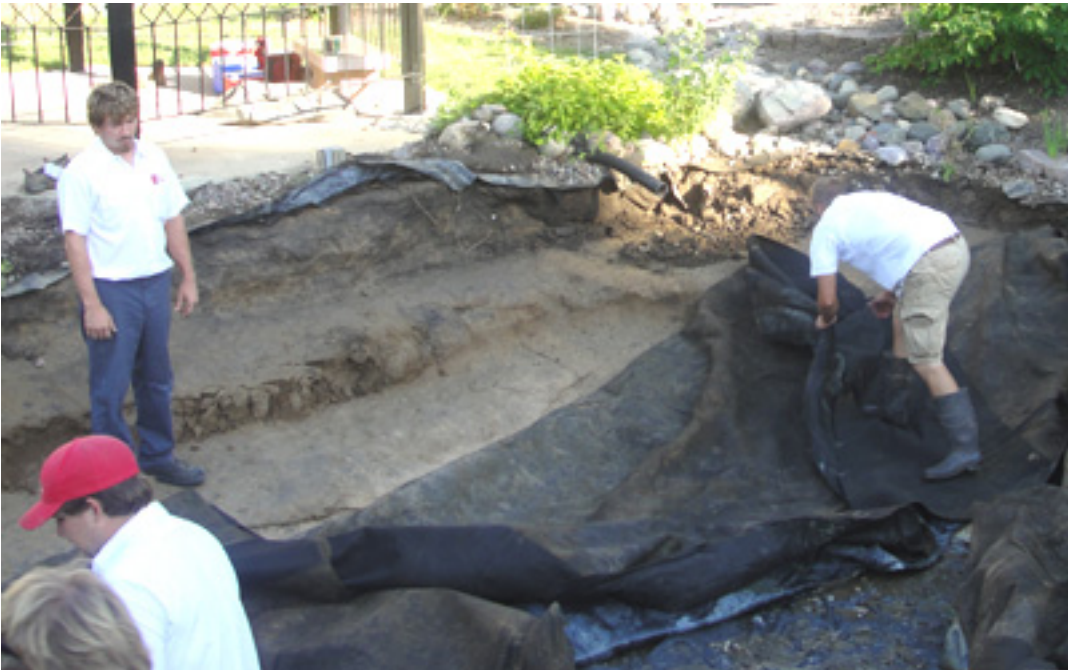
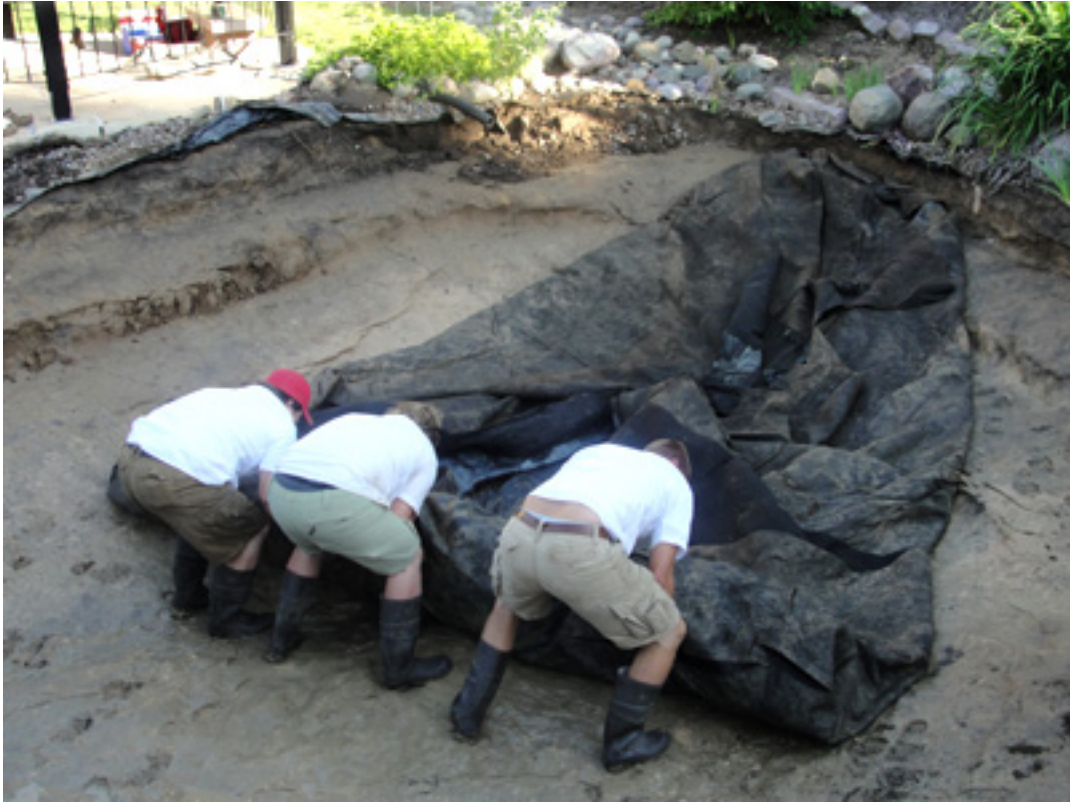
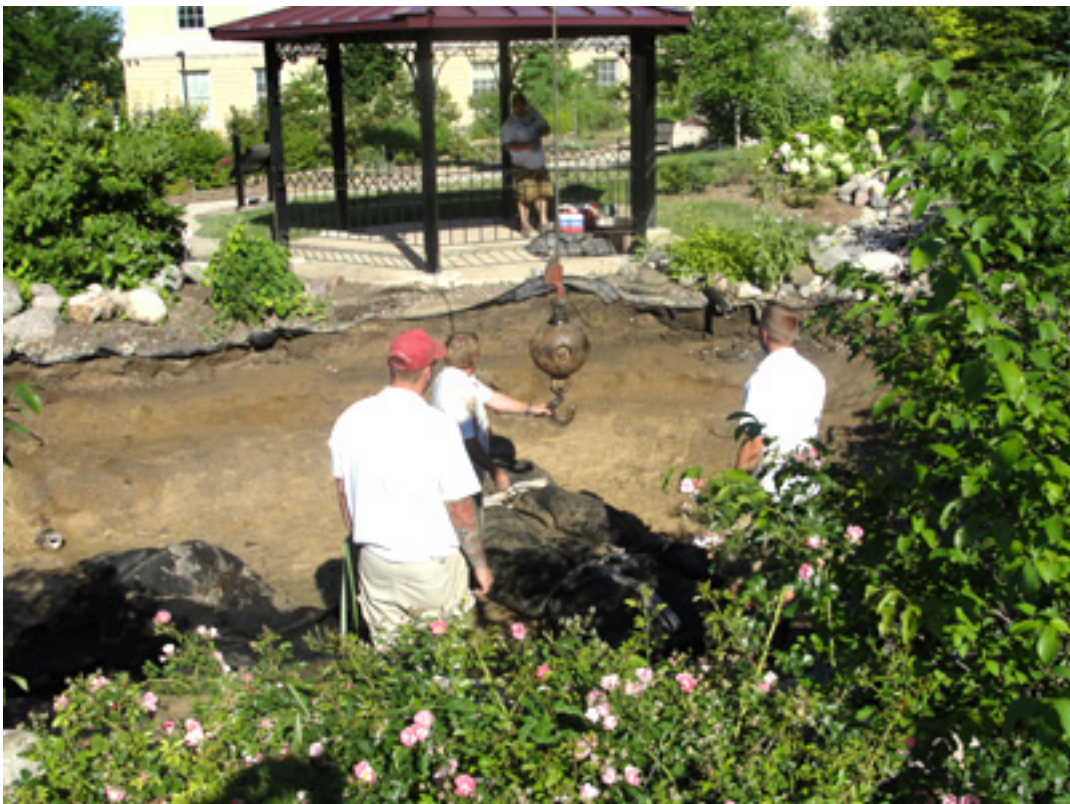
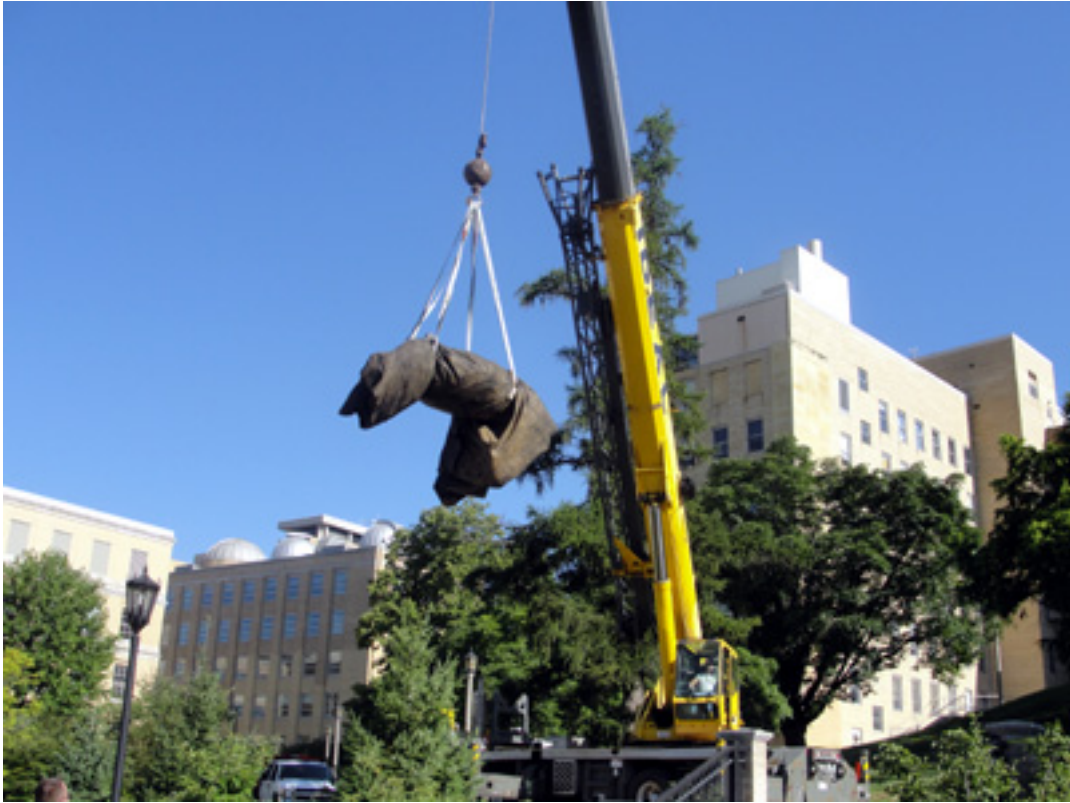
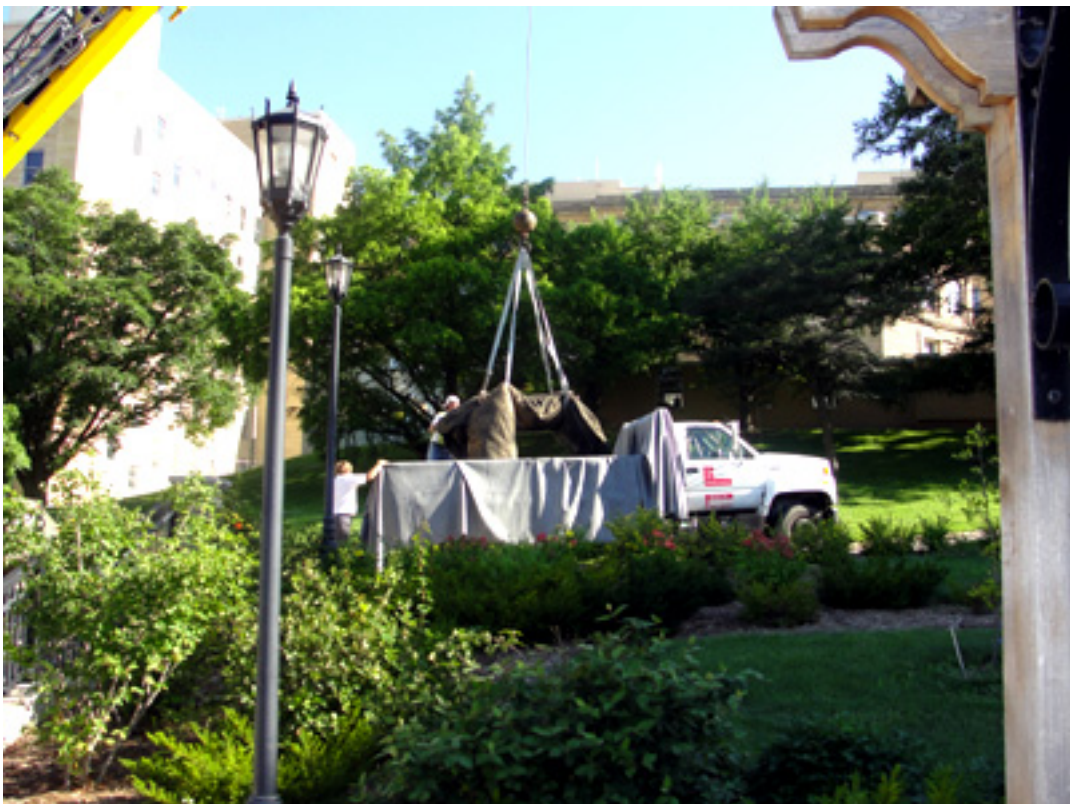
10. As soon as possible after all gravel has been removed, the liner was disconnected from the ground at the circumference, from the waterfall area where it is glued down, and from the 3 drains. It rolled up “like a burrito”, securely tied, and carried to the disposal truck via a crane. Tarp covering the contents was secured.

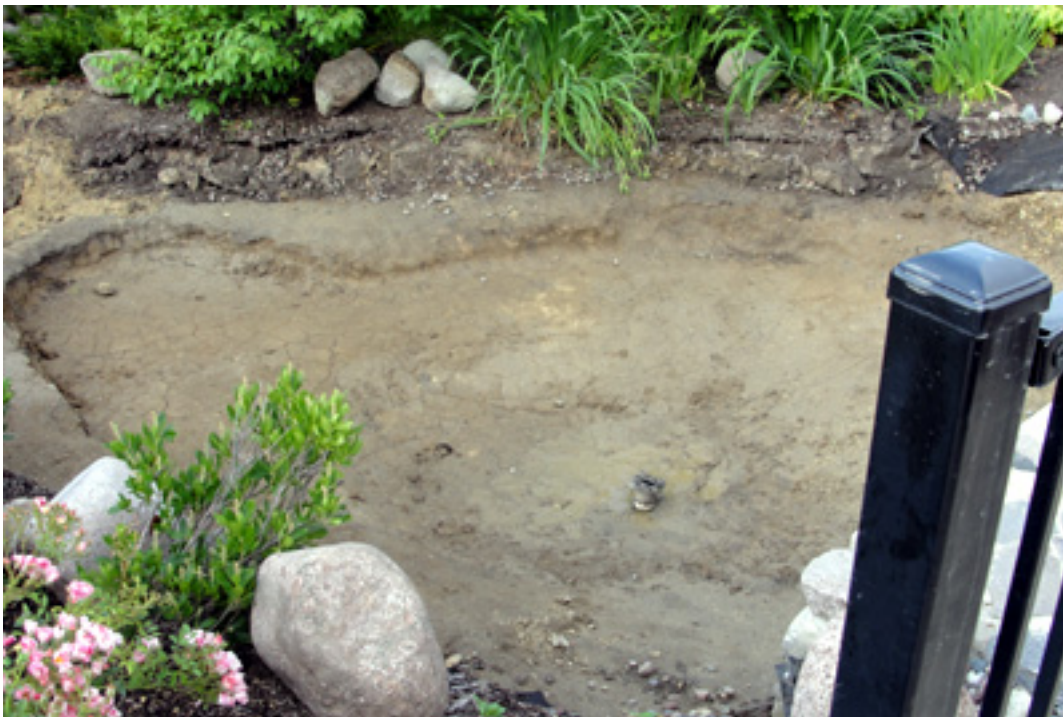
1. Preparation of the pond bed and cleaning the drainage.

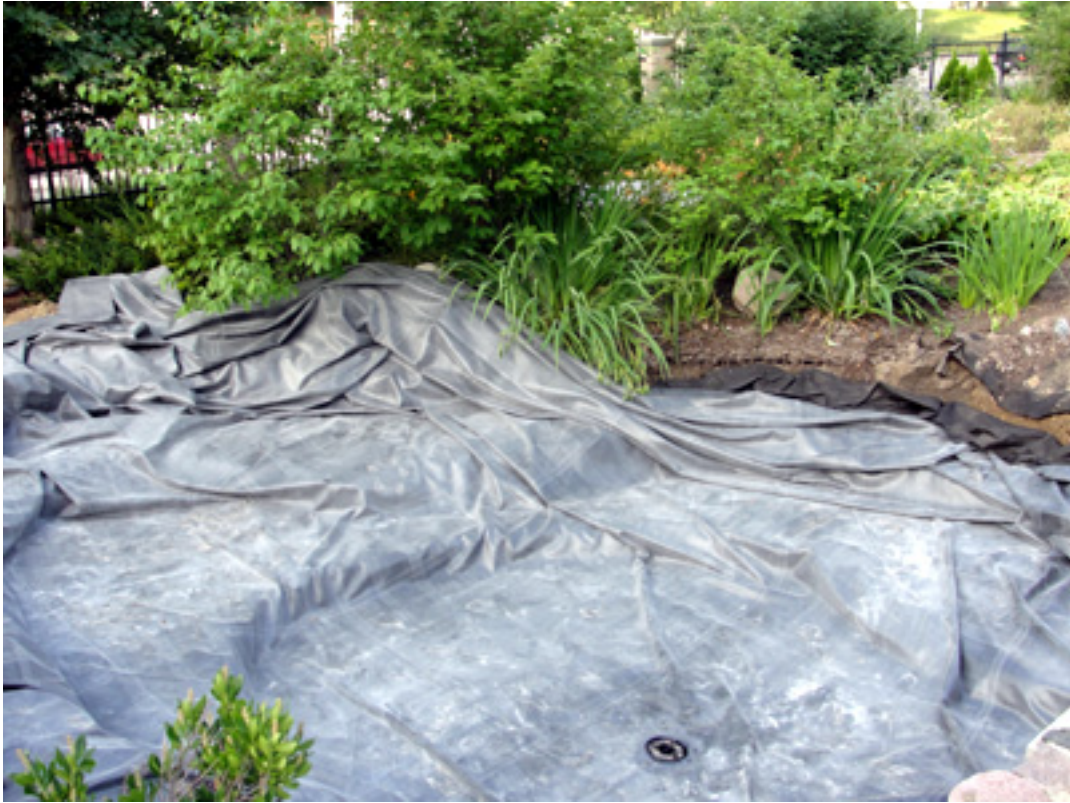
2. Covering the pond with liner.

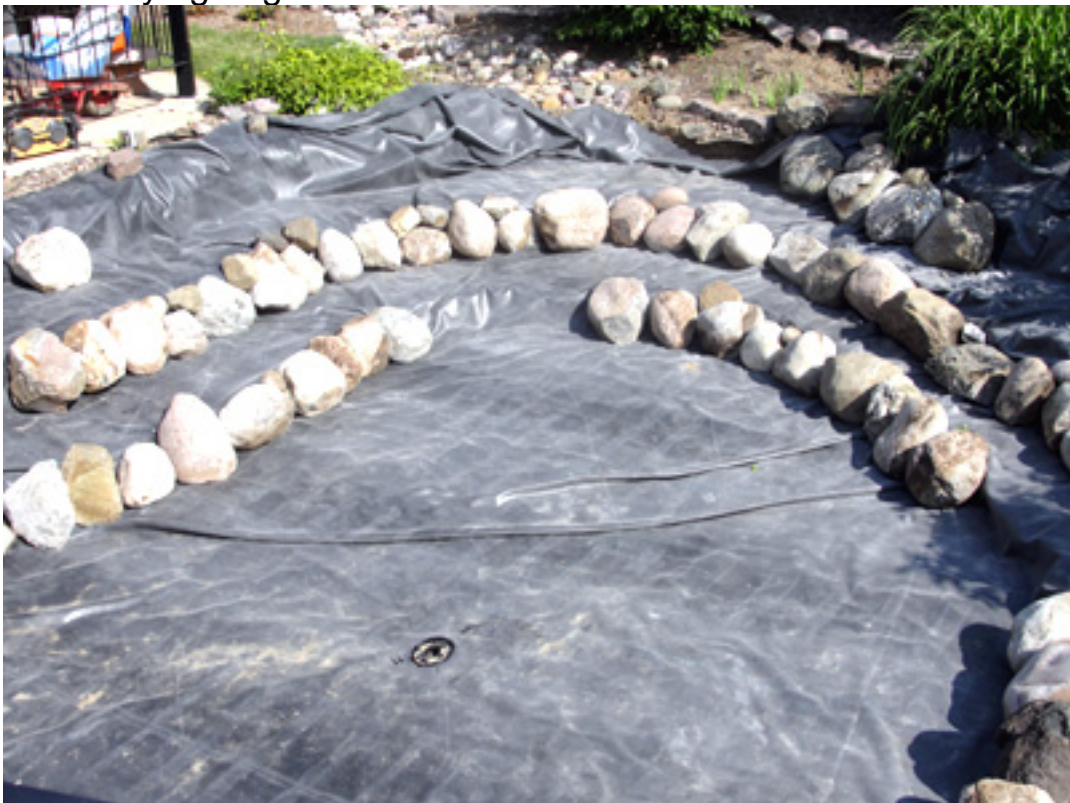
2. Laying large stones.

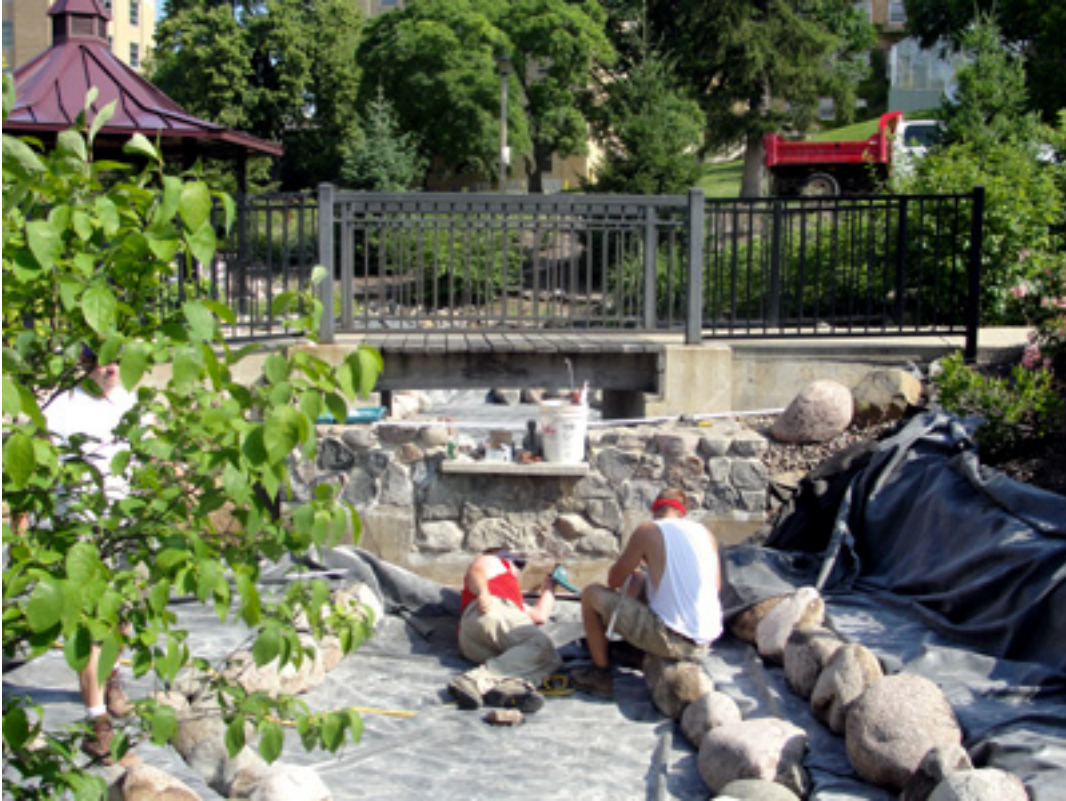
3. Sealing Liner to the waterfall.

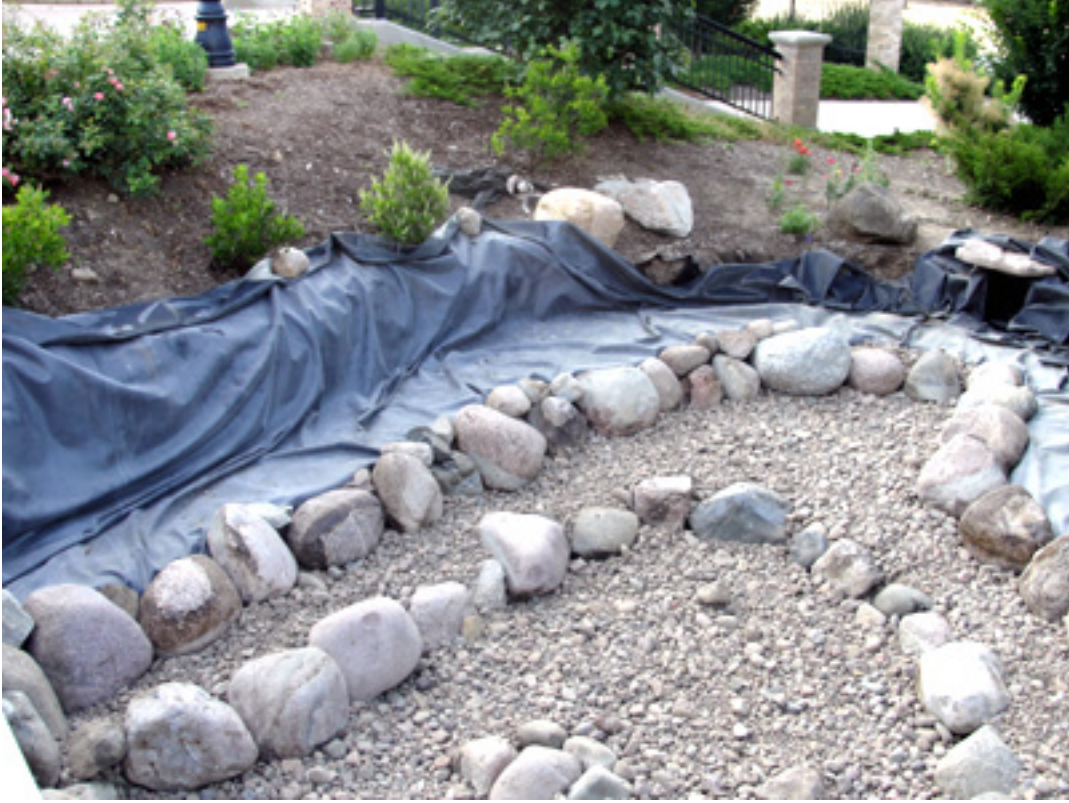
4. Adding small rock among large boulders.

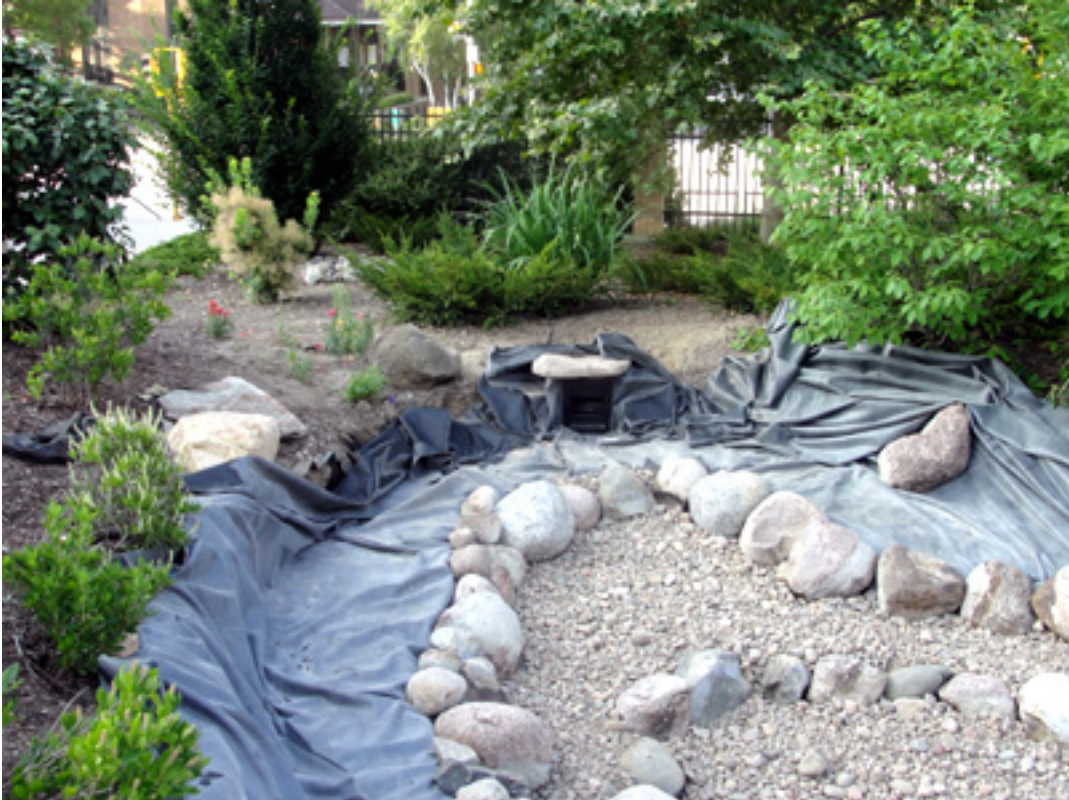
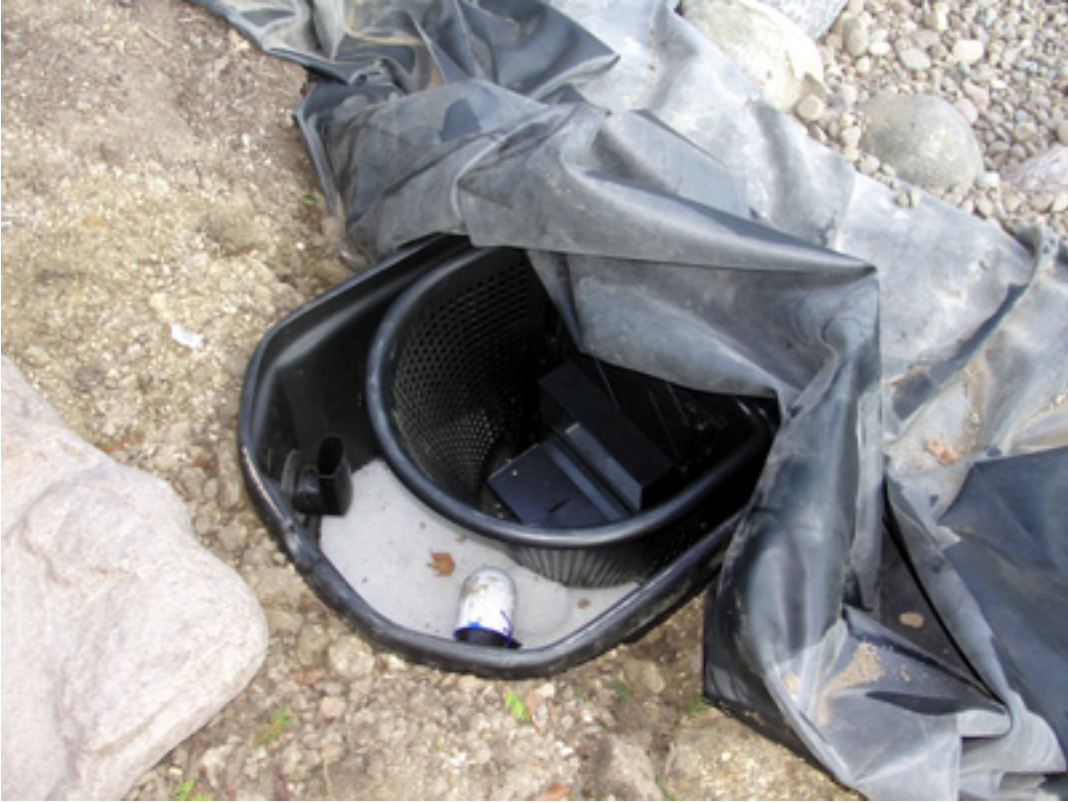
5. Inserting the skimmer to the pond for drainage of excess water.

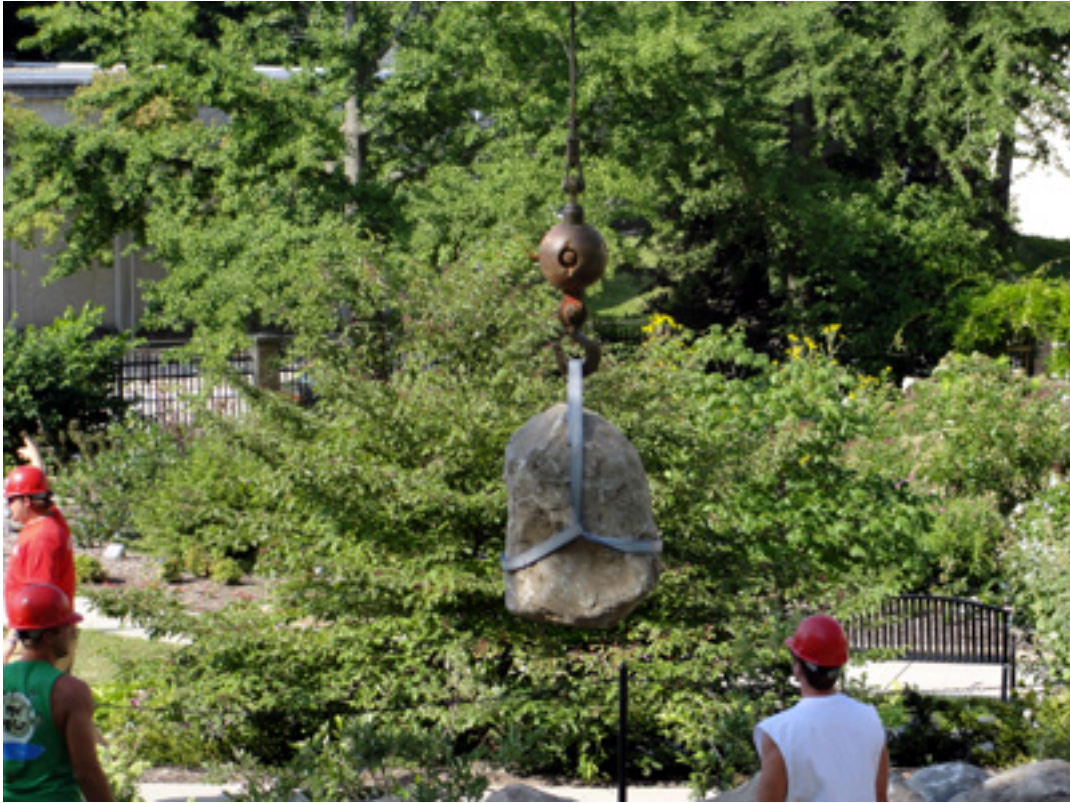
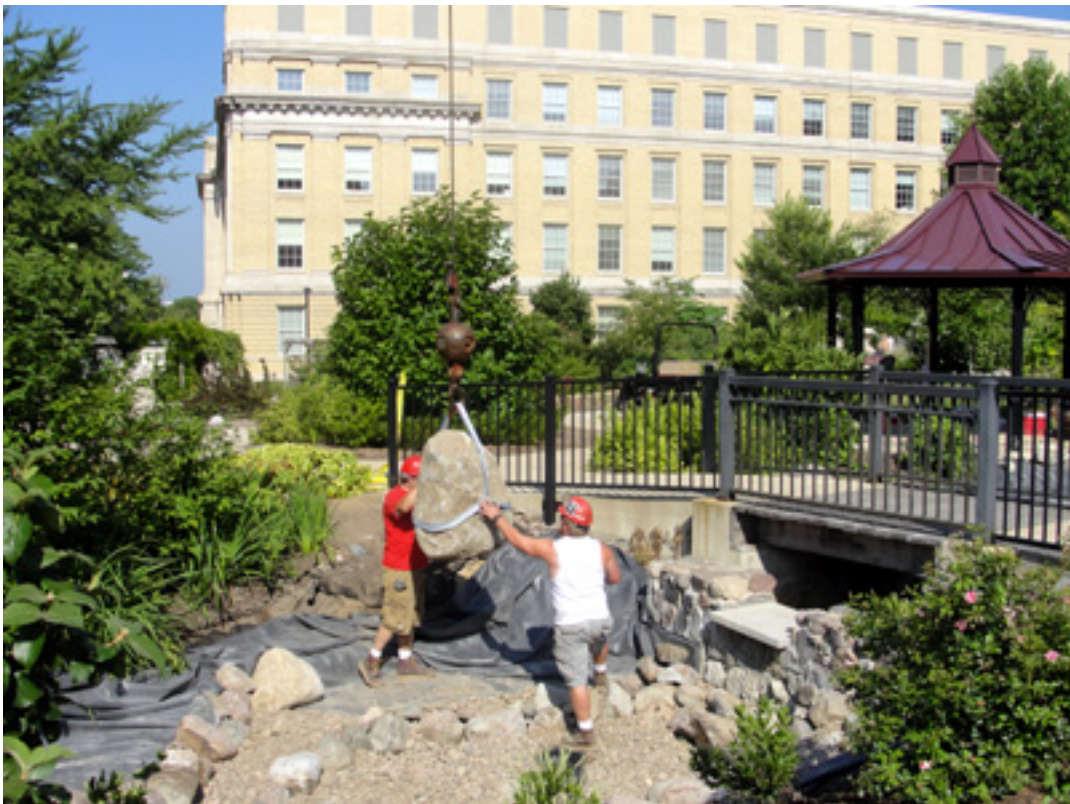
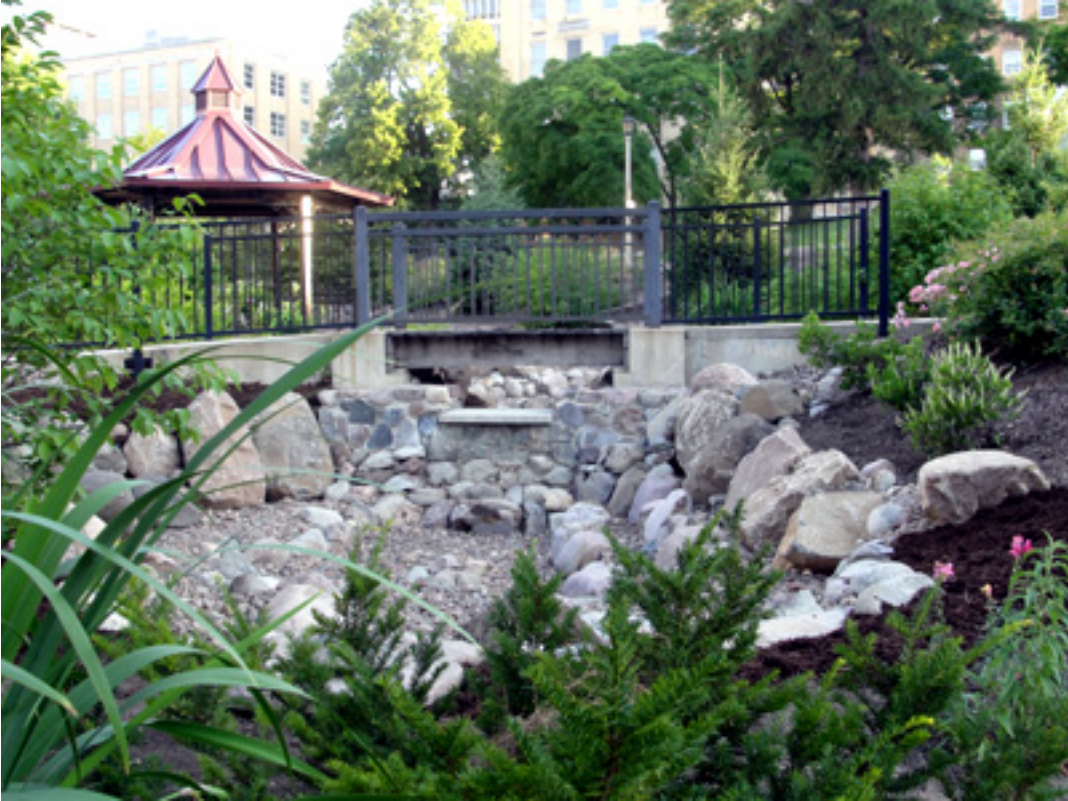
6. Using large boulders for the foundation of the pond. They carried to the pond by crane.

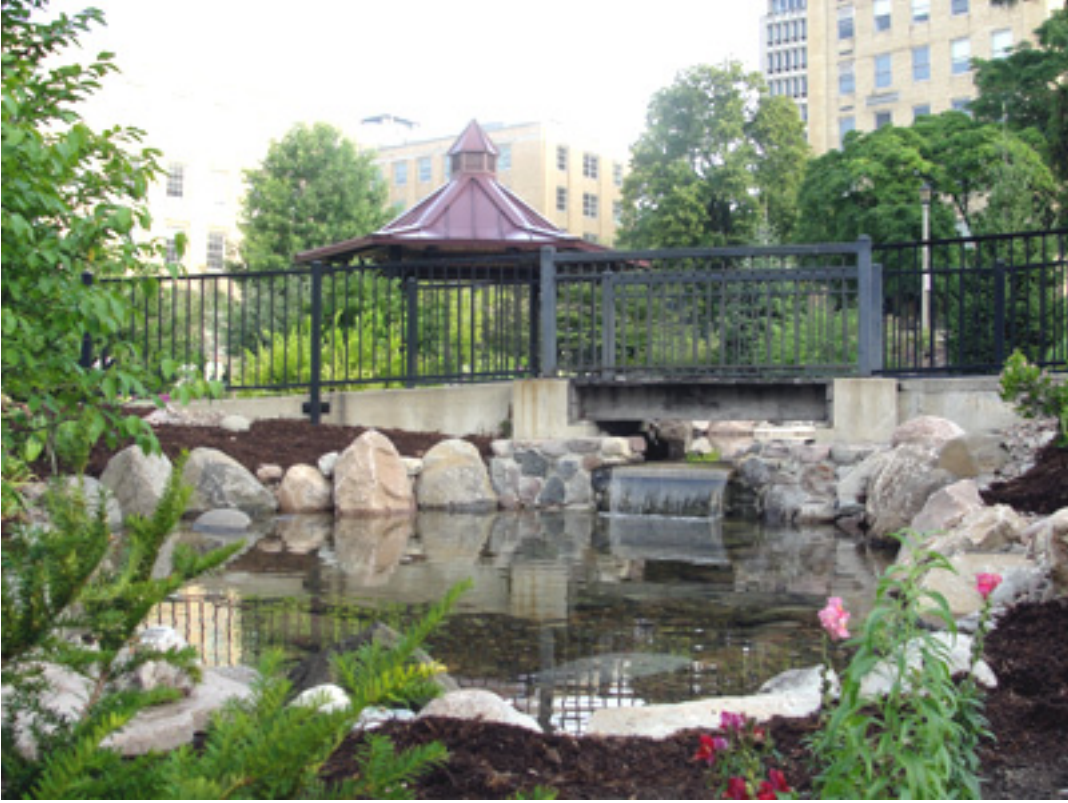
7. Adding water to the pond and checking for leak.

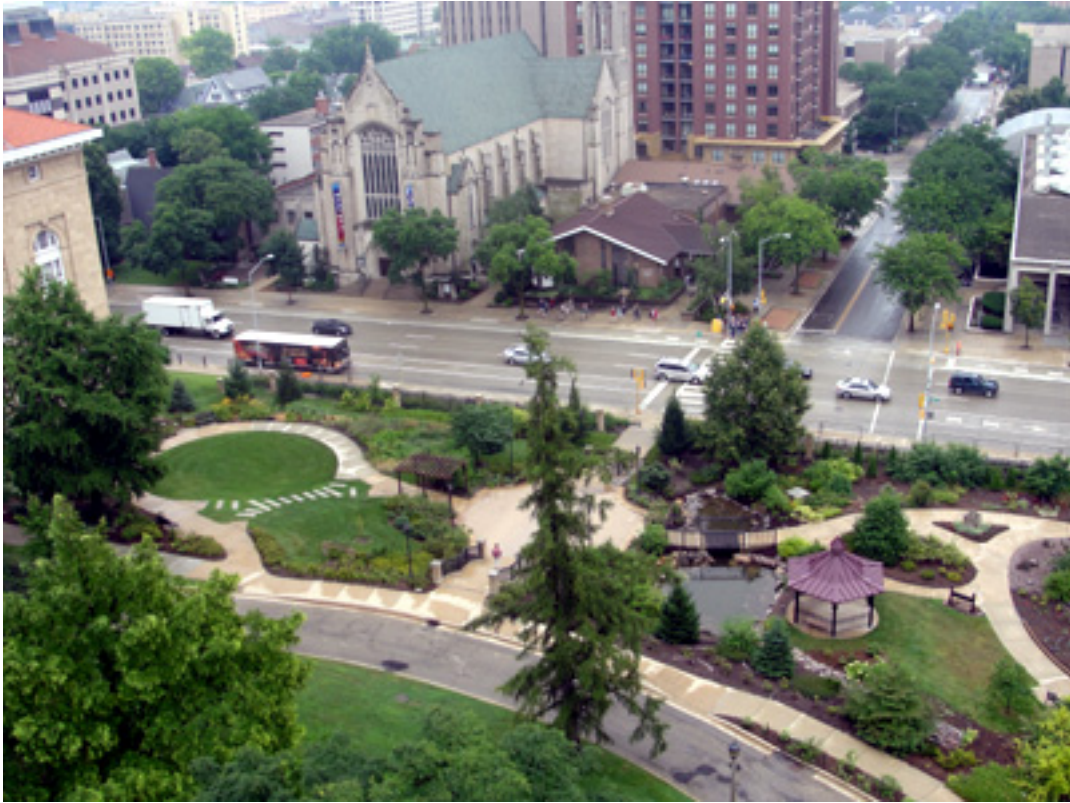
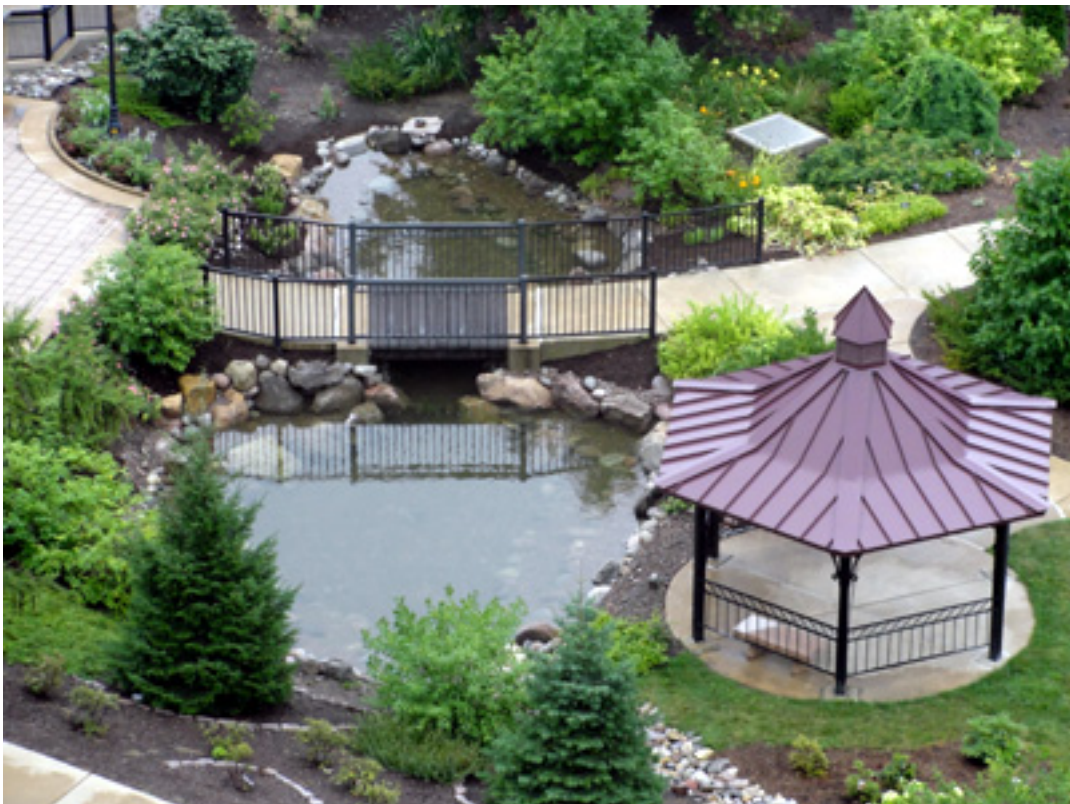
8. Finally, the pond was constructed and everything was done according to the schedule.
