**Curly-leaf Pondweed and Bed Mapping Surveys
Upper and Lower Vermillion Lakes
Barron County, Wisconsin
WBIC: 2098800 and 2098200**

Survey Conducted by and Report Prepared by:
Endangered Resource Services, LLC
Matthew S. Berg, Research Biologist
St. Croix Falls, Wisconsin
May - June 2009

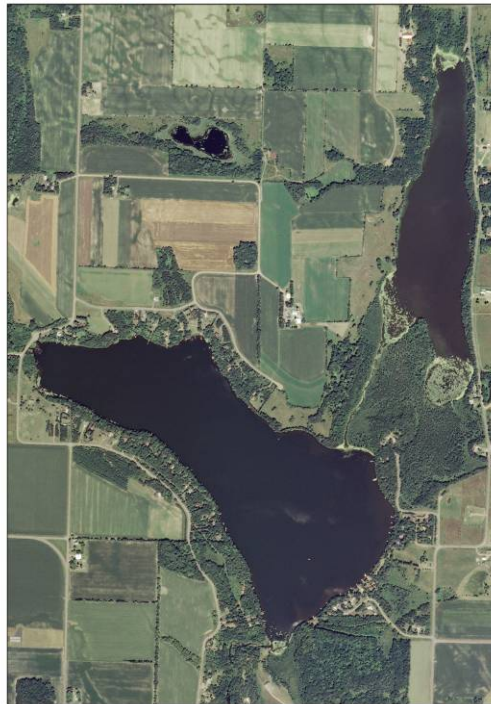
Figure 1: Aerial Photo of Vermillion Lakes

Upper Vermillion Lake (WBIC 2098800) and Lower Vermillion Lake (WBIC 2098200) combine to form a 297-acre (Upper Vermillion 89 acres and Lower Vermillion 208 acres) stratified drainage system in northwestern Barron County, Wisconsin in the Town of Cumberland (T35N R13W S15 SE NE and T35N R13W S22 SW NE). Upper Vermillion Lake achieves a maximum depth of 9ft in the east-central basin with an average depth of approximately 6ft. Lower Vermillion Lake reaches its maximum depth of 55 feet in the central basin and has an average depth of approximately 25ft (Busch et al, 1967). Upper Vermillion is borderline eutrophic/mesotrophic in nature and water clarity is poor to very poor with historical top summer Secchi readings from 3-6ft. Lower Vermillion is mesotrophic, and water clarity is fair to good with historic top summer Secchi readings from 7-12ft (WDNR 2009). The early season littoral zone reached approximately 7ft in Upper Vermillion and 10ft in Lower Vermillion. Upper Vermillion's bottom substrate is predominately muck with scattered gravel areas, while Lower Vermillion's has many rocky and sandy shoreline areas with muck and sandy muck in deeper water.

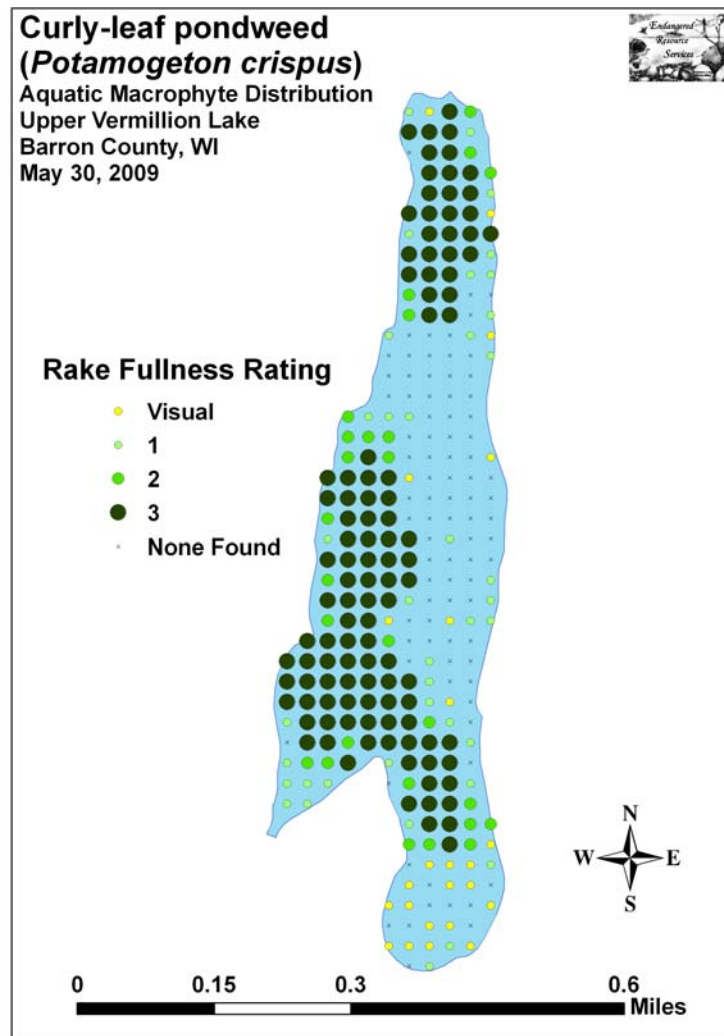
Figure 3: Upper Vermillion Lake CLP Density

We checked all 286 points on Upper Vermillion as they potentially all could have fallen in the littoral zone. We found CLP present or visible at 200 locations or 70% of the points surveyed. Of these, 111 had a rakefull rating of 3 and another 26 a 2 indicating approximately 48% of the lake had a significant infestation. In general, all areas of the lake that had organic muck bottom and were between 1 and 6ft deep had dense CLP present. These densities declined rapidly in water deeper than 7 feet (Figure 3).
