FINAL REPORT:

WATER QUALITY MONITORING AND EVALUATION OF POLLUTANT SOURCES WITHIN THE SOUTHWEST SUBWATERSHED OF ROCK LAKE

Rock Lake, Jefferson County, Wisconsin

Rock Lake Improvement Association, Inc.

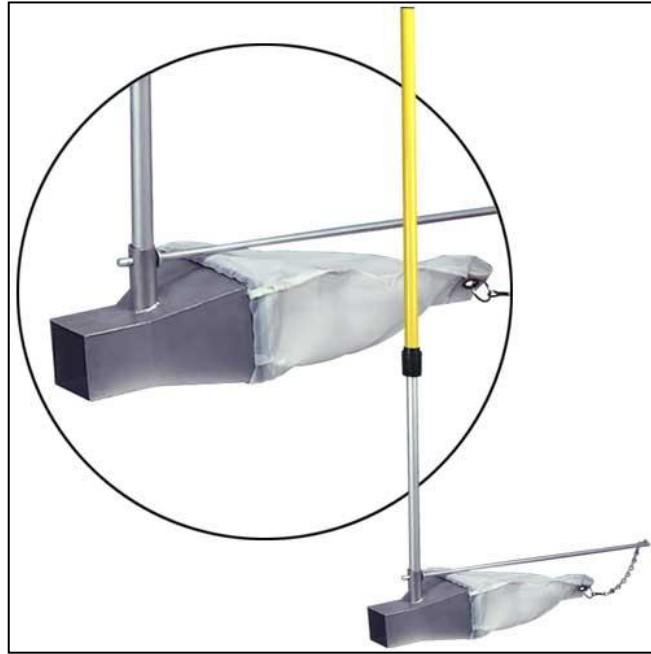
Bed load mass can be measured using a device called a "Helley-Smith Sampler". The Helley-Smith sampler was designed by the United States Geological Survey (USGS) to conduct stream bed load studies. By design, the Helley-Smith sampler is intended to collect sediment particles that are moving along the bottom, or close to the bottom, by rolling, sliding, or bouncing (actually, those particles moving within 0.25 ft. of the bed). The

device consists of a 3- by 3-inch rectangular funnel fitted with a catch bag made of 0.25 mm opening nylon mesh that is attached to the flared end of the sampler (Figure 5). It is placed on the channel bottom for a fixed time period and the amount of sediment collected in the bag is then measured.

Figure 5
Photograph of “Helley-Smith” Stream Bed Load Sampler

On November 13, 2009 Hey and Associates conducted a bed load sample at sample site B the inlet to the Miljola Channel. On this date the staff gauge reading at the site was 0.38 and flow was measured using a Marsh-McBirney, Inc. FlowMate flow meter at 0.46 cfs. During a five minute period 0.225 pounds (3.6 oz) of bed load material was collected. The material was all peat. If we assumed that this value represented a typical day and multiply it by 365 days we get an annual loading level of **23,652 pounds per year**. This value should be considered a low estimate of bed load as the one sample was collected during a period of very little flow and does not represent the quantity of material that is likely moving during storm events or higher base flow. Additional sampling would be required to accurately estimate the real bed loading to the channel and lake.

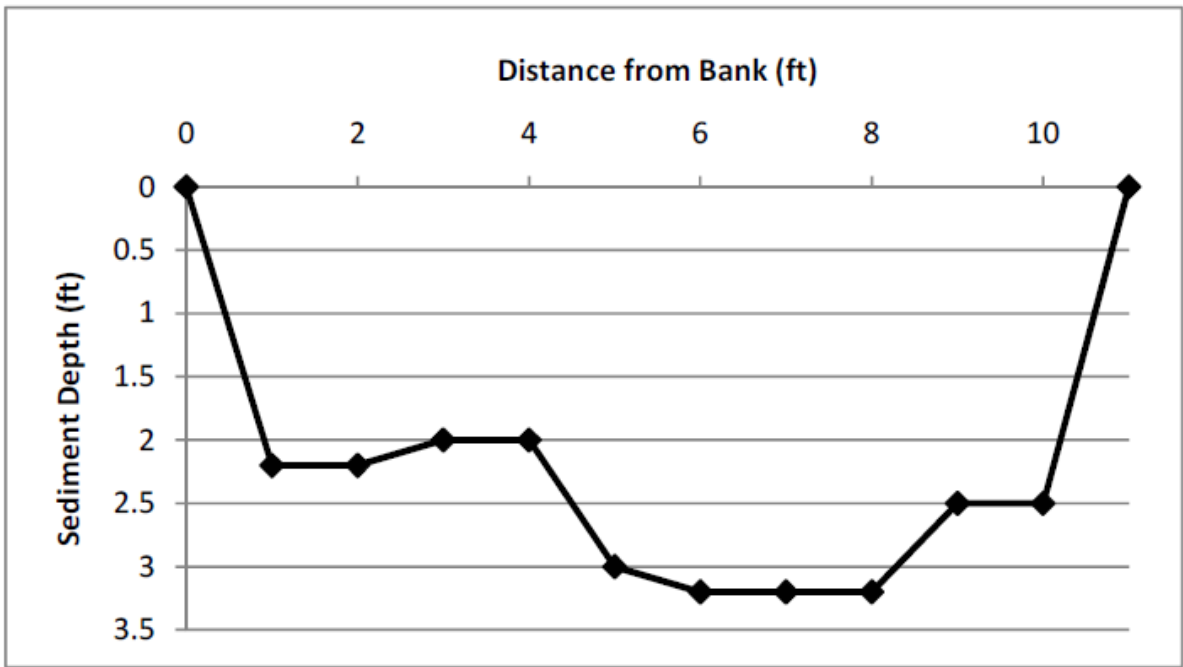
Given the sediment profiles (Figures 7 & 8), an estimate of sediment that is located in the stream channel and has the potential to be delivered downstream during storm events can be determined. Based on field observations, an estimate was made as to the length of stream that contains sediment in the bottom of the channel. The estimated amount of sediment in the stream channel bottom alone is 9,200 cubic yards.

Figure 7
Sediment Depths at Site 5 (see Figure 5)

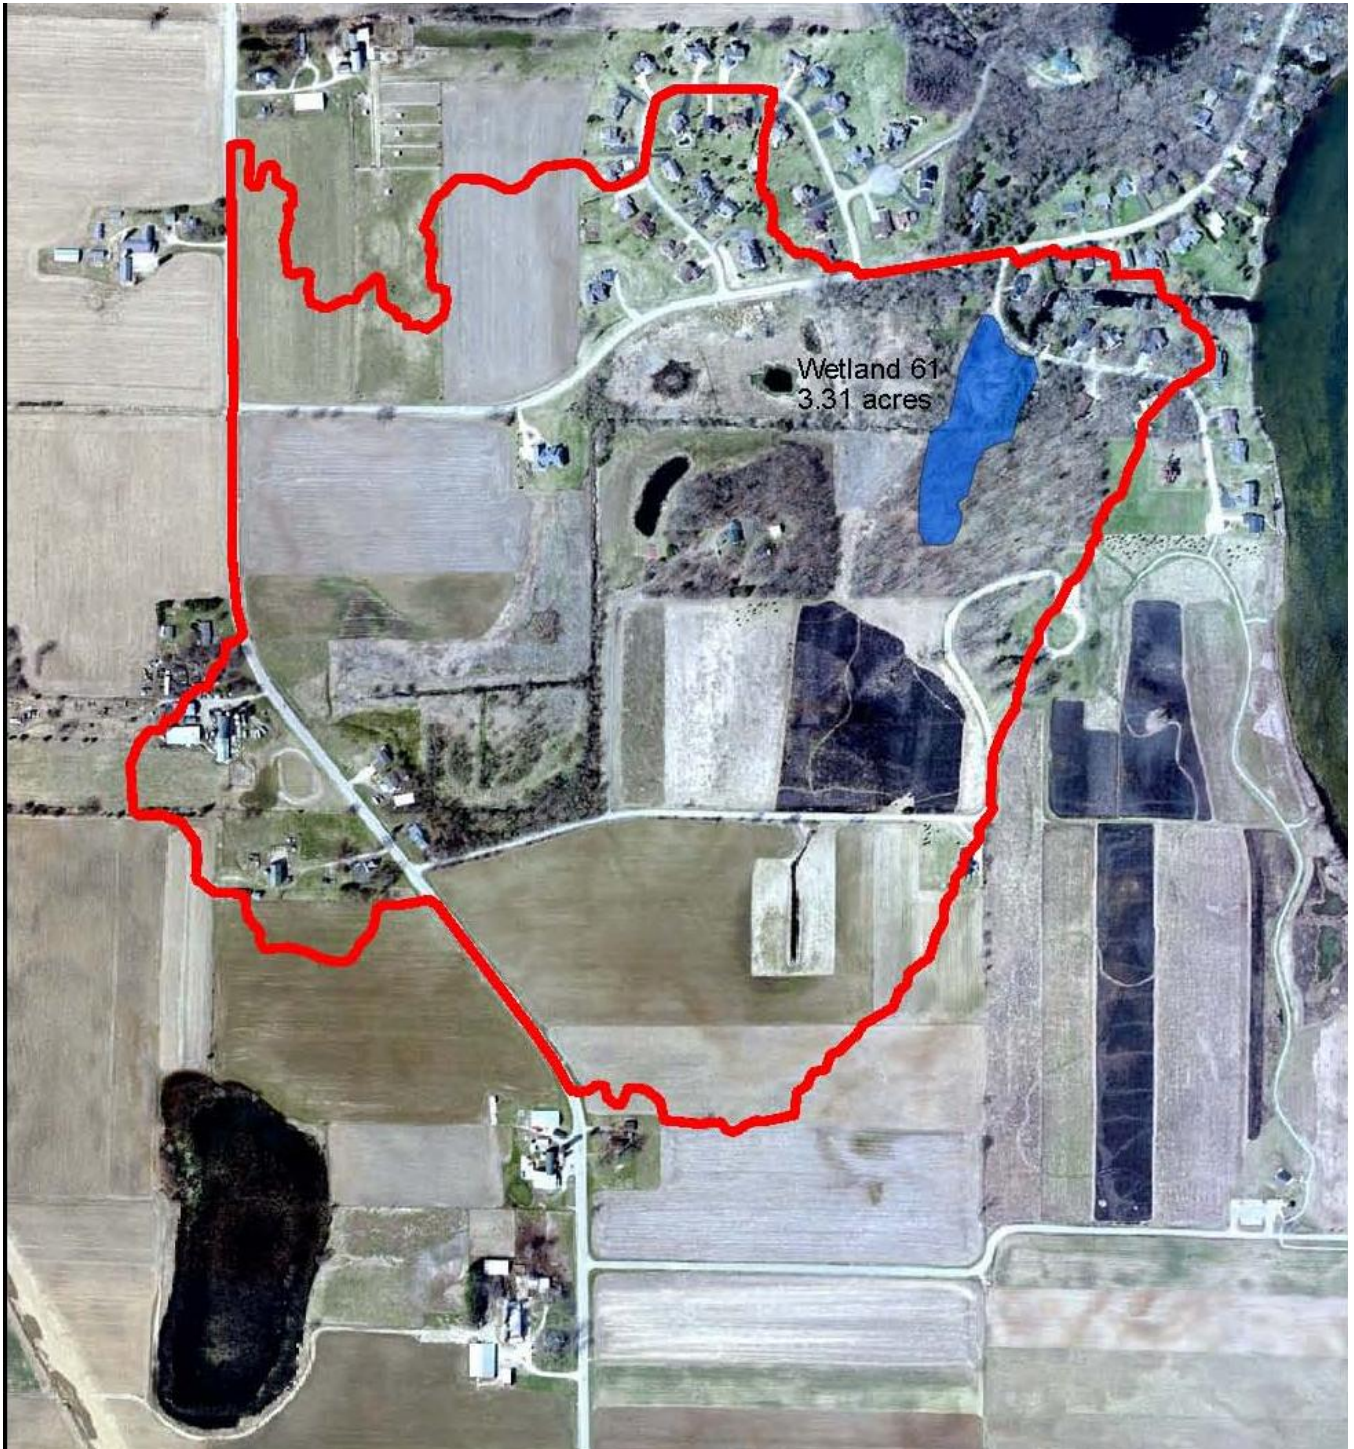
Figure 16
WDNR Mapped Wetlands Miljola Channel Tributary Watershed
(Includes only wetland 2-acres and larger in size)

Caution needs to be taken when identifying locations for management practices. If possible the practices should not be installed in natural wetland or in environment corridors as identified in Jefferson County Agricultural Preservation and Land Use Plan (1999) to protect native plants and wildlife. Figure 16 and 17 illustrate the locations of mapped wetlands and environmental corridors in the study watershed respectively.

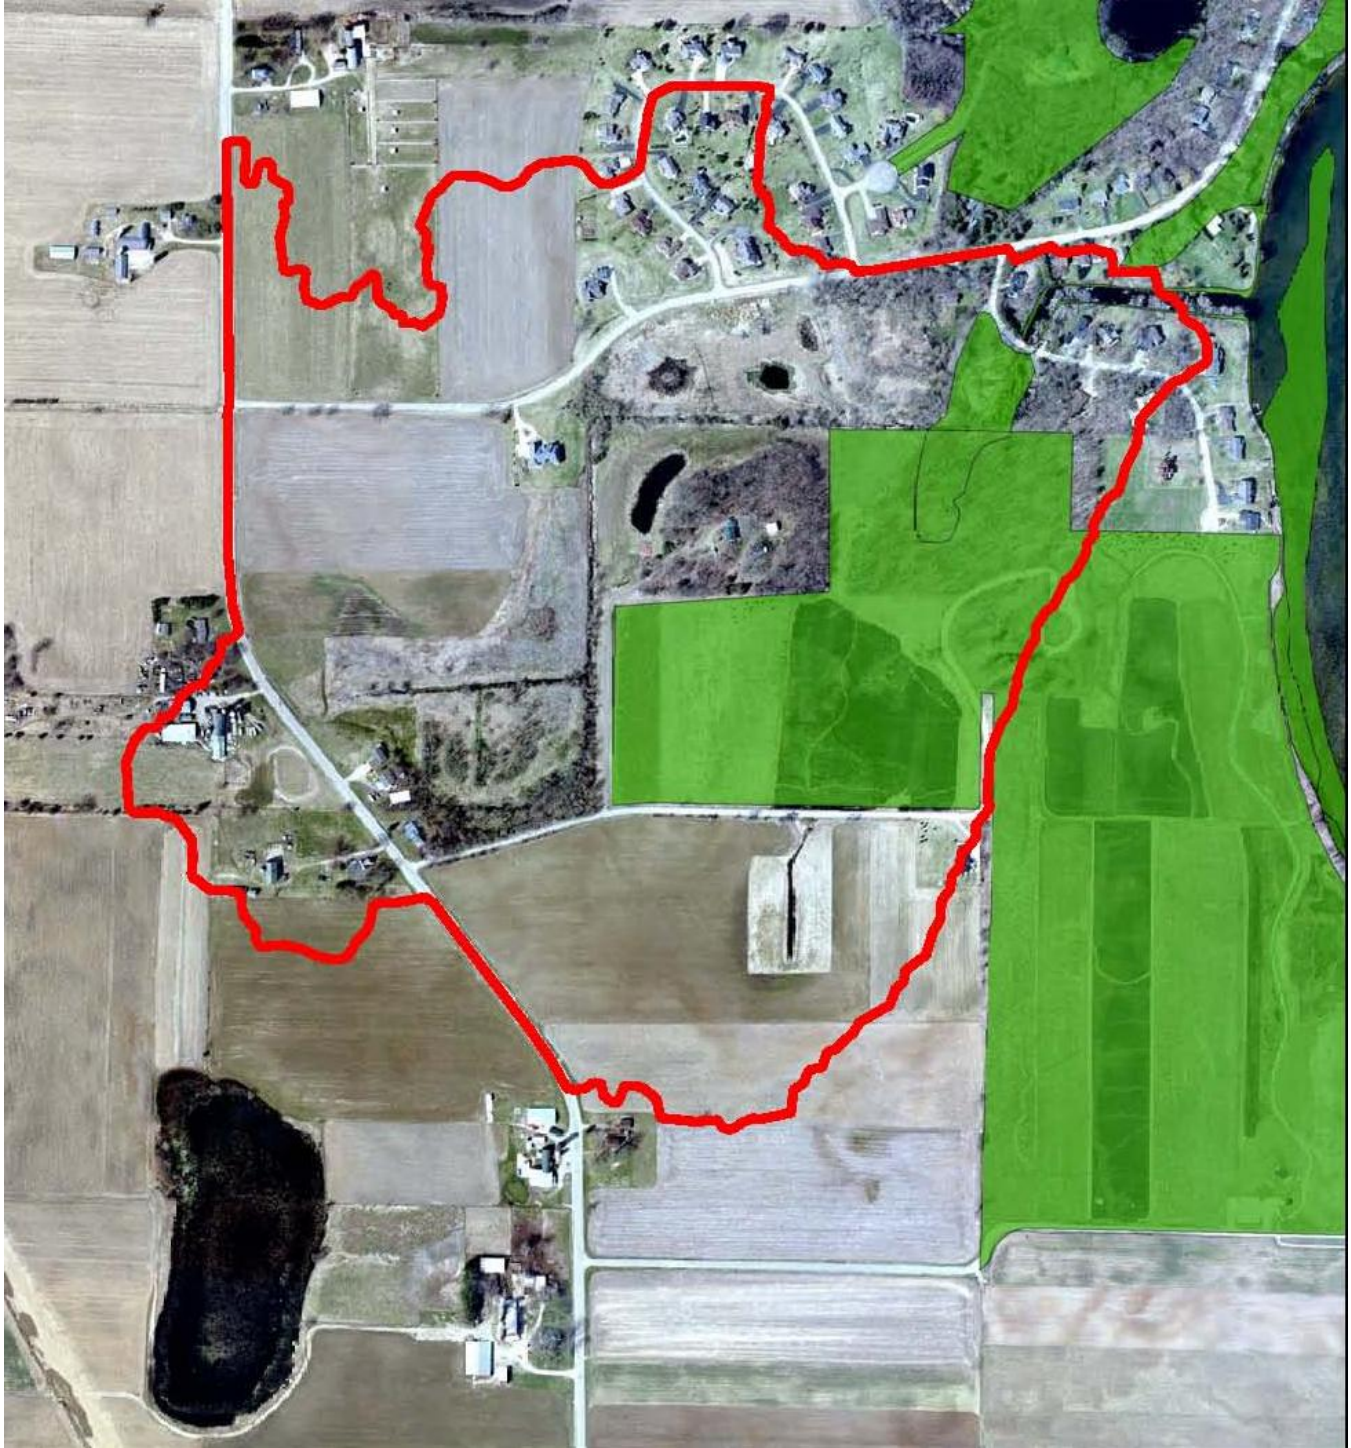
Figure 17
Primary Environmental Corridors Miljola Channel Tributary Watershed
(Source Jefferson County)
