**Curly-leaf Pondweed P/I, Bed Mapping, and  
Pre/Post Herbicide Surveys  
Balsam Lake WBIC: 2620600  
Polk County, Wisconsin**

Balsam Lake Protection and Rehabilitation District, Harmony Environmental, and  
the Wisconsin Department of Natural Resources

Endangered Resource Services, LLC  
Matthew S. Berg, Research Biologist  
St. Croix Falls, Wisconsin  
April 27, June 2-6, 9-10, 2009

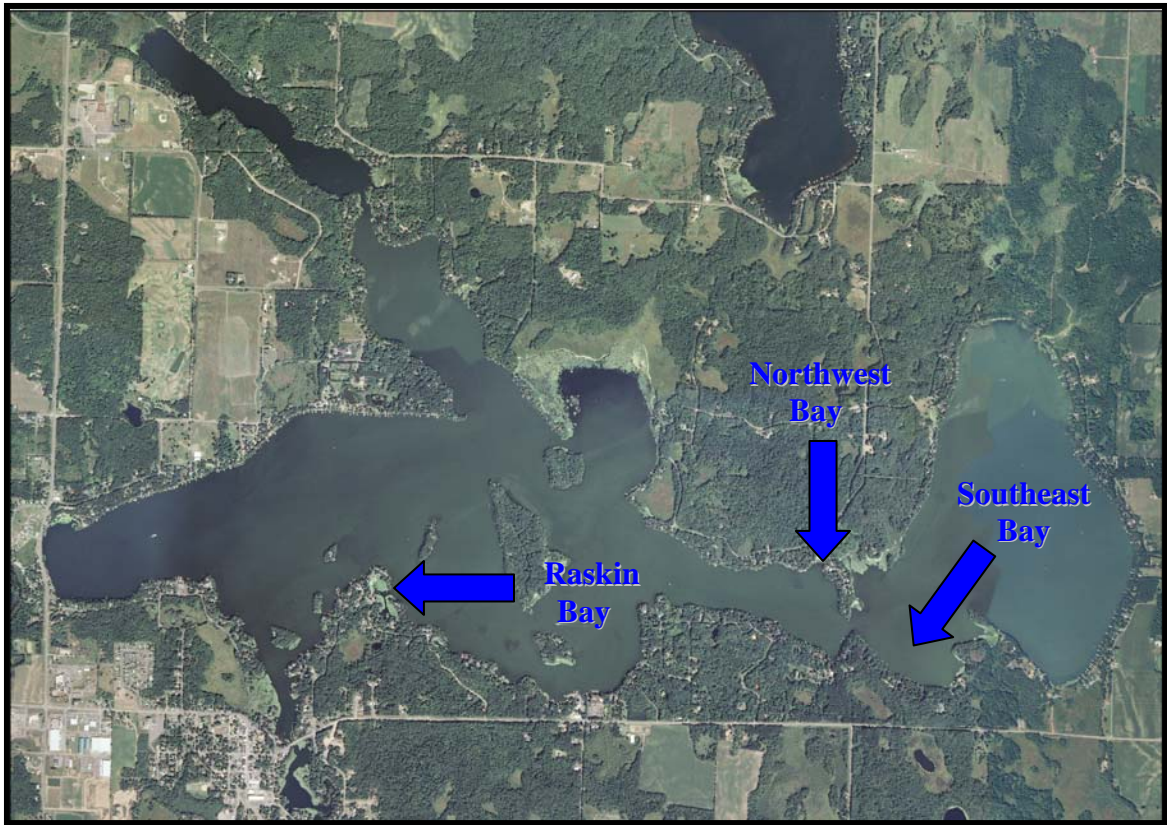
**Figure 3: Pre/Post Survey Areas**

Frank Koshere of the WDNR authorized three areas to be surveyed as potential CLP herbicide treatment areas (Figure 3). For each of these areas, we used Forestry Tools Extension to ArcMap 9.3 to generate pre/post survey points based on the size and shape of the bay: Raskin Bay's 5.5 acres produced a 29 point grid, the 1.0 acre bay northwest of the Big Narrows produced a nine point grid, and the 11.4 acre bay southeast of the Big Narrows produced a 113 point grid (Appendix II).

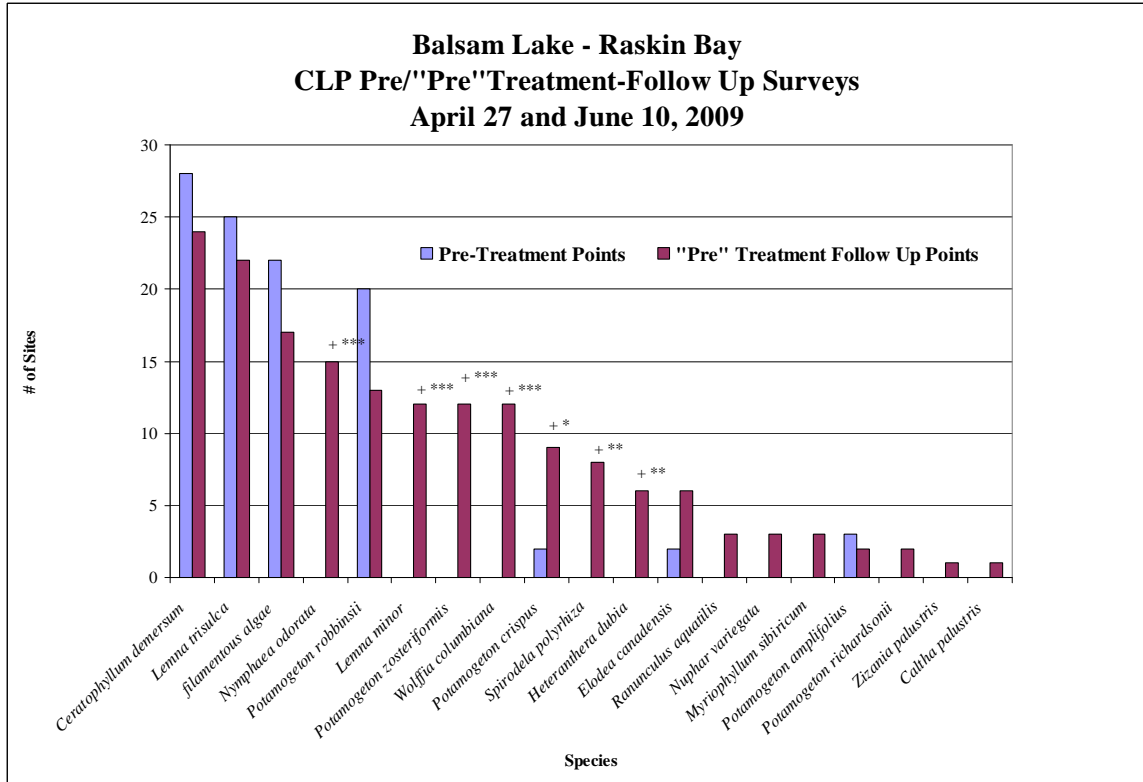
**Figure 13: Significant Macrophyte Changes in Raskin Bay**

From the pretreatment to the follow up survey, White water lily, Small duckweed (*Lemna minor*), Flat-stem pondweed (*Potamogeton zosteriformis*), Common watermeal (*Wolffia columbiana*), Curly-leaf pondweed, Large duckweed (*Spirodela polyrhiza*), and Water star-grass (*Heteranthera dubia*) all increased significantly. As the pretreatment survey was early in the growing season and all these species generally do not overwinter their leaves, this change is likely what would be expected over the course of any April-June period. The reduction (insignificant) of the four dominant species found in the pretreatment survey is likely the result of channels being cut by propellers and manual removal by lakeshore owners.
