Sand Lake and Little Sand Lake Project Summary

Aquatic Plant/Lake Management and Education Project

Barron County, Wisconsin

WDNR No. AEPP-203-10
SEH No. SLKMD 111066

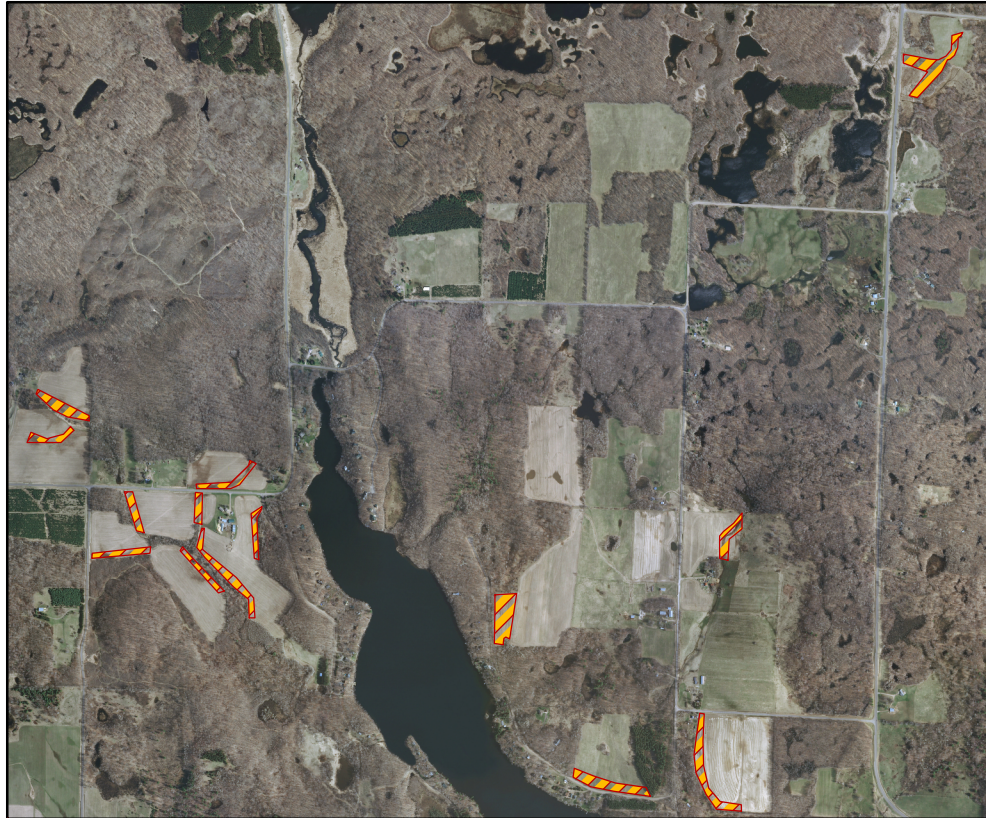
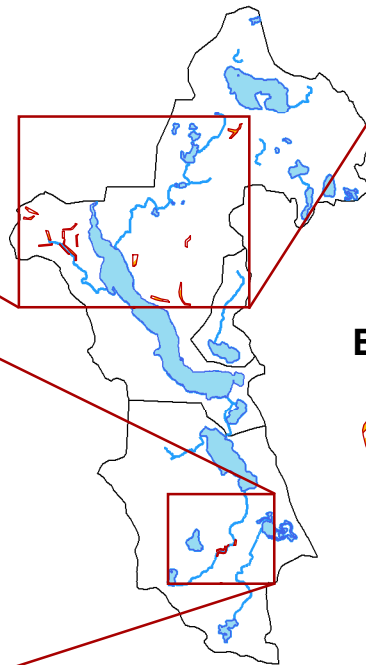
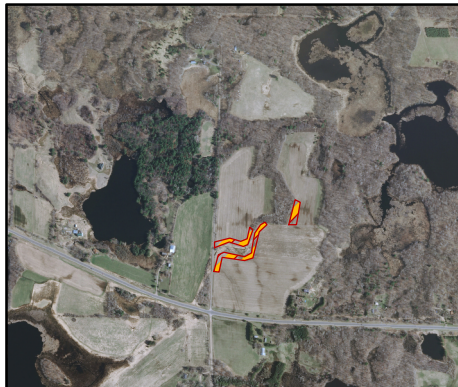
Figure
4

Potential Ag Best Management Practice (buffer, grassed waterway, etc.)

Potential Agricultural BMPs
Sand Lake
Barron County, Wisconsin

The SWCD also identified over 30 acres of agricultural land where buffers and (or) grassed waterways would be beneficial to water quality in the watershed (Figure 4). These areas are primarily located at the edge of field or act as waterways for spring runoff and during large rain events. Best management practices in these areas will not only slow runoff and increase infiltration, but will also utilize excess nutrients carried by the runoff.

5. Due to the proximity of agricultural land use to tributaries of Sand Lake (Figure 3), BMPs, such as grassed waterways and buffer strips, should be implemented. The SLMD should work with the Barron County SWCD to provide education and information to agricultural landowners in the watershed. Nutrient management planning should be pursued if not already in action. Some areas of special concern were identified during this project (Figure 4) and can be expanded upon during plan development.
