**Early Detection/Rapid Response to Control Eurasian Watermilfoil in
Blackhawk Lake, Iowa County, Wisconsin**

**Final Report
for Wisconsin Department of Natural Resources
AIS Early Detection/Rapid Response Grant AIRR-018-07**

Cobb-Highland Recreation Commission
Blackhawk Lake Recreation Area
and
Donna and Laura Sefton
DFS Conservation Consulting

April, 2013

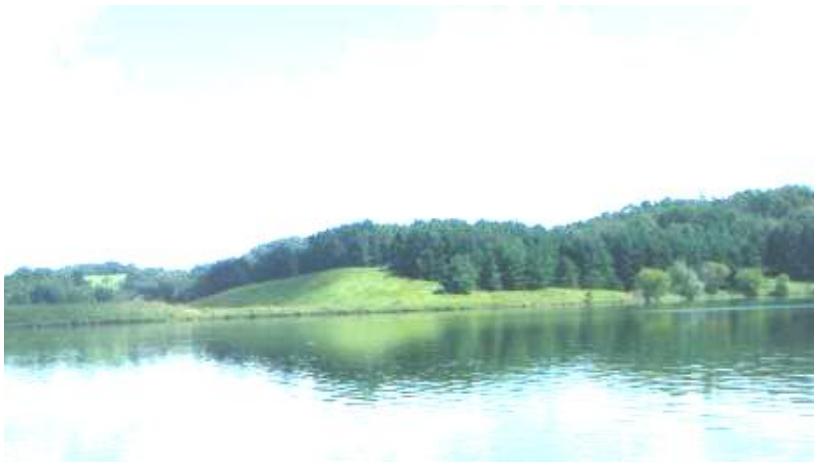
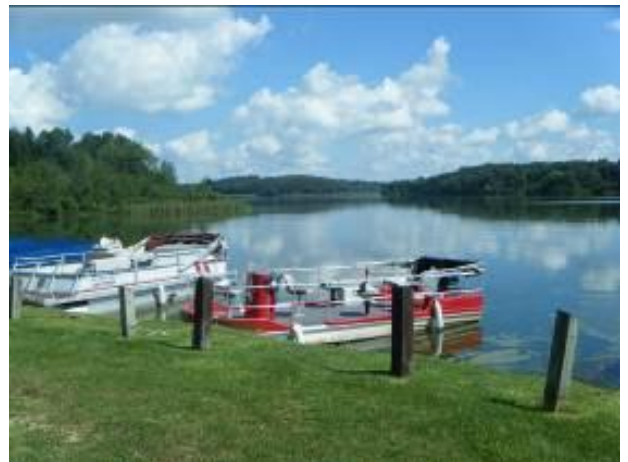
Fig. 4. Blackhawk L, areas of pioneer EWM infestation, 2006.

Eurasian watermilfoil was not found at any of the points sampled with a rake during the June, 2006 survey. However, two small (10' X 10' and 15' X 20') pioneer infestations of EWM were visually recorded in 10-15 feet of water between aquatic plant sampling sites near the NNW side of the lake just S of the left dam and sand ridge spawning area. A third colony was later found on the SSE side of the lake pontoon mooring bay. (See Fig. 4-7).

NNW side of lake, right side of photo (to right of left dam)

SSE side of lake, Pontoon Bay

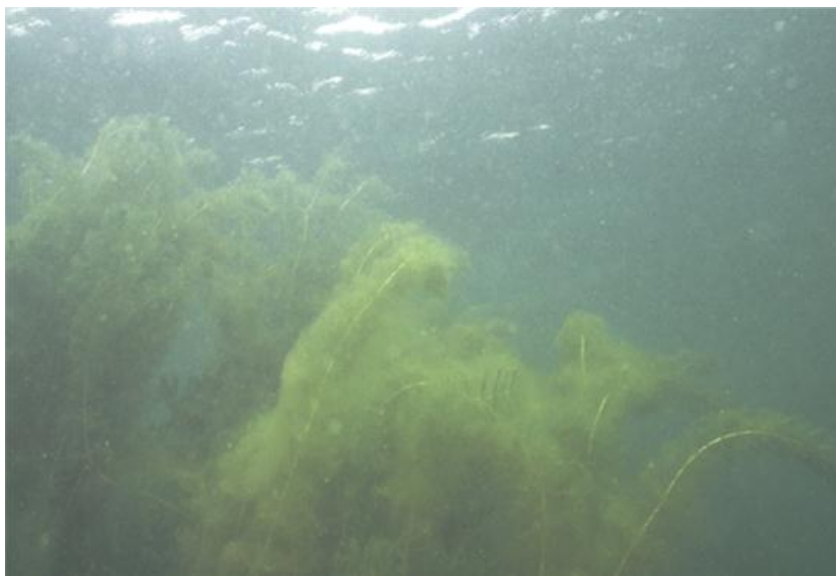
**Fig. 6. EWM colony in Blackhawk L, June 2006
(photo by UHI)**

On June 24, 2006, the two beds of EWM on the NNW side of the lake were uprooted and/or cut at the root crown below the sediment surface by a SCUBA diver from UHI. Abundant *Ceratophyllum demersum* (coontail) on the bottom made uprooting difficult. The uprooted plants were collected in nets by volunteers as they came to the surface. The wind was blowing toward the NNW shoreline, and fragments that drifted in were collected to the extent feasible.

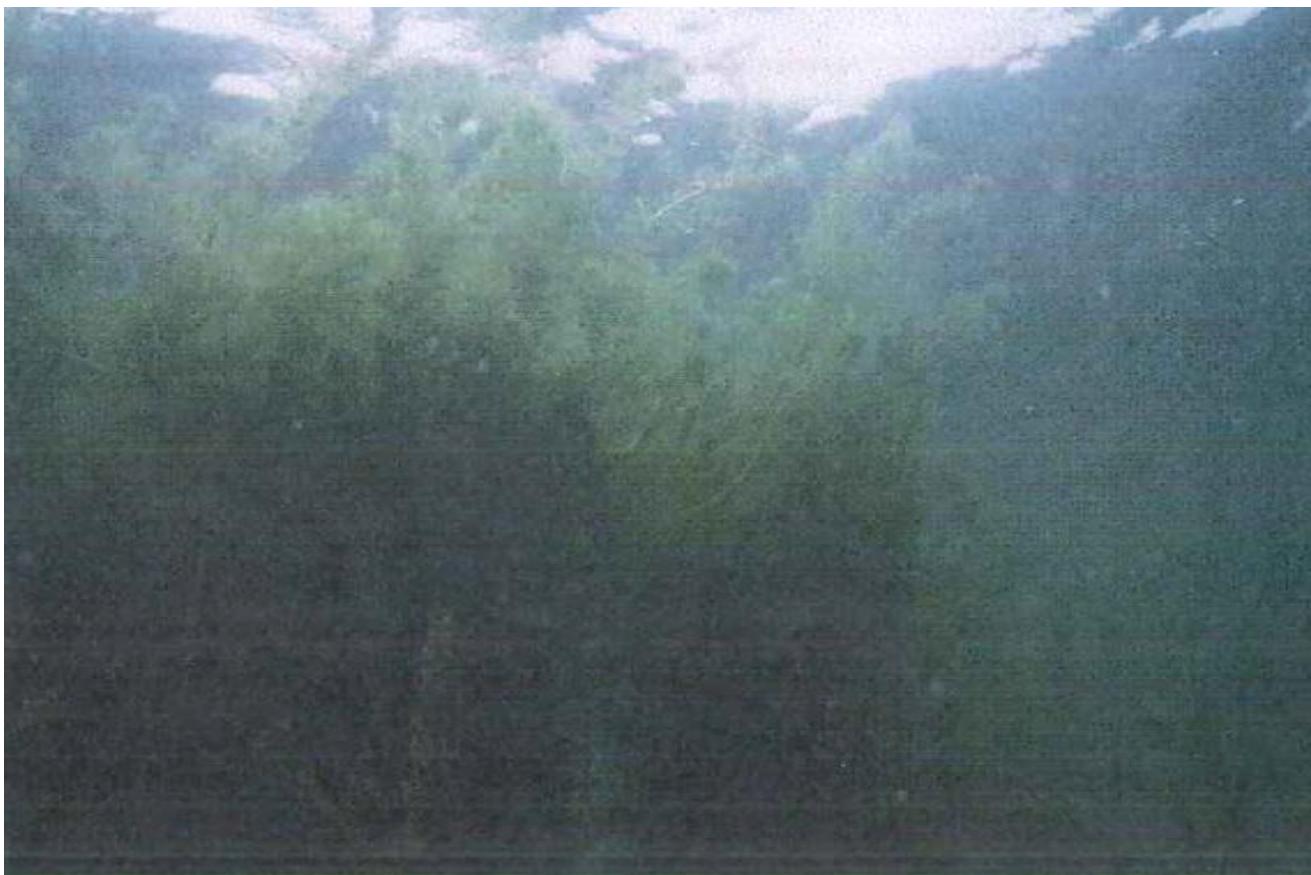
Fig. 7. EWM growing above native species, Blackhawk L, 2006 (photo by UHI)

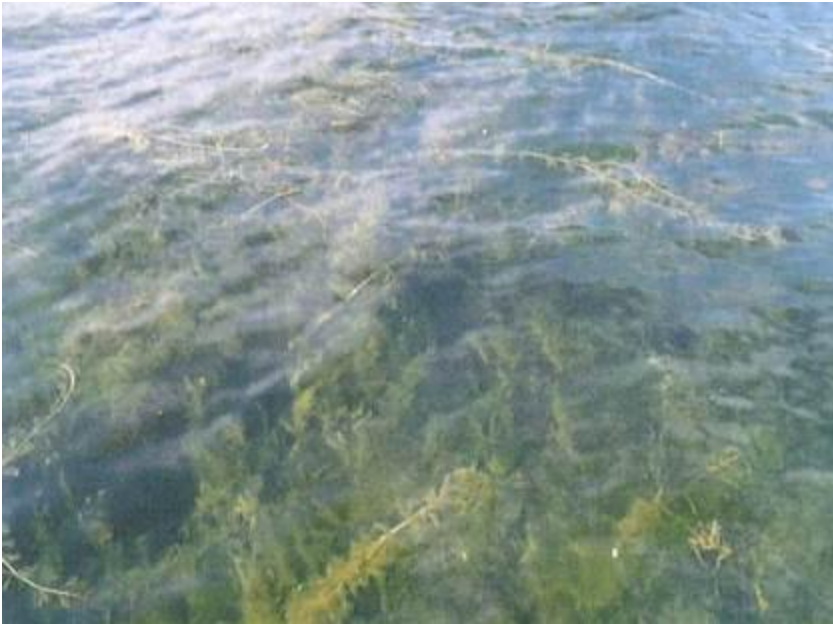
On April 20, 2007, UHI conducted an assessment of EWM along the shorelines with previously identified EWM beds. At the time, EWM growth was advanced compared to most other species in the clear water, including the dominant plant coontail (Fig. 8). Locations were mapped using a Garmin 76 GPS unit. Water temperature was 53 degrees F and the Secchi clarity was 16 feet. Based on the survey results, an early season 2,4-D application was recommended and a chemical Aquatic Plant Management permit received from WDNR.

Fig. 8. EWM, Blackhawk Lake, 2007 (photo by UHI)

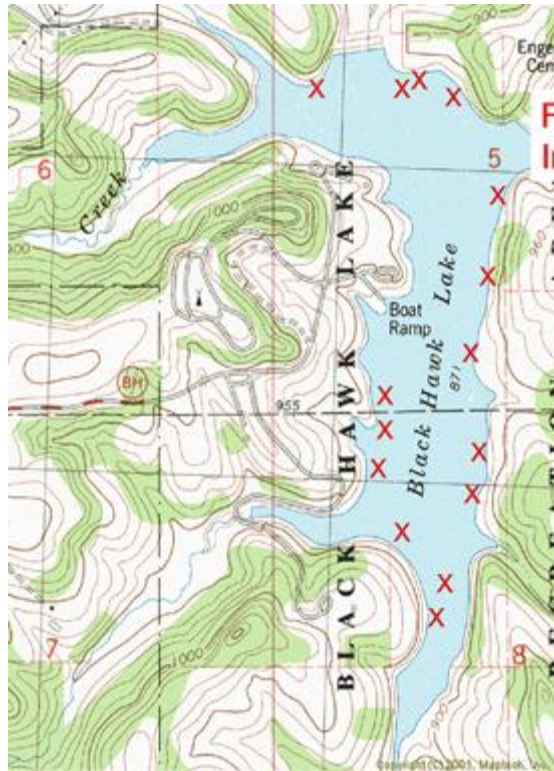
Fig. 10. Blackhawk L EWM distribution post-treatment, June 2007. Red X's where EWM found.

UHI conducted a post-treatment EWM survey around the entire lake (Fig. 10). Water clarity was optimum with the Secchi exceeding 20 feet. Polarized glasses were used to reduce glare. The survey showed significant reduction of colonies within the two areas of highest EWM densities, the pontoon mooring area and near the left “dry” dam. However, additional colonies were observed north of the pontoon mooring area, near the mouth of Otter Creek bag, and along the entire east shore. Colonies were not observed with the bays, perhaps due to dense growths of both macrophytes and filamentous algae.

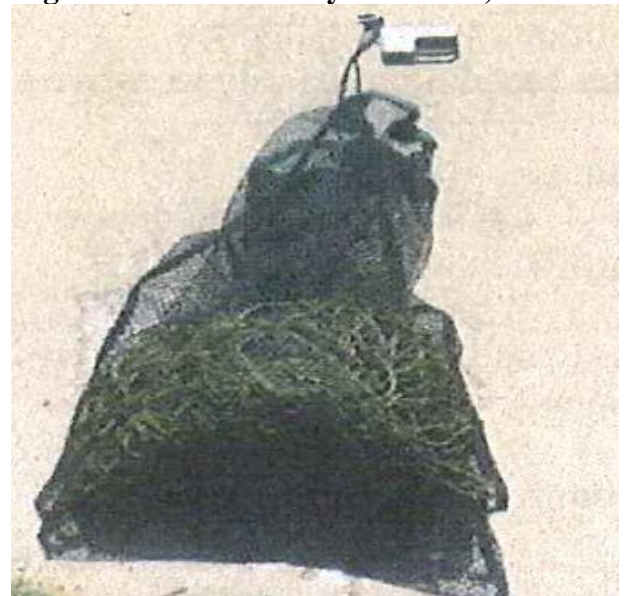
Fig. 11. EWM manually harvested, 2007.

UHI conducted an experimental manual harvest of EWM along the east shoreline from the pontoon mooring area north for 270 feet. UHI harvested all observed EWM colonies using a long pole rake. Non-target species were returned and any floating EWM fragments were collected with a dip net. A large mesh bag and spring scale was used to weight the wet biomass of plants collected from that area. Excess water was removed by swinging the mesh bag vigorously in the air. 7-1/2 lbs (wet weight) of EWM was collected (Fig. 11).

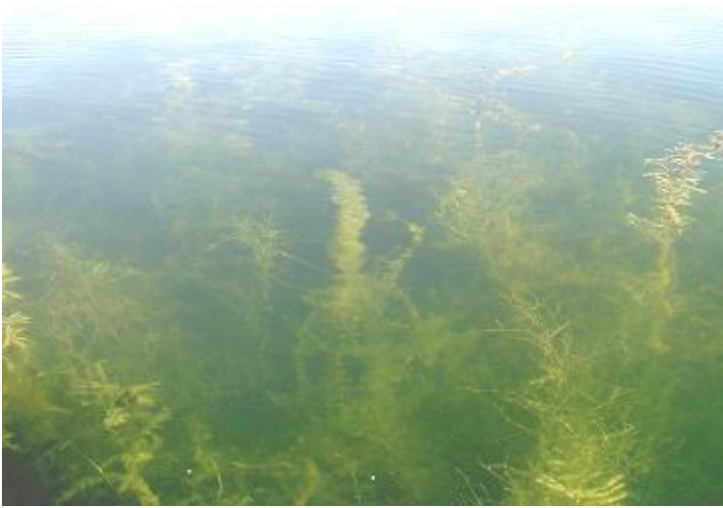
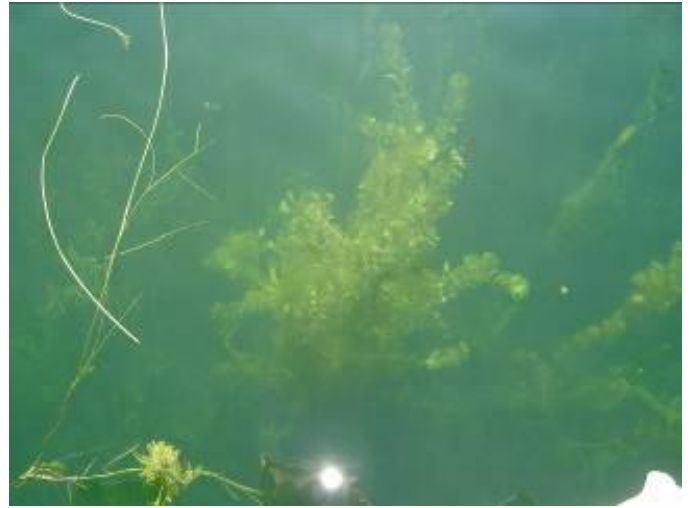
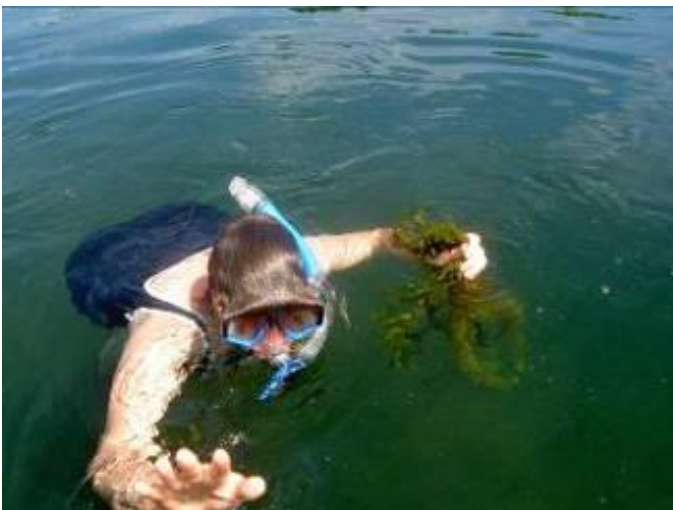
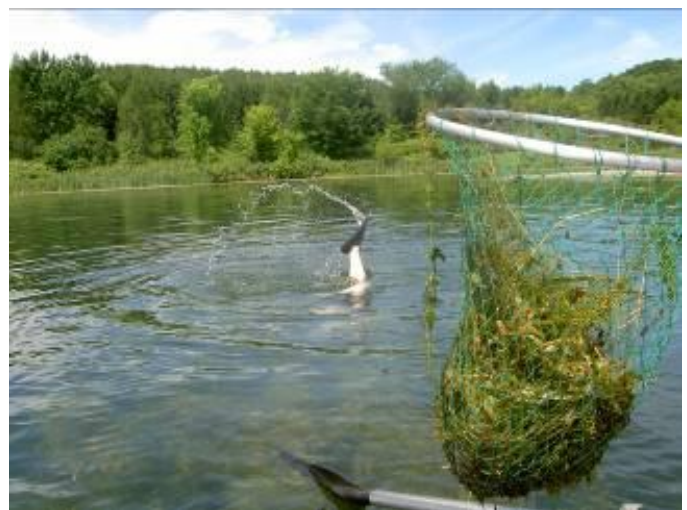
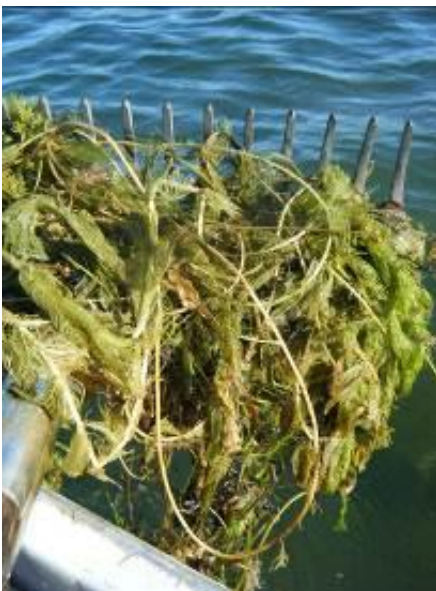
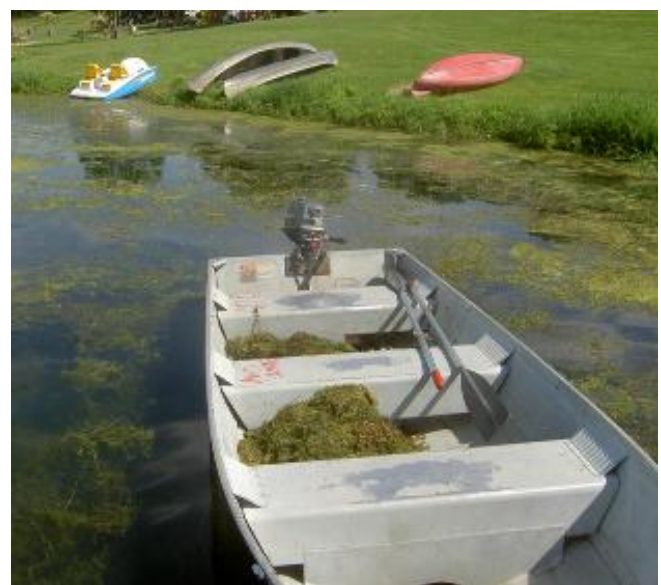
Fig. 13. Photos of EWM and manual control efforts in Blackhawk L, June 26, 2009.

EWM interspersed with other plants, Pontoon Bay

Colony of EWM littoral area just south of left dam.

Snorkeling to remove colonies of EWM

Collecting EWM with net, Blackhawk

EWM on rake

Harvested EWM

On June 26, 2009, Susan Graham of WDNR snorkeled and hand pulled EWM, while DFS CC and staff from Blackhawk Lake collected the plants in nets and placed them in the boat for disposal on shore (see photos Fig. 13). This was done in Pontoon Bay and near the left (dry) dam, just south of the sand ridge (Fig. 12). The Secchi clarity was excellent for the task (17 feet). In Pontoon Bay, the EWM was scattered among other plants (mostly coontail, sago pondweed, and elodea), so complete removal of the EWM was not possible. There were distinct patches of EWM near the left dam (just south of the sand ridge) that were manually removed. This effort was much more successful in removing all the EWM. There was thick growth of curly leaf pondweed, coontail, sago pondweed, elodea, water buttercup, and other plants on the sand ridge, but no EWM was found there.

The plants collected weighed approximately 45 lbs wet weight. They were disposed in the garbage.

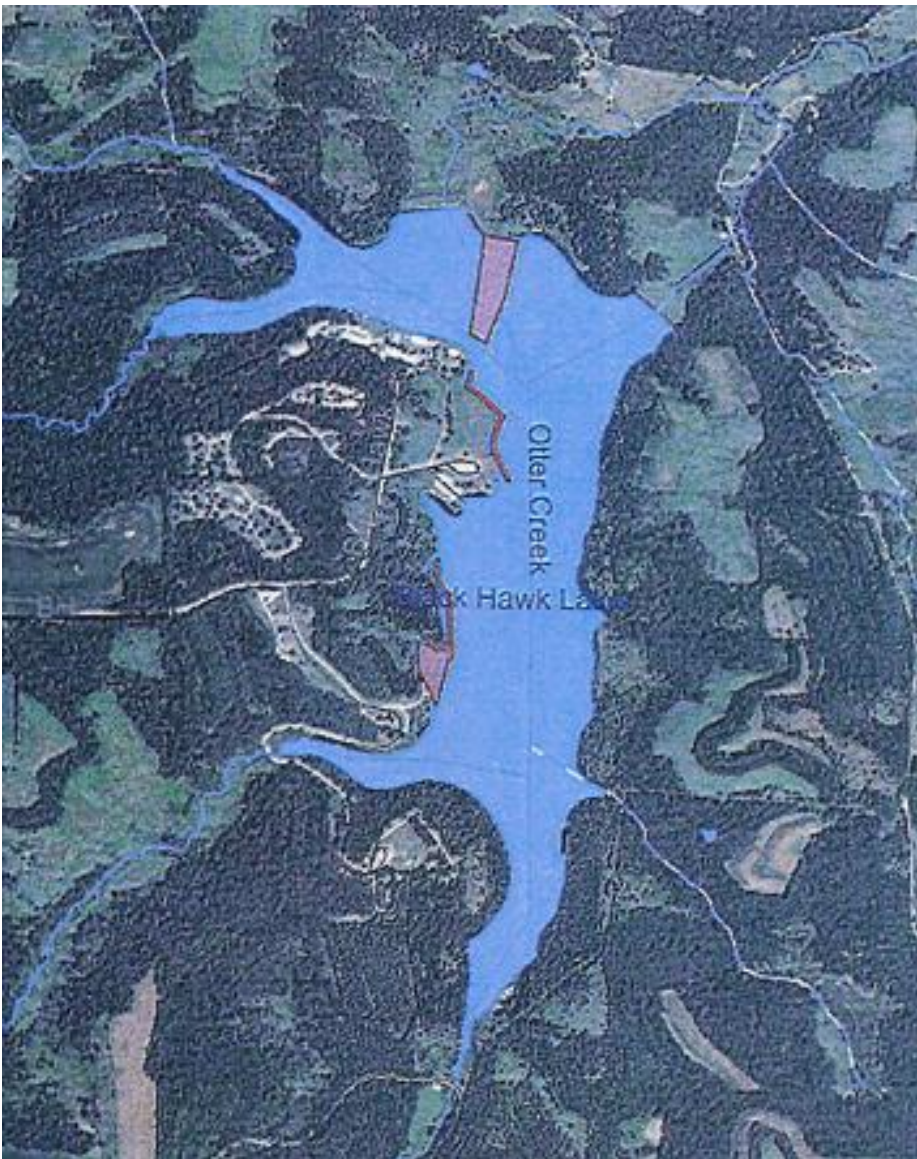
Visual and rake surveys by DFS CC on May 28 and June 9, 2010 found large amounts of EWM (approximately 5 acres) in the sand ridge spawning area just south of the left dam and extending toward the beach and concession area on the northeast shore (Fig. 14). The excellent water clarity (24 feet) made it easy to survey (see photos, Fig. 15). Patches were also found in Pontoon Bay.

Fig. 14. Distribution of EWM in Blackhawk L, June 9, 2010

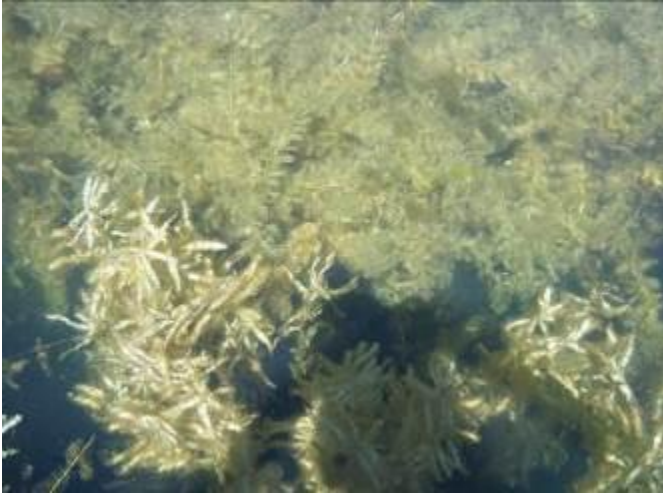
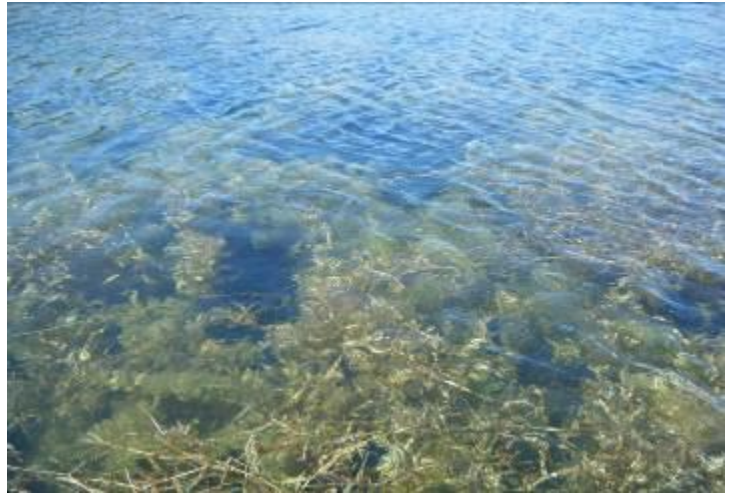
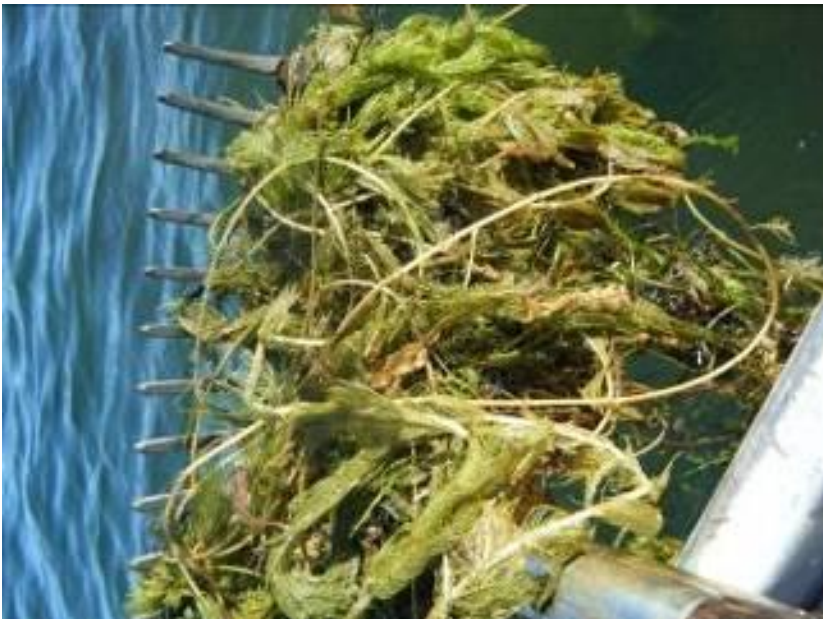
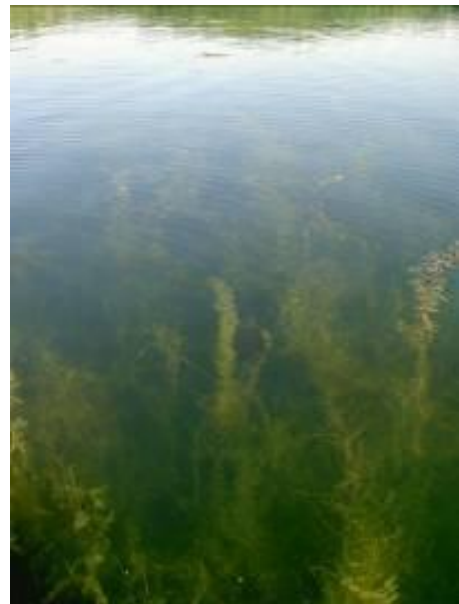
Fig. 15. Photos of EWM, Blackhawk L, May 28 & June 9, 2010.

EWM and curly-leaf pondweed on sand ridge

EWM on rake.

Scattered colonies of EWM, Pontoon Bay

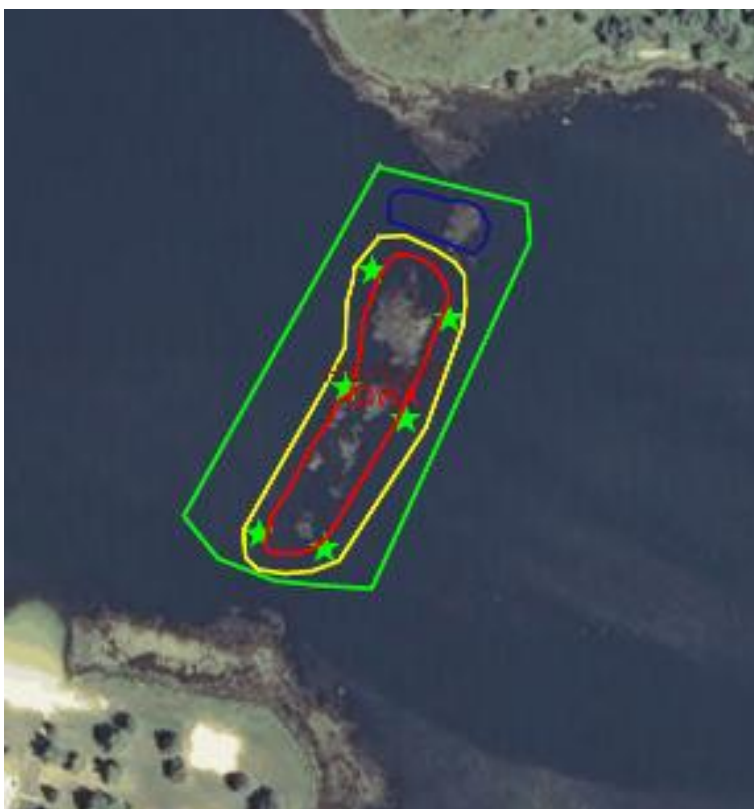
**Fig. 16. Areas treated with 2,4-D, Blackhawk L
June 14 and 16, 2010**

The Blackhawk Lake Recreation Area obtained an Aquatic Plant Management (APM) permit to apply 2,4-D (Navigate) granular to treat the EWM. On June 14, 2010, licensed applicator Bradd Sims, with the help of WDNR staff and DFS CC treated the sand ridge area with granular Navigate, concentrating on areas where colonies were evident within the green lines. This treatment was at a rate of approximately 50-55 lbs/acre. (See green line in Fig. 16).

On June 16, 2010, buoys were placed along the core area. Buoy GPS readings are represented by the green stars. The area inside the red treatment line is just under 1.25 acres. It was treated with 3.5 bags (175 lbs) of granular 2,4-D. The fringe area (that area between the red and yellow lines) was treated with 3 bags. This put both of these areas in the 195 lb/acre range when combined with the June 14 treatment (Table 3). The remaining ½ bag was used for spot treatment just north of the core area. This is outlined by the dark blue line in Fig. 16. The plants treated on June 14 were already showing signs of turning brown and weakening.

EWM treatment 2010	Application rate lbs/acre 2,4-D		
	6/14/2010	6/16/2010	Total
Treatment area			
Between green & yellow lines (2.25 acres)	55	0	55
Between yellow & red lines (1.25 acres)	55	120	175
Within red line (1.25 acres)	55	140	195
Within blue line (0.25 acre)	55	88	144

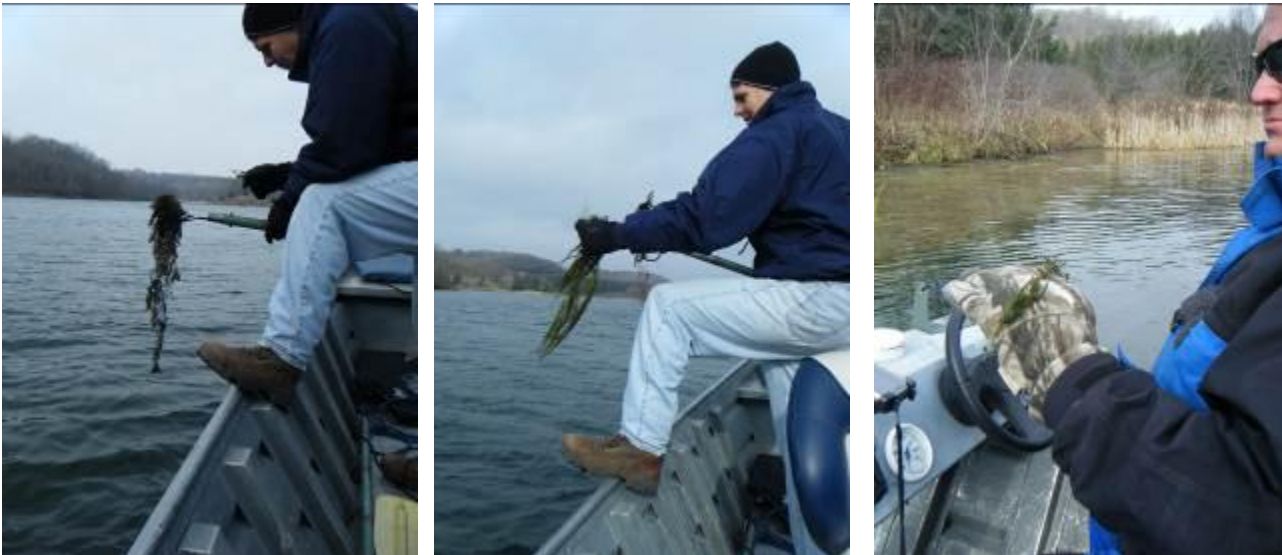
Fig. 17. Visual and rake survey of plants in Blackhawk L, Nov. 19, 2010.

On November 19, 2010, John Skogerboe of the U.S. Army Corps of Engineers, Bill Ratajczyk of Applied Biochemists, and DFS CC conducted a visual and rake survey of Blackhawk Lake (Fig. 17). Applied Biochemists was interested in doing some research with early spring treatments using their new triclopyr product, Navitrol. No EWM was found, but water stargrass and water buttercup were present in the shallower areas, along with abundant coontail, sago pondweed, and some curly-leaf pondweed. Applied Biochemists was interested in doing some research with early spring treatments using their new triclopyr product, Navitrol.

Coontail on rake

Sago pondweed on rake

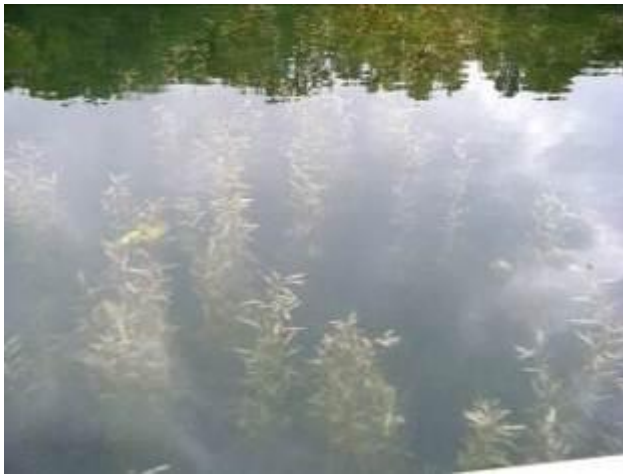
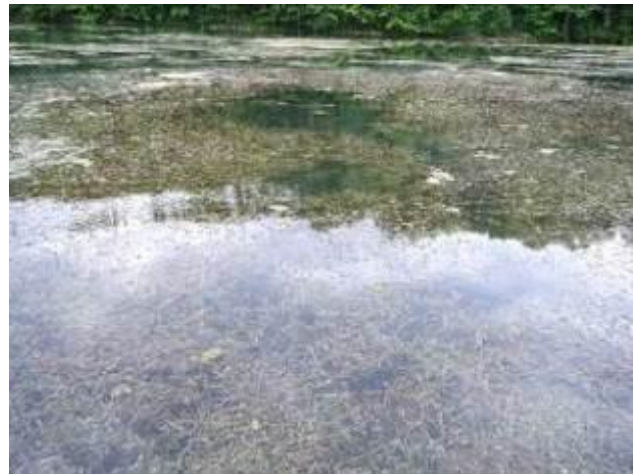
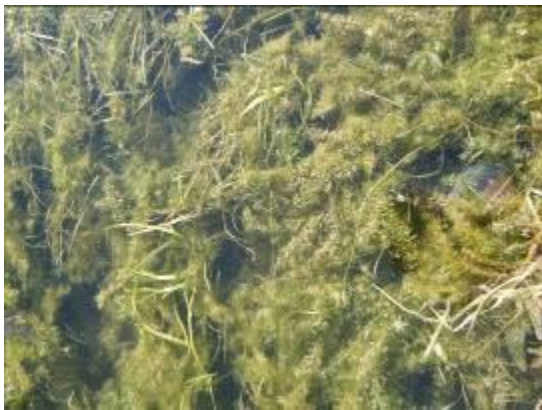
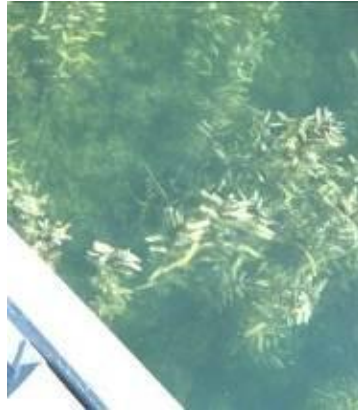
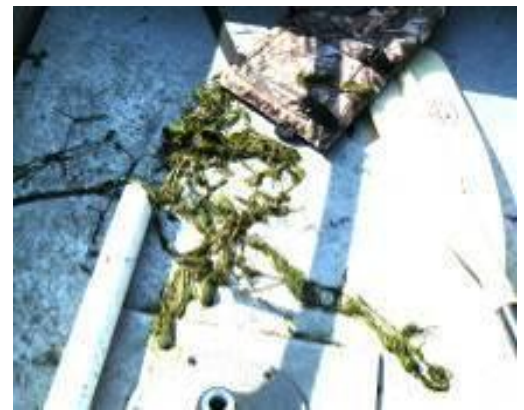
Fig. 18. Blackhawk L Aquatic Plant Survey, June 4, 2011

John Skogerboe of the U.S. Army Corps of Engineers and DFS CC conducted a point-intercept aquatic plant survey of Blackhawk Lake on June 4, 2011 (see photos, Fig. 18). The visibility was excellent, with a Secchi disk transparency of 20 – 25 feet and calm conditions. No EWM was found in the sand ridge area where it was abundant in 2010, nor in Pontoon Bay where it was common in 2009 and 2010f. There was a small patch of EWM on the edge of the southern (Otter Creek inlet) bay. This was harvested using a rake.

Curly-leaf pondweed in 8-10' water on sand ridge

Curly-leaf pondweed, coontail in NE (Narveson) Bay

Elodea, water stargrass, narrow-leaf in Pontoon Bay

Curly-leaf & water buttercup in Pontoon Bay

EWM colony found S (Otter Cr) bay
