Lake Metonga

Aquatic Plant Management Plan

December 2007

Lake Metonga
Forest County, Wisconsin
Aquatic Plant Management Plan
December 2007

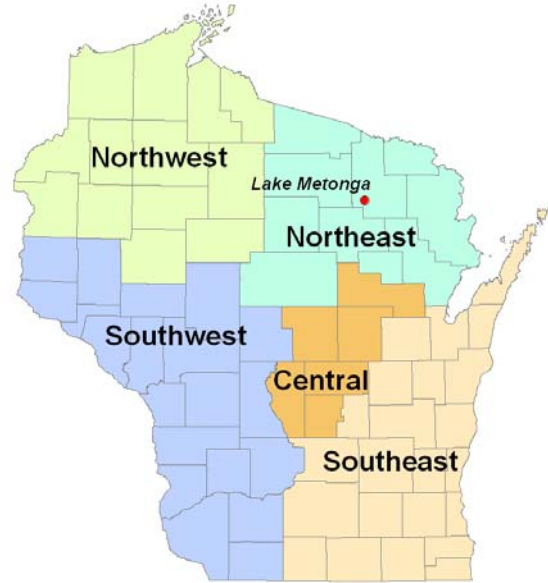
Figure 1. Location of Lake Metonga within the regions utilized by Lillie and Mason (1983).

Lillie and Mason (1983) is an excellent source for comparing lakes within specific regions of Wisconsin. They divided the state's lakes into five regions each having lakes of similar nature or apparent characteristics. Forest County lakes are included within the study's Northeast Region (Figure 1) and are among 242 lakes randomly picked from the region that were analyzed for water clarity (Secchi disk), chlorophyll-*a*, and total phosphorus. These data along with data corresponding to statewide natural lake means, historic, current, and average data from Lake Metonga are displayed in Figures 2-4. Please note that the data in these graphs represent concentrations and depths taken only during the growing season (April-October) or summer months (June-August). Furthermore, the phosphorus and chlorophyll-*a* data represent only surface samples. Surface samples are used because they represent the depths at which algae grow and depths at which phosphorus levels are not greatly influenced by phosphorus being released from bottom sediments.

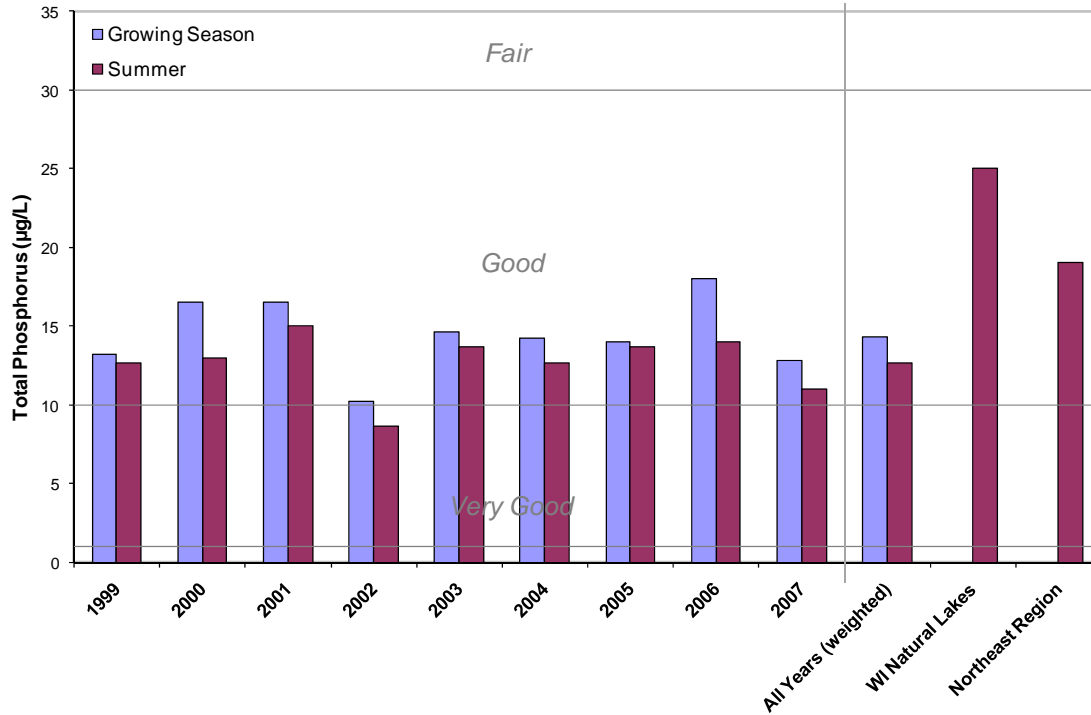
Figure 2. Lake Metonga total phosphorus concentrations. Mean values calculated with summer and growing season surface sample data. Water Quality Index values adapted from Lillie and Mason (1983).

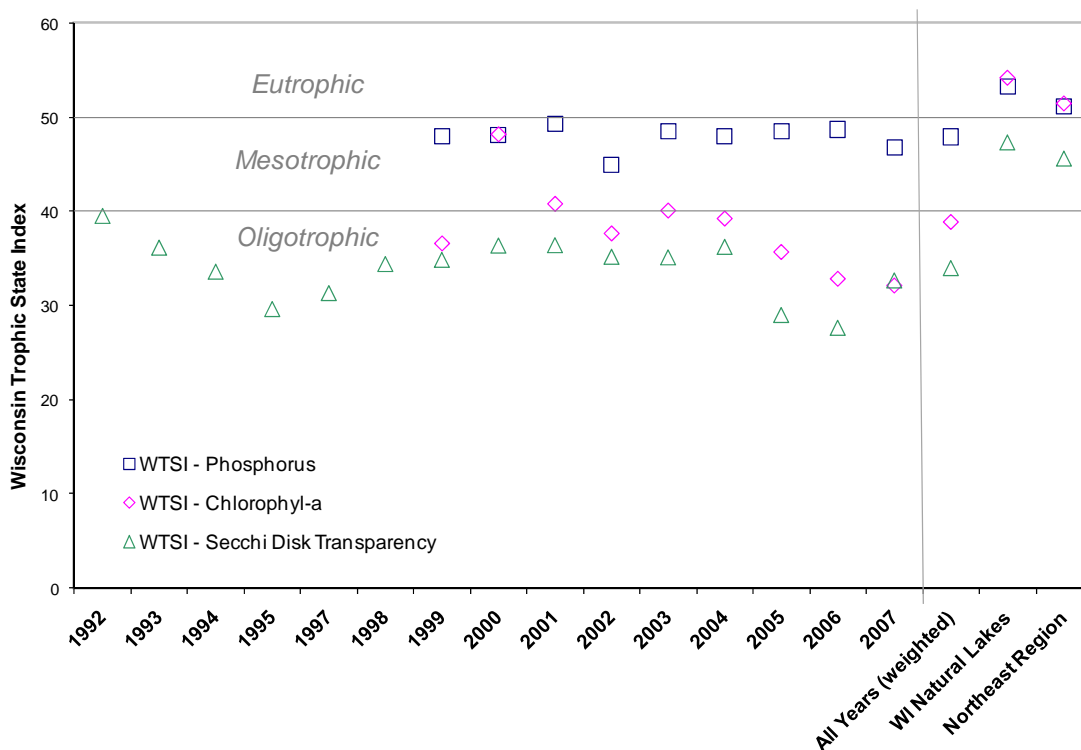
Figure 5. Lake Metonga Wisconsin Trophic State Index values. Values calculated with summer month surface sample data using Lillie et al. (1993).

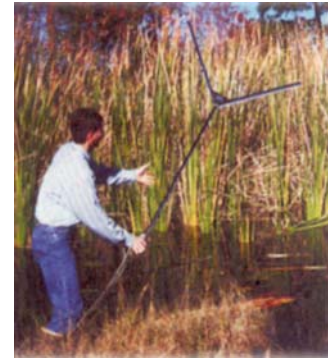
Manual removal methods include hand-pulling, raking, and hand-cutting. Hand-pulling involves the manual removal of whole plants, including roots, from the area of concern and disposing them out of the waterbody. Raking entails the removal of partial and whole plants from the lake by dragging a rake with a rope tied to it through plant beds. Specially designed rakes are available from commercial sources or an asphalt rake can be used. Hand-cutting differs from the other two manual methods because the entire plant is not removed, rather the plants are cut similar to mowing a lawn; however Wisconsin law states that all plant fragments must be removed. One manual cutting technique involves throwing a specialized “V” shaped cutter into the plant bed and retrieving it with a rope. The raking method entails the use of a two-sided straight blade on a telescoping pole that is swiped back and forth at the base of the undesired plants.

In addition to the hand-cutting methods described above, powered cutters are now available for mounting on boats. Some are mounted in a similar fashion to electric trolling motors and offer a 4-foot cutting width, while larger models require complicated mounting procedures, but offer an 8-foot cutting width.

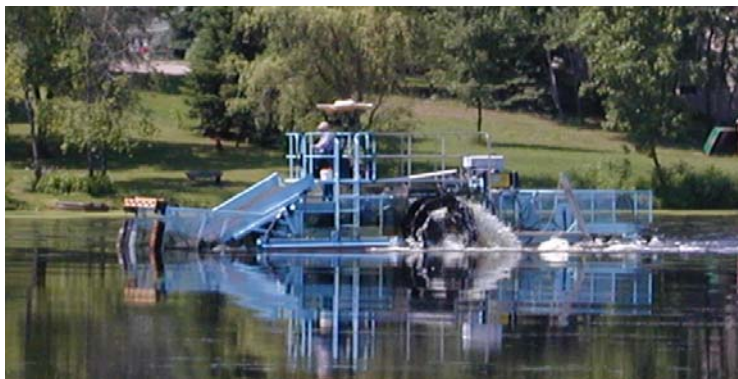
Aquatic plant harvesting is frequently used in Wisconsin and involves the cutting and removal of plants much like mowing and bagging a lawn. Harvesters are produced in many sizes that can cut to depths ranging from 3 to 6 feet with cutting widths of 4 to 10 feet. Plant harvesting speeds vary with the size of the harvester, density and types of plants, and the distance to the off-loading area. Equipment requirements do not end with the harvester. In addition to the harvester, a shore-conveyor would be required to transfer plant material from the harvester to a dump truck for transport to a landfill or compost site. Furthermore, if off-loading sites are limited and/or the lake is large, a transport barge may be needed to move the harvested plants from the harvester to the shore in order to cut back on the time that the harvester spends traveling to the shore conveyor.

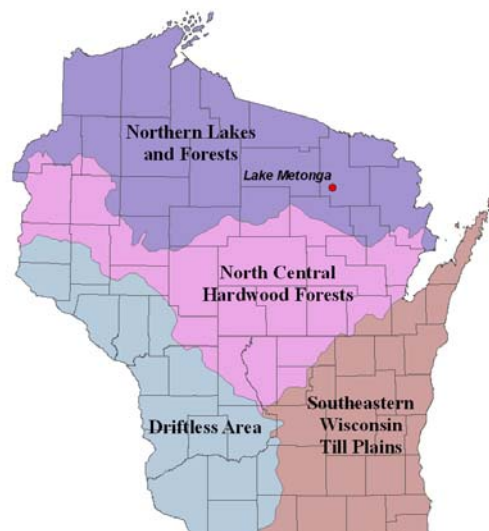
Figure 9. Location of Lake Metonga within the ecoregions of Wisconsin. After Nichols 1999.

Floristic Quality Assessment (FQA) is used to evaluate the closeness of a lake's aquatic plant community to that of an undisturbed, or pristine, lake. The higher the floristic quality, the closer a lake is to an undisturbed system. FQA is an excellent tool for comparing individual lakes and the same lake over time. In this section, the floristic quality of Lake Metonga is compared to lakes in the same ecoregion and in the state (Figure 9).

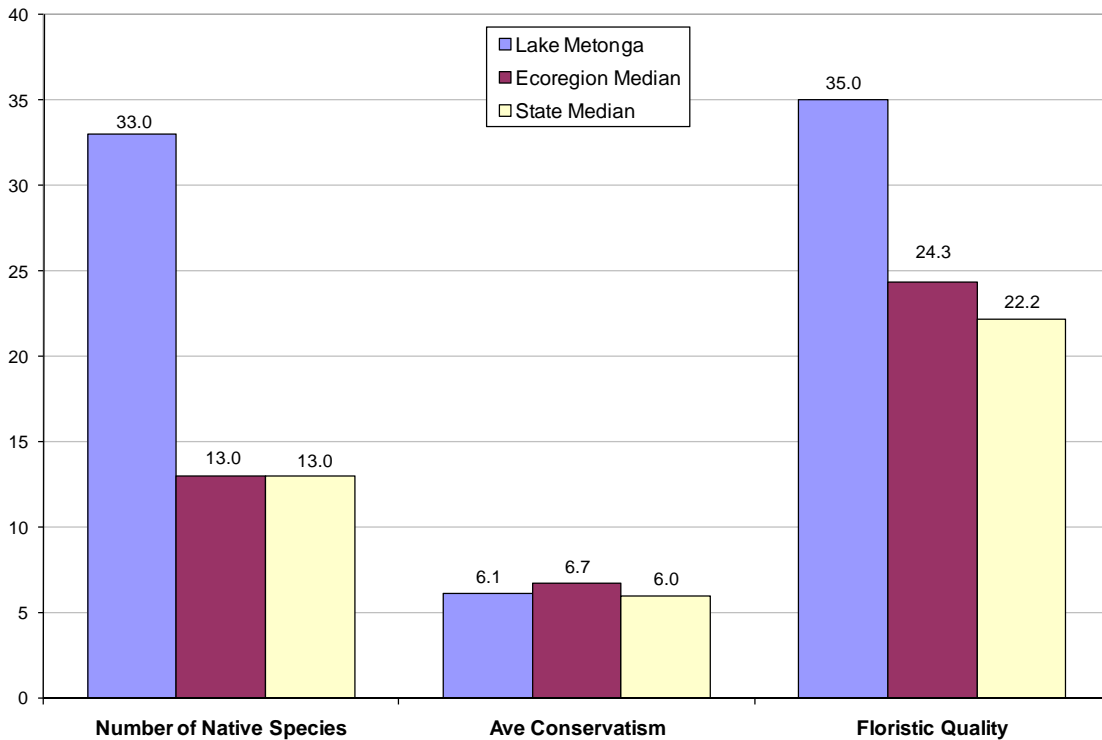
Figure 11. Lake Metonga Floristic Quality Assessment of 2005 survey data. Analysis following Nichols 1999.

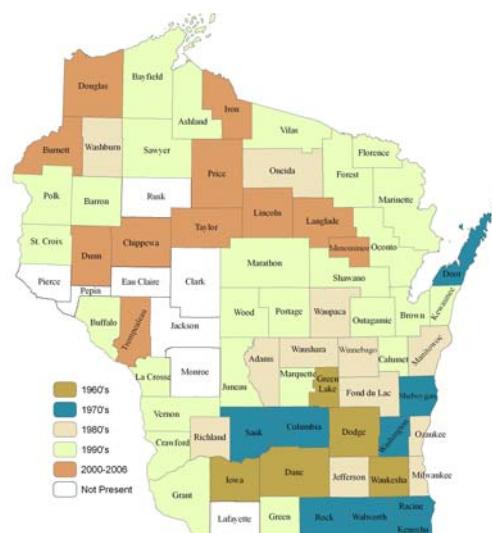
Figure 12. Spread of Eurasian water milfoil within WI counties. WDNR Data 2006 mapped by Onterra.

Eurasian water-milfoil is an invasive species, native to Europe, Asia and North Africa, that has spread to most Wisconsin counties (Figure 12). Eurasian water-milfoil is unique in that its primary mode of propagation is not by seed. It actually spreads mostly by shoot fragmentation, which has supported its transport between lakes via boats and other equipment. In addition to its propagation method, Eurasian water-milfoil has two other competitive advantages over native aquatic plants; 1) it starts growing very early in the spring when water temperatures are too cold for most native plants to grow, and 2) once its stems reach the water surface, it does not stop growing like most native plants, instead it continues to grow along the surface creating a canopy that blocks light from reaching native
