Herbicide Treatment Analysis- *Potamogeton crispus*

Spooner Lake
Washburn County WI
2013

Prepared by: Ecological Integrity Service, LLC
Amery, WI

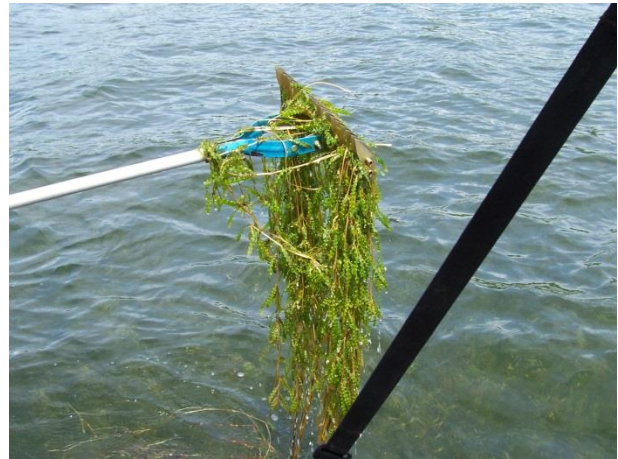
Figure 2: Density rating system and example CLP rake sample.

The second survey is referred to as the post treatment survey. This survey involves going to the same GPS coordinates as the pre-treatment survey and doing a rake sample at the point. If any CLP is on the rake, the density of the CLP is recorded (see Figure 2 for reference). All other species are also recorded from the rake sample in order to verify no damage to the native plants.

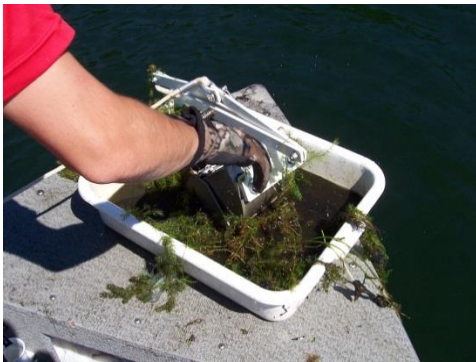
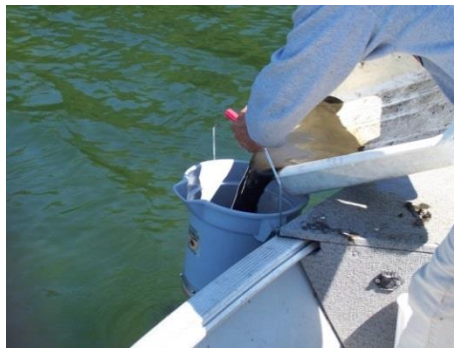
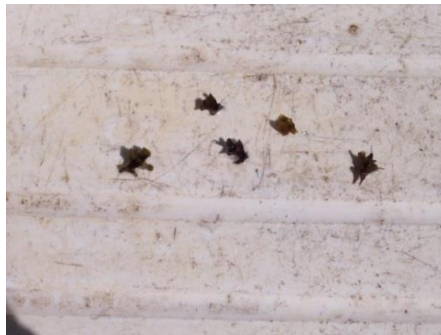
Figure 3: Pictures showing turion density methods. a. shows sediment sample; b. shows separation; c. shows separated turions.

near the middle of the CLP bed (assuming this will reflect the highest density). At each sample point a sediment sampler is lowered to the lake sediment and a sediment sample is obtained. Two samples are obtained from each side of the boat at each location. The samples are then separated with a screened bucket to isolate the turions. The turions are then counted and the density of turions is calculated in turions/square meter. Consistently successful treatments should show a trend of reduced turion density each year. This way we know the treatments are killing plants prior to turion production, resulting in overall reduction in CLP in those beds.

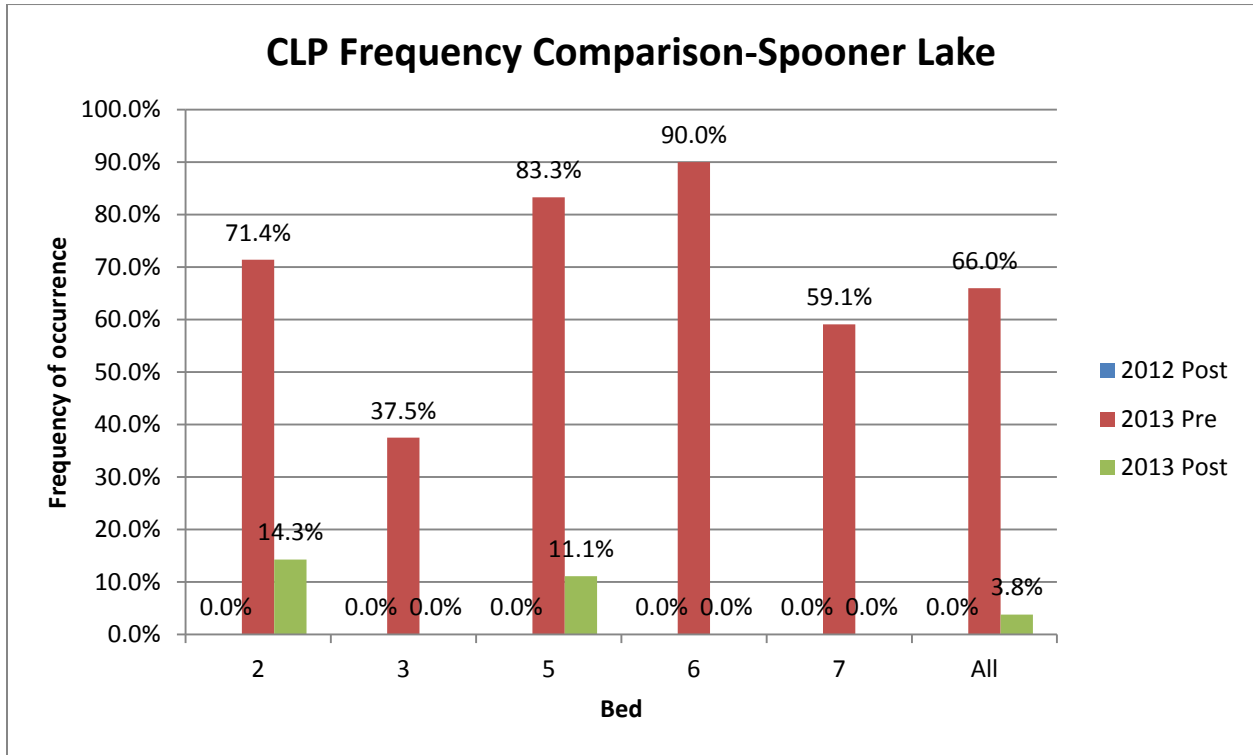
Figure 7: Graph showing frequencies from pretreatment and post treatment surveys.

reduction was impossible. The frequency for 2013 after treatment was very small at 3.8%. See Figure 7 for a graphical comparison.
