Restoring Lakeshore Habitat on Little St. Germain Lake, Vilas County  
Developing Best Management Practices and Evaluating the  
Ecological and Water Quality Benefits.

A Final Report Prepared by:

Prepared For:

Lake Protection Grant LPT344-10

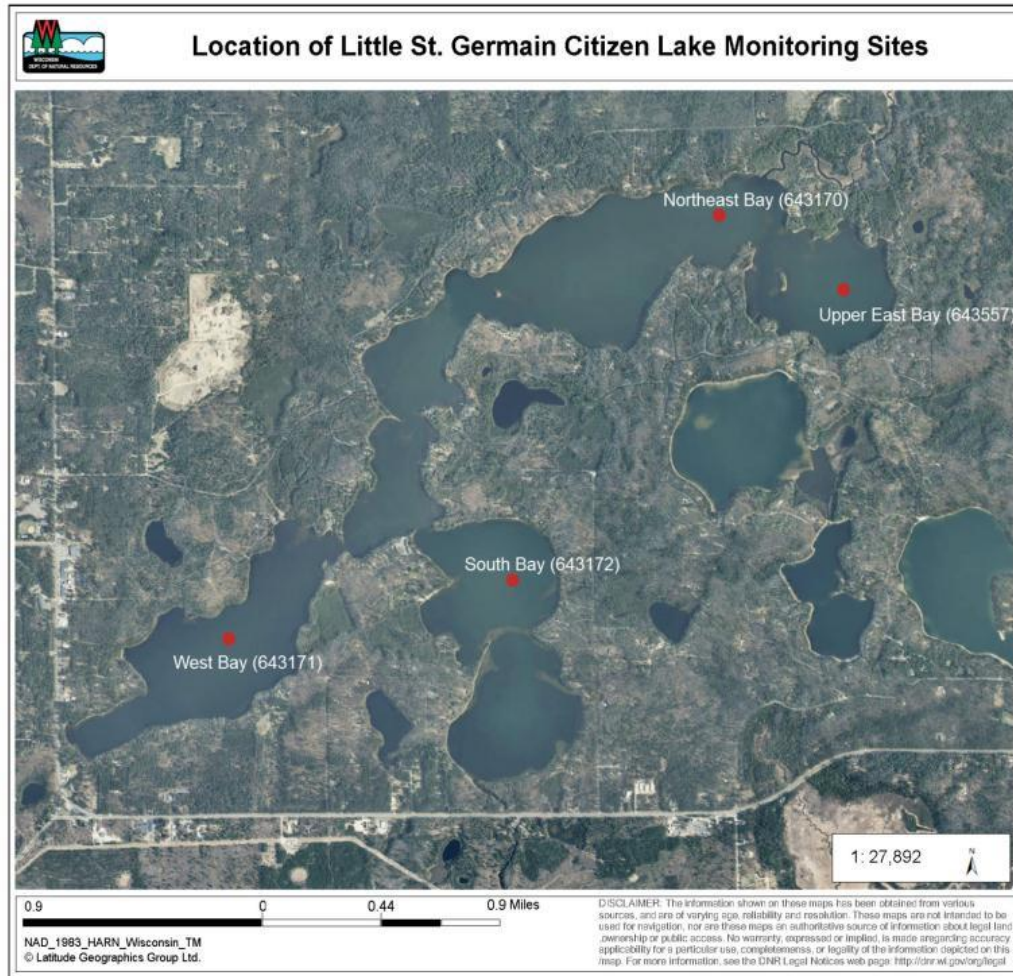
Figure 2 Location of Little St. Germain lake monitoring sites

We used data from the Wisconsin Citizen Lake Monitoring Network to assess recent water quality characteristics of Little St. Germain Lake (<http://dnr.wi.gov/lakes/clmn/Stations.aspx?location=64>) at 4 monitoring sites, as well as to evaluate long-term trends at one site, West Bay. A map of the monitoring stations can be found below (Figure 2), and the data for the monitoring stations can be found at these links:

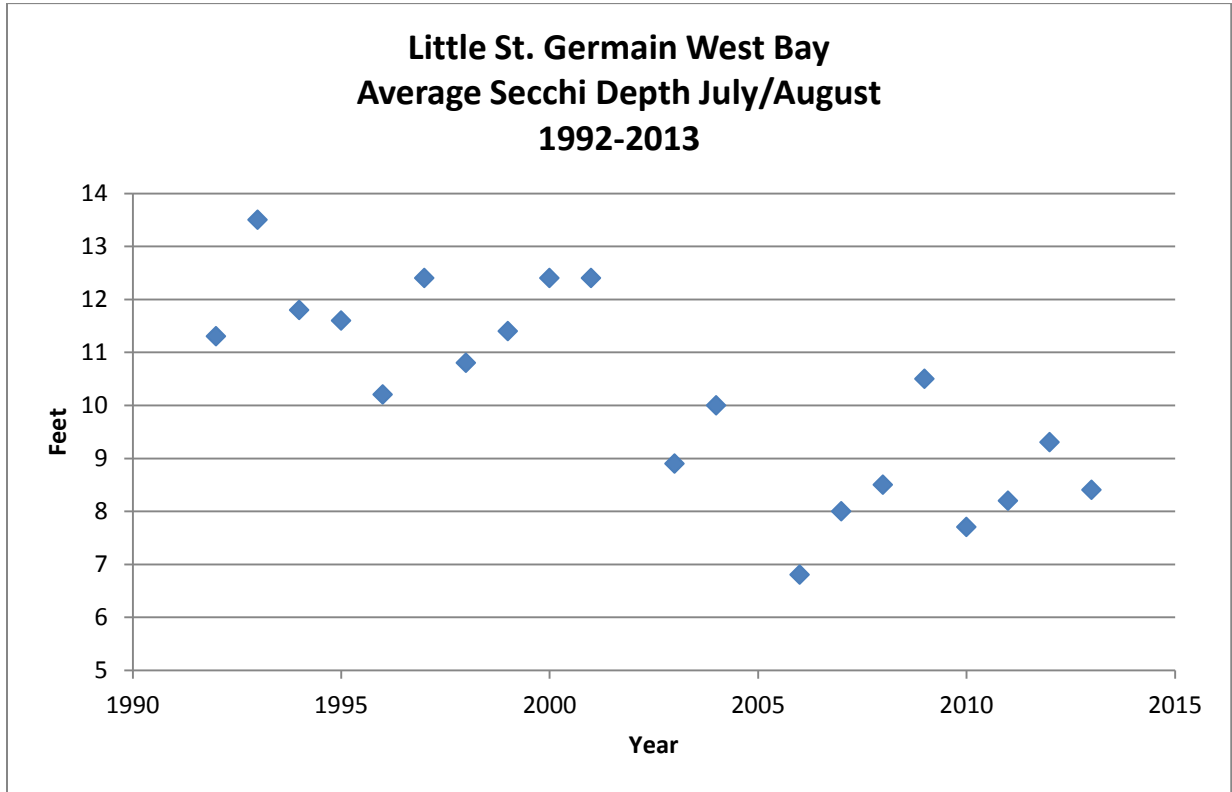
Figure 3 Trends in West Bay average July/August Secchi depth (feet) 1992-2013.

Water quality has recently declined across all basins of Little St. Germain Lake (Robertson and Rose 2000). The West Bay has consistently scored the best in water quality in terms of trophic status (as indexed by Chlorophyll TSI, see Table 1). The South Bay has intermediate, and East Bay the worst water quality (Table 1). While LSG water quality was relatively stable 1991-2000, it has since worsened. The West Bay has changed in trophic status from oligotrophic to mesotrophic, and recently to eutrophic (Figures 3-4). The South Bay changed from a mesotrophic status to eutrophic, and the East Bay from eutrophic to occasionally hypereutrophic (Robertson *et al.* 2005). Seasonal trends in water quality show that degradation occurs during the summer when phosphorus contributions from inflows are lower but internal phosphorus loading is elevated. The degraded water quality has negative impacts on aesthetics and fish populations, leading to lower enjoyment of the lake by residents and others who use the lake for these purposes (Robertson *et al.* 2005). The soils in the watershed consist of mainly well-drained sand and sandy loam types. These soils are thought to be naturally high in phosphorus content.

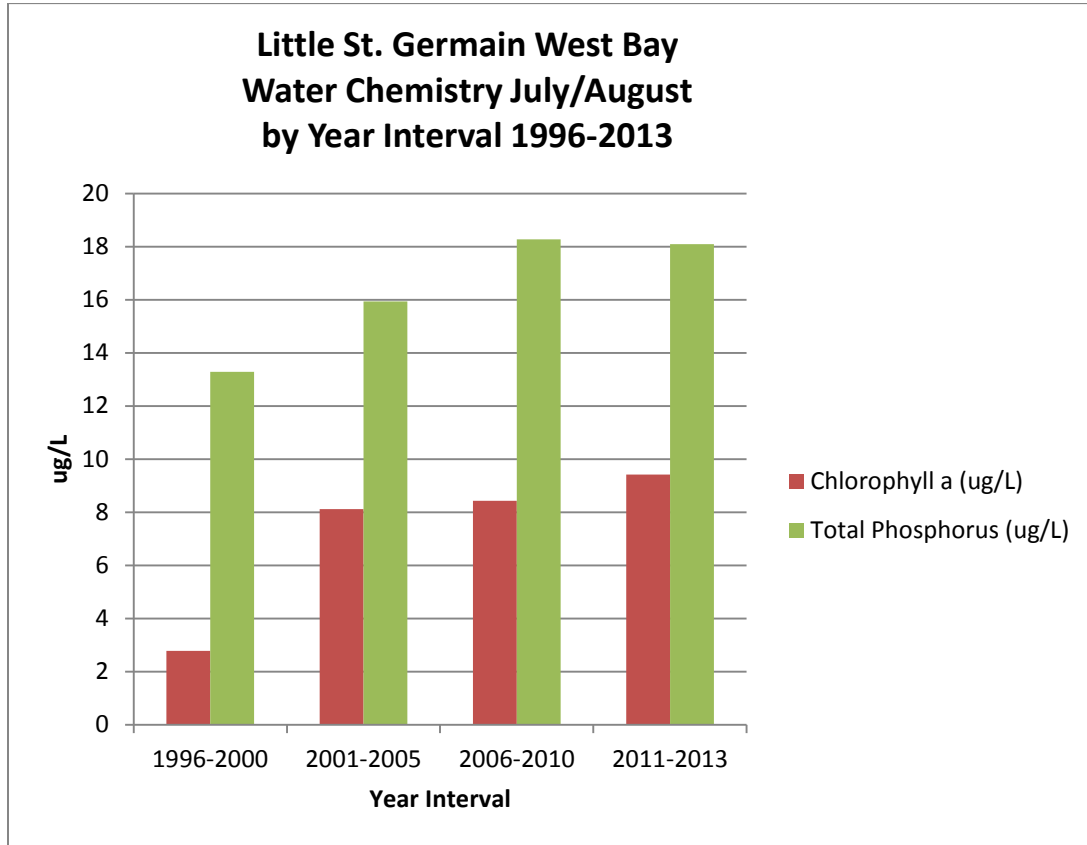
Figure 4 Trends in West Bay average July/August chlorophyll a (ug/L) and total phosphorus (ug/L) 1996-2013.

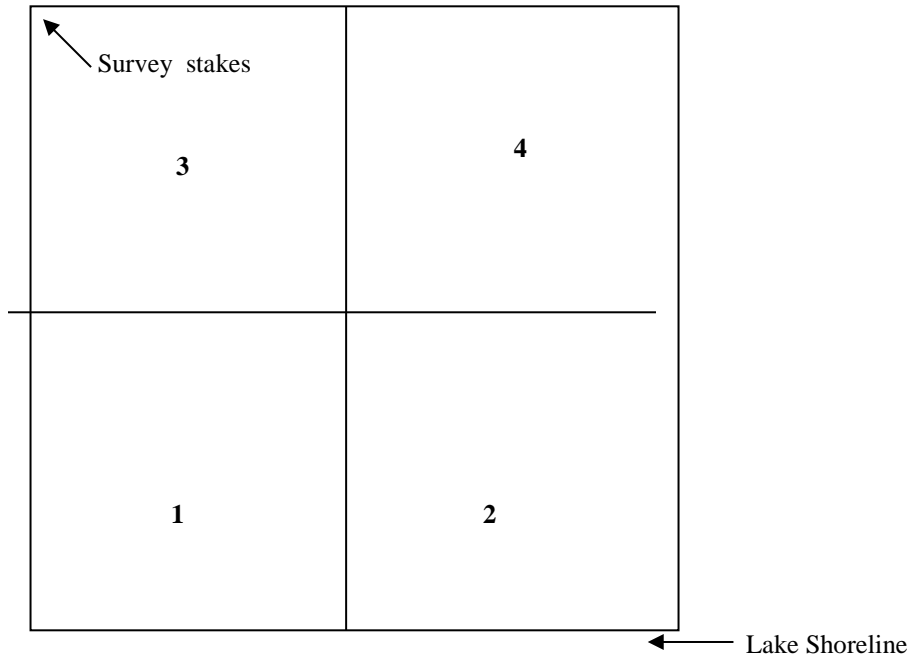
**Figure 5** Example of 10 m × 10 m vegetation sampling plot with four 5 m × 5 m subplots LSG and Star Lakes in 2011. All live trees ≥ 5 cm DBH were recorded in plot and live saplings and shrubs were recorded in two subplots. All plot corner locations were marked by a survey stake sunken into the ground at corner of the plot.

An attempt was made to survey every point that fell on the letter “a” (i.e. 1a, 2a, 3a). Each survey plot always began to the right of the point (start of 10 m × 10 m plot at point, end of plot to the right when facing shore from the lake). However, if a point fell on a usage area or access area to the lake (e.g. designated for no restoration) then an alternate sub-segment was randomly picked, using a random number table, until the vegetation plot did not fall on a usage or access area. For example, if plot 3a fell on a usage area then another point was randomly picked such as 3b, 3c, 3d or 3e. A metal rebar (1.25 cm × 15 cm) with a 1.25 cm flat washer welded to one end was used for a permanent survey stake and driven flush with the ground at an inland corner of the vegetation plot. The metal stakes can be relocated in subsequent years with a metal detector to reconfigure and resample the plots. Each plot was divided into four 5 m × 5 m subplots (Figure 5).

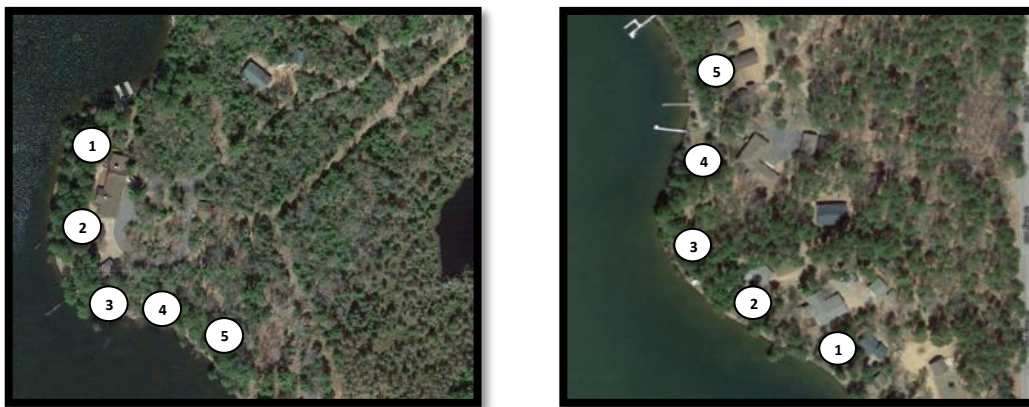
Figure 6 Hypothetical configuration of a survey transect with systematically placed 10m x 10m vegetation plots laid out parallel to the lake shoreline.

A) Restoration Transect (plots 1-5)

B) Control Transect (plot 1-5)

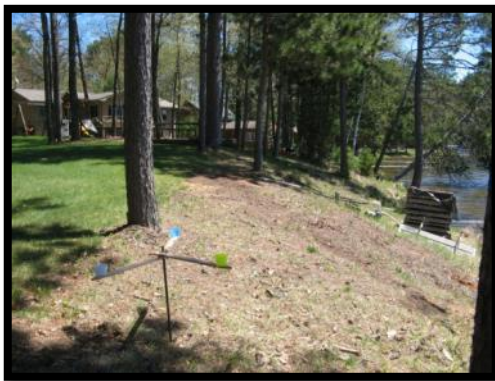
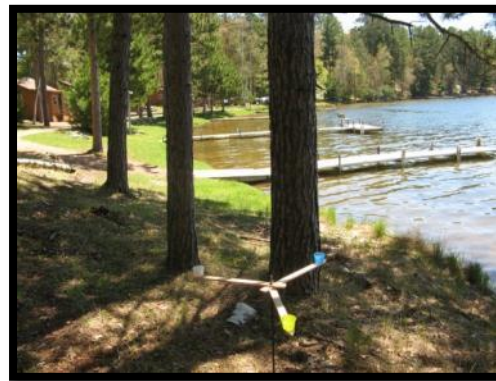
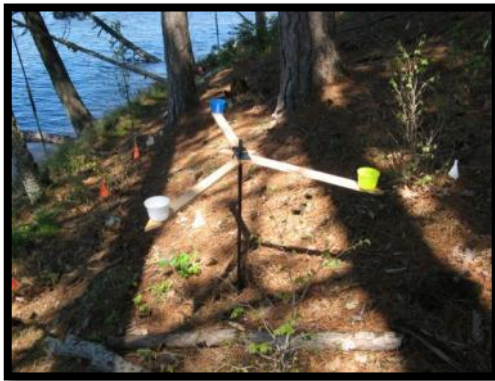
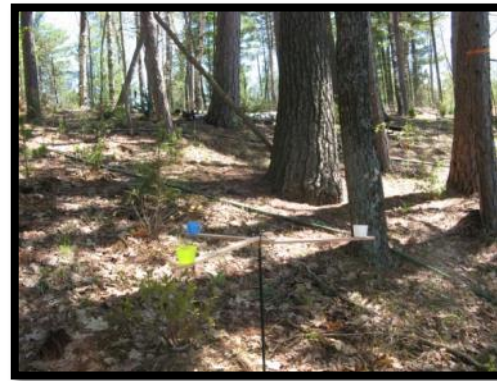
**Figure 9** Photos A-D represent photos of bee sample stations installed at opposite ends of the 210-meter long control transect and 200-meter long restoration transect (see Figure 3). A single bee station was installed in the center of each of the five 10m x 10m plots per transect. Plot centers were located approximately 5 meters from the lake's ordinary high water mark.

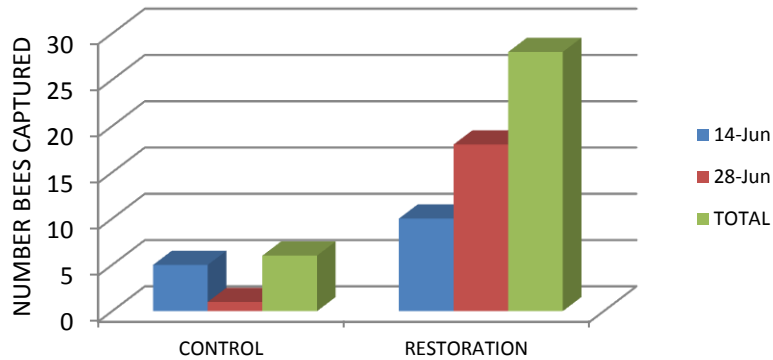
Figure 11 Relative abundance of total bees captured per date and treatment type

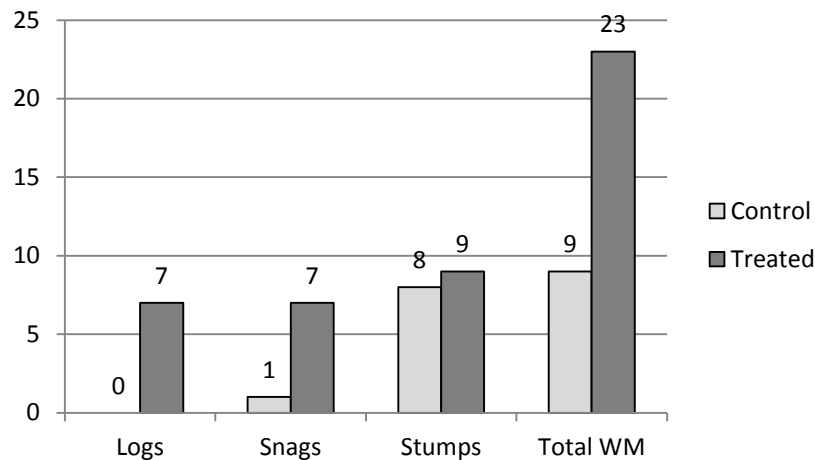
**Figure 12** Relative abundance of available dead, woody material (WM) totals and by type as measured at the control and treated (restoration) sites during 2011.

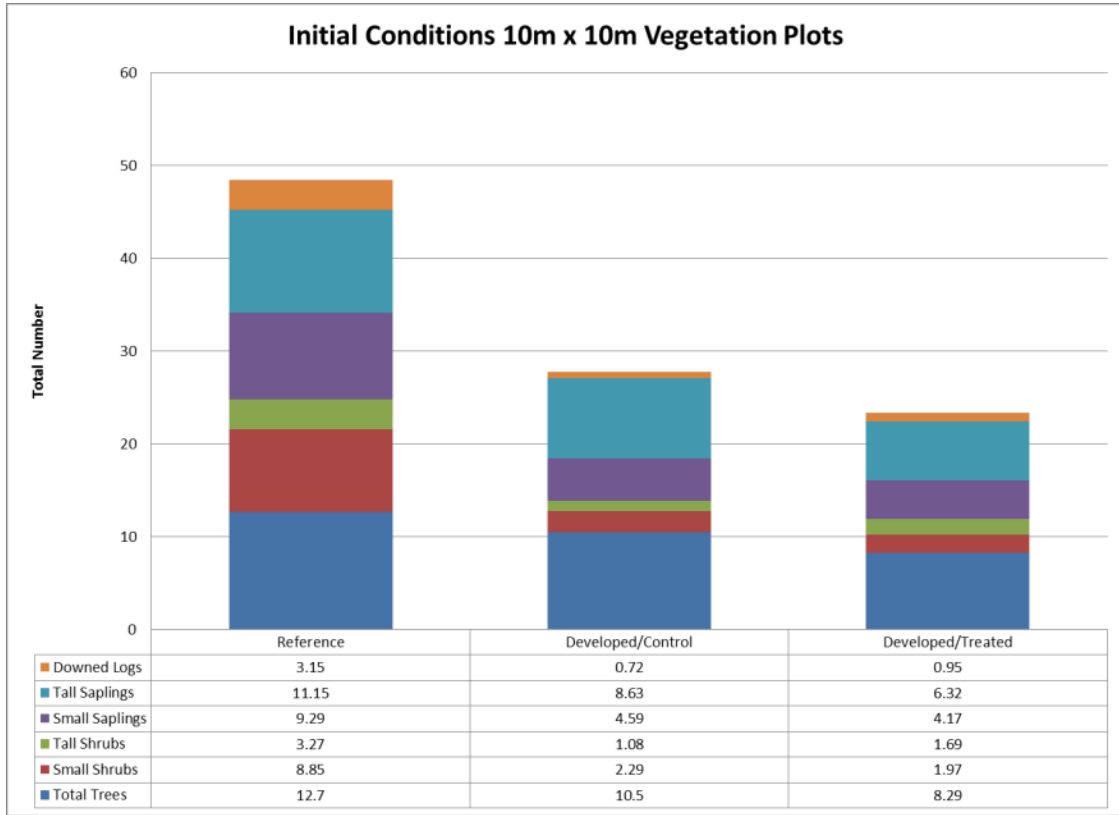
Figure A2-1. Initial habitat structure at vegetation plots along reference shorelines on undeveloped lakes (n=5) as compared to vegetation plots at control shorelines on developed lakes (n=5) and treated shorelines (shorelines selected for habitat restoration) on developed lakes (n=5).

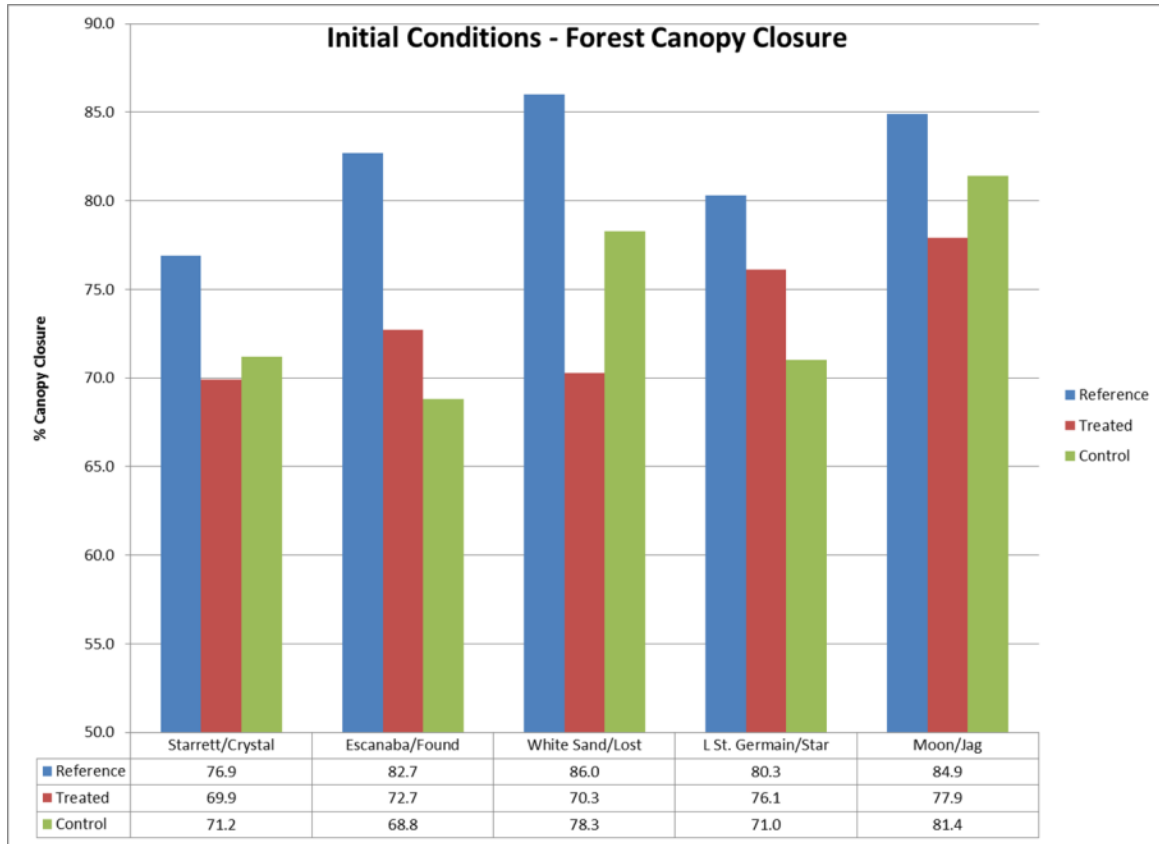
Figure A2-2. Initial forest canopy closure at vegetation plots along reference shorelines on undeveloped lakes (n=5) as compared to canopy closure at vegetation plots at control shorelines on developed lakes (n=5) and treated shorelines (shorelines selected for habitat restoration) on developed lakes (n=5).

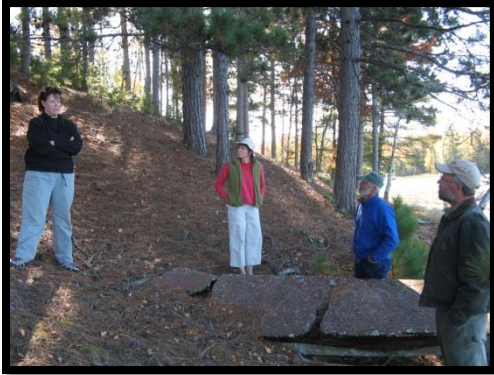
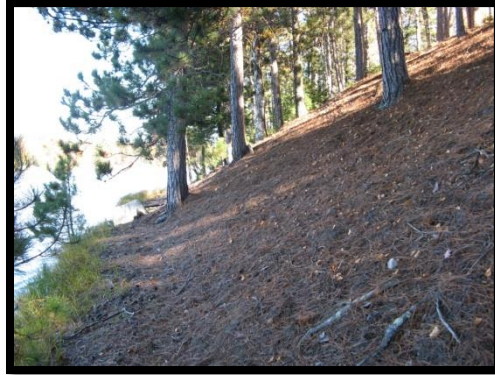
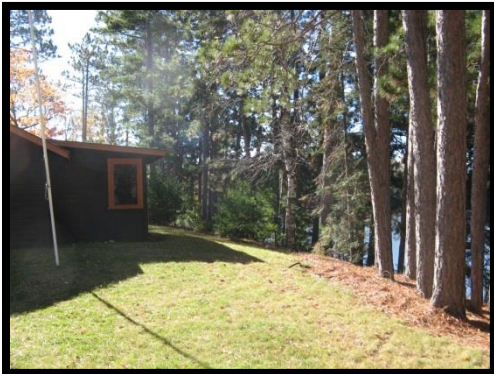
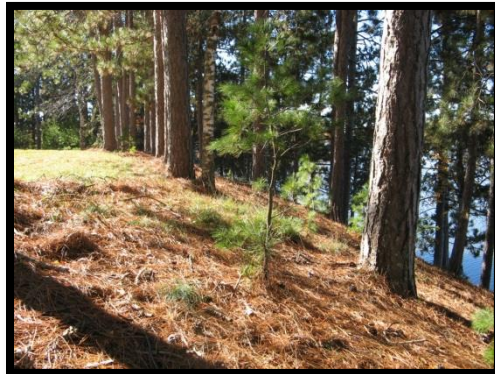
*Photographs A-D in Figure 14 represents the private shoreland area selected to implement shoreland restoration efforts and overland runoff measurements. The shoreline is characterized by a westerly-facing 20%-35% slope with sandy soils covered by a layer of pine needle duff that varies from 0 to 6 inches in depth. Prior to restoration, the shoreline was sparsely vegetated by native northern forest shrub and tree species considered resistant to deer-browse. The canopy remains dominated by mature red pines (*Pinus resinosa*) planted several decades earlier, and combined with the few hardwood tree species, creates canopy cover ranging from <5% to near 75% of total sky area.*

A) Restoration consultants on site

B) Shoreline prior to restoration

C) Lawn area above sloping shoreline

D) Transition zone from lawn to shoreline

**Figure 14 Shoreland zone prior to restoration and installation of the runoff collector plots.**

*The Project Investigator, Michigan Technological University (MTU), Vilas County and consultant specialists met on-site (Photo A in Figure 14) during fall of 2011 to determine the general location to install three experimental study plots. The sites were selected within context of the overarching shoreland buffer restoration concept. Once the sites were selected, optional design considerations were discussed in reference to the advice from USGS hydrology scientists provided during a previous meeting and reported in Graczyk et al. 2003. Runoff collector design considerations included the practical needs for site customization and most importantly, to standardize performance so that the design and sample collection methods would produce comparable results across different sites (or treatment plots) within the study area. Additional considerations included a desire to stay within the current project budget and the interest to develop a low-cost prototype collector to measure overland runoff at multiple sites as part of an expanded future study. In practical terms, this omitted the purchase and installation of costly specialized instrumentation typical in large-scale runoff studies designed by the USGS.*

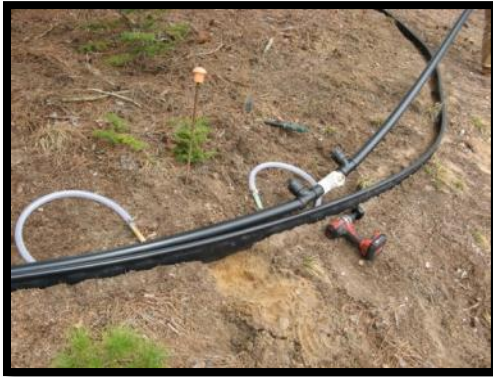
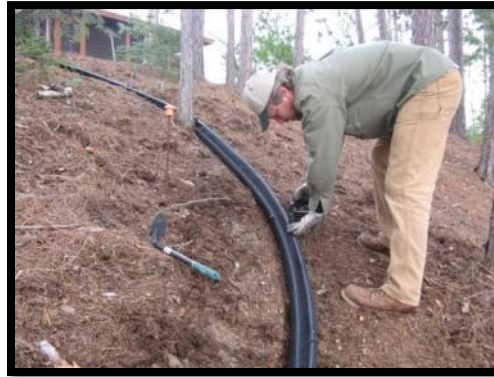
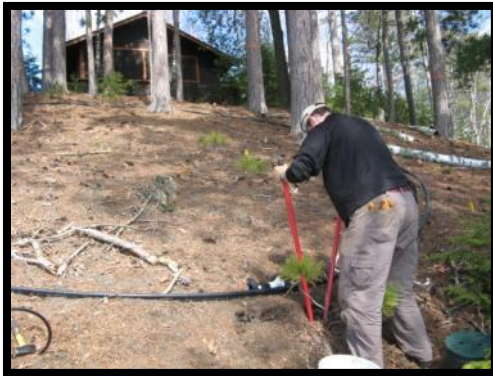
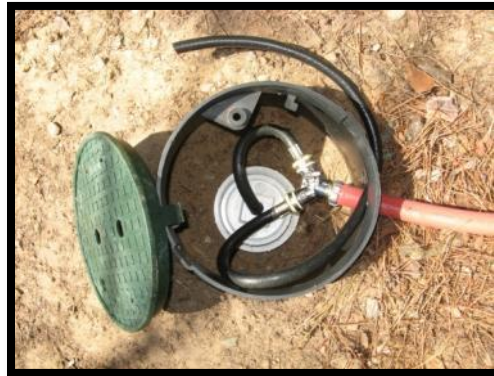
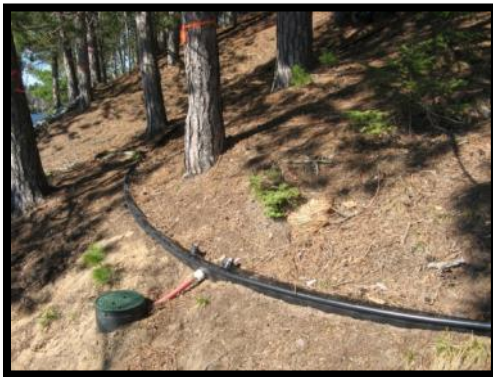
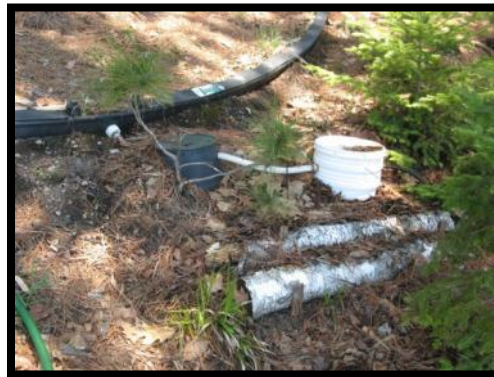
A) 2" ABS pipe connected end-to-end

B) Author installing leaf screen

C) Project assistant on site; facing uphill

D) Runoff collector and sampler housing

E) Completed installation (plot L)

F) 5-gallon pail added to increase capacity

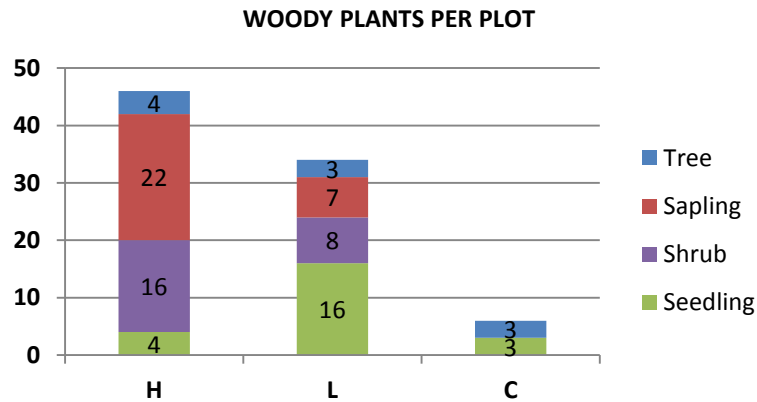
Figure 17 Relative proportions of trees and shrubs by plot treatment type.

A list of the associated species, form, and count is provided in Table 13. All three plots had similar proportions of dominant trees prior to supplemental planting of potted stock for reasons of applying the treatment prescribed by the restoration. Once the restoration installation was completed, the high-density plot (H) had a total of 46 combining canopy trees, tree saplings and seedlings and shrubs as compared to a combined total of 34 for the low-density (L) plot. Although the low-density plot had similar numbers of dominant trees, the high-density treatment reflected a substantially greater combined density of dominant and sapling trees (total 26) relative to the low-density plot (total 10). The control treatment (plot 3) was void of tree saplings and woody shrubs. Herbaceous, ground-cover plants were not quantified; however they were sparse or non-existent across all three plots reflecting a very high percent plot cover of un-vegetated soil covered by a 0- to 6-inch deep layer of duff consisting primarily of red pine needles.

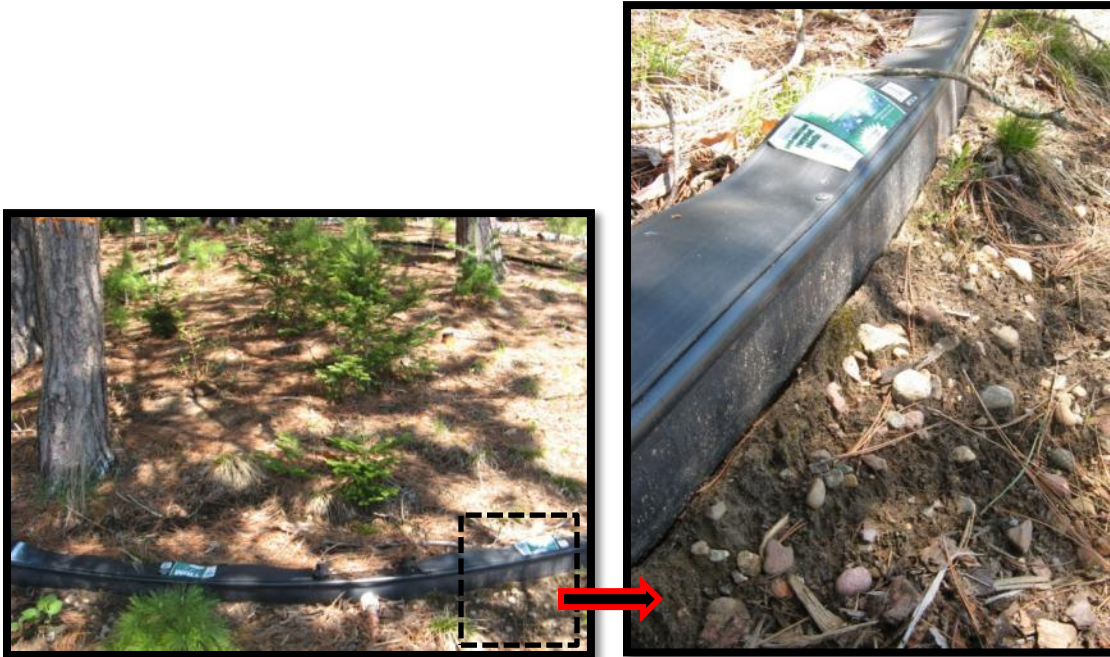
**Figure 18** Collector in plot L (low-density planting) - post-planting 2013. Note inset highlighting potential “curbing” effect at bottom edge of collector. Visual observations suggest this problem is likely due to water impact from sprinkler irrigation.

*A potential third problem relating to function may be the effect of installing the edging on steep slope that may produce change in the rate of slope erosion on the down-slope side outside of the collector creating a curb-like effect (Figure 18). Observations of sprinkler irrigation performance suggest that water from the sprinklers is the primary cause of this erosion problem. It's conceivable that over a longer period of time (5-10 years) this curb-like effect may worsen requiring installation of additional erosion-control infrastructure (e.g., Enviro-lok® bags, rolled E-C fabric, natural or bio-core logs) to mitigate the effect of runoff sampling devices. It's also possible that this effect may occur with any design installed on steep slope with sandy soil that has an active sprinkler irrigation system (typical for new restoration sites). An example of project action to minimize the curbing downside of the collectors can be seen in photo J of Figure 4 where natural birch logs were placed to moderate the slope after installing the 5-gallon pail to increase sample storage capacity. Other control efforts might include strategic placement of sprinkler heads and/or the installation of alternate sprinkler models or sprinkler system deflectors.*

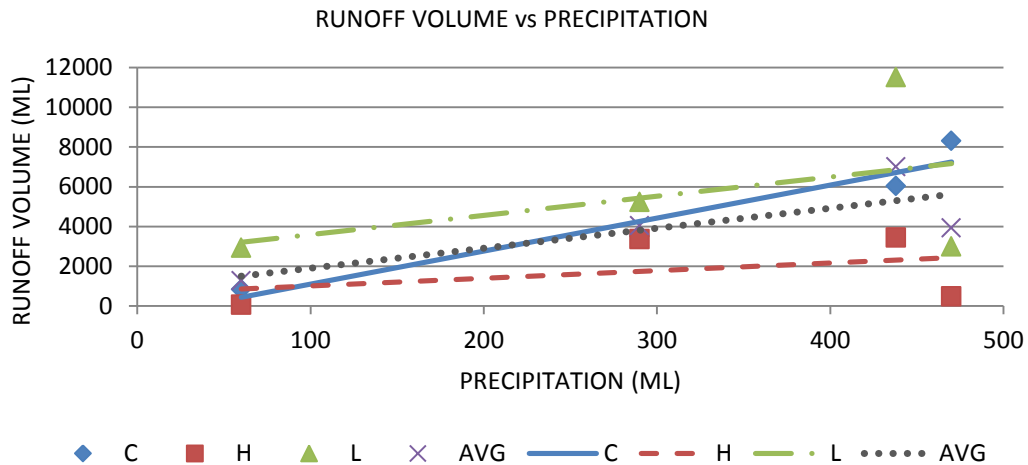
**Figure 19 Relationship between amounts in runoff volume and precipitation. AVG: average calculated from total of four independent precipitation periods 2011-2013.**

AVG: average calculated from total of four independent precipitation periods 2011-2013. Pearson correlation coefficients for total precipitation and runoff volume per plot. R values can range from -1 to + 1, where 0 represents no correlation and 1 a perfect correlation; minus sign (-) if present would indicate an inverse correlation (i.e., when one variable increases the other tends to decrease). \*R-value pooling all plots and years.

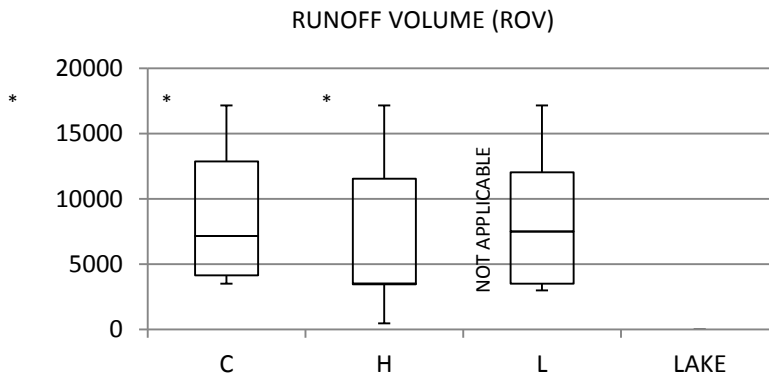
Figure 21 Box and whisker plots presenting the variation in overland runoff volume (ml) by plot type (treatment) over the 3-year period 2011 to 2013; Chart description: Minimum and maximum values (whiskers), the 25th-50th percentile range (lower box), the 50th-75th percentile range (upper box) and median (horizontal line). The narrower the box and shorter the whiskers indicates lower year-to-year variation in sample concentrations. \* indicates maximum measurable storage capacity

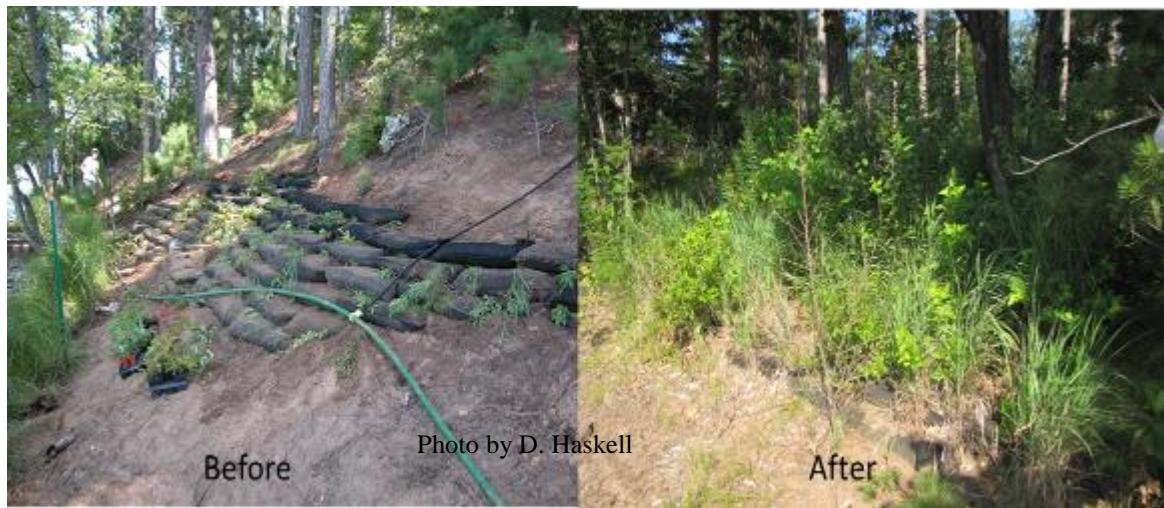
**Figure 23** Photos of geotextile bags installed on Lou Mirek's property during the summer of 2011 and 2012.

plants were becoming established and no gully erosion was visible. All materials were purchased from local nurseries, and bags were constructed and installed according to manufacturers' specifications.

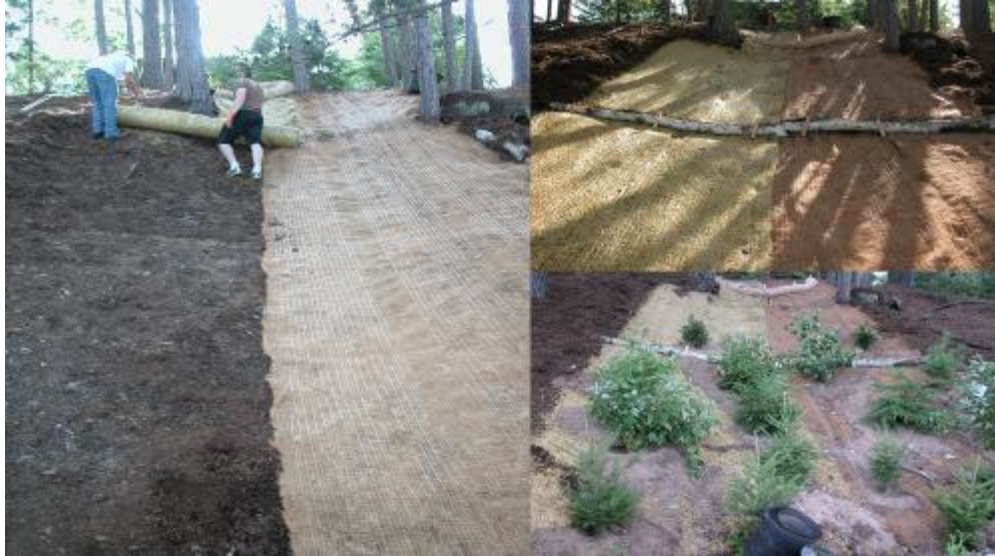
**Figure 24** Installation of erosion control blankets in the summer of 2011 on Mirek’s Property, LSG Lake. Two types of blankets were used, coconut coir and straw

*Erosion Control Blanket:* Approximately 300 square yards of coconut coir and straw-filled erosion control blankets were installed at locations along the restoration lakeshores exhibiting moderate to high erosion. Blankets were secured with 8" sod pins and planted with native trees, shrubs, forbs, and grasses (Figure 24). The coconut coir is a long-term, double netted erosion control blanket that is machine-assembled using 100% coconut fibers. The straw blanket is composed of wheat straw and is machine-assembled into rolls on polypropylene netting. These mats are designed to reduce soil erosion and assist in the growth of vegetation. The blankets were rolled out vertically down-slope or horizontally across a slope in areas that had moderate erosion issues. Both the coconut and straw blankets were installed according to manufacturer's instructions. Following blanket installation, plants were then placed throughout blanket by cutting a slot large enough to get the plant root mass through the blanket and into the soil. This procedure reduces loosened soil from eroding down slope and into the lake. In addition, it provides a work area and walking path when traversing the slope during planting further reducing the impact on the soil and slopes. Both products are biodegradable; however, the coconut longevity will surpass the straw blanket. We feel that a combination of both types of blankets would perform well on highly erodible areas. The coconut coir should be used on steeper slopes (20 degree or greater), due to its longevity.

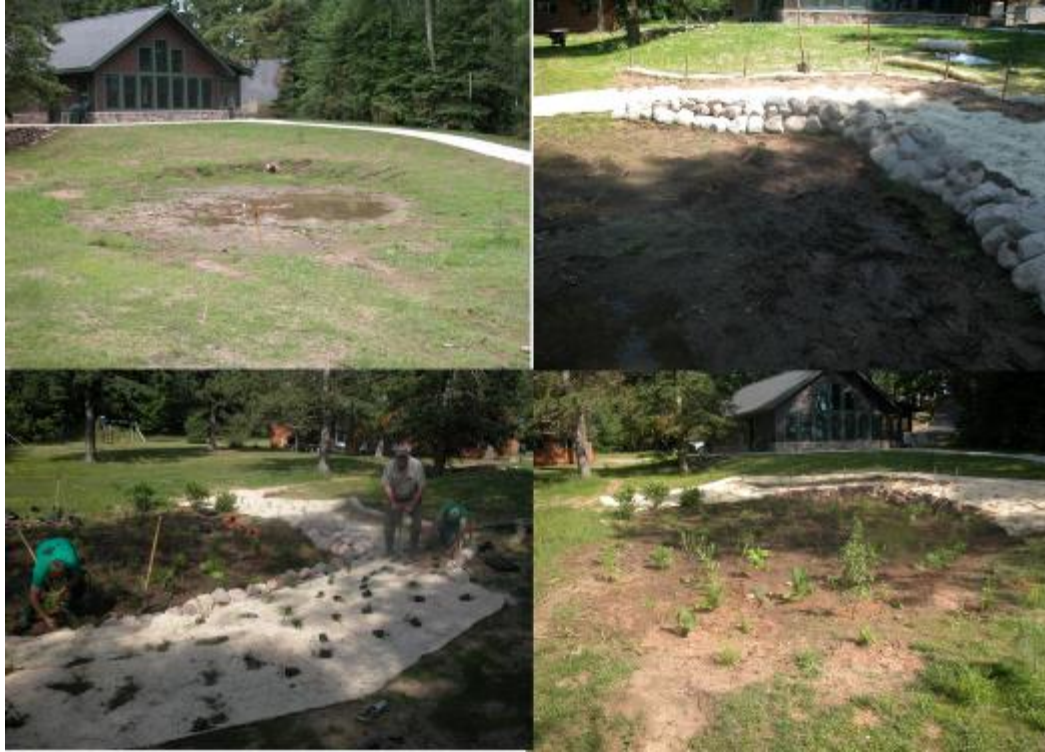
**Figure 25 Construction of rain garden on Waldmann’s Sunset Pine property in 2011. Rain garden was designed to retain water runoff from hard surfaces surrounding rental cabins. Native wetland plants were integrated throughout the rain garden.**

*Sunset Pine Rain Garden:* Water runoff from a large gravel driveway, parking lot, roof, and surrounding wooded upland was channeled into a 1,200 square foot rain garden excavated by a local contractor. This rain garden was constructed at BJW-SP property in East Bay during the spring of 2011 (Figure 25). We planted a variety of wetland plants recommended by a private consultant and native plants were provided by a local nursery. To date the rain garden is functioning properly, retaining water runoff without spill over into lake and no standing water has persisted for more than a few days. One issue - fencing was not constructed around the rain garden therefore deer browsed restoration plants occasionally.

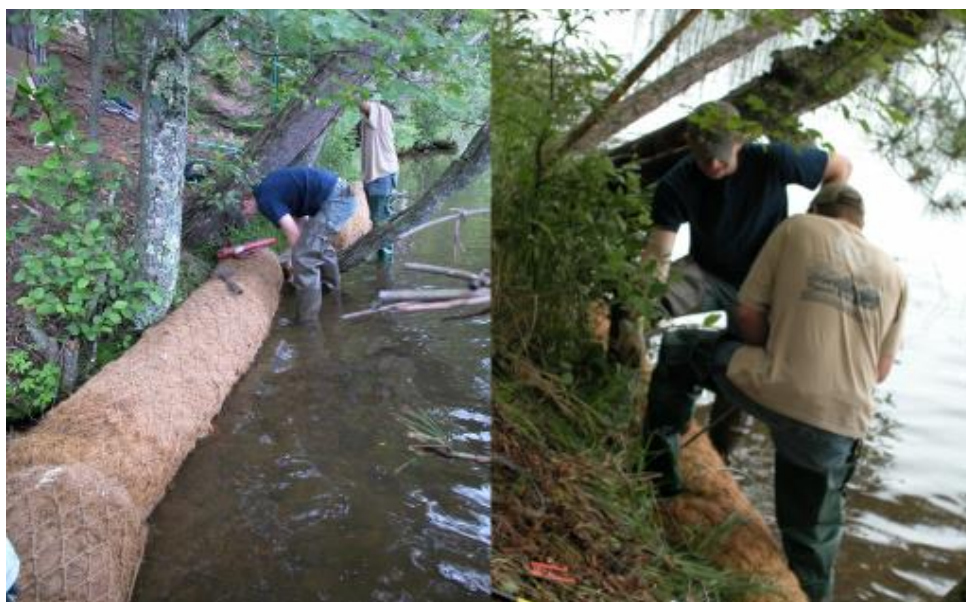
**Figure 26** Installation of biologs at BJW-SP property on LSG in June 2011. Biologs were secured to the lake bed using cabled earth anchors and then planted with native wetland plants.

biologs are still anchored in place along the restoration project shorelines. All biologs were acquired from a local nursery and installation materials were purchased from local hardware stores.

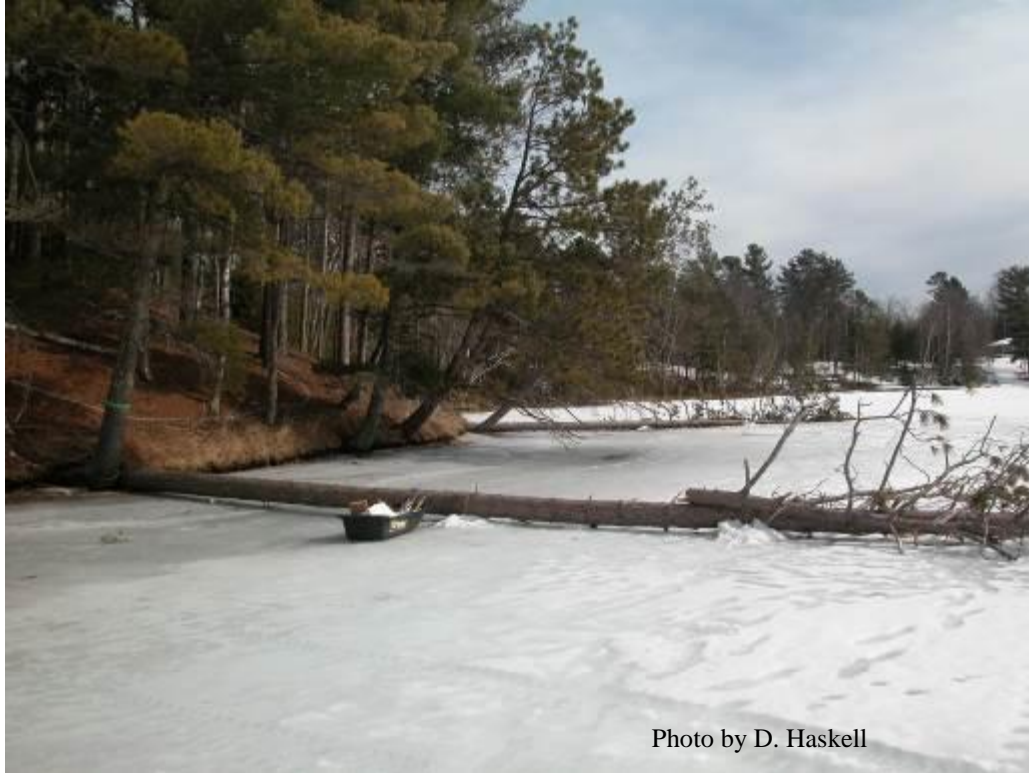
**Figure 27** Tree drops installed at Lou Mirek’s Property on LSG Lake during the winter of 2011. Trees were later secured to lake bed using steel cables and earth anchors.

Tree drops were placed at the BJW-SH and BJW-PH rental properties, anticipating the renters would enjoy the fishing opportunity the tree drops provide. All the trees on BJW properties were brought in from an offsite location using construction equipment during the winter of 2012. Trees were placed at least 50 feet apart with root wads intact. Root wads were placed on shore while the crowns reached out into the lake. Once ice was out, a local landscaper was contracted to secure tree drops to the lake bed using cables and earth anchors. The trees used on LDM property were placed by a private consultant and local landscaper in the winter of 2011. The trees selected were stressed red pines growing on the LDM shoreline (the shoreline site is covered with a red pine plantation). These trees were also secured to lake bed using cables and anchors. In 2013, a cable on one tree broke loose causing the top of the tree to be pushed parallel to shore. All other trees are still intact and used extensively by recreational fishers (personal observation).

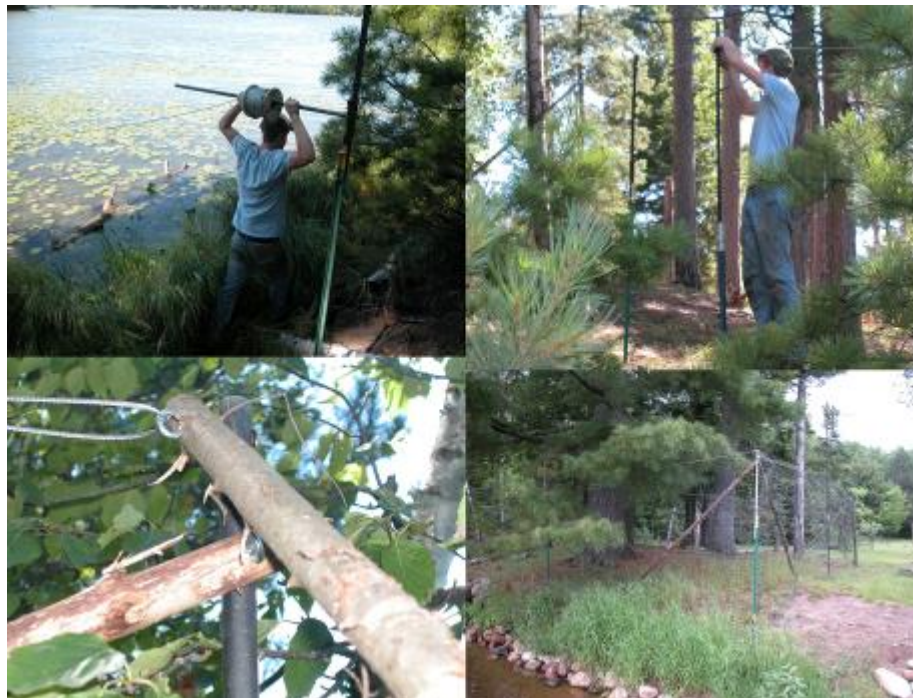
**Figure 28 Construction of deer abatement fence on LSG Lake in 2011-2012.**

the fence. Fence maintenance should be scheduled regularly - walking the entire perimeter and inspecting and repairing any damages that are present. The fence maintenance person(s) should carry the following materials in their vehicle: a roll of 16 gauge tie wire, a bag of zip ties, extra post extensions, t-post and extra hardware (eye bolts, cable clamps, turnbuckles, nuts and bolts, 16d and 8d nails, various lengths of deck screws, and the tools needed: slip joint pliers, wire cutters, fence pliers, post pounder, 16-20 oz. claw hammer, a hand bow saw, adjustable end wrenches, cordless or conventional screw drivers [Philips #2], various drill bits, set of end wrenches and hacksaw.
