Management Plan:  
Miljala Channel Tributary Watershed,  
Town of Lake Mills, WI

April 2014

Final Report for  
Wisconsin Department of Natural Resources  
Lake Planning Grants LPL-1412-11 and LPL-1413-11

Project #1511a

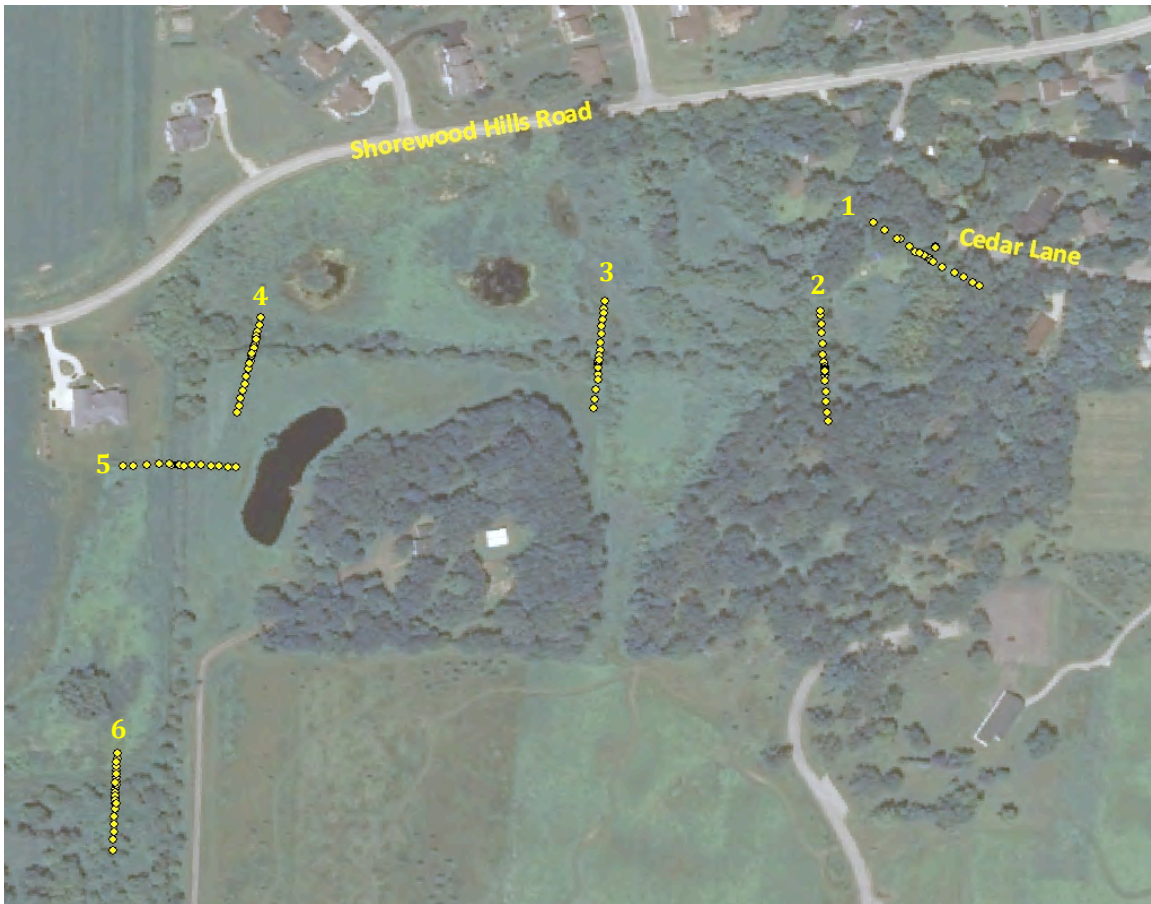
Figure 3. Topographic survey transects.

The Jefferson County Surveyor conducted an elevation survey along several transects crossing the ditch (Figure 3). This provides data useful in evaluating pollution control alternatives. Although the survey was limited to several transects, this provides information on the longitudinal slope of the ditch (Table 1). It also provides a check on the accuracy of Jefferson County’s LiDAR mass points, which provide much greater coverage of the project area. The LiDAR point elevations are typically about 0.5 to 1 foot higher than the elevations of nearby survey points; thus they appear to provide a reasonable representation of the land surface but should not be used to determine precise elevations.

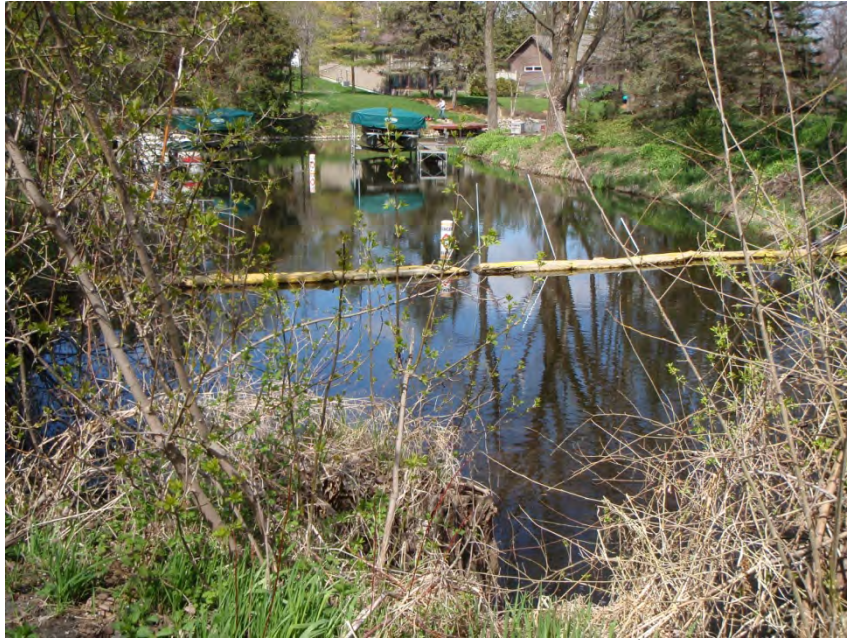
Figure 6. Turbidity barrier in Miljala Channel

The turbidity barrier (Figure 6) can be kept in place in the channel below Cedar Lane until sediment has been controlled by other methods and the barrier is no longer needed. This would require continued dredging of sediment trapped upstream of the barrier. The frequency of dredging will depend on climatic patterns, particularly the number of large storms that occur each year because these events have been shown to transport much of the accumulated sediment. The channel was dredged in 2005 and 2009 before the turbidity barrier was installed in 2009, and again in 2011. This suggests that additional dredging may be needed every several years until other methods can begin to reduce the sediment load from the watershed.

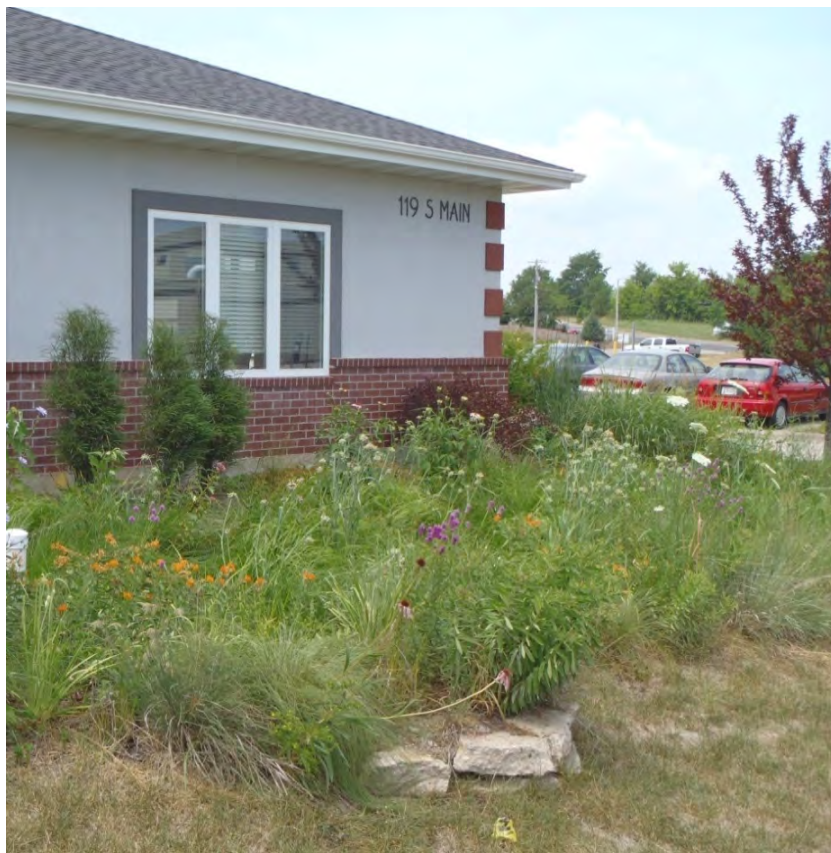
Figure 8. Rain garden capturing roof runoff.

This alternative could be used to reduce runoff volume and peak discharge throughout the watershed, particularly in residential areas and along roadways. “Green infrastructure” refers to stormwater management practices that use vegetated areas to reduce stormwater runoff, rather than engineered basins and sewers. Some of these stormwater practices are inexpensive and easily implemented by property owners, including rain gardens that allow runoff to soak into the soil, and rain barrels that capture roof runoff for irrigation use (Figures 8 and 9). The RLIA could conduct outreach to promote such voluntary stormwater management measures on private property and town road right-of-ways. Reducing stormwater runoff would help reduce the flow and sediment transport in the ditch.

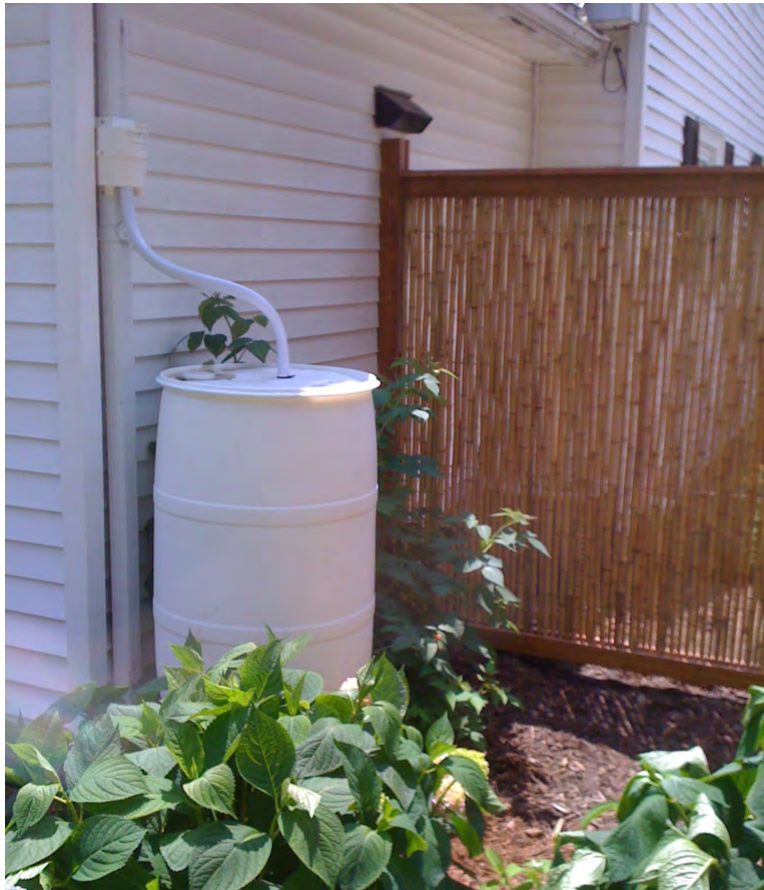
Figure 9. Rain barrel capturing roof runoff (from Sustain Dane)

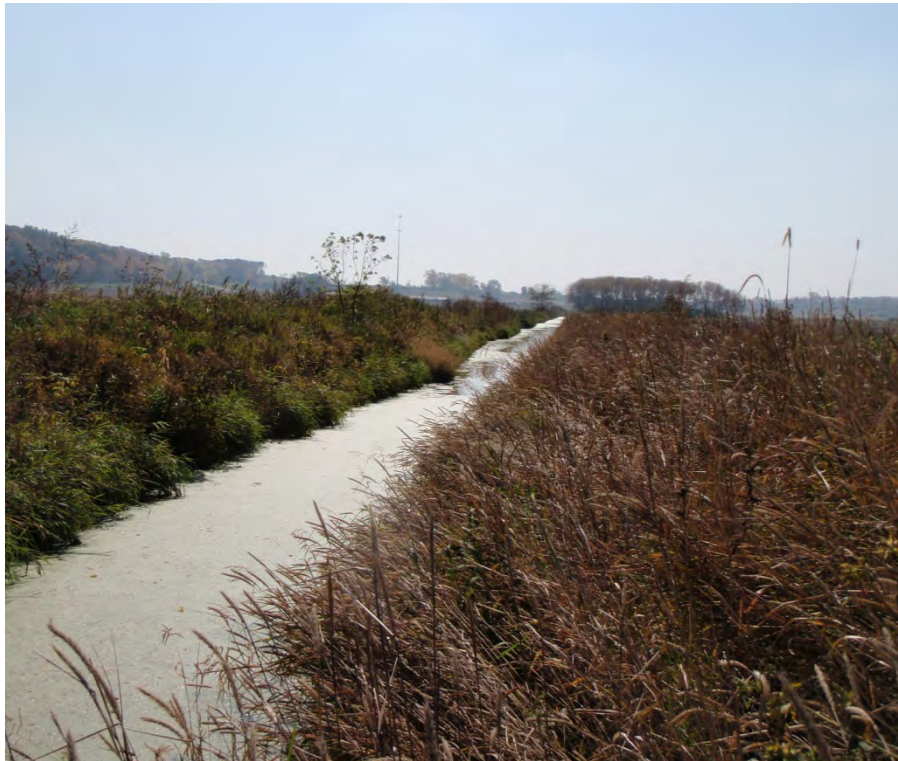
Figure 11. Ditch with right bank recently re-sloped and planted with grass. Left bank not stabilized.

Stabilization of this 1,200 ft section of the ditch would entail removing trees from the ditch banks, excavating the ditch banks to a shallow, stable angle, and seeding native wet meadow vegetation (e.g. Figure 11). Appendix C includes conceptual drawings for both the ditch stabilization and marsh restoration, which ideally would be implemented in tandem.

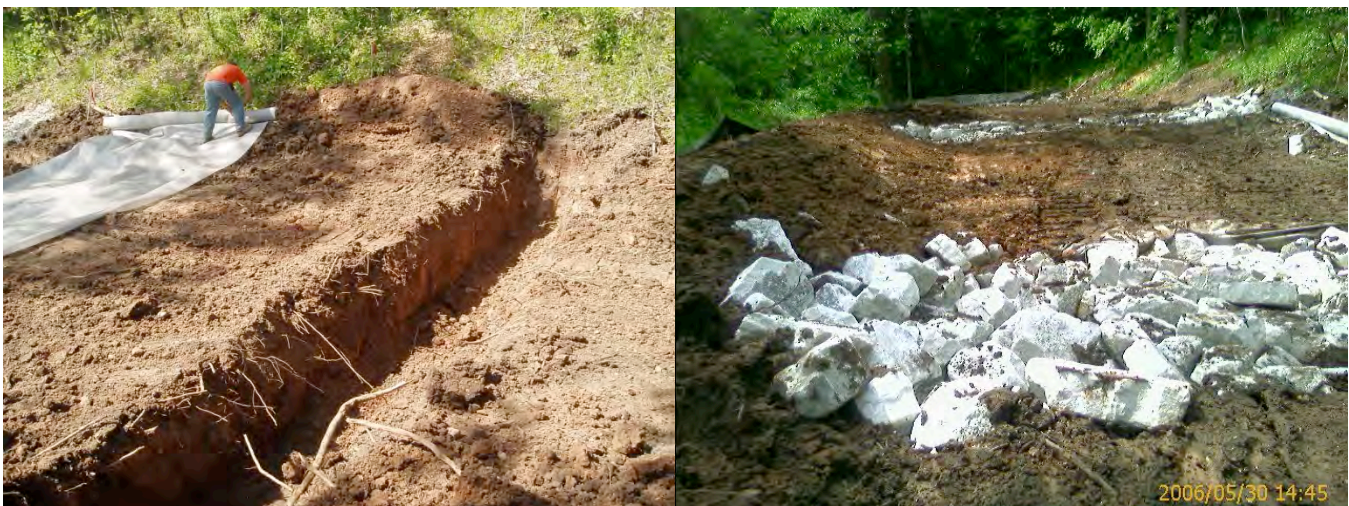
Figure 12. Example of rip rap grade control buried in channel bed.

The relatively steep slope of this ditch reach (approximately 5%) suggests that the ditch is actively downcutting into its bed. Continued downcutting could destabilize the banks by undercutting them. Therefore, two rock grade control structures (e.g. Figure 12) are recommended to prevent further downcutting. These structures entail a narrow section of rip-rap placed perpendicular to flow and buried in a trench so that the top of the rock structure is at the current ditch bed elevation. These structures would be approximately 4 feet wide and 3 feet deep; exact dimensions and the size of rock should be determined during final design. Suggested locations for grade controls are shown on Figure C-2.
