2009 Summary of *Potamogeton crispus* Big Arbor Vitae Lake, Vilas County, WI

## **Big Arbor Vitae Lake**

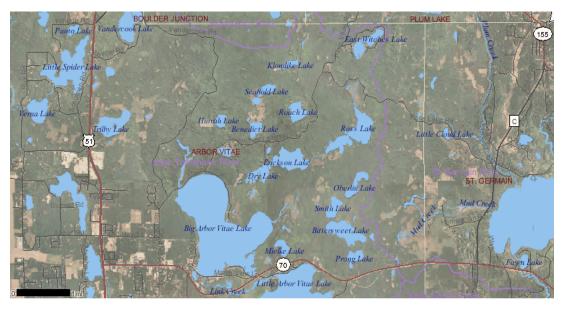
Figure 1: Map of Big Arbor Vitae Lake, land cover and northeastern boundary of the Upper Tomahawk River Watershed.

Big Arbor Vitae Lake is located within the Town of Arbor Vitae. It is a drainage lake in the north eastern section of the Upper Tomahawk River Watershed (Figure: 1). The surface water area is 1090 acres, the maximum depth is 41 feet and there is 7.8 miles of shoreline. Four percent of the lake area has an average depth of 3 feet or less and 49% of the lake area has an average depth of 20 feet or more. The substrate is primarily gravel and sand (WDNR-Website). There are three public boat landings on Big Arbor Vitae Lake: two at the southeastern side of the lake and one at the far northern side of the lake. The boat landing at the northern end has a public beach and picnic area. The southern shoreline is developed with a moderate to high concentration of homes and resorts. The northern shoreline has limited to no development and is relatively undisturbed.

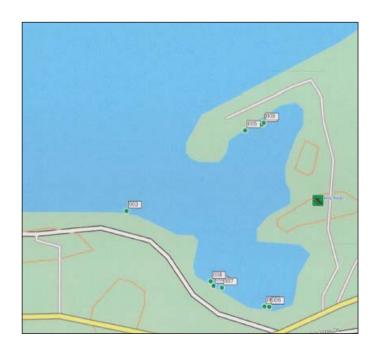
Figure 3: 2009 CLP locations from June 2009 survey.

The first survey was conducted on the 15<sup>th</sup> & 16h of June, 2009. The survey included: relocating CLP at the initial areas of discovered by GLIFWC, quantify if the distribution and abundance had changed and determine the presence of CLP in other parts of the lake. The initial discoveries were all relocated and the population distribution and abundance were consistent with the 2008 findings (Figure: 3 & Table: 1). Based on the location and abundance from the information gathered by GLIFWC, there was no detectable change between 2008 to 2009 in the distribution and abundance of CLP. It was noted that the plants were not at their peak biomass and several inches below the water surface.

Grid Datum Dates	Lat/Lon hddd.ddddd" WGS 84 6.15.09 & 6.16.09	
GPS ID	GPS WAYPOINT	RELATIVE ABUNDANCE
GPS ID	GPS WAYPOINT N45.91775 W89.63796	RELATIVE ABUNDANCE
1	N45.91775 W89.63796	1 plant
1		1 plant 1 plant
2	N45.91775 W89.63796 N45.91858 W89.63988	1 plant 1 plant 1-50 plants
1 2 4 5	N45.91775 W89.63796 N45.91858 W89.63988 N45.92313 W89.63805	1 plant 1 plant 1-50 plants 1-10 plants
1 2 4 5	N45.91775 W89.63796 N45.91858 W89.63988 N45.92313 W89.63805 N45.92296 W89.63863	1 plant 1 plant 1-50 plants 1-10 plants 1-10 plants
GPS ID 1 2 4 5 6 7 8	N45.91775 W89.63796 N45.91858 W89.63988 N45.92313 W89.63805 N45.92296 W89.63863 N45.91777 W89.63799	1 plant 1 plant 1-50 plants 1-10 plants

Once the CLP 2008 sites were relocated, larger areas surrounding the sites were traversed using an underwater camera. During these traverses, no additional CLP was located. Once the surrounding areas were traversed, the entire southeastern bay was traversed in 10-15 meter strips. First a visual method was used to identify any new locations of CLP, then a second pass was performed to detect CLP that may have been missed visually by using an underwater camera. No new locations of CLP were found.

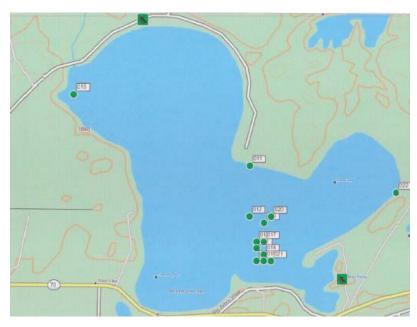
Figure 4: 2009 CLP locations from point intercept survey.

In July of 2009 a WDNR plant survey crew conducted a point intercept (PI) survey for Big Arbor Vitae Lake. One thousand ninety (1090) points were sampled at a 63-meter resolution. During the survey, 13 additional locations of CLP were found (Figure: 4 & Table: 2). The largest concentration was found in the central portion of the southern basin (Figure: 5). There were three additional PI points where CLP was collected: the far northwestern bay (point number 010), the northeastern bay (point number 022) and the north central shoreline (point number 011). The rake fullness for CLP for at all sites was not greater than 1. The overall the rake fullness for native vegetation was greater than that for CLP at all these sites.

Grid Datum	Lat/Lon hddd.ddddd" WGS 84		
ene in			
GPS ID	GPS WAYPOINT	RAKE FULLNESS	PINUMBER
10	N45.93744 W89.66594	1	7
11	N45.93114 W89.64648	1	738
12	N45.92661 W89.64650	1	746
13	N45.92434 W89.84571	1	769
14	N45.92377 W89.64571	1	770
15	N45.92264 W89.64572	1	772
16	N45.92604 W89.64488	1	785
17	N45.92434 W89.64489	1	788
18	N45.92320 W89.64490	1	790
19	N45.92263 W89.64490	1	791
19 20 21 22	N45.92660 W89.64407	1	803
21	N45.92263 W89.64409	1	810
The state of the s	N45.92883 W89.63024		010

Big Arbor Vitae should be monitored annually for CLP. Feasibility may determine the extent and time dedicated, however five main areas should be prioritized. These areas include the three PI locations (PI #'s 010, 022 & 011). Information gathered from this will assist in determining if these particular populations are changing. The remaining two priority areas are the southern basin site and the entire southeastern bay. Fine resolution sampling in these areas would be beneficial to determine changes in population extant and extent. Annual findings should be provided to the WDNR office in Rhinelander and to the Vilas County Invasive Species Coordinator.

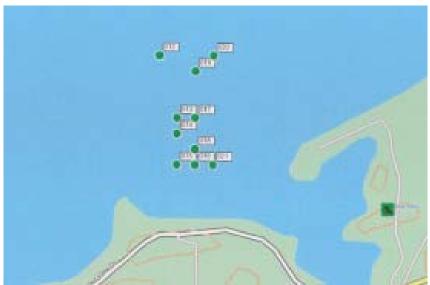
Figure 5: Largest concentration of CLP in the southern basin, based on the point intercept survey.

that even though CLP was present, it was not dominating the substrate. In addition it was noted that the CLP plants were significantly smaller in stature than the native plants. The two main areas of concentration are within the southeastern bay and the central area of the southern basin. Since CLP is found in a multiple of locations through out the entire lake it is critical to continue monitoring its spread and any changes in density.
