**Aquatic Macrophyte Survey for
Chetac Lake
Sawyer County, Wisconsin
WBIC: 2113300**

Project Initiated by:
Wisconsin Department of Natural Resources,
Big Chetac Chain Lake Association and
Short Elliott Hendrickson Inc.

Survey Conducted by and Report Prepared by:
Endangered Resource Services, LLC
Matthew S. Berg, Research Biologist
St. Croix Falls, Wisconsin
Summer 2008

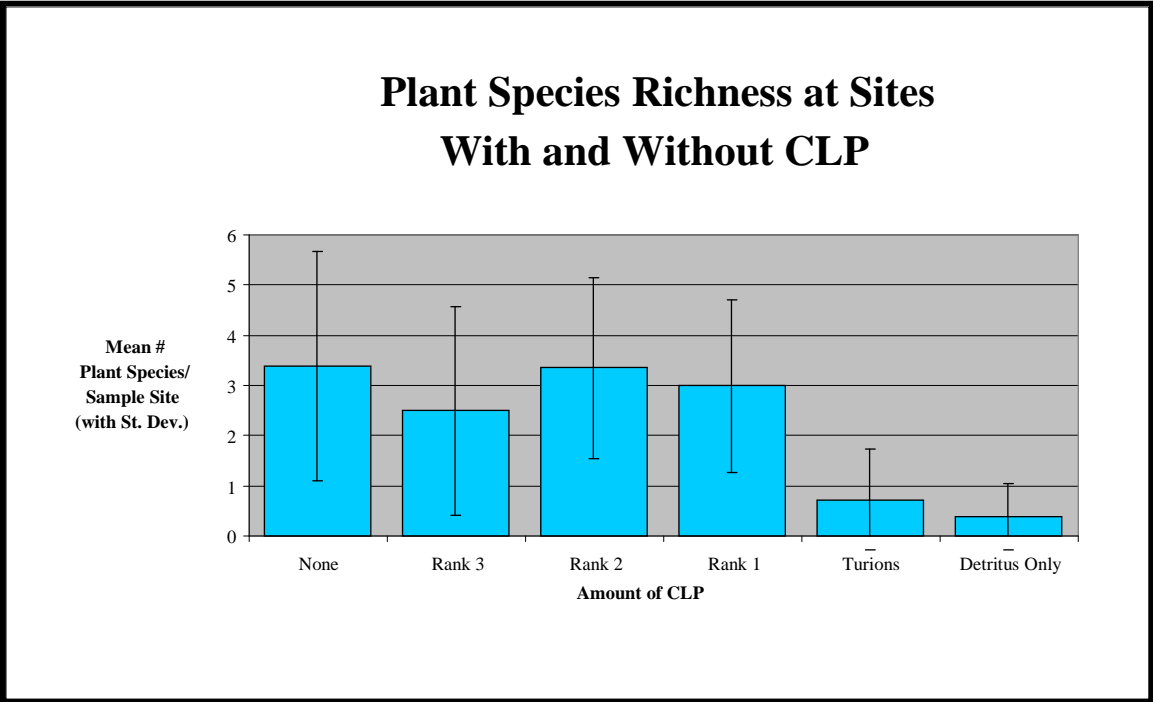
Figure 7: Species Richness With and Without CLP

With one exception, analysis of species richness at survey sites that did and did not have Curly-leaf pondweed failed to show a significant negative relationship. Only CLP Detritus locations had significantly lower species richness than areas with no CLP (Figure 7). The observed nearly significant negative trend with turions and the significant trend with detritus only locations may have more to do with the depths at these locations than with CLP. Many of the turion and detritus sites were at the edge of the July littoral zone where few native plants filled in the areas left vacant by the now senesced CLP. This was not the case in shallower water where native plants were found growing in many areas where CLP seemed to have excluded everything in June. In general, the high standard deviation rates seen in each analysis likely indicates that other factors such as depth, substrate and light penetration are likely more important than CLP presence/absence in determining species richness at any given site.

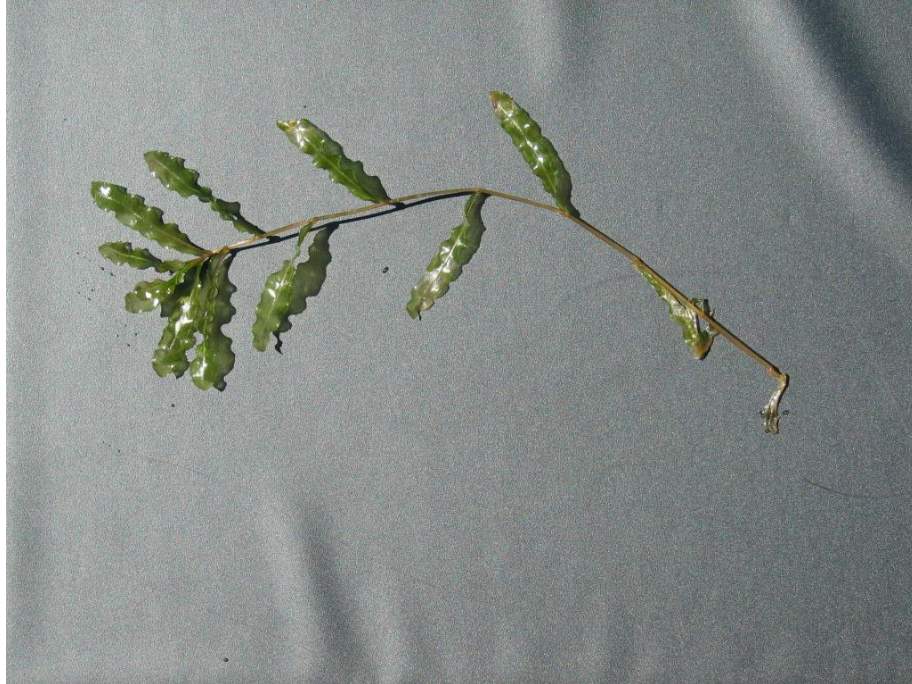
DESCRIPTION: Curly-leaf pondweed is an invasive aquatic perennial that is native to Eurasia, Africa, and Australia. It was accidentally introduced to United States waters in the mid-1880s by hobbyists who used it as an aquarium plant. The leaves are reddish-green, oblong, and about 3 inches long, with distinct wavy edges that are finely toothed. The stem of the plant is flat, reddish-brown and grows from 1 to 3 feet long. The plant usually drops to the lake bottom by early July

LIFE HISTORY AND EFFECTS OF INVASION: Curly-leaf pondweed spreads through burr-like winter buds (turions), which are moved among waterways. These plants can also reproduce by seed, but this plays a relatively small role compared to the vegetative reproduction through turions. New plants form under the ice in winter, making curly-leaf pondweed one of the first nuisance aquatic plants to emerge in the spring.

It becomes invasive in some areas because of its tolerance for low light and low water temperatures. These tolerances allow it to get a head start on and out compete native plants in the spring. In mid-summer, when most aquatic plants are growing, curly-leaf pondweed plants are dying off. Plant die-offs may result in a critical loss of dissolved oxygen. Furthermore, the decaying plants can increase nutrients which contribute to algal blooms, as well as create unpleasant stinking messes on beaches. Curly-leaf pondweed forms surface mats that interfere with aquatic recreation. (Taken in its entirety from WDNR, 2008 http://www.dnr.state.wi.us/invasives/fact/curlyleaf_pondweed.htm)

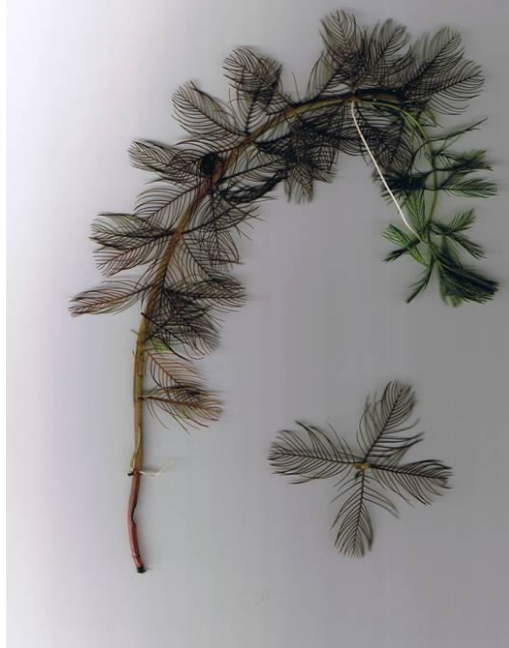
DESCRIPTION: Eurasian water milfoil is a submersed aquatic plant native to Europe, Asia, and northern Africa. It is the only non-native milfoil in Wisconsin. Like the native milfoils, the Eurasian variety has slender stems whorled by submersed feathery leaves and tiny flowers produced above the water surface. The flowers are located in the axils of the floral bracts, and are either four-petaled or without petals. The leaves are threadlike, typically uniform in diameter, and aggregated into a submersed terminal spike. The stem thickens below the inflorescence and doubles its width further down, often curving to lie parallel with the water surface. The fruits are four-jointed nut-like bodies. Without flowers or fruits, Eurasian water milfoil is nearly impossible to distinguish from Northern water milfoil. Eurasian water milfoil has 9-21 pairs of leaflets per leaf, while Northern milfoil typically has 7-11 pairs of leaflets. Coontail is often mistaken for the milfoils, but does not have individual leaflets.

Once established in an aquatic community, milfoil reproduces from shoot fragments and stolons (runners that creep along the lake bed). As an opportunistic species, Eurasian water milfoil is adapted for rapid growth early in spring. Stolons, lower stems, and roots persist over winter and store the carbohydrates that help milfoil claim the water column early in spring, photosynthesize, divide, and form a dense leaf canopy that shades out native aquatic plants. Its ability to spread rapidly by fragmentation and effectively block out sunlight needed for native plant growth often results in monotypic stands. Monotypic stands of Eurasian milfoil provide only a single habitat, and threaten the integrity of aquatic communities in a number of ways; for example, dense stands disrupt predator-prey relationships by fencing out larger fish, and reducing the number of nutrient-rich native plants available for waterfowl.

Dense stands of Eurasian water milfoil also inhibit recreational uses like swimming, boating, and fishing. Some stands have been dense enough to obstruct industrial and power generation water intakes. The visual impact that greets the lake user on milfoil-dominated lakes is the flat yellow-green of matted vegetation, often prompting the perception that the lake is "infested" or "dead". Cycling of nutrients from sediments to the water column by Eurasian water milfoil may lead to deteriorating water quality and algae blooms of infested lakes. (Taken in its entirety from WDNR, 2008 <http://www.dnr.state.wi.us/invasives/fact/milfoil.htm>)

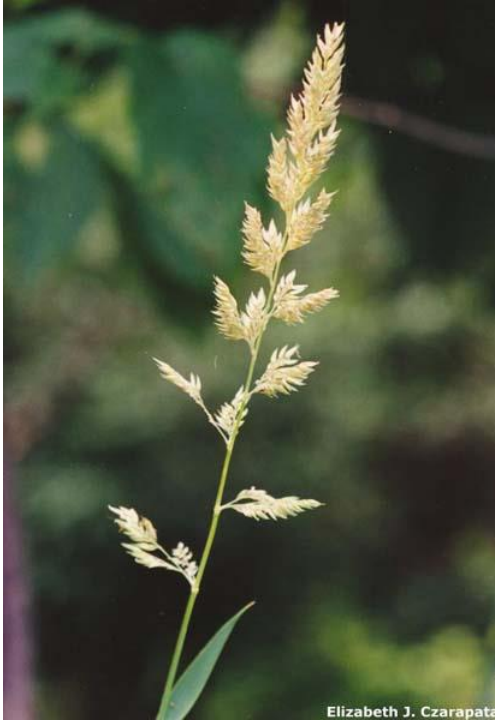
DESCRIPTION: Reed canary grass is a large, coarse grass that reaches 2 to 9 feet in height. It has an erect, hairless stem with gradually tapering leaf blades 3 1/2 to 10 inches long and 1/4 to 3/4 inch in width. Blades are flat and have a rough texture on both surfaces. The lead ligule is membranous and long. The compact panicles are erect or slightly spreading (depending on the plant's reproductive stage), and range from 3 to 16 inches long with branches 2 to 12 inches in length. Single flowers occur in dense clusters in May to mid-June. They are green to purple at first and change to beige over time. This grass is one of the first to sprout in spring, and forms a thick rhizome system that dominates the subsurface soil. Seeds are shiny brown in color.

LIFE HISTORY AND EFFECTS OF INVASION: Reed canary grass reproduces by seed or creeping rhizomes. It spreads aggressively. The plant produces leaves and flower stalks for 5 to 7 weeks after germination in early spring, then spreads laterally. Growth peaks in mid-June and declines in mid-August. A second growth spurt occurs in the fall. The shoots collapse in mid to late summer, forming a dense, impenetrable mat of stems and leaves. The seeds ripen in late June and shatter when ripe. Seeds may be dispersed from one wetland to another by waterways, animals, humans, or machines.

This species prefers disturbed areas, but can easily move into native wetlands. Reed canary grass can invade a disturbed wetland in less than twelve years. Invasion is associated with disturbances including ditching of wetlands, stream channelization, deforestation of swamp forests, sedimentation, and intentional planting. The difficulty of selective control makes reed canary grass invasion of particular concern. Over time, it forms large, monotypic stands that harbor few other plant species and are subsequently of little use to wildlife. Once established, reed canary grass dominates an area by building up a tremendous seed bank that can eventually erupt, germinate, and recolonize treated sites. (Taken in its entirety from WDNR, 2008
http://www.dnr.state.wi.us/invasives/fact/reed_canary.htm)

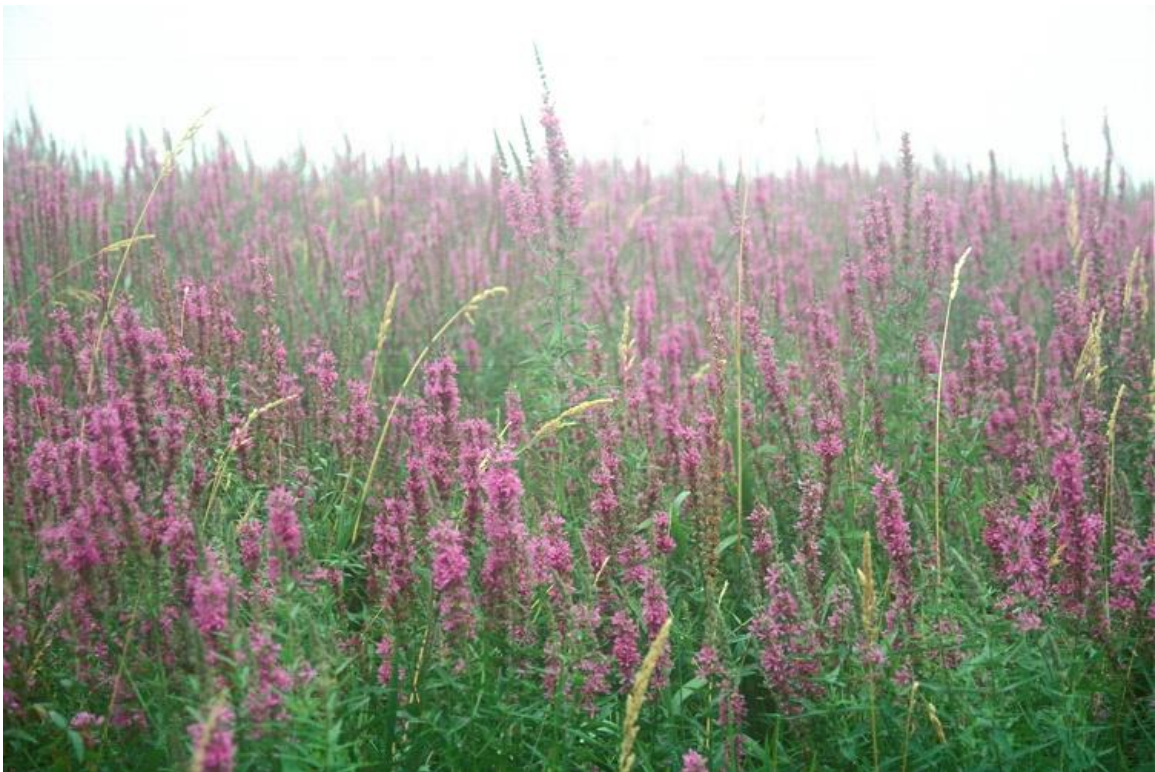
DESCRIPTION: Purple loosestrife is a perennial herb 3-7 feet tall with a dense bushy growth of 1-50 stems. The stems, which range from green to purple, die back each year. Showy flowers vary from purple to magenta, possess 5-6 petals aggregated into numerous long spikes, and bloom from July to September. Leaves are opposite, nearly linear, and attached to four-sided stems without stalks. It has a large, woody taproot with fibrous rhizomes that form a dense mat.
