AQUATIC PLANT MANAGEMENT PLAN

**BIG SAND LAKE
VILAS COUNTY, WISCONSIN**

July 5, 2007
Revised August 3, 2007

Northern Environmental Technologies, Incorporated
1203 Storbeck Drive
Waupun, Wisconsin 53963

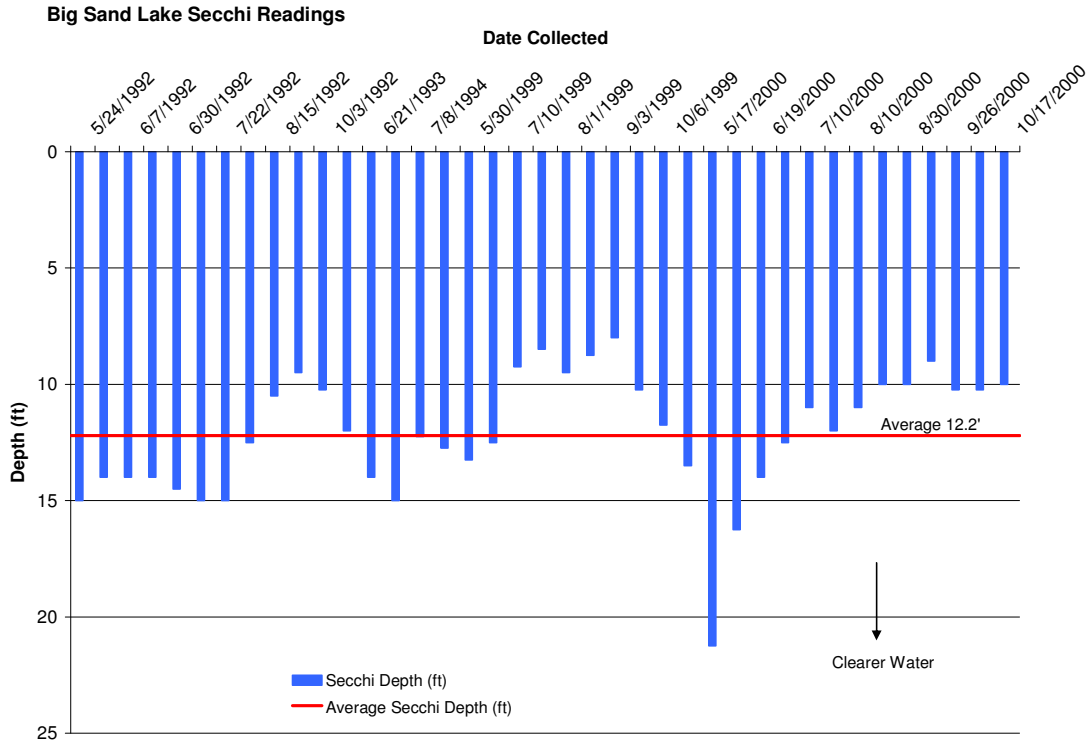
The historical water clarity average is 12.1 feet (3.7 meters). The following graph illustrates the historical and current water clarity measurements on Big Sand Lake.

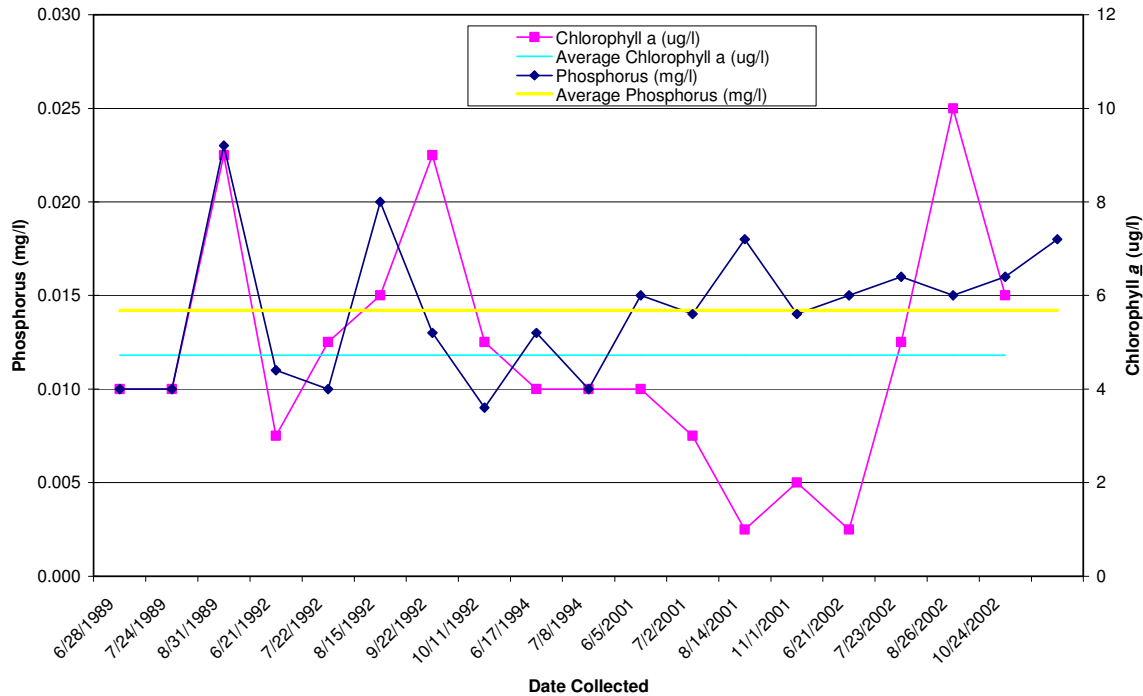
Big Sand Lake Chemistry Data

The following table illustrates the historical water quality parameters measured on Big Sand Lake.

The historical water clarity and chlorophyll *a* data indicate that Big Sand Lake is an oligotrophic lake. The total phosphorus data collected indicate an oligotrophic to mesotrophic lake system, according to the Wisconsin TSI.

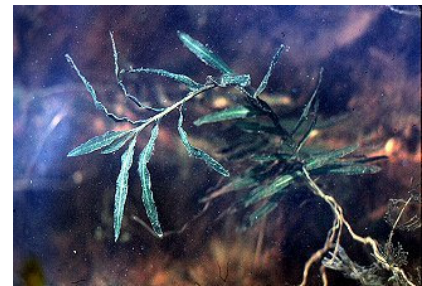
Fern Pondweed
Source: UW Herbarium Website

Potamogeton robbinsii (Fern Pondweed) is a submergent pondweed with robust stems and strongly two-ranked leaves, creating a feather or fern-like appearance while in the water. Fern pondweed sprouts in the spring and thrive in deeper water. Fern pondweed provides habitat for invertebrates that are grazed by waterfowl and also offers good cover for fish, particularly northern pike (Borman, et al., 1997).
