**AQUATIC PLANT MANAGEMENT PLAN**

**SCATTERING RICE LAKE  
VILAS COUNTY, WISCONSIN**

June 28, 2007  
Revised August 6, 2007

Northern Environmental Technologies, Incorporated  
1203 Storbeck Drive  
Waupun, Wisconsin 53963

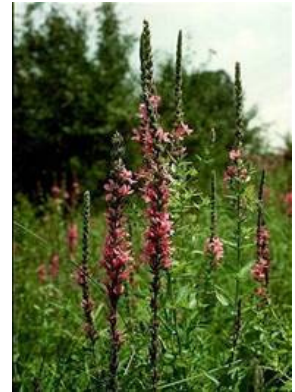
Purple loosestrife is a perennial herb 3-7 feet tall with a dense bushy growth of 1-50 stems. The stems, which range from green to purple, die back each year. Showy flowers vary from purple to magenta, possess 5-6 petals aggregated into numerous long spikes, and bloom from July to September. Leaves are opposite, nearly linear, and attached to four-sided stems without stalks. It has a large, woody taproot with fibrous rhizomes that form a dense mat

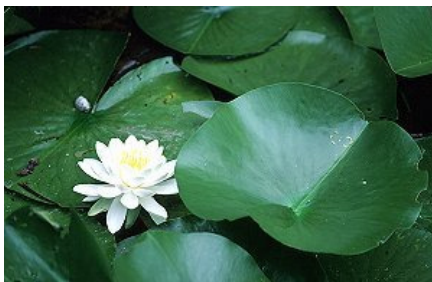
White Water Lily  
Source: UW Herbarium Website

*Nymphaea odorata* (White Water Lily) has a flexible stalk with a round floating leaf. White Water Lily can be found growing in a variety of sediment types in less than 6 feet of water. Fragrant white flowers occur throughout the summer. The floating leaves provide shelter and shade for fish as well as habitat for invertebrates (Borman, et al., 1997).

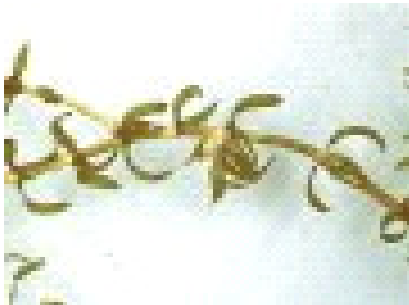
Elodea  
Source: UW Herbarium Website

*Elodea canadensis* (Elodea or common waterweed) is an abundant native plant species that is distributed statewide. It prefers soft substrate and water depths to 15 feet (Nichols, 1999). Elodea reproduces by seed and sprigs (USDA, 2002). The stems of elodea offer shelter and grazing to fish, but very dense elodea can interfere with fish movement. Elodea can be considered invasive at times and out-competes other more desirable plants.

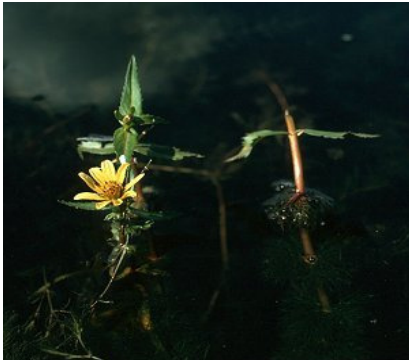
Water marigold  
Source: UW Herbarium Website

*Megalodonta beckii* (Water marigold) often is only seen below the surface of the water. The submersed leaves are finely cut into many thread-like divisions. When flowering occurs, a yellow daisy-like bloom develops on a sturdy stalk above the water surface. Water marigold is usually found growing in soft sediment in clear water lakes. It is considered an “indicator species.” It is sensitive to changes in water quality and may be one of the first submersed plants to disappear from a lake when water quality declines. (Borman, et al, 1997)

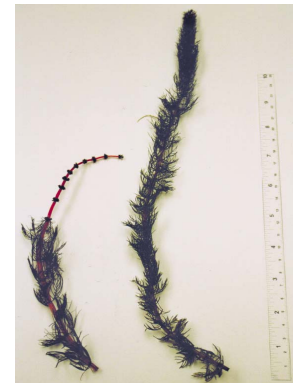
*Myriophyllum sibiricum* (Northern watermilfoil) is usually found growing in soft sediment in fairly clear-water lakes. Leaves are divided like a feather, with five to twelve pairs of thread-like leaflets. Leaves are arranged in whorls. Northern watermilfoil is more desirable than its invasive cousin, Eurasian watermilfoil. Waterfowl eat the foliage and fruit, while beds of this plant provide cover and foraging opportunities for fish and invertebrates.

Northern watermilfoil  
Source: UW Herbarium Website

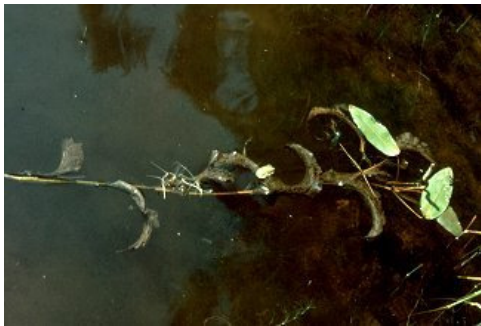
Large-leaf Pondweed  
Source: UW Herbarium Website

*Potamogeton amplifolius* (Large-leaf Pondweed) is also often referred to as musky weed or cabbage by anglers. Large leaf pondweed has robust stems and broad submersed leaves, which are slightly folded and lined with many veins. Floating leaves are oval and on long stalks. It is found mainly in soft sediments in water one to several feet deep and is sensitive to increased turbidity. The plant is commonly grazed by waterfowl, offers habitat for invertebrates, and foraging opportunities for fish (Borman, e al., 1997).

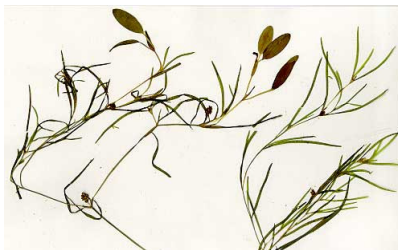
Spiral-Fruited Pondweed  
Source: UW-Green Bay website

*Potamogeton spirillus* (Spiral-Fruited Pondweed) is another pondweed with frequently branched stems and narrow, submersed leaves. When present, the floating leaves are elliptical in shape. This can be easily distinguished from other narrow-leaved pondweeds by its spiral-shaped fruit. Spiral-fruited pondweed grows abundantly when present and is important in stabilizing the sediment in shallow water. It also provides a food source for waterfowl, habitat for invertebrates, and foraging opportunities for fish (Borman, et al., 1997).

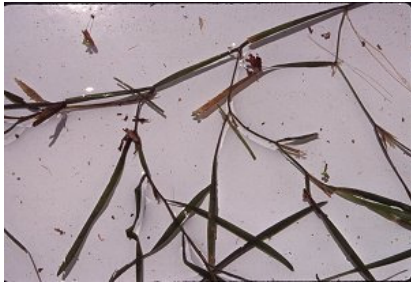
Flat- Stem Pondweed  
Source: UW Herbarium Website

*Potamogeton zosteriformis* (Flat-Stem Pondweed) is a submergent pondweed with freely-branched flattened stems. Flat stem pondweed is commonly confused with water stargrass (*Heteranthera dubia*) but Flat-stem Pondweed can be distinguished by its prominent mid-vein and many fine, parallel veins.

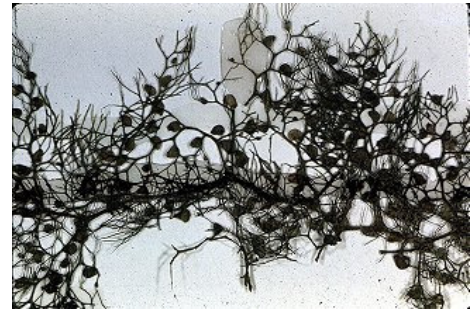
*Utricularia vulgaris* (Common bladderwort) has floating stems that can reach 2-3 meters in length. Along the stem are leaf-like branches that are finely divided. The divisions are filament-like, have no midrib, and fork 3-7 times. Scattered on these branches are the bladders that trap prey. Young bladders are transparent and green tinted, but they become dark brown to black as they age. The branches also have fine spines (spicules) scattered along their margins. Yellow, two-lipped flowers are produced on stalks that protrude above the water surface. Common bladderwort is free-floating and can be found in water ranging from a few inches to several meters deep. The trailing stems of common bladderwort provide food and cover for fish. Because they are free-floating, they can grow in areas of very loosely consolidated sediment. This provides needed fish habitat in areas that are not readily colonized by rooted plants (Borman, et al., 1997).

Common bladderwort  
Source: UW-Herbarium Website

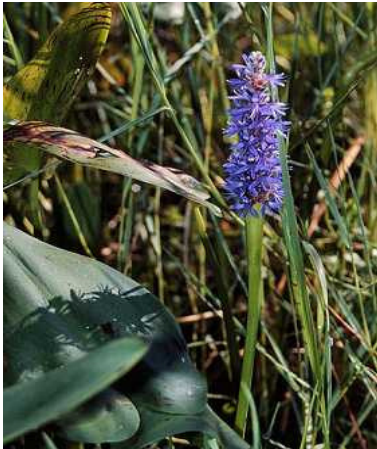
Pickerelweed  
Source: UW Herbarium Website

*Pontederia cordata* (Pickerelweed) has glossy, heart-shaped leaves that emerge from a robust, sprawling rhizome. The leaves have long, air-filled stalks with firm blades. The flower spike is crowded with small blue flowers. The blue-flowered spike of pickerelweed is distinctive. When it is not in flower, the leaves might be mistaken for arrowhead (*Sagittaria* sp.), water plantain (*Alisma* spp.) or wild calla (*Calla palustris*). The flowering stalk of pickerelweed is a haven for many insects—some seeking nectar and others a spot to rest. The seeds are consumed by waterfowl as well as muskrats. Beds of pickerelweed can be important shoreline stabilizers and help dampen wave action (Borman, et al., 1997).

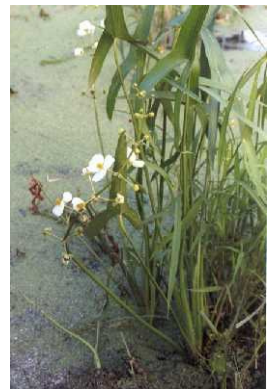
*Sagittaria* spp. (Arrowhead) is an emergent plant that usually produces leaves that are true to its name – shaped like an arrowhead. The size and shape of the leaf is highly variable with blades that range from a slender “A” shape to a broad wedge. Arrowhead is found in the shallow water of lakes, ponds, streams and marshes and usually found in water only ankle-deep, but will sometimes grow in water about 1 meter deep. Arrowhead is one of the highest value aquatic plants for wildlife and waterfowl depend on the high-energy tubers during migration. The seeds are also consumed by a wide variety of ducks, geese, marsh birds and shore birds. (Borman, et al., 1997).

Sagittaria spp.  
Source: UW Herbarium website
