Aquatic Plant Management Plan

Minocqua and Kawaguesaga Lakes
(Along with the Minocqua Thoroughfare and a portion of
Tomahawk Thoroughfare)

2008

Prepared by: Ecological Integrity Service, LLC and the
Minocqua-Kawaguesaga Lakes Aquatic
Plant Management Committee

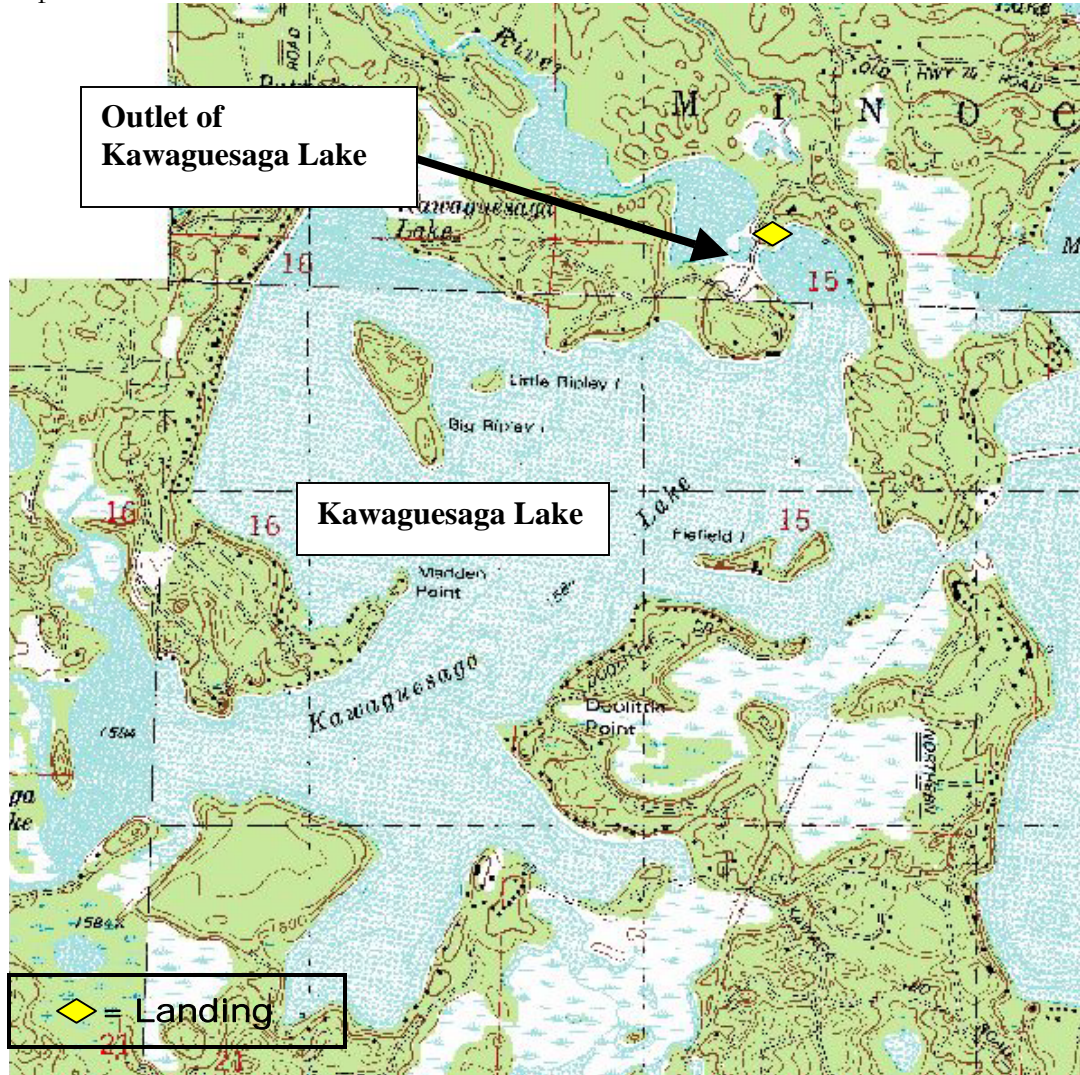
Figure 1: Topographical map of Kawaguesaga Lake

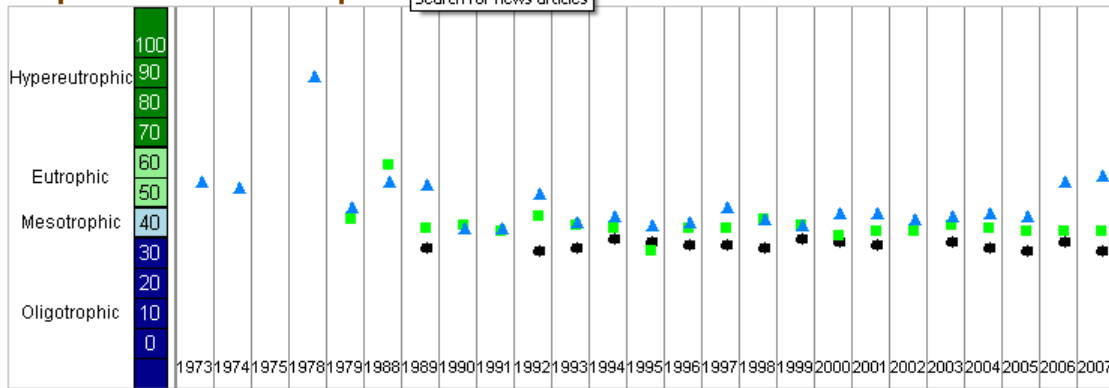
Monitoring Station: MINOCQUA LAKE - CENTER BASIN, Oneida County
 Past Summer (July-August) Trophic State Index (TSI) averages.

◆ = Secchi ■ = Chlorophyll ▲ = Total Phosphorus

Figure 6: Trophic State Index Graph-Minocqua Lake 1973-2007.

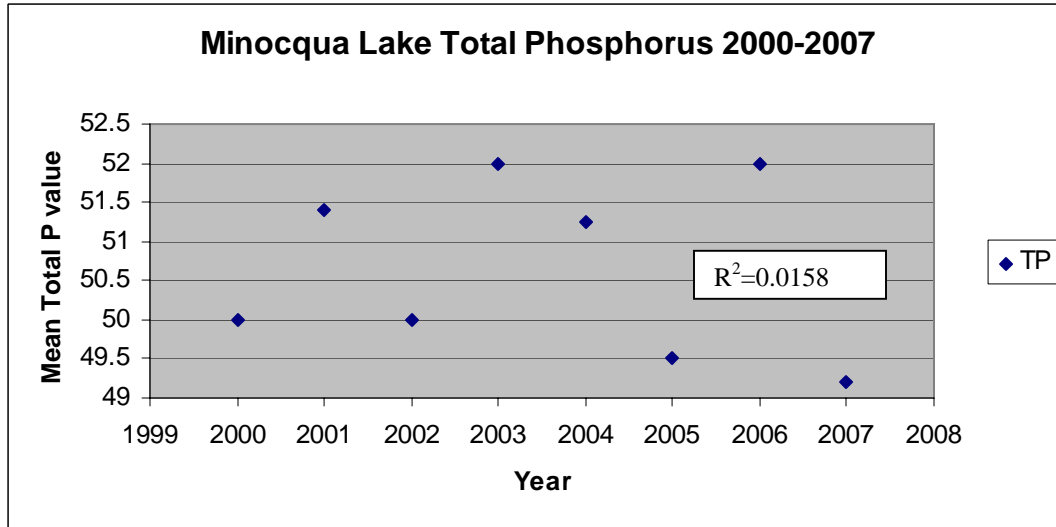
Figure 8: Total phosphorus trends Minocqua Lake 1998-2007

The trend lines for phosphorus are not necessarily valid. For Kawaguesaga Lake, there appears to be a slightly downward trend in total phosphorus since 2000. However the correlation is low and therefore this potential trend should be used with caution. As for Minocqua Lake, the total phosphorus readings since 1998 have been very erratic with no real correlation to a trend (although the trend line appears to be decreasing slightly).

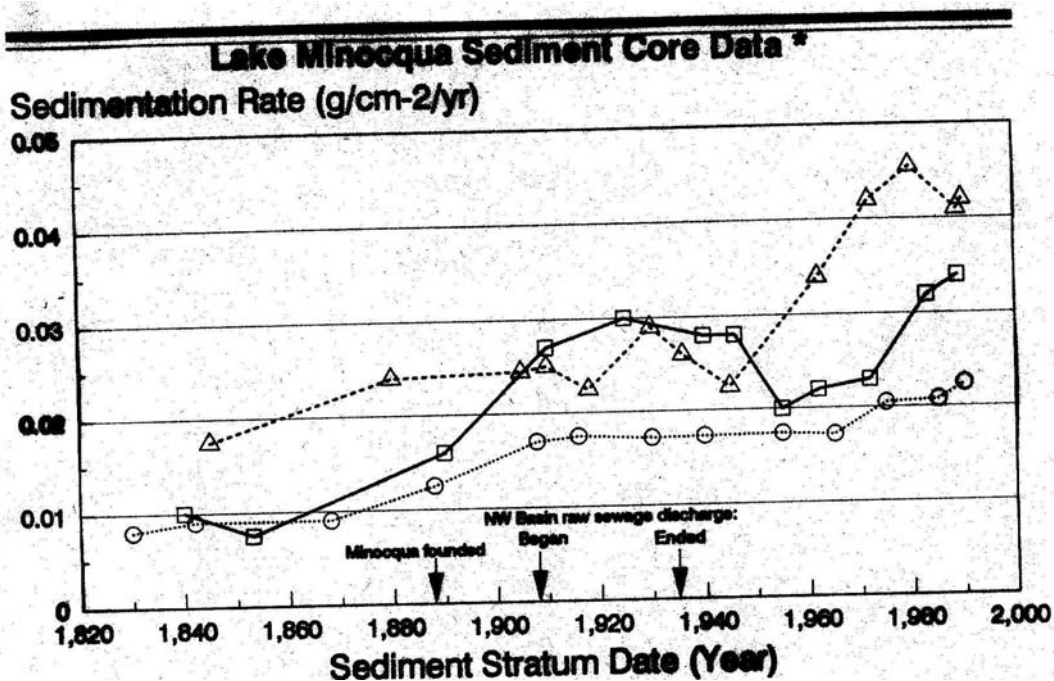
Figure 9: Sediment core graph⁸. Line differences are unknown.

Recently sediment cores were obtained and analyzed for historical sedimentation rates. The results suggest that sedimentation rates were relatively stable for many decades until about 40 years ago. From that point on, the sedimentation rates have increased immensely. This is most likely due to increased development on and near Kawaguesaga Lake and Minocqua Lake during the last few decades⁷.

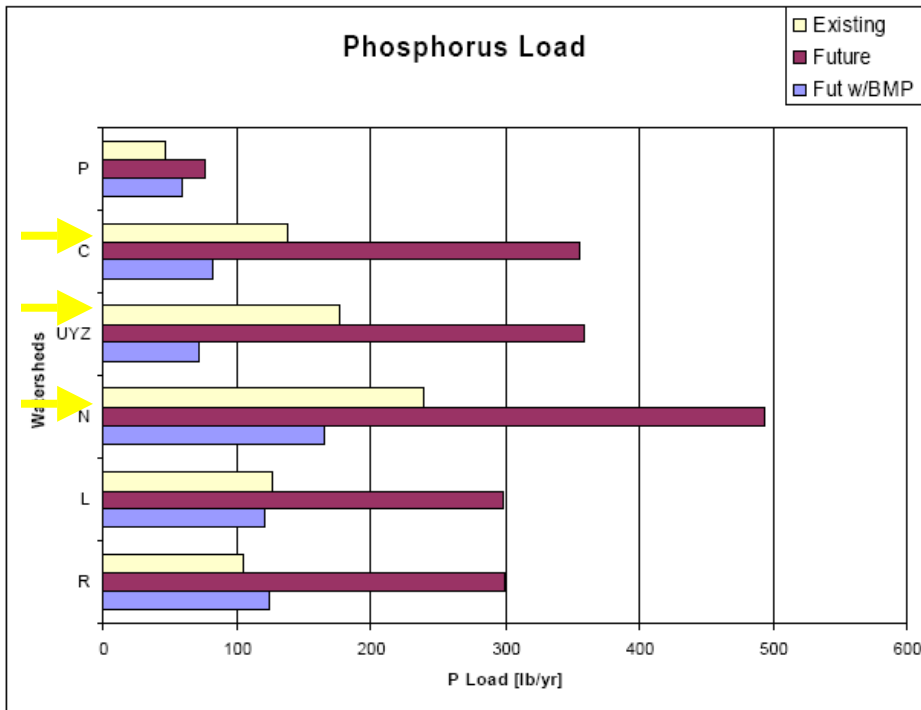
Figure 12: Phosphorus loading (lb/yr) by watershed (highest 3 marked).

Each sub-watershed (A to Z) contributes to the total phosphorus load. Table XX shows the area of each sub-watershed. Figure 12 graphically shows the highest phosphorus contributing sub-watersheds. Sub-watersheds N, C and UYZ (collectively) contribute the most respectively. Sub-watershed N makes up only 5.84% of the total watershed, yet has the most phosphorus load by a rather significant amount.

Sub-watersheds L, P and R are also significant contributors. All of these watersheds, along with C and N are adjacent to dense EWM stands. This nutrient influx can contribute to high nutrient sediments and exacerbate EWM growth.

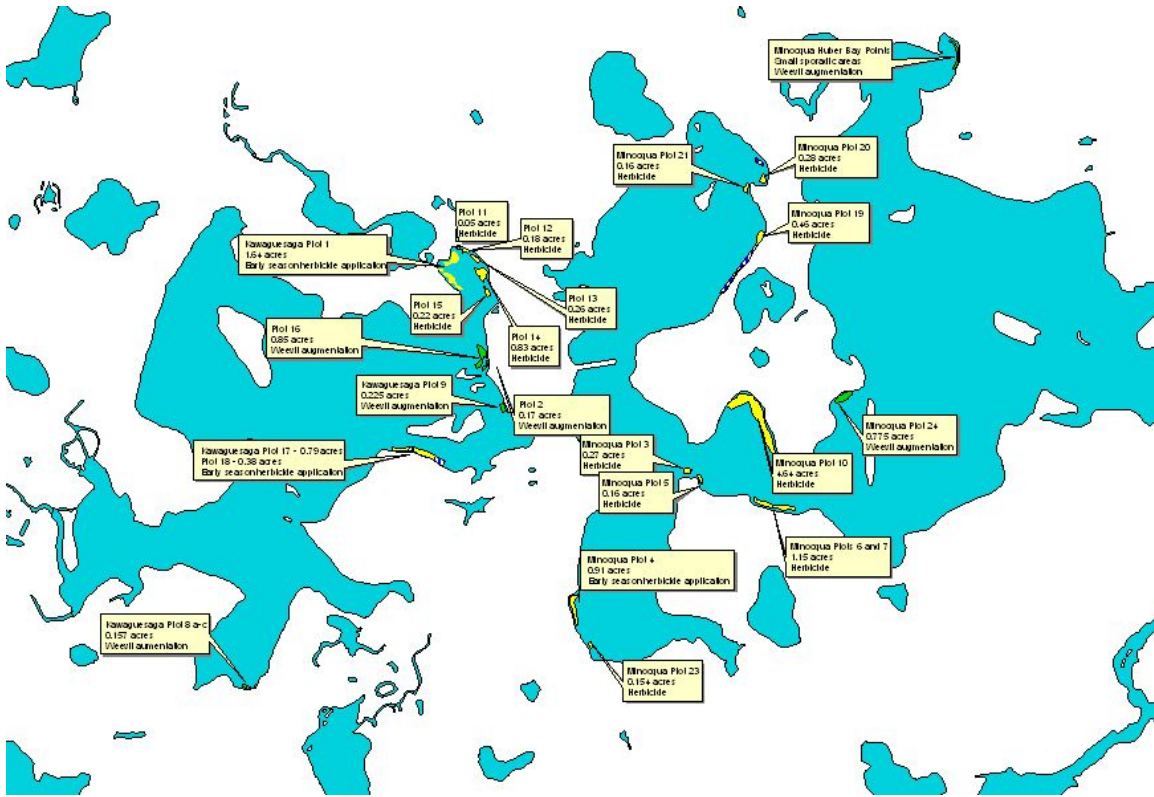
Figure 57: EWM locations with treatable beds-verified Sept. 2008

Any plot that has consistent density of 2 or higher throughout, has a defined boundary, and is navigable to map (or 400 sq ft or more), will be considered for herbicide application. The plot will be surveyed following the pre-treatment protocol outlined by the Wisconsin DNR.

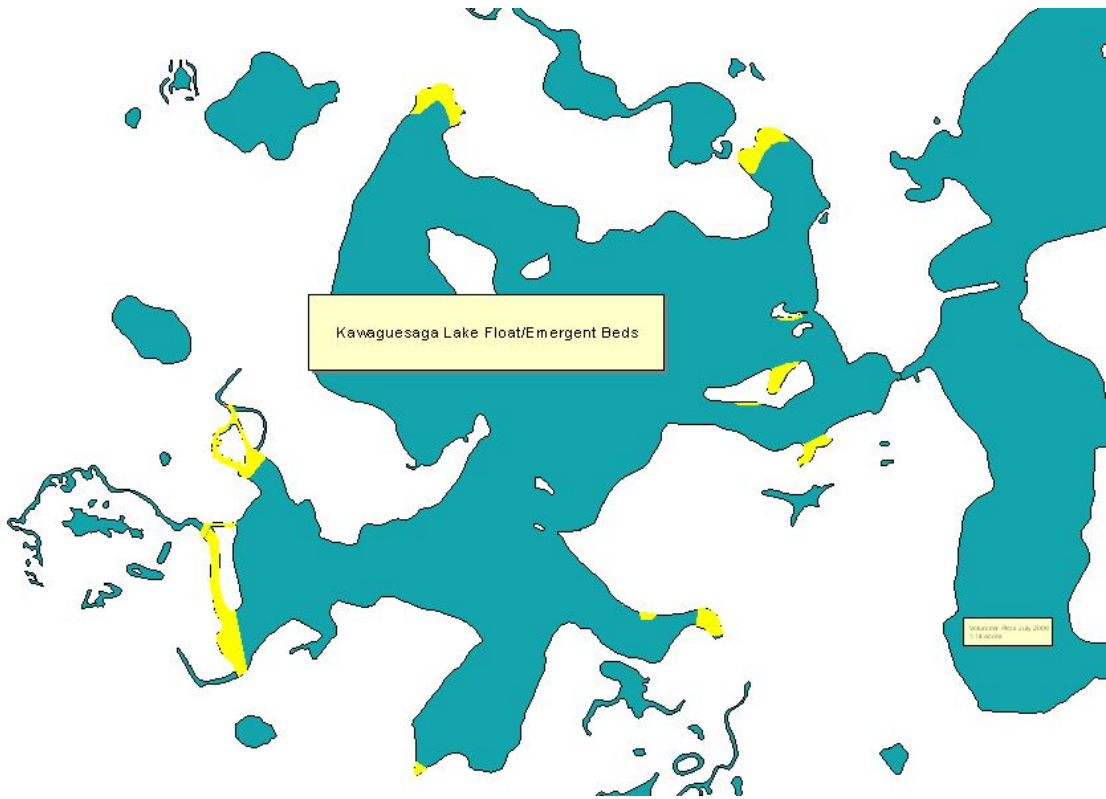
Figure 62: Map of floating-leaf and emergent plant areas in Kawaguesaga Lake.

Figure 62 shows the areas of Kawaguesaga Lake that have floating leaf plants and where emergent plants were sampled. These areas provide important fish, wildlife and bird habitat. Every effort should be used preserve these important areas. These efforts could include educating residents and lake users about their importance and the need for preservation and to avoid herbicide applications in or near these areas. Although a sensitive area survey has not been conducted, the areas highlighted in Figure 62 would be a good start for sensitive area designation.
