SUMMARY REPORT
FOR THE
BIRCH LAKE RESTORATION PROJECT – PHASE II

IOWA COUNTY
WISCONSIN

APRIL 2013

PREPARED
FOR
THE VILLAGE OF BARNEVELD

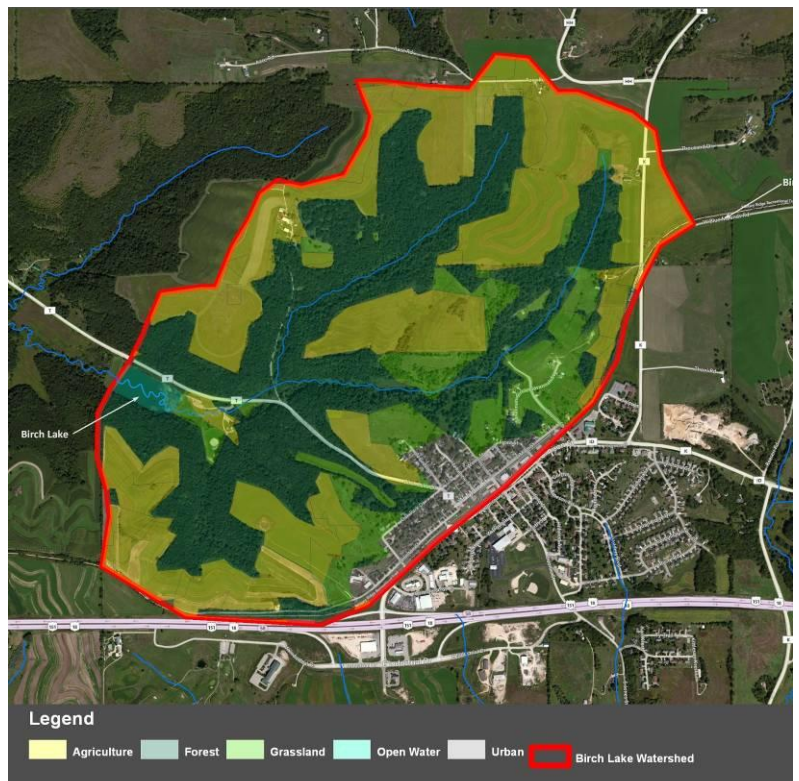
Figure 1.1. Birch Lake watershed boundaries and land use

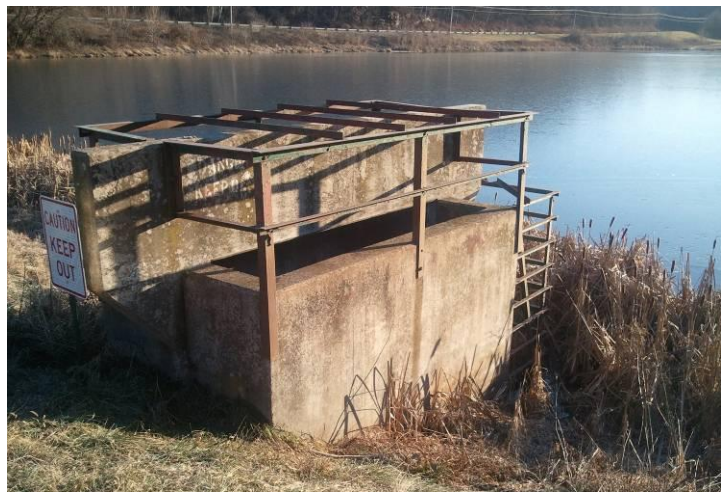
Figure 1.4. Existing dam control structure

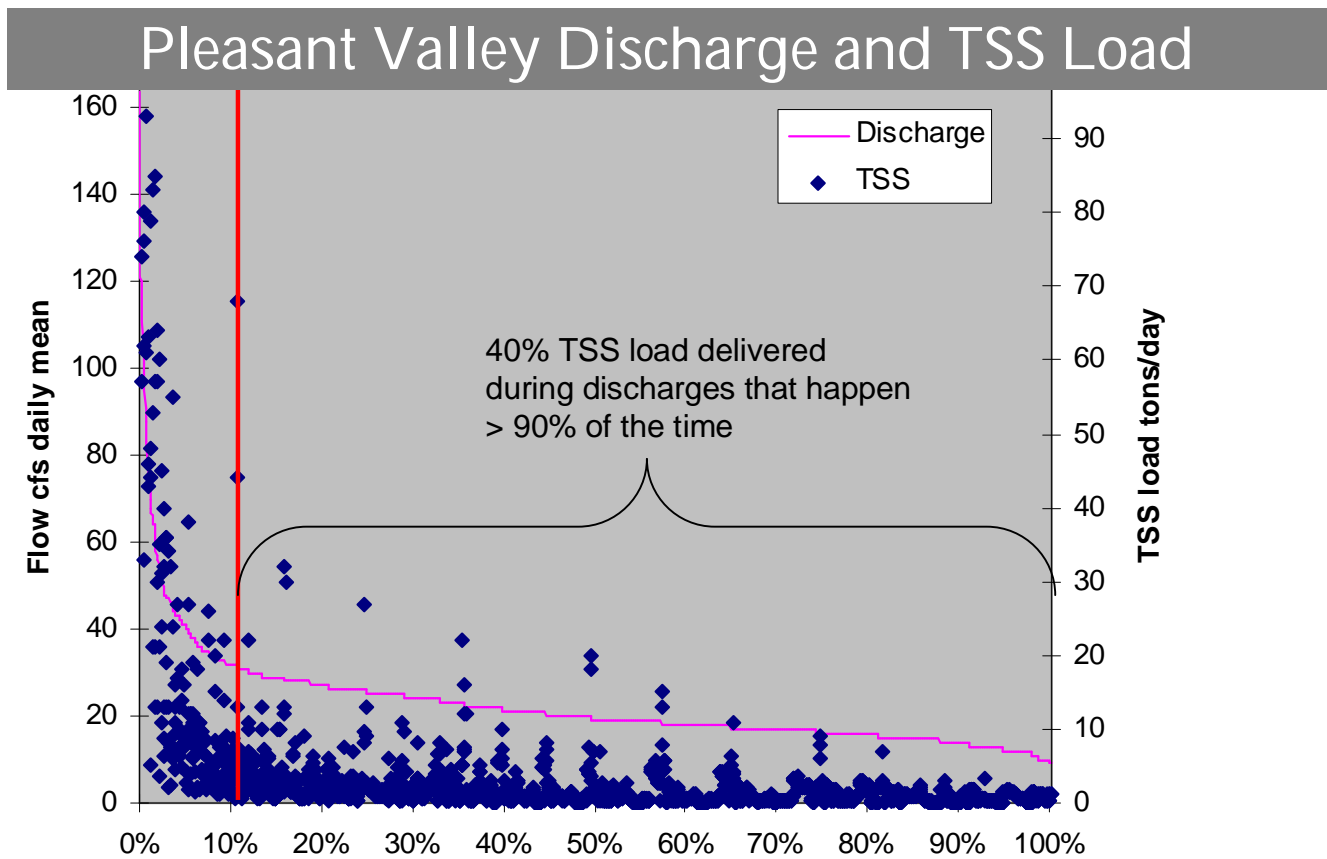
Figure 4.5. Pleasant Valley discharge and TSS load exceedance graph.

Data collected from four watersheds in Grant and Iowa Counties, where the Wisconsin DNR had performed 2 year TMDL's studies (DNR, 2007 and DNR, 2008), were evaluated. In addition, in Pleasant Valley, a tributary to the Pecatonica River, located just across Military Ridge, the USGS has been monitoring rainfall, discharge and total suspended solids (TSS) since 2007. Data from all five watersheds indicate that approximately 60% of all sediment load discharged was during high flow events, e.g. times that happened less than 10% of the time (see *Figure 4.5*).

The graph in Figure 4.5 indicates that for the majority of the time (over 90% of the time) we have low flow conditions that deliver as much as 40% of the annual sediment loads. The implication for the Birch Lake watershed is that by just diverting the low flows (< 1-year recurrence) significant reduction in annual sediment inputs to the lake could be accomplished. Baseflow sampling from 2009 in Trout Creek upstream of Birch Lake show fairly high TSS concentrations (20 mg/l) similar to what was found in the Pleasant Valley watershed (about 22 mg/l during periods of baseflow or low flow events). The similarity in TSS concentrations suggests that the similar conditions of low flow sediment delivery could be found in the Birch Lake Watershed.

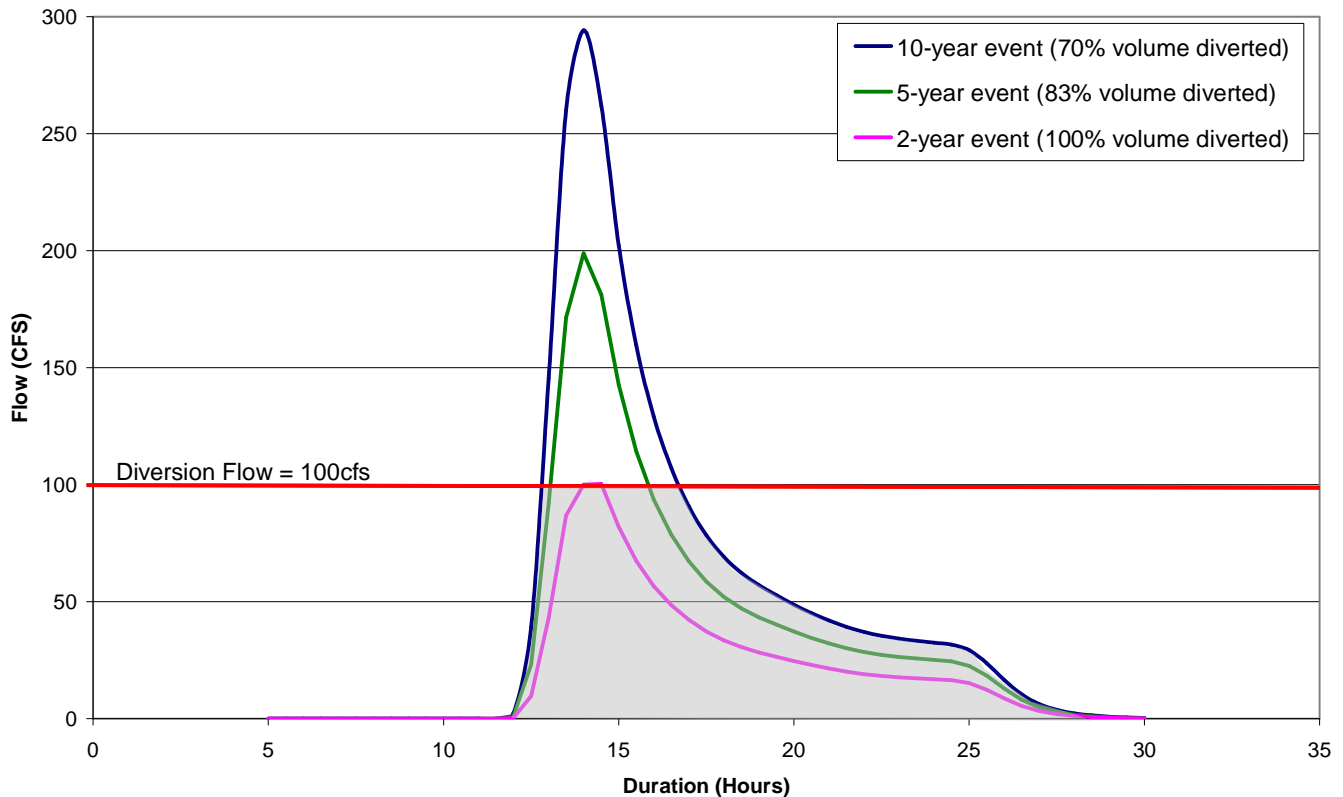
Figure 4.7. Birch Lake flow hydrographs showing volume diverted if 2-year event peak flow is fully diverted.

The red line shows the flow for the 2-year event. The volume of water during an event is represented by the area underneath the lines for each event. The area shaded in gray in Figure 4.7 represents all volume that is diverted from going into the lake. If 100 cubic feet per second are diverted, then 100% of the 2-year event volume is diverted but up to 83% of the 5-year event and as much as 70% of the 10-year event volume is also bypassed the lake.

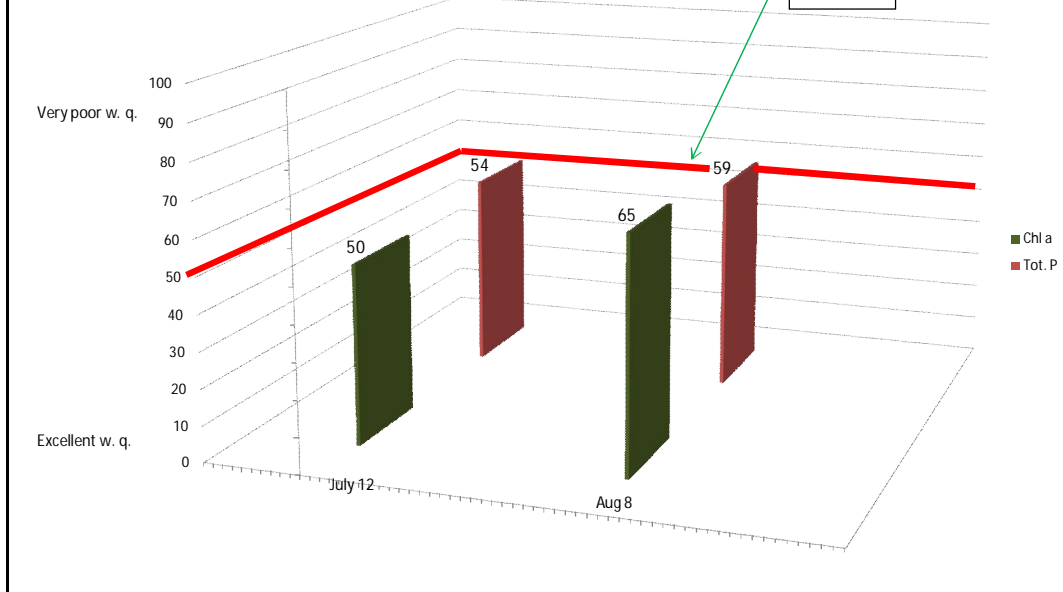
Figure 7: 2012 Birch Lake Chlorophyll-a and Total Phosphorus TSI Values

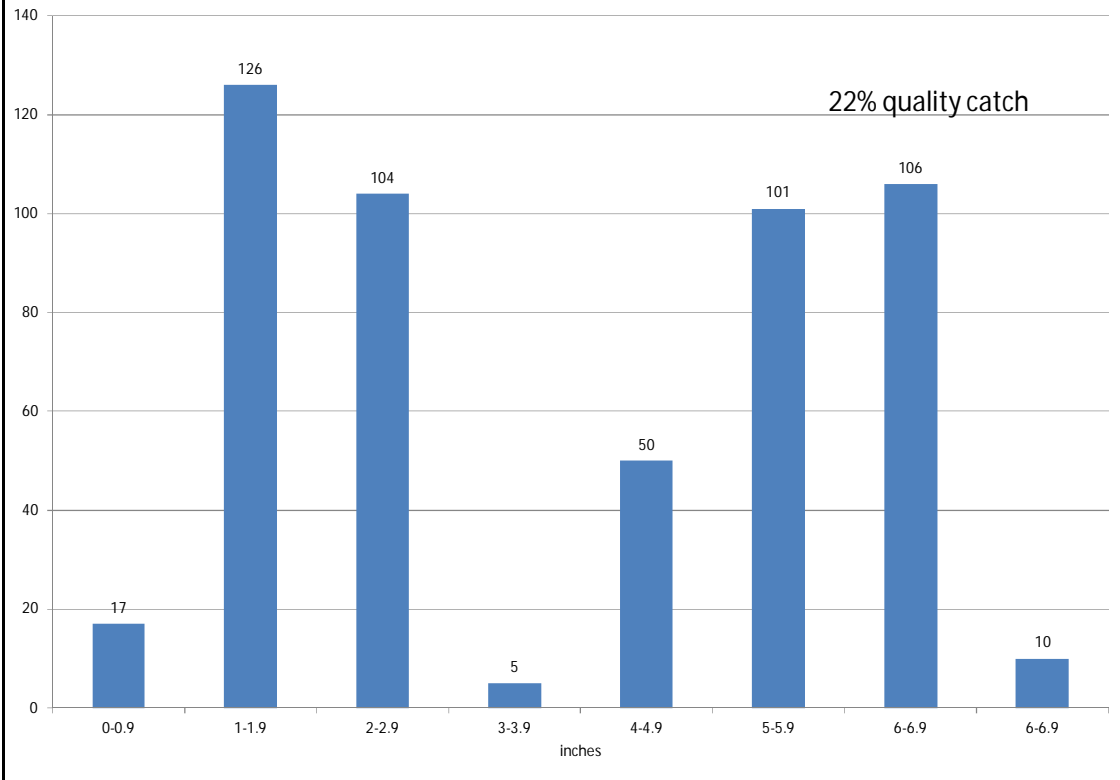
Figure 11: Birch Lake Bluegill Size Distribution

Birch Lake Fish Populations: Recent boomshocking and fyke net surveys conducted by DNR revealed that Birch Lake is predominantly a largemouth bass-bluegill lake, typical of many fish ponds in Wisconsin. Low numbers of black crappie are also found in the lake. Figures 11 and 12 display the length distributions for bluegills and largemouth bass. These data reveal that quality size fish occur in the lake but the overall size structures provides only a modest sport fishery. The dense growths of Elodea can result in over-populations of slow growing panfish and bass. The data revealed that quality catches of bluegill were limited to about 22% of the population while only 11% of the largemouth bass were legal harvest sizes.

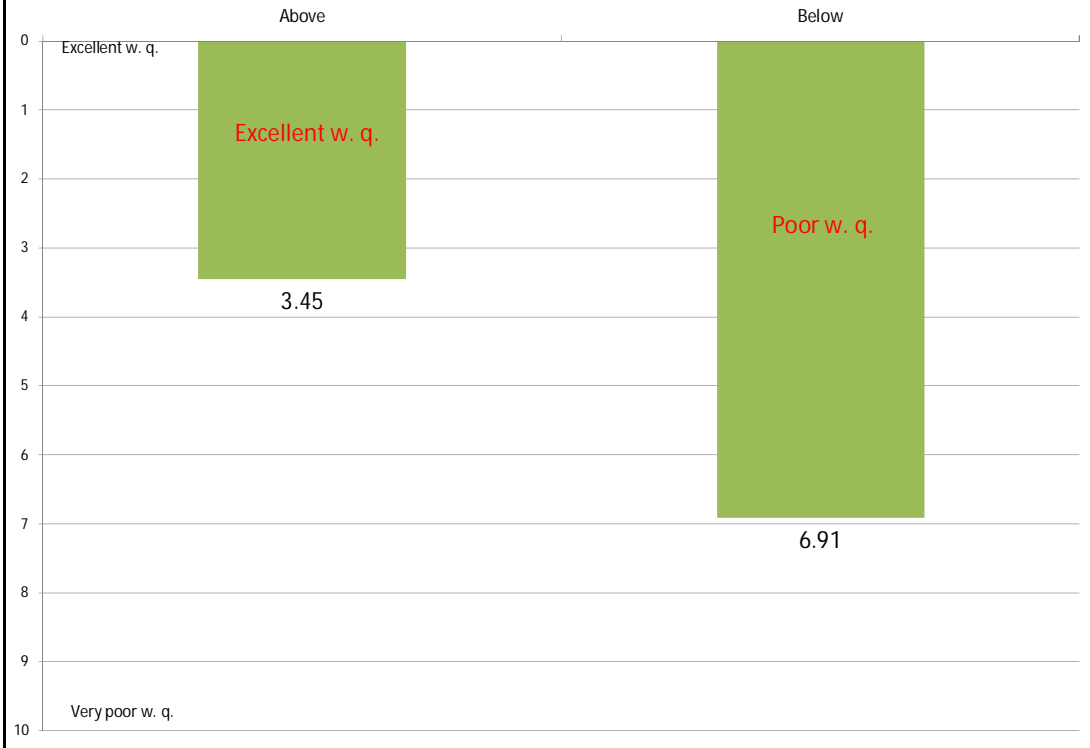
Figure 13: Trout Creek Aquatic Insect FBI - 5/15/2012

Trout Creek Macroinvertebrates: Consistent with both previous studies and other water quality parameters measured during this study, stream macroinvertebrates (aquatic insects and crustaceans) displayed much better water quality above the dam. The Family-level Biotic Index revealed "excellent" water quality of the stream within the park but "poor" water quality below the dam (Figure 13).
