**SUMMARY REPORT OF THE
HYDRAULIC CONVEYOR SYSTEM**

**TOMAHAWK LAKE ASSOCIATION
TOMAHAWK, WISCONSIN**

March 16, 2009

Project Number: 400-1067

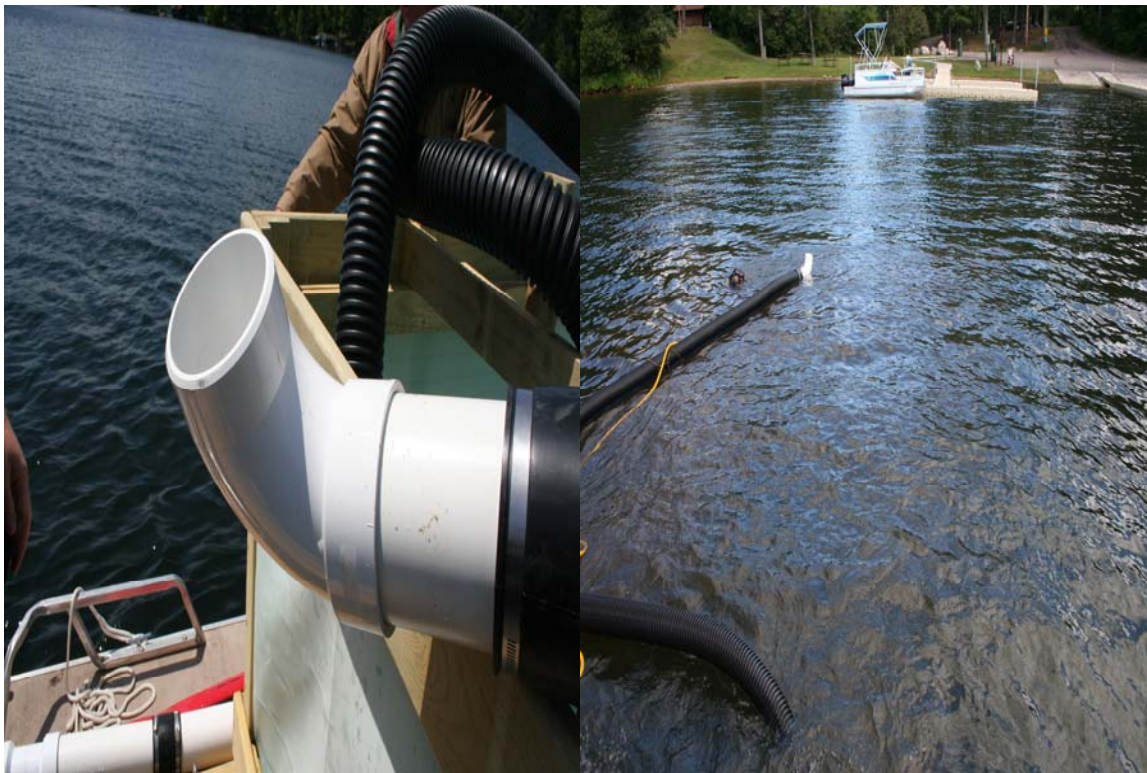
Figure 1. The upward facing flange (left) on the end of the HSC 8” diameter hose (right).

Extending from the front of the pontoon boat itself there is a 20-foot long suction hose made of ribbed plastic, 8” in diameter (the hydraulic-siphon hose). At the end of the hose there is an intake with a handle and a water-surface facing flange (Figure 1). The surface facing flange is a design measure that insures that the suction tube cannot be placed in direct contact with the lake bottom substrate. There is no suction removal of non-suspended lake bottom substrate with the HCS. The HCS is not intended to be and dose not function as a dredge of any kind.

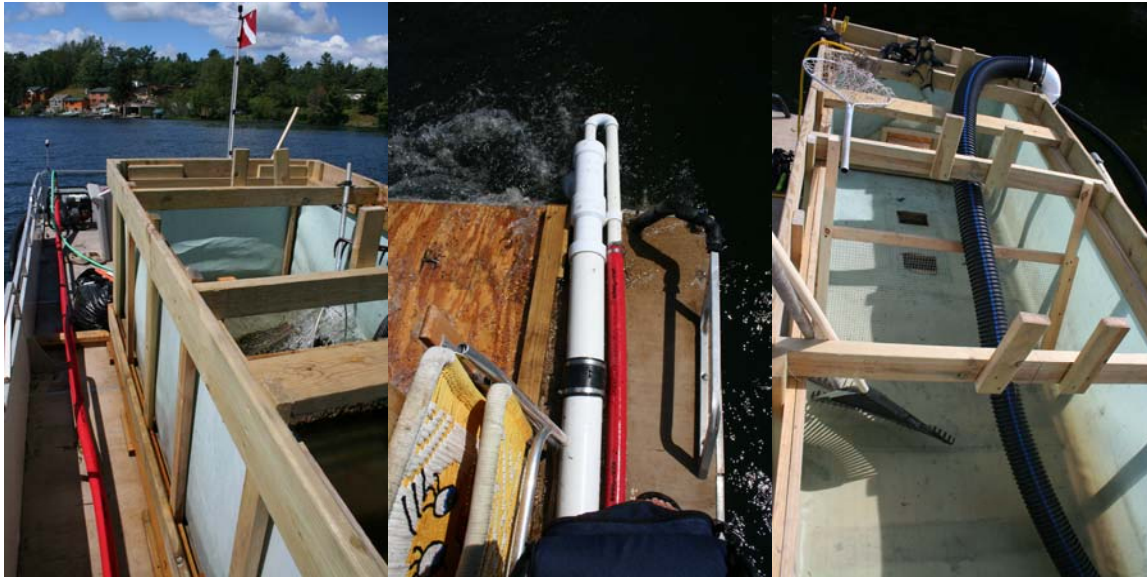
Figure 2. HCS pumps, hoses, and catch basin.

The hydraulic-siphon hose is attached to a pumping system that uses water under pressure and the venture effect to create suction. The Suction draws water and suspended plant material through the hose. The hose empties into a ten-foot by four-foot catch basin that stands just over three feet high (Figure 2). The catch basin is made out of a plastic-coated mesh, textile with pour spaces to allow water to drain from the catch basin, while retaining plant material. Modifications were made to the catch basin throughout the demonstration period so that water and sediment could pass more efficiently through the catch basin and efficient harvest could be maintained.

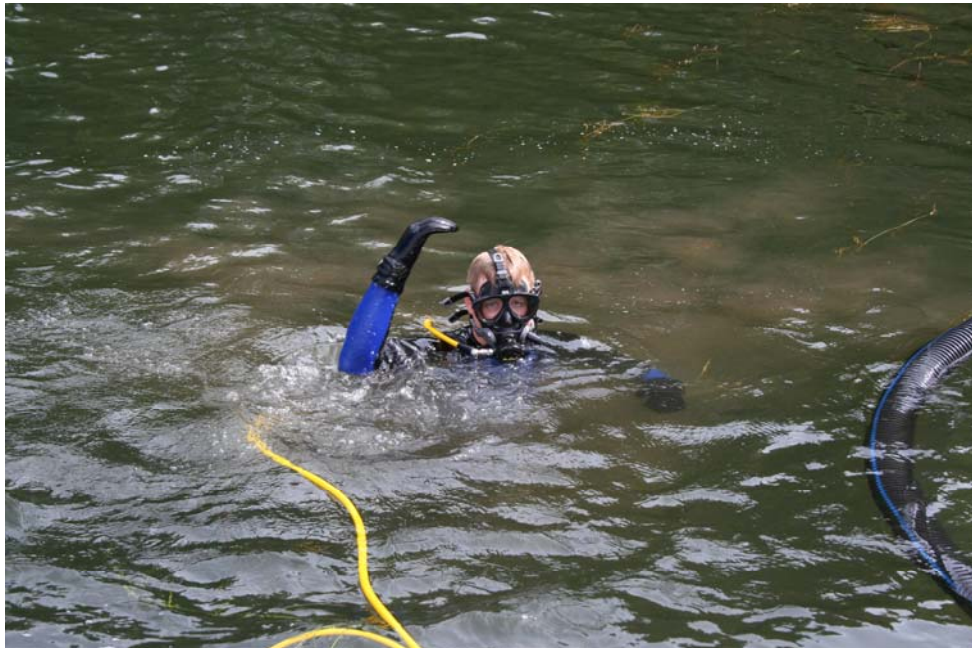
Figure 3. HCS diver with the hookah air-supply system.

A hookah air-supply system that pumps surface air to a diver through a one-inch diameter hose is mounted on the pontoon boat's deck (Figure 3). The hose is attached to the diver's face-mask. A diving flag and text on the side of the boat warns boaters that divers are in the area (Figure 4).

For the most part water flowing out of the HCS was very clear and carried relatively little sediment (Figure 11). Depending on how much of the root wad was removed along with the EWM plant there were pulses of water with a high degree of sediment moving through the system. The degree to which sediment was disturbed depended somewhat on the very localized type of lake bottom substrate in which the divers were working. If divers were in thick muck and the roots held a lot of bottom substrate, sediment would occasionally move through the system and cause a plume. When present the sediment plume settled quickly (less than five minutes) and the suspended sediment did not compare to the plume created by the diver's feet as seen in Figure 3.

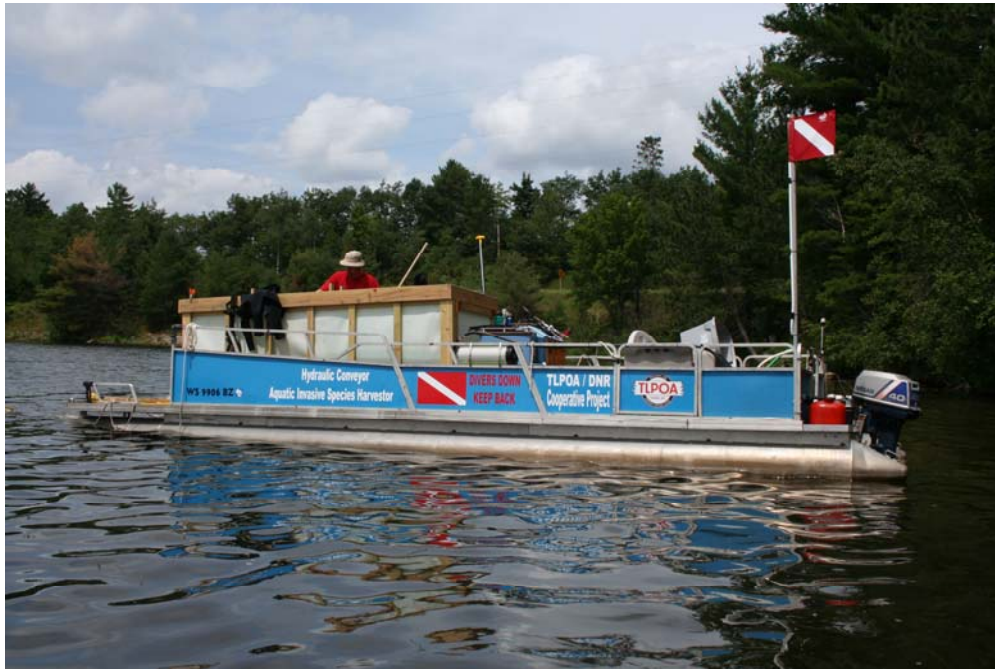
Figure 4. The modified pontoon boat that became known as the HCS.

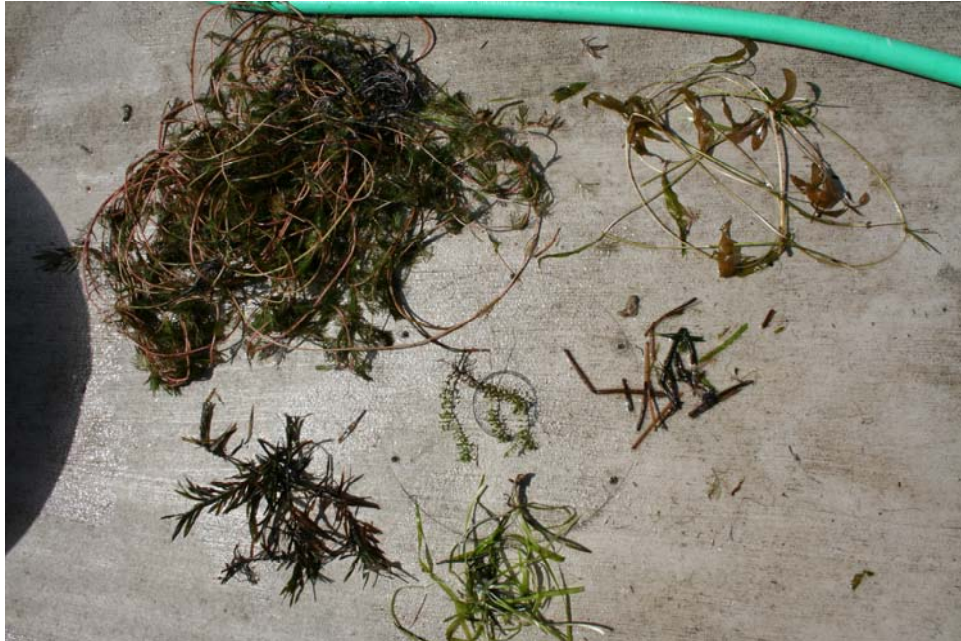
Figure 5. Typical by-catch for operation of HCS while targeting EWM (upper left).

The by-catch data recorded by Northern Environmental during visits to the HCS showed an average of 84% of the plant mass removed was EWM (Figure 5). Secchi Disk results were not recorded because much of the time the HCS was in operation the water was too shallow for a reading and water clarity extended to the bottom of the lake in that depth. The Secchi Disk was still used as a guide to water clarity (see example image in Figure 6), but only used to see if outflow created a sediment plume which could be perceived as a problem.

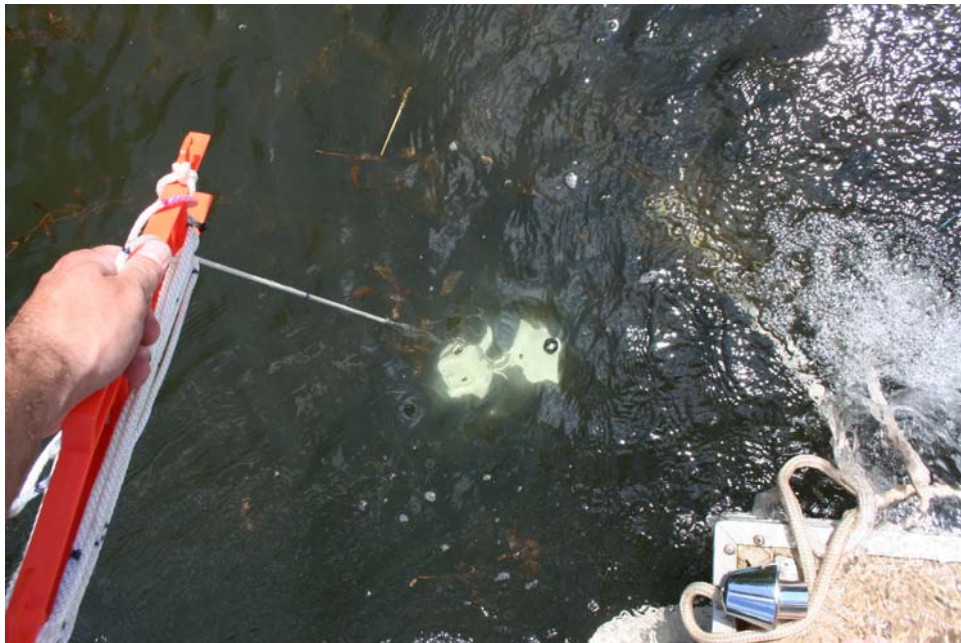
Figure 6. Secchi Disk reading off bow of HCS while in operation.

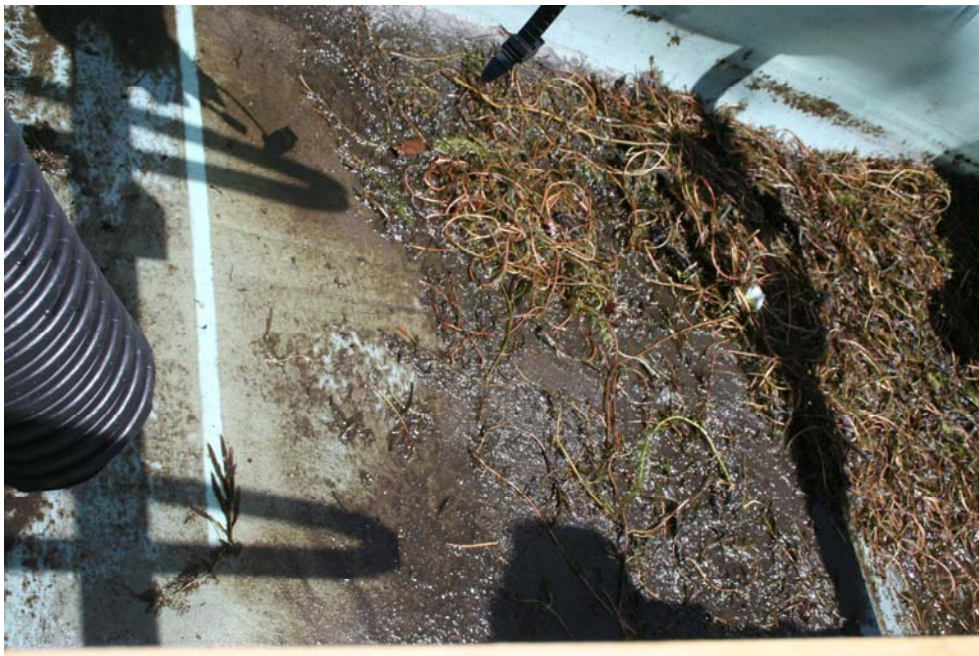
Figure 7. Sediment that was caught in the HCS catch basin.

The catch basin on the HCS was made of a poly-coated fabric screen used for draining paper pulp. It seemed to work well for containing all EWM fragments and sediment that was captured from the water column near the root wad of the plant removed (Figure 7). Sediment would, however, build up in the catch basin and not allow water to drain. This condition allowed water to fill up the catch basin and make the boat top heavy. When this situation occurred, all operations were halted and both divers cleaned the catch basin.

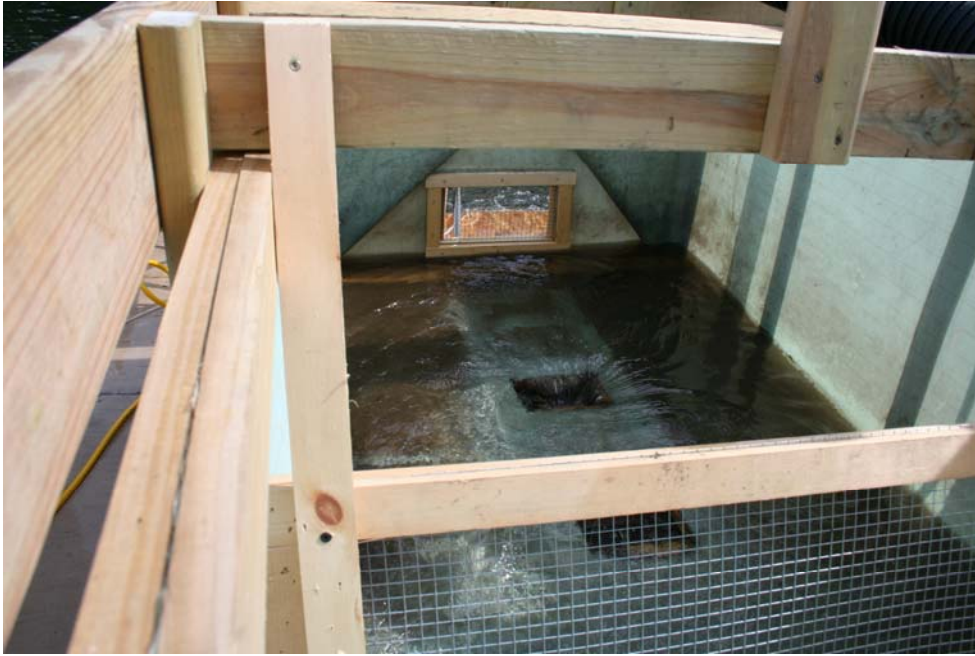
Figure 8. Screened holes added to the HCS catch basin looking from the primary containment area.

The crew members added several of these screened openings, including one off the front of the catch basin (Figure 8). Eventually they moved to a primary containment system that caught most of the EWM before it entered the catch basin (Figure 8) and they removed and bagged the EWM from this smaller area. Sometimes the crew had a fishing net at the end of the suction hose and used the net as a pre-primary containment system (Figure 9). This allowed for easy transportation of the EWM to the garbage bag. Even with these modifications the crew had to

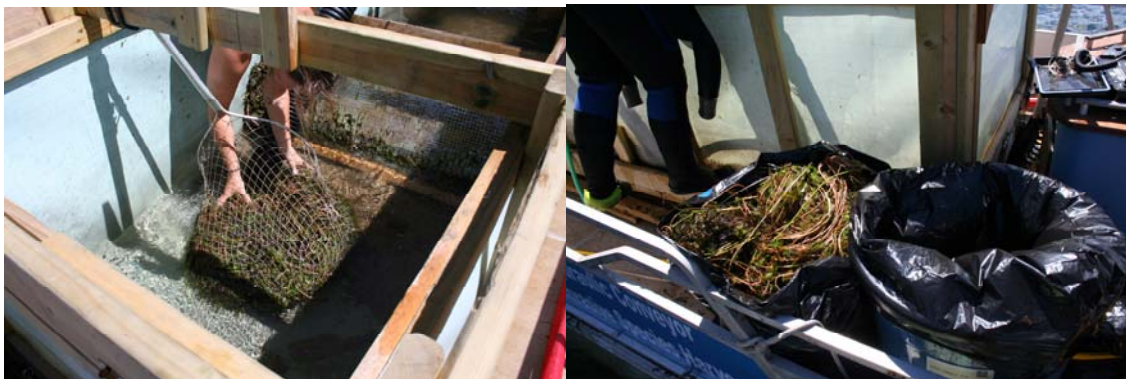
Figure 9. HCS crew collecting and bagging EWM from the primary containment area.

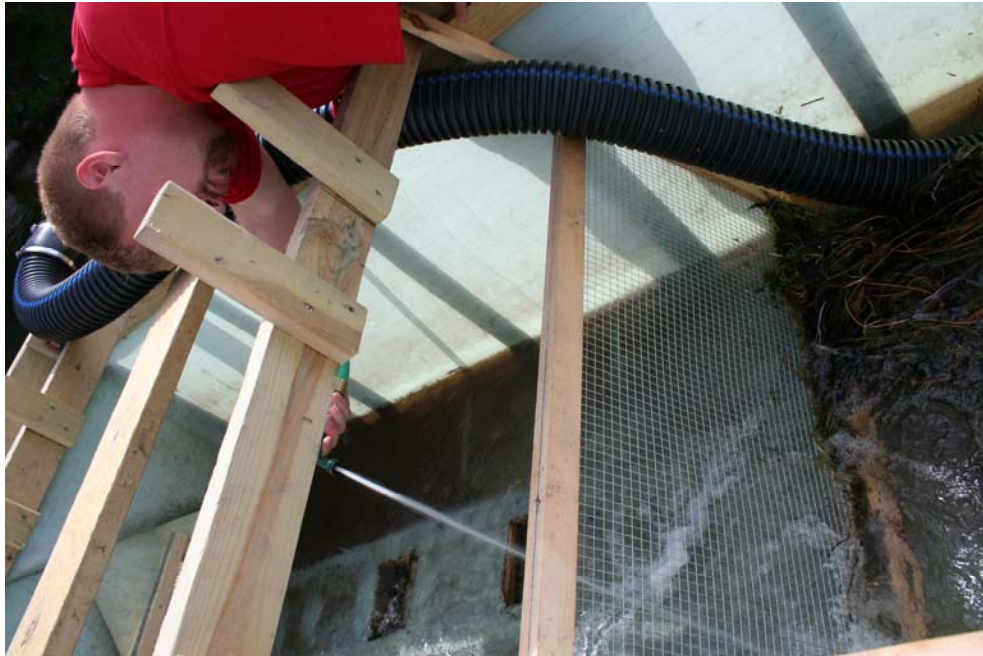
Figure 10. HCS crew hosing of the screen of the primary containment area.

constantly maintain the opening using the high pressure hose (Figure 10) which kept clean water moving through the system.

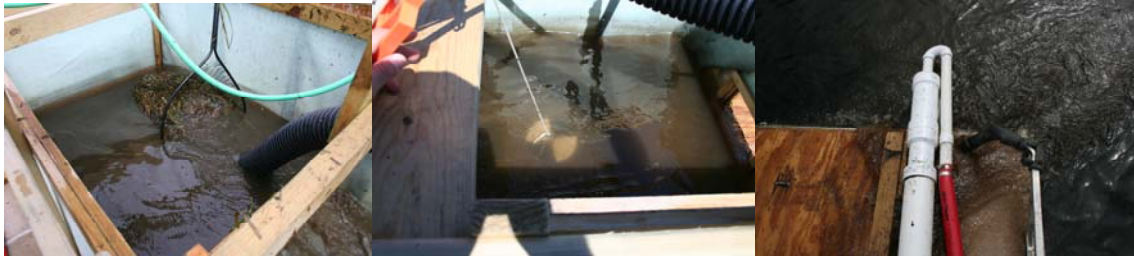
Figure 12. Water with a relatively high sediment load flowing through and off the HCS.
