APPENDIX A

Public Participation Materials

Deer Lake Management Planning Project
Planning Meeting I
 April 15, 2010

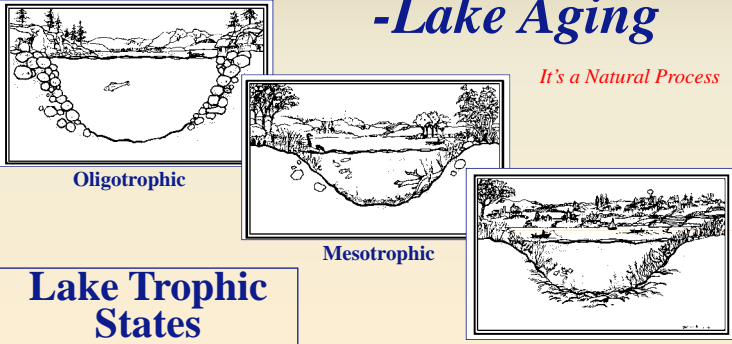
Lake Trophic States

Eutrophication

Oligotrophic **Mesotrophic** **Eutrophic**

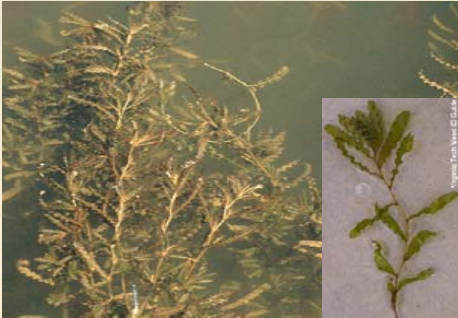
Curly-leaf Pondweed

Non-native Aquatic Plants

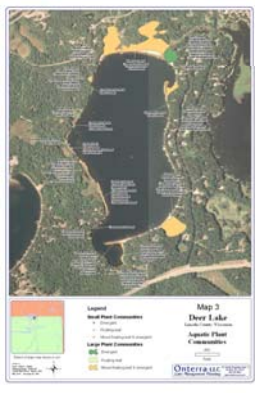
Map 3
Deer Lake
Aquatic Plant Community Mapping

- Mapped Communities
 - Floating-leaf
 - Emergent
- Important Indicators
 - Vulnerable to ecosystem changes
 - Loss of species
 - Expansion or recession

Legend:
 Small Plant Community
 Large Plant Community
 Emergent Plant Community

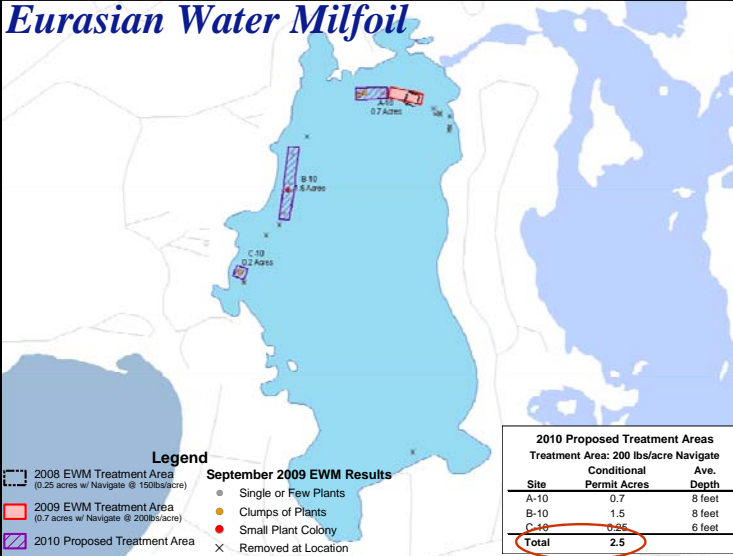
September 2009 EWM Results

Legend:
 2008 EWM Treatment Area (0.25 acres w/ Navigate @ 150lb/acre)
 2009 EWM Treatment Area (0.7 acres w/ Navigate @ 200lb/acre)
 2010 Proposed Treatment Area
 Single or Few Plants
 Clumps of Plants
 Small Plant Colony
 Removed at Location

2010 Proposed Treatment Areas		
Treatment Area: 200 lbs/acre Navigate		
Site	Conditional Permit Acres	Ave. Depth
A-10	0.7	8 feet
B-10	1.5	8 feet
C-10	0.26	6 feet
Total	2.5

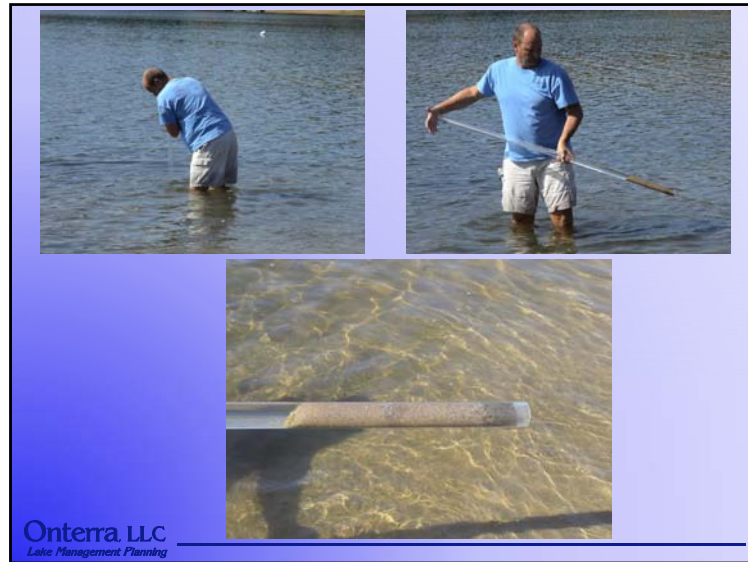
Deer Lake Outlet

- Concerns raised that channel bottom has been scoured.
 - Scouring maybe caused by reversed flow of outlet during Rice Reservoir filling in spring.
 - Sand delta is apparent on Deer Lake side of outlet indicating possible reverse flow and bottom scouring.
 - Shallow cores collected by Onterra staff during Sept. 09 indicate that sand from channel has covered native sediments in delta area.
 - With this limited and unscientific information, it does appear that the concerns are valid.

- Major issues exist:
 - There is no known record of original channel bottom elevation.
 - How much of the low water level issue is caused by the extended drought? – Deer is a spring lake.
 - If a dam were built, at what elevation?
 - Dam construction would be incredibly difficult and likely expensive.
 - Property ownership issues (WVIC, private?).
 - Navigation issues.
 - Fish and wildlife issues.
 - Permitting issues (State and Federal).
