Re: Wausau Paper, Rhinelander, Wisconsin
Hydro Electric Project FERC 2161 Invasive Species Report for 2012

**2012
INVASIVE SPECIES REPORT
FOR THE
RHINELANDER HYDROELECTRIC PROJECT
ONEIDA COUNTY, WISCONSIN
FERC PROJECT NO. 2161**

**December 2012
Prepared By
Nicholas Giannola
Wausau Paper Mills, LLC**

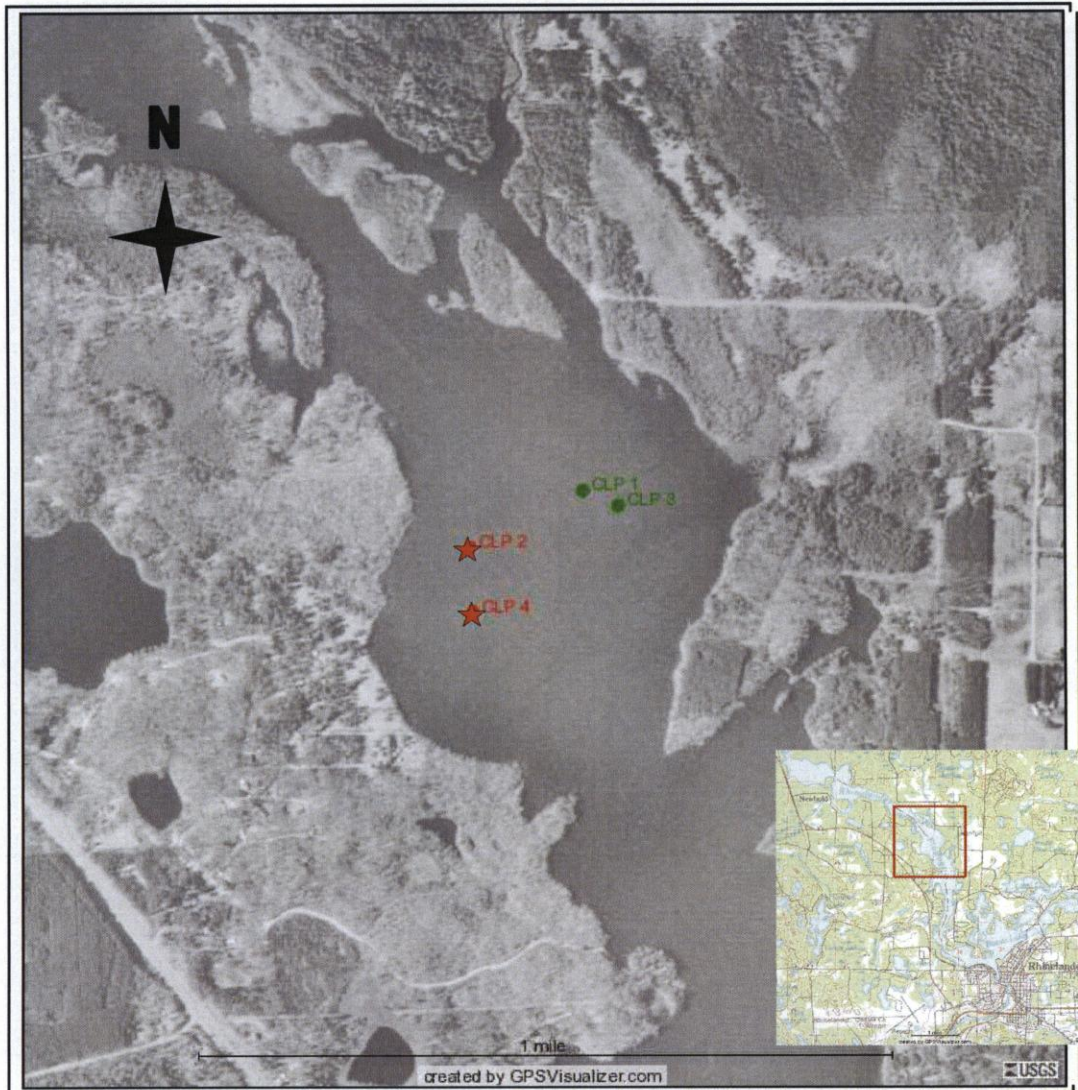
Upper Rhineland Flowage Curly-Leaf Pondweed Locations

Above the dam only three floating pieces of CLP were found. Two of these pieces were found near preexisting CLP sites, one on July 24th 2012 and the other on July 25th 2012. The other piece was found in a new area in Bass Lake, on July 24th 2012. The Bass Lake site was searched again on July 25th 2012 but no rooted colonies were found. Areas where CLP was recorded last year were searched July 24th, 25th 2012 and again on August 7th 2012, no rooted colonies were found. This absence of rooted colonies may be due to CLP's normal growing season. CLP begins to grow in late winter, early spring and then starts to die back in mid-to-late-summer. An early die back may be the reason no rooted colonies were found.

- Curly-leaf pondweed locations observed prior to but not including 2012
- ★ Curly-leaf pondweed locations observed in 2012

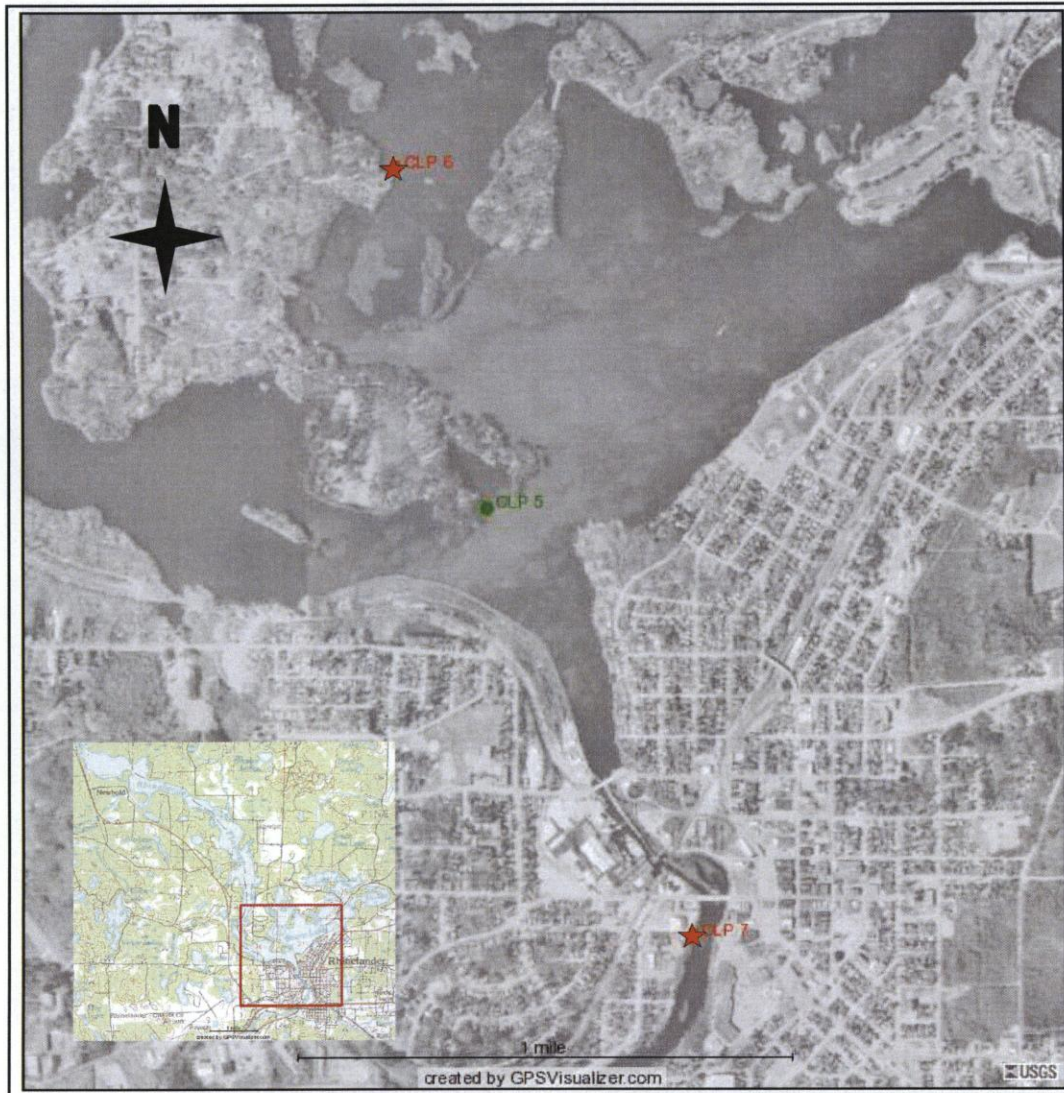
Lower Rhineland Flowage Curly-Leaf Pondweed Locations

Below the dam one CLP colony was found, this was the first report of CLP below the dam. The area was located behind the DNR office and was marked, with a GPS, point CLP 7. The colony was relatively small and found in water between six and twelve inches. All plants seen were pulled. This was the only area where CLP was found below the dam.

- Curly-leaf pondweed locations observed prior to but not including 2012
- ★ Curly-leaf pondweed locations observed in 2012

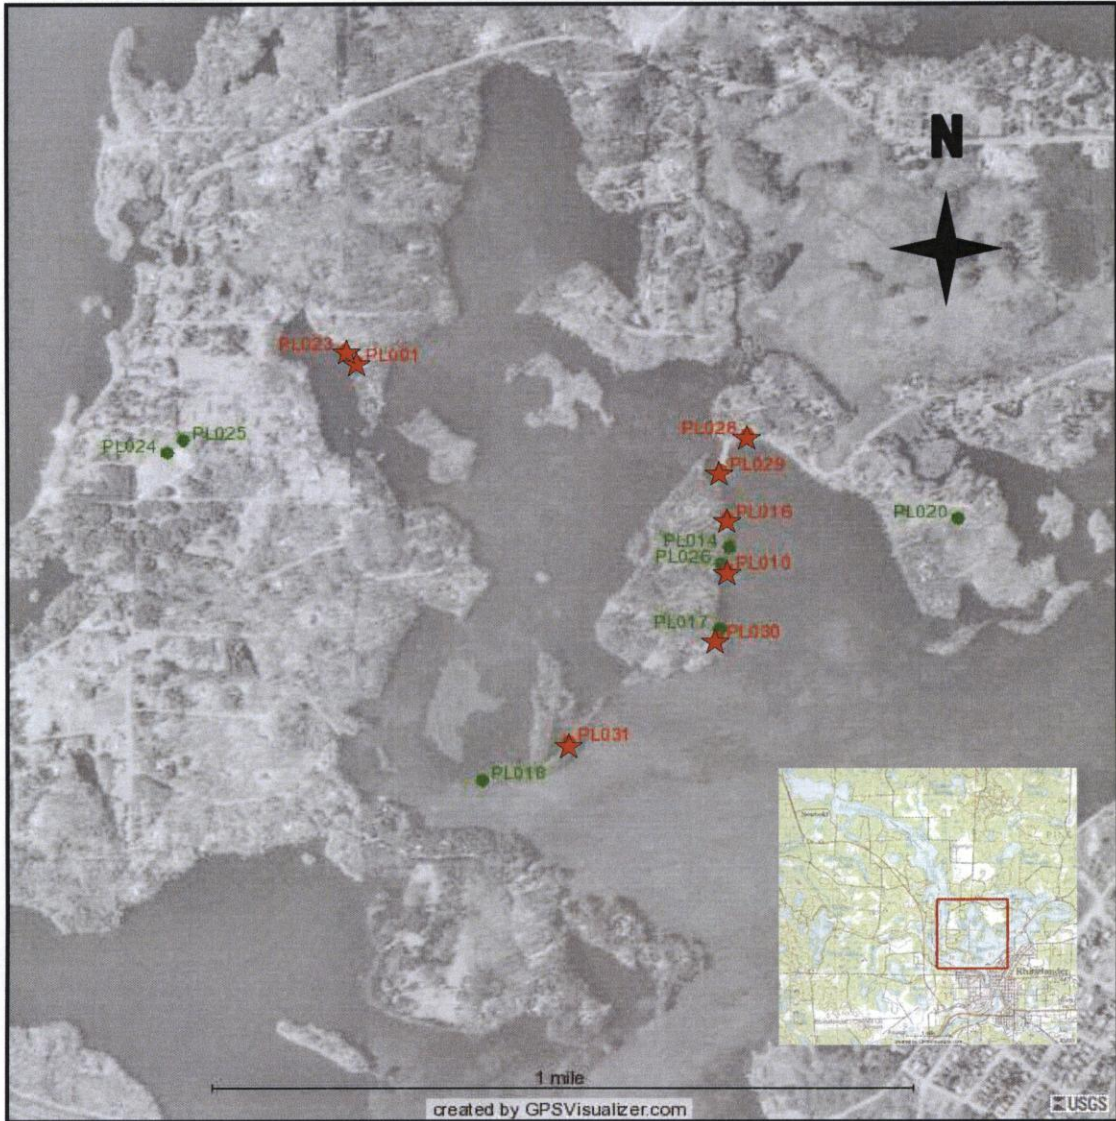
Above Dam Rhineland Flowage Purple Loosestrife Locations

Four of the eleven previous locations still had PL growth and four new locations were discovered. Brochures were lefts for land owners with PL on their property and the plants at site PL037 were pulled. No sites above the dam showed signs of beetle damage.

- Purple loosestrife locations observed prior to but not including 2012
- ★ Purple loosestrife locations observed in 2012

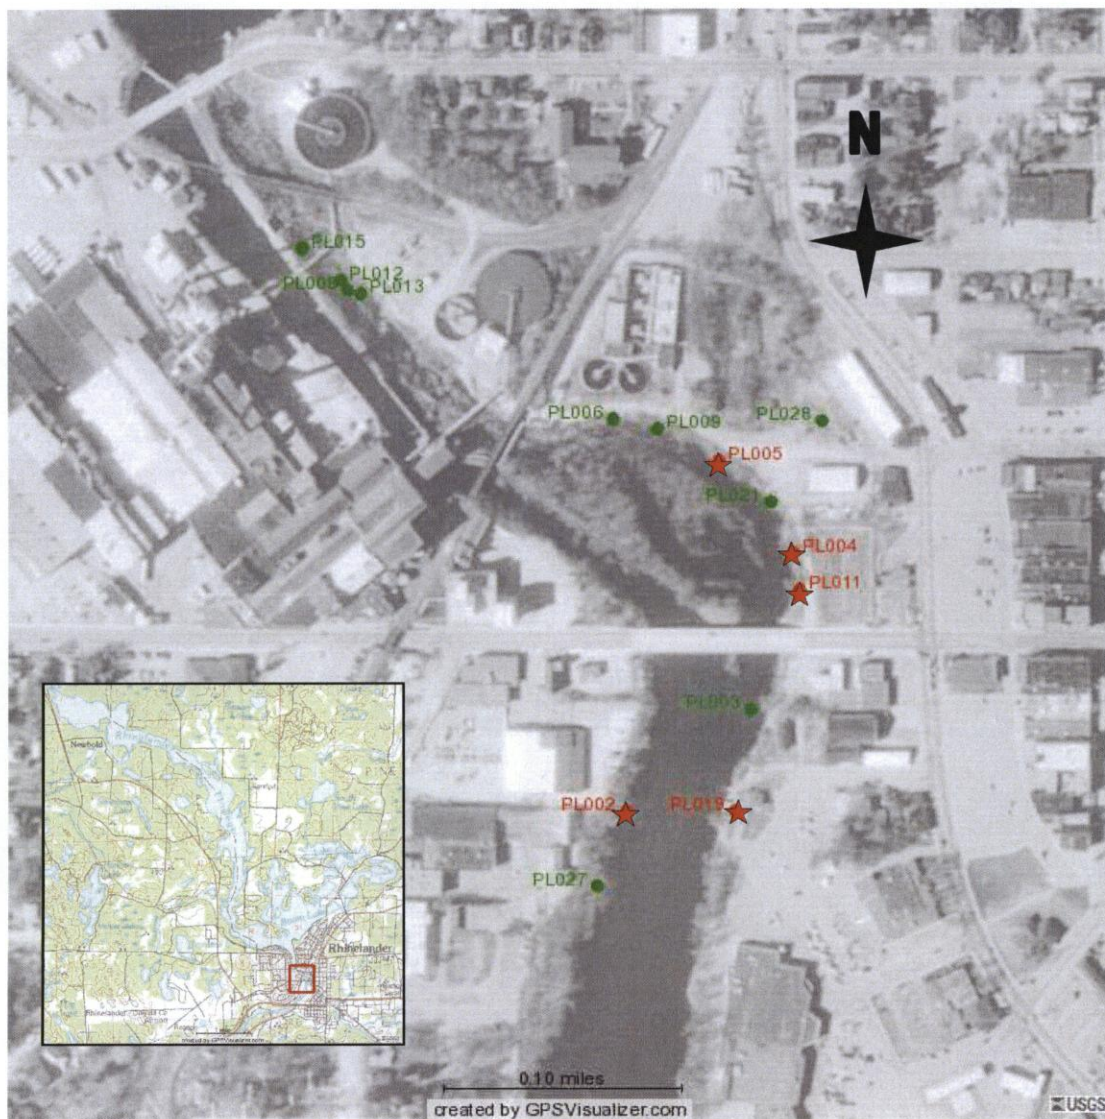
Below Dam Rhineland Flowage Purple Loosestrife Locations

There were a total of five sites below the dam with PL growth. All of these sites were previously known to have PL. Ten sites where PL was previously found did not have plant growth this year. Beetle damage was found throughout the below dam locations.

- Purple loosestrife locations observed prior to but not including 2012
- ★ Purple loosestrife locations observed in 2012

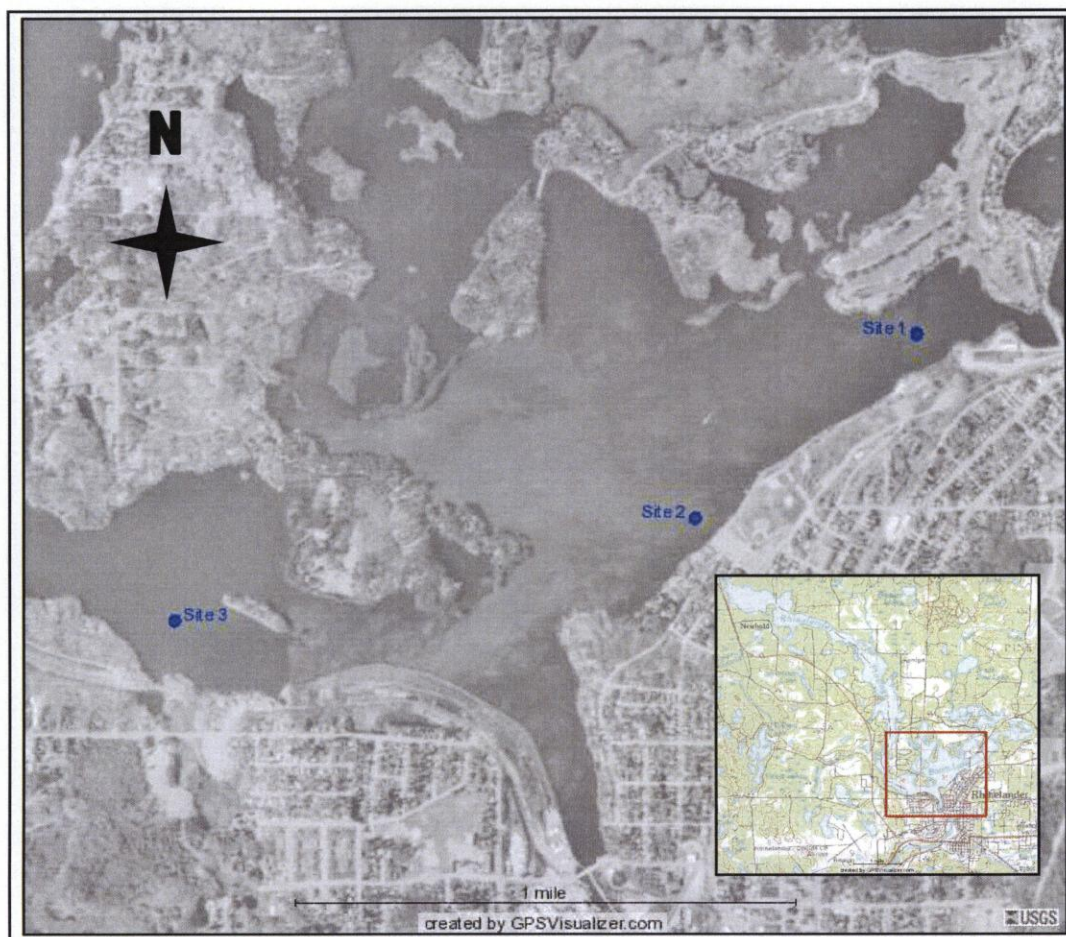
Rhineland Flowage Zebra Mussel and Spiny Water flea Monitoring Locations

The specimen bottle from the spiny water flea tows was sent to the Wisconsin DNR – Plymouth Service Center for identification. The lab results were negative. No spiny water fleas have been detected in the Rhineland flowage in previous years.

The specimen bottle from the zebra mussel veliger tows was sent to the Wisconsin DNR – Plymouth Service Center for identification. The lab results were negative. No zebra mussels have been detected in the Rhineland flowage in previous years.

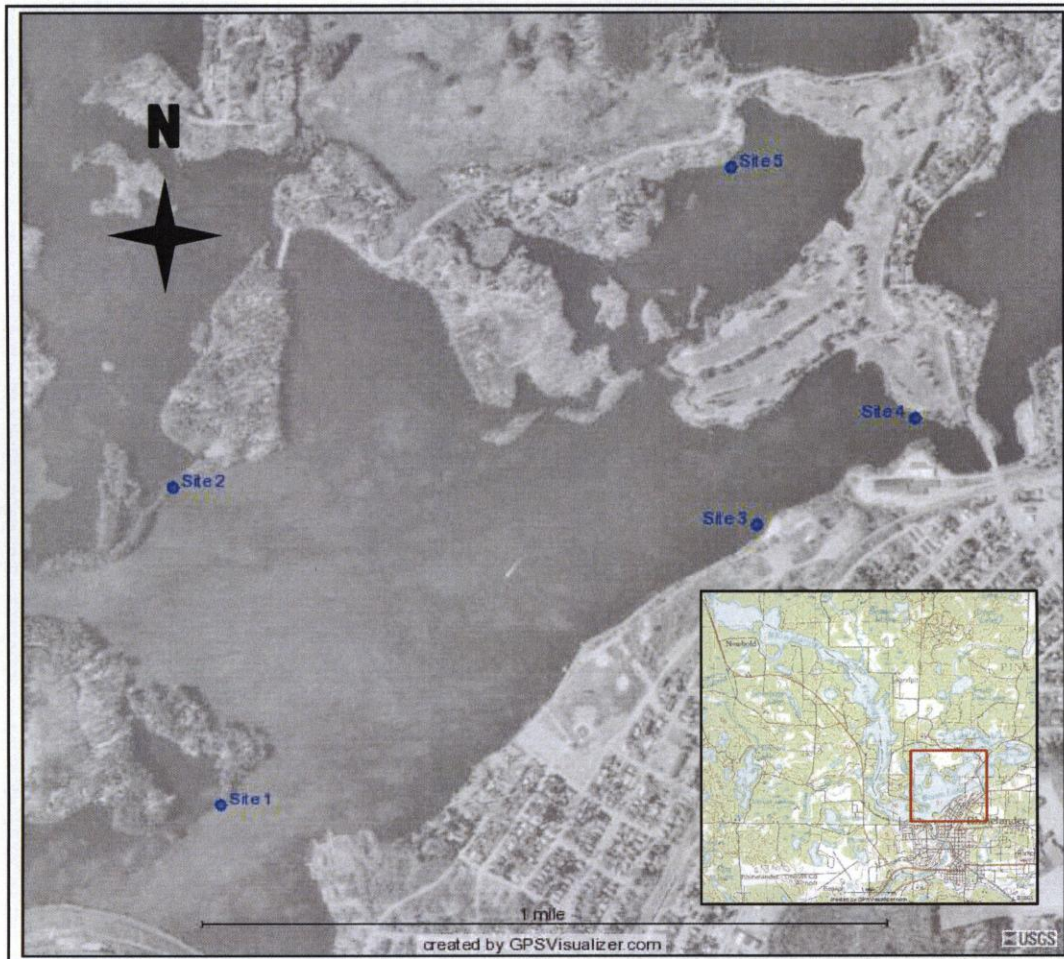
Great Lakes Restoration Initiative Survey Site Locations

Along with the meander survey, five locations were selected for a more thorough inspection. These sites were selected near inlets, outlets and areas of high traffic. At each of these sites one crew member would snorkel around the area looking for invasive species while the other took plant samples and substrate samples. The substrate samples were done with a dip net; a method used to look for invasive snails and mussels. Plant samples were taken by using a rake to collect plants. Each site was searched for ten looking minutes. A looking minute is defined as one minute of time while one person is looking. Since there were two people looking, ten looking minutes equals five actual minutes.
