**Re: Grandmother Falls Hydroelectric Project, FERC License No. 2180 – Exotic Species Monitoring Report for CY2008**

# GRANDMOTHER FALLS HYDROELECTRIC DAM

FERC PROJECT 2180-WISCONSIN

## EXOTIC SPECIES MONITORING REPORT YEAR 4 – 2009

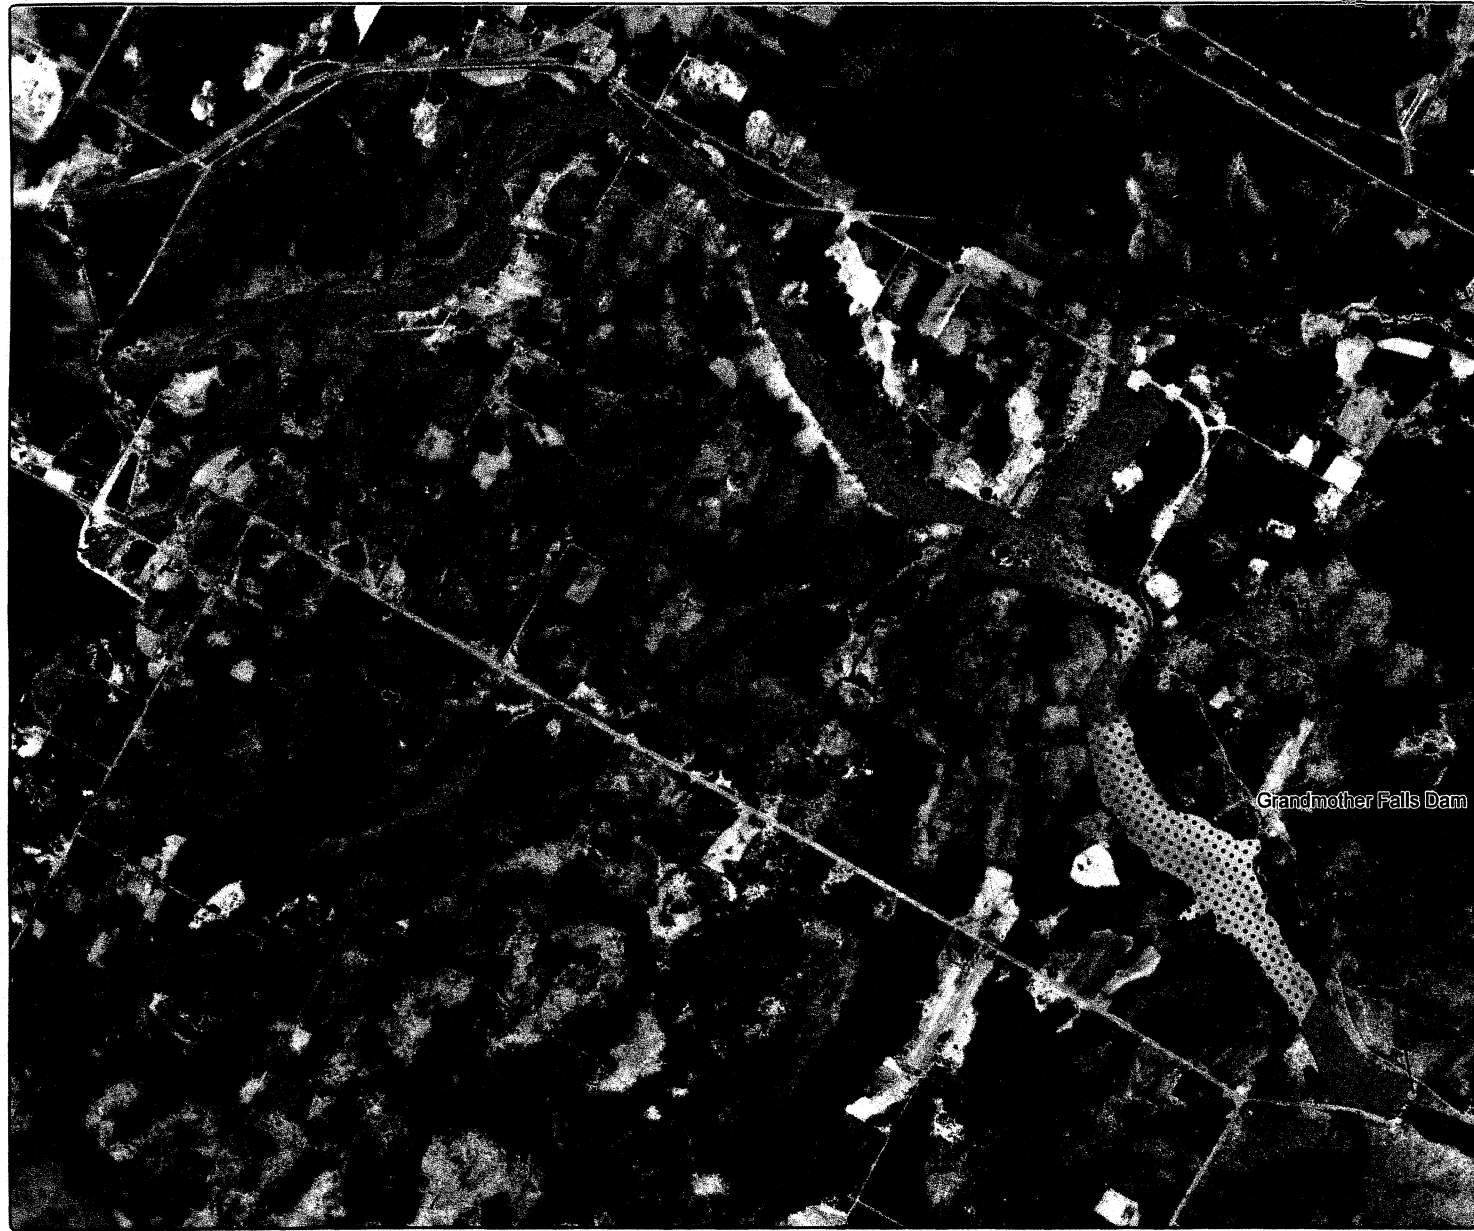
# Map 1

### Project Waters & Base Point-Intercept Locations

Point-intercept surveys allow the systematic sampling of submerged plants within project waters and ensure all areas of the littoral zone are visited. Based upon calculation techniques supplied by the WDNR (WDNR 2005) that employ water surface area (624 acres) and shoreland development factor (7.29), a plot resolution of 55-meters was applied to the project waters displayed in Map 3. Using this information, a total of 885 points were selected to be surveyed within the Grandmother Falls Flowage.

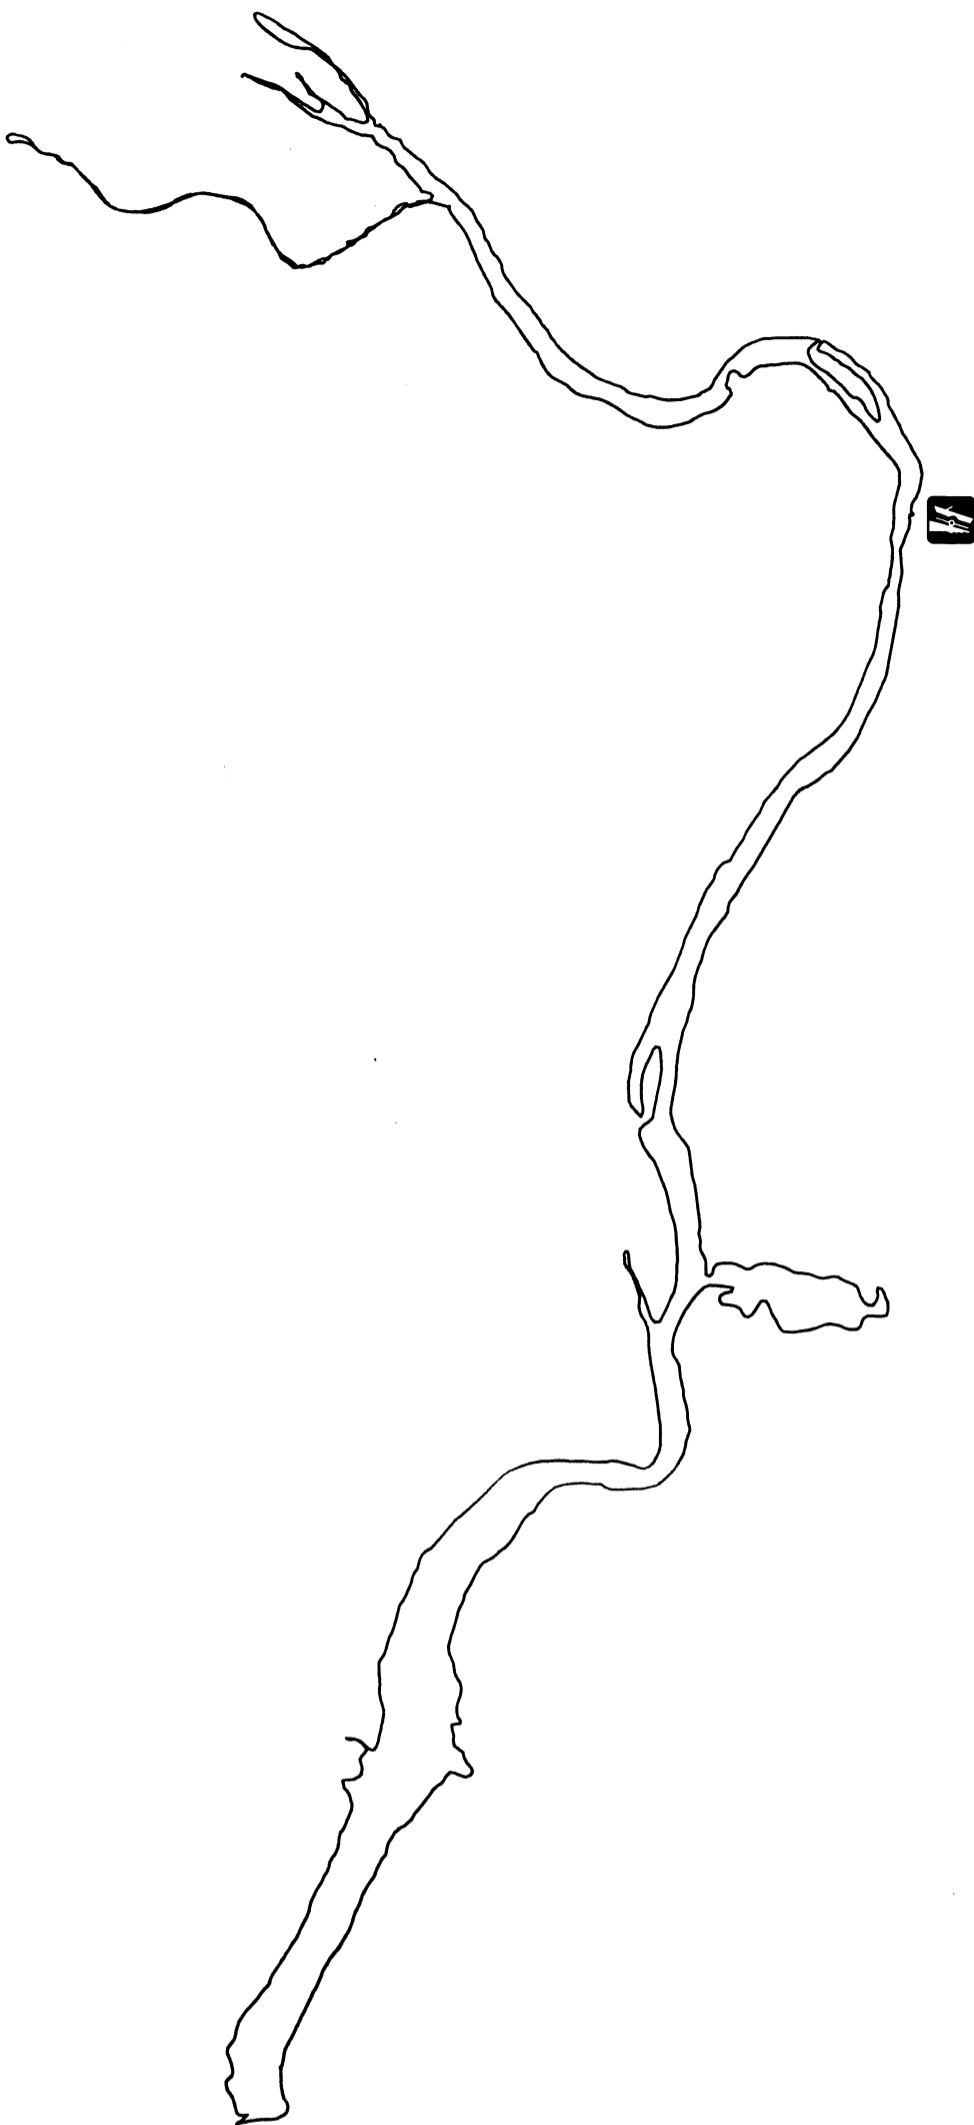
**Map 2**

**Curly-leaf Pondweed  
Survey Track  
Grandmother Falls Flowage**  
Lincoln County, Wisconsin

No colonies of curly-leaf pondweed were encountered during the meander survey conducted on June 11, 2009. To document the mid-June survey, GPS tracking logs were automatically recorded and are displayed on Map 2.

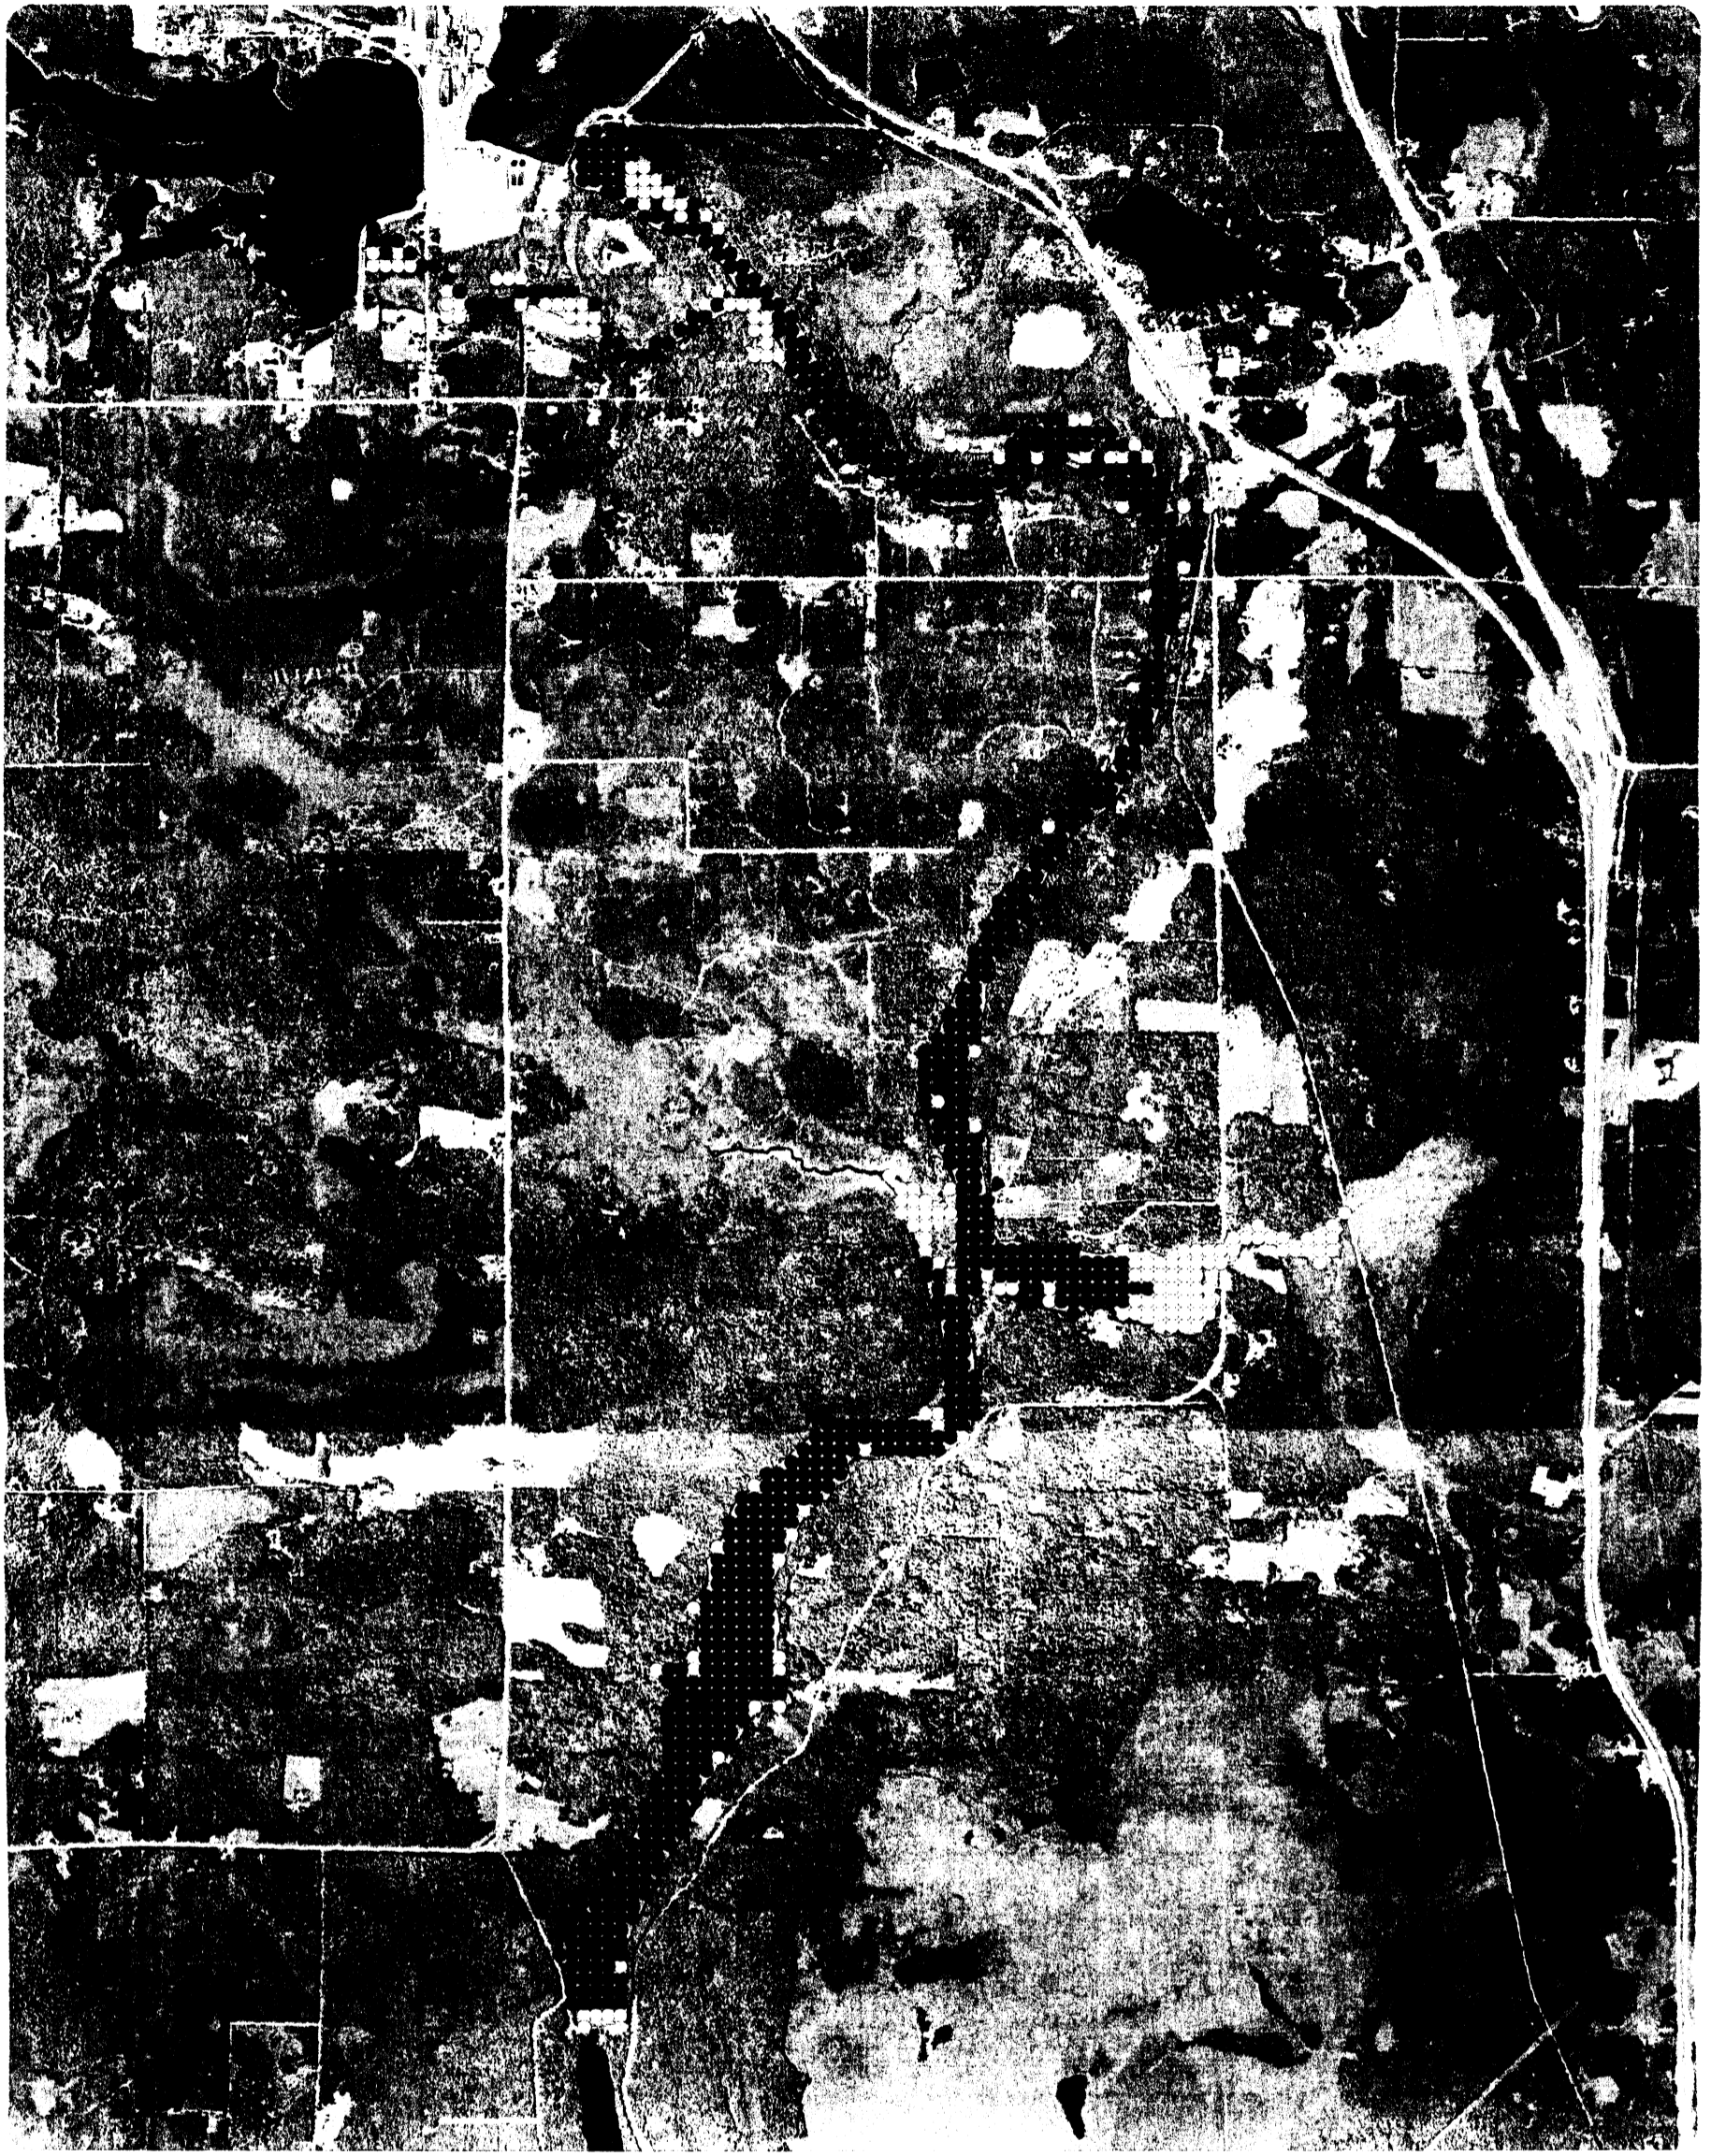
### Map 3

**Base Point-Intercept Locations**  
**Grandmother Falls Flowage**  
 Lincoln County, Wisconsin

A total of 885 points were selected within the project waters based on WDNR guidelines; however, only 518 of these points were surveyed due to existing field conditions. The remaining 367 points were either inaccessible by boat ("not visited") or they were at depths of  $\geq 10$  feet ("too deep"), beyond the depth of plant growth (Map 3).
