**Re: Winter Hydroelectric Project
 FERC Project Number P-2064
 Flambeau Hydro LLC
 Final 2012 Land & Wildlife Management Report**

**Winter Hydroelectric Project Boundary
Exhibit G - Figure G-1**

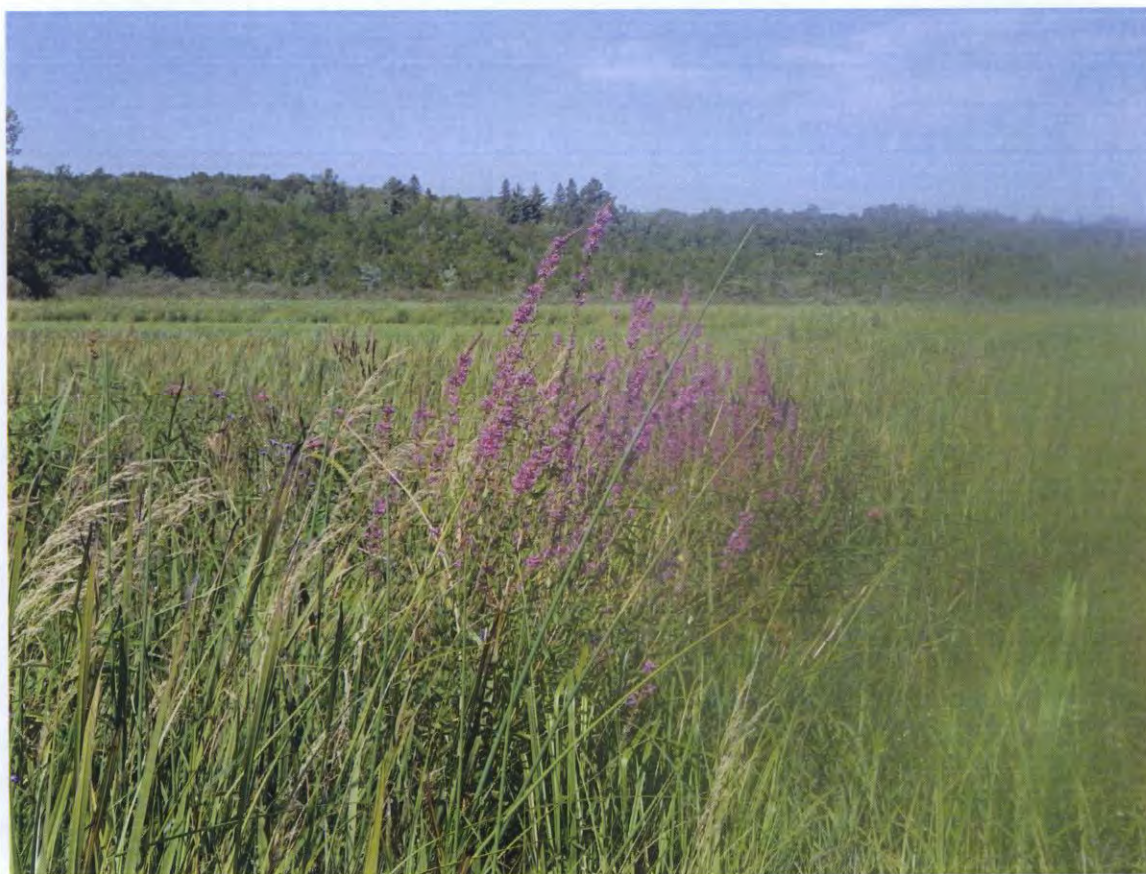
2012 PHOTO OF WNTR PL002 / WNTR PL003

The impoundment was surveyed by boat beginning at 3:46 and ending at 6:00 p.m. WNTRPL001 was seen again this year as 1 plant located in a marshy area with no boat access. The mud was too deep to attempt to wade out and remove this plant. WNTRPL002 / WNTRPL003 was located in a marshy low lying peninsula of grasses and cattails adjacent to the river (see included photo). These 9 clumps of PL were not in a navigable section of the river. WNTRPL004 was a stand of 2 Loosestrife located beyond a piece of solid ground in the marsh. The survey crew proceeded upstream outside of the project boundary as during previous surveys to explore if any plants existed that may be contributing to the infestation by spreading seeds downstream into the impoundment. The 2010 survey had revealed four areas of blooming purple loosestrife plants located ~240 yards upstream from the project boundary. This site, (WNTRPLNA01) was checked out on foot and no Purple Loosestrife was observed in 2012.

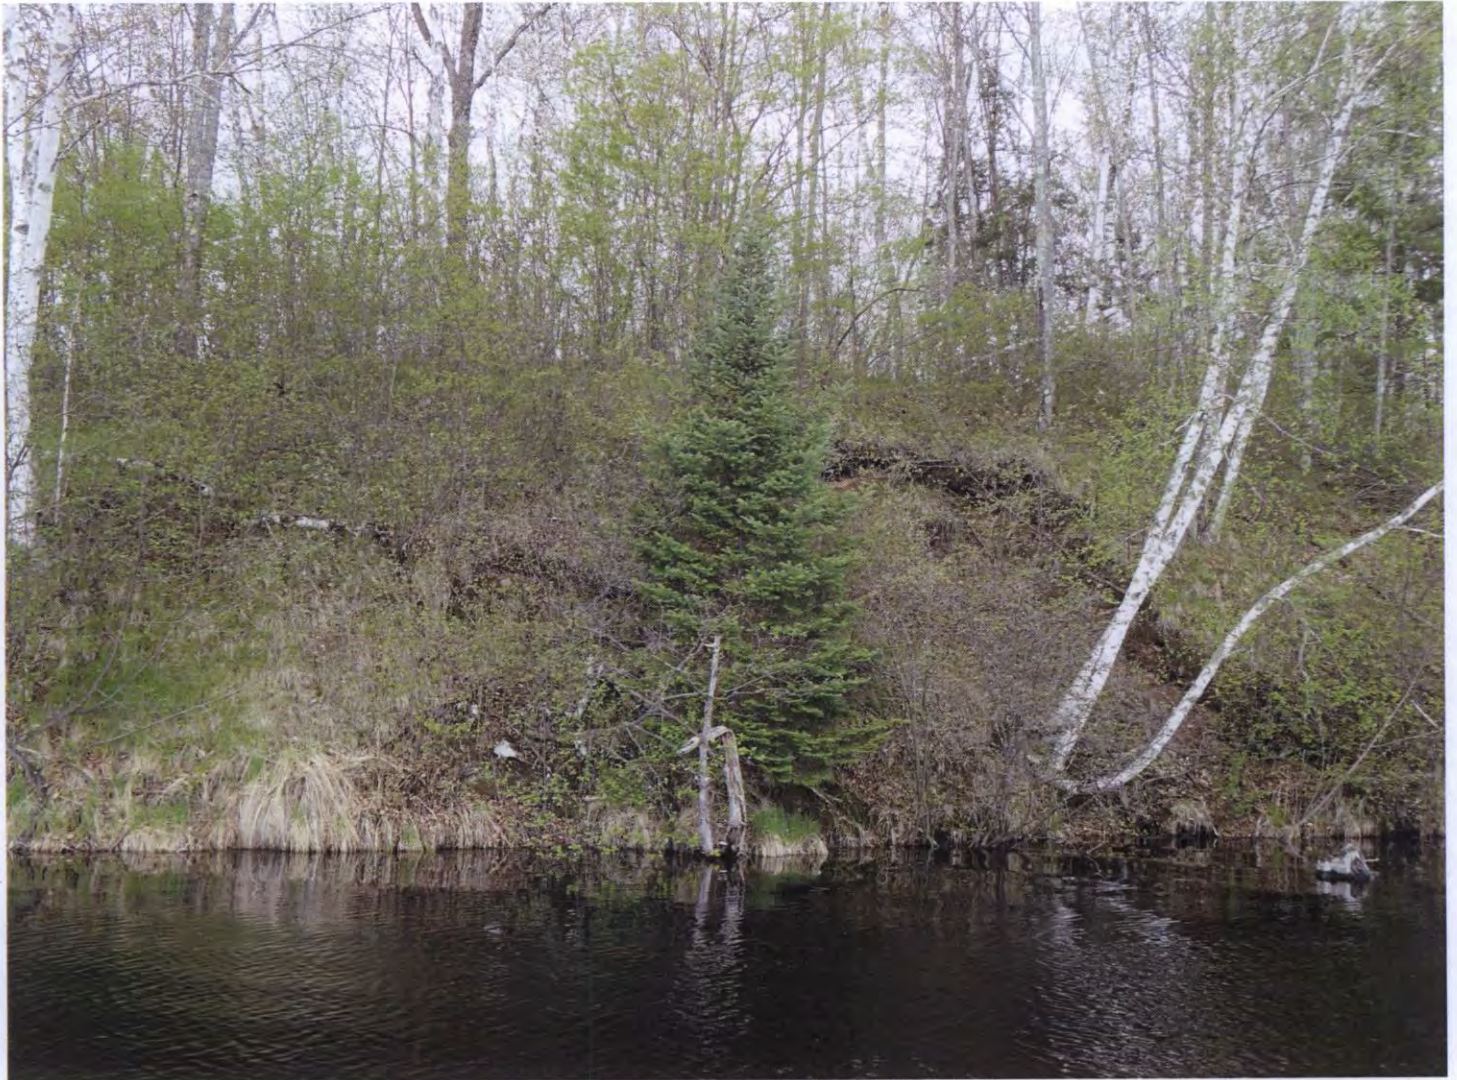
Photo 1 – WNTR ER001

WNTR ER001 is located on the right side of the river at the confluence of Fishtrap Creek and the East Fork of the Chippewa River about 0.90 miles upstream from the powerhouse. This site is not located on FHLLC property. It is considered a Minor site due to the stability of the toe. The entire toe is firmly established with trees, shrubbery, and other vegetation. No noticeable erosion has been evident during the monitoring period of 2008 through 2012. In fact it appears to be healing. It is unlikely to contribute noticeable sediment to the river in its current condition.

GPS Point	Latitude	Longitude	Length of Site	Height of Banks	Comments
WNTR ER001	N45 55.957'	W90 56.904'	25'	15'	First observed in 2006 as Minor site. Right side of river at confluence of Fishtrap Creek and East Fork of the Chippewa River. Toe is stable with trees, shrubs, and other vegetation. No noticeable erosion from 2008 through 2012 and appears to be healing. No remediation. Photos taken in 2008, 2010, and 2012.
WNTR ER002	N45 55.760'	W90 57.347'	15'	4'	First observed in 2006 as Minor site. Right side of river near spillway. Toe is stable with rocks and gravel. No noticeable erosion from 2008 through 2012. No remediation. Photos in 2008, 2011, and 2012.
WNTR ER003	N45 55.830'	W90 57.988'	25'	6'	First observed in 2006 as Minor site. Located on a point of land formed at the confluence of the powerhouse tailrace and the by-pass reach. Popular fishing site with moderate pedestrian traffic. Site is stable with rocks. No noticeable erosion from 2008 through 2012. No remediation. Photos in 2008, 2011, and 2012.

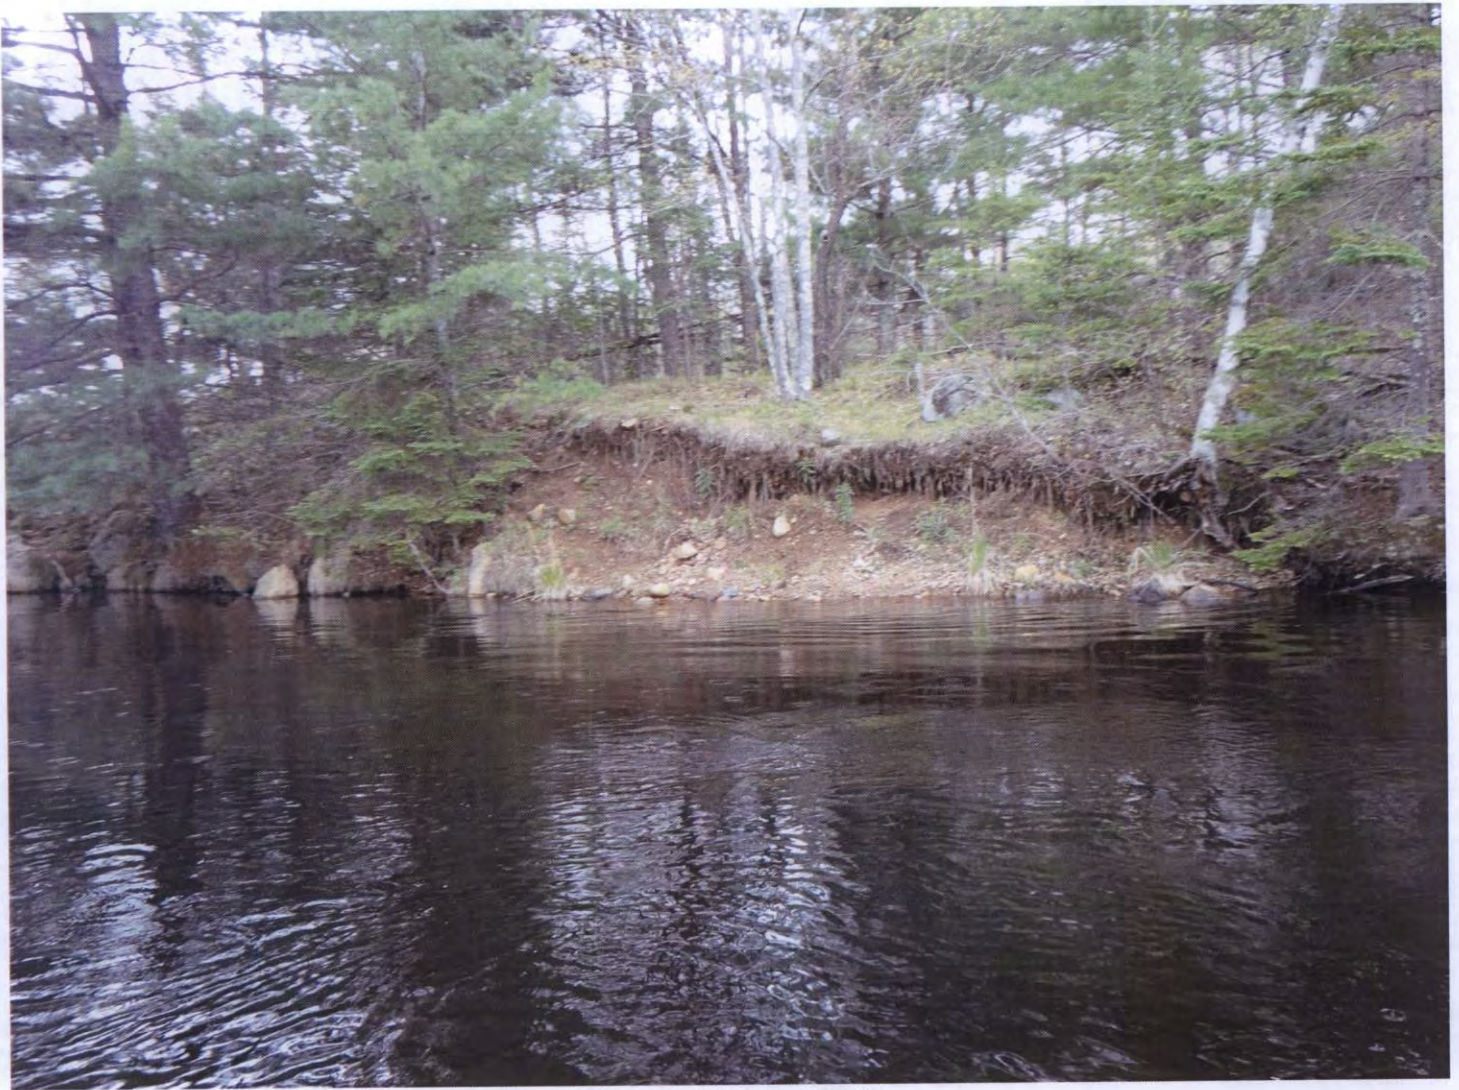
Photo 2- WNTR ER002

WNTR ER002 is located on the right side of the river near the spillway about 0.43 miles upstream from the powerhouse. This site is not located on FHLLC property. It is considered a Minor site due to the small size and stability of the toe. The entire toe is established with rock and gravel. No noticeable erosion has been evident during the monitoring period of 2008 through 2012. It is unlikely to contribute noticeable sediment to the river in its current condition.

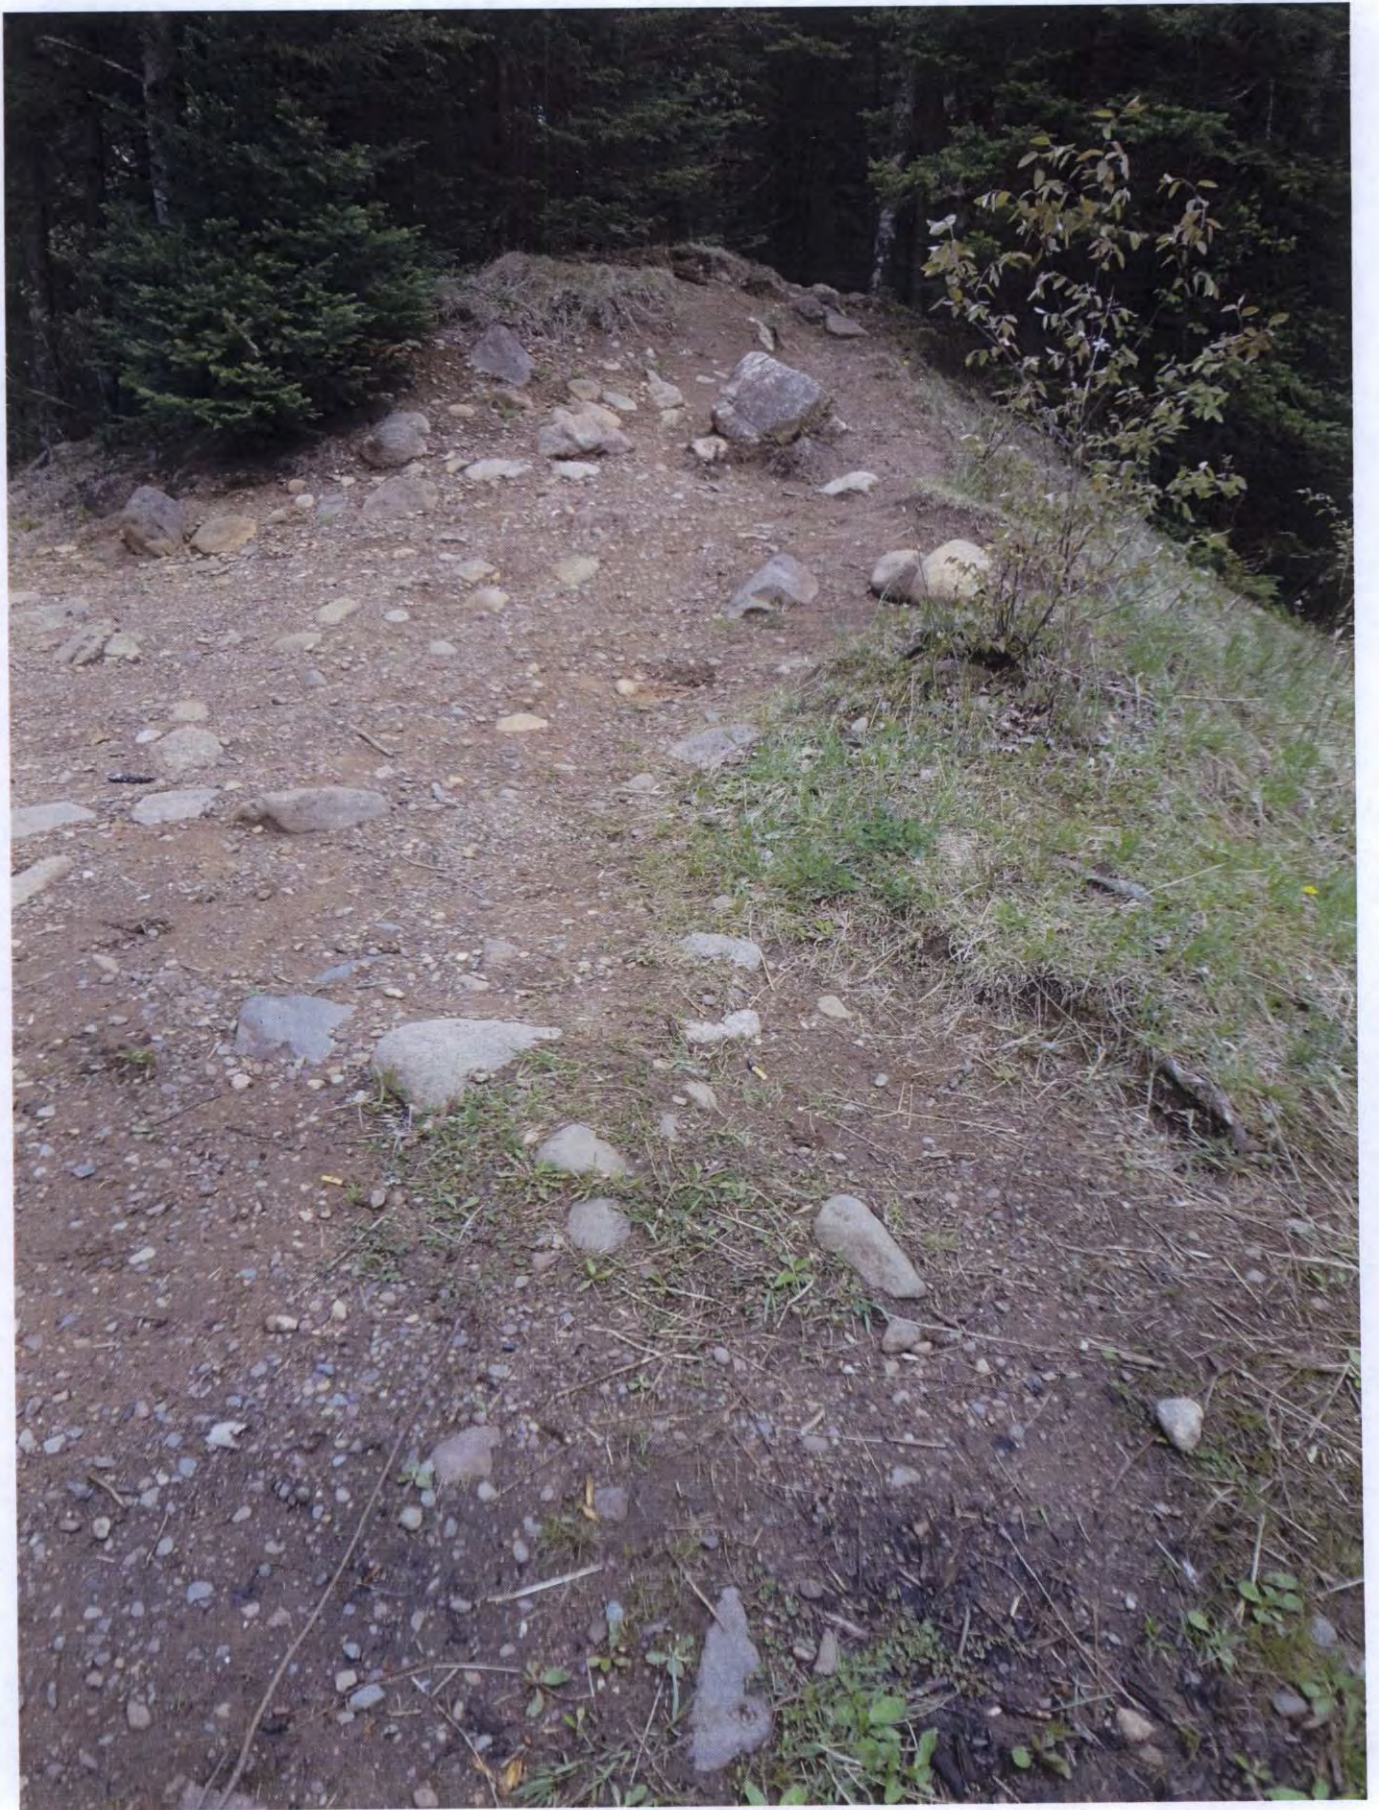
Photo 3- WNTR ER003

The FHLLC owned property within the project boundary was surveyed on foot and one minor erosion site (WNTR ER003) was observed.

classed as an erosion site. It is unlikely to contribute noticeable sediment discharge to the river in its current condition.

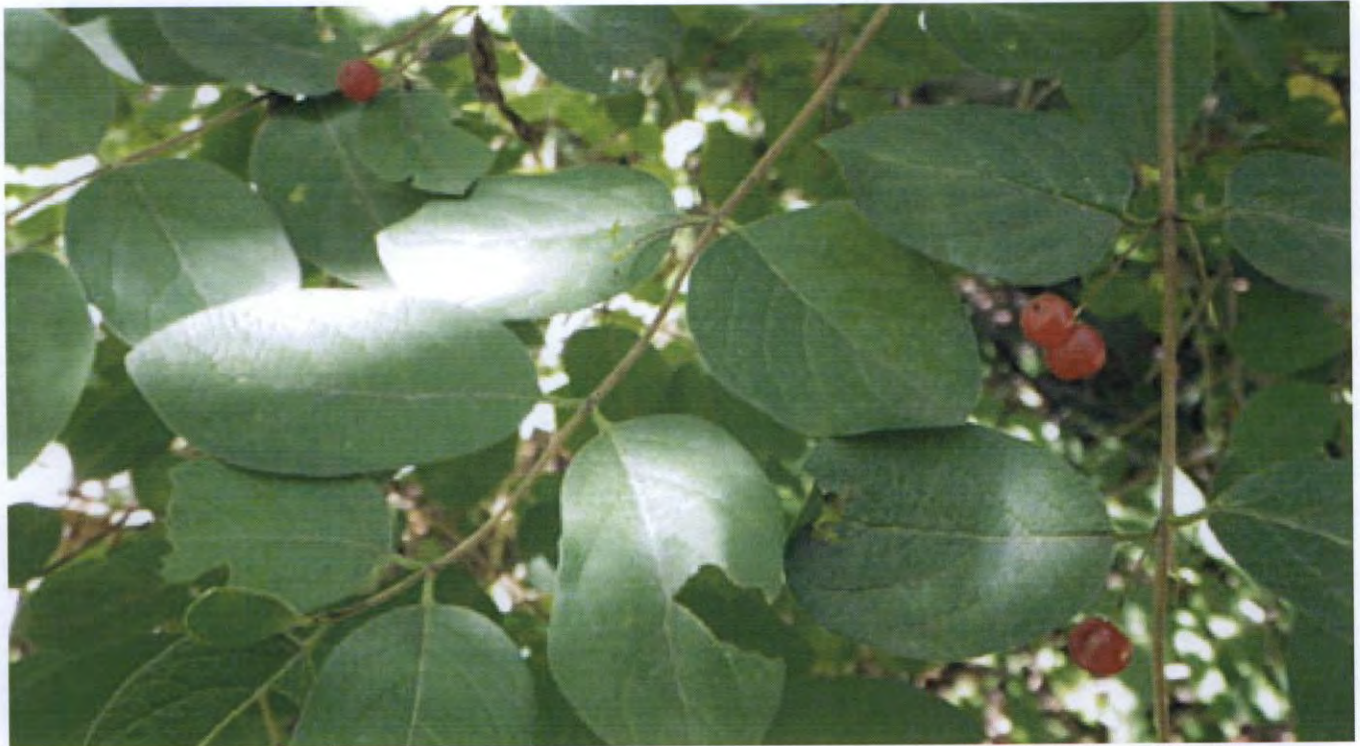
Honeysuckle was observed on the Tailrace Canoe Portage Trail and Fishing Access Trail as well as on the Bypass Reach Roadway to dam. The coordinates with photos are attached in the survey documents. None of the other invasive species were noted during this survey.

PHOTO 1- HONEYSUCKLE ON PORTAGE TRAIL-CLOSEUP

Gary, my crew was unable to treat honeysuckle at Winter Dam this year, they got tied up with a large honeysuckle eradication project near Drummund, WI and are now laid off for the season (too little time, too many invasives!). They did survey the up-river flowage area from the dam to upper Blaisdell for Loosestrife and eradicated what they found. I have to do the data entry and when I get that finished, I'll send you acres treated. On a side note, I have a contractor surveying the entire Chip system within the National Forest boundary in 2013 for aquatic invasives and I will share that data with you when its available next year.

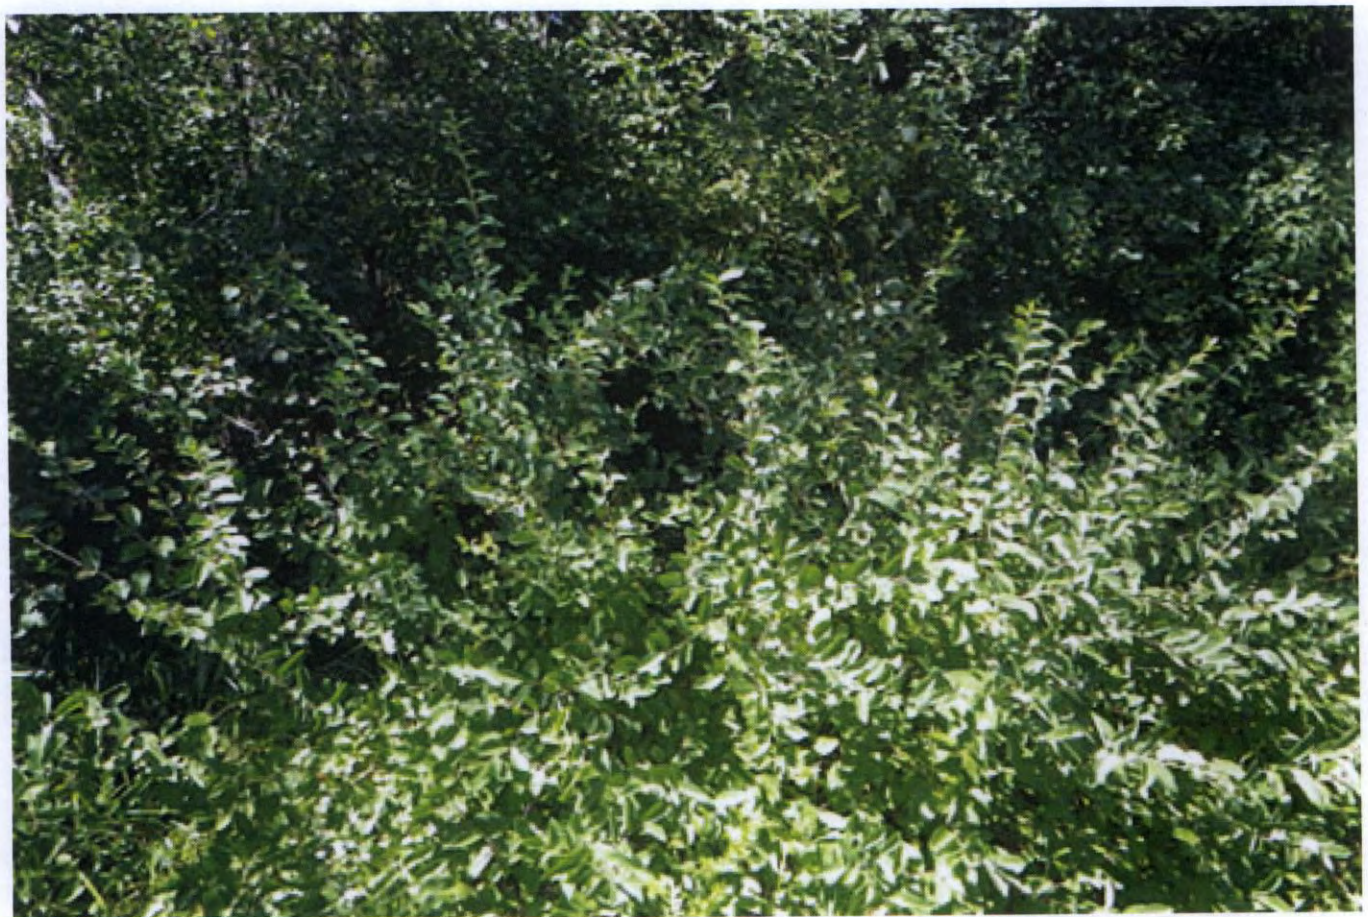
PHOTO 2 - HONEYSUCKLE ON PORTAGE TRAIL

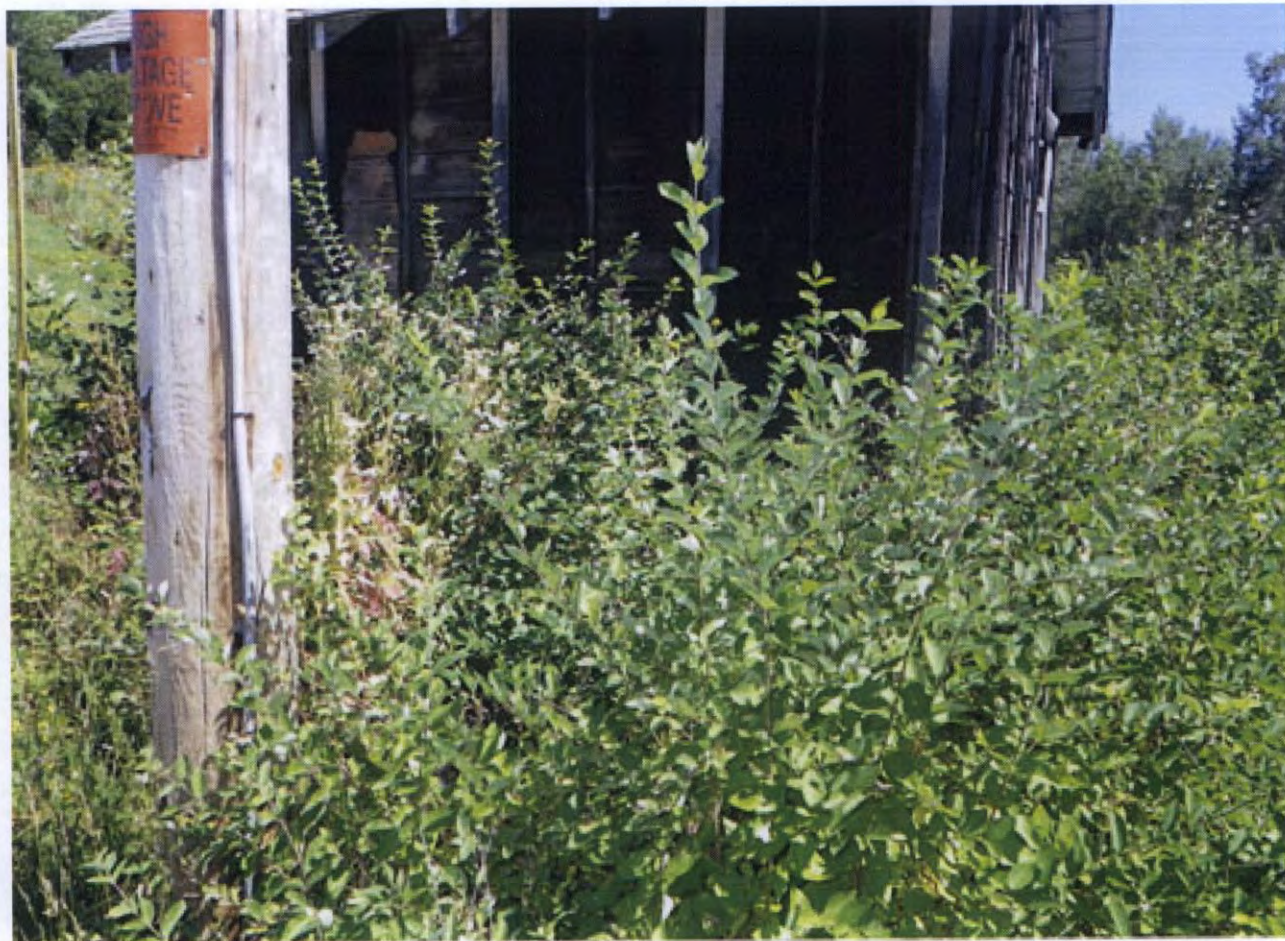
PHOTO 3- HONEYSUCKLE ALONG ROAD

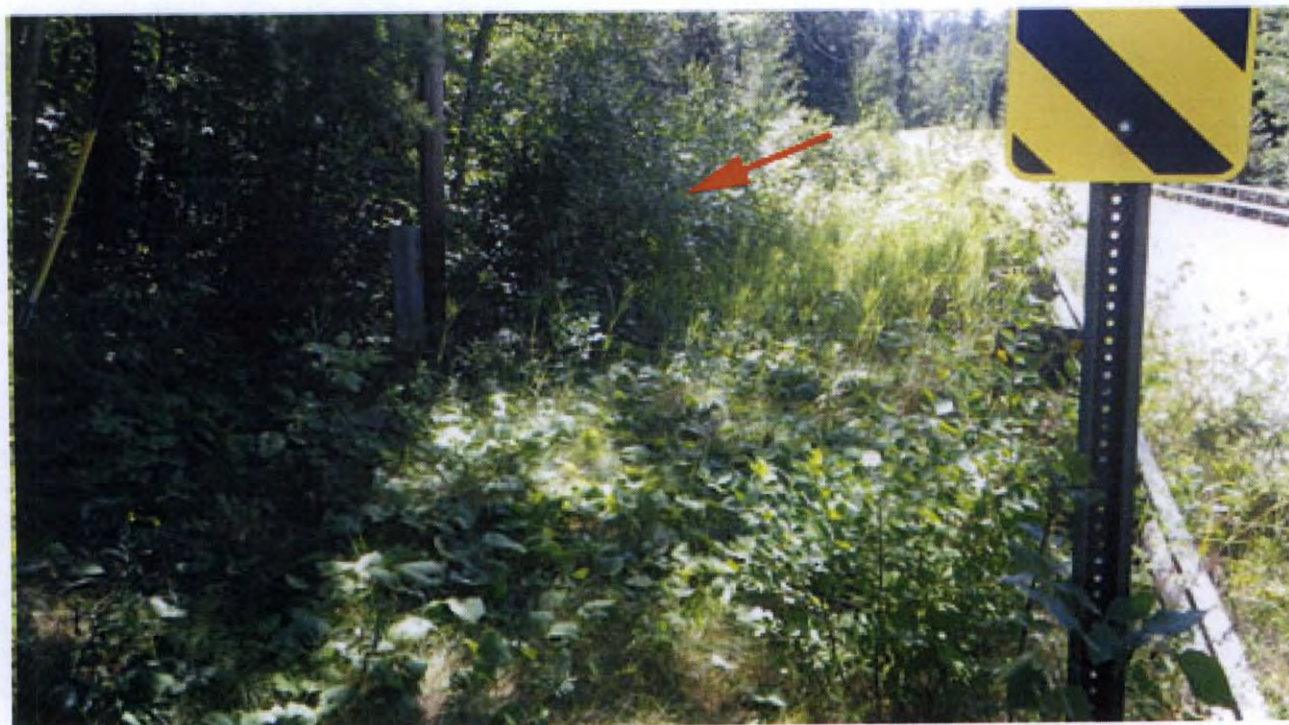
PHOTO 4- HONEYSUCKLE ALONG ROAD BY BRIDGE

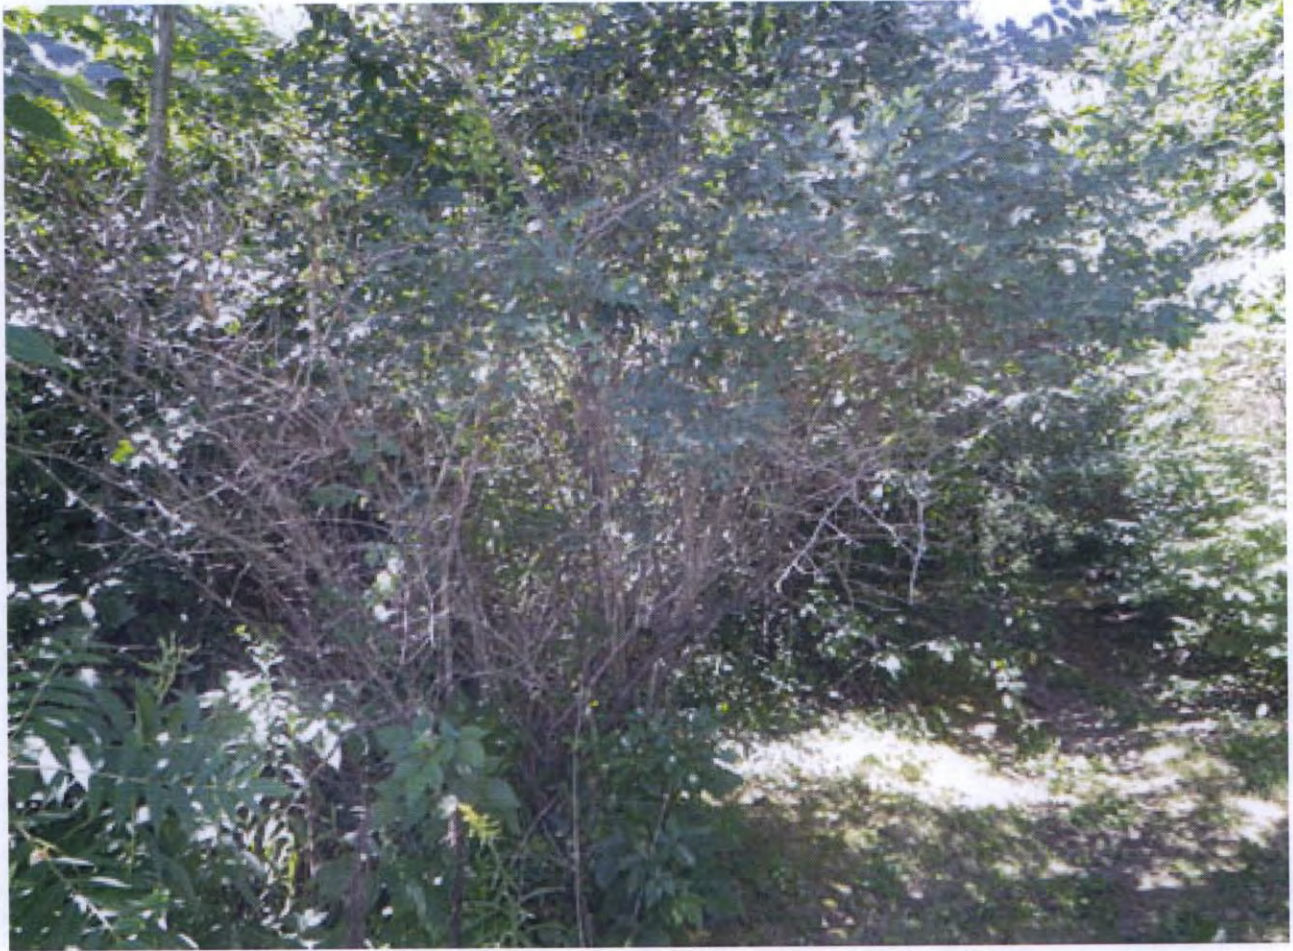
PHOTO 5- HONEYSUCKLE ALONG FISHING TRAIL

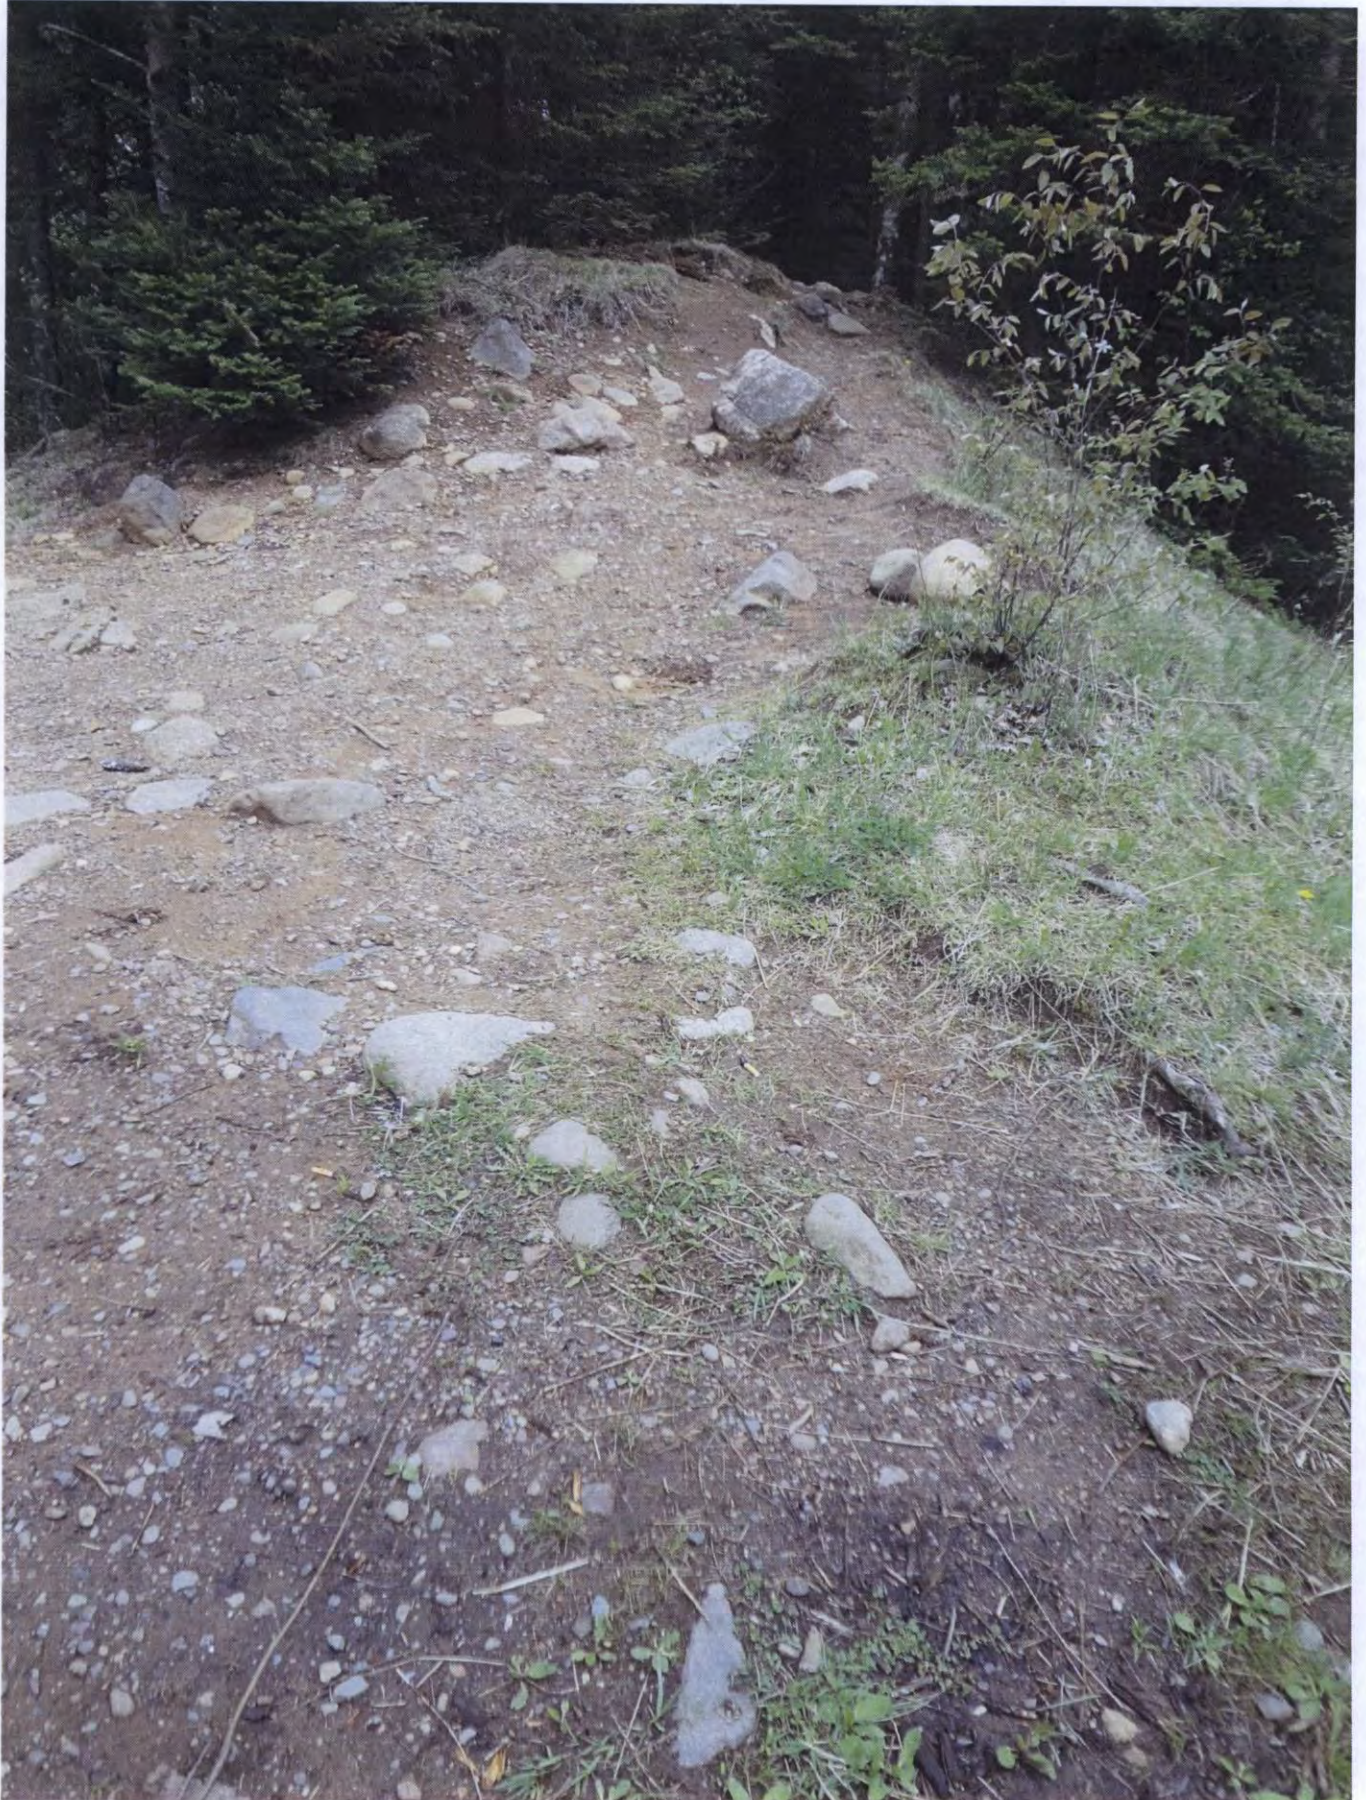
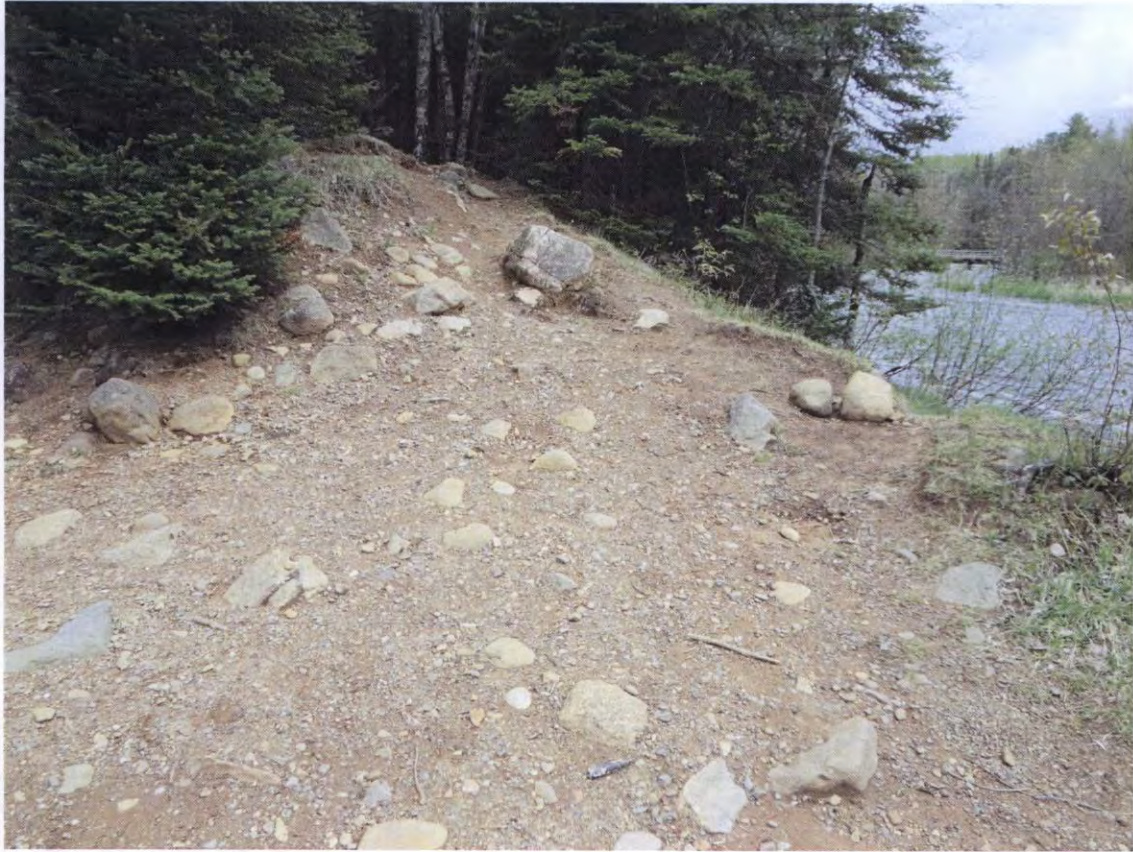
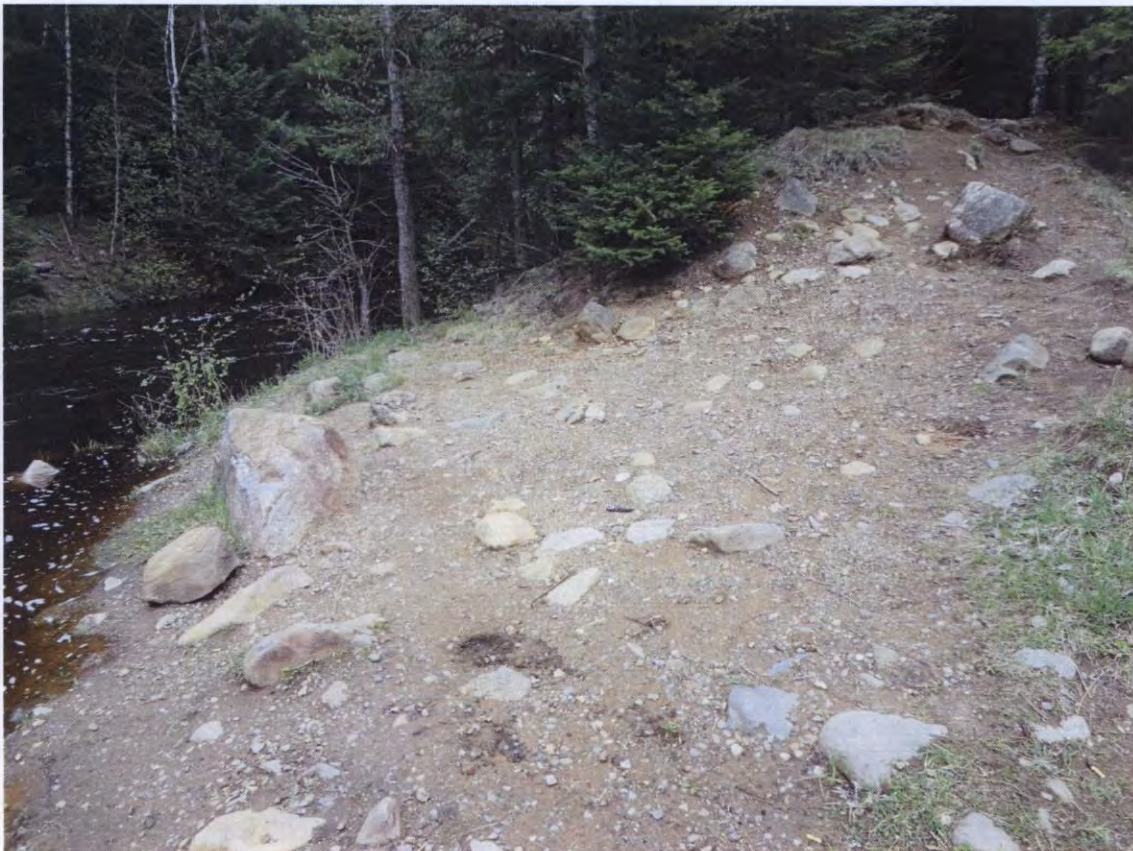
Photo 3 – WNTR ER003

Photo 4 – ER003

Photo 5 – WNTR ER003

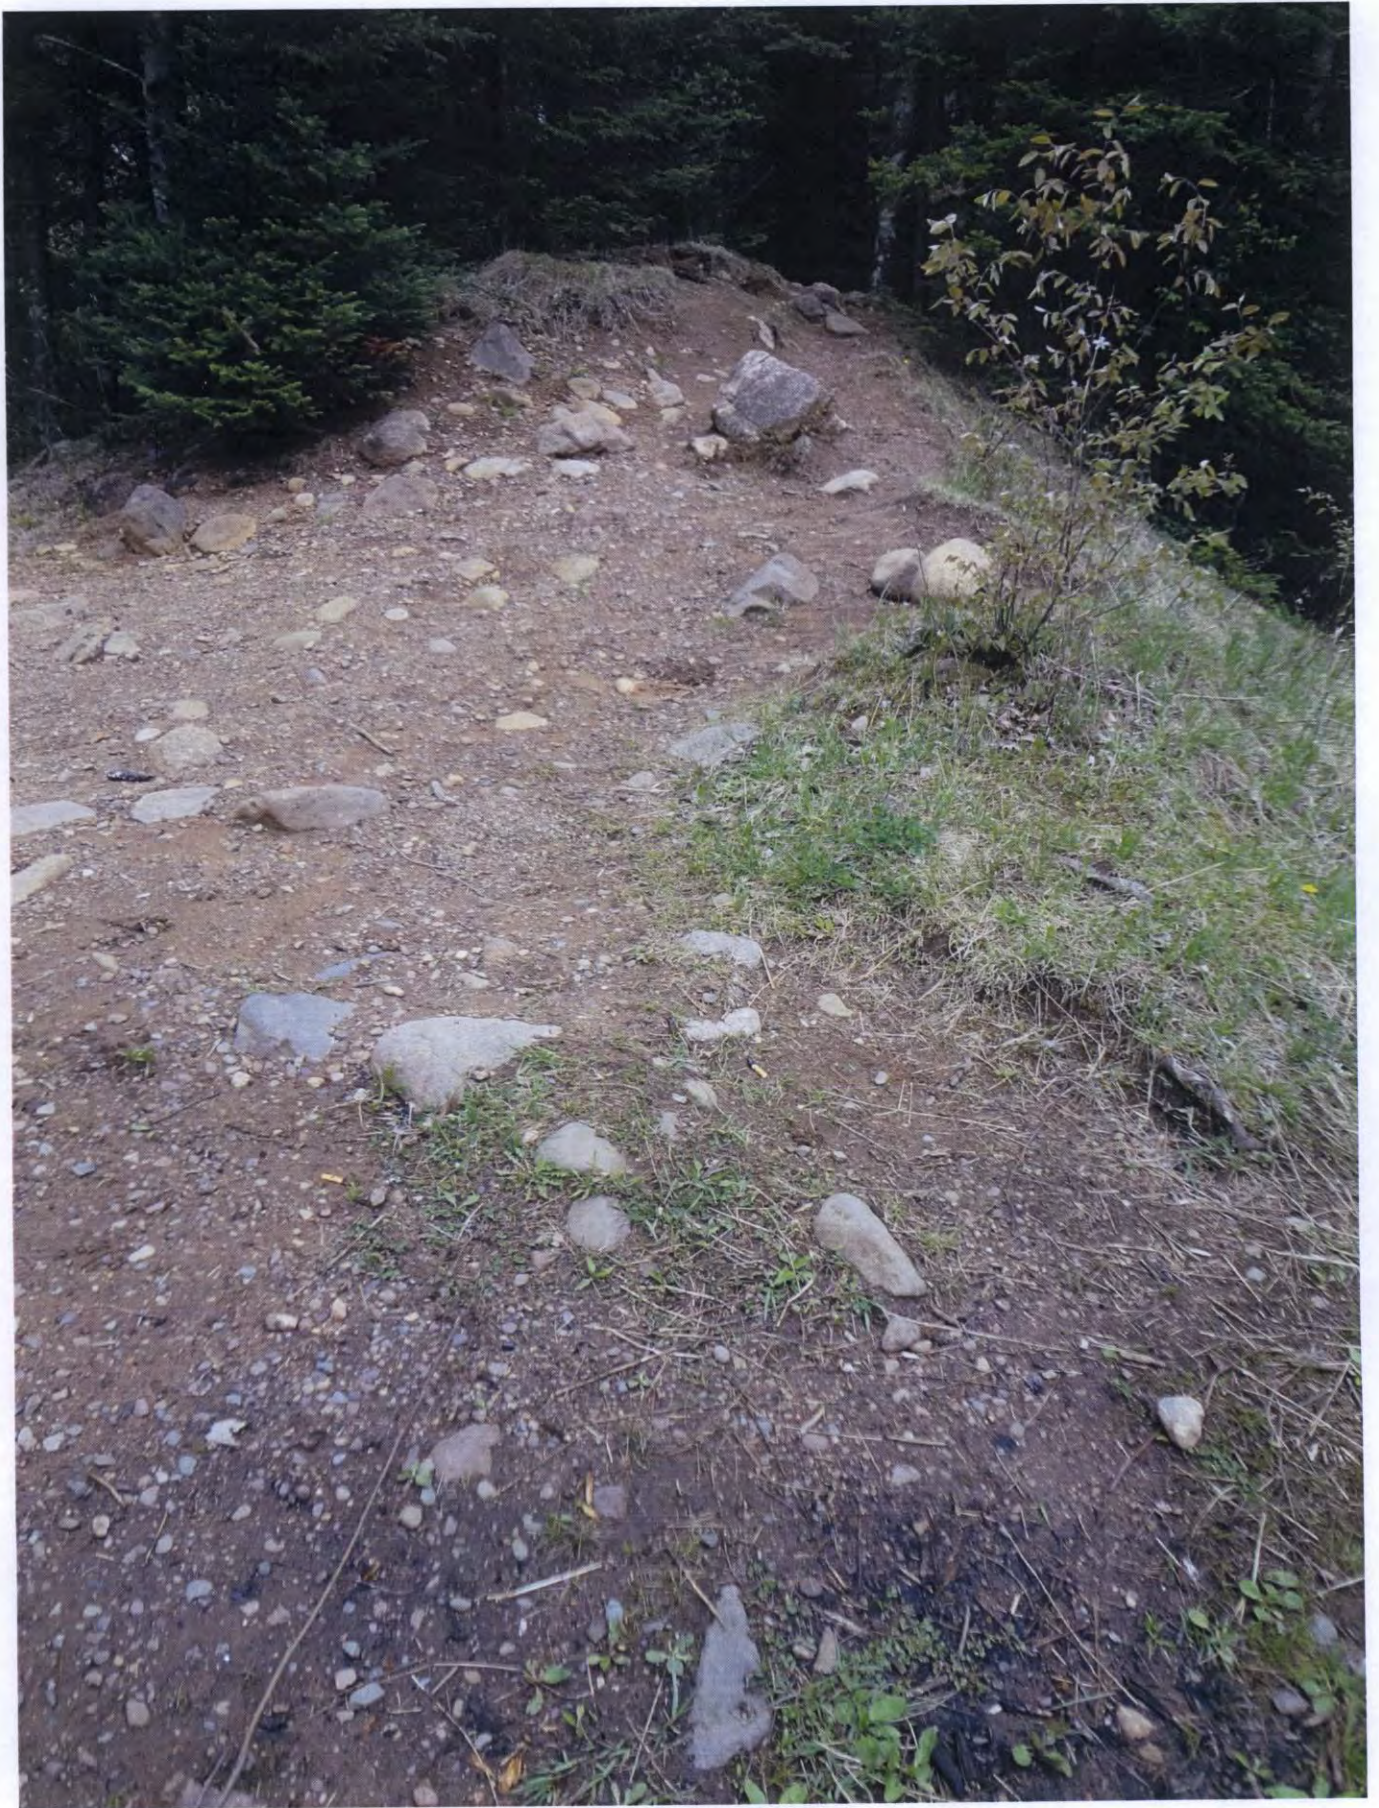
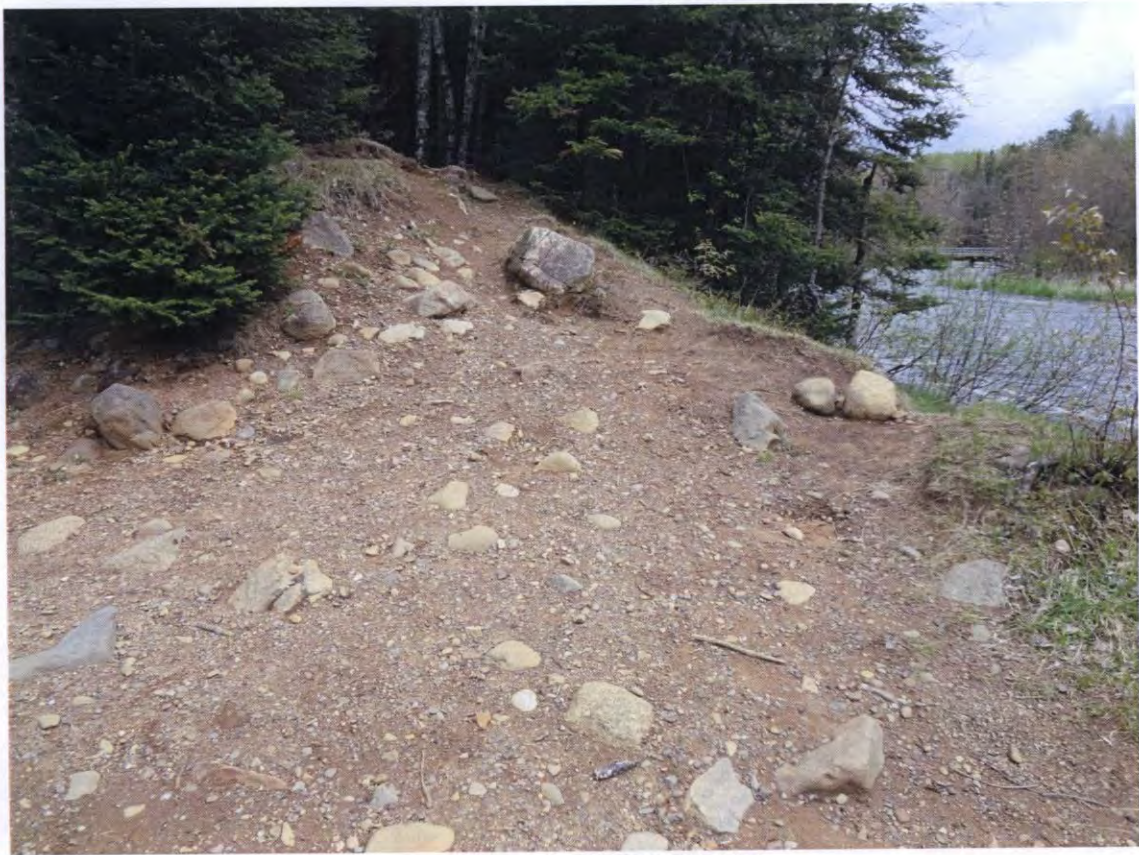
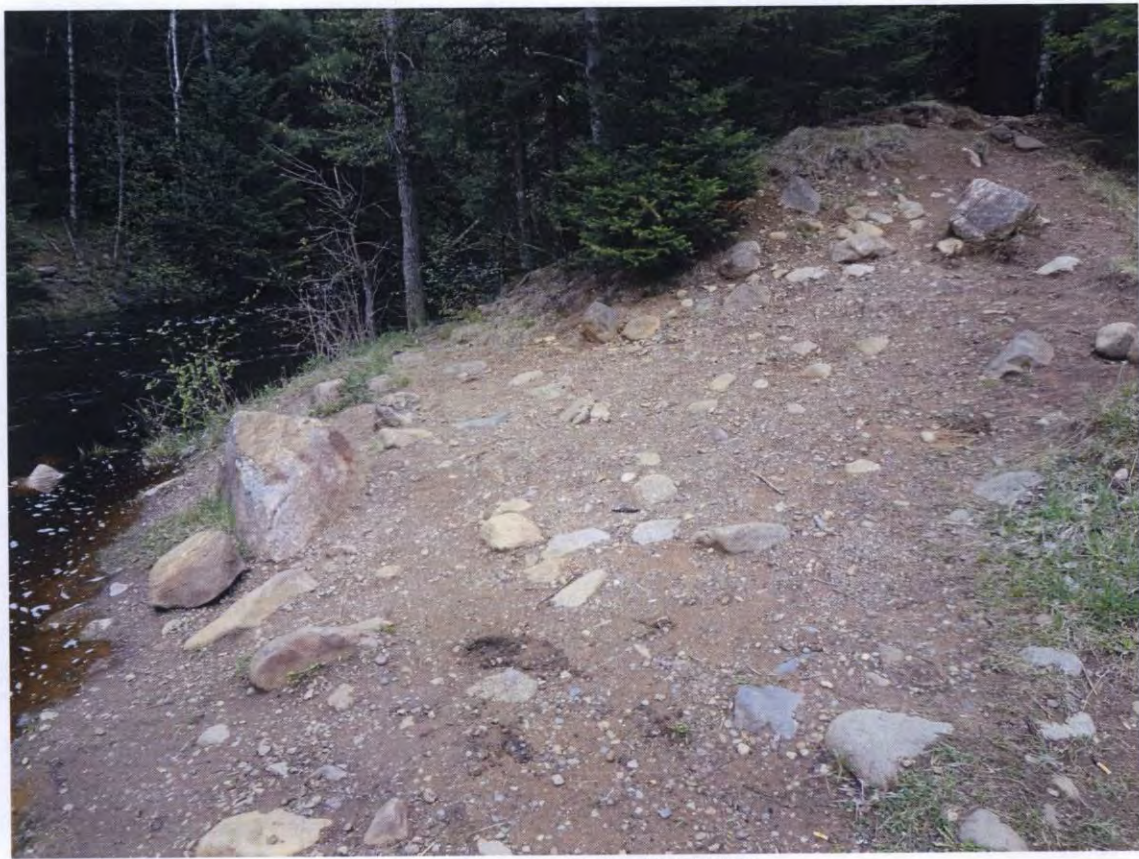
Photo 3- WNTR ER003

Photo 4- WNTR ER003

Photo 5 – WNTR ER003
