**Re: Winter Hydroelectric Project
 FERC Project Number P-2064
 Flambeau Hydro LLC
 Final 2012 Land & Wildlife Management Report**

**Winter Hydroelectric Project Boundary
Exhibit G - Figure G-1**

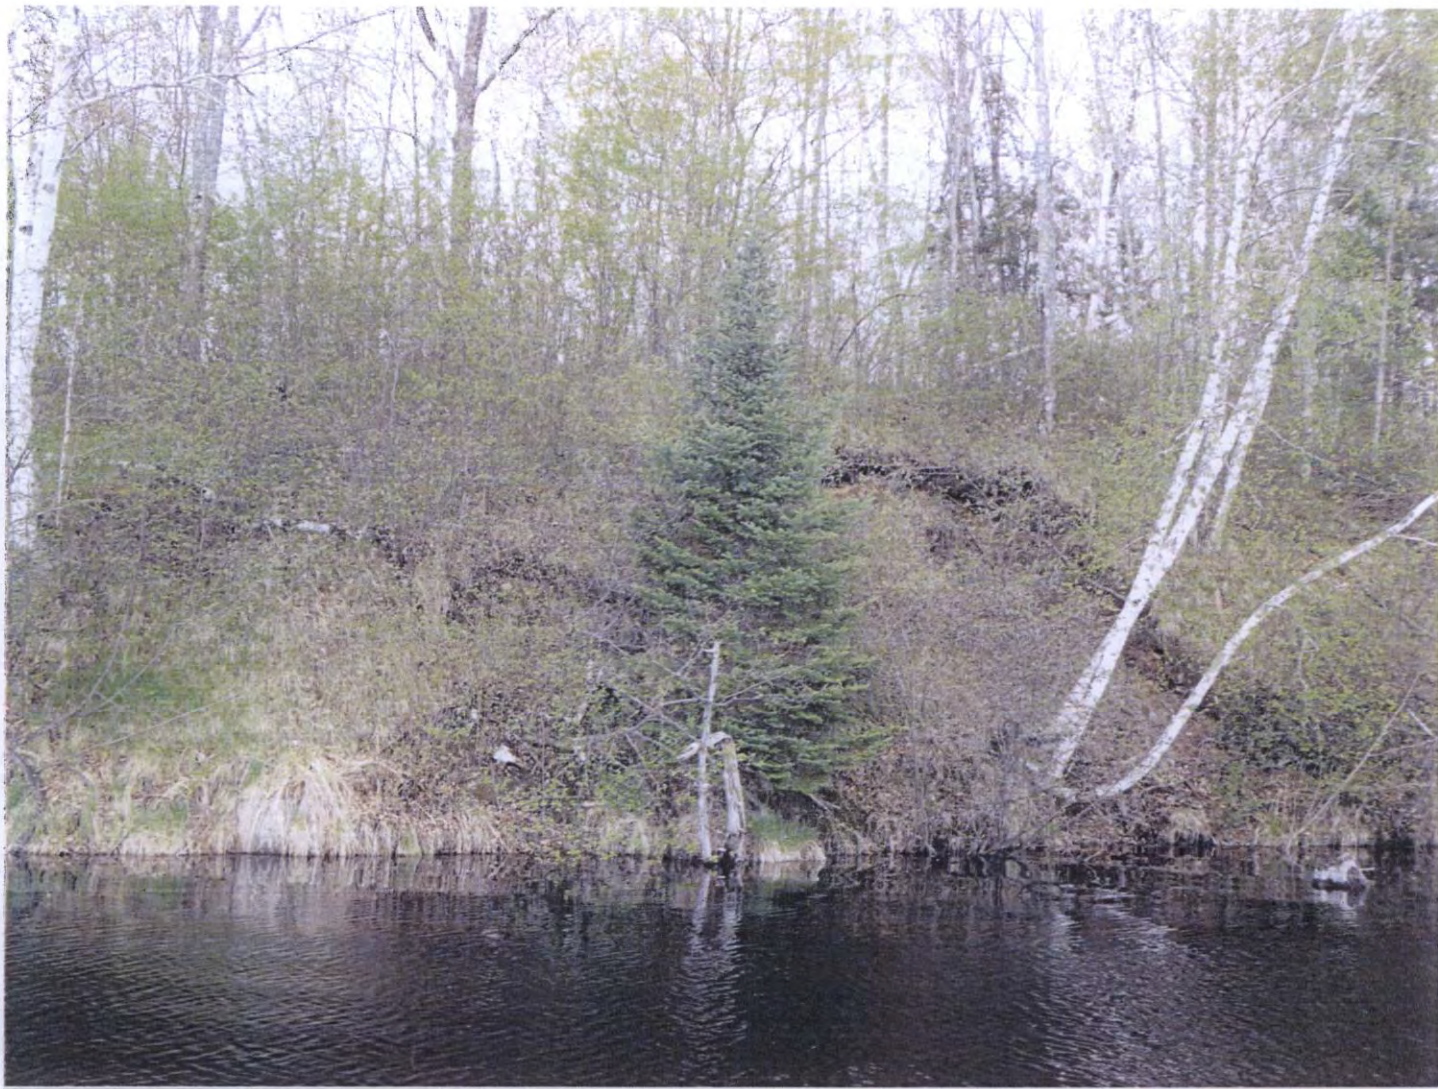
Photo 1 – WNTR ER001

WNTR ER001 is located on the right side of the river at the confluence of Fishtrap Creek and the East Fork of the Chippewa River about 0.90 miles upstream from the powerhouse. This site is not located on FHLLC property. It is considered a Minor site due to the stability of the toe. The entire toe is firmly established with trees, shrubbery, and other vegetation. No noticeable erosion has been evident during the monitoring period of 2008 through 2012. In fact it appears to be healing. It is unlikely to contribute noticeable sediment to the river in its current condition.

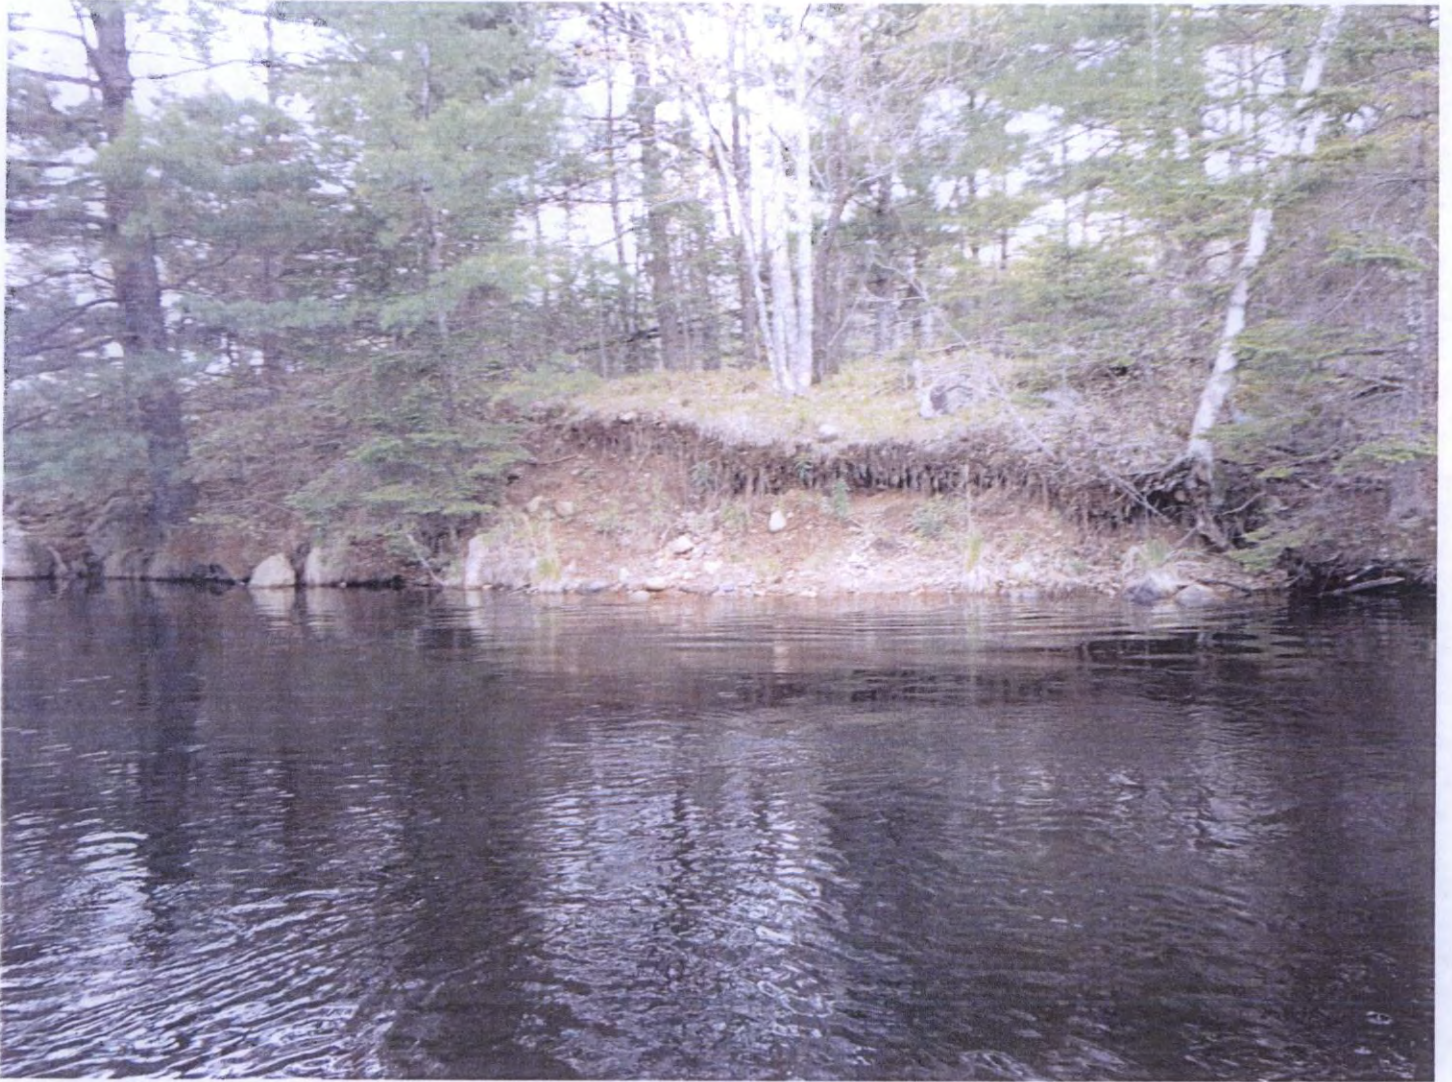
Photo 2 – WNTR ER002

WNTR ER002 is located on the right side of the river near the spillway about 0.43 miles upstream from the powerhouse. This site is not located on FHLLC property. It is considered a Minor site due to the small size and stability of the toe. The entire toe is established with rock and gravel. No noticeable erosion has been evident during the monitoring period of 2008 through 2012. It is unlikely to contribute noticeable sediment to the river in its current condition.

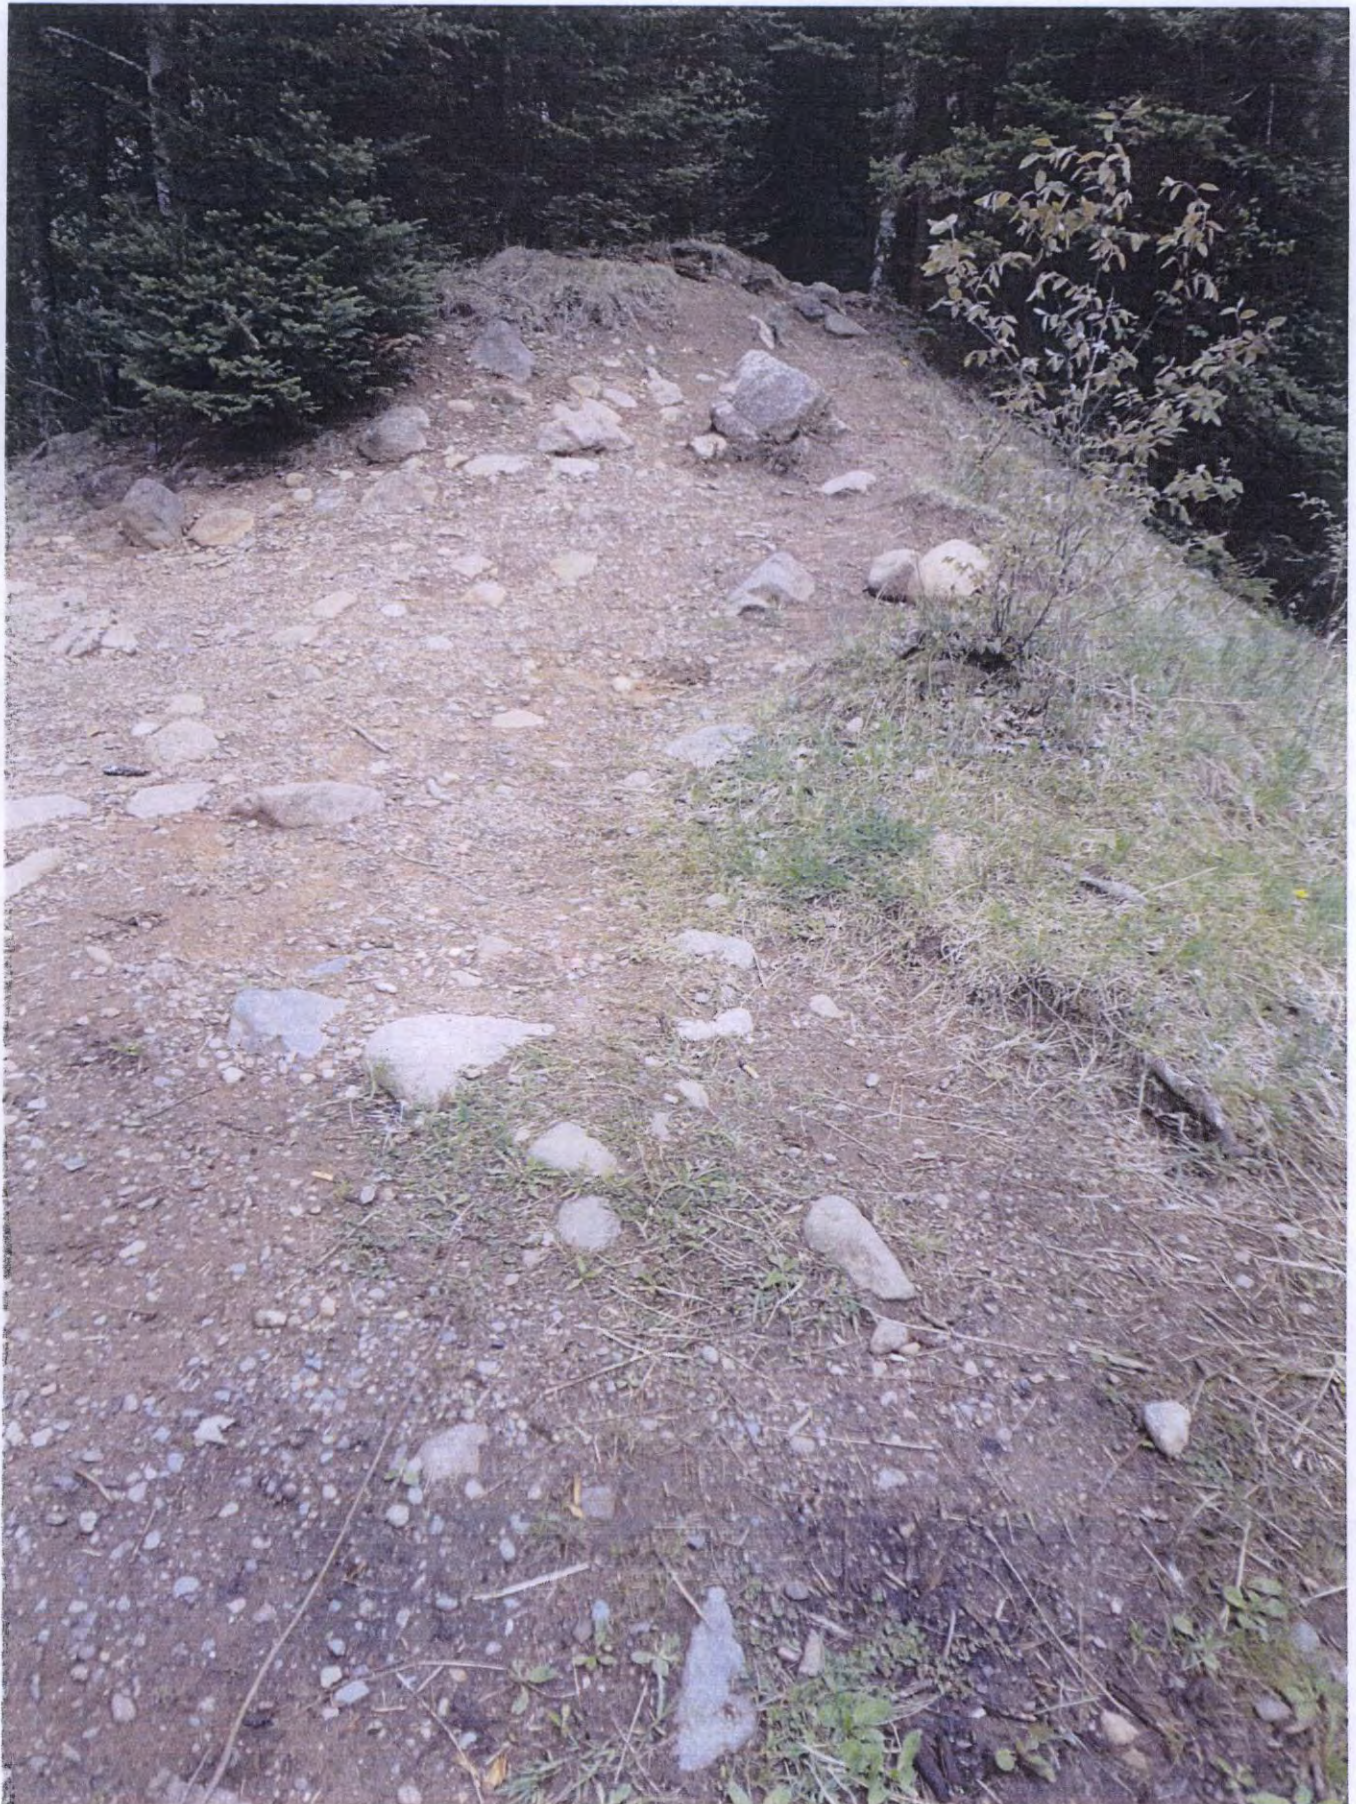
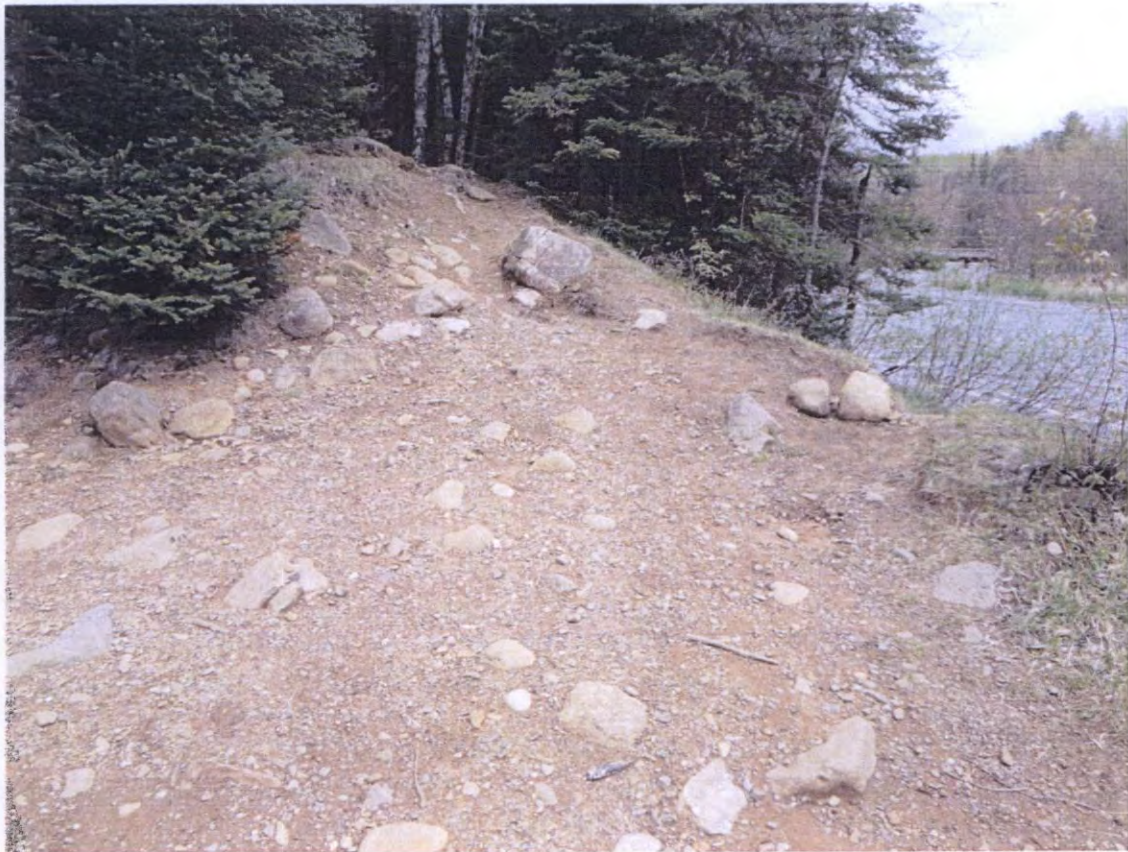
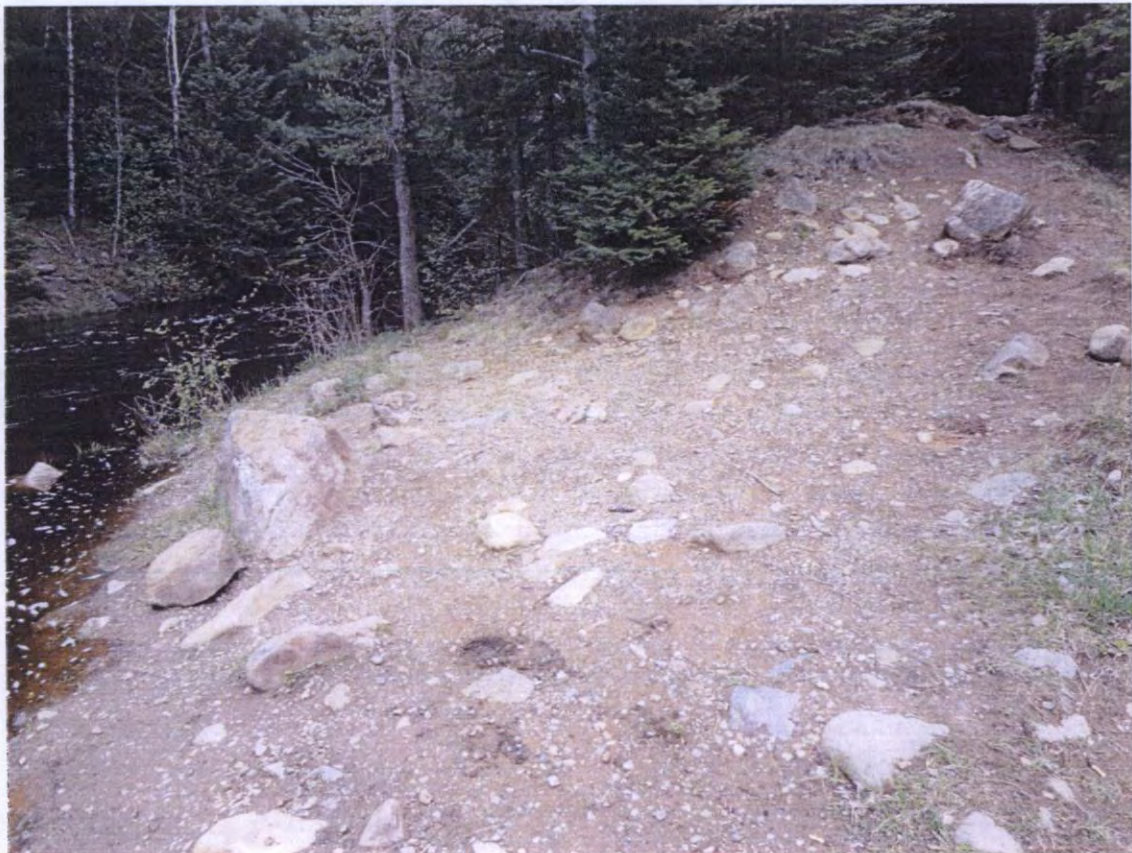
The FHLLC owned property within the project boundary was surveyed on foot and one minor erosion site (WNTR ER003) was observed.

Photo 3 – WNTR ER003

Photo 4 – ER003

Photo 5 – WNTR ER003
