Re: Mosinee Hydroelectric Project, FERC Project No. 2207
Invasive Species Survey Report - 2011

**2011
INVASIVE SPECIES REPORT
FOR THE
MOSINEE HYDROELECTRIC PROJECT
MARATHON COUNTY, WISCONSIN
FERC Project No. 2207**

December 2011

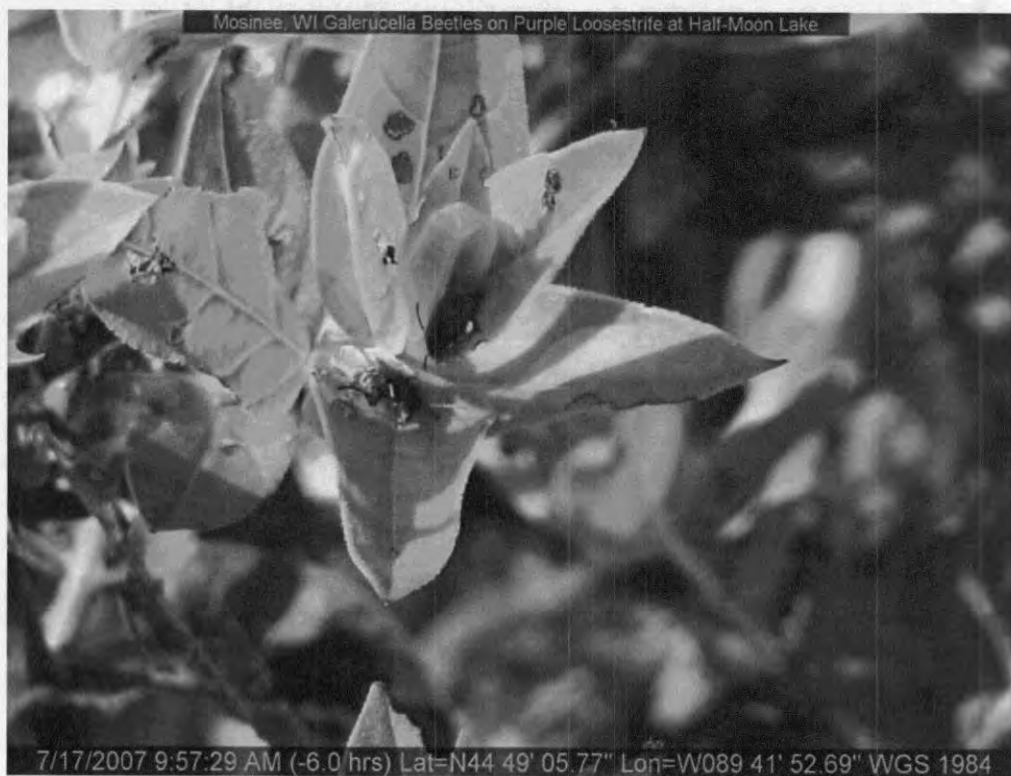
Galerucella Beetles on Purple Loosestrife (2007)

During the baseline survey in 2007, Cella beetles were discovered to be present at a quite a number of PL occurrences. Upon closer inspection, it was noted that the beetles were partially defoliating and stunting the

growth of a large amount of PL plants to the point where the flowers were not developing. At that point, the crew found it necessary to slow down, stay closer to shore, and look for additional plants by color and texture rather than just looking for the flowering seed heads. Damaged plants took on a yellow/green or brown color and were readily identified against the darker green surrounding vegetation. These conditions were found to be similar in the 2008, 2009, and 2010 surveys. Although Cella beetle damage was much less in 2011 than previous years, the survey crew was still able to adequately identify PL plants by color and texture rather than just looking for flowering seed heads.

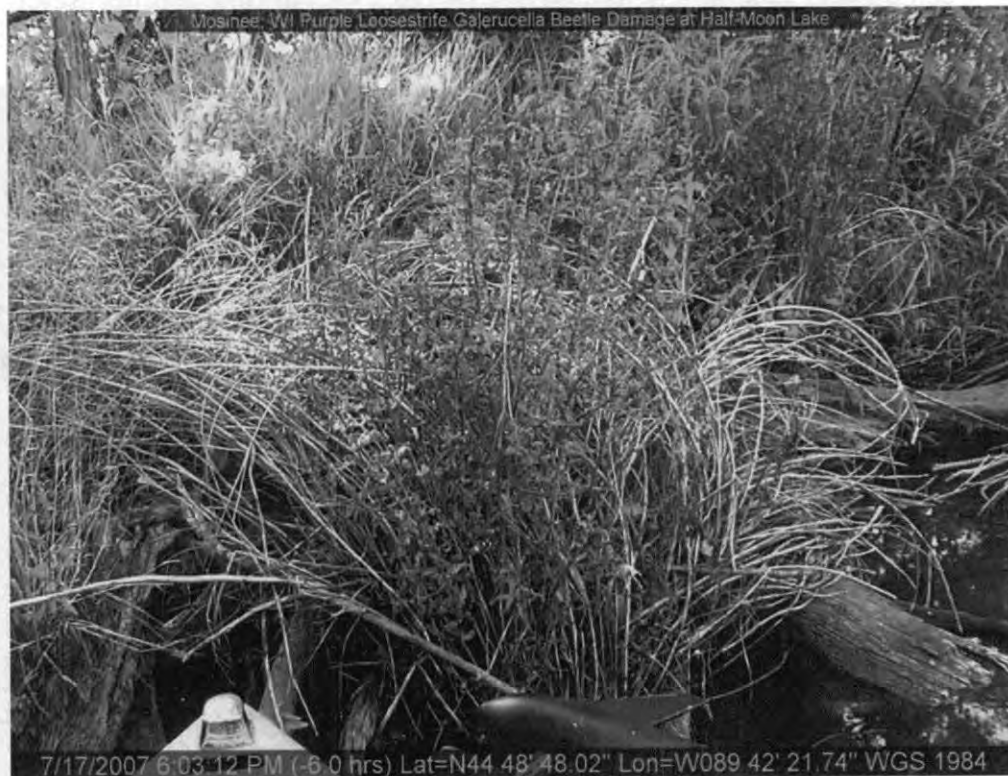
Mosinee, WI Purple Loosestrife Galerucella Beetle Damage at Half-Moon Lake
 7/17/2007 6:03:12 PM (-6.0 hrs) Lat=N44 48' 48.02" Lon=W089 42' 21.74" WGS 1984
 Beetle Damage on Purple Loosestrife Against Darker Green Surrounding Vegetation (2007)

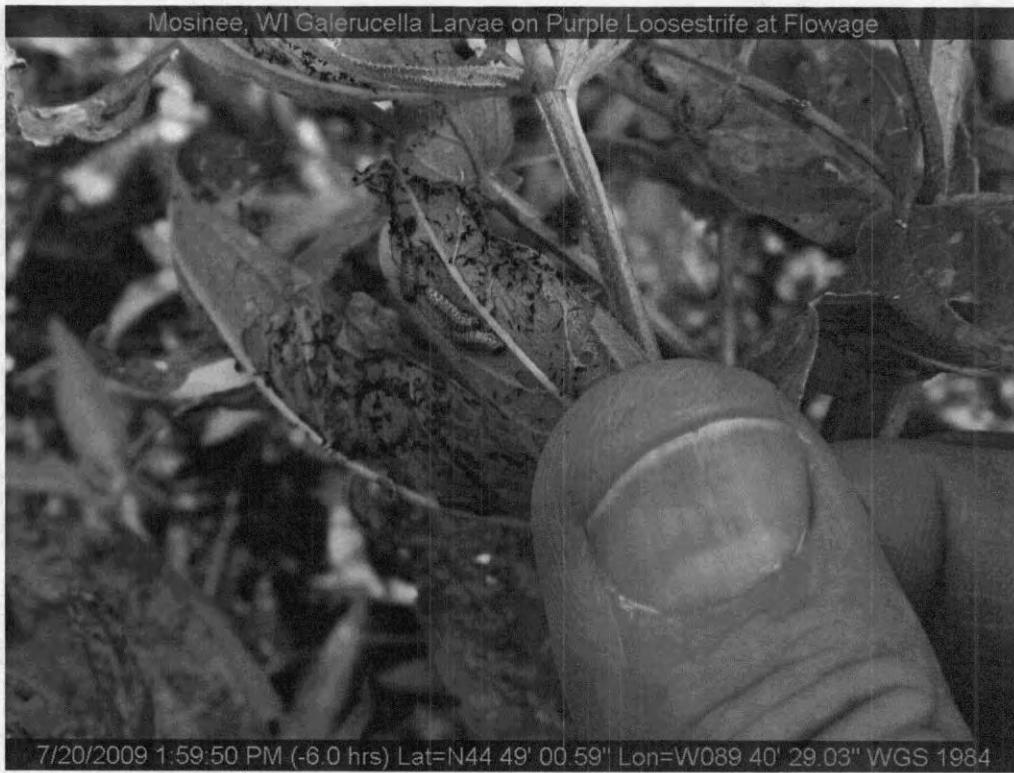
Beetle Larvae on Purple Loosestrife at Mosinee Flowage (2009)

In the 2008, 2009, and 2010, Cella beetle larvae were found on PL plants in a slough in the northeastern area of the Mosinee Flowage (N44° 49' 00.59" W89° 40'.03") along with other locations throughout the project area. During the 2011 survey, no larvae were observed within the survey area.

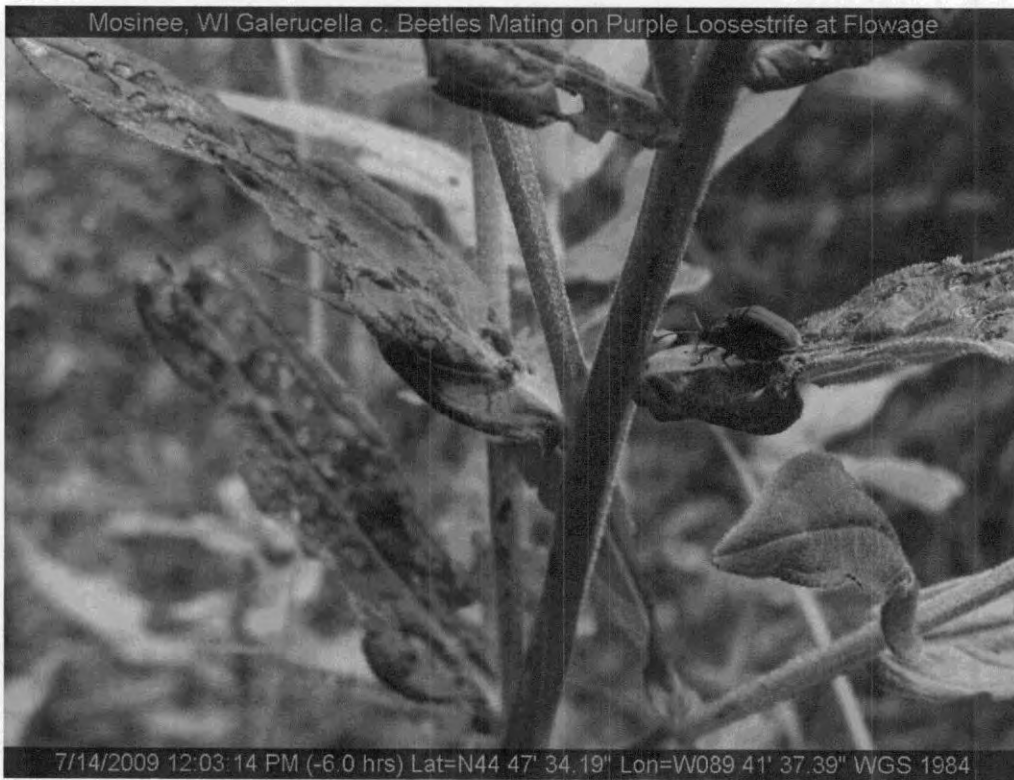
Galerucella Calmariensis Beetles Mating on Purple Loosestrife at Mosinee Flowage (2009)

In 2009, two species of beetles (*Galerucella pusilla* and *Galerucella californiensis*) were detected at the project. On 7/14/09, *Galerucella c.* beetles were observed mating at MOSN PL0155 (N44° 47' 34.19" W89° 41' 37.39"), and, the following day, new eggs were detected on the plants. Eggs were found on PL at a number of other locations during the 2009 survey, however, in 2010, no eggs were found at any location in the survey area. In 2011, Cella beetle eggs were found at a number of locations within the survey area.

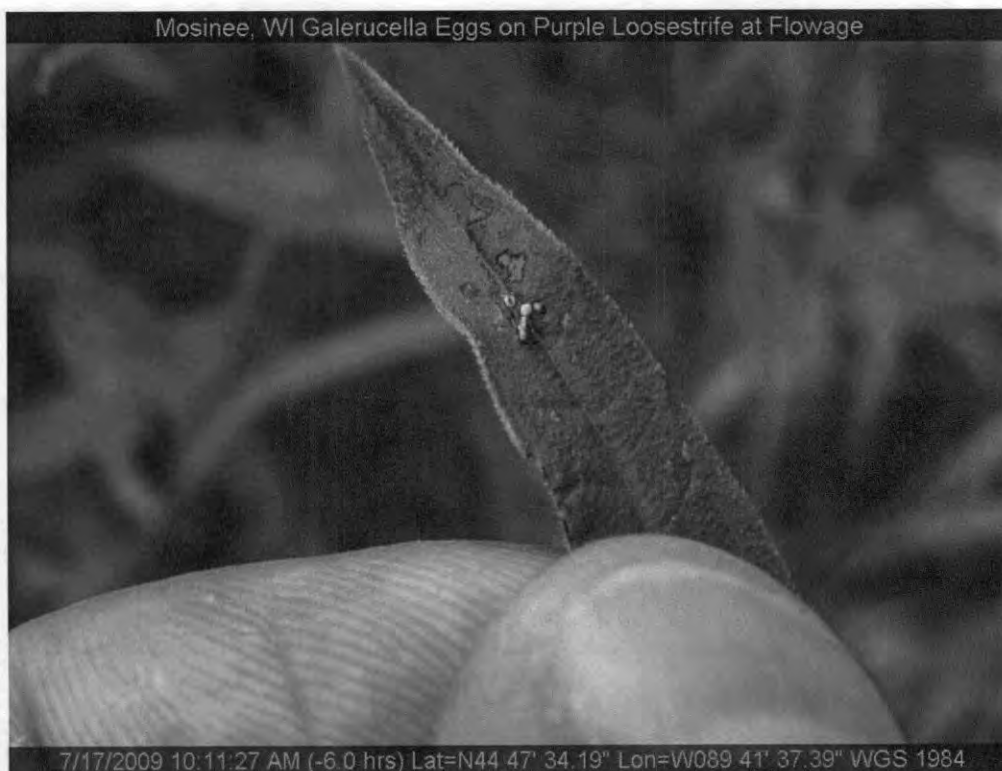
Galerucella Beetle Eggs on Purple Loosestrife at Mosinee Flowage (2009)

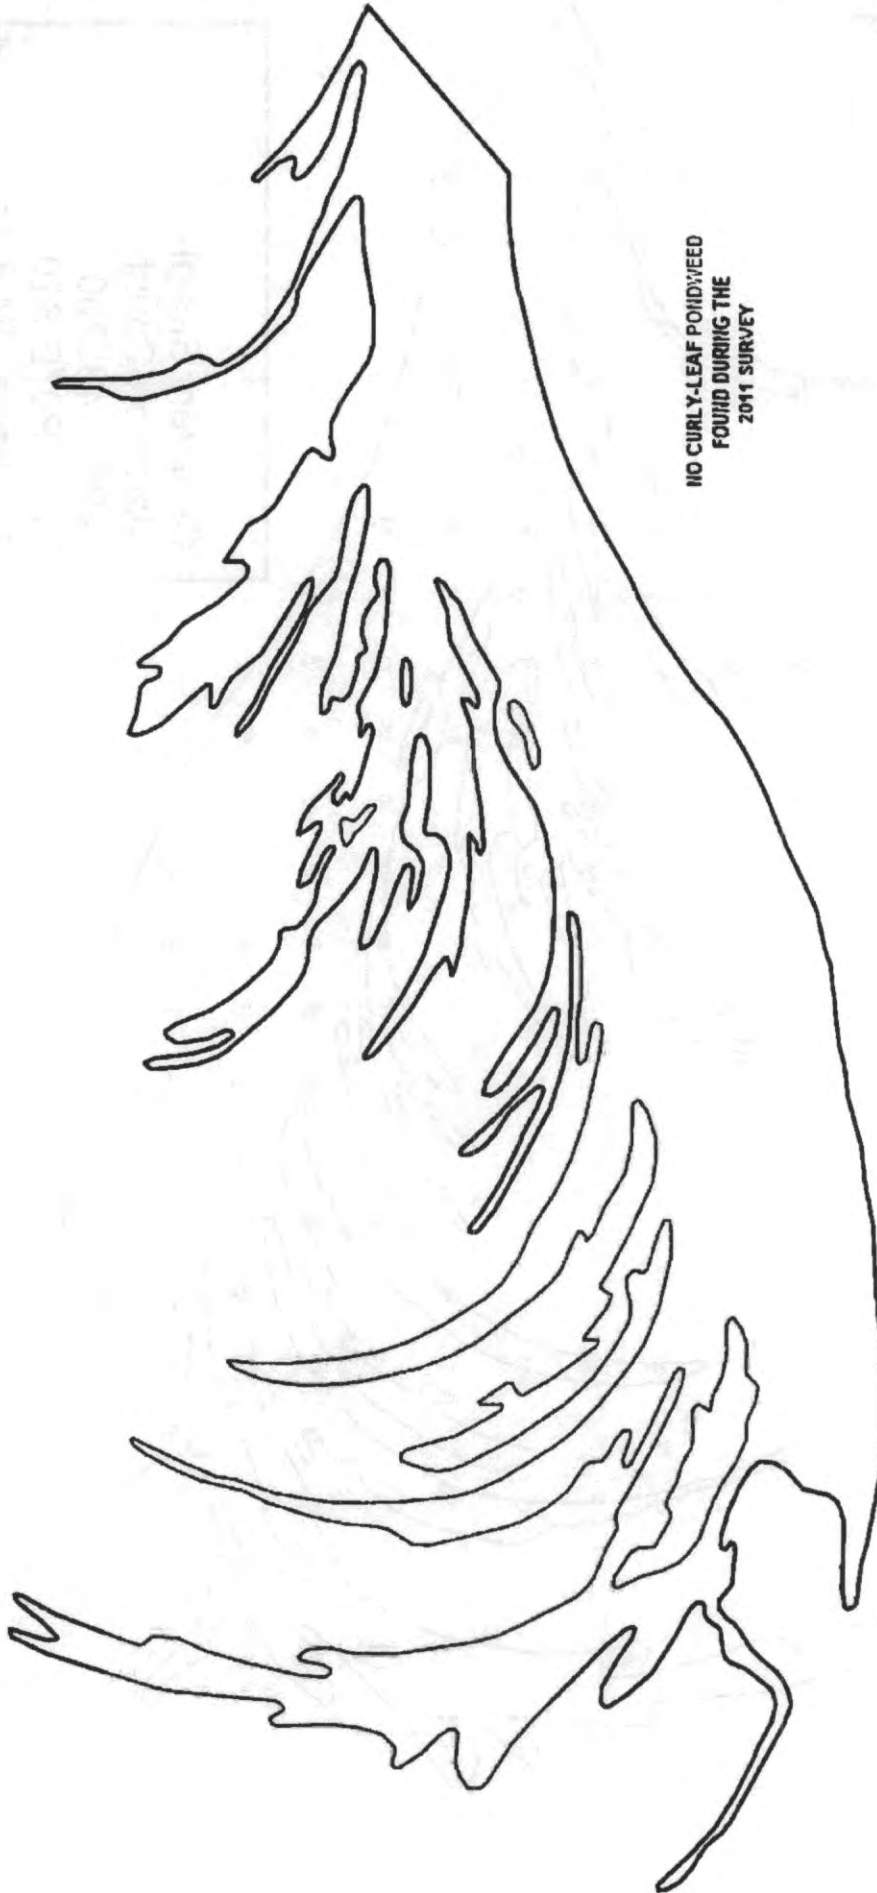
**MOSINEE HYDROELECTRIC PROJECT
CEMETERY SLOUGH 2011
CURLY-LEAF PONDWEED
DISTRIBUTION**

**NO CURLY-LEAF PONDWEED
FOUND DURING THE
2011 SURVEY**

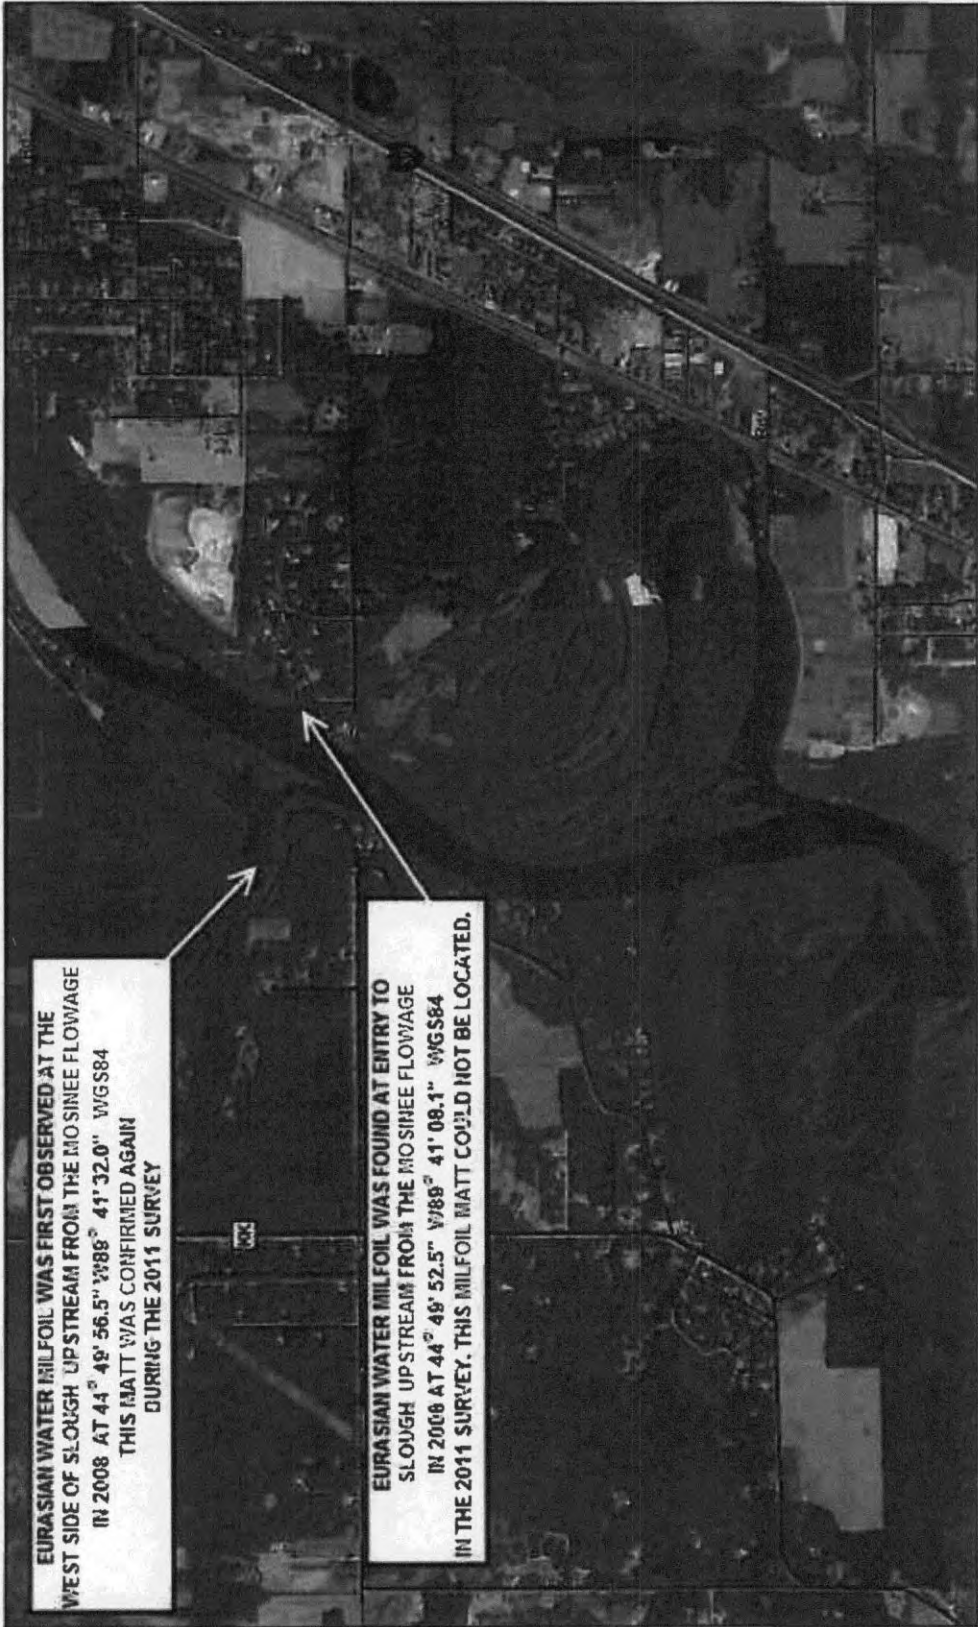
EURASIAN WATER MILFOIL WAS FIRST OBSERVED AT THE WEST SIDE OF SLOUGH UPSTREAM FROM THE MOSINEE FLOWAGE IN 2008 AT 44° 48' 56.5" N 88° 41' 32.0" W GCS84 THIS MATT WAS CONFIRMED AGAIN DURING THE 2011 SURVEY

EURASIAN WATER MILFOIL WAS FOUND AT ENTRY TO SLOUGH UPSTREAM FROM THE MOSINEE FLOWAGE IN 2008 AT 44° 48' 52.5" N 88° 41' 08.1" W GCS84 IN THE 2011 SURVEY. THIS MILFOIL MATT COULD NOT BE LOCATED.

of Fourmile Creek (N44° 49' 56.5" W89° 41' 32.0" WGS84) on the right side of the river upstream from the Mosinee Flowage. In 2009, the number of EWM plants at both these locations decreased to where only a few plants were found, and, in 2010, no EWM plants were detected. In 2011, EWM was found again in the inlet slough of Fourmile Creek (N44° 49' 56.5" W89° 41' 32.0" WGS84) at a size and density estimated to be equal to or greater than that of the 2008 survey when it was first discovered.
