Comprehensive Lake Management Plan for Upper Turtle Lake, Barron County, Wisconsin

August 2003

Prepared by Steve McComas, Blue Water Science
with contributions from Wisconsin Department of Natural Resources
and the Upper Turtle Lake Association

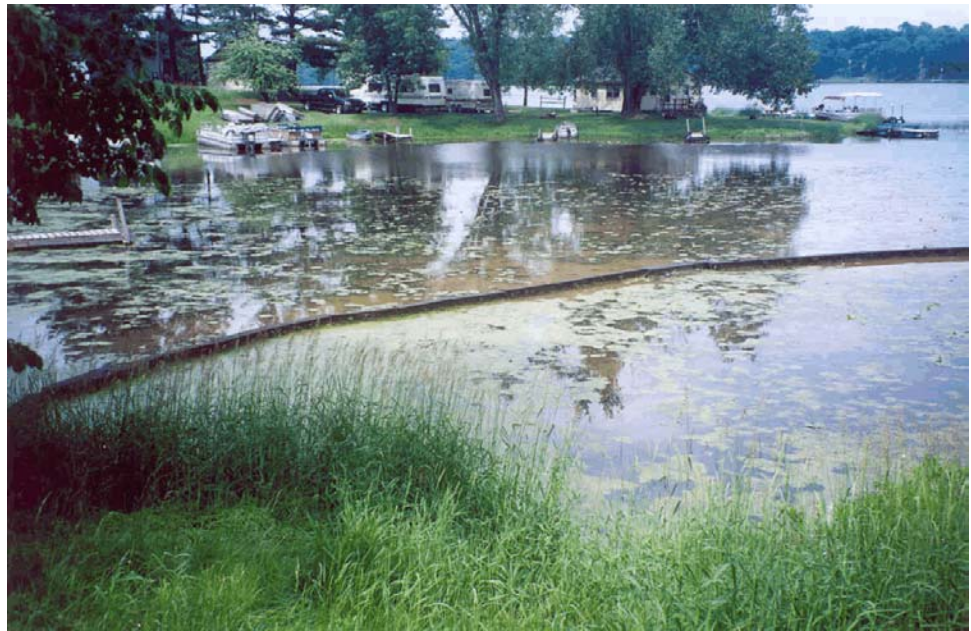
Turbid inflows to the cove in the southwest end of Upper Turtle Lake were observed in 2002.

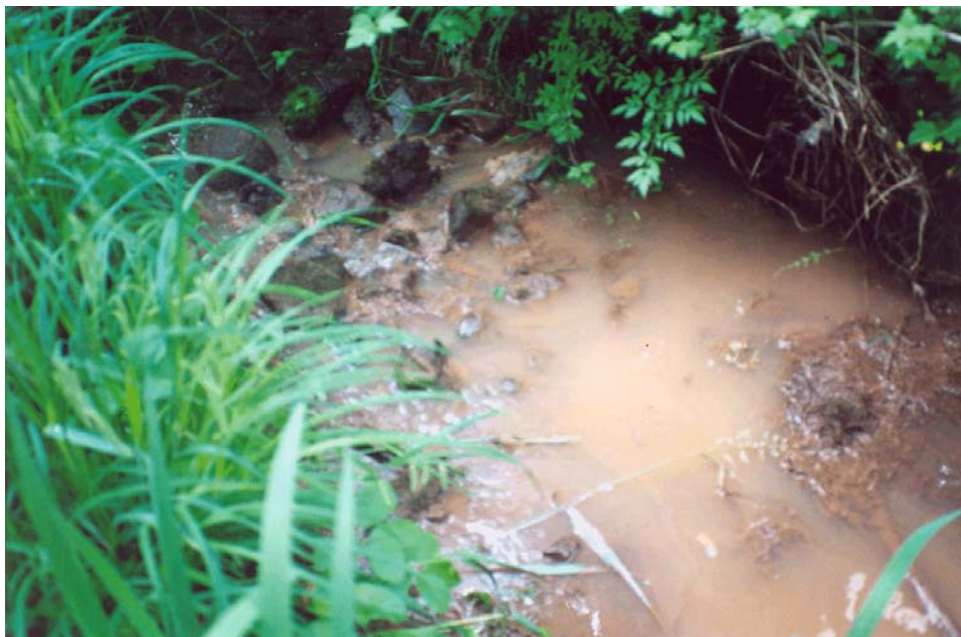
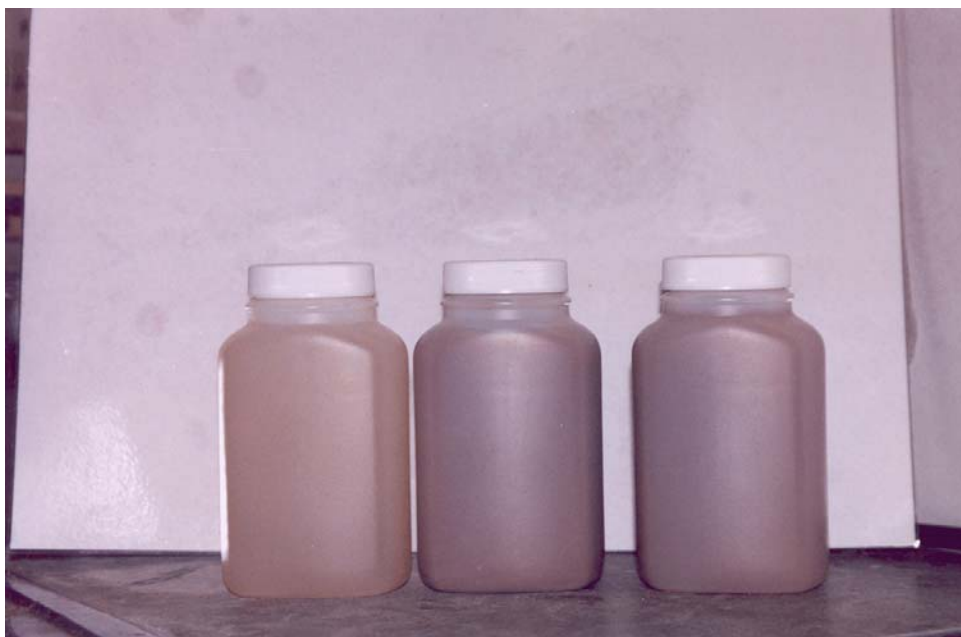
Figure 6. (top) Streams on the west side of Upper Turtle Lake carried high sediment loads during rainfall events in 2002. (bottom) This is the color of the water collected from streams after a significant rainfall. The brownish/tannish color is from suspended sediments.

Nutrients Carried into the Lake with Streams: A major source of nutrients to Upper Turtle Lake is from inflowing streams that carry in phosphorus along with suspended sediments. Stream sample results for 2002 are listed in Table 4.

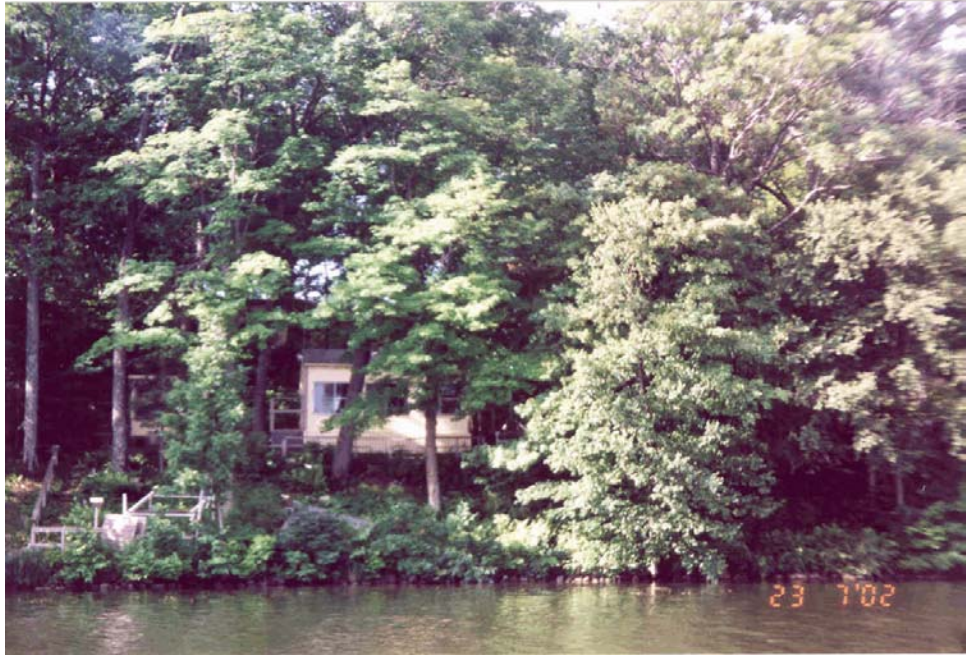
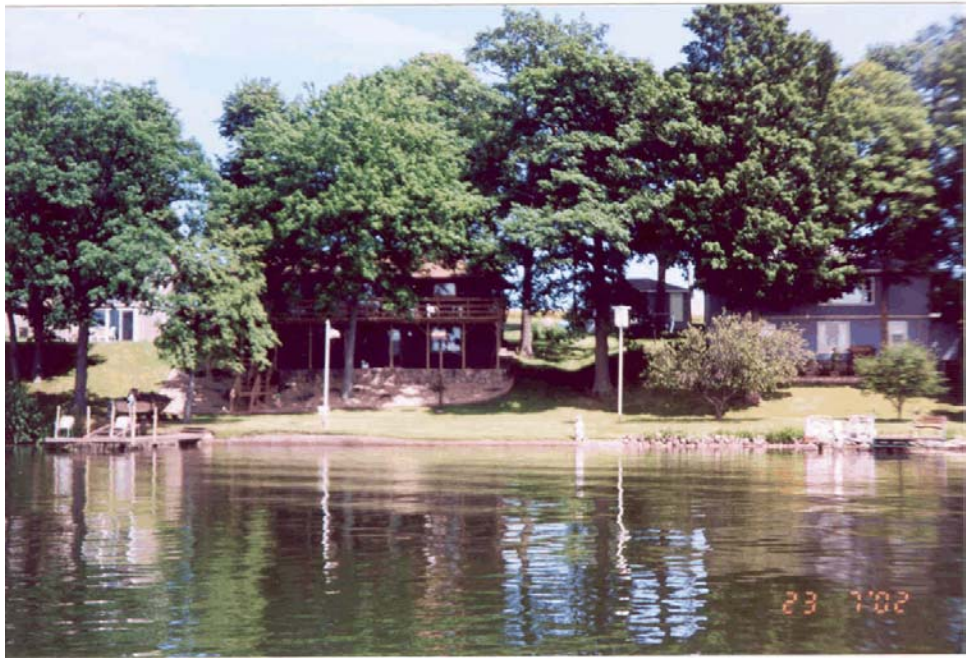
Figure 7. [top] This parcel would rate as having a shoreline with a buffer greater than 50% of the lot width and an understory with greater than 50% natural cover.

For each photograph we looked at the shoreline and the upland condition. Our criteria for natural conditions were the presence of 50% native vegetation in the understory and at least 50% natural vegetation along the shoreline in a strip at least 15 feet deep. We evaluated shorelines and uplands at the 75% natural level as well (Figure 7 illustrates the methodology).

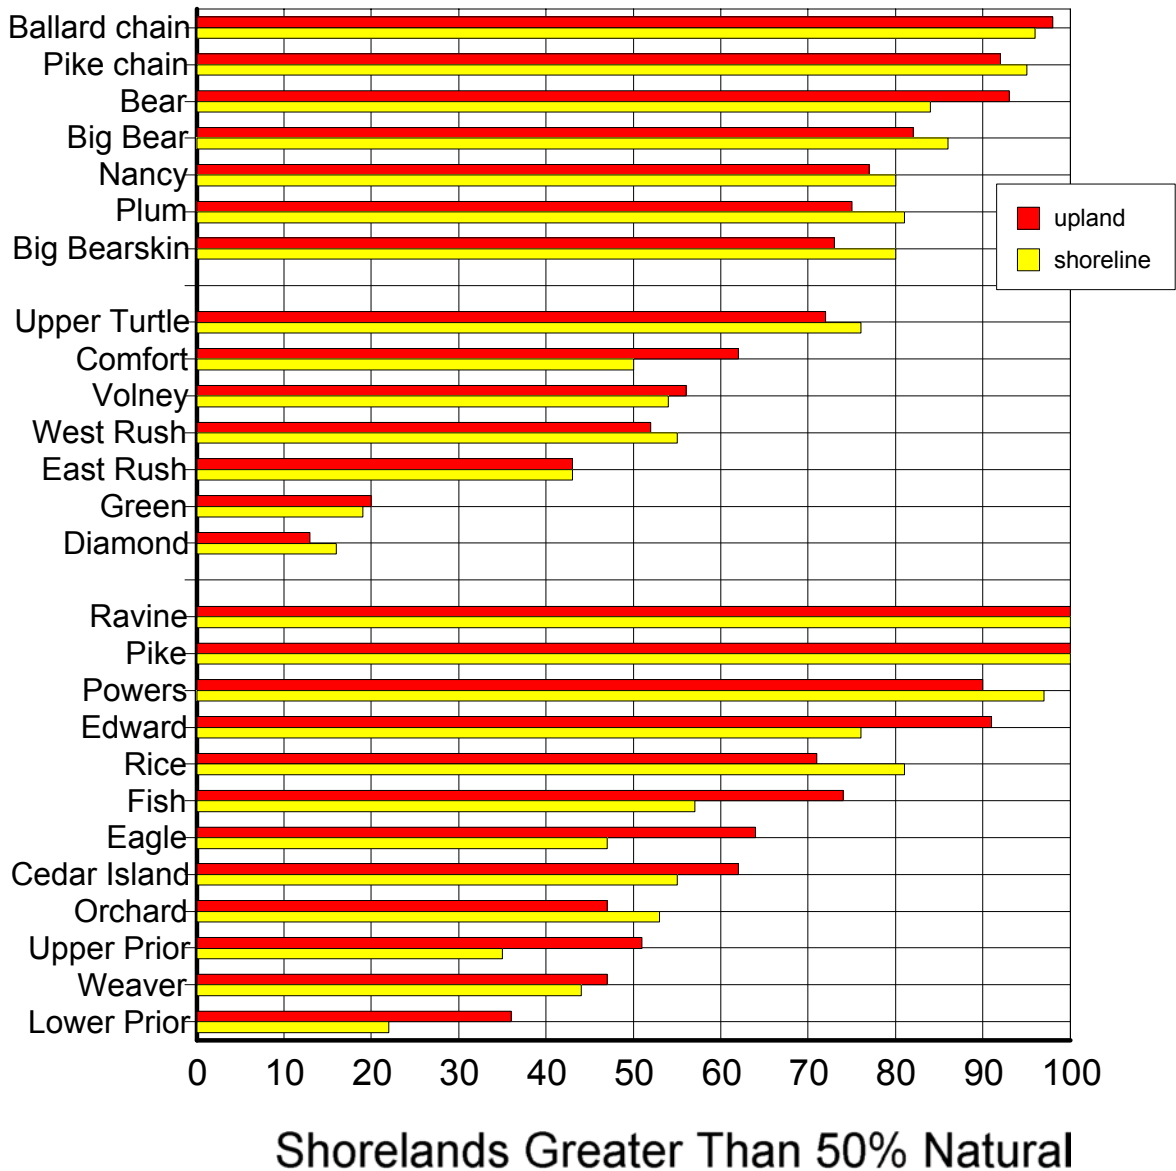
Figure 8. A summary of shoreland inventory results for lakes using an evaluation based on shoreland photographs. For each lake the percentage of shoreline and upland conditions with greater than 50% natural conditions is shown. The first tier of lakes are located in northern Wisconsin. The lower tier of lakes are in the Twin City Metropolitan area and are considered urban lakes. Although several lakes are “urban” lakes most of the shoreland is owned by the city and there is a high percentage of natural conditions. The middle tier of lakes are about an hour’s drive from the Twin Cities, and are not considered to be urban lakes, they are “country” lakes.

Upper Turtle Lake is a country lake. It’s natural shoreland conditions are above average compared to the other country lakes in the middle tier.

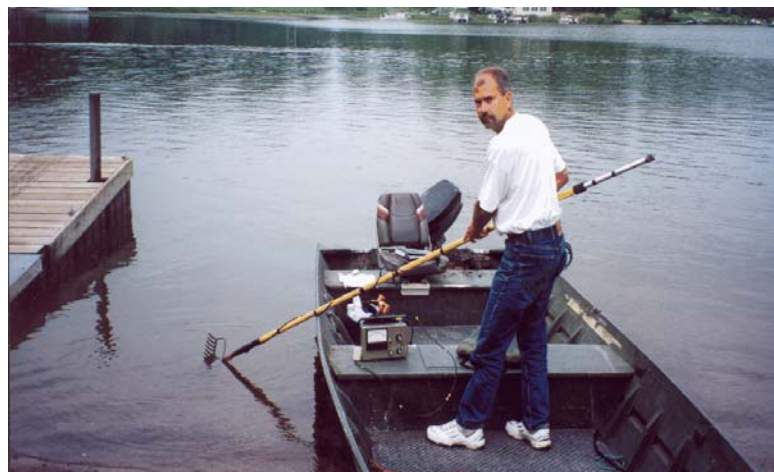
Figure 9. The conductivity survey consisted of attaching a conductivity probe to the end of a pole and moving around the lake in the shallow shoreline area. The conductivity meter recorded changes in conductivity.

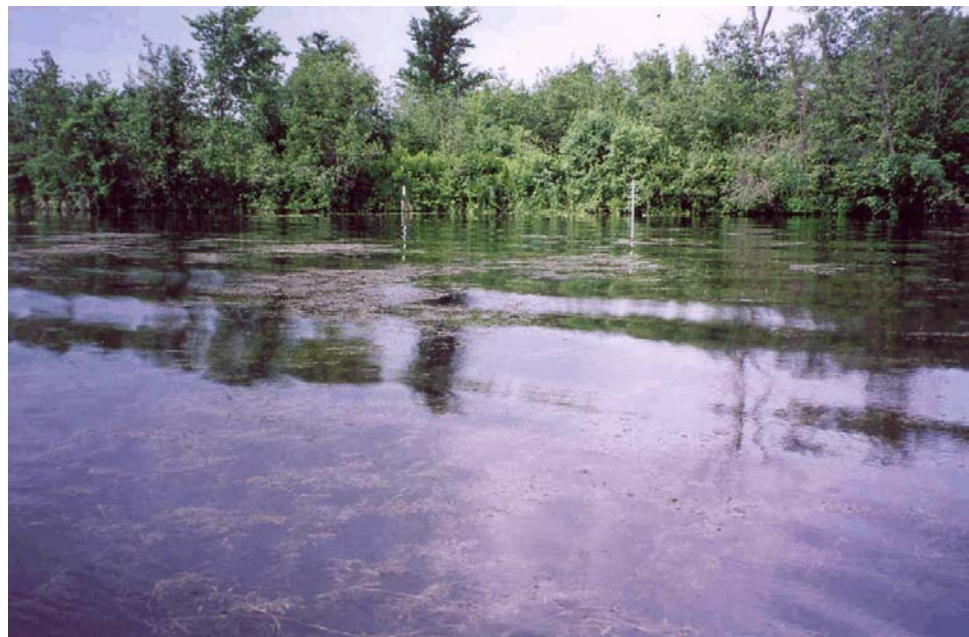
Aquatic plants were growing close to the lake surface in June on the west side of Upper Turtle Lake.

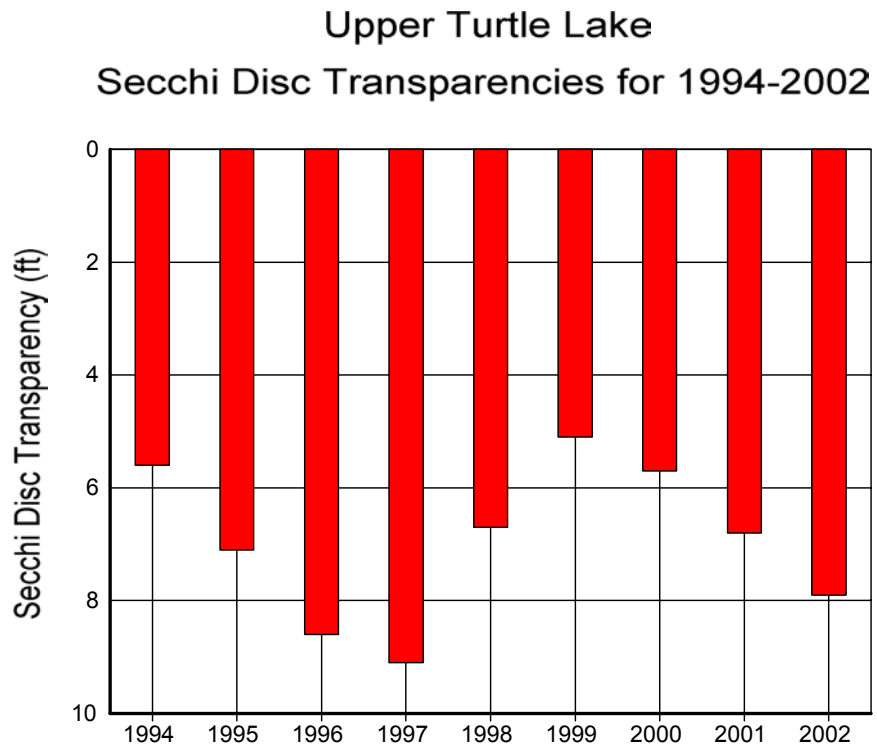
Figure 14. Annual summer Secchi disc averages for Upper Turtle Lake.

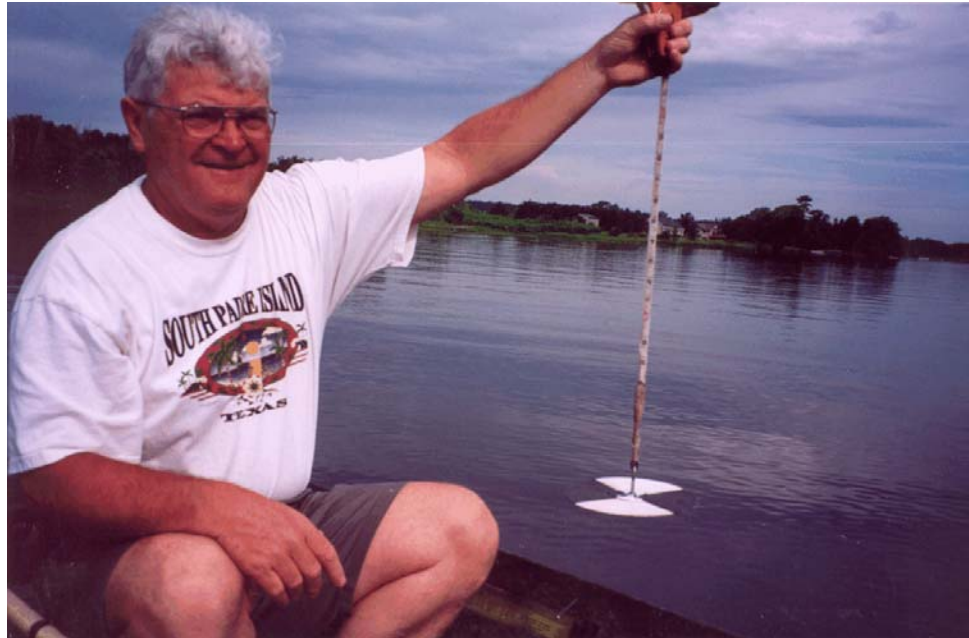
Ken Klehr holding a Secchi disc which is used to measure water clarity.

Water clarity is commonly measured with a Secchi disc. A typical seasonal pattern shows good clarity in May and June with a drop off in July, August, and September (Figure 15). This is a typical pattern for lakes like Turtle Lake.

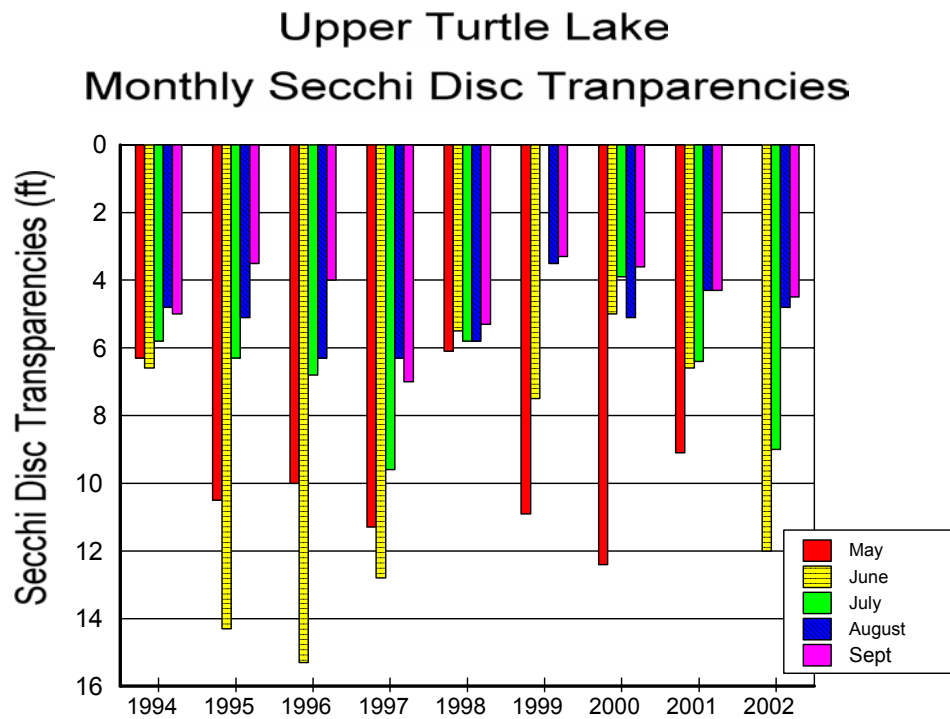
Figure 15. Monthly Secchi disc readings from 1994-2002.

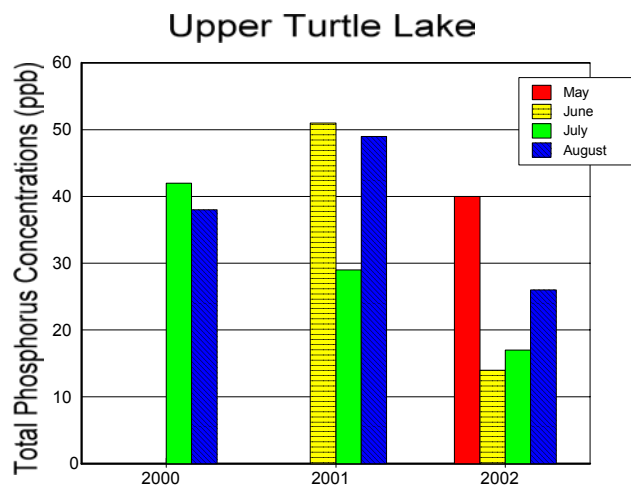
Figure 16. [top] Monthly phosphorus concentrations for 2000, 2001, and 2002. [bottom] Monthly phosphorus concentrations in Upper Turtle Lake for 2002. The north and south ends of the lake have similar concentrations.

Phosphorus is the nutrient more often associated with stimulating nuisance algae growth. Lake phosphorus concentrations for 2000, 2001, and 2002 are shown in Figure 16. Phosphorus concentrations in Upper Turtle Lake are moderate. However, by the end of the summer they are high enough to produce moderate algae blooms.

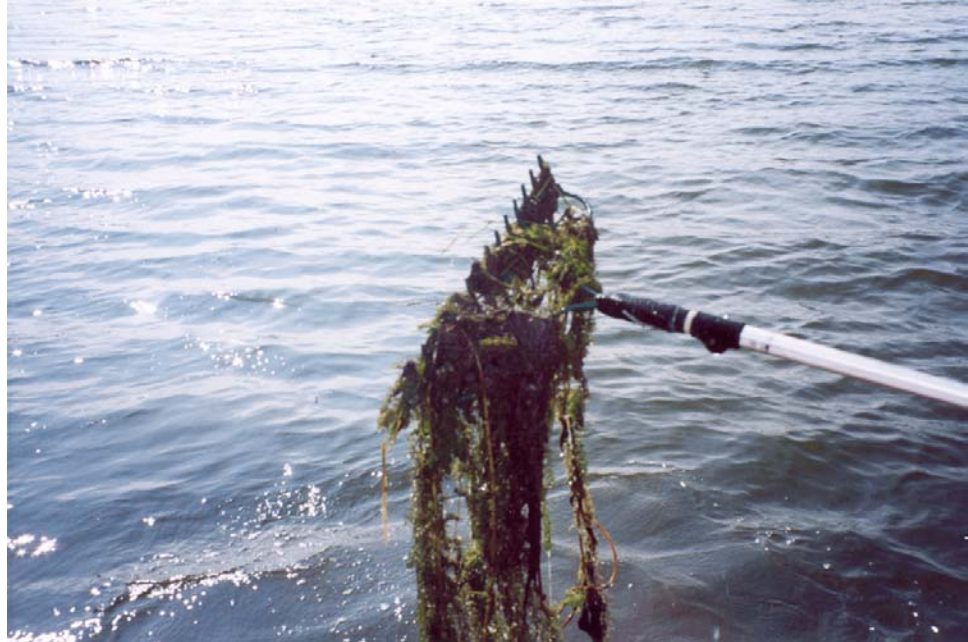
Figure 21. [top] Example of diversity of aquatic plants found in Upper Turtle Lake. [bottom] Upper Turtle Lake aquatic plant coverage based on the 2002 survey conducted by Blue Water Science.

The coverage of aquatic plants over the lake bottoms for Upper Turtle Lake is shown in Figure 21. Details for individual transects for the plant survey is found in Table 14 and summary statistics are listed in Table 14a.

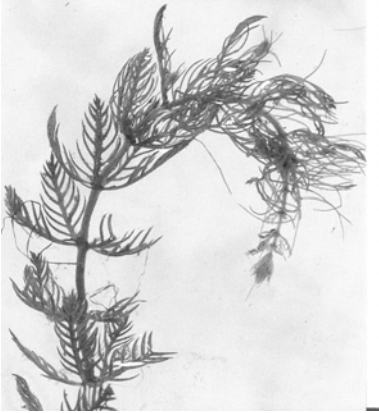
Northern watermilfoil (*Myriophyllum sibiricum*) is found in water depths to 10 feet.

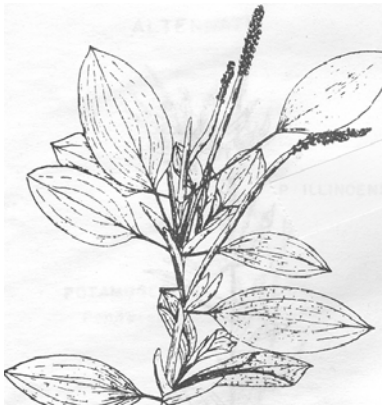
Illinois pondweed (*Potamogeton illinoensis*) is found in water depths to 10 feet.

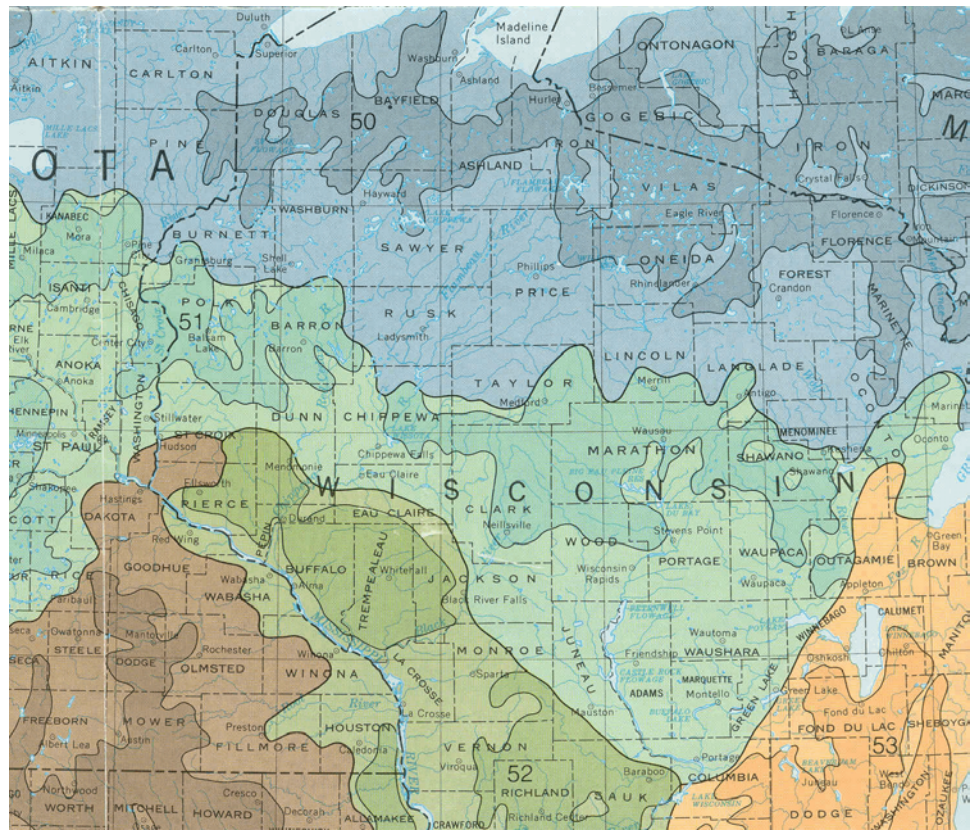
Figure 23. Ecoregion map for Wisconsin. Areas that are labeled with a “50” are bluish and are within the Northern Lakes and Forest Ecoregion. Areas labels with a “51” are blue-green and are in the Central Hardwood Forest Ecoregion. Upper Turtle Lake, located in northwestern Barron County is officially in the Central Hardwood Forest Ecoregion but close to the Northern Lakes and Forest Ecoregion.

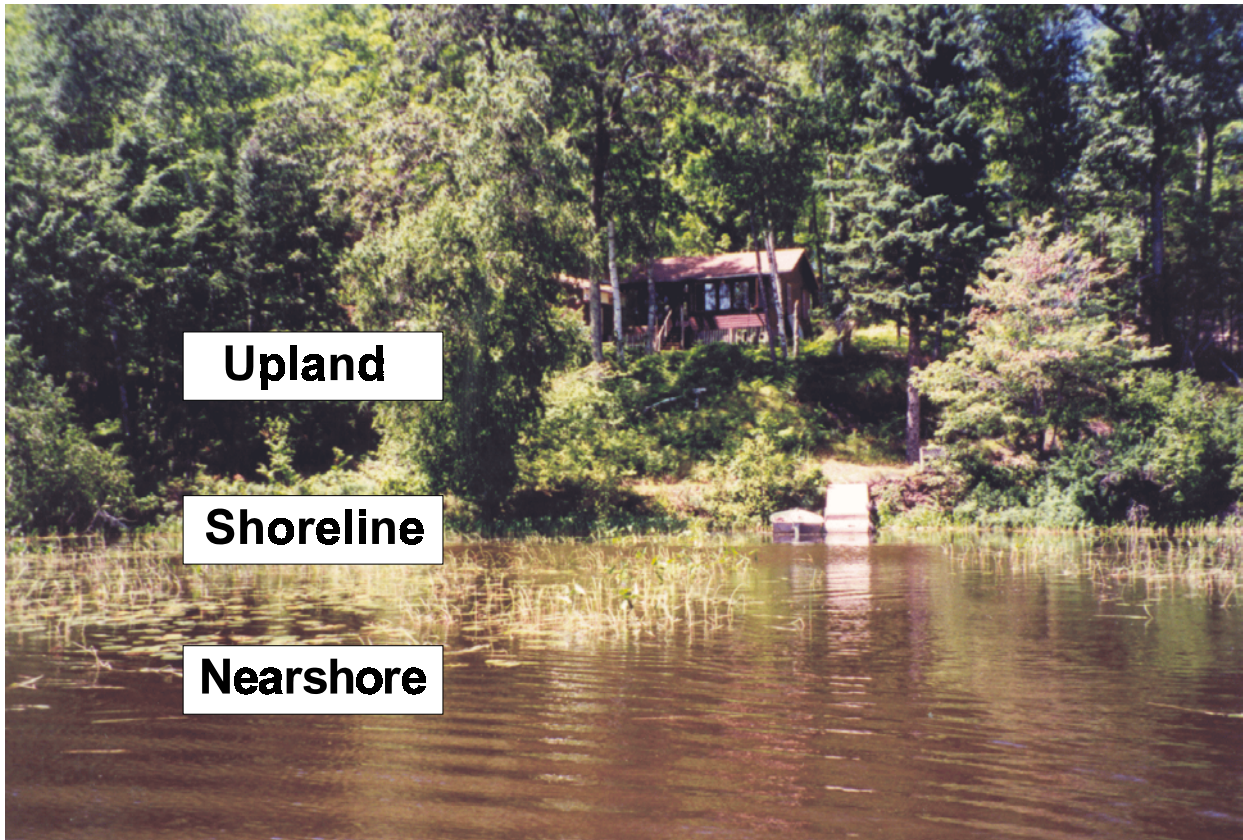
Figure 23. Cross section of the lake shoreland habitat.

The shoreland area is valuable for promoting a natural lake environment and a natural lake experience for lake users. The shoreland is defined as the upland area about 300 to 1,000 feet back from the shoreline, and out into the lake to about the end of your dock (Figure 23). A shoreland with native vegetation offers more wildlife and water quality benefits than a lawn that extends to the lake's edge. A summary of attributes and functions of native plants in the shoreland area is shown in Table 16.

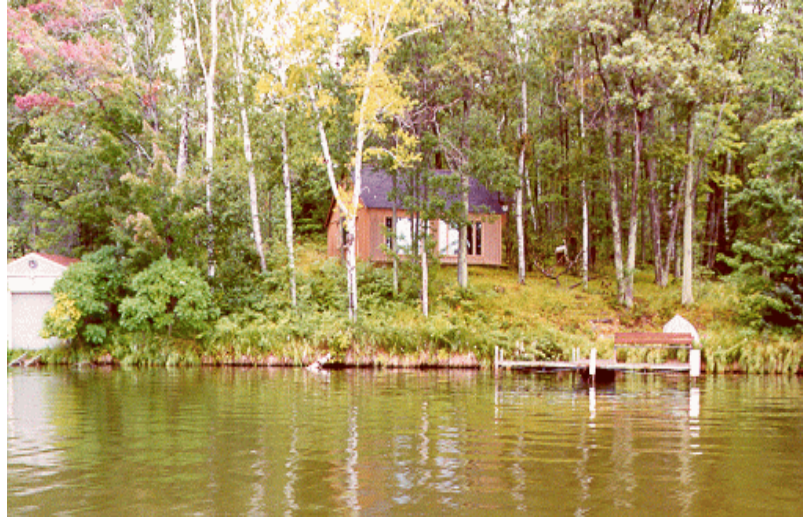
1. Naturalization: The easiest way to implement a natural shoreline setting is to select an area and leave it grow back naturally.

Examples of three shoreland management options.

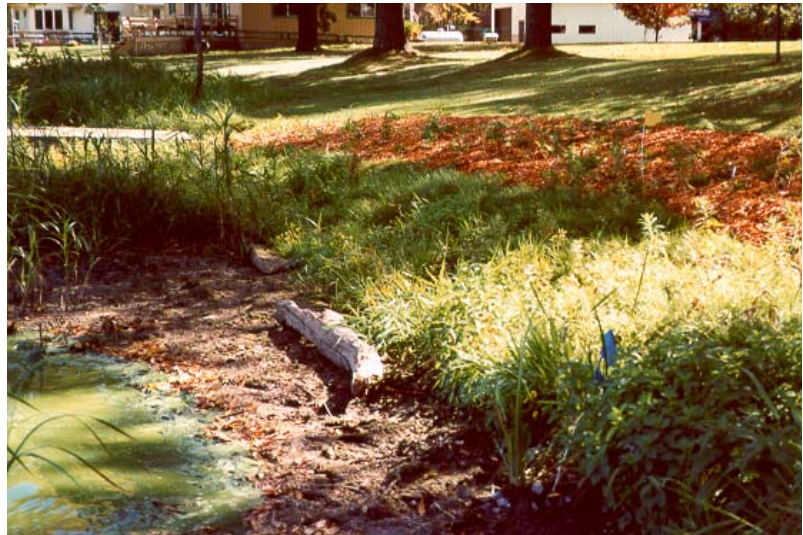
2. Accelerated Naturalization: To accelerate the naturalization, plant shrubs, wild flowers, or grasses into a shoreland area.

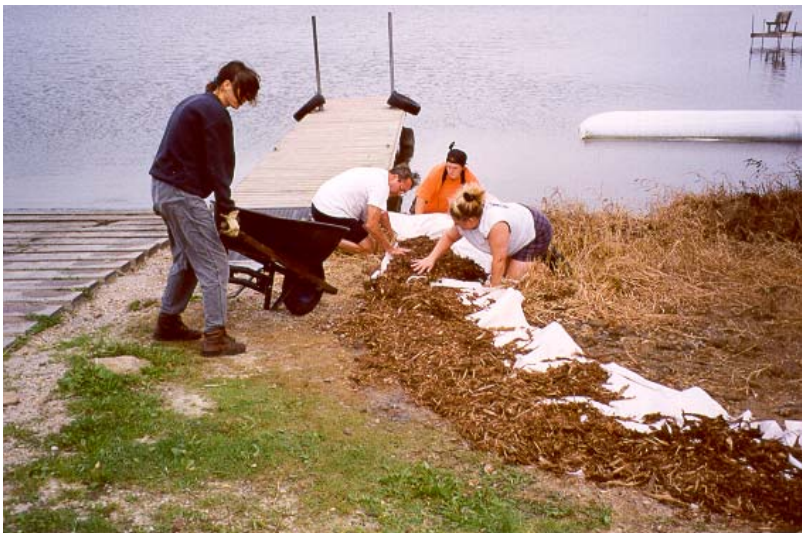
3. Restoration: This involves removing existing vegetation through the use of paper mats and/or mulching and planting a variety of native grasses, flowers, and shrubs into the shoreland area.

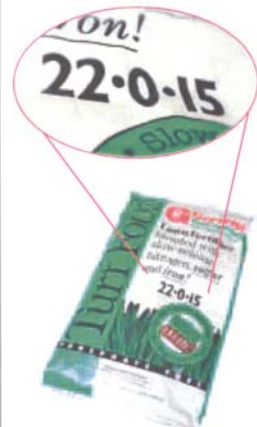
On any bag or box of fertilizer, there is a string of three numbers. The middle number indicates phosphorus content and should read "0" in the Twin Cities seven-county metropolitan area, and "3" or less in Greater Minnesota.
