Ixonia Tributary to the Rock River Tributary
and the Rock River Trib. to the Rock River

Triennial Standards Review

October 1993

Bureau of Water Resource Management
Wisconsin Department of Natural Resources

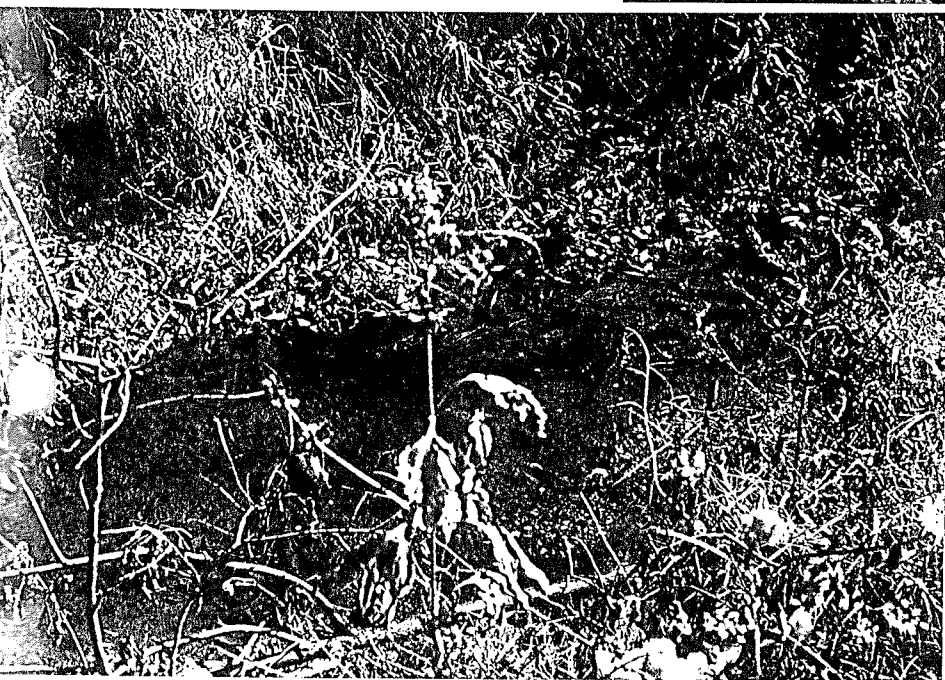
Photo 2 - The Ixonia Trib. is characterized by shallow depths and lack of instream vegetation. Logs and brush provide some good forage fish habitat.

Instream vegetation is lacking within the tributary. Instream cover is about 10%, mostly coming from fallen trees, roots, and brush (photo 2). No large boulders are present instream to provide cover with most of the substrate consisting of fine inorganic silt causing embeddedness close to 100%. A few sand and gravel sections exist causing a slight riffled area and providing some habitat.

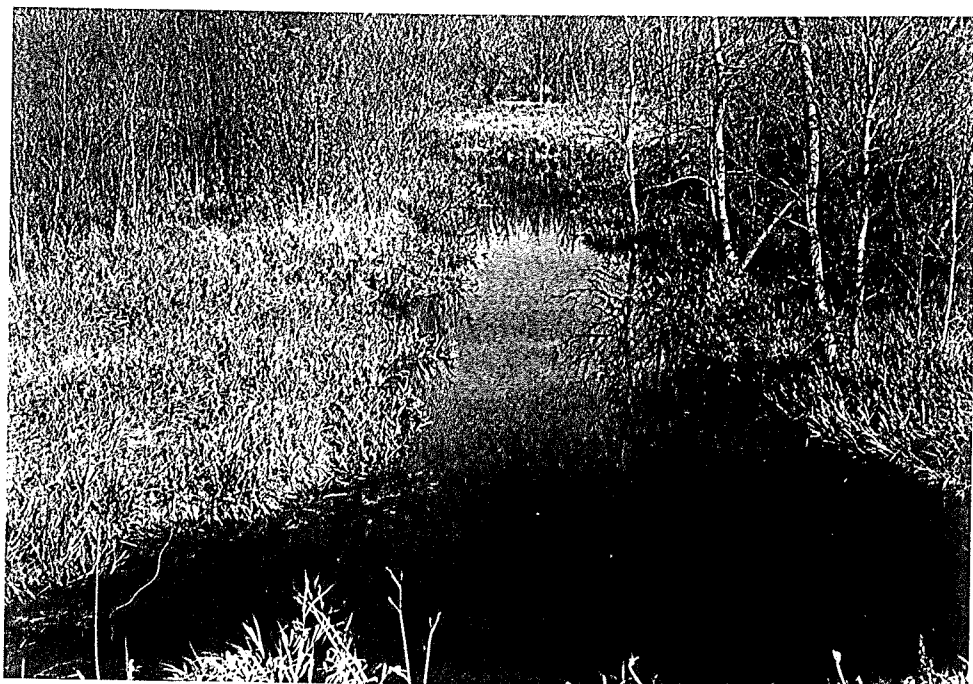
Photo 3 - The Rock River Trib. has very limited instream cover. No aquatic vegetation is present and the substrate consists of thick muck.

One of the stream's biggest limiting factors is lack of instream cover. Aquatic vegetation is sparse throughout its entire length, with logs, boulders, and other aquatic cover limited (photo 3).

The substrate in the tributary consists of fine organic and inorganic silt. Sediment depths average over six inches with depths up to a foot not uncommon. This high degree of siltation has most likely smothered any type of aquatic vegetation within the stream. There were no riffled sections, as there was no firm substrate. Deep pools (over 5 feet) were also not apparent.
