Comprehensive Lake Management Plan for Plum Lake, Vilas County, Wisconsin

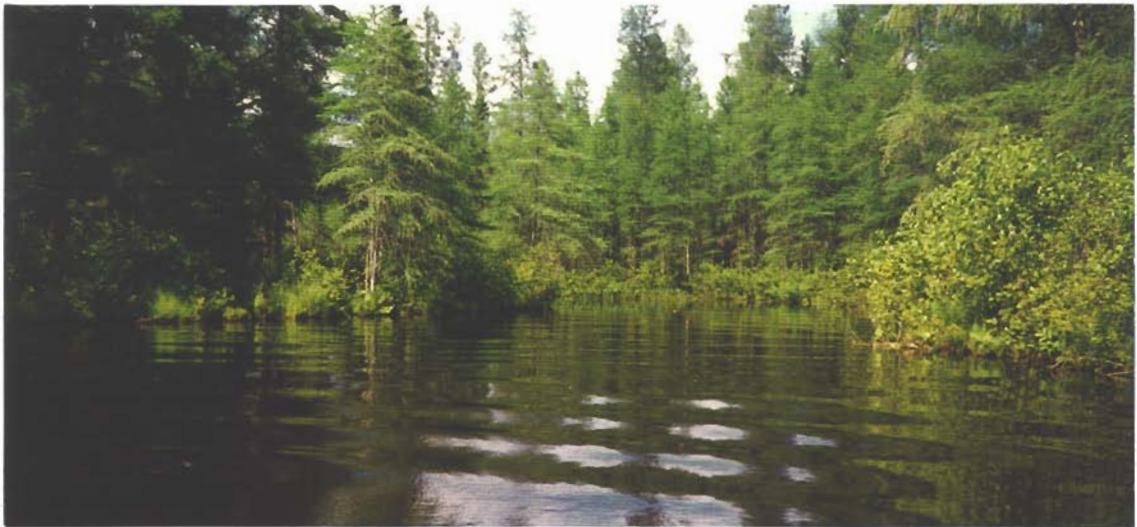
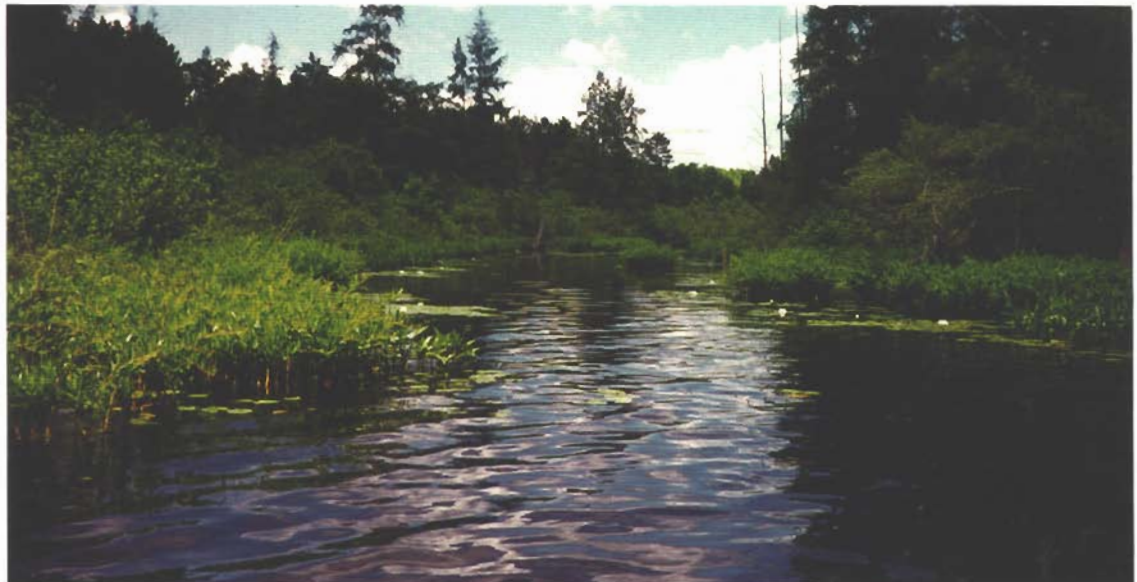
Star Creek comes from Star Lake and is a clear water stream.

Figure 5. Aurora Creek has a dark stain and comes out of Aurora Lake. The stain is actually dissolved organic compounds leaching from wetlands. The water is clean and low in fertility. These two pictures are from the summer of 1996.

Aurora Creek was sampled for phosphorus on four occasions from July 17, 2000 to August 25, 2001. Results show low phosphorus concentrations in Aurora Creek representative of natural background conditions (Table 4). This is good news for Plum Lake. It implies that there is "good" water coming into Plum Lake.

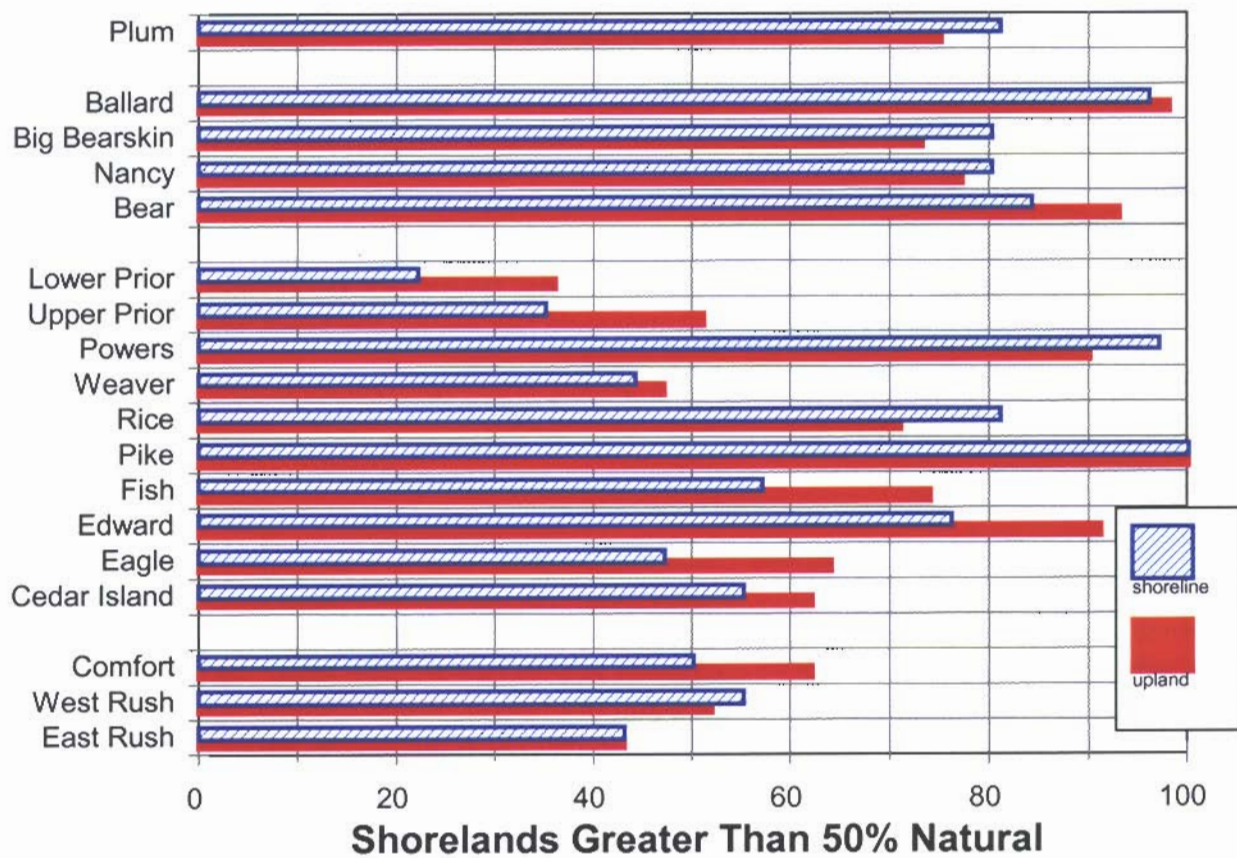
Figure 8. A summary of shoreland inventory results for 18 lakes using an evaluation based on shoreland photographs. For each lake the percentage of shoreline and upland conditions with greater than 50% natural conditions is shown.

A comparison of Plum Lake conditions to other lakes in Wisconsin and Minnesota is shown in Figure 8.

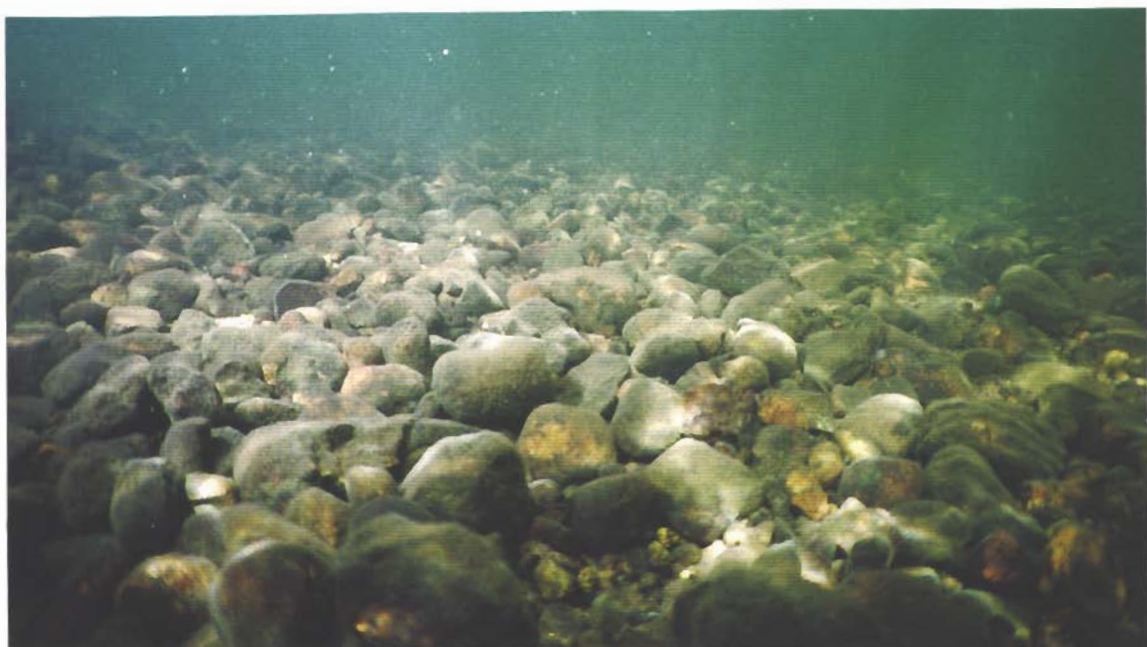
Gravel and cobble are typical shallow sediment conditions in Plum Lake. These are relatively infertile habitats.

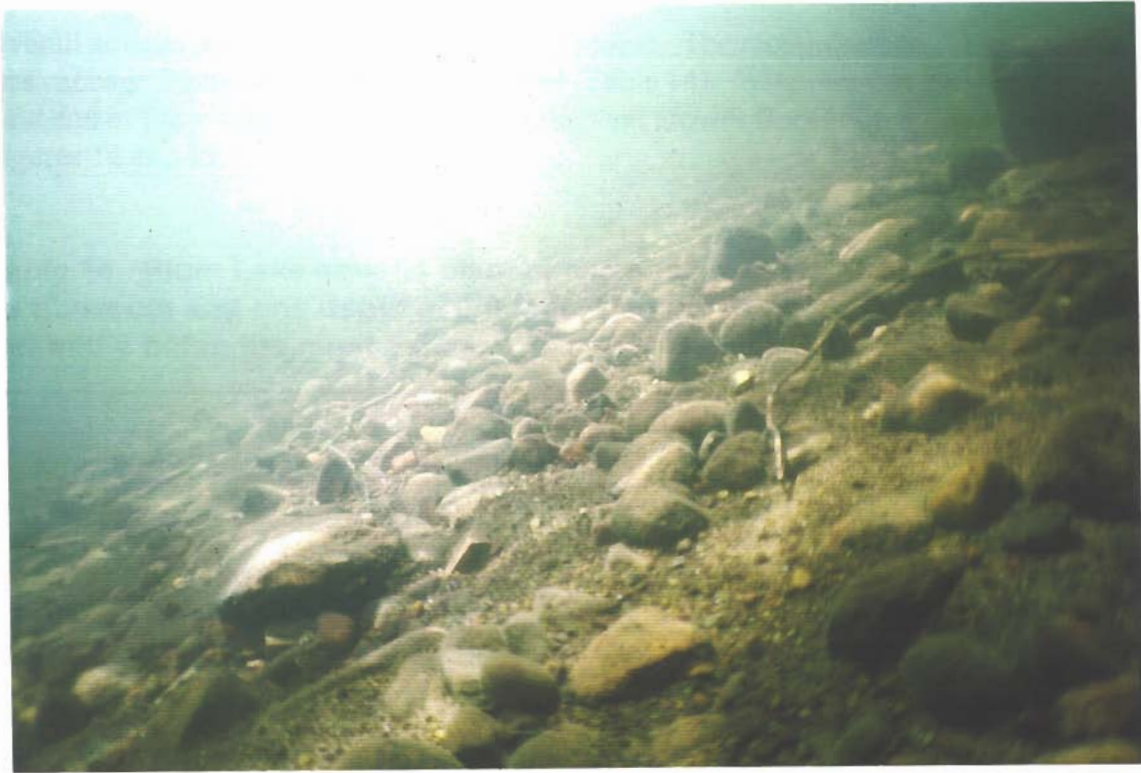
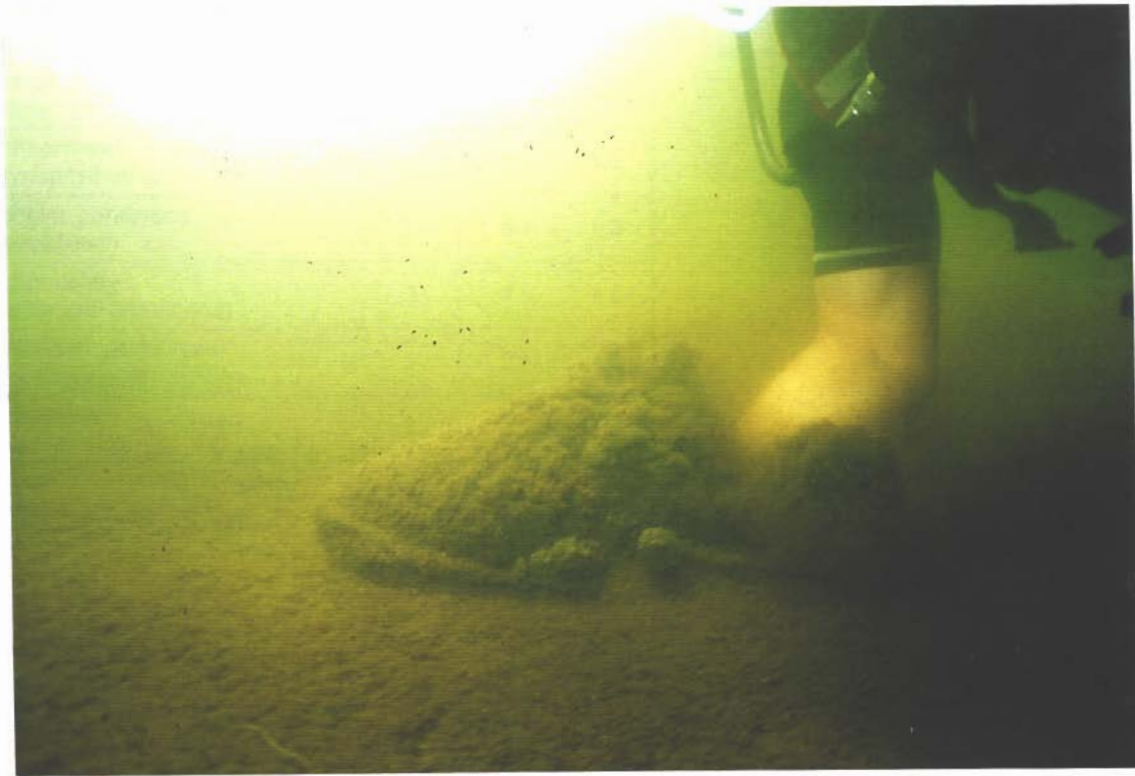
Figure 16. [top] It's a small boulder field on Transect 20 located in the east end of Plum Lake. This is the location of a steep drop off. The picture was taken on August 26, 2001. [bottom] In about 25 feet of water on Transect 20, the rocks are buried in soft sediments. No plant growth was found this deep, although there was enough light to support growth. Crayfish were observed down here also.

The same 44 transects sampled in 1996 were sampled again in 2001. The percent occurrence of individual plant species is shown in Table 15. In 2001, the most common plant was water celery followed by cabbage (Table 15). Aquatic plant habitat conditions (Figure 16) and aquatic plant characteristics are shown in Figures 17 and 18.

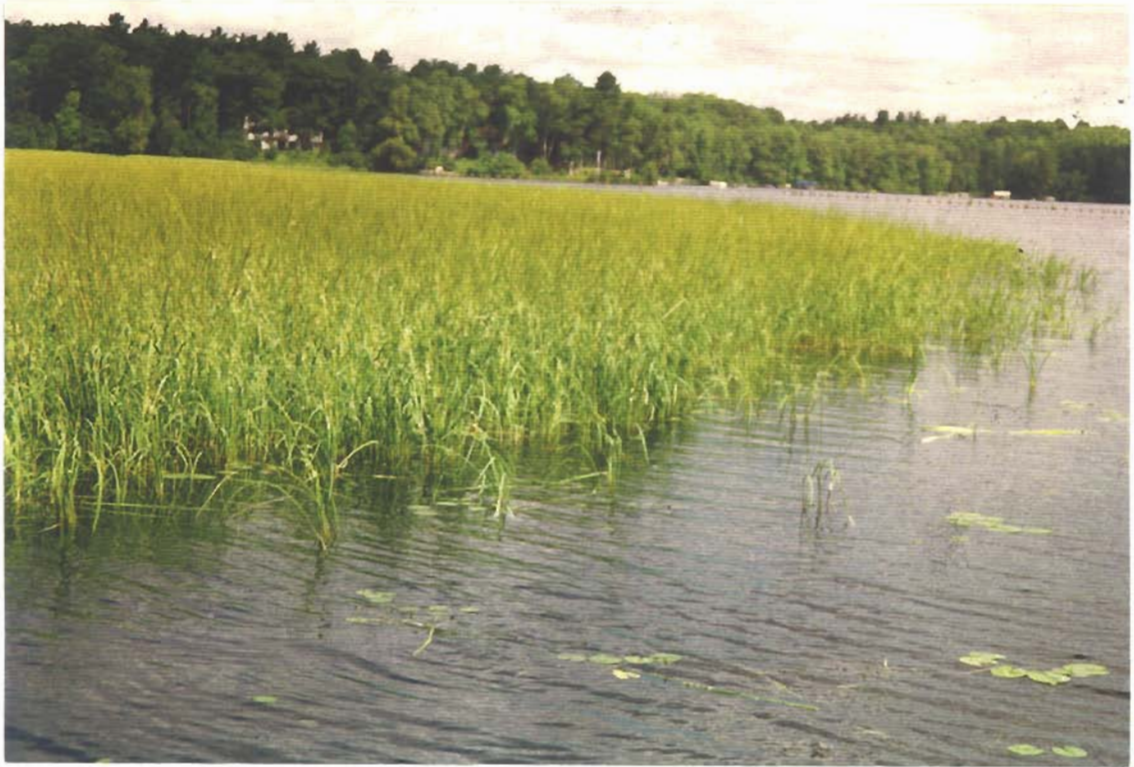
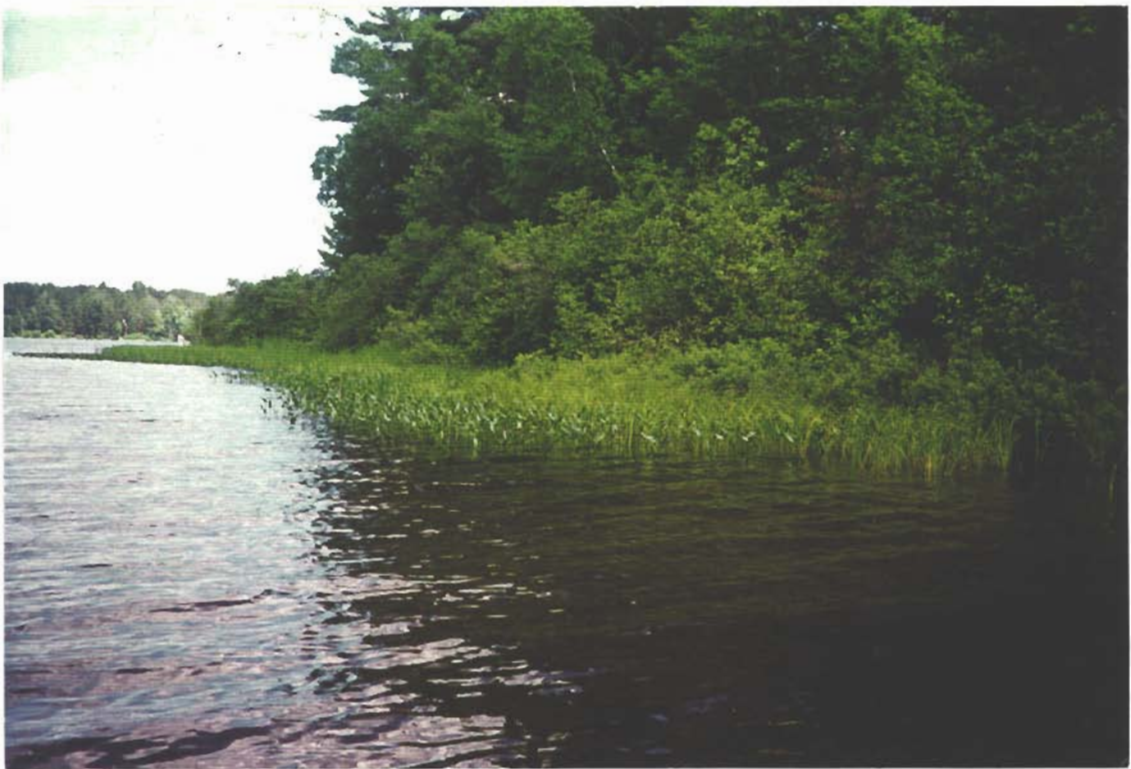
**Figure 14. Examples of emergent plants in Plum Lake are shown above.
[top] Wild rice beds are found at the west end of Plum Lake.
[bottom] Occasional beds of arrowhead are found in Plum as well. Emergent plants offer good fish habitat. More emergent plant beds would be good for Plum Lake.**

Overall aquatic plant abundance in 1996 was sparse. The most common submerged plant was cabbage followed by flatstem pondweed (Table 14). Wild rice was common in the west end of Plum Lake. Examples of aquatic plant growth from 1996 are shown in Figures 14 and 15.

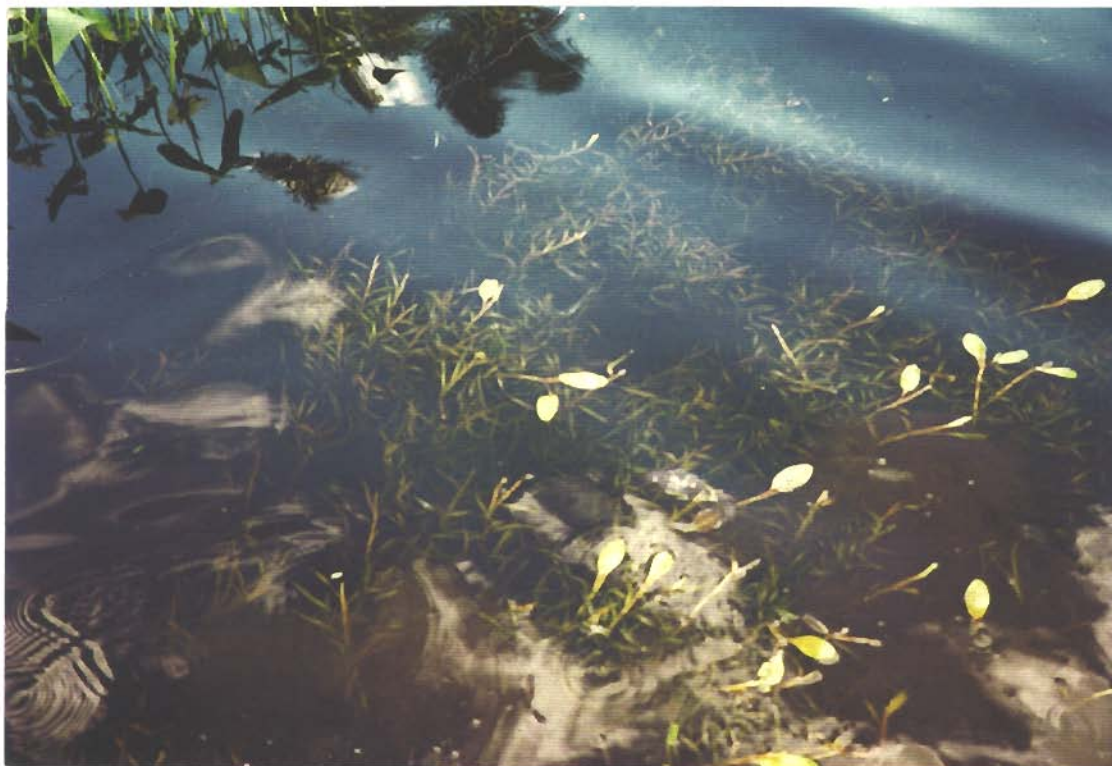
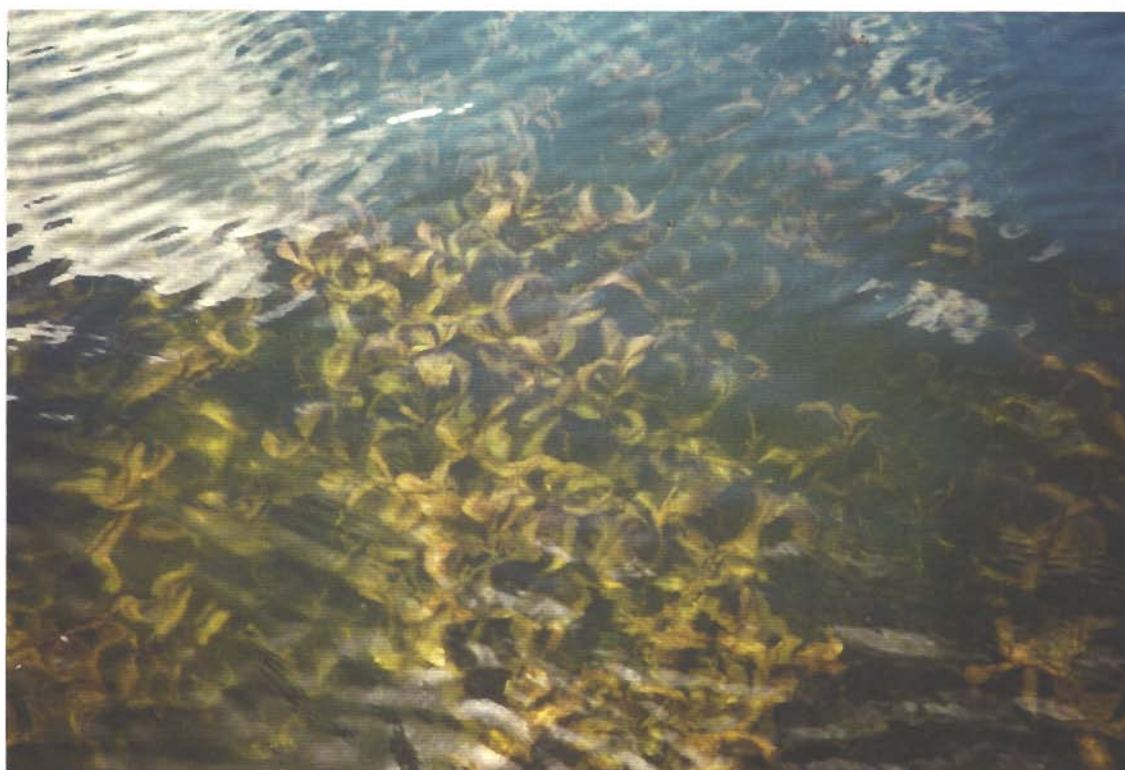
Figure 15. [top] Variable pondweed (*Potamogeton gramineus*) grows in shallow water, but in limited amounts.

[bottom] "Cabbage" (*Potamogeton amplifolius*) is a good aquatic plant to have in a lake. It is found in Plum Lake but is scarce. It seems to be a popular food for rusty crayfish.

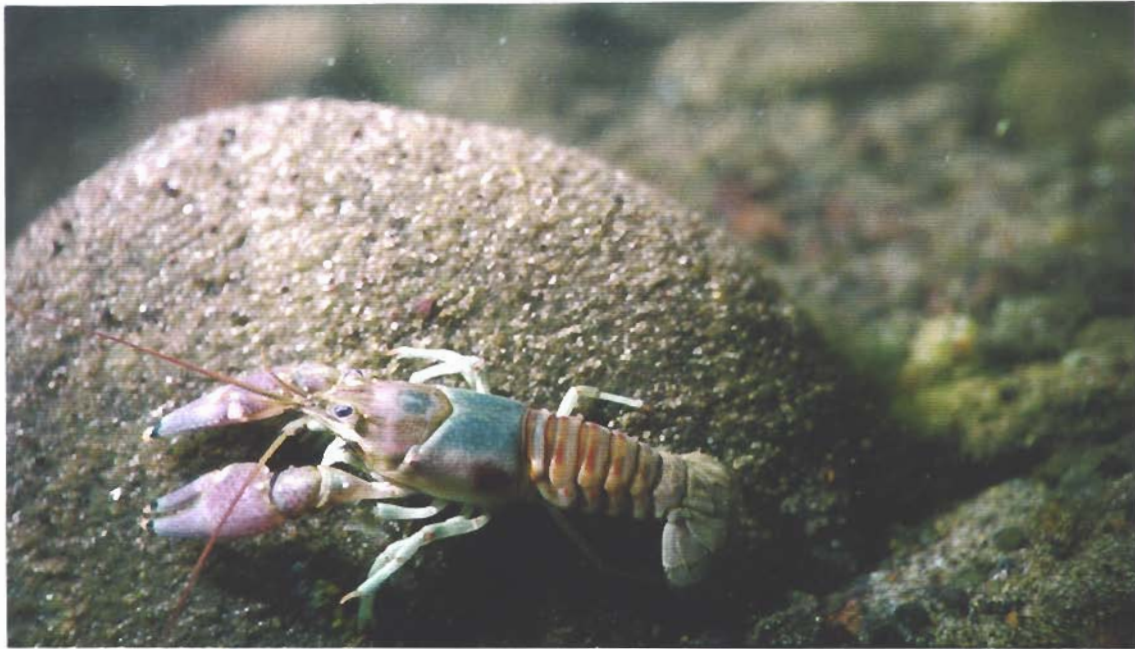
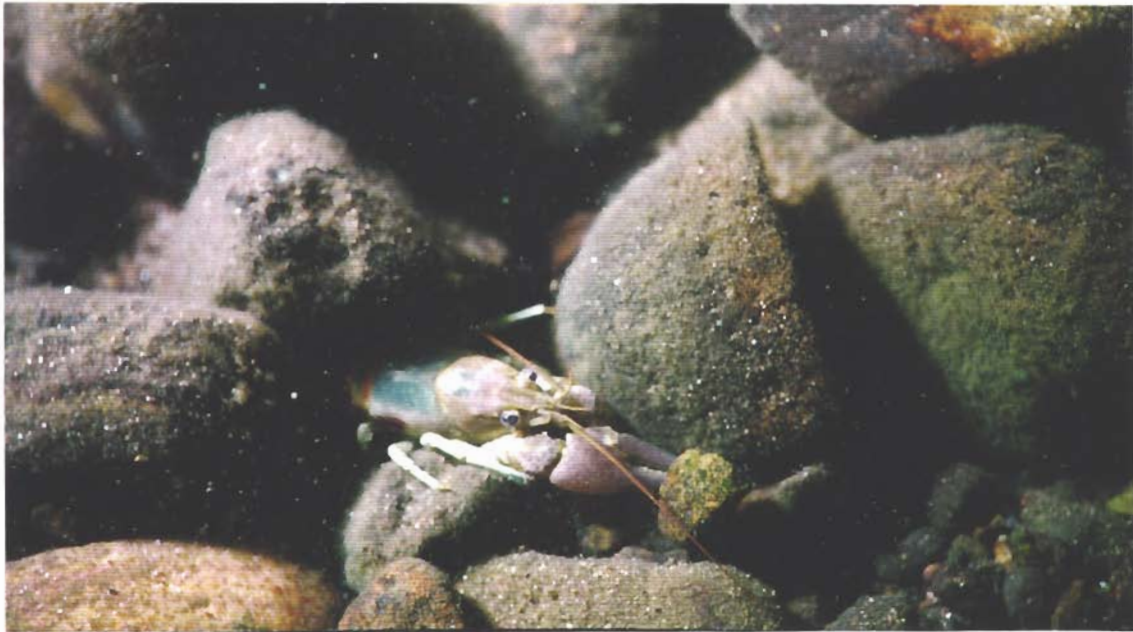
Figure 19. Rusty crayfish are an unwelcome guest in Plum Lake at this time. However, in the future, their number should decline as their food source declines and as fish learn how to eat them.

Plum Lake rusty crayfish are shown in Figure 19. Plant beds they apparently have been feeding on are shown in Figures 20 and 21.

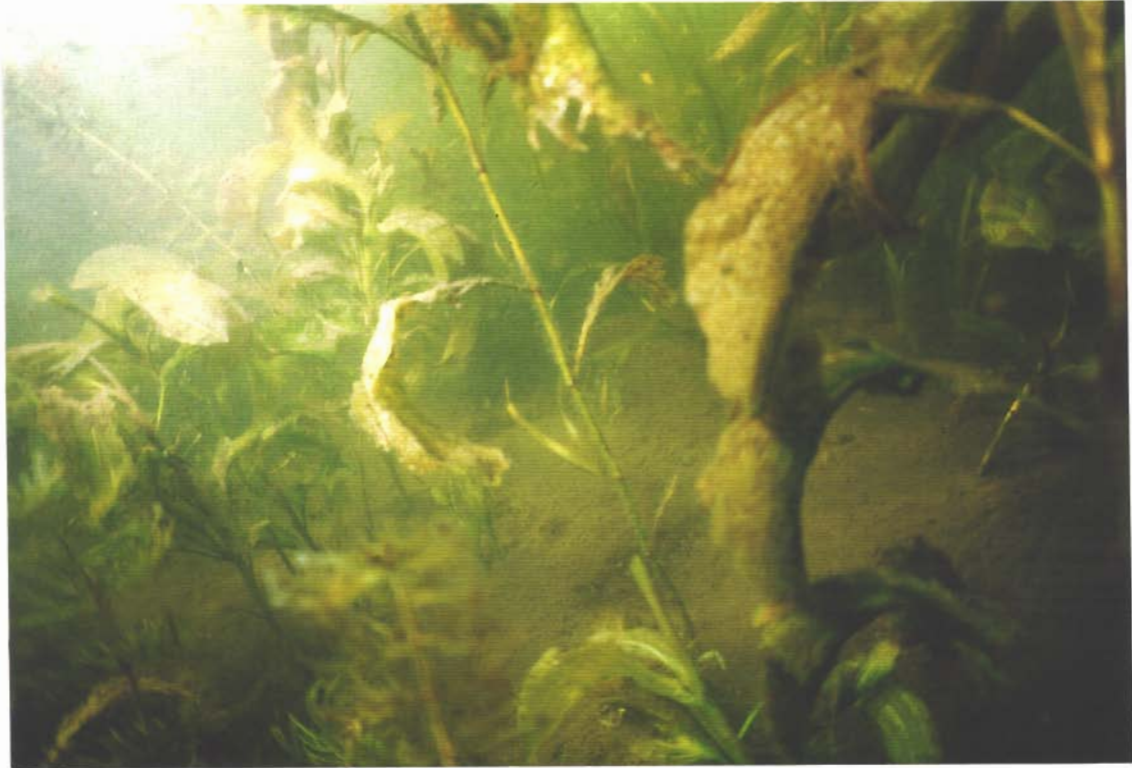
Figure 20. [top] A few aquatic plant beds seem to be unaffected from grazing by rusty crayfish in Plum Lake. This is the underwater scene of plants from Transect 20. [bottom] It's a different scene in a cabbage patch on Transect 13. This cabbage patch seems to be heavily grazed down.

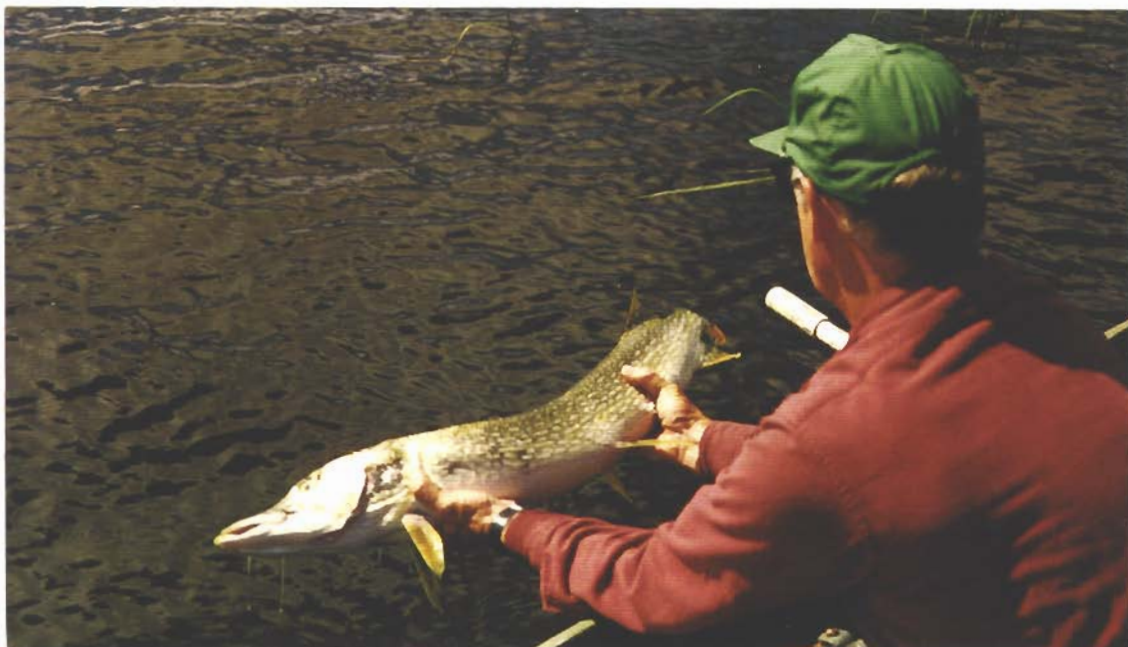
Figure 22. We found this dead northern pike floating in the west end of Plum Lake in 1996. Northern pike and walleye are the dominant fish predators in Plum Lake.

Catch rates of the common fish species in Plum Lake are shown in Table 16 and a Plum Lake northern pike is pictured in Figure 22.

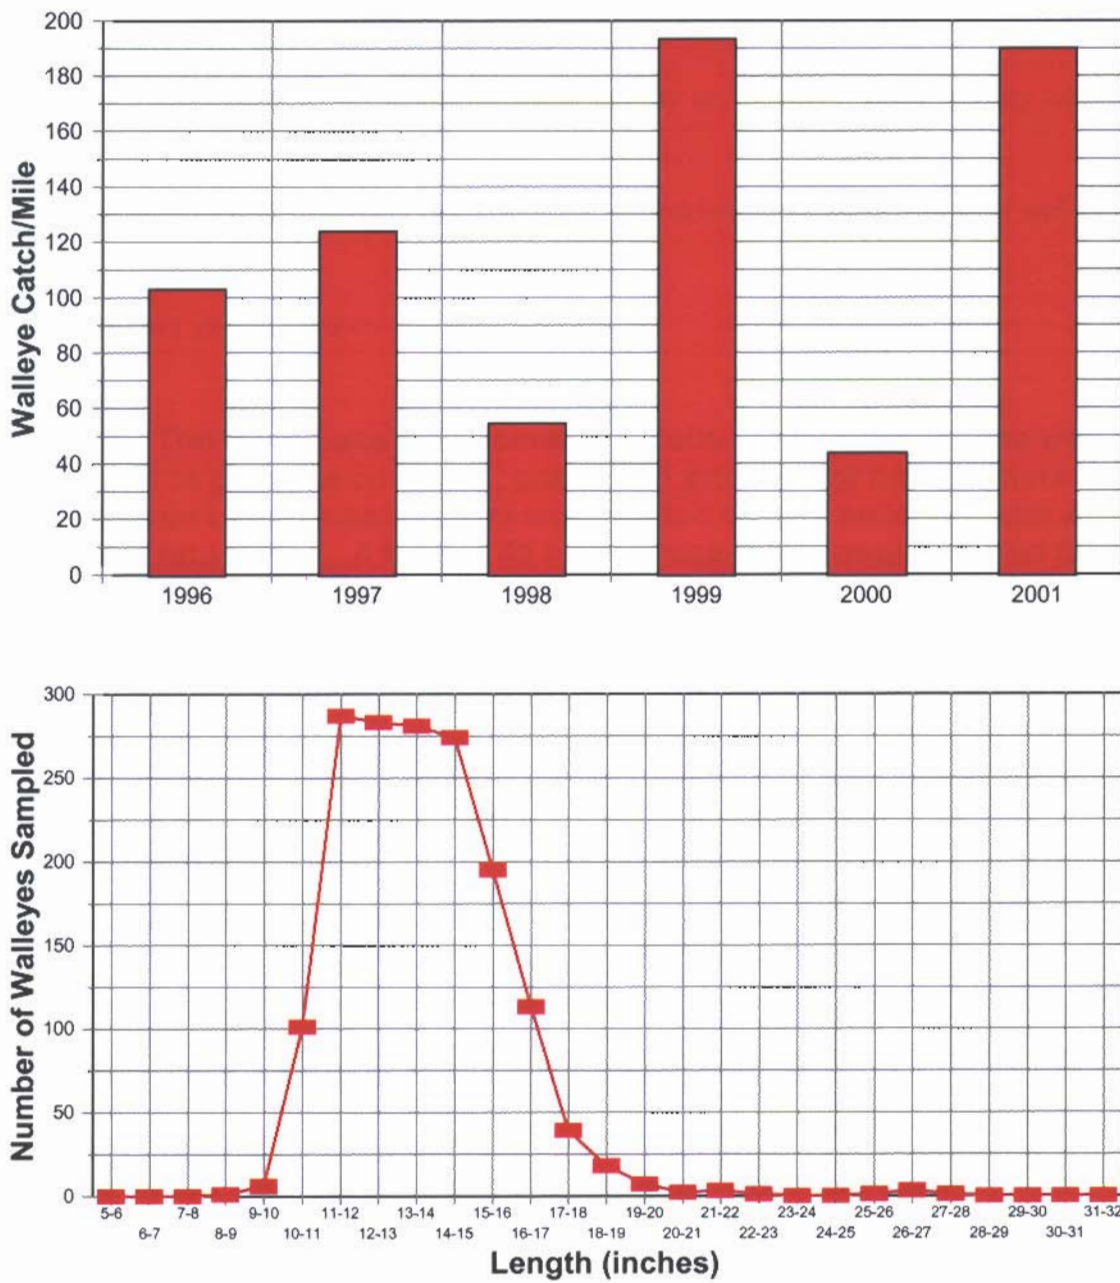
Figure 23. [top] Electrofishing results for walleyes from 1996 through 2001. Catch rates vary from year to year. [bottom] Most of the walleyes sampled in Plum Lake measured from 11 to 15 inches.

Walleyes have been sampled annually since 1996 by electrofishing. Results show varied catch rates from year to year, although their sizes have remained somewhat constant (Figure 23).

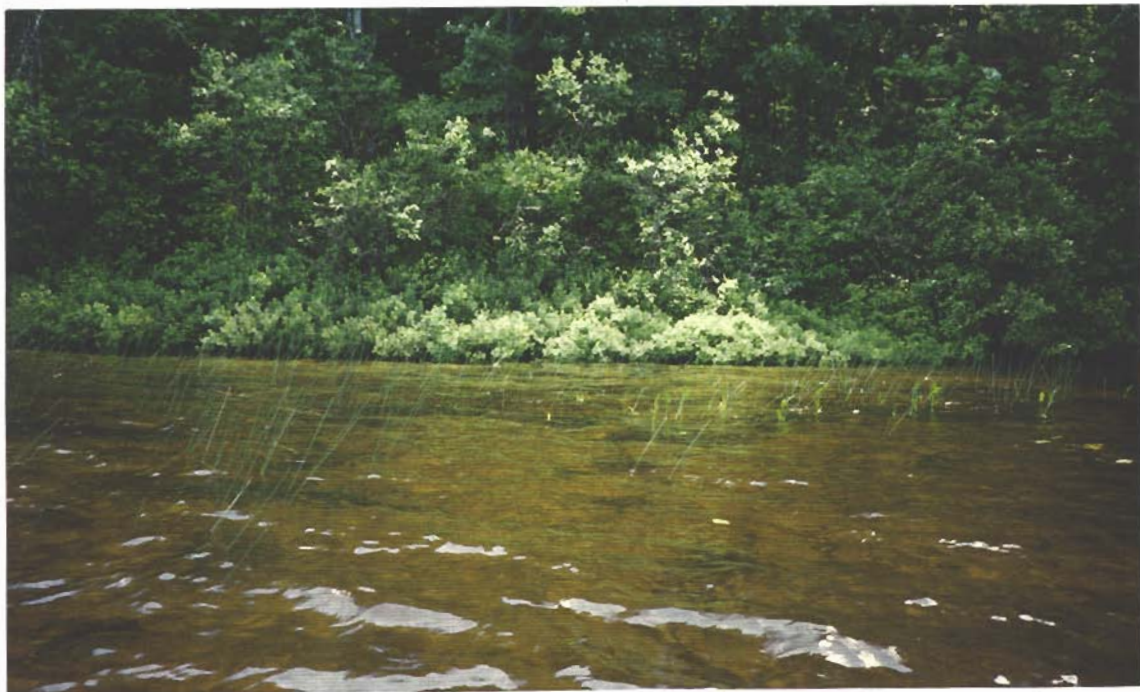
Figure 25. Shown above are existing weed patches in Plum Lake. As rusty crayfish populations decline, aquatic plant communities should increase.

At this time, I would not recommend transplanting submerged aquatic plants. Because rusty crayfish are still a factor, they would probably eat the new sprouts. Also, survivorship of transplanted plants is low.

Rather, I would wait until rusty crayfish numbers go down and see if submerged plants can come back on their own. The seedbank is there.

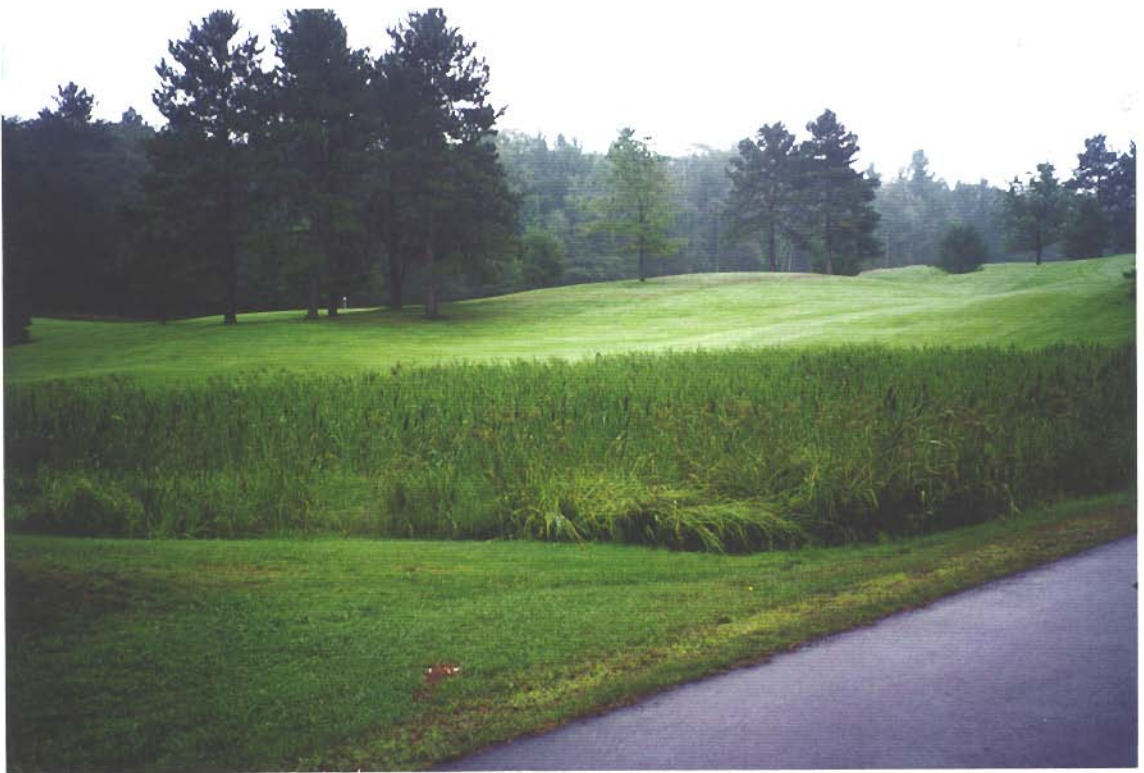
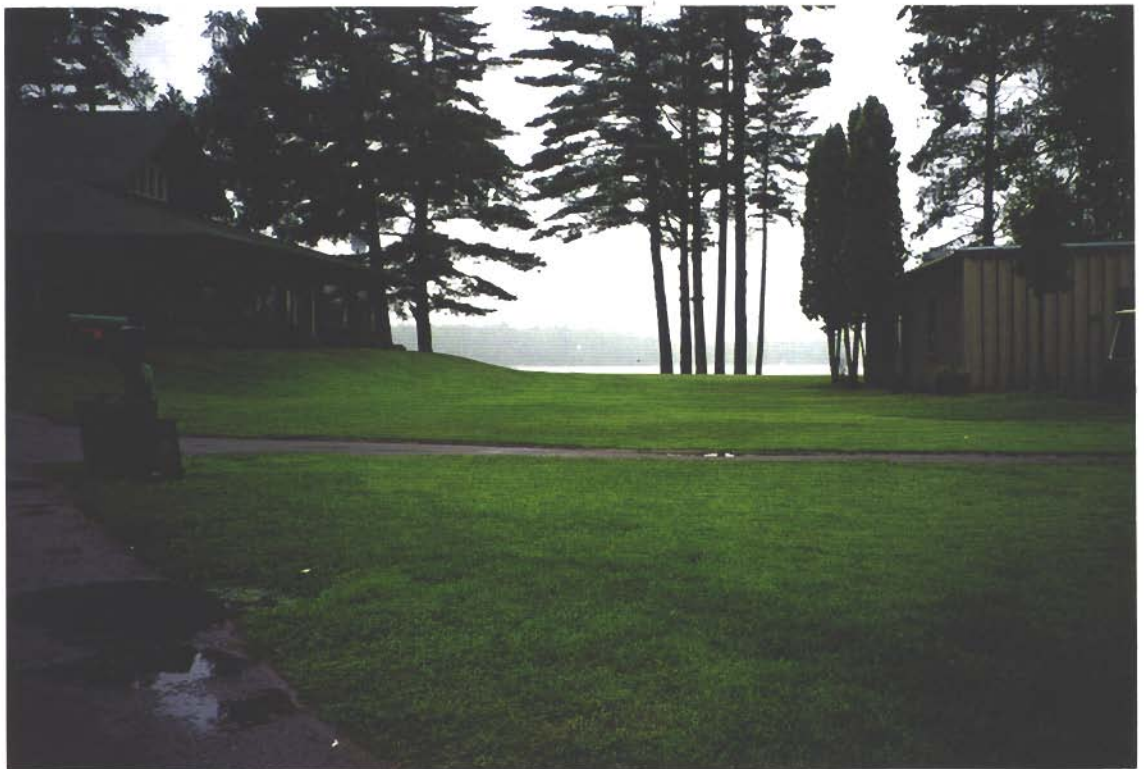
Figure 27. [top] Several wetland areas are being enhanced around the golf course. Nutrient management programs apply only the minimum amount of fertilizer needed. [bottom] Not much surface runoff enters Plum Lake. Low spots collect and infiltrate water.

Monitoring runoff that drains the golf course land and flows into Plum Lake would provide valuable information about whether the golf course is exporting unusually high levels of nutrients and/or sediments to the lake.

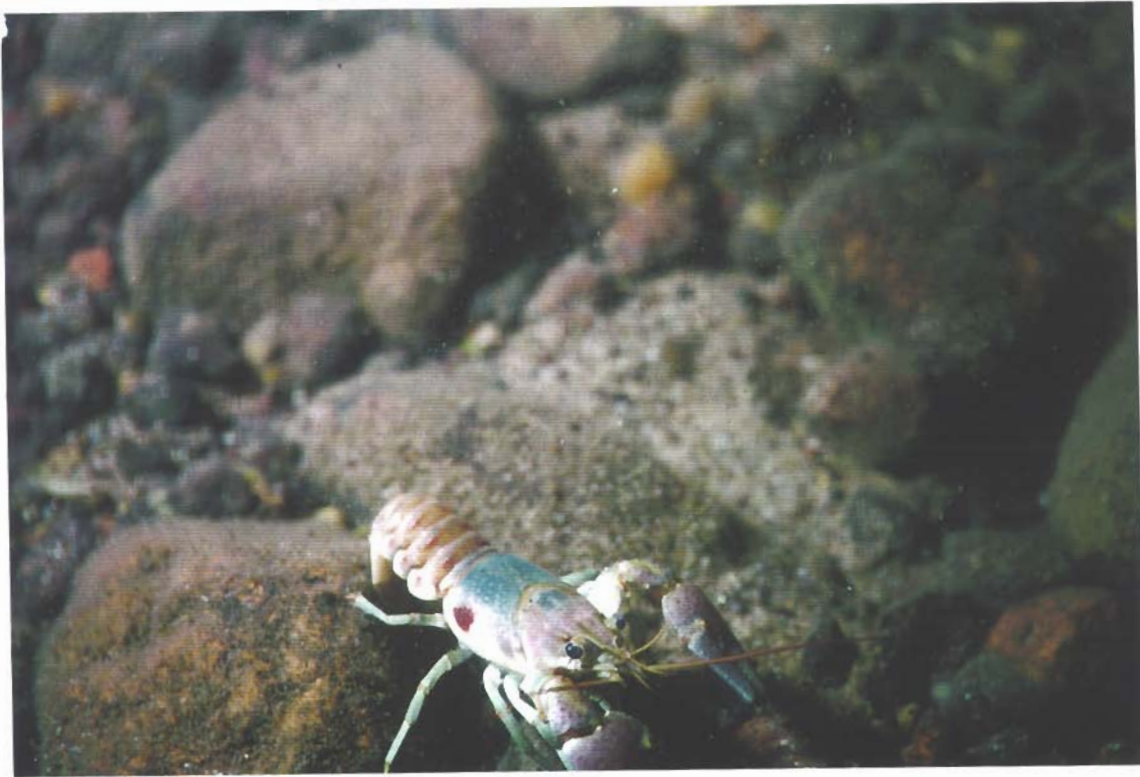
Figure 28. [top] Managing the Plum Lake crayfish situation is a high priority for lake residents based on questionnaire returns. [bottom] A funnel-shaped trap fitted over a bucket with bait is an effective crayfish trapping device and could be used in Plum Lake.

For Plum Lake, at least 200 traps should probably be set for 5 to 6 years. This may be a project area that Lake Association volunteers could participate in.

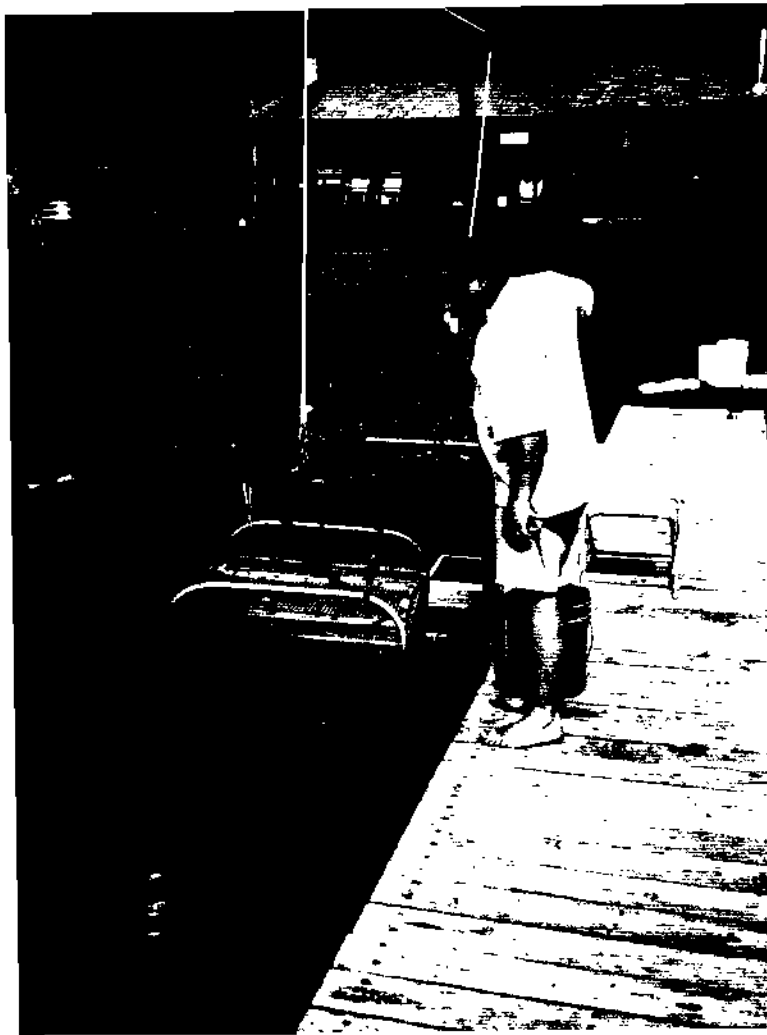
Figure 29. [top] Big Bearskin crayfish traps are ready to go into the lake. Plum Lake volunteers could make and install traps as well. [bottom] Roger Soletski, Big Bearskin Lake, checks the crayfish holding cage at Big Bearskin. The larger crayfish can be sold.
