# Cason & Associates, LLC

## MEMORANDUM

SUBJECT: **Results of the recent survey for exotic species on Chute Pond, Oconto County**

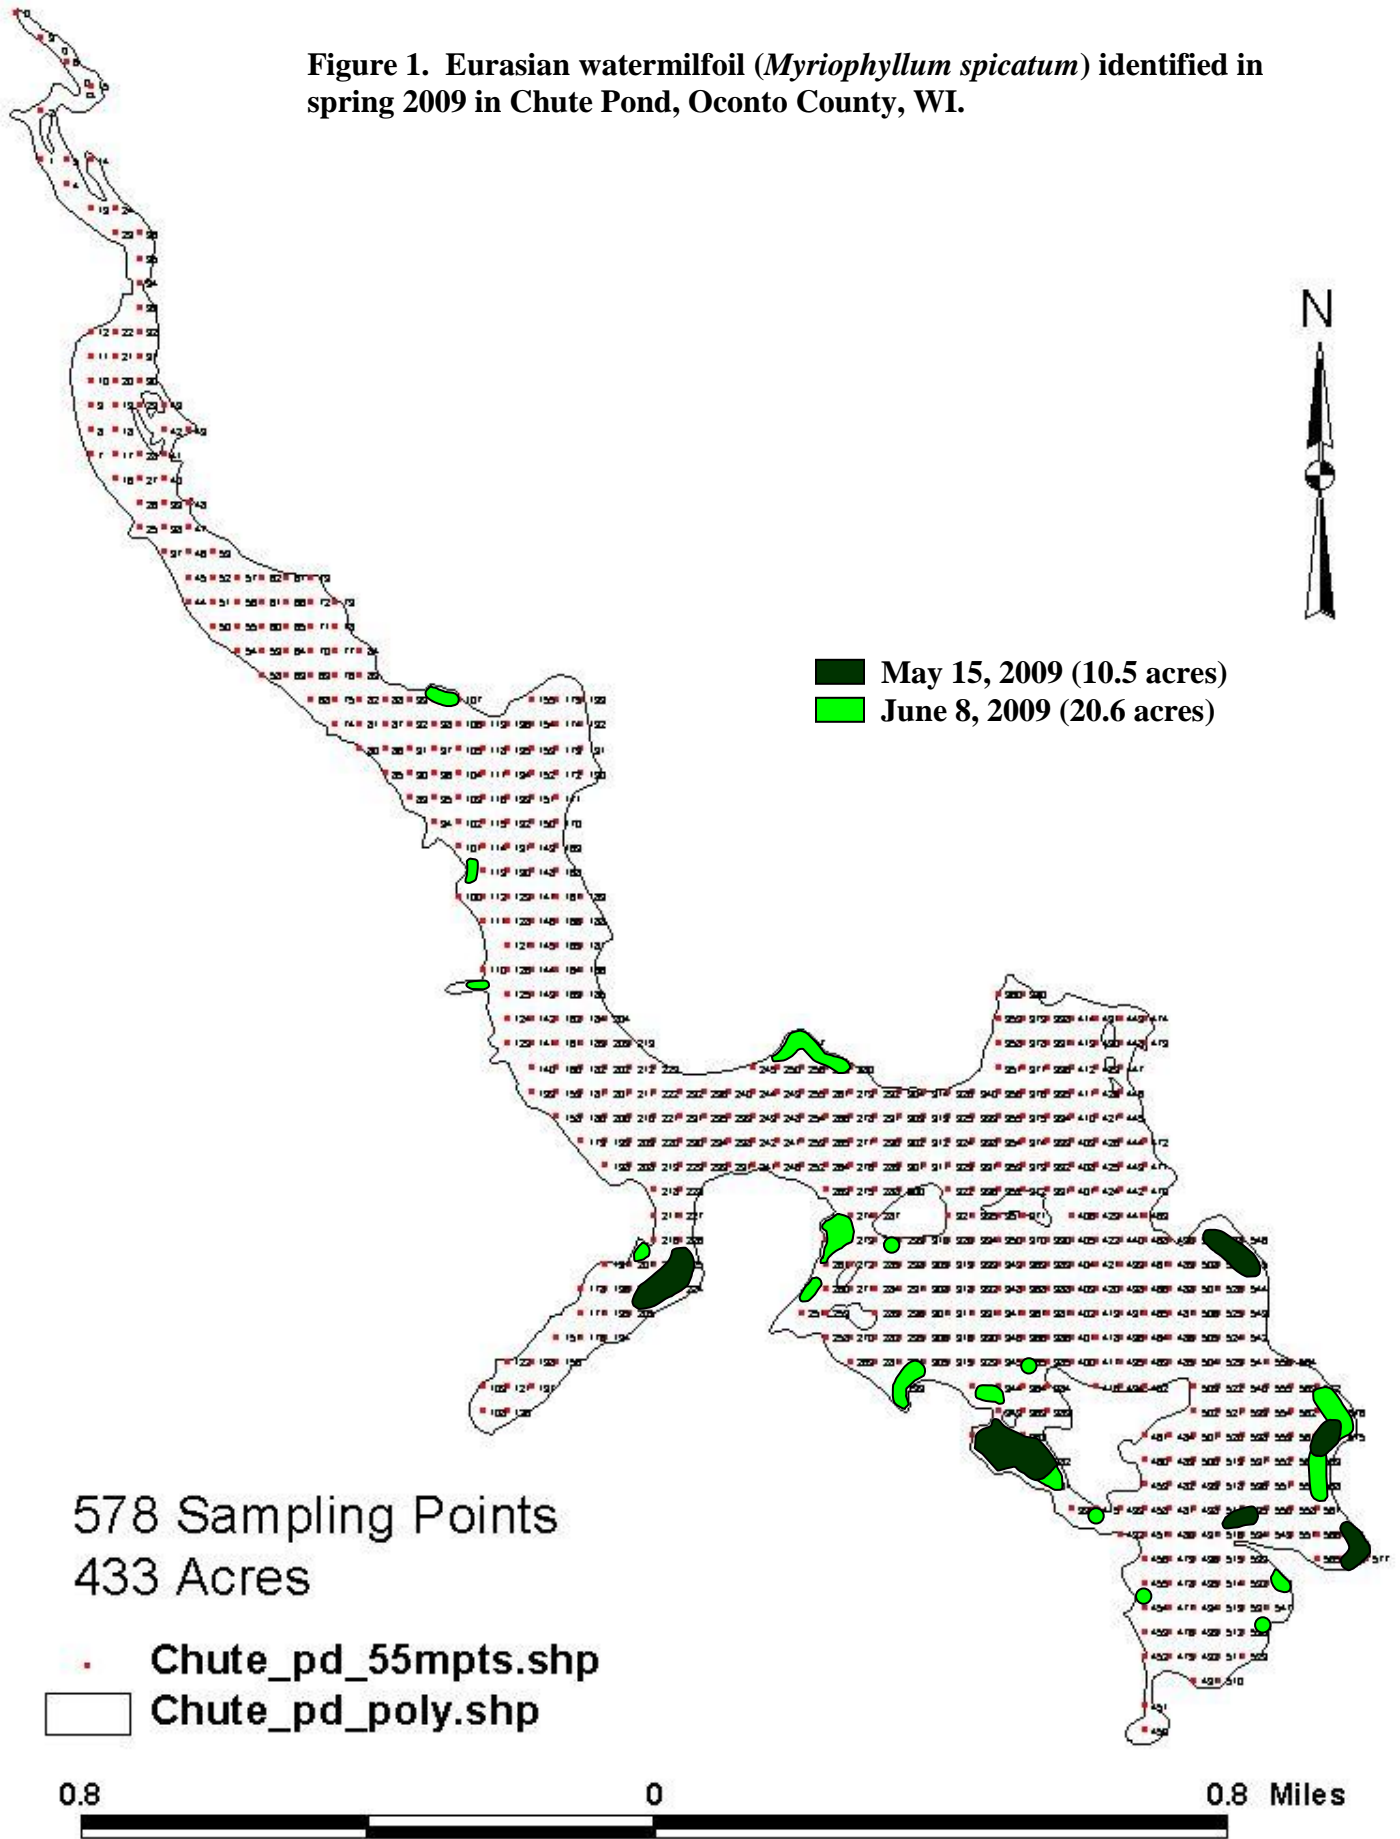
The locations of Eurasian watermilfoil on Chute Pond in May and June 2009 are shown in **Figure 1**. The locations of milfoil have been drawn on the point-intercept map to facilitate locating and treating these areas in the future. The locations of milfoil in **Figure 1** represent a total of 31.1 acres.

Figure 1. Eurasian watermilfoil (*Myriophyllum spicatum*) identified in spring 2009 in Chute Pond, Oconto County, WI.

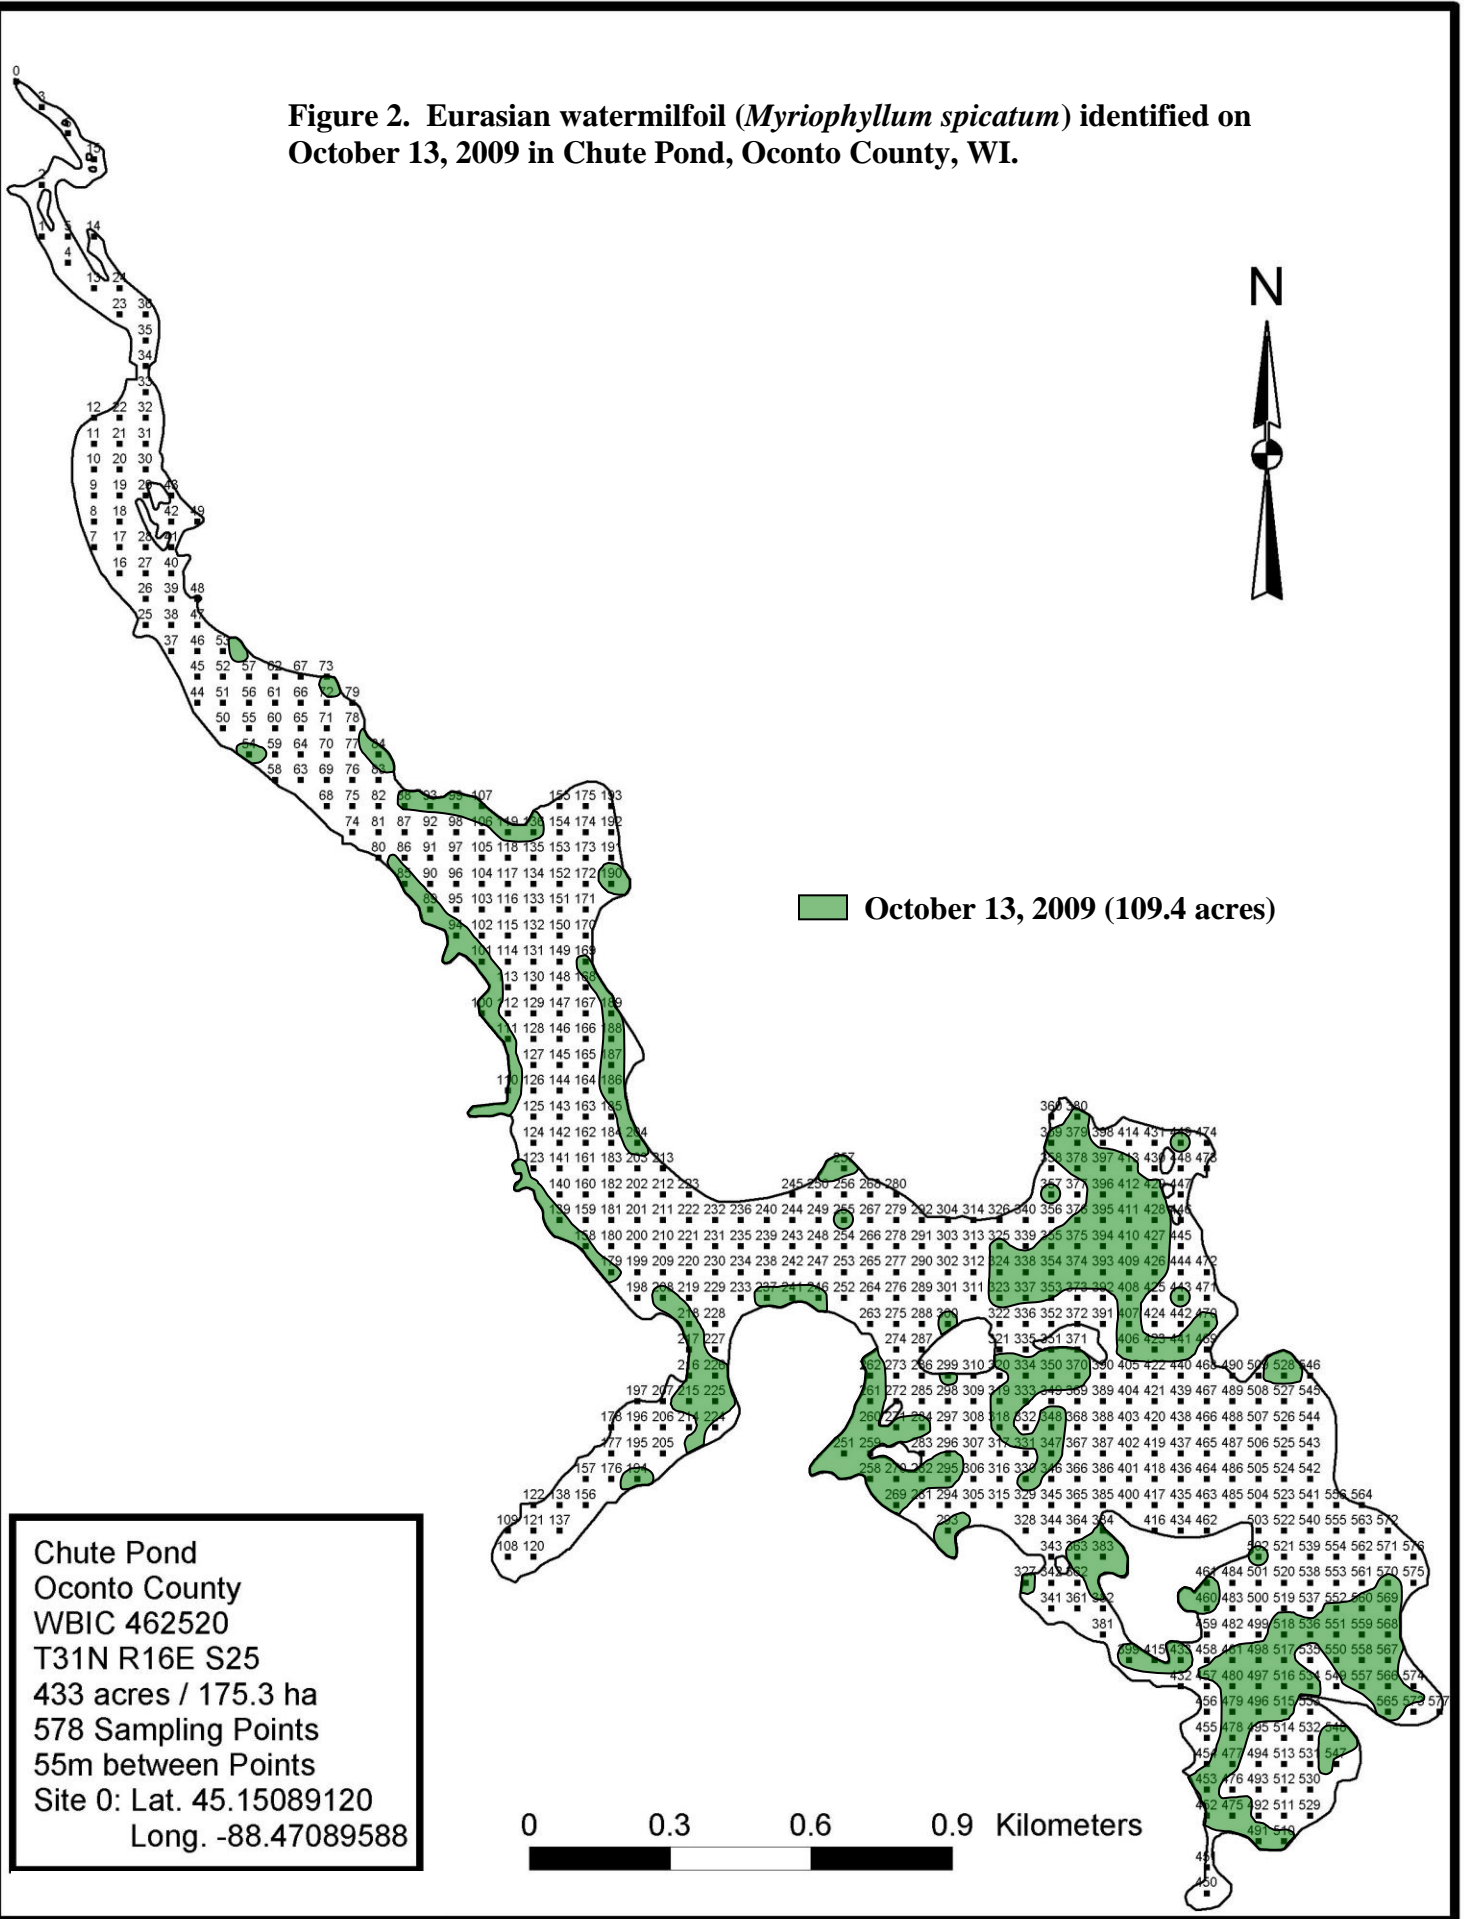
**Figure 2** shows the results of the October 2009 survey of Chute Pond. There were a total of 109.4 acres of milfoil mapped during this survey. The density of milfoil in the areas indicated varied from sparse to very dense. In previously treated areas, either no milfoil or sparse milfoil was found. In some newly identified areas, milfoil was dense enough to interfere with navigation.

**Figure 2. Eurasian watermilfoil (*Myriophyllum spicatum*) identified on October 13, 2009 in Chute Pond, Oconto County, WI.**

Going forward, it is recommended that the District continue to sponsor annual surveys to stay proactive in the management of Eurasian watermilfoil in Chute Pond. With the wide-spread distribution of milfoil in the lake, it is recommended that the point-intercept survey methodology continue to be employed to locate and map milfoil in Chute Pond. If funds are available, it is also recommended that all known milfoil be treated again in 2010. If the full distribution of milfoil cannot be treated, a prioritized list of locations can be developed to effectively treat the areas of highest need. Keep in mind if a drawdown is considered or pursued, it will mean waiting a year during which time milfoil will likely spread further if left untreated. Management of curly-leaf pondweed should be put on hold until such time as the milfoil is under control and funds are available to address the curly-leaf pondweed situation further.
