Curly-leaf Pondweed (*Potamogeton crispus*) Pre/Post Herbicide and Bed Mapping Surveys Balsam Lake - WBIC: 2620600 Polk County, Wisconsin

Endangered Resource Services, LLC
Matthew S. Berg, Research Biologist
St. Croix Falls, Wisconsin

May 16-17, June 15, 17-20, 2014

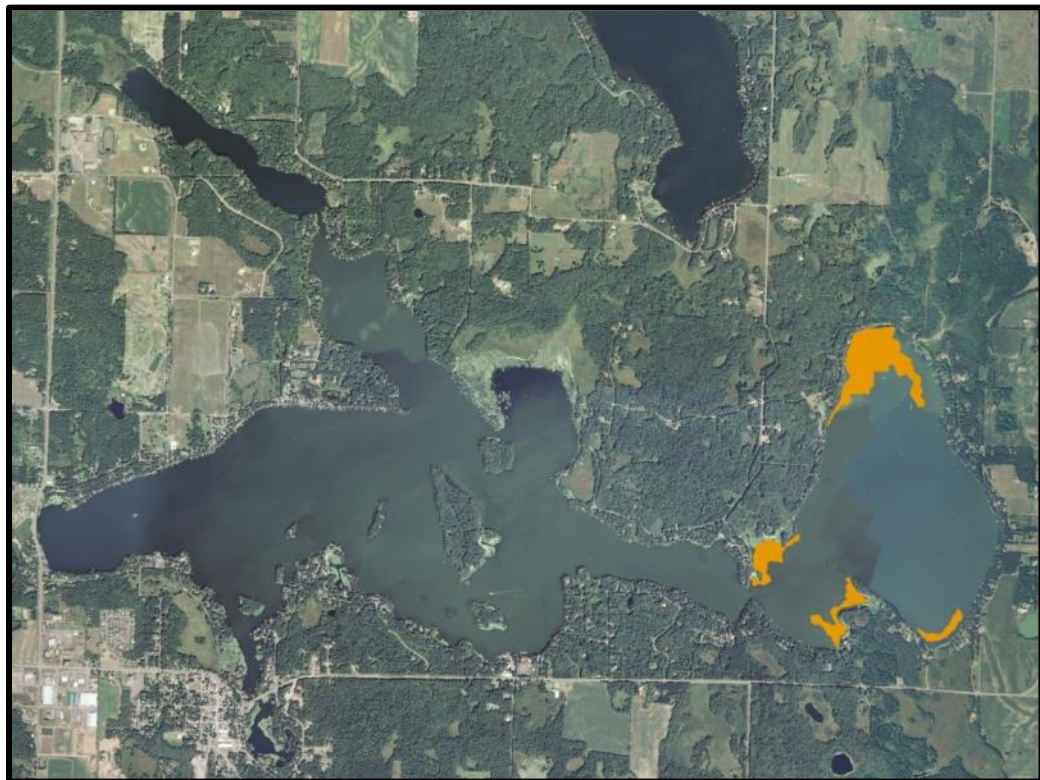
Figure 1: Balsam Lake with 2014 CLP Treatment Areas

In the spring of 2014, the Balsam Lake Protection and Rehabilitation District (BLPRD) and the Wisconsin Department of Natural Resources (WDNR) authorized the herbicide treatment of five Curly-leaf pondweed (*Potamogeton crispus*) (CLP) beds totaling 65.49 acres or approximately 3.19% of the lake's total surface area (Figure 1). These beds were selected based on the 2013 spring CLP bed mapping survey that found CLP in these areas was interfering with boat traffic and/or restricting resident access to the lake from their docks. On May 16th and 17th, we conducted a pretreatment survey to document spring CLP densities and to finalize treatment plans. Following the herbicide application on May 28th, we completed a June 15th posttreatment survey to evaluate the effectiveness of this control effort. From June 17-20th, we also searched the lake's visible littoral zone and mapped all CLP beds found. These maps will be used to guide any potential CLP management in 2015. This report is the summary analysis of these three field surveys.
