**Subject: 2014 Purple Loosestrife Monitoring Report
Holcombe Hydro (P-1982), Cornell Hydro (P-2639), Jim Falls Hydro (P-2491),
Wissota Hydro (P-2567), Chippewa Falls Hydro (P-2440) and Dells Hydro (P-
2670)**

PURPLE LOOSESTRIFE ASSESSMENT – 2014

**Dells Pond, Chippewa Falls Flowage, Lake Wissota, Old Abe Lake, Cornell
Flowage, Lake Holcombe and Jim Falls Spillway Channel**

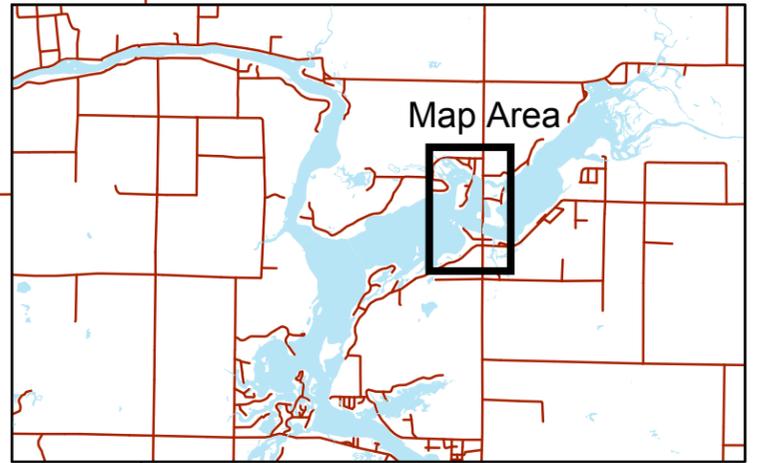
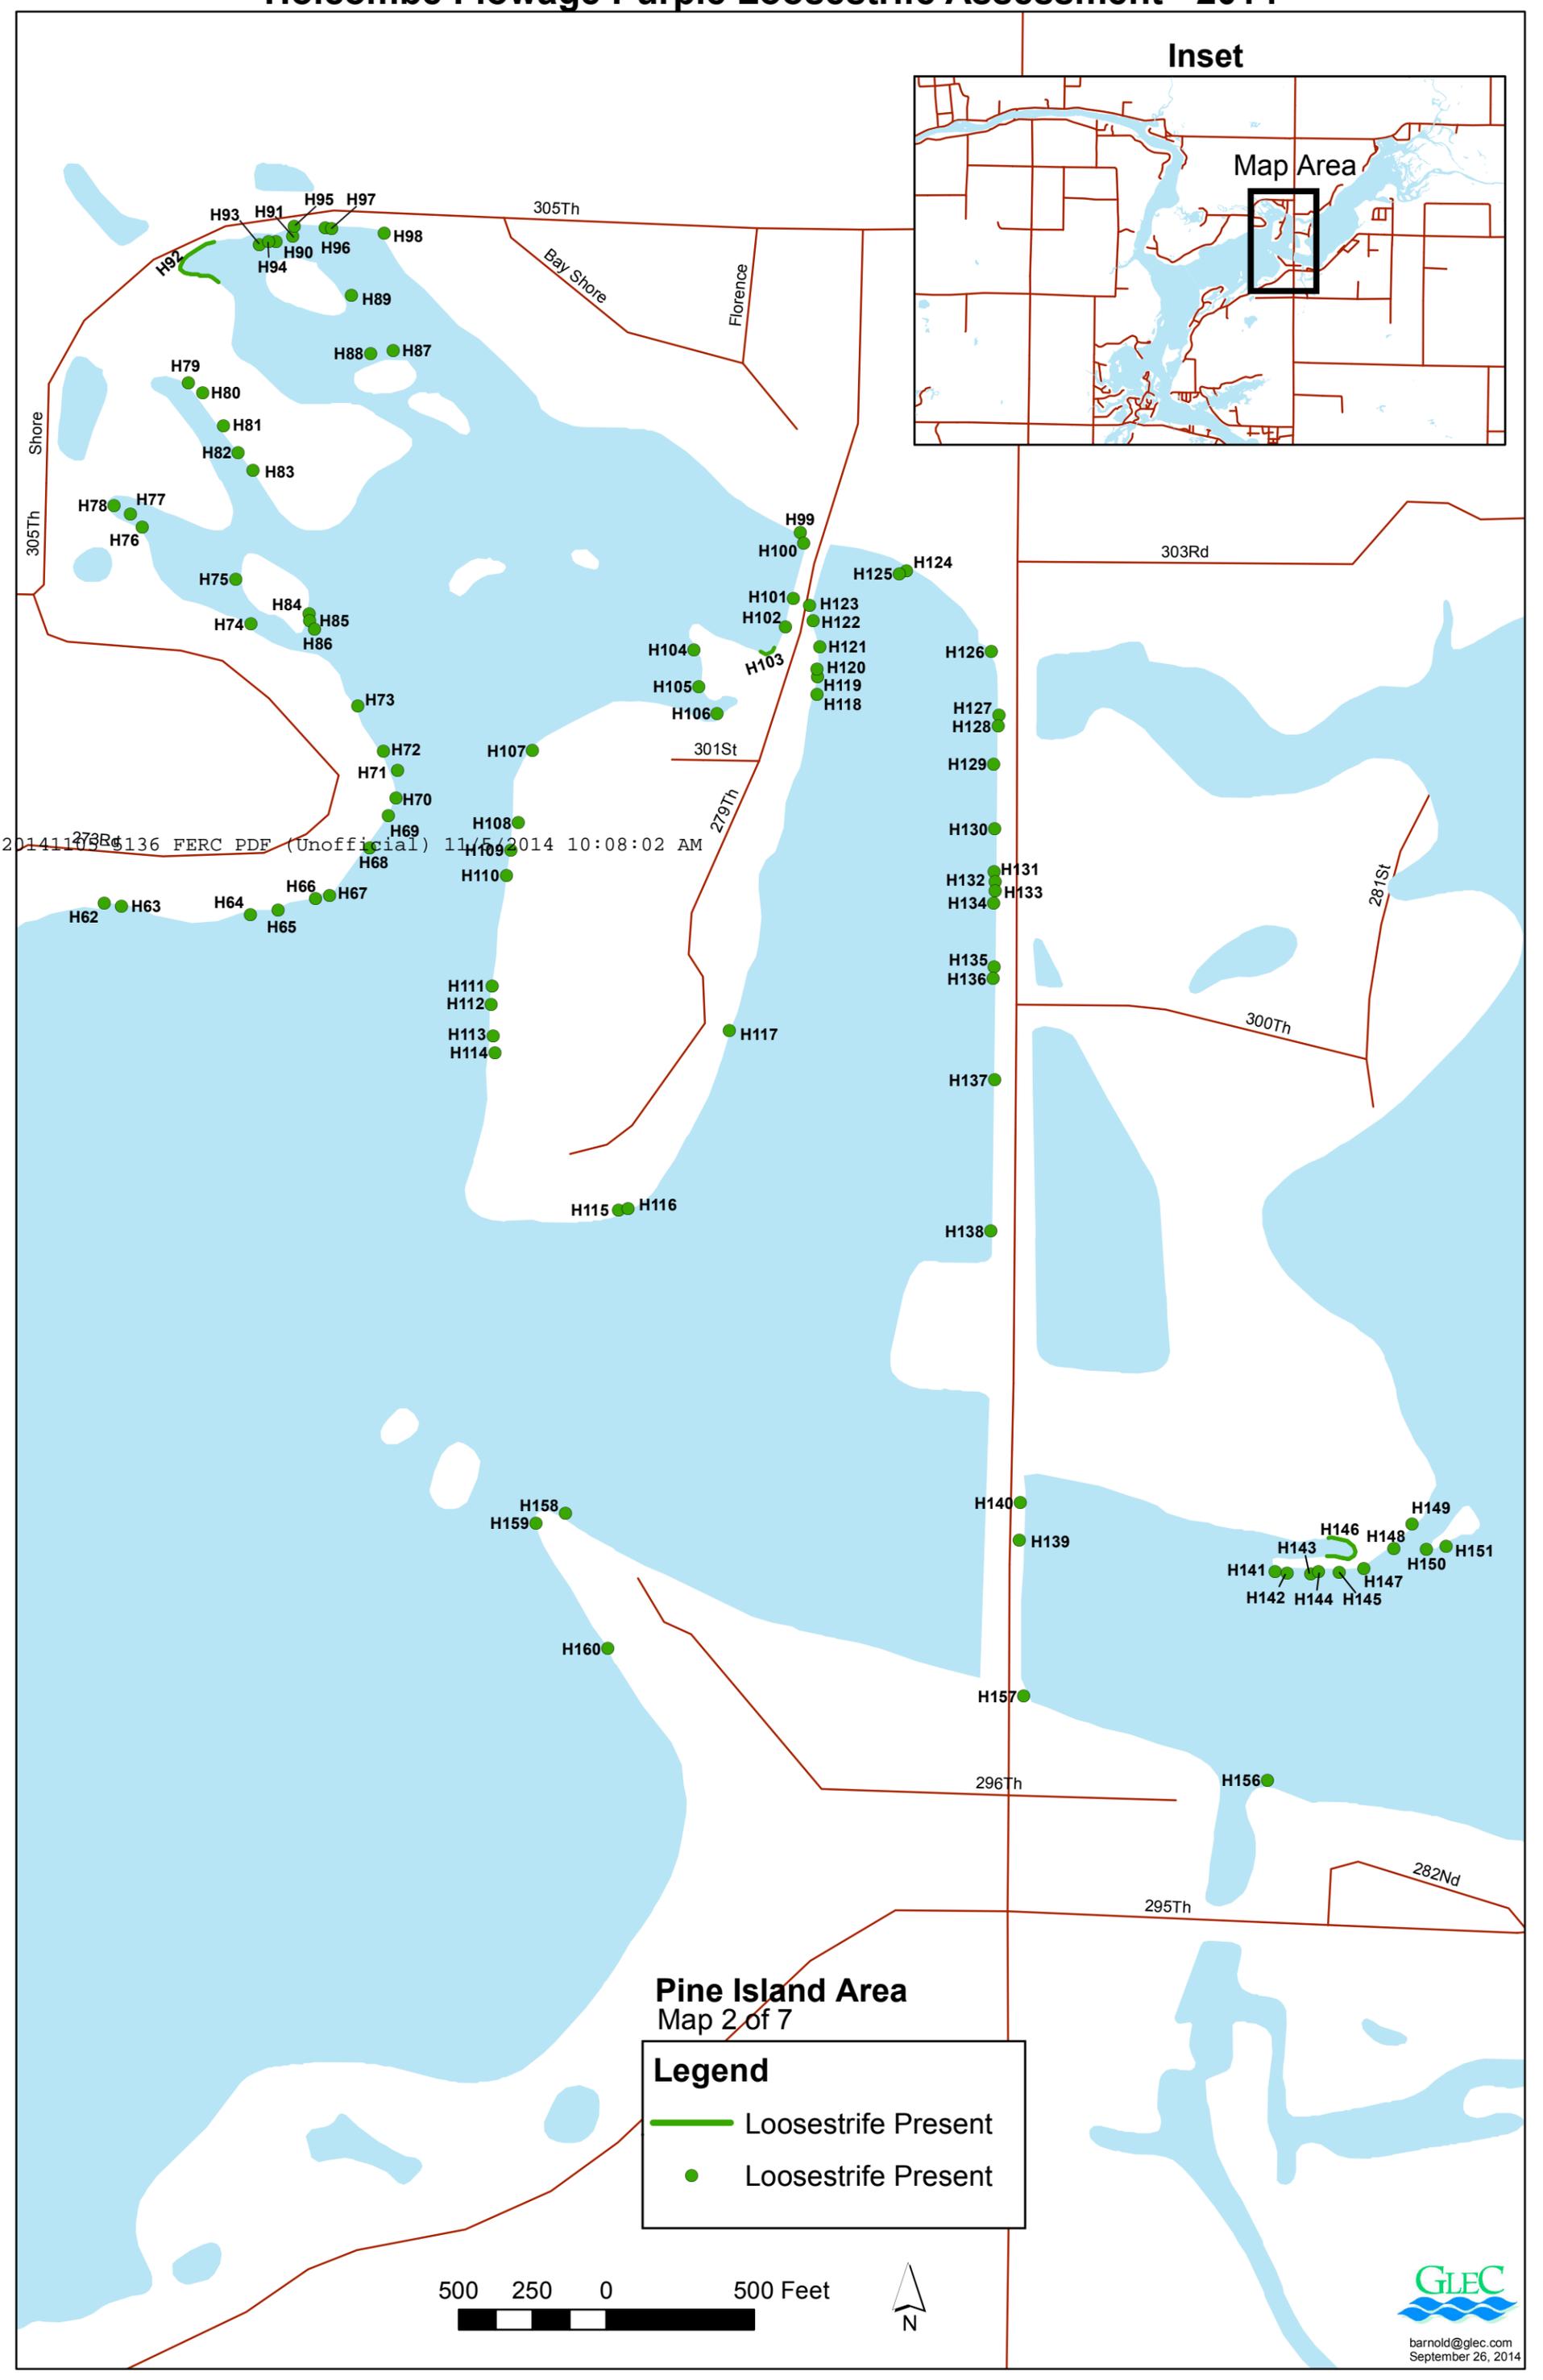
Holcombe Flowage Purple Loosestrife Assessment - 2014

Holcombe Flowage contained the most purple loosestrife among the six impoundments surveyed. There were 185 locations categorized as present and no locations categorized as abundant (see Holcombe Flowage Map 1). Despite the fact that the number of infestations increased from the previous year's survey, the amount of shoreline affected decreased significantly. While a few new plants were found during the survey, the majority of the infested areas have been noted in previous years. New infestation is generally associated with areas where the native vegetation has been disturbed. This disturbance can come from urbanization (clearing for home sites, swimming areas or fishing areas), road improvements, or erosion. It is also common to have plants grow only during select years. This may be the case on Holcombe Flowage, with new plants growing this year, while previously observed plants did not.

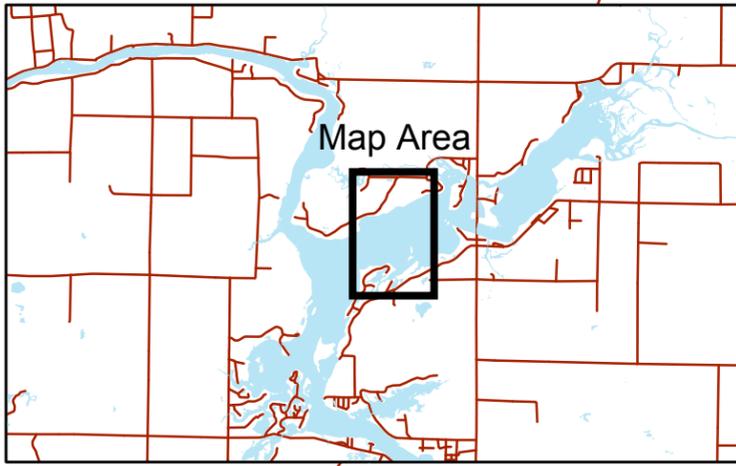
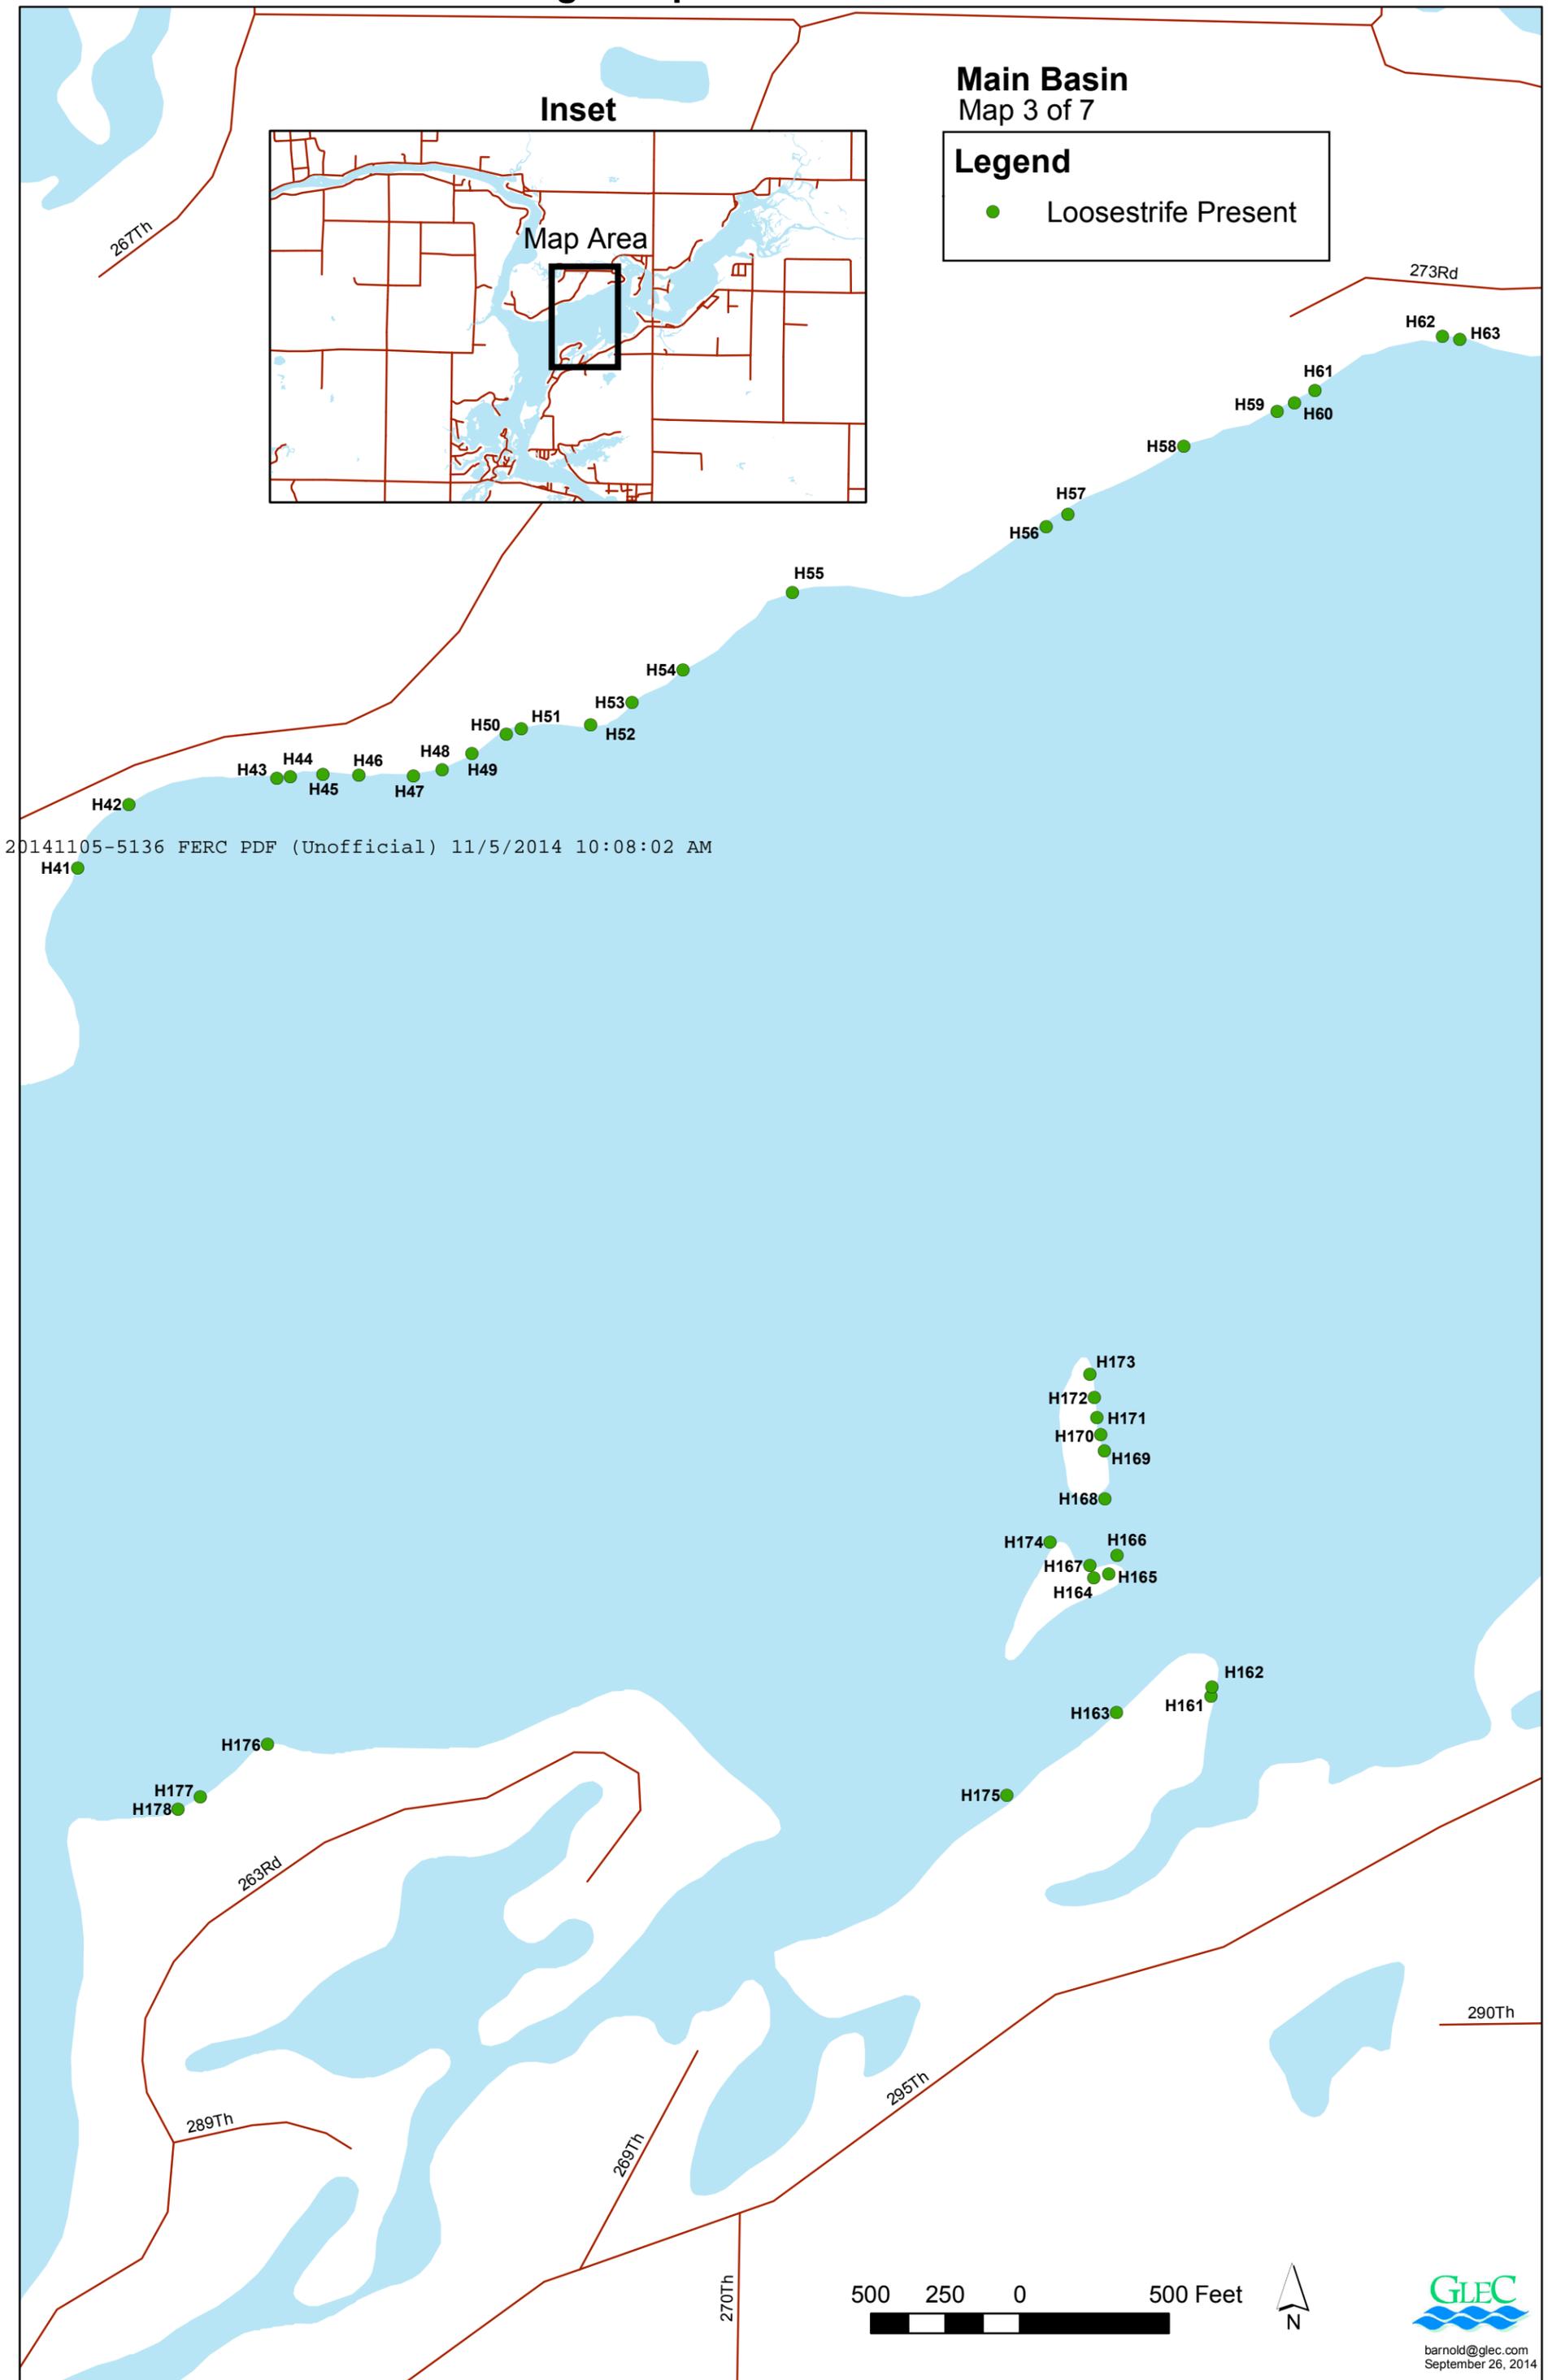
Main Basin
Map 3 of 7

Several plant clumps were found scattered along the north and south shores of the main flowage (see Holcombe Map 3 and 4) with many of these plants having been documented in the past. The large islands near the south shore of the main flowage also contain several plants. Overall, there was a general decrease in plant density in the main basin.

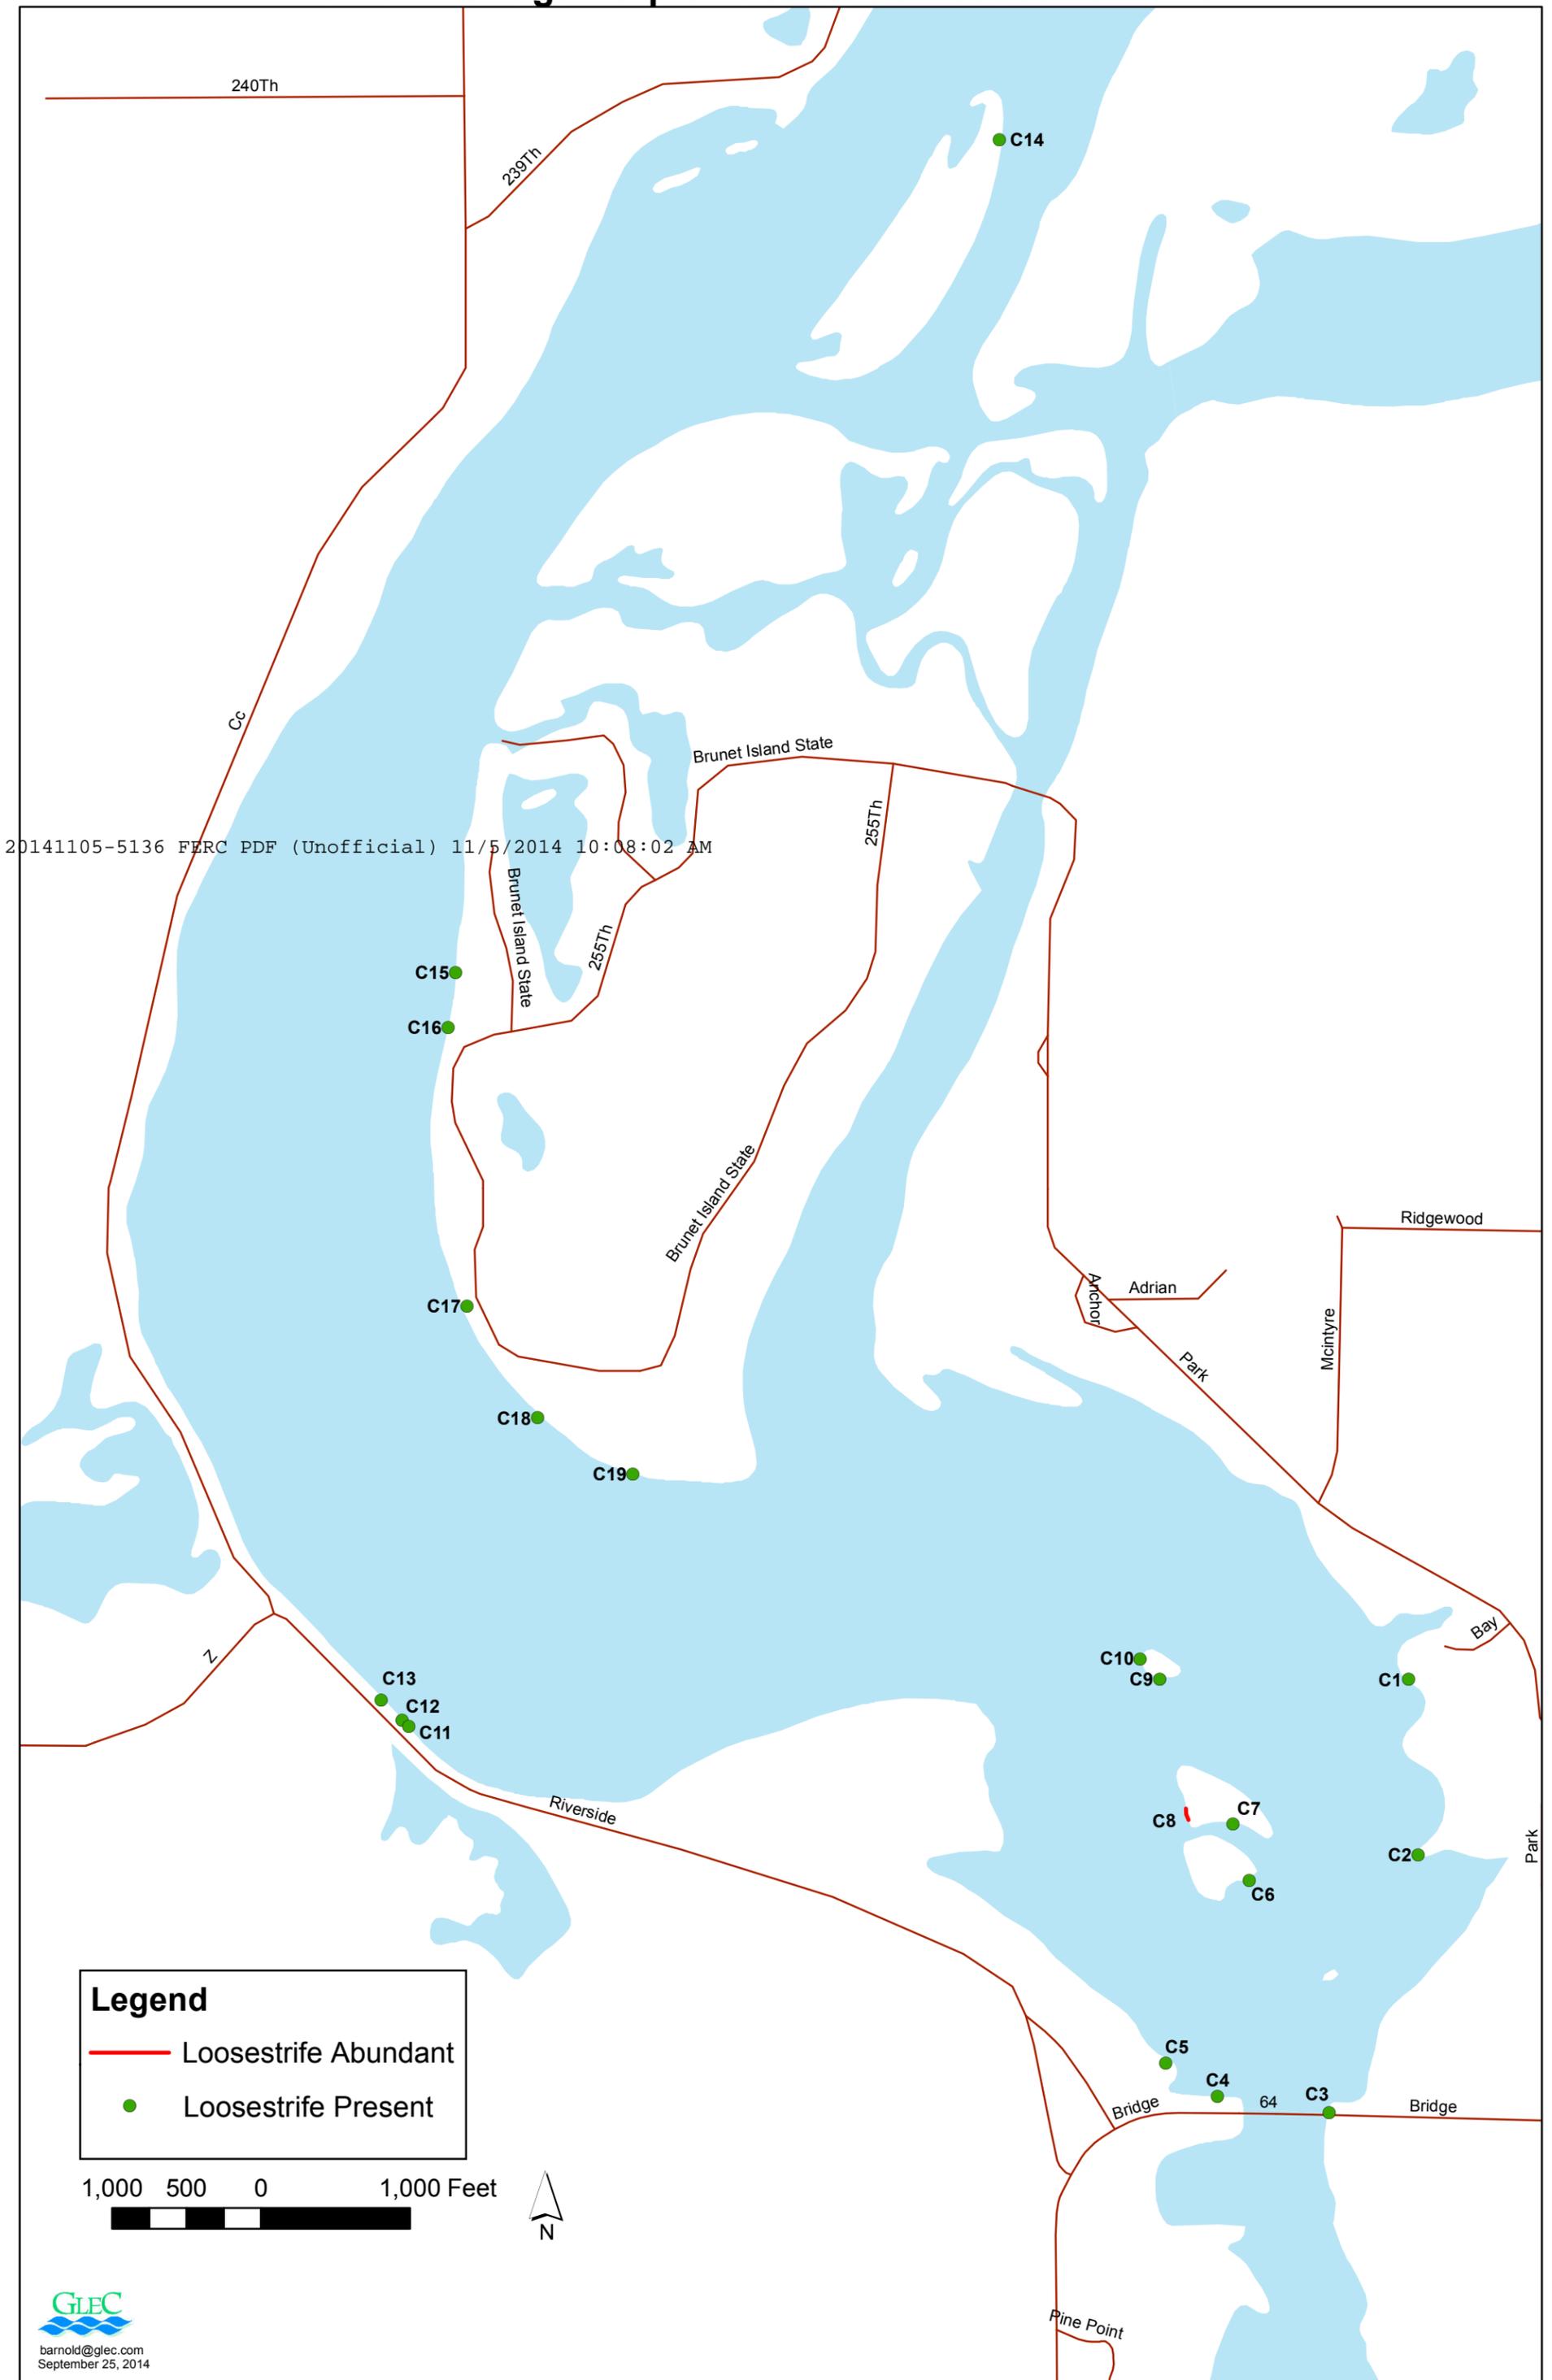
Cornell Flowage Purple Loosestrife Assessment - 2014

Cornell Flowage was found to contain 18 minor infestations classified as present and one location classified as abundant (see map of Cornell Flowage). Many of these locations had been noted in surveys from the last several years. The only area classified as abundant was located in a low lying area on an island just upstream from the State Highway 64 Bridge. This location has been classified as abundant in several previous surveys, including 2012 and 2013. While the overall number of loosestrife locations increased slightly from 2013, the total amount of shoreline affected decreased from 139 feet of shoreline in 2013 to 127 feet in 2014.

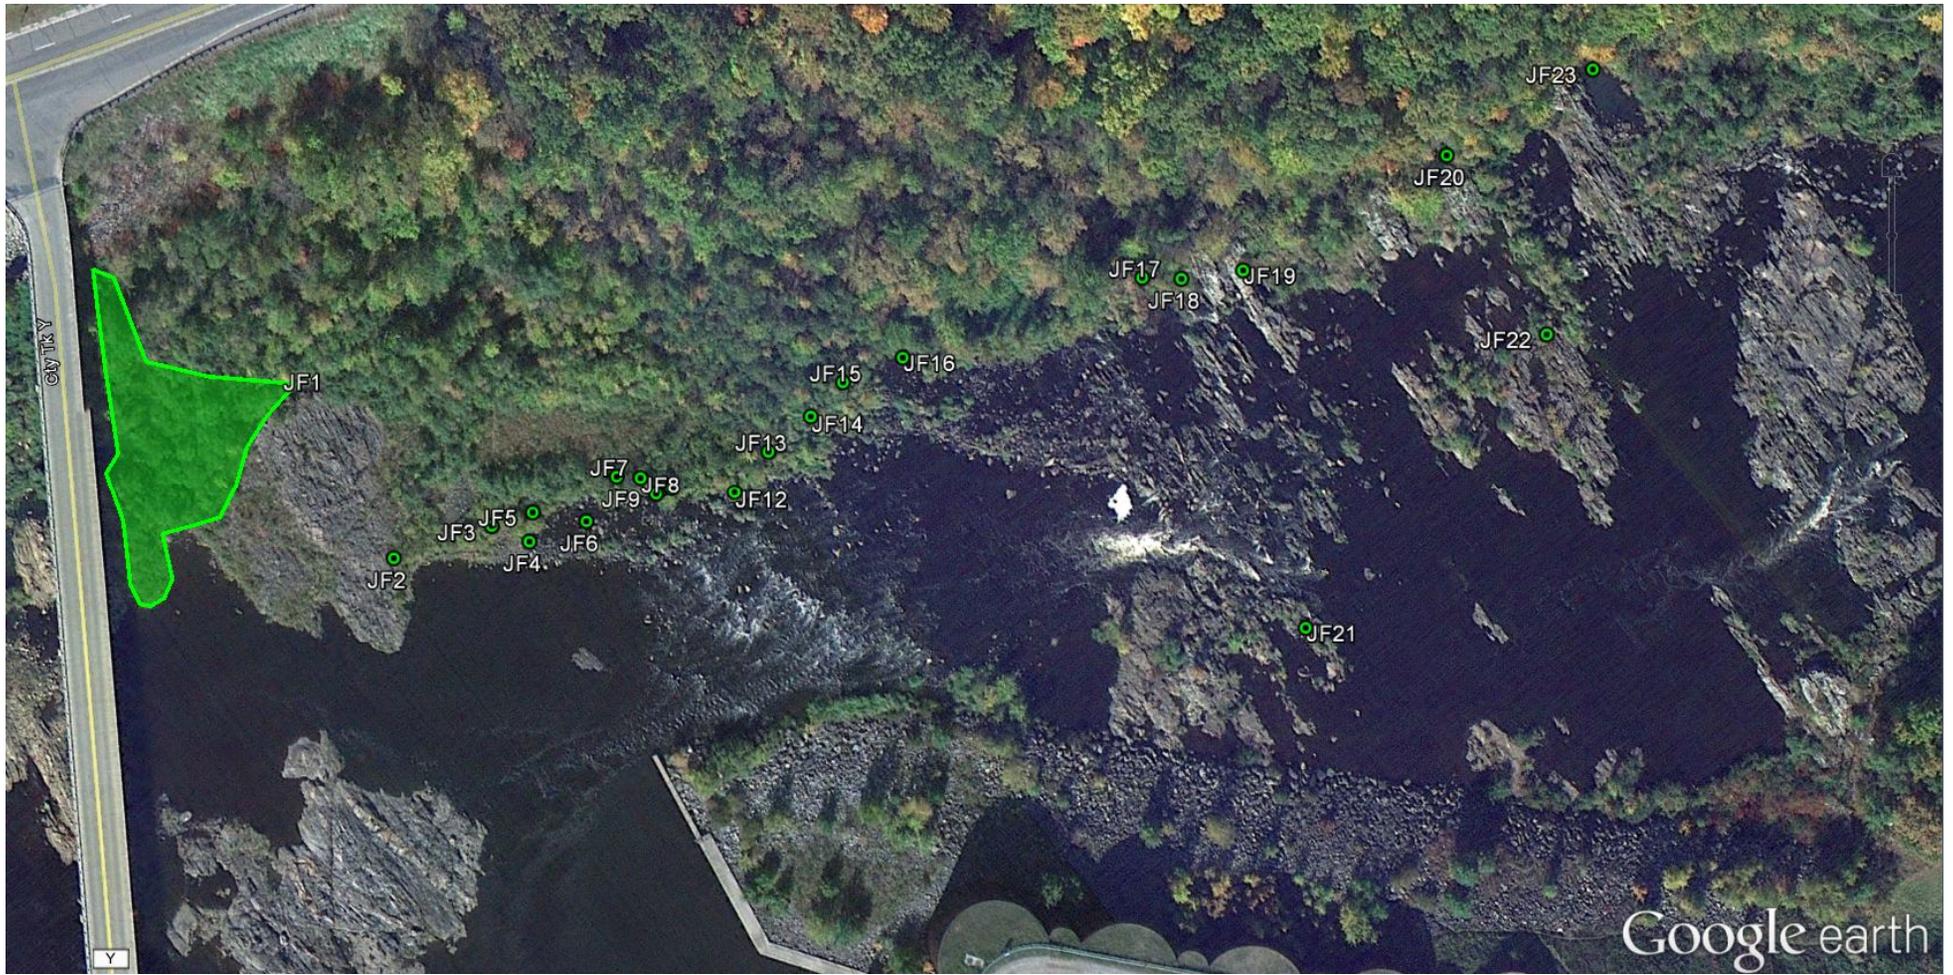
Jim Falls Spillway Channel Purple Loosestrife Assessment – 2014 (Map 2 of 4)

The minimum flow channel at Jim Falls Hydro remains infested with a relatively high concentration purple loosestrife plants. A significant decrease in the number of plants was noted in 2012; however, plant numbers have rebounded somewhat in 2013 and have increased further this year (Table 3). Loosestrife was found scattered throughout the channel, with the lower third of the channel being moderately infested (see maps of Jim Falls Spillway Channel). The area of greatest concentration occurs in the area just upstream from the County Highway Y Bridge (see Jim Falls Spillway map 2). The coverage of loosestrife in this area has decreased from approximately 16,165 square feet in 2013 to 11,064 square feet in 2014 (Table 4). The loosestrife is scattered throughout the area and therefore is not classified as abundant. Small loosestrife locations in both the upper and lower portions of the spillway channel increased slightly in both number and coverage. Overall, the number of loosestrife

locations increased from 36 in 2013 to 42 in 2014. Collectively, these amounted to 239 feet of infested shoreline versus 153 feet in 2013. Most of these locations were comprised of small plant clumps infesting between one and ten feet of shoreline, with a few more significant areas of infestation. Four years have passed since the introduction of the bio-control beetles. While it is still early to make a determination as to their success, the fact that the density of loosestrife in the lower area of the spillway channel is continuing to decrease is encouraging.
