Region NER County Manitowoc Report Date 3/1990 Classification LAL
 Water Body: Pine Creek
 Discharger: Stuck Mfg Corp & Supper Club

Triennial Review

Tim Doelger

On September 11, 1989, three sites were evaluated on Pine Creek in Manitowoc County (see map). An abbreviated field check consisting of photographs, Habitat Rating Form (3200-68), and a data sheet was conducted at each site.

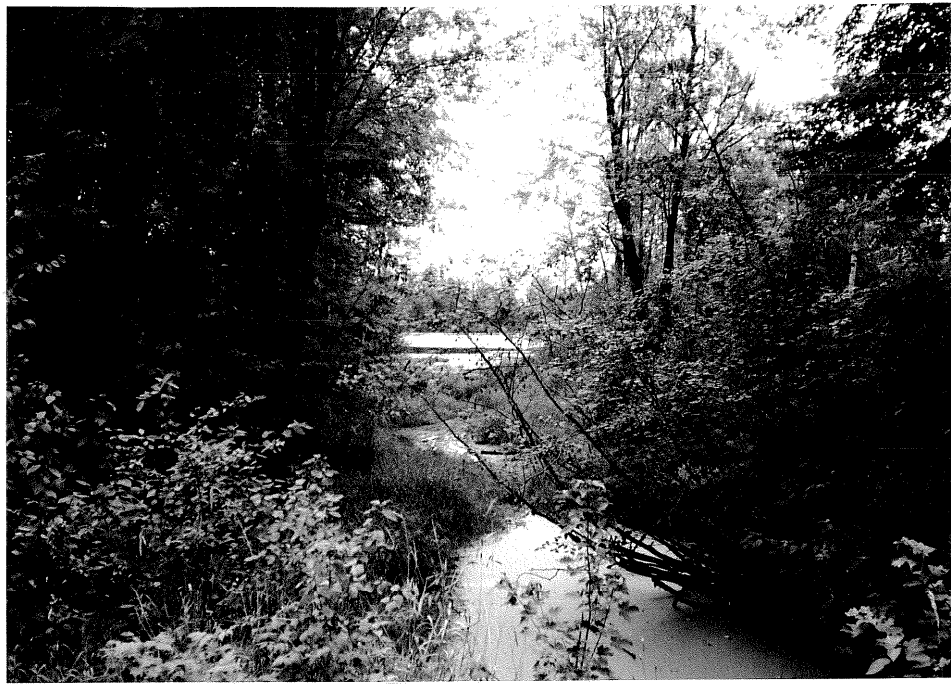
CARSTENS LK. RD.
FACING UPSTREAM

Stream PINE CR Reach Location CARSTEN'S LK RD T.18N, R23E, S4c 21 Reach Score/Rating 231/POOR
 County MANITOWOC Date 9/11/89 Evaluator DOELGER Classification MARGINAL

D.O. _____ TEMP _____ pH _____ AVG WIDTH 5'
AVG DEPTH 4" FLOW MEAS _____ LENGTH OF SEGMENT _____

SLUDGE _____ MUD A MACROPHYTES _____ SLIMES _____
FILAMENTOUS ALGAE _____ LITTER & DETRITUS _____
PLANKTONIC ALGAE A IRON BACTERIA _____ TURBIDITY A
COMMENTS:

AGRICULTURAL S CHANNELIZATION M CONSTRUCTION _____
STORM SEWERS _____ POINT SOURCES _____
COMMENTS:

It is my recommendation that until such time that electrofishing can be performed to determine if forage species inhabit the stream on a continuous basis, that it remain at its current classification.

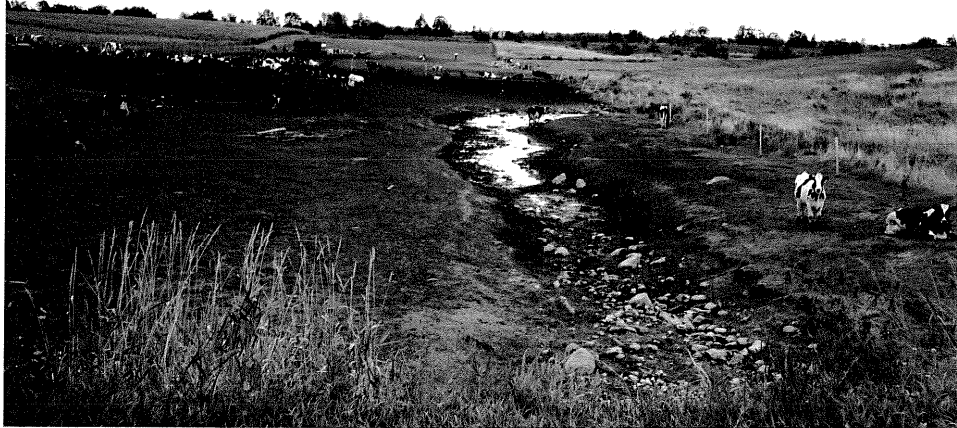
CENTER RD.
FACING DOWNSTREAM

Stream PINE CR Reach Location CENTER RD, T18 N, R 23E, SEC 22 Reach Score/Rating 254/POOR
 County MANITOWOC Date 9/11/90 Evaluator DOELGER Classification MARGINAL

D.O. _____ TEMP _____ pH _____ AVG WIDTH 10'
AVG DEPTH <1" FLOW MEAS 0 LENGTH OF SEGMENT _____

INTENSE PASTURING

AGRICULTURAL X CHANNELIZATION X CONSTRUCTION _____

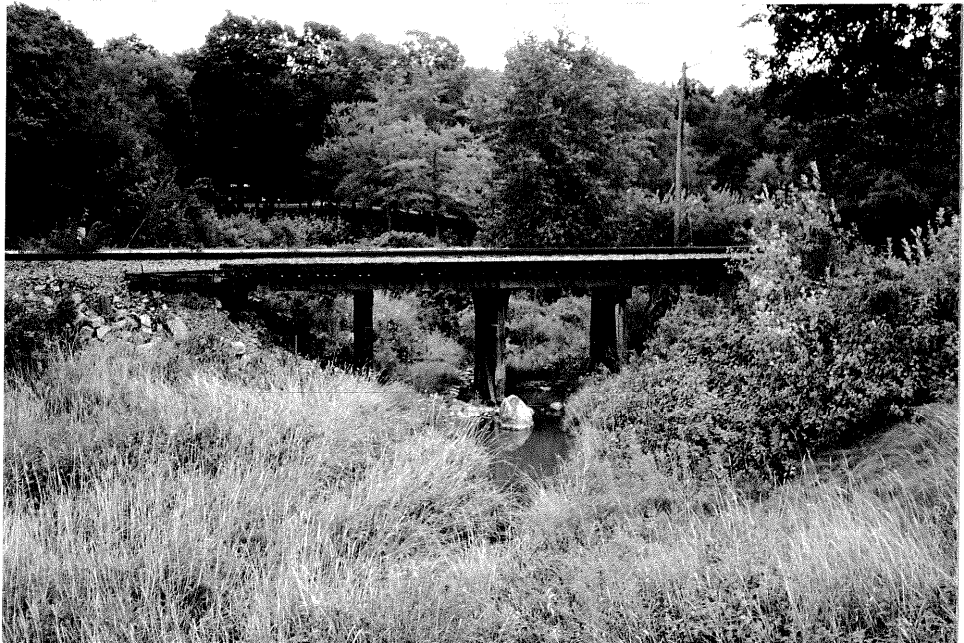
CTH R
FACING DOWNSTREAM

Below CTH R, a tributary enters which adds enough water to provide a continuous flow, but stream morphology and upstream impacts still preclude a balanced community.

Stream PINE CR Reach Location CTH R (OLD 141) T18N, R23E SEC 27 Reach Score/Rating: 205/POOR
 County MARSHWATER Date 9/11/90 Evaluator DOELGER Classification MARGINAL

D.O. _____ TEMP _____ pH _____ AVG WIDTH 5'
AVG DEPTH 6" FLOW MEAS <1 LENGTH OF SEGMENT _____

PLANKTONIC ALGAE _____ IRON BACTERIA _____ TURBIDITY A

AGRICULTURAL X CHANNELIZATION _____ CONSTRUCTION _____

STORM SEWERS _____ POINT SOURCES X
