**LAKE AND WATERSHED ASSESSMENT  
AND MANAGEMENT RECOMMENDATIONS REPORT,  
VOLTZ LAKE,  
NEAR TREVOR, WISCONSIN**

Applied Ecological Services, Inc.  
RR 3, Smith Road  
P.O. Box 256  
Brodhead, Wisconsin 53520  
608 897-8547

Voltz Lake Management District  
22820 122nd Street  
Trevor, Wisconsin 53179

May 15, 1992

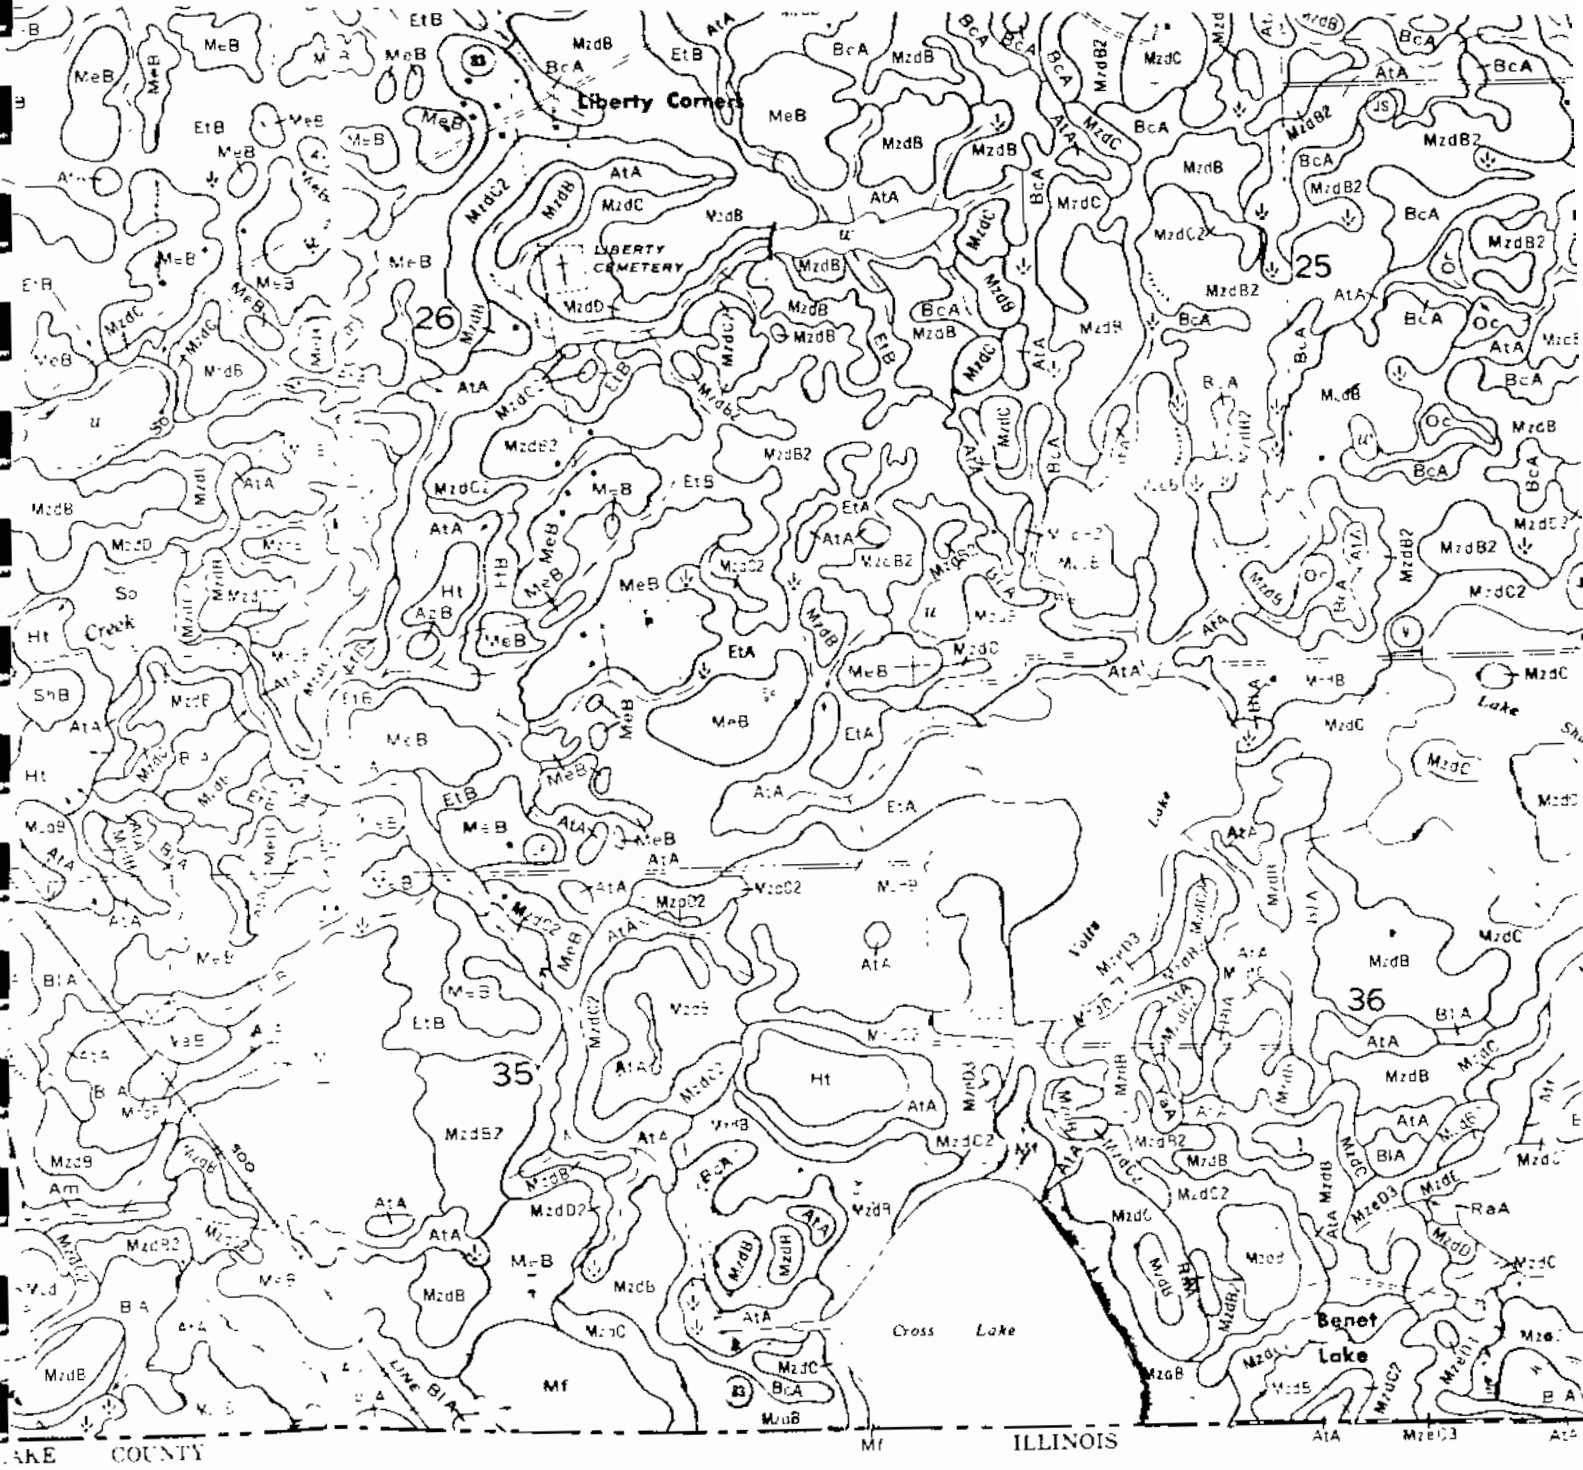
APPENDIX 2. Soils map and description for the Voltz Lake watershed.

Soils present within Voltz Lake watershed.

SYMBOL	SOIL UNIT	CHARACTERISTICS
MzdC	Morley Silt Loam	6-12% slope, moderate erosion, slow permeability
MzdD	Morley Silt Loam	12-20% slopes, found on ridges and knolls, severe erosion hazard
MzdB2	Morley Silt Loam	2-6% slope, eroded, low ridges, moderate erosion potential
MzdC2	Morley Silt Loam	6-12% slopes, eroded, ridges and knolls, moderate erosion potential
Mf	Marsh	Adjacent to lake, ponds, inundated with water at many times throughout year
AtA	Ashkum Silty Clay Loam	0-3% slopes, found on flats and drainageways, very poorly drained
B/A	Blount Silt Loam	1-3% slopes, found along drainageways and in depressions, poorly drained
MzeD3	Morley Soils	12-20% slopes, severely eroded, found on ridges
EtA	Elliot Silty Clay Loam	0-2% slopes, found along drainageways and in depressions, poorly drained
BcA	Beecher Silt Loam	1-3% slope, found along drainageways and in depressions, poorly drained
Oc	Ogden Muck	0-2% slopes, found in marshy areas, very poorly drained

YaA	Yahara Fine Sandy Loam	1-3% slopes, occupies flats, depressions, in lake-laid areas
RaA	Radford Silt	0-3% slopes, depression and wetlands that border eroded slopes, poorly drained
McB	Markham Silt Loam	2-6% slopes, on ridges and knobs, slight erosion hazard

Two soil types dominate the border of Voltz Lake. Morley silt loam dominates the western shore while Ashkum silty clay loam dominates much of the rest of the border (See Appendix 2). Both soils have limitations for development, being poorly drained and having severe erosion potential.

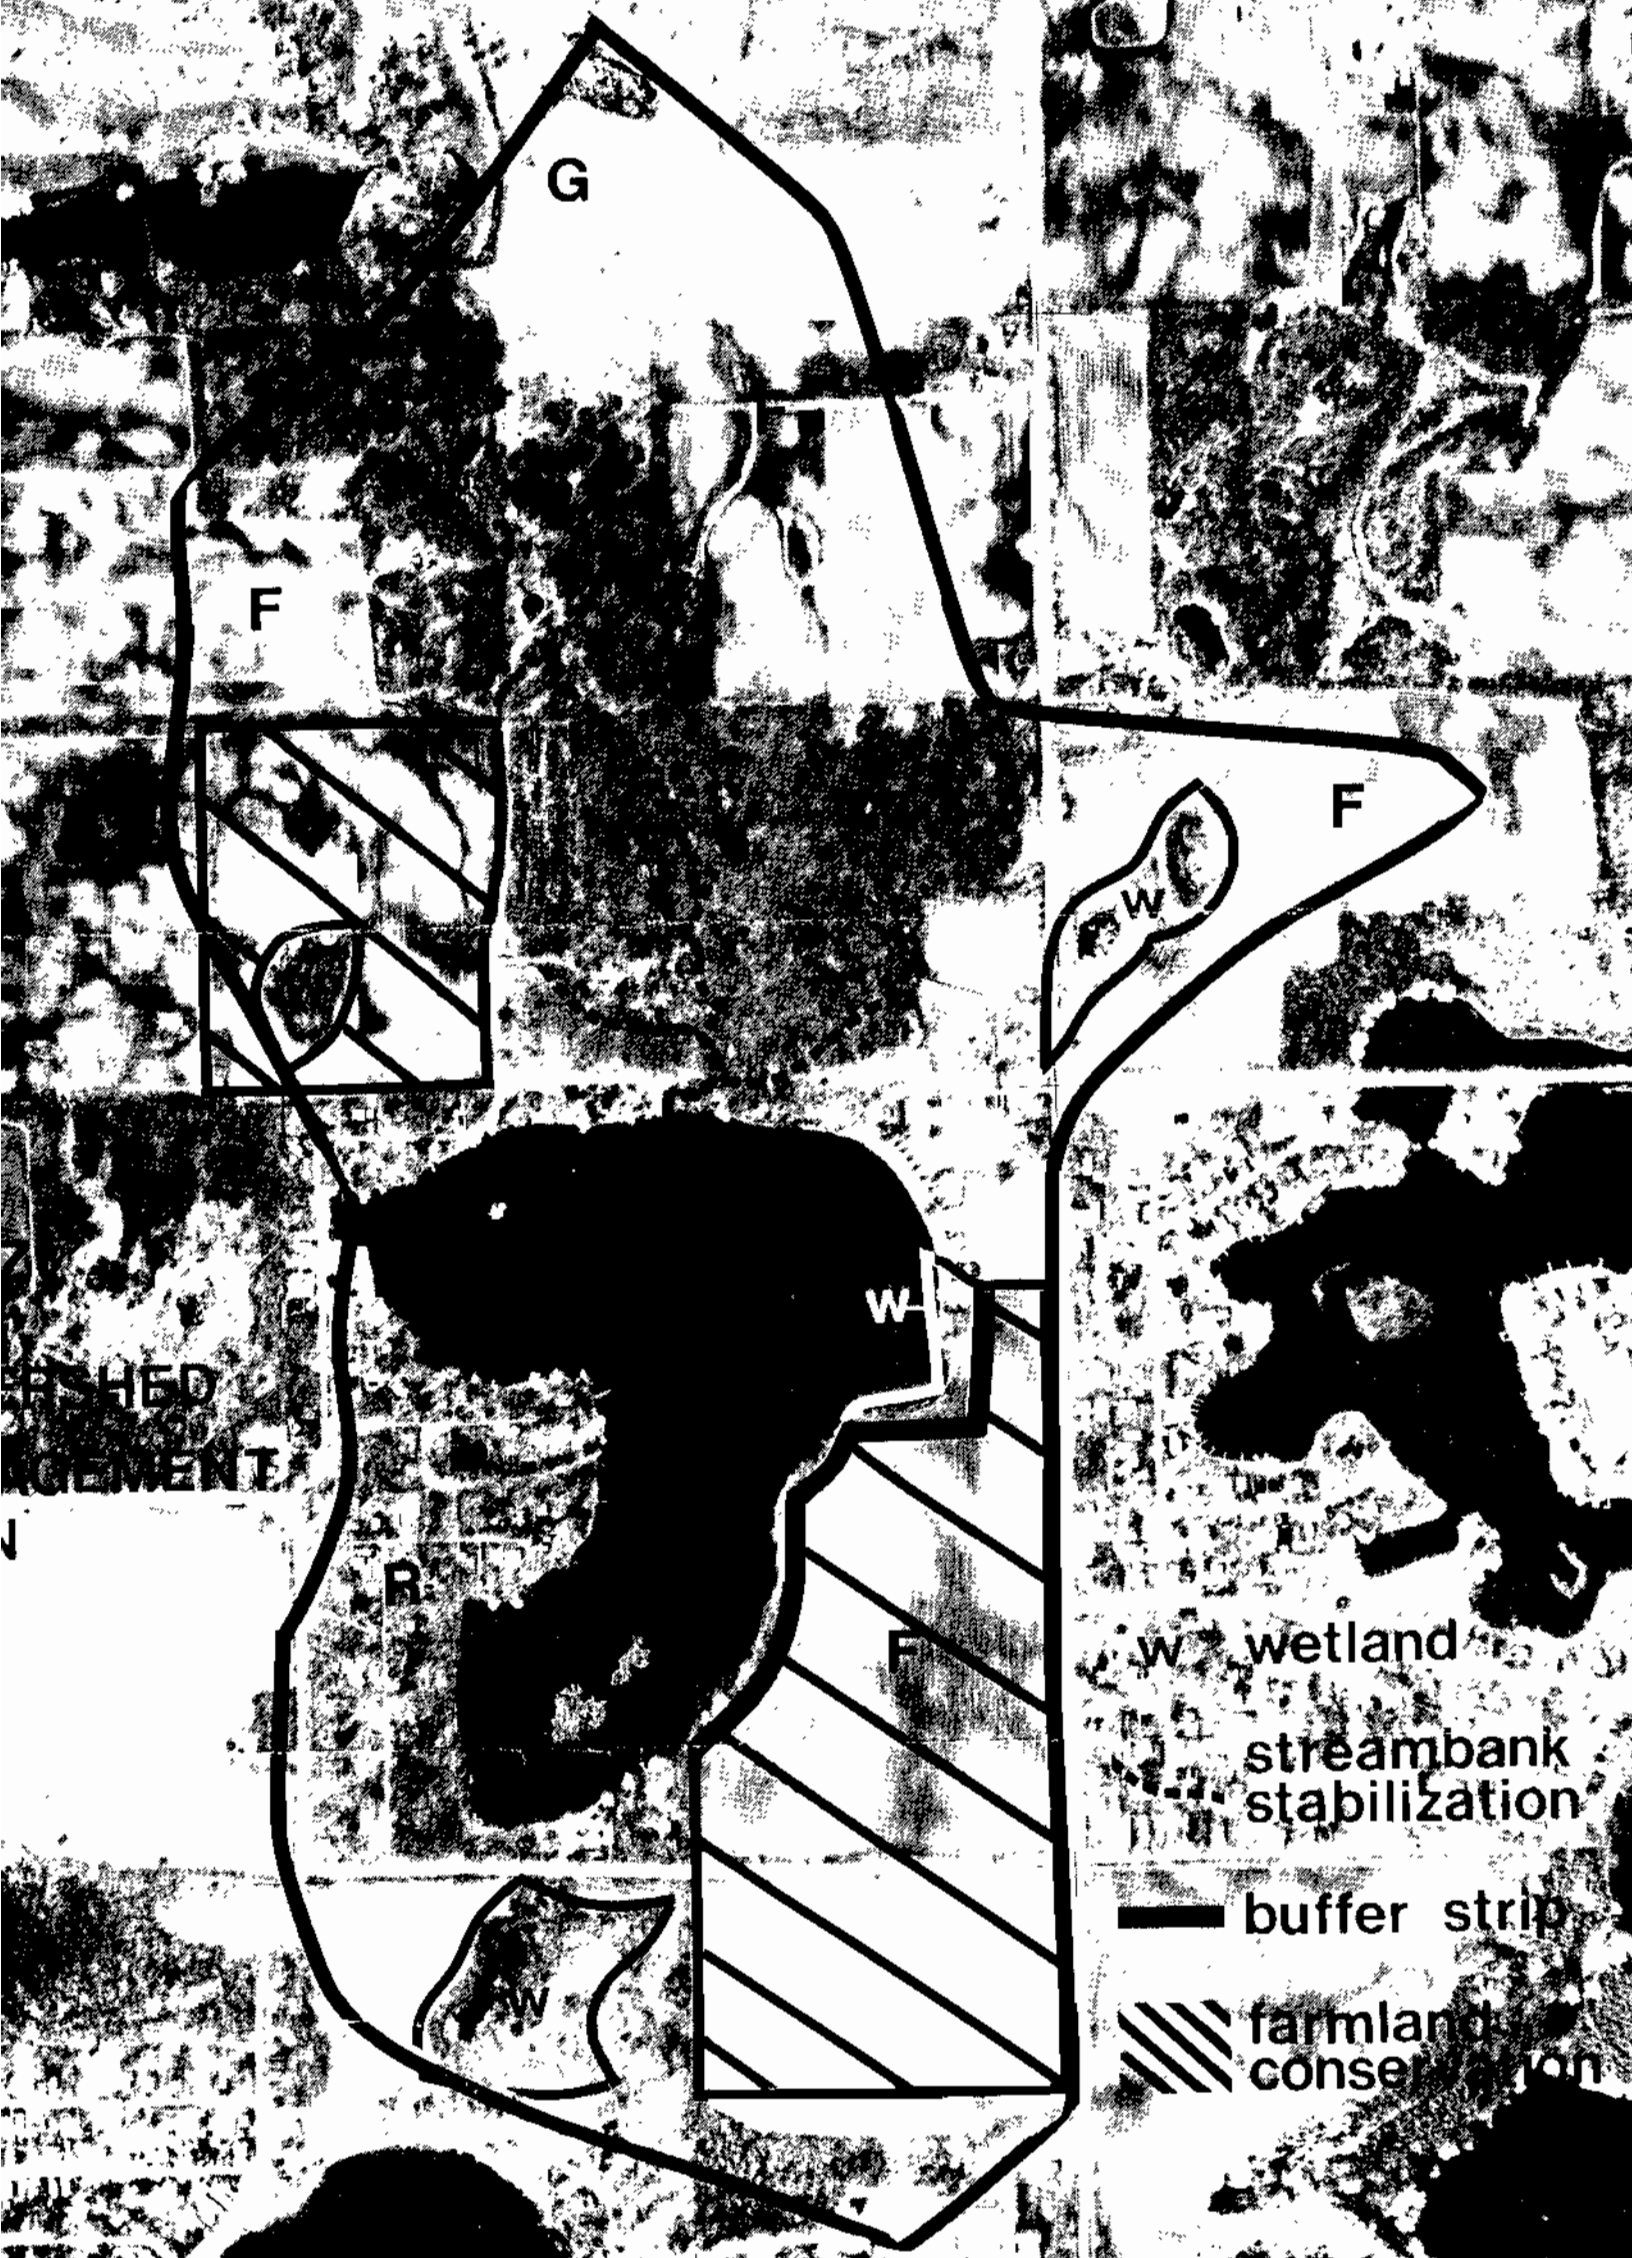
**APPENDIX A. Land use cover map and approximate watershed boundary of Voltz Lake.**

W = Wetland

R = Residential

WATERSHED  
BOUNDARY

- w wetland
- - - streambank stabilization
- buffer strip
- /// farmland conservation

Stream and ditch bank stabilization is a practice which will help reduce sediment loads entering the lakes. The stream channels have been examined and included are specific areas which should be concentrated on (See Appendix 5, Figure 1). The most serious erosion problem appears to be on the stream channel entering the northern end of the lake. Bank instability leads to erosion of the bank during high water flow conditions. Bank instability exacerbated by the invasion of undesirable trees such as box elders, willows, and cottonwoods along with various shrubs and decline of shoreline stabilizing grasses which cannot survive in the dense shade when trees and shrubs invade. Examples of bank stabilization practices follow.

management practices are implemented. We have marked areas on a map (see Appendix 5, Figure 1) where management is recommended.
